# Thermo-Electric Cooler Module Reliability improvement for CT Detector Subsystem

**Mahesh Narayanaswamy and Reinaldo Gonzalez**

GE Healthcare  
Waukesha, WI  
[reinaldo.gonzalez@ge.com](mailto:reinaldo.gonzalez@ge.com)

# Thermo-Electric Cooler Module Reliability Improvement for CT Detector Subsystem

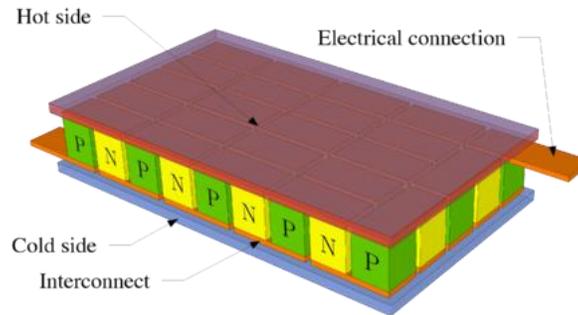
**Figure1. Peltier TEC schematic, ref [1]**

A thermoelectric cooler is a bi-directional device that utilizes the Peltier effect to create a heat flux between the junctions of two types of materials. The primary advantages include lack of moving parts, small size, long life, and a flexible shape. Disadvantages include relatively high cost and poor power efficiency. Due to the electric structure of the PN junction connection, both heating and cooling modes are available by simply changing the bias voltage across the electrode junctions. A schematic of the TEC is shown below:

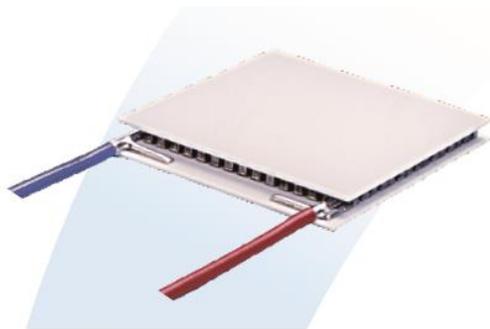
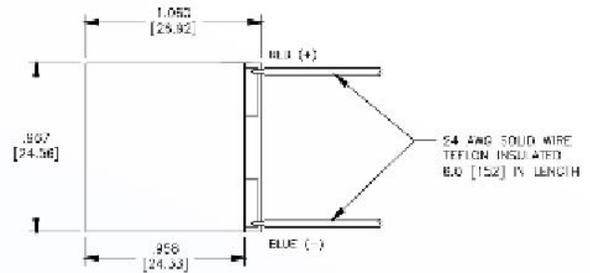
**Figure 2. Product TEC design**

In our application, a specific TEC was selected, primarily due to power and size constraints. A picture and appropriate specification of the TEC selected is shown in Figure 2 below.

Ceramic Material 96% Alumina Ceramics  
Solder Construction: 138°C BiSn

Hot side temperature (°C)	25	50
Qmax (watts)	69	75
Delta Tmax (°C)	69	79
I <sub>max</sub> (amps)	7.9	7.99
V <sub>max</sub> (volts)	14.4	16.2
Module resistance (ohms)	1.678	1.892

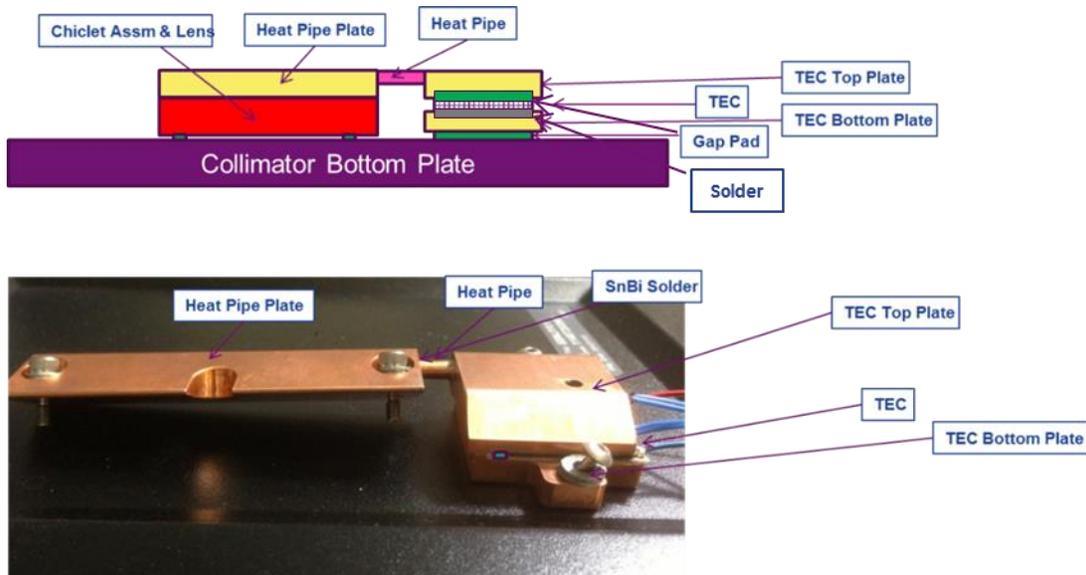
**Figure 3. SSRD TEC Assembly design construction**

In the SSRD design, an integrated TEC assembly is utilized to heat and cool the detector element, herewith referred to as the Chiclet. The TEC assembly includes the TEC element, top and bottom plates that attach to the cold and hot side respectively, a heat pipe and an angle plate that interfaces with the Chiclet. Between the TEC cold side and the TEC top plate (Cu), there is a thermal gap pad. Between the TEC hot side and the TEC bottom plate (Cu), a solder interface exists, that is, the TEC hot side is soldered directly to the TEC bottom plate. Between the TEC bottom plate and collimator (which acts as a heat sink), another thermal gap pad exists. The TEC top and bottom plate are screwed together. The heat pipe serves to transfer the heat effectively from the TEC to the Heat Pipe Plate, which is connected directly to the Chiclet subassembly. A detailed diagram of the SSRD TEC assembly is shown below:

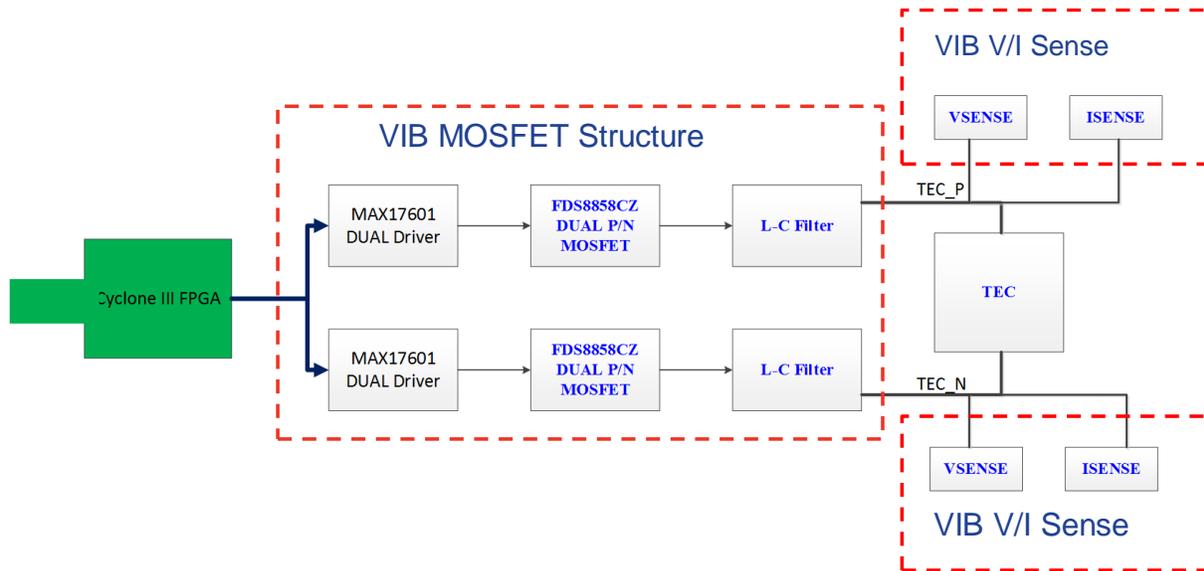
**Figure 4. SSRD Hardware control block diagram of TEC Assembly**

The TEC Assembly is controlled through a PID scheme from an FPGA. Essentially, the FPGA controls a gate driver/MOSFET hardware circuit, which delivers the appropriate voltage to the TEC electrodes, only variable DCV is applied to TEC. In addition, current and voltage sense circuitry can monitor the TEC parameters back to the FPGA. The board which contains this circuitry is known as the Vyper Interface Board, or VIB. The details of the control scheme are outside the scope of this paper, but for completeness, a high-level block diagram of the control hardware is shown.

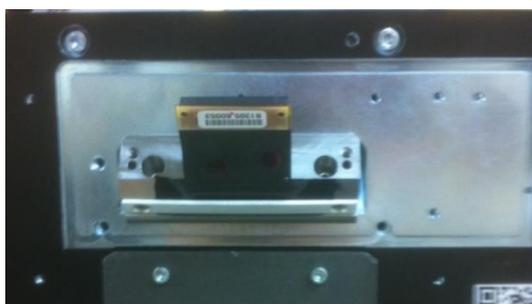
**Figure 5. SSRD Chiclet subassembly**

Lastly, the detector Chiclet subassembly is shown below, assembled into a housing that is bolted onto the collimator bottom plate. This element is responsible for collecting the reference X-ray signal, digitizing the signal, and passing the digital signal to the VIB electronics via the flexible circuit shown.

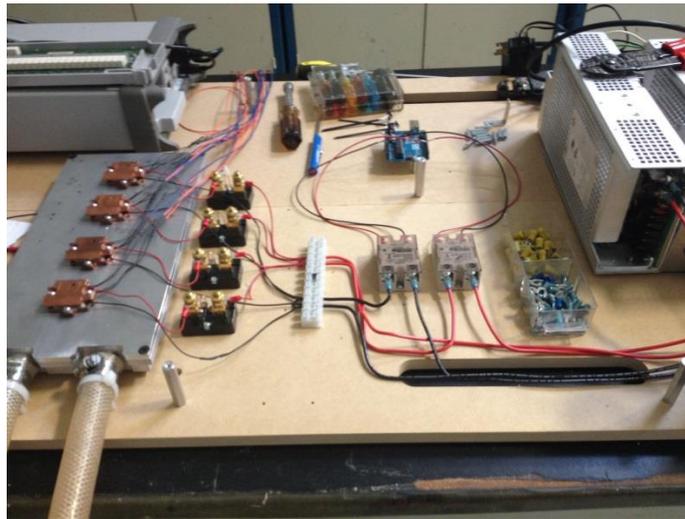
Figure 6.- PTC test set up

Four devices were available for PTC testing. Parts were attached to a large cold plate set at 20C with water circulating to maintain the temperature. The two TEC plates temperatures were monitored as well as the current drawn by means of R-

shunt circuits. A production data logger was used to collect data. Two 5VDC power supplies, two SSRs (Solid State Relays) and a production controller [5] were used to power up the TECs and to change voltage polarity every 3 minutes. A picture of the test set up can be seen in Figure 6. Power supplies were connected in reverse polarity and the production controller timed the corresponding SSRs such that, at all times, only one power supply was connected to TECs. Full current was applied to TECs (~2Amps).

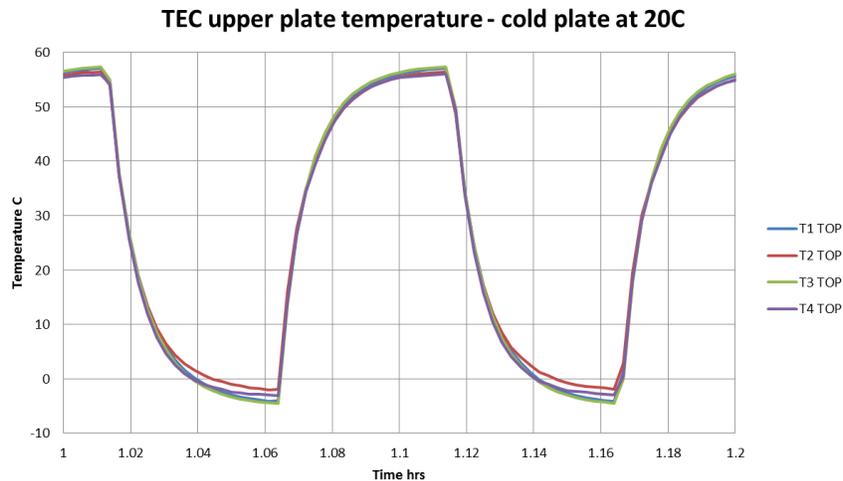
Figure 7.- Load plate temperature

The temperatures seen by the load (upper) plate fluctuates from -5C to 55C (Figure 7), this plate will experience the largest thermos-mechanical stress, having the gap pad as interface mitigates the shear stresses expected. The heat sink is a cold plate connected to a reservoir (heat exchanger) set at 20C. Since we apply full load, the heatsink TEC plate can not follow the cold plate set point, there are transients of ~2 mins, where the temperature drifts by 5 to 10C above/below the set point. After this transient the plate reaches a stable 22C (Figure 8).

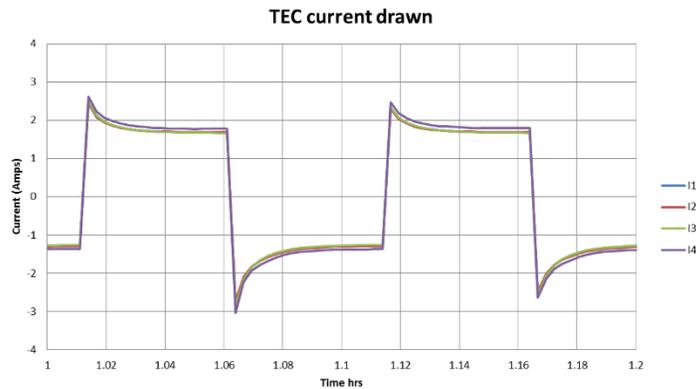
**Figure 9 - Current drawn by TEC**

During this test the current drawn is monitored, Figure 9 is an example. The current profile also has a small transient at the beginning of power cycle transitions, the transient is ~30 sec. During cooling the current draw is 1.8Amps and during heating it is -1.3Amps.

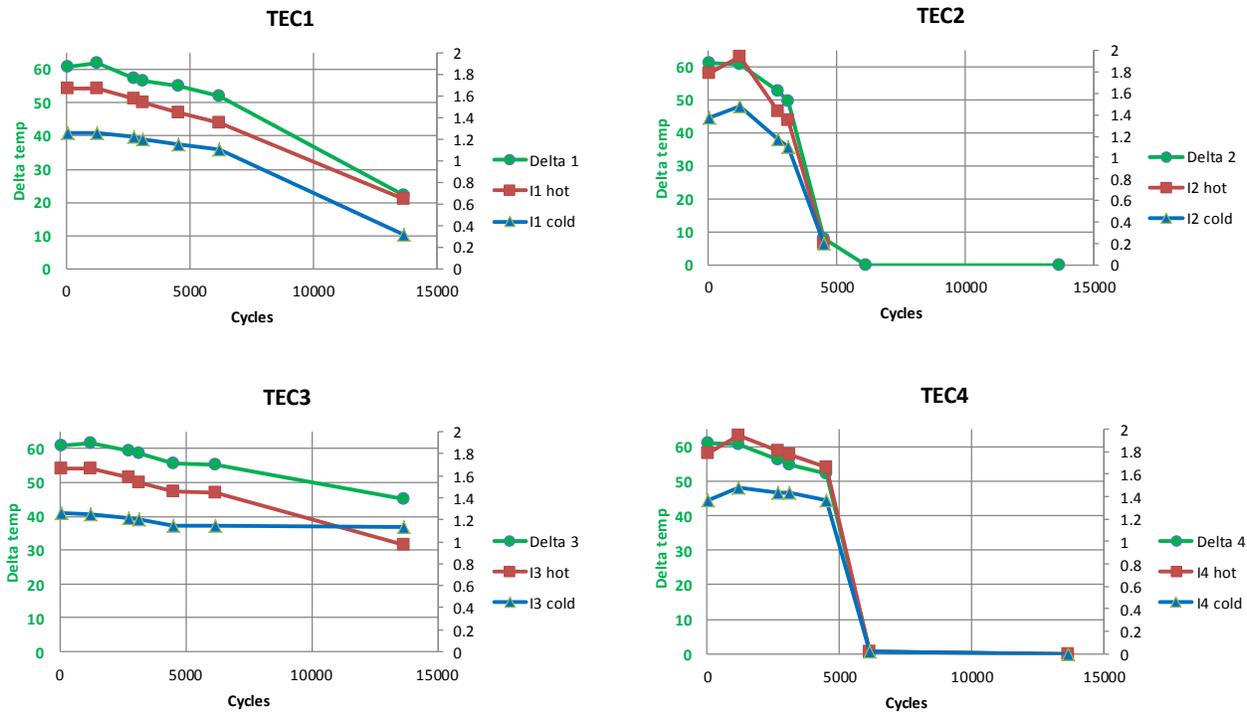
**Figure 10.- Power thermal cycle results on baseline parts**

This data shows that parts cannot survive 5000 cycles. Current draw and delta temperature start to decrease after 2000 cycles for the weakest part. The best part shows decent stability up to 5000 cycles. TEC2 and TEC4 are worst compared to TEC1 and TEC3. TEC1 and TEC3 were covered with thermal insulation during testing. This insulation likely diminished the delta temperature between hot plate and environment, making these TEC's last longer.

The requirement is to pass 7000 cycles. Using binomial distribution, to demonstrate this goal with 90% confidence level, with four parts, we need to run for 38k cycles without failures. The assumption is that life means a B10 of 10yrs (B10 means 90% of parts surviving), so current design is not meeting reliability goal.  
 TEC Failure Root Cause Investigation and Design Change

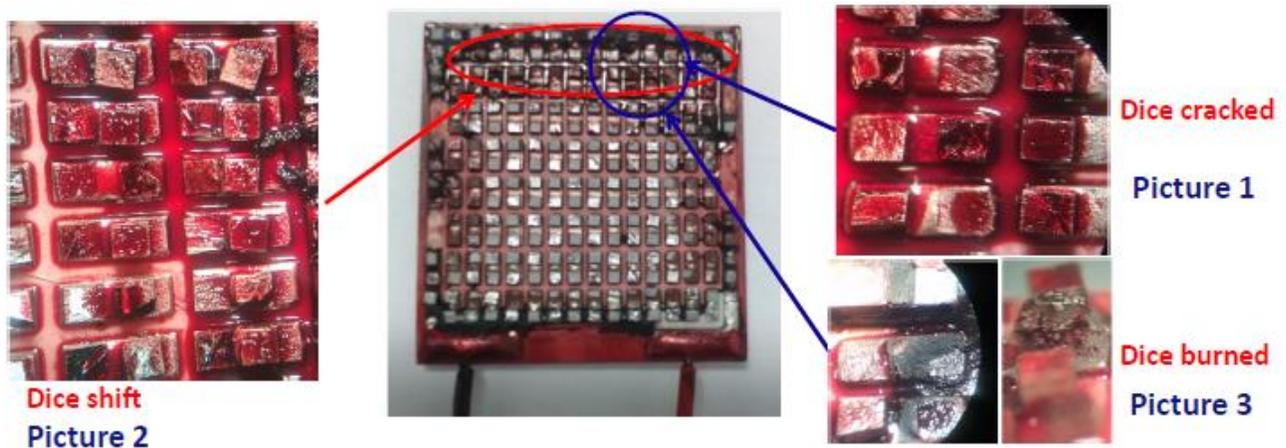
**Figure 13. Internal die inspection**

Some cracked dices surface were pressed red dye as Picture 1 in Figure 13, so these dices have been damaged before prying TEC. These cracked dice will cause high resistance, high current and high temperature. The high temperature will cause solder reflow, dice shifted and dice burned.

Some dices were obvious shifted as Picture 2 in Figure 13.

One dice were serious burned as Picture 3 in Figure 13.

Through these observations, more likely the TEC got damaged by an uneven external force during assembly process. The thermal excursions likely propagated the dice microcracks and eventually caused the resistance increase.

Based on this autopsy/ failure analysis investigation, a design change to the TEC dice solder material was proposed. The new solder is a high temperature solder material that would withstand the high thermal excursions. Samples with the new solder material were created by the vendor and given to the company for further cycling.

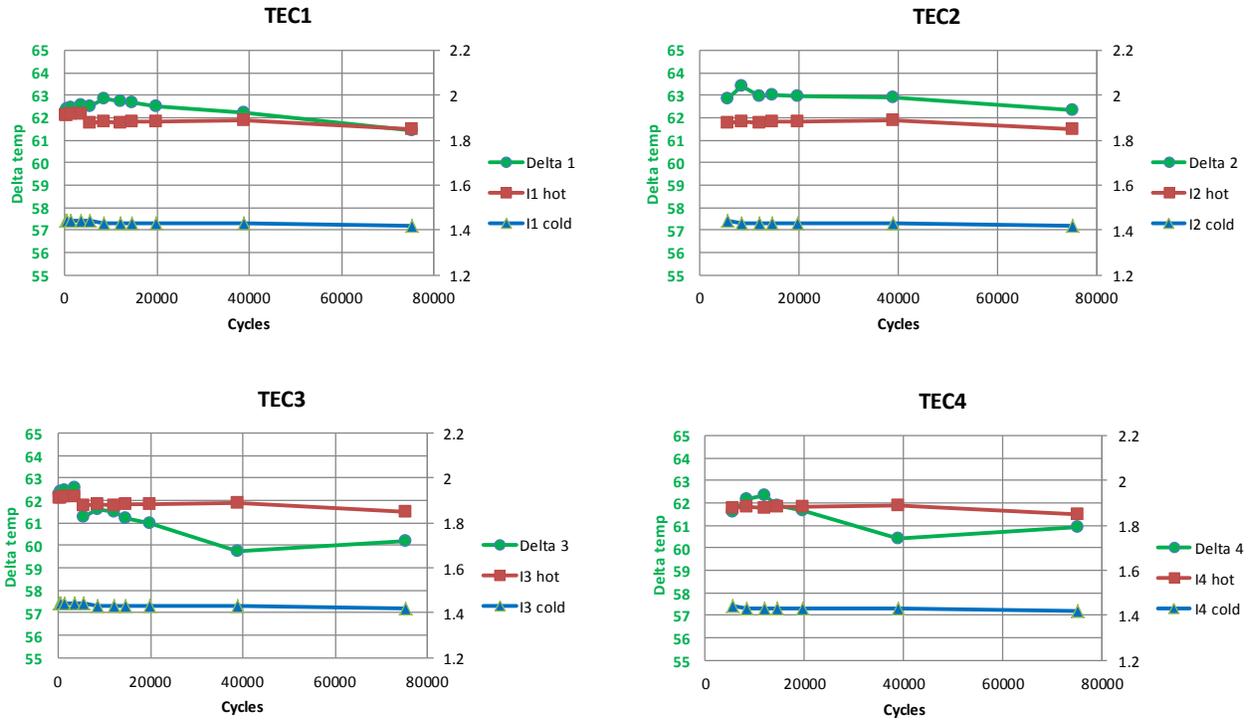
Figure 14.- PTC results with high temperature solder

The PTC data on high temperature solder TEC's shows great improvement. No current degradation up to 80 thousand cycles, with parts still under test beyond this cycle count. Only two degrees Celsius degradation on delta temperature, with TEC3 and TEC4 showing higher degradation since these modules are not thermally insulated.

The reliability goal is to demonstrate a B10 of 10yrs with 90% confidence level. As indicated before to achieve this goal, we need to pass ~40k cycles. B10 means that 10% of parts can fail in 10 years, 10 years means 7k cycles. With this high temperature solder, we met and exceeded this goal.

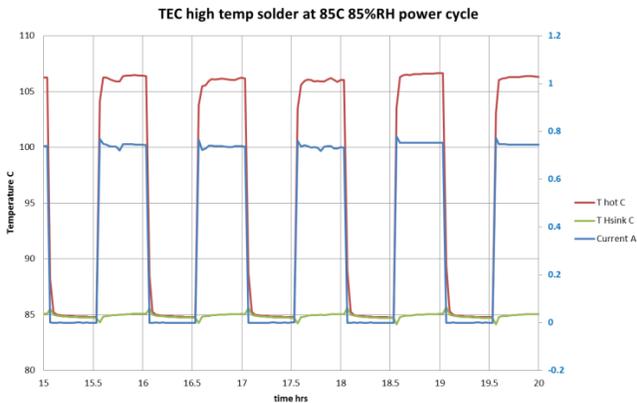
Figure 15.- Initial data (time ~0hrs)

Practically no change in current drawn was observed up to 970 hours. The only difference observed at the end of the test is that a current spike transient was now present.

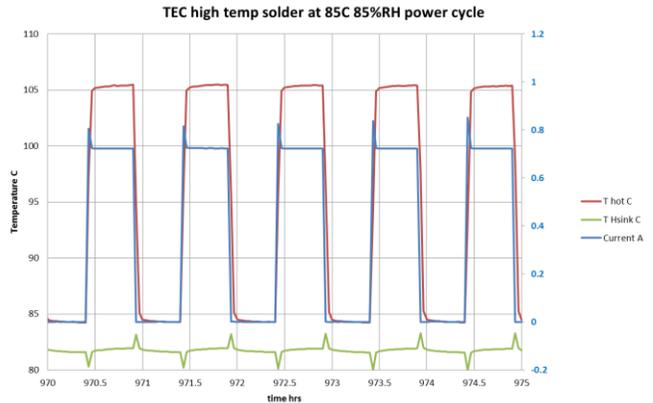
Figure 16.- Final data (time ~1000hrs)

The delta temperature of the hot plate decreased a little, initially the delta temperature was 22C, at 970hr the delta was 21C, so some small degradation was observed.

We observed a temperature drift on the heatsink thermistor. At end of test the temperature sensor was reading 3C lower than the chamber temperature. This may be due to the temperature difference being driven by a cracked thermistor.

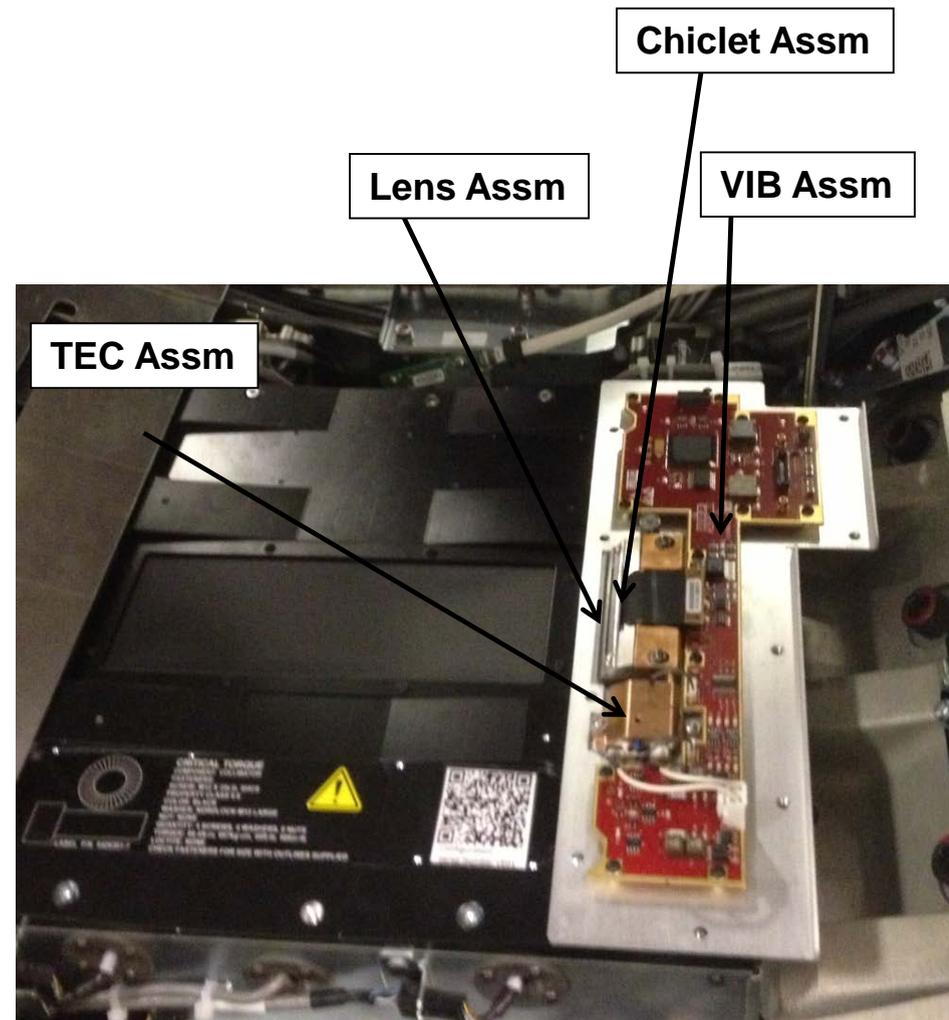
- SSRD – external detector close to X-ray source that measures key X-ray tube parameters and is also the main reference normalization signal for the imaging detector
- TEC Assembly – Responsible for active heating cooling of the SSRD detector element.

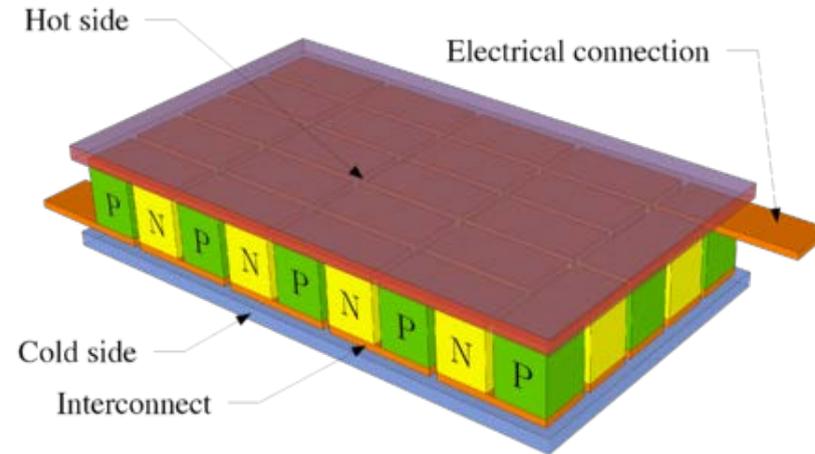
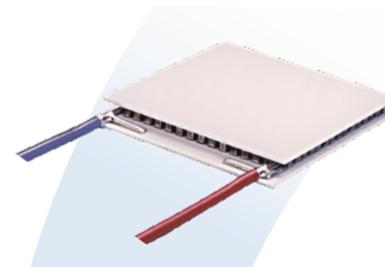
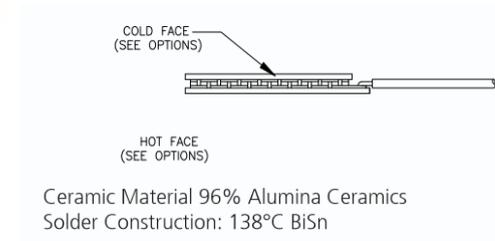
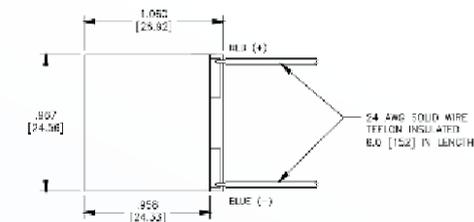
- Thermo-Electric Cooler
  - Bi-directional device that utilizes the Peltier effect to create a heat flux between the junctions of two types of materials.
  - The primary advantages include lack of moving parts, small size, long life, and a flexible shape.
  - Disadvantages include relatively high cost and poor power efficiency. Due to the electric structure of the PN junction connection
  - Both heating and cooling modes are available by simply changing the bias voltage across the electrode junctions
  - Key parameters include Qmax, Delta Tmax, and Module resistance.
- TEC selected for SSRD application was optimized for Qmax, voltage operating range and physical size.

PERFORMANCE SPECIFICATIONS		
Hot side temperature (°C)	25	50
Qmax (watts)	69	75
Delta Tmax (°C)	69	79
I <sub>max</sub> (amps)	7.9	7.99
V <sub>max</sub> (volts)	14.4	16.2
Module resistance (ohms)	1.678	1.892

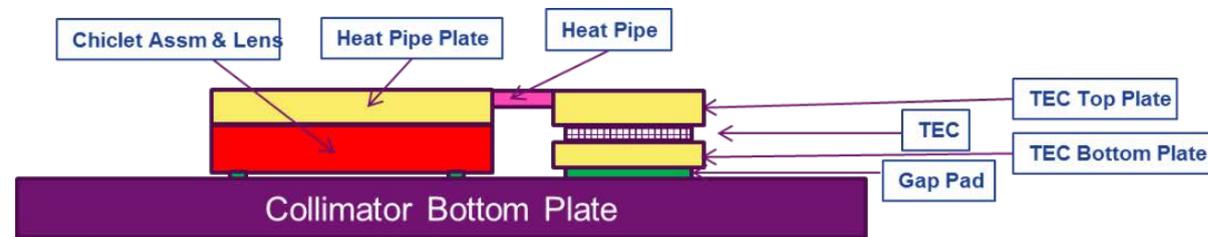
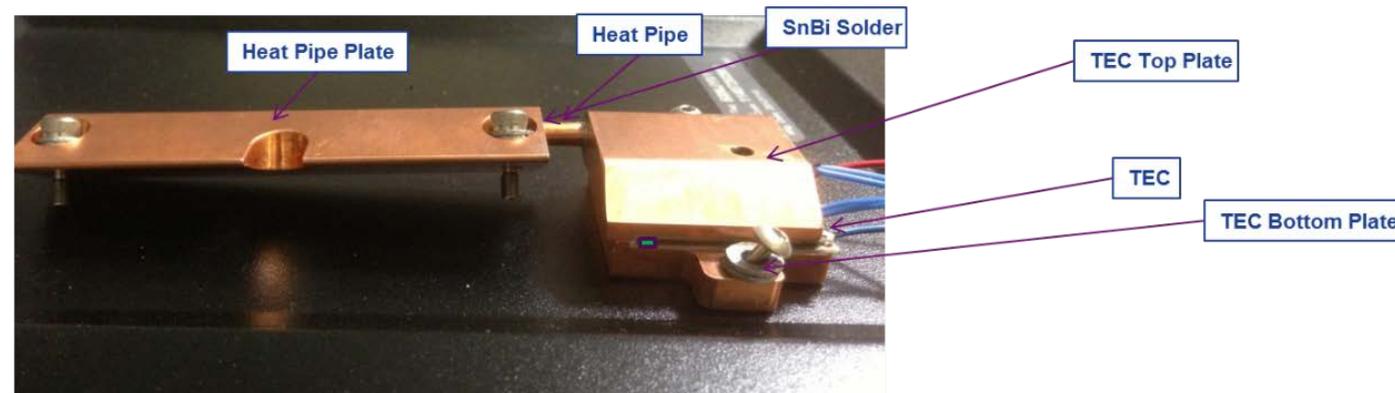
- TEC Assembly for SSRD subsystem: Key Components
  - TEC
  - TEC Top/Bottom Plate – allows conduction from TEC to Collimator plate (sink) and to Detector element
  - Heat Pipe – heat transfer between TEC top plate and Heat Pipe plate
  - Heat Pipe plate – main interface to Detector element
  - Other consummables (gap pads and solder) are used between various TEC interfaces.
  - Key components (Top/Bottom Plate, Heat Pipe, Heat Pipe plate) made out of copper for optimal conduction

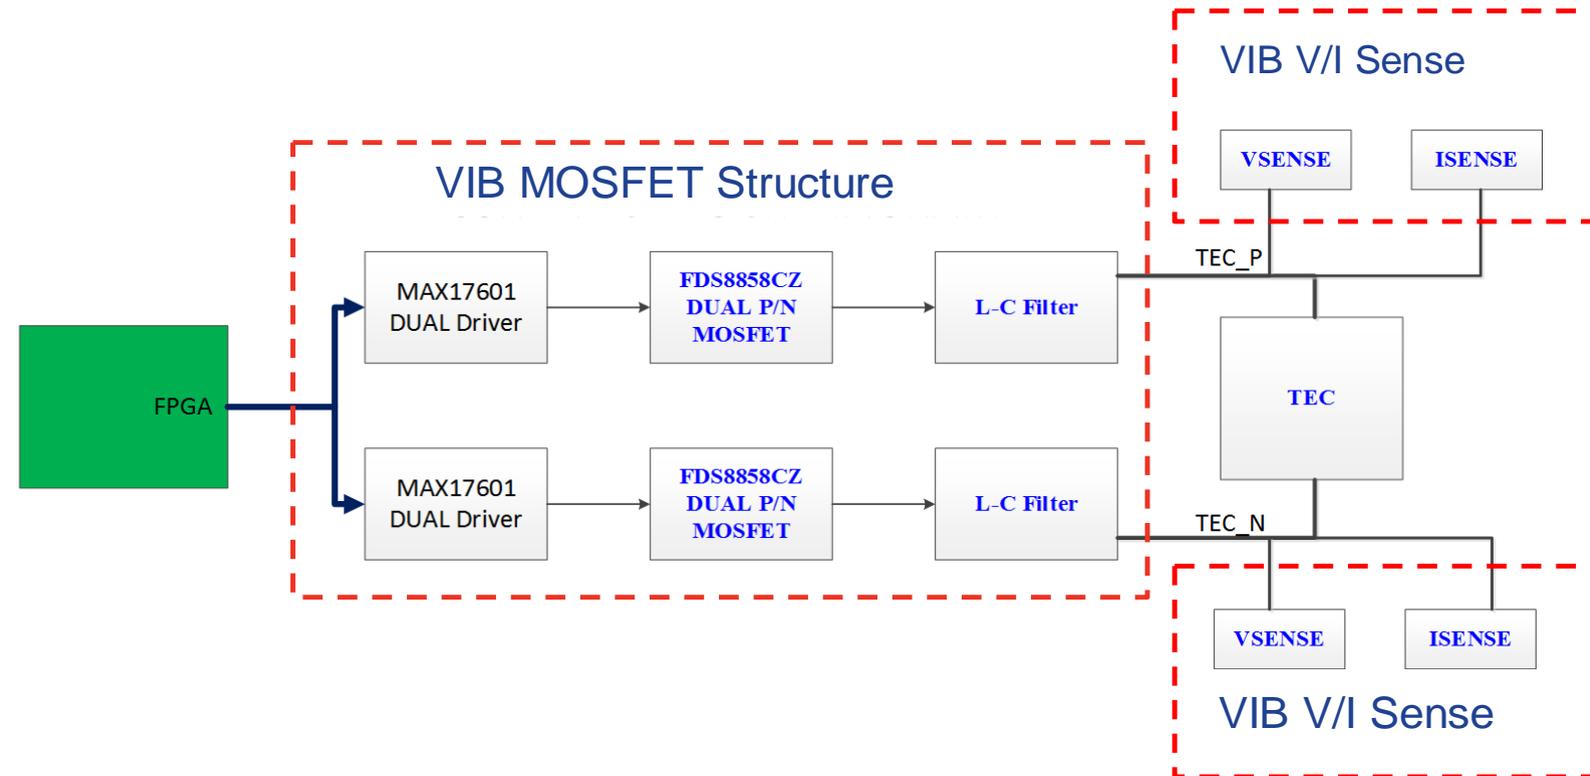
- Hardware Control Overview
  - FPGA control based (PI scheme)
  - FPGA PWM output signals feed into driver circuit – supplies current for MOSFETs
  - 2 Dual P/N MOSFETs used to create H-Bridge topology to TEC
  - L-C Filter at output of MOSFETs used to filter PWM signal to DC level
  - TEC accepts DC voltage between 0V and 6V, TEC current varies from 0A to 3A max
  - Voltage and Current sense circuitry used to monitor TEC parameters

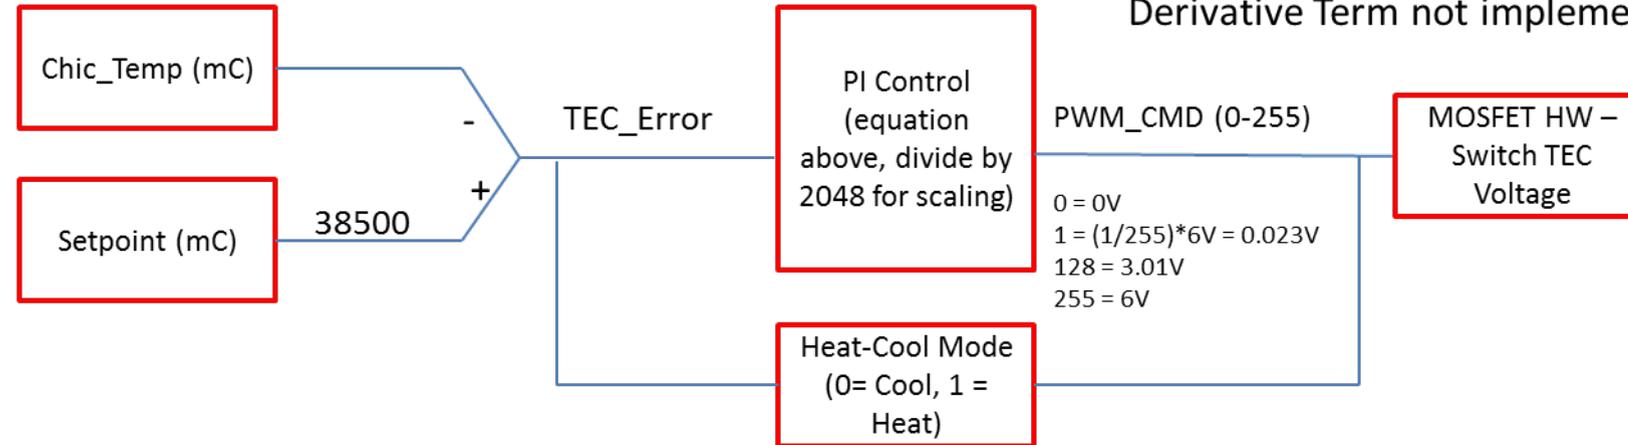
$$PWM\_CMD(n) = Kp * e(n) + Ki * \sum e(n) + \boxed{Kd * (e(n) - e(n - 1))}$$

Derivative Term not implemented

- PI equation used to generate PWM Command signal
- State machine with PWM Command signal as input to determine PWM output signals
- Deadband region implemented to avoid fast cycling on TEC
- Anti-windup feature implemented to avoid integral term saturation

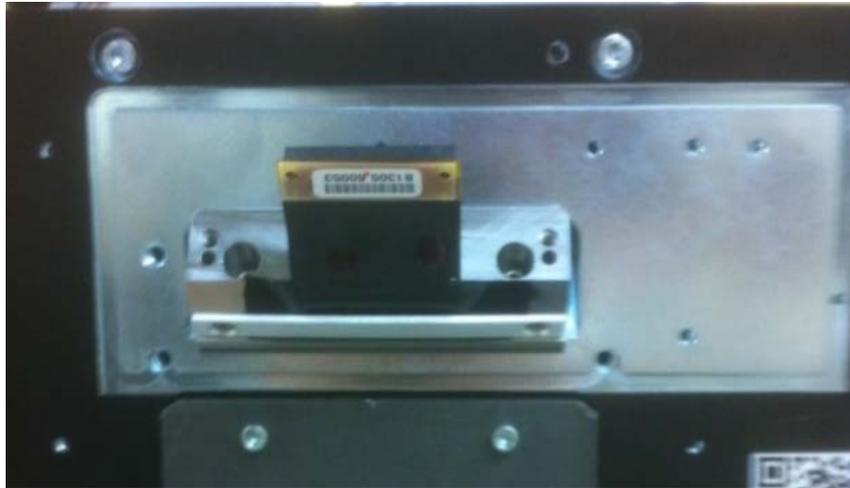
- Detector Element
  - Proprietary technology for the x-ray sensor element
  - Detector element housed in a stainless steel housing for dimensional stability
  - TEC assembly bolts on directly to stainless steel housing
  - Based on gantry environmental conditions, appropriate accelerated cycling conditions were setup for the TEC assembly.

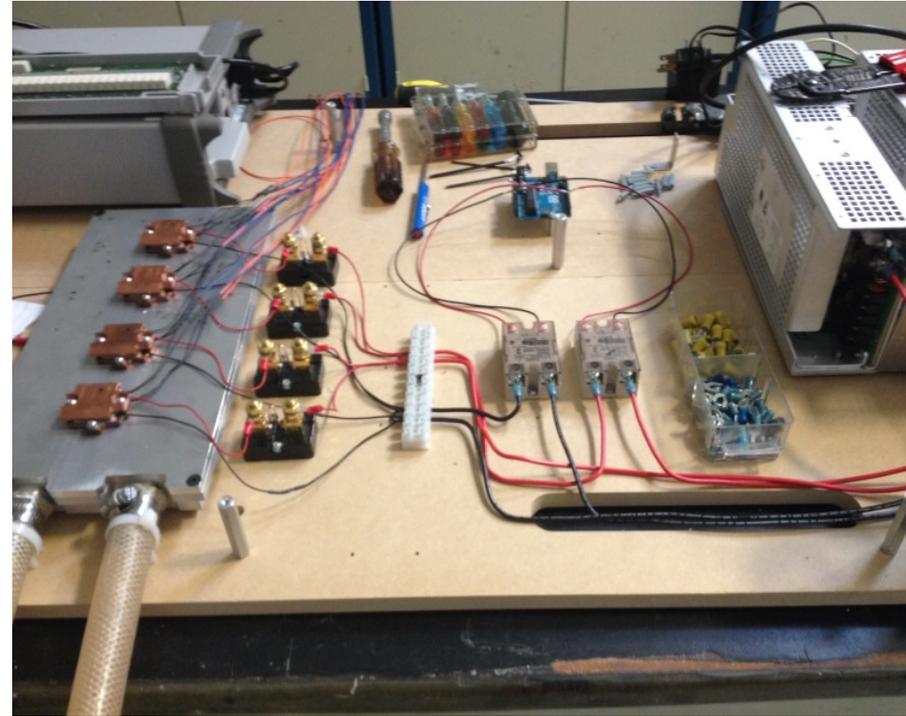
- Parts were attached to a large cold plate set at 20C with water circulating to maintain the temperature.
- The two TEC plates temperatures were monitored as well as the current drawn by means of R-shunt circuits.
- A production data logger was used to collect data.
- Two 5VDC power supplies, two SSRs (Solid State Relays) and
- A production controller [5] was used to power up the TECs and to change voltage polarity every 3 minutes
- Power supplies were connected in reverse polarity and the production controller timed the corresponding SSRs such that, at all times, only one power supply was connected to TECs

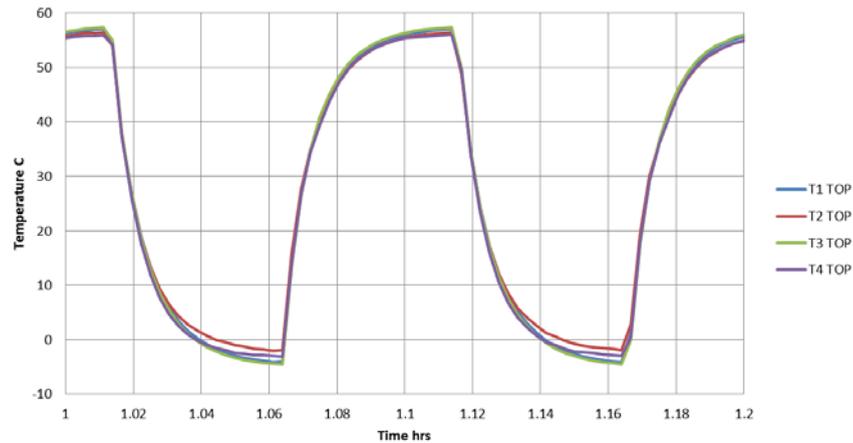
TEC upper plate temperature - cold plate at 20C

- Load plate temperature cycles from -5C to 55C
- Heat sink plate at 22C with relatively large transients at beginning of power transition
- During heating current draw is -1.3Amps and during cooling, the current draw is 1.8Amps
- Small spikes seen when voltage reverses polarity

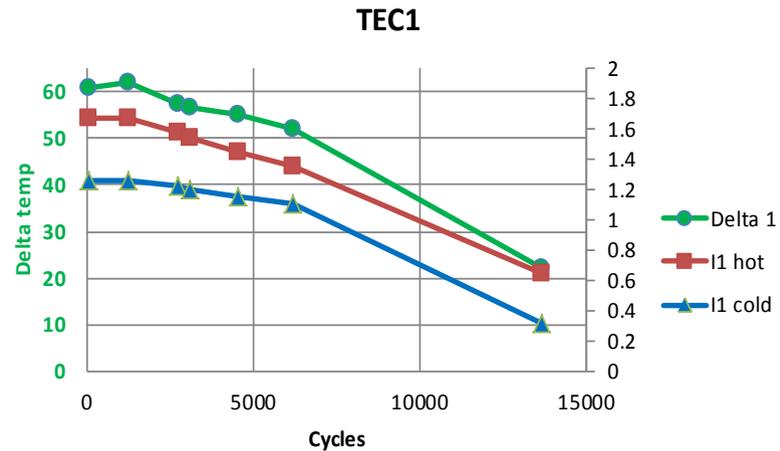
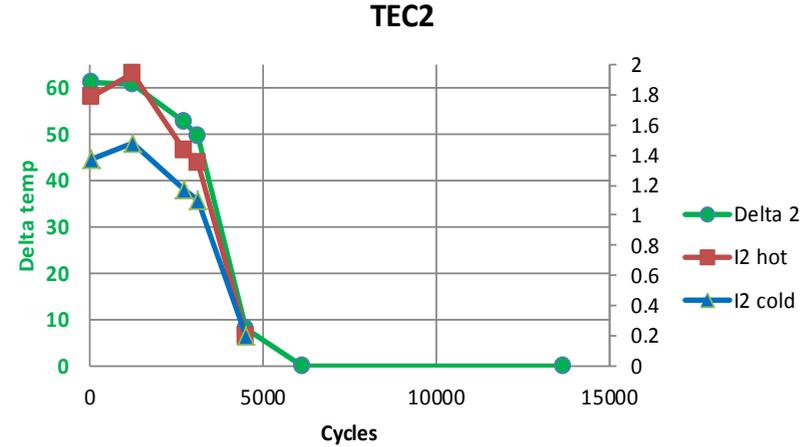
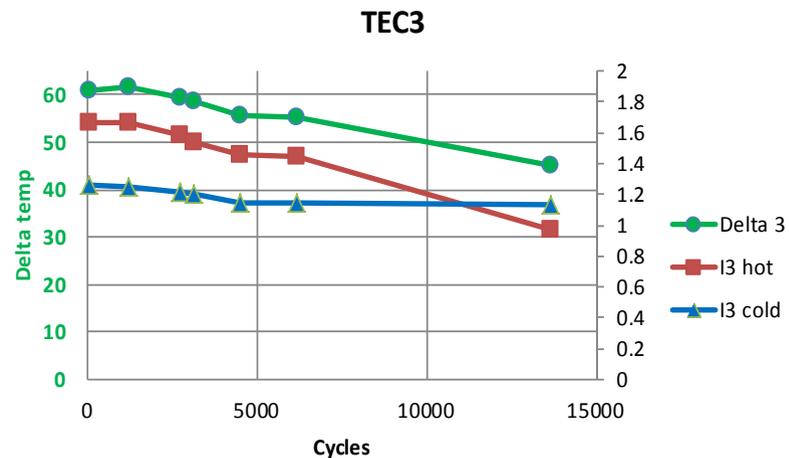
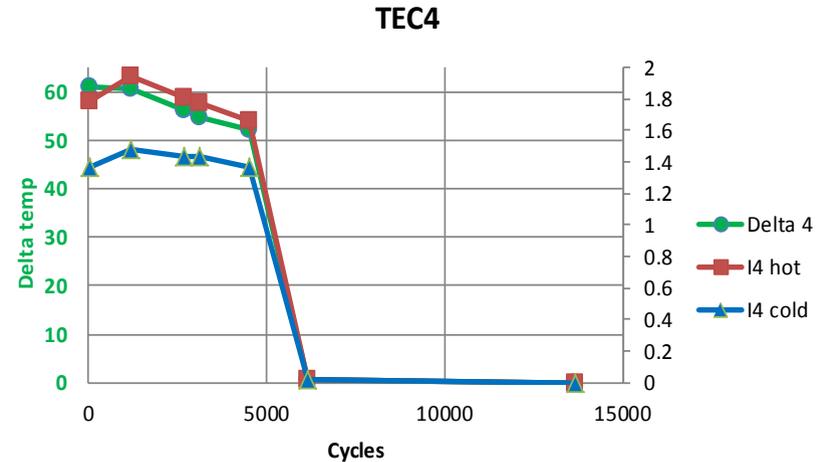
This data shows that parts cannot survive 5000 cycles. Current draw and delta temperature start to decrease after 2000 cycles for the weakest part. The best part shows decent stability up to 5000 cycles.

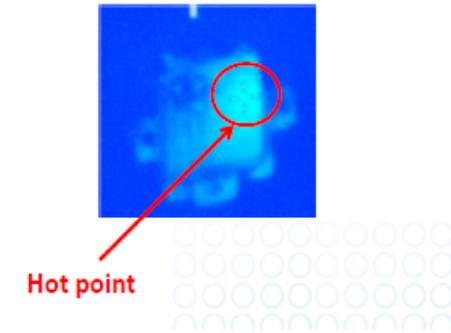
The TEC have a serious hot point, see right picture.

Hot spot determined using IR Imaging, standard destructive autopsy performed on TEC.

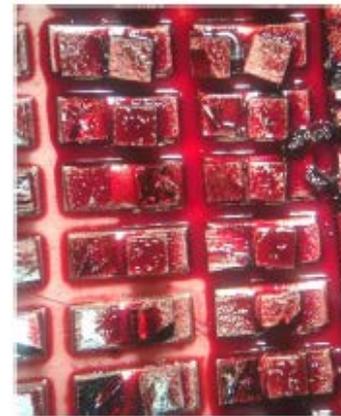
Dice shift  
Picture 2

Evidence of dice cracking, shifting and burning observed within TEC

Through these observations, more likely the TEC got damaged by an uneven external force during assembly process. The thermal excursions likely propagated the die microcracks and eventually caused the resistance increase.

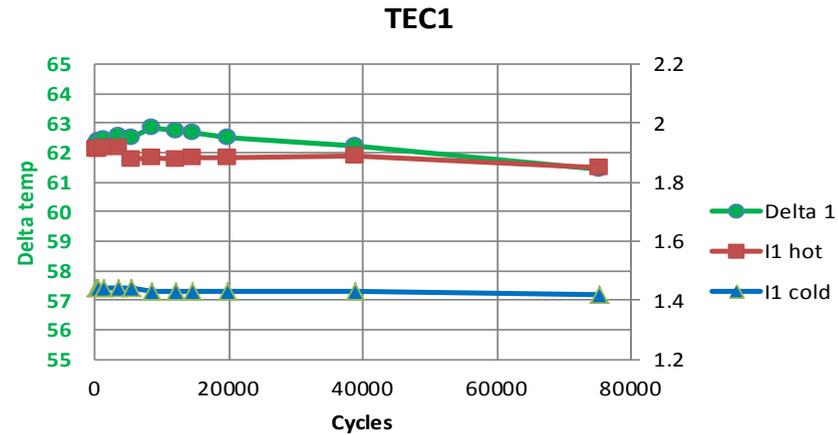
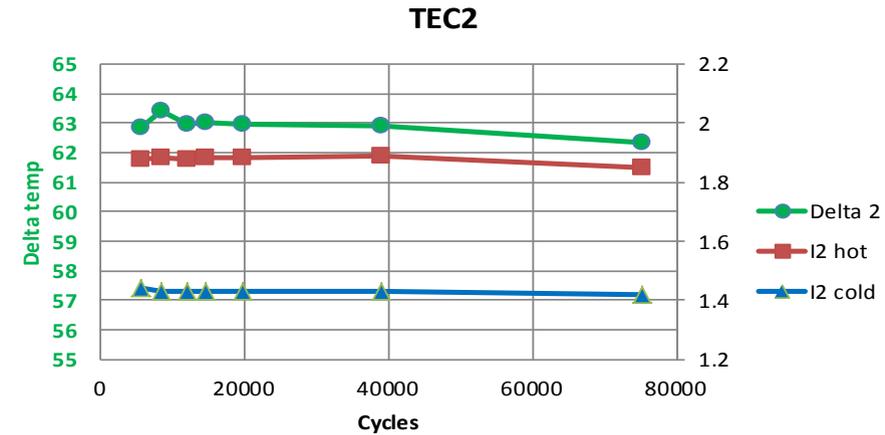
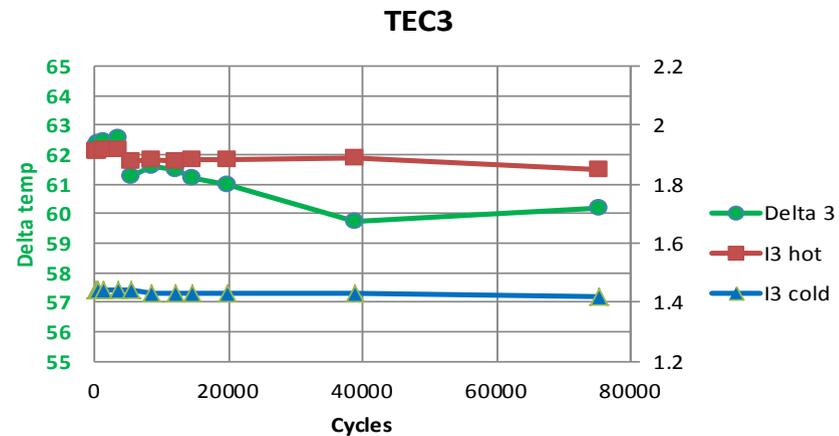
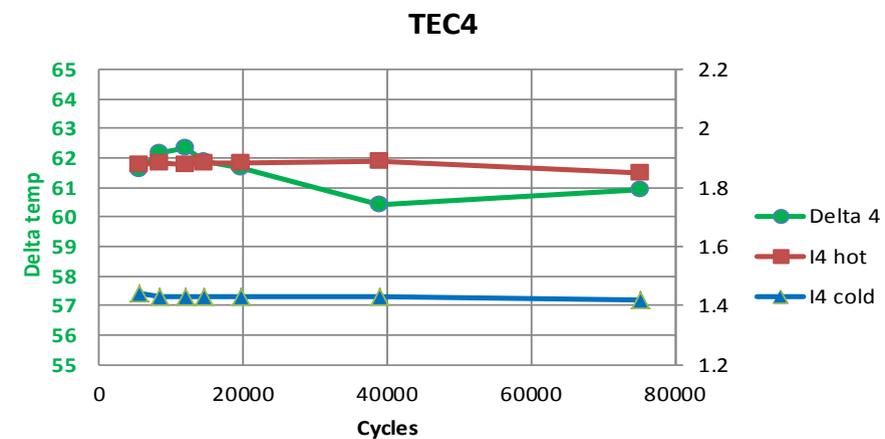
The PTC data on high temperature solder TEC's shows great improvement. No current degradation up to 80 thousand cycles, parts still under test beyond this cycle count. Only two degree Celsius degradation on delta temperature, TEC3 and TEC4 show higher degradation since these modules are not thermally isolated

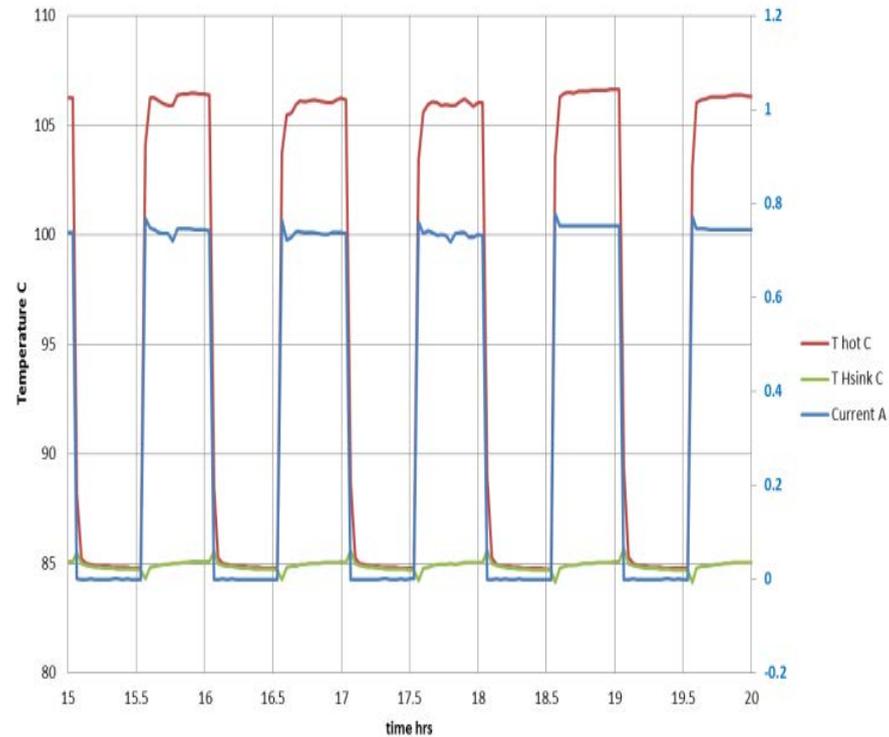
TEC high temp solder at 85C 85%RH power cycle

Practically no change in current drawn observed up to 970hrs. The only difference observed at end of test is that a current spike transient is now present

The delta temperature of hot plate decreased a bit, initially the delta temperature was 22C, at 970hr the delta was 21C, so some small degradation observed.

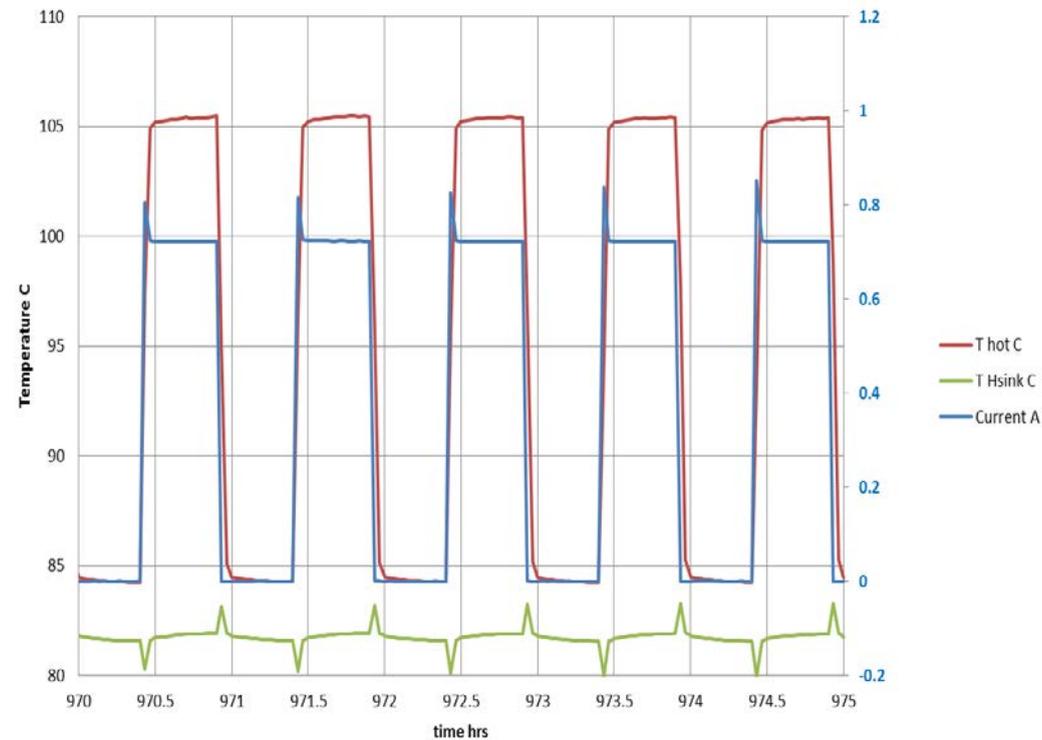
TEC high temp solder at 85C 85%RH power cycle

We observed a temperature drift on the heatsink thermistor. At end of test the temperature sensor is reading 3C lower than the chamber temperature. We think this temperature difference is driven by a cracked thermistor.
