# NSOP Reduction for QFN RFIC Packages

**Mumtaz Y. Bora**

Peregrine Semiconductor

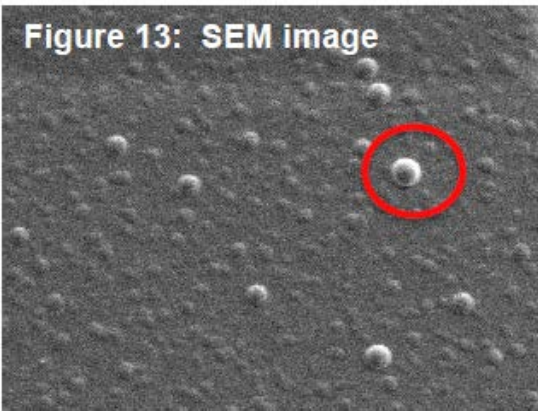
Figure 13: SEM image

Hillocks Characterized  
Aluminum Composition  
Non- issue with wire bond  
IQC Reject Criteria Revised
