# Challenges on ENEPIG Finished PCBs: Gold Ball Bonding and Pad Metal Lift

Young K. Song and Vanja Bukva  
Teledyne DALSA Inc.  
Waterloo, ON, Canada

## Abstract

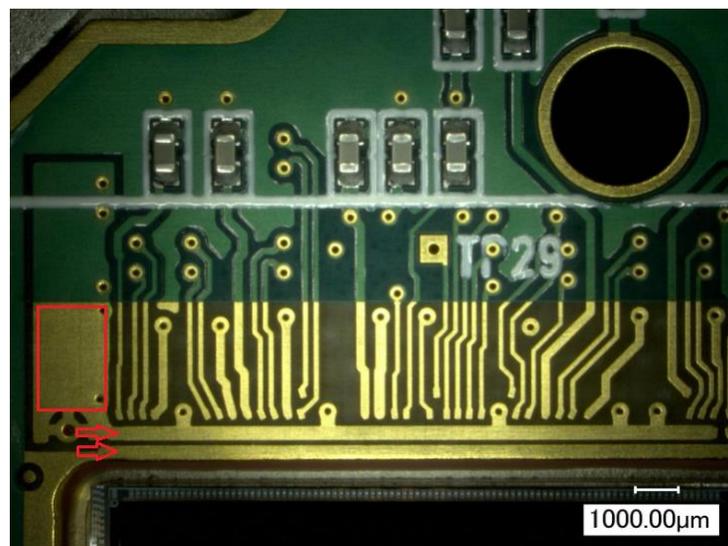
**Figure 1- Partial View of Sample PCB**

The evolution of gold ball bonding process on ENEPIG surface finished PCBs is to be examined. Figure 1 shows a partial view of the PCB layout used for one of the image sensor products showing surface mounted components and wire bonding pads with wire bonding rings indicated by arrows as well as individually defined wire bonding pads. The area shown in a rectangular shape in red is representative of 4 similar areas on the subject board and was used for standard gold bonding and will be the subject of the subsequent evaluation.

Wire bonds were made in PCB areas as shown in Figure 1 in red for wire pull strength comparison for the standard gold bonding process. For comparison between bare and populated boards, boards from the same bare board batch were used to eliminate the effect of batch to batch variation. As shown in Figure 4 and Figure 5, it is obvious that wire pull strength of populated boards is lower than that of bare boards. However, the bare boards baked at 245°C/5min., in order to simulate thermal effect during SMT process, do not show any degradation in wire pull strength compared to bare boards, indicating that Ni migration is not likely to occur to wire bonding surfaces during the SMT process.

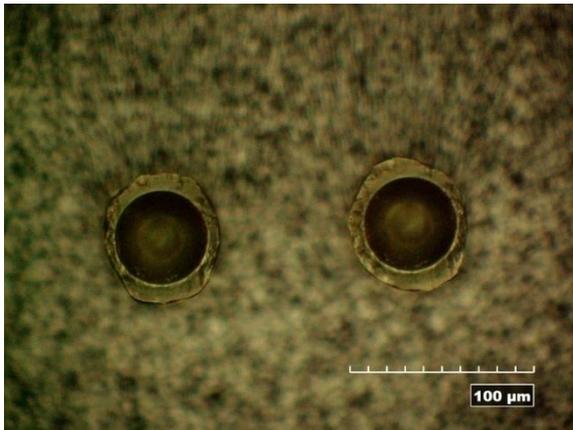
Figure 2 - Ball Bonds (1<sup>st</sup> bonds)

The standard gold ball bonding process makes a bonded wire that consists of a ball bond and a stitch bond as shown in Figure 2 and Figure 3, respectively. The ball bond, also called the first bond, is commonly made on die bonding pads, and the stitch bond, also called the second bond, is made on substrate bonding pads. In Figure 2 and Figure 3, both ball bonds and stitch bonds are made on a PCB substrate and the wire bonding evaluation is focused on stitch bond (second bond) capability on a PCB. In general, bonding windows for the stitch bonds (second bonds) are smaller than those for the ball bonds (first bonds) which means that stitch bonds are more susceptible to non-sticking due to plating quality or surface contamination compared to ball bonds.

For standard bonding and security bonding processes, a ball bond is made on the die bonding pad (Figure 2 and Figure 8) and a stitch bond is made on the substrate (PCB) bonding pad (Figure 3 and Figure 9). However, for SSB process, a bump is first applied on the die bonding pad. Next, a ball bond is made on the substrate (PCB) bonding pad (Figure 10) and then a stitch bond is made directly on the bump on the die bonding pad (Figure 11). Therefore, ball bonding is applied on both die and PCB bonding pads, unlike the standard gold bonding and security bump processes. As mentioned earlier, the ball bonding process has a much larger bonding window tolerance variation in plating quality and the level of contamination than the stitch bonding process.

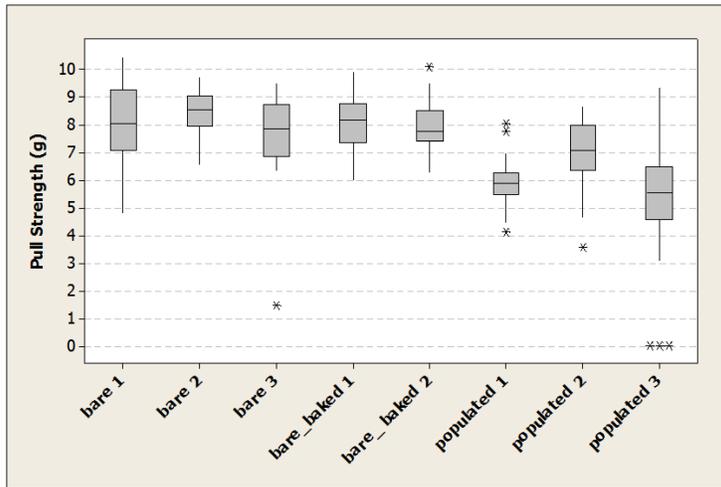
**Figure 4 - Wire Pull Strength Comparison Between Bare and Populated Boards from Sample A**

from the SMT process affecting wire bondability. However, contamination was not noticeable on an optical microscope from the populated boards used in Figure 4 and Figure 5.

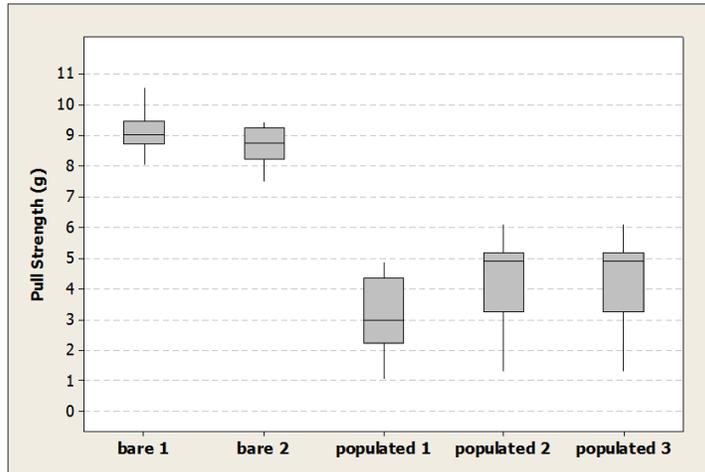
**Figure 5 –Wire Pull Strength Comparison Between Bare and Populated Boards from Sample B**

In addition to potential contamination during the SMT process, another potential issue observed was variation in flatness and/or roughness of the bonding surface, which was indicated by non-uniform tool marks on the PCB pad surface. There was one outlier with low pull strength value obtained from bare board 3 and there were three non-sticking bonds during wire bonding from populated boards 3 in Figure 4. Low pull strength from bare board 3 and non-sticking bonds from populated boards might be related to insufficient squash of bonding wire due to the non-flat bonding surface. Otherwise, ENEPIG plated boards seem to show good wire bondability on the bare board level.

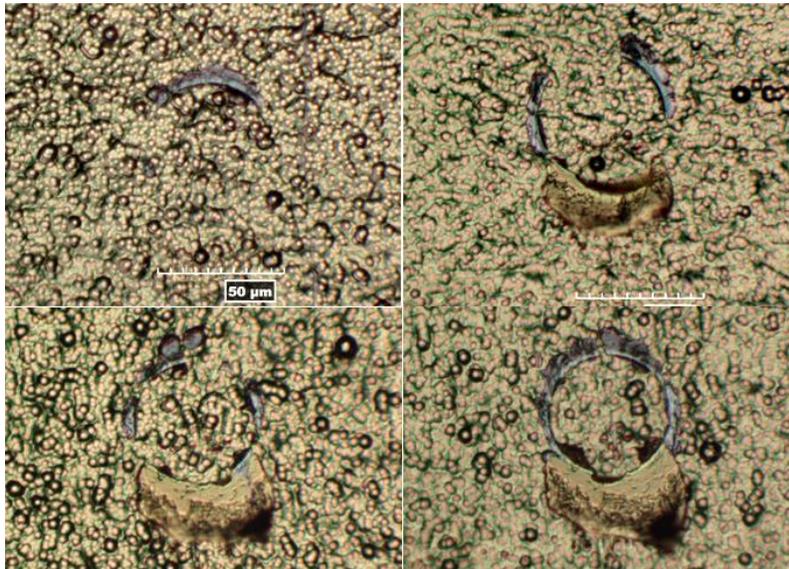
**Figure 6 - Variation in Tool Marks**

Figure 6 shows tool mark variation observed during evaluation, likely related to surface flatness or roughness. A tool mark shape (Figure 6, right-bottom) exhibits the preferred full circle, but most tool mark shapes are broken circles. One low pull strength value from bare board 3 in Figure 4 is from the bond with the tool mark at the left-top in Figure 6 (half or less than half circle opposite to squashed wire). Very similar tool marks are also observed from the non-stuck wire bonds on populated boards 3 in Figure 4.

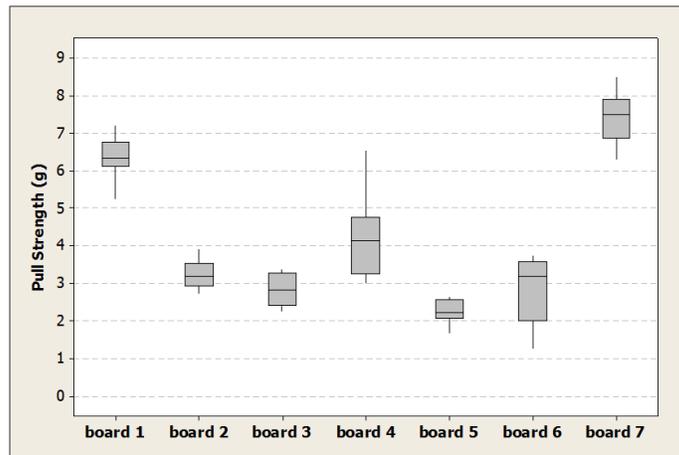
**Figure 7 - Wire Pull Strength from Mixed Batches of Populated Boards from Sample C**

Figure 7 shows the pull strength variation of mixed batches of populated boards from sample C as an example of potential wire pull variation of populated boards using the standard gold ball bonding process. However, it could not be clearly determined whether the plating process or the SMT process was responsible for the variation in pull strength for each board used for Figure 7.

Due to the variation and degradation of wire bondability of the standard gold bonding process on populated boards for our image sensor applications, the wire bonding process was changed, first from the originally planned standard ball bonding process, then to security bump process, and ultimately to the stand-off-stitch bond (SSB) process (also called the ball-stitch-on-ball process). The security bump process and the SSB process are also types of gold ball bonding process and the difference between standard bonding, security bump, and SSB processes is described in detail in the following paragraphs.

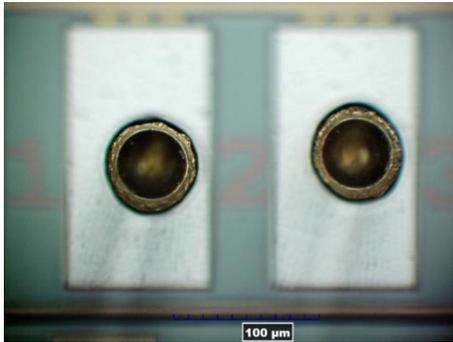
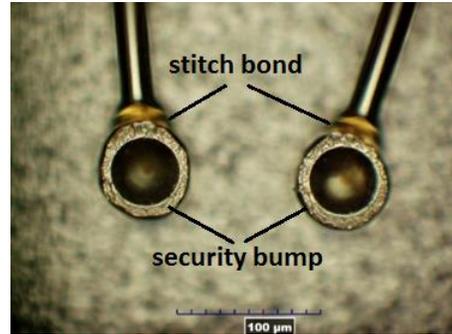
Figure 8 and Figure 9 show the shapes of ball bonds on the die and stitch bonds on the PCB bonding pads for the security bump process. Compare stitch bond shapes between the standard gold bonding process in Figure 3 and the security bump process in Figure 9. The security bump process enhances wire pull strength on the stitch bond since additional bump is applied on the stitch bond as shown in Figure 9, but the process still requires continuous bonding capability without non-sticking or losing the tail during the stitch bond process.

**Figure 8 - Ball Bonds for Security Bump Process**

**Figure 9 - Stitch Bonds with Security Bumps for Security Bump Process**

However, when the wire bondability of the populated PCBs is not adequate, the implementation of the security bump process does not guarantee a satisfactory result in preventing non-sticking or losing tails. A stable bonding process without wire

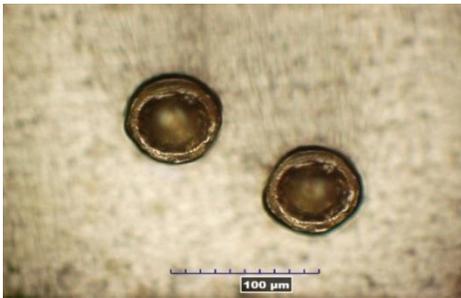
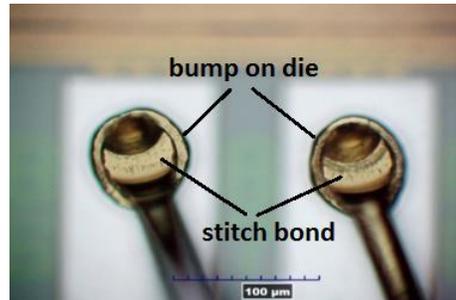
bonding failure is critical for applications with a large number of wire bond counts in a device. Figure 10 and Figure 11 show the shapes of ball bonds on PCBs and stitch bonds on die bonding pads for the SSB process.

**Figure 10 - Ball Bonds for Stand-off Stitch (SSB) Process**

**Figure 11 - Stitch Bonds Made on Bumps for SSB Process**

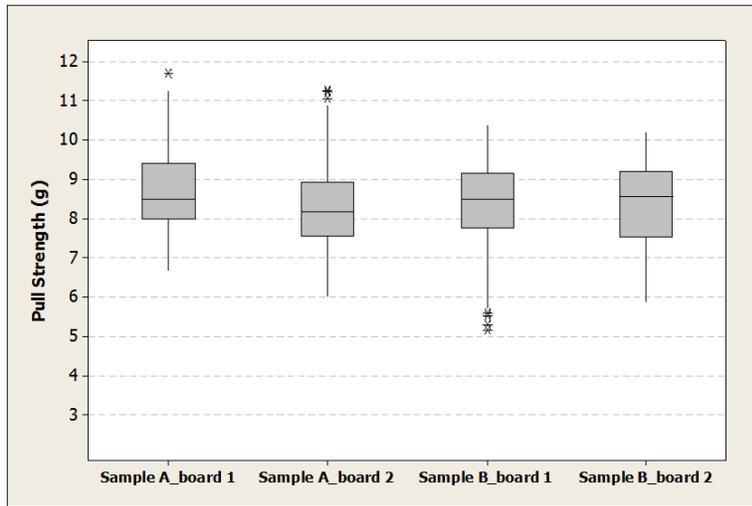
**Figure 12 - Wire Pull Strength from Populated Boards with SSB Process**

Figure 12 shows the pull test result from the SSB process on populated boards from samples A and B. There were between 145-155 bonds pull tested on each board. There is no failure related to PCB plating quality such as bond lift failure on the PCB bonding pads. Several wire bonds exhibited a stitch break failure mode (on die), but most wire bonds showed neck break failure which was the preferable failure mode. The variation in pull strength in Figure 12 is due to the fact that wire bonds tested were from a mixture of short and long wire bonds with loops at different heights rather than due to variation in bondability on the PCB. Machine stoppage or non-sticking had rarely been reported since the SSB process was introduced, however, a new issue, pad metal lift (PML), was observed in ENEPIG plating in some batches of PCBs not related to the SSB process. Details about this issue are discussed in the following section.

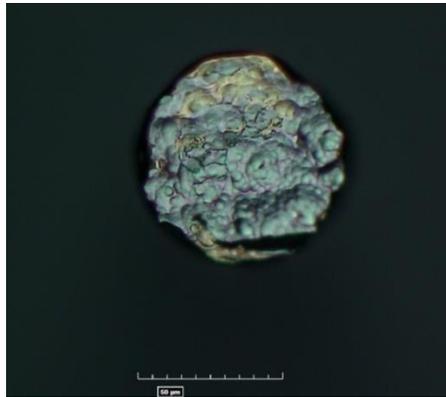
**Figure 13 - Bottom of a Lifted Bond**

Another area of concern was pad metal lift (PML) experienced on some PCBs and PCB batches where the palladium (Pd) layer was completely separated from the nickel (Ni) either during wire bonding or during the sample destructive wire pull tests. PMLs have been observed from both bare and populated boards, therefore, they do not seem to be related to the SMT process. Figure 13 shows the bottom of the lifted bond as an example.

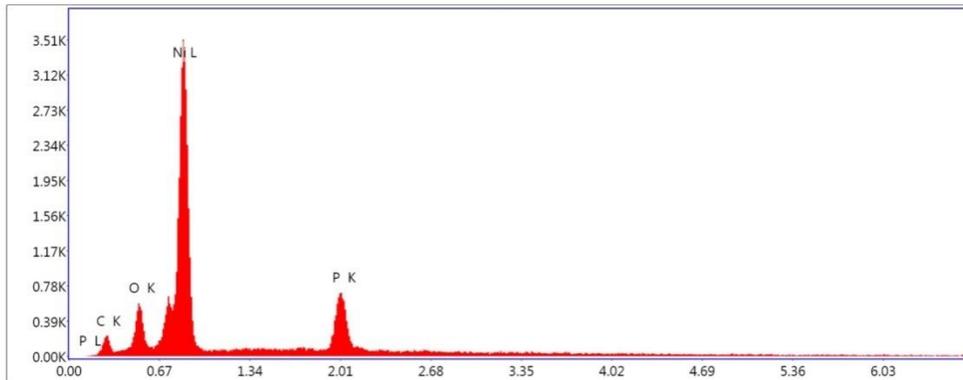
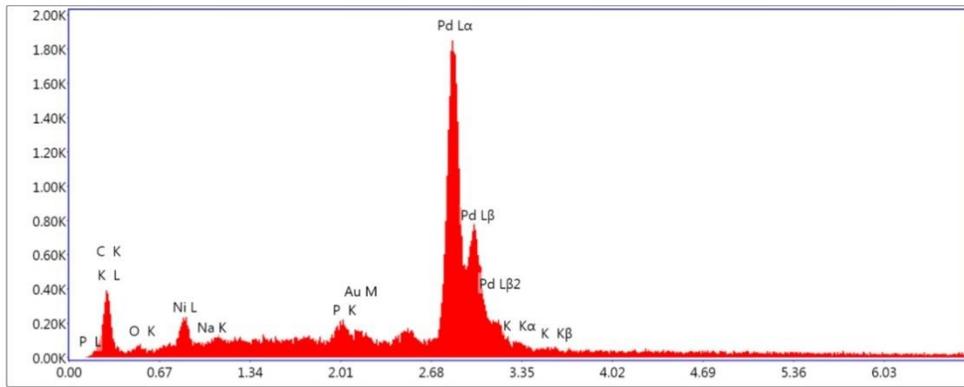
Separation of the Pd layer from the Ni layer was confirmed by EDS analyses conducted on the area on the bonding pad with the lifted bond and the bottom of lifted bonds as shown in Figure 14 and Figure 15, respectively. Ni was the major element in the area on the bonding pad with a lifted bond in Figure 14 and Pd was the major element detected at the bottom of the lifted bond in Figure 15.

**Figure 14 - EDS Analysis Spectrum Obtained from The Area on Bonding Pad with Lifted Bond**

**Figure 15 - EDS Analysis Spectrum Obtained from The Bottom of Lifted Bond**

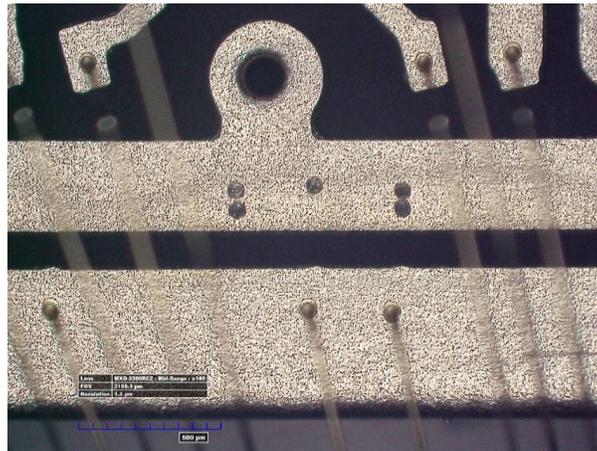
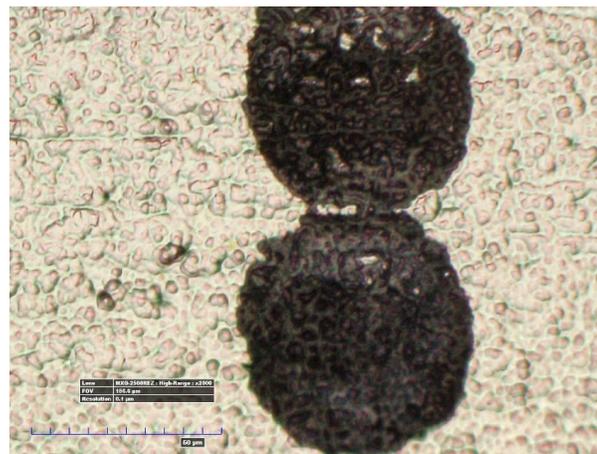
One of the incidents where PML was observed on the sample A of the PCBs is shown as per Figure 16 and Figure 17.

**Figure 16 - Five Black Circles Represent PML Including Attempts to Repair**

**Figure 17 – Zoom in on PML Area**

The circular shape of the pad metal lifted area is the shape of the wire bond. Using an optical microscope, it is clear that the entire area with pad metal lift looked black in color, which was different from those identified from other samples presented in the following sections.

A supplier noticed a process issue during the production of this batch. The root cause proposed by the supplier was an overactive Ni bath, which can be caused by temperature or excessive copper loading, or a combination of both. In this case, it was determined that the copper loading had been excessive over the course of several consecutive loads. ENEPIG plating was found on the solder mask and some boards failed the tape test for poor Pd adhesion to Ni. However, the tape testing, which was performed per IPC-TM-650, was not effective in completely screening out the PCBs affected and wire bonding failures were observed as per Figure 16 and Figure 17.

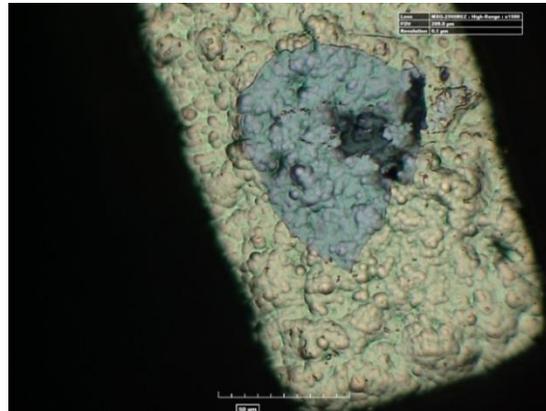
**Figure 18 - PML from Sample D**

Figure 18 shows an example of PML occurring in one of PCB batches from the sample D. PML was observed during wire bonding. The color of the area with the lifted bonds showed mostly a mixture of fresh Ni-like color and spots in black color as shown in Figure 18, but some showed just fresh Ni-like color in the entire area.

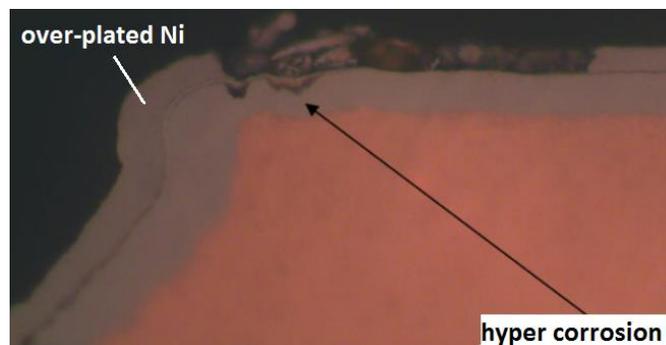
**Figure 19 –Image of Edge Hyper Corrosion at Lens 1000x (ignore top, over-plated layer for sample preparation)**

Boards were sent for cross-section, XRF measurements and SEM analysis. Hyper-corrosion was observed through the analysis as shown in Figure 19. It was believed that hyper-corrosion was the cause of the PML, where Pd had separated from the Ni layer. Hyper-corrosion is a result of hyperactivity of the immersion gold bath causing severe corrosion of the nickel, which then creates the possibility of the Pd layer having poor adhesion. Note that the top thick layer in Figure 19 is an over-plated nickel layer, the purpose being for sample preparation.

Comparison between batches that have been successfully wire bonded and the batch which failed at wire bonding was made in respect to plating thickness. XRF measurements of the failed board demonstrated the thinnest Pd deposit combined with the thickest Au deposit, both within tolerance of the IPC-4556 specification for plating thickness. The combination of thin Pd and thick Au deposit appeared to compromise Pd bond strength possibly from the undercutting of the Ni/Pd interface due to localized heavy hyper corrosion. In technical discussions with multiple experts, it was suggested to reduce the Au thickness range from specified 0.05 – 0.15 um to the range of 0.03 – 0.06um, and increase Pd thickness range from the specified 0.10 – 0.20 um, to 0.15 – 0.30 um as shown in Table 2. Two trials were performed with the modified plating thickness specification, with two different suppliers and results were encouraging. No PML was observed during wire bonding and wire pull tests. The cross-section was performed on trial boards from both suppliers and hyper corrosion was not observed.

Thickness	Original specification	Modified specification to minimize hyper-corrosion
Au	0.05 – 0.15 um (2 – 6 uin)	0.03 – 0.06 um (1.2 – 2.4 uin)
Pd	0.10 – 0.20 um (4 – 8 uin)	0.15 – 0.30 um (6 – 12 uin)
Ni	3 – 5um (118 – 200 uin)	3 – 6 um (118 – 236 uin)*

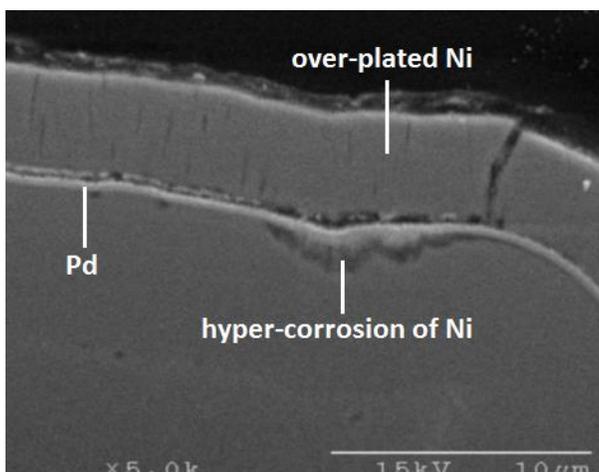
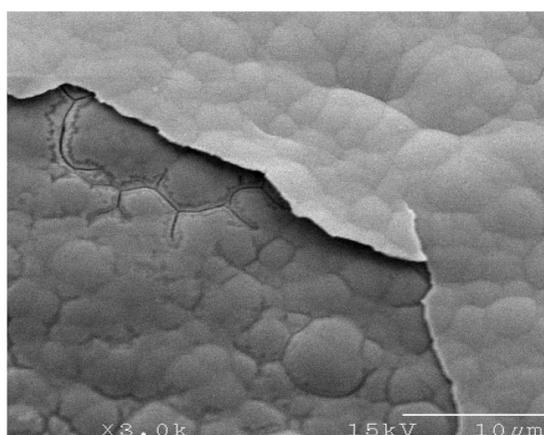
Figure 20 shows a cross-sectioned view of the edge of the bonding pad. The top thick layer is the over-plated Ni layer for the purpose of sample preparation. Hyper corrosion of Ni beneath Pd is visible in Figure 20. Figure 21 shows hyper corrosion of Ni in the wire bonding pad in the area with the lifted Pd layer.

**Figure 20 – SEM Image of the Edge of the Pad Showing Hyper Corrosion of the Ni Beneath the Pd**

**Figure 21 – SEM Image of the Same Failed Site Showing Lifted Pd and Hyper Corrosion of the Ni**

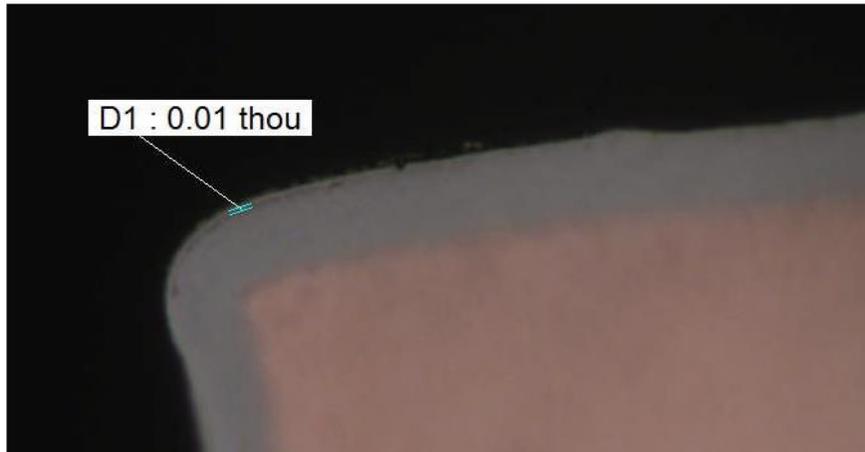
**Figure 22 - Edge of the Pad Showing Demarcation Line at 1000x Lens.**

A second PML incident involving another PCB batch occurred during wire bond and wire pull tests. Boards were sent for cross-section, XRF measurements and SEM analysis. It was determined that the cause of Pd and Ni separation in this case

was not due to hyper corrosion. Cross-sectioned boards exhibited the separation between the Pd and the Ni without hyper corrosion of nickel. Figure 22 shows a demarcation (separation) line which should not normally be visible.

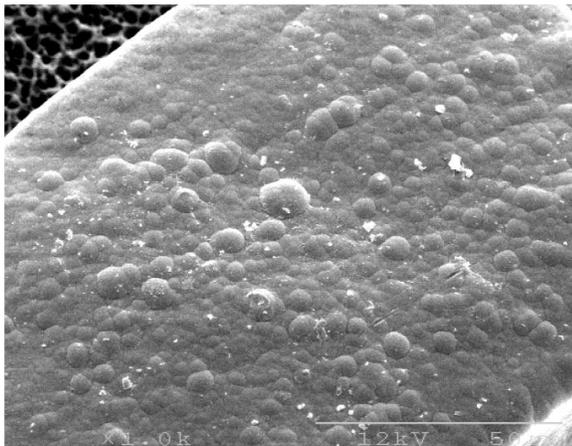
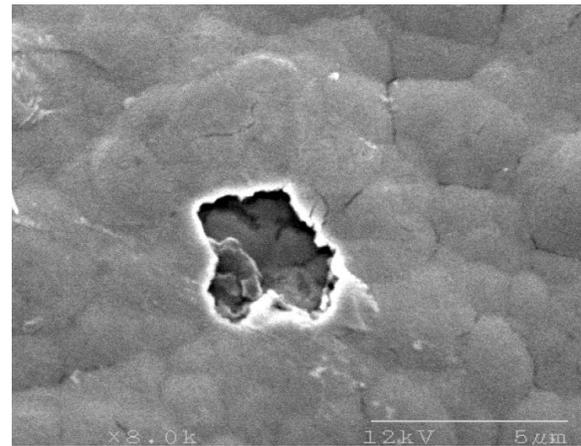
SEM analysis showed some variation in the grain size of the Ni deposit from failed boards in Figure 23. However, variation in grain size of Ni is not expected to be responsible for PML. Figure 24 shows a small area with missing Pd layer from the surface and the grain boundary attack on the underlying nickel indicating that the Pd layer was missing when the sample was plated in the Au bath.

**Figure 23 – SEM Image of Wire Bond Pad Showing Variation in the Grain Size of Ni Deposit at 1000x**

**Figure 24 – SEM Image Showing Missing Pd at 8000X**

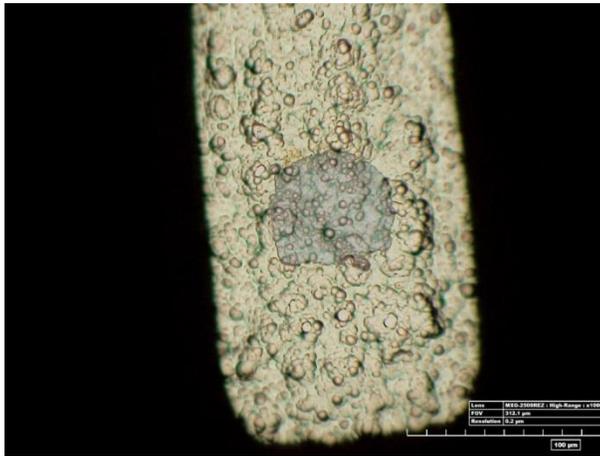
**Figure 25 – Optical Microscope Image of PML**

The third incident of PML was observed from a new batch of PCBs. Figure 25 shows an optical microscope image of PML observed on this batch.

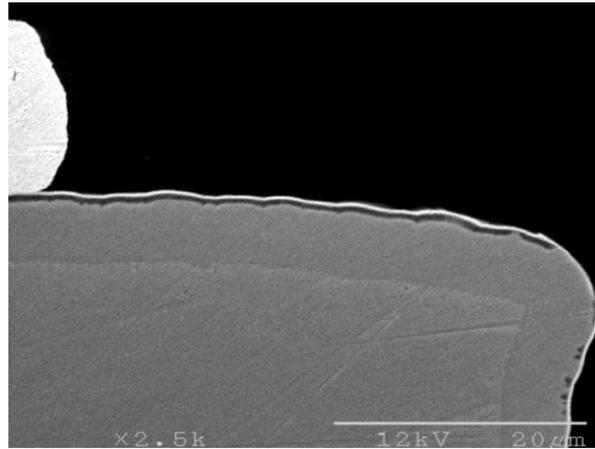
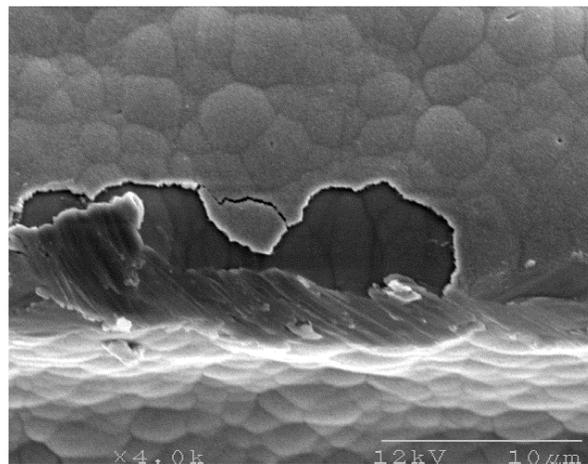
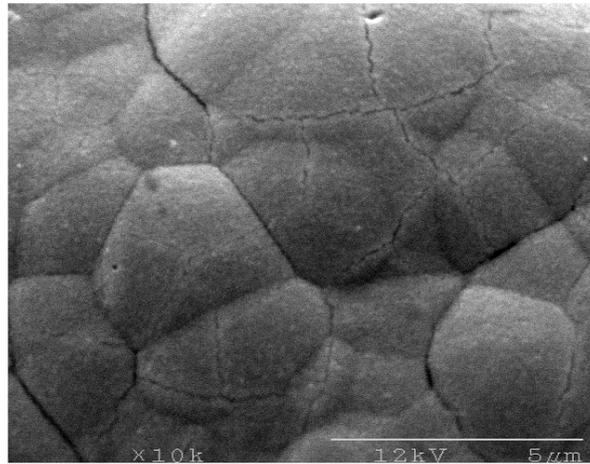
Plating thickness measurements using XRF on a same board of this batch showed inconsistency of Au and Pd thickness. The board showed extensive hyper corrosion, causing Pd and Ni separation as shown in the cross-section of the board in Figure 26 and also showed the evidence of flaked or lifted off Pd layer at the edge of bonding pad in Figure 27. Trans-granular cracking in the Pd layer was also observed as shown in Figure 28 even though it is not known if trans-granular cracking is related to PML.

**Figure 26 – SEM Image at 2500X Showing Extensive Hyper Corrosion**

**Figure 27 –SEM Image at 4000X Showing the Lifting Pd Layer**

**Figure 28 – SEM Image of the Pd Surface Showing the Trans-granular Cracking of the Pd**

The root cause investigation of PMLs possibly with 3 different root causes from 3 different batches of sample D involved review of multiple variables at the PCB manufacturer as follows:

- Si content in the plant DI water was found to be 4 PPM. The Si levels dropped to 0.004 PPM after DI columns were added to strip Si from the water supply.
- The rinse time after Ni plating (before Pd plating) was reduced from 60s to 30s to minimize possibility of Ni oxidation.
- The practice was improved by eliminating panels being placed on hold prior to final Au finish in order to reduce the amount of oxidation on panels.
- A custom heating coil and a cooling coil were added in Pd tank.
- Improvement of Ni bath Metal Turn Overs (MTOs) to 1 MTO.

The final conclusion was that the root cause was most likely high MTOs and overall life of the Ni bath, with all other causes as possible contributing factors.

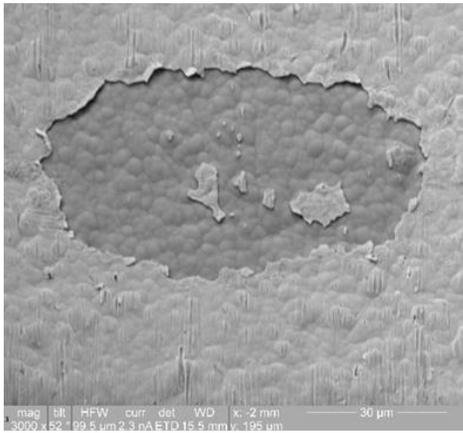
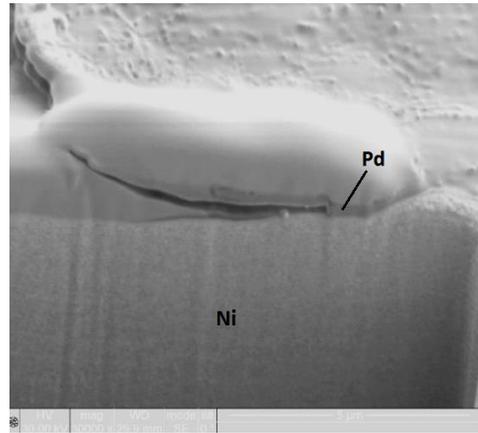
PCBs from sample E were wire bonded using aluminum wedge bonding unlike PCBs from samples A and D which were wire bonded using gold wire bonding. Figure 29 shows an example of PML from sample E observed during the aluminum wedge bonding process.

Cross-sectioning of PCBs for the analysis of PML from sample D showed that the separation between Pd and Ni layer was along a relatively large interface area. However, cross-sectioning of the PCB from sample E showed that the separation between Ni and Pd layer was very localized as shown in Figure 30. There is no evidence of any hyper corrosion present in Ni in this instance. Particularly noted is the “step” or 90 degree portion of the Pd layer where the lifting starts. Pd would not be considered a ductile material and this would appear to indicate that some disturbance caused the change in plating direction and may potentially be responsible for the lack of adhesion.

**Figure 29 - SEM Image of the Lifted Bond at 3000x**

**Figure 30 - FIB Image of the Lifting Pd from Ni at 30,000X**

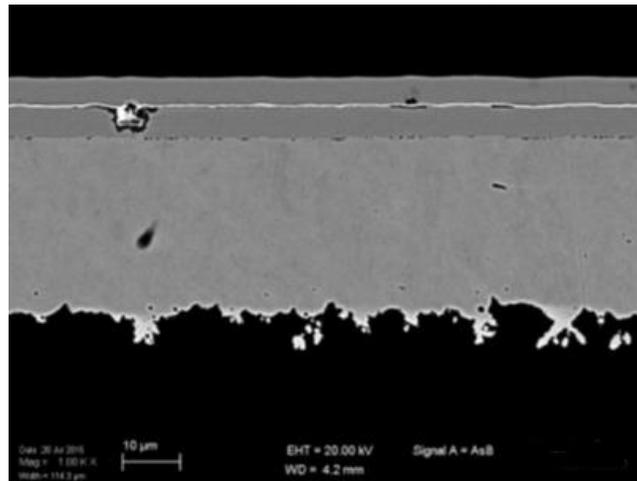
**Figure 31 -Inclusion in Ni layer and Ni Hyper Corrosion**

Figure 31 shows a cross-sectioned view of another PCB from sample E, in which inclusion in the Ni layer was observed and also hyper corrosion of Ni was present. The size of interface defects, an inclusion and Ni hyper corrosion, was much smaller (about 5 um wide) than those which were observed on sample D PCBs (usually about 50 um).

Even though a tape test as per IPC-TM-650 had been implemented on each PCB at the supplier, as well as at receiving, PML still occurred during wire bonding. Attempts to repair wire bonds in the adjacent area where PML occurred were successful without PML during the wire bonding and pull test. Boards were sent for temperature cycling testing (TCT). A sample of 13 boards with repaired bonds was temperature cycling tested with the following condition: temperature range of -15°C to 60°C with ramp up and down at 2.5°C per min. for 100 cycles. Dwell time was 55min. at -15°C and 60°C. There were no wire bond failures observed.

The root cause investigation of PML was halted before the root cause had been found and verified. The important factors that would be looked into if we proceeded with the investigation were infrequent use and overall cleanliness of the ENEPIG line.

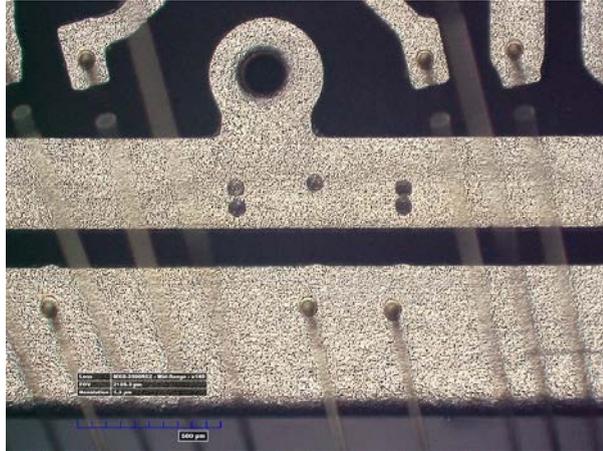
**Figure 16 - Five Black Circles Represent PML Including Attempts to Repair**

- A supplier noticed a process issue during the production of this batch.
- The root cause proposed by the supplier was an overactive Ni bath.
- Caused by temperature or excessive copper loading, or a combination of both.
- It was determined that the copper loading had been excessive over the course of several consecutive loads.
- ENEPIG plating was found on the solder mask and some boards failed tape test for poor Pd adhesion to Ni.
- The tape testing, which was performed per IPC-TM-650, was not effective in completely screening out the PCBs affected and wire bonding failures were observed.
