Test Method Development for Detecting Pitting / Crevice Corrosion Formation on Electronic Assemblies

Mike Bixenman, Kyzen Corporation

Abstract

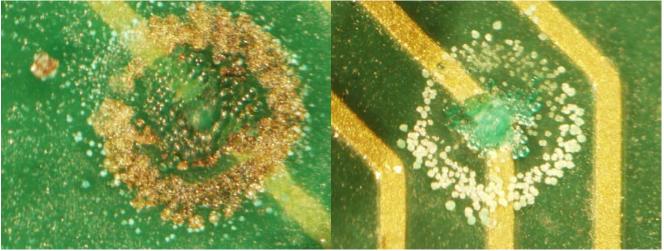
Figure 1 – Images illustrating Pitting Corrosion

Pitting starts as an advanced form of uniform etch. It is believed that the combination of small active anodes to large passive cathodes initiates the corrosion (Figure 1). Residue on the surface of the board that is mobilized from humid environments can remove oxides from exposed copper. A small cell can form as mono-layers of moisture initiate small active anodes that are attracted to metal cathodes. As corrosion propagates, it can worsen into very severe corrosion that result in localized and relatively deep holes in the metal. The corrosion will eventually eat through the metal, which creates an open circuit (Figure 2).

Pitting usually initiates at breaks in protective coatings or film, scratches, and irregularities that are exposed to an aggressive electrolyte. Even though a pit is slow to initiate, once started, it will progress at an ever-increasing rate and will tend to undercut the surface as it grows. There is a close similarity "open pad" corrosion events that have access to oxygen in the atmosphere versus a pitting event that is isolated from the oxygen in the atmosphere by the solder mask. As the oxygen in the pit is depleted by the corrosion reaction, it becomes very acidic and drives the localized anode / cathode pitting cell. A ring of precipitation tends to migrate out of the pitting site in a circular ring. One corrosion expert consulted stated that "this might be a change in pH of the residue as it migrates away from the corrosion sites." As the pH of the ion migration increases, it has a tendency to migrate away from the corrosion site until it reaches an equilibrium point with equal distant circular formation around the pitting site (Figure 1).

Notice how the nucleus where the corrosion starts to propagate is on a copper trace protected with solder mask. If the copper under the solder mask is not fully sealed or if a scratch exposes the underlying copper, there is potential for pitting corrosion to occur. Boards waved and selectively soldered with no-clean flux materials can help propel the corrosion mechanism. When the right conditions are present, pitting corrosion can take place.

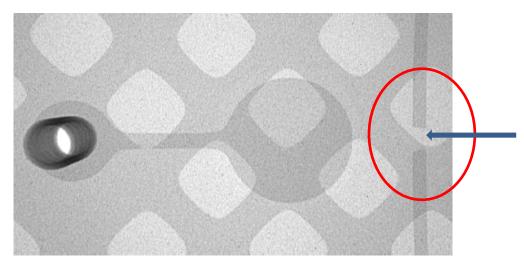
Figure 2 is an X-ray image of a board that failed from pitting corrosion. Conditions were right for a scratch or defect on top of the power trace to create a site for pitting corrosion to occur. The corrosion eventually ate through the copper trace. This created an open circuit.

Figure 2: Open Power Trace that resulted from Pitting Corrosion

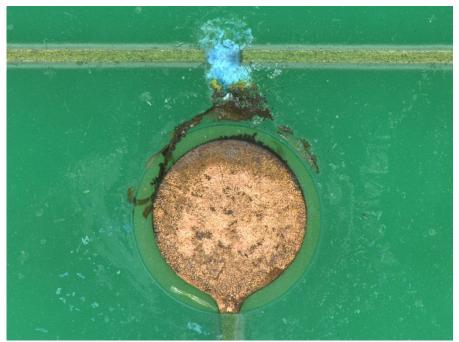
Figure 3: Electrochemical Migration from a Power Trace not covered with Solder mask and the Ground Pad

In contrast to pitting corrosion, many equate corrosion on a printed circuit board to electrochemical migration. Electrochemical migration (ECM) is the growth of conductive metal filaments on a printed circuit board (PCB) through an electrolyte solution under a DC voltage bias. These failures can be either intermittent or permanent, depending on the morphology of the resulting dendrites and the current density. The occurrence of ECM requires an electrolyte, a voltage bias, and migrating metal. The electrolyte comprises dissolved ions from condensed moisture absorbed on the surface. Figure 3 illustrates electrochemical migration from an open in the power trace next the ground pad.

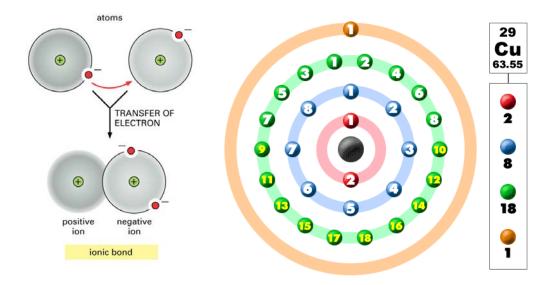
Figure 4 - Transfer of Electrons with a Metal and Ionic Residues in an Electrolytic Solution Initiates the Corrosion Process

One of the jobs of flux is to remove surface oxides. As the activity level of the flux increases, there is a greater chance of forming pitting corrosion.¹ The formation mechanism occurs when the copper gives up electrons (Figure 4). Thin pits within

Each of those colored balls shown in Figure 4 is an electron. In an atom, the electrons spin around the nucleus⁵. The electrons like to be in separate shells/orbitals even though these electrons do not stay in defined areas around the nucleus. They are found in clouds that have different shapes that include spheres and dumbbell like shapes. Copper is one of the transition elements that does not place the additional electrons in the outer shell, but in the one underneath. The electron in the outer shell makes copper a positive ion, commonly referred to as a cation.

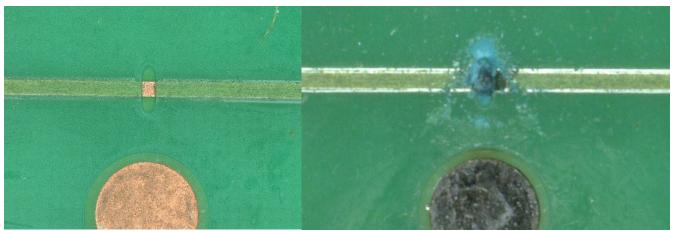
Figure 7 - Board with No-Clean Flux before and After Environmental Testing

To summarize the corrosion mechanism, the residues mobilized in water, form an electrolytic solution. An electrolyte is a substance that produces an electrically conducting solution when dissolved in a polar solvent, such as water. The ionic residues from residual flux or other surface contamination dissolved within the electrolytic solution can be either acidic or basic. This electrolyte removes trace metal oxides, which are cations. The dissolved electrolyte separates into cations and anions, which disperse uniformly through the monolayers of moisture that serve as the solvent. When there is an electrical potential (voltage) present in the corrosion cell, the metal oxides within the solution are drawn to the electrode that has an abundance of electrons, while the anions are drawn to the electrode that has a deficit of electrons. The movement of anions and cations in opposite directions within the solution creates a current. The metal cations within the electrolytic solution start to form a circular morphology growth. This circular morphology growth can be seen where the pits develop (Figure 7). The corrosion grows outward with the potential nuclei remaining intact. Over time the corrosion grows and starts to move outward. Galvanic coupling in these areas where metal dissolution occurs initiates the formation of small anodes. These small anodes surrounding the nucleus form the negative side of the terminal of the primary corrosion cell.

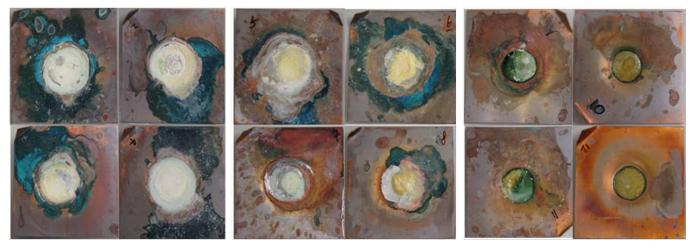
Figure 8 - Corrosion Data Findings on the Three Fluxes Selected for this Research Phase

All test methods passed with the exception of the Corrosion Test method. All three fluxes were graded as "Major Corrosion" when exposed to highly accelerated life testing the procedures called out in the Corrosion Test method. The corrosion test method is designed to determine the corrosive properties of flux residues under extreme environmental conditions. After the exposure period, the test specimens removed from the humidity chamber are examined using 20X magnification. Corrosion is defined as a chemical reaction between the copper, the solder, and the constituents of the flux residues, which occurs after soldering and during exposure to defined environmental conditions. Minor corrosion is any initial change of color, which may develop when the test panel is heated during soldering. Major corrosion is any initial change of color which may develop when the test panel develops green-blue discoloration with observation of pitting of the copper panel or excrescences at the interfaces of the flux residue and copper boundary. For the three classified No-Clean fluxes tested, all three failed (Figure 8).

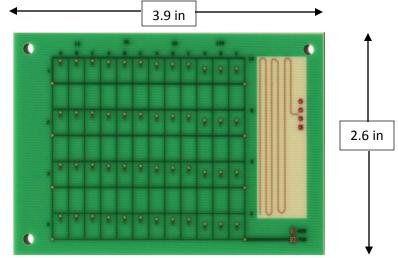
Figure 9 - Pitting/Crevice Corrosion Test Board

The ECM project team designed a test board for studying pitting and crevice corrosion. The test board, Figure 9, has exposed copper features designed to indicate which factors most contribute to corrosion. These corrosion sites were designed with variable openings in the solder mask and spacing to ground. The tests were done at 40°C and 85% relative humidity (RH) and for at least 4 weeks, at two voltages and with and without a selective wave fixture.

The test board is a standard 0.062 thick card with OSP finish over copper pads. A Liquid Photo Image solder mask was applied.

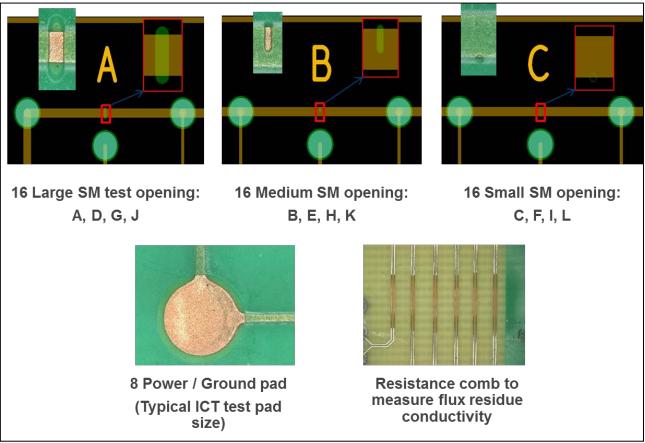
Figure 11 - 56 Corrosion Sites designed into the Test Board

The test board has 56 corrosion sites as illustrated in Figure 11. There are 16 type "A" corrosion site solder mask openings, 16 type "B" corrosion site solder mask openings, 16 type "C" corrosion site solder mask openings, and 8 power pads (typical in circuit test probe pad configuration) on each test board.

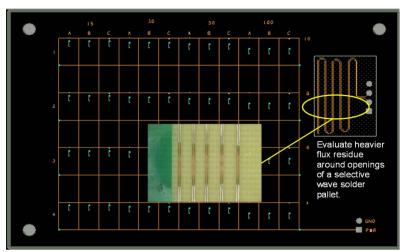
Figure 13 - Flux Residue Comb Pattern Test Site

In addition to the corrosion test sites and dog bone ground vias, a resistance comb was added to determine if the flux residue film has a measureable resistance level. See Figure 13. Some flux formulations leave a thicker or wetter flux residue than others, which can absorb and hold moisture, providing a conductive path on the surface of the board for ionic migration.

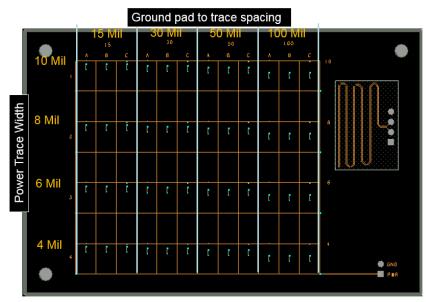
Figure 14 - Ground Pad to Trace Spacing

Figure 14 illustrates the ground pad to trace spacing.

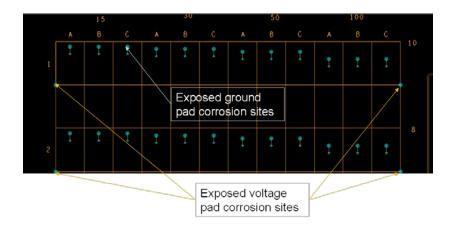
Figure 15 - Test Board Corrosion Features

- o Ground pad to power trace spacing variation (15, 30, 50 & 100 mil)
- Corrosion site trace width variation (4, 6, 8 & 10 mil)
- o Corrosion site solder mask opening variation (A, B, C)
- o Ground pad. voltage pad, and via exposure
- Circuit line solder mask interface
- o Flux residue resistance grid

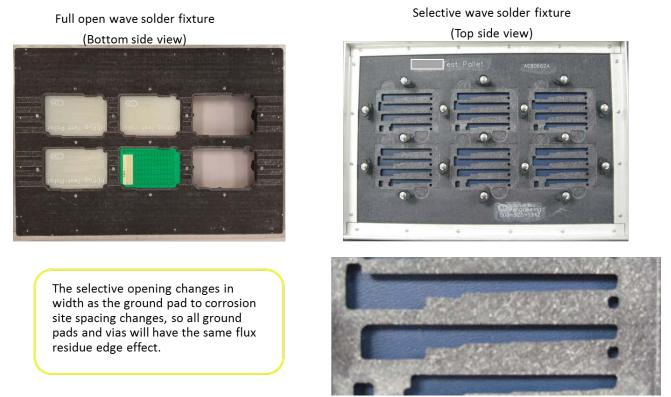
Figure 16 – Open and Selective Wave Soldering Pallet Designs

Figure 16 illustrates the design of the Open and Selective solder pallets. The selective solder pallet is design to accumulate flux near the power and dog-bone ground pads.

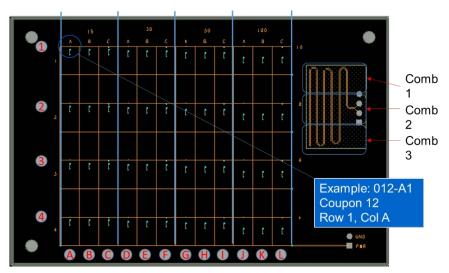
Figure 17 - Test Sites Nomenclature

For each board tested there are 48 solder mask opening test sites (Figure 17). Each site was imaged and scored using the grading scale (Figure 18). The total number of data points captured was 5,780.

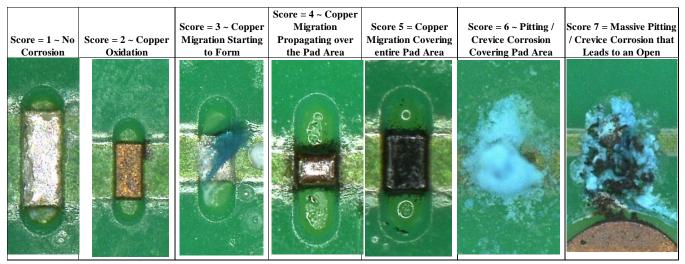
Figure 18 - Grading Scale Following Environmental Testing

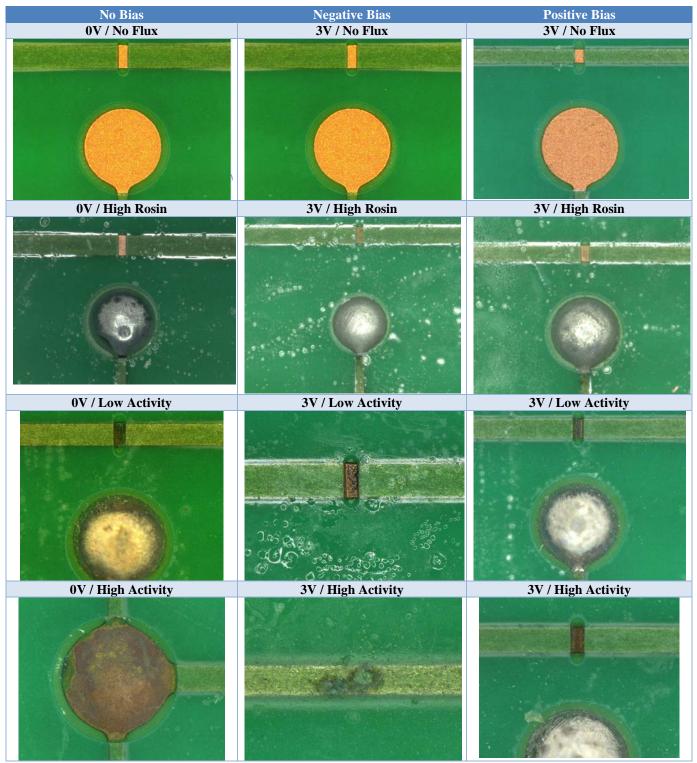
Figure 19 – Visual Images from a Subset of Conditions Tested

The un-fluxed boards did not corrode at (40°C, 85% RH), while some of the fluxed samples corroded significantly when exposed to the moisture in the test chamber. Figure 19 provides a look at a subset of boards for the control and three fluxes tested.

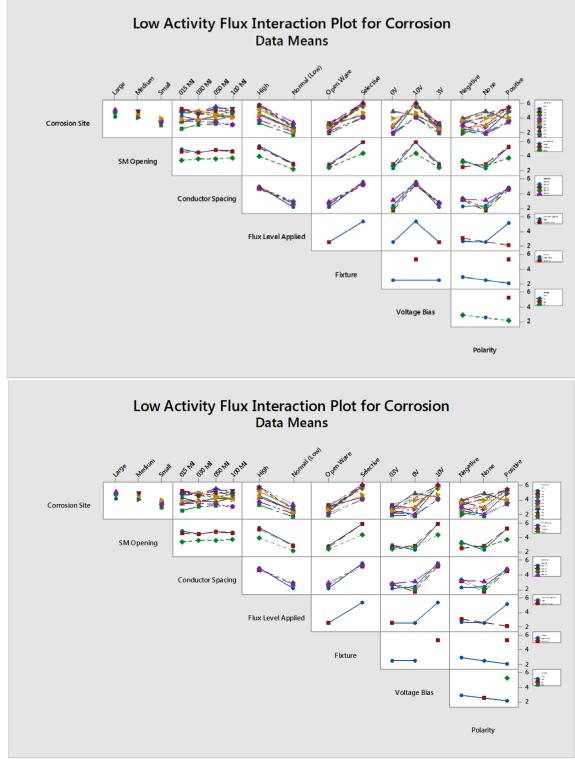
Figure 20 – Effect of Low Activity No-Clean Flux

For the Low Activity No-Clean Flux, the data findings in Figure 20 reveal key factors that accelerate corrosion. The samples using a selective solder fixture, which shields flux residues from activation temperature, showed higher corrosion than those soldered with an open solder fixture. On sites with larger exposed copper features, sizes A and B, corrosion was worse, particularly at 10V. Conductor spacing from power to ground was not material. Voltage bias is a significant factor with higher voltage increasing corrosion. The higher quantity of flux applied resulted in more corrosion.

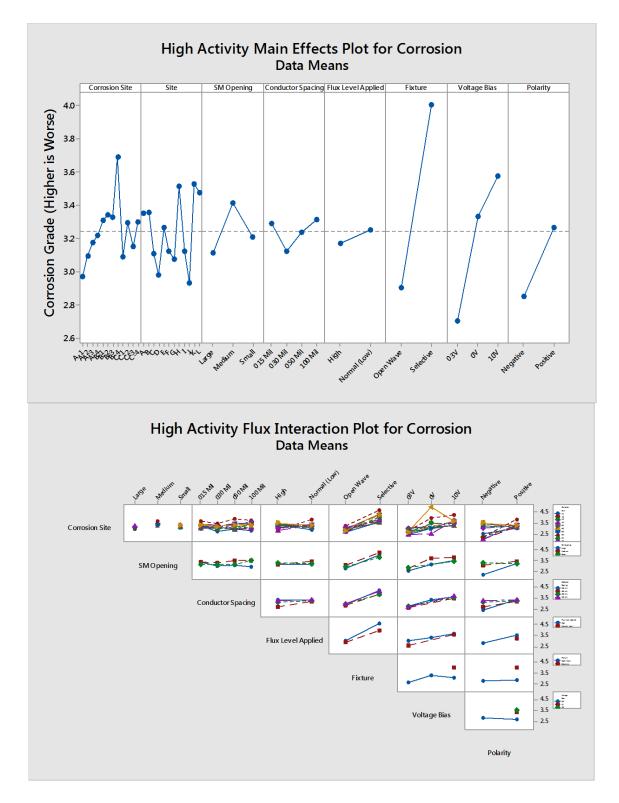
Figure 21 - Effect of High Activity No-Clean Flux

For the High Activity No-Clean Flux, Figure 21, the data finds the flux level applied was not statistically significant. The data did find that the boards processed with the Selective wave fixture corroded at higher levels than boards' process within the Open wave fixture. The data found the spacing between the ground and power was not materially significant. Voltage bias is a significant factor with higher voltage increasing corrosion.

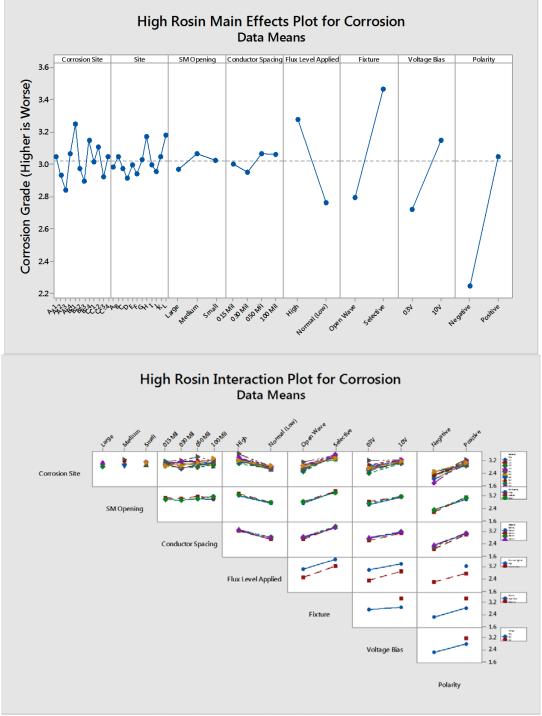
Figure 22 – Effect of High Rosin Flux

For the High Rosin Flux, Figure 22, the data finds the higher flux levels increased corrosion potential. The data did find that the boards processed with the Selective wave fixture corroded at higher levels than boards' process within the Open wave fixture. The data found the spacing between the ground and power was not materially significant. Voltage bias is a significant factor with higher voltage increasing corrosion. A positive bias showed more corrosion than boards applied with a negative bias.

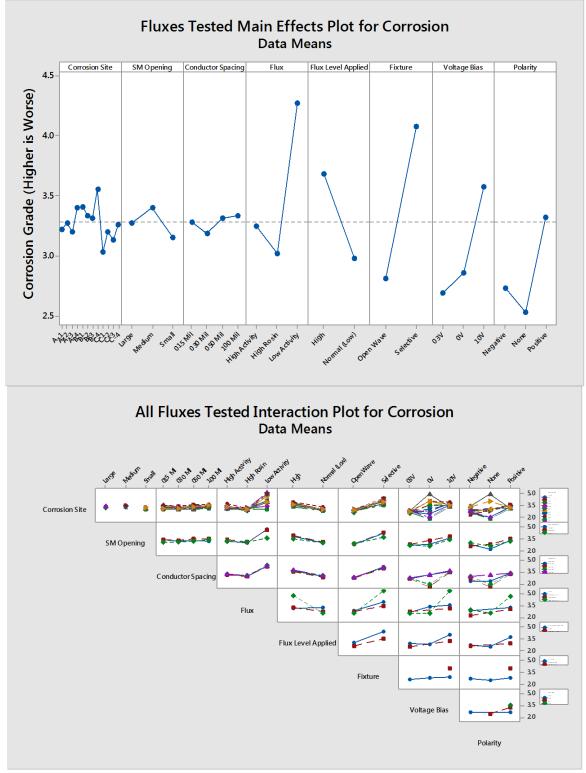
Figure 23 - Pitting / Crevice Corrosion Potential from Factors Tested

The Low Activity No-Clean flux showed the greatest levels of corrosion to copper. On boards using the selective soldering fixture, the corrosion levels were greater as compared to the open wave fixture. Even though the data can be misleading, the higher voltage applied correlated to greater the corrosion potential. The number of boards tested without bias was low but on the boards tested, the corrosion seen on copper was higher than expected.

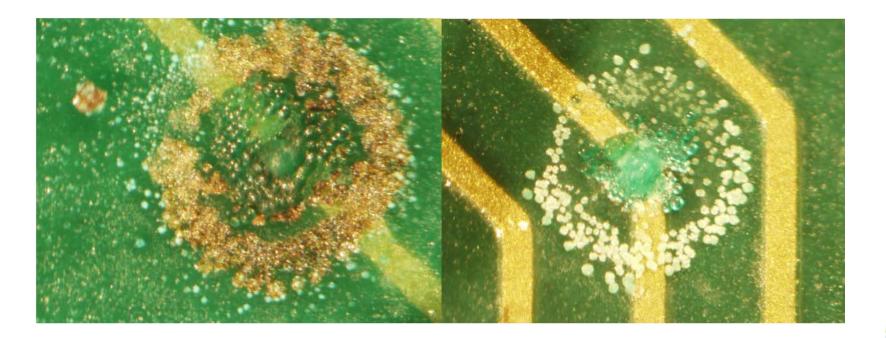
- Starts as an advanced form of uniform etch
- The combination of small active anodes attracted to large passive cathodes initiates the corrosion

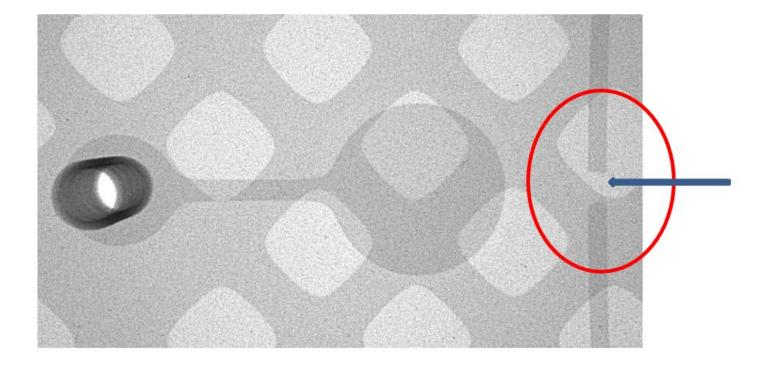
Failed Board

- X-Ray image of a board that failed from pitting corrosion
- Corrosion ate through the copper power trace

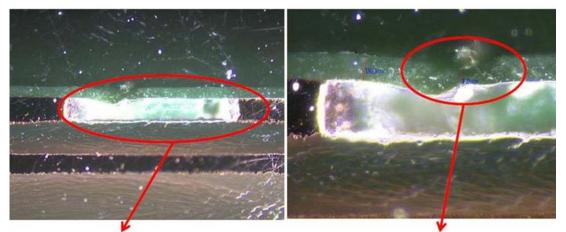
Open trace from pitting corrosion

Solder mask defect that initiated pitting

ECM corrosion

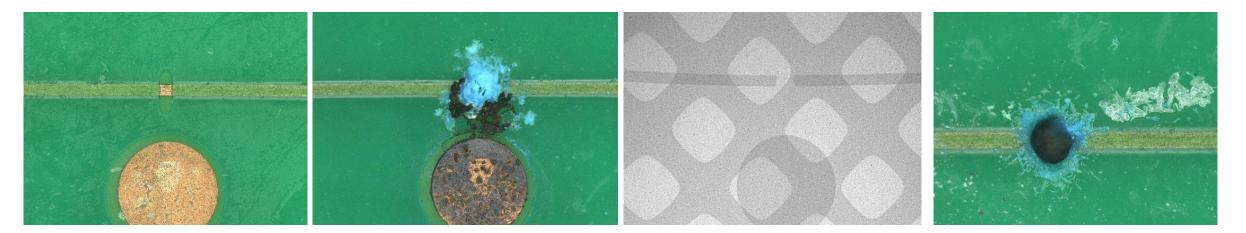
Has been reproduced in the test environment, and key testing variables have produced significant differences in corrosion rates.

Time Zero Inspection

6 weeks in T&H chamber: ECM and pitting X Ray showing the open trace

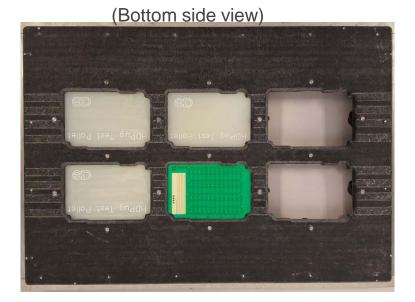
Full open wave solder fixture

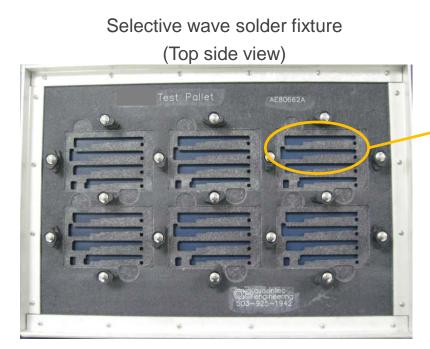
Selective wave solder fixture opening

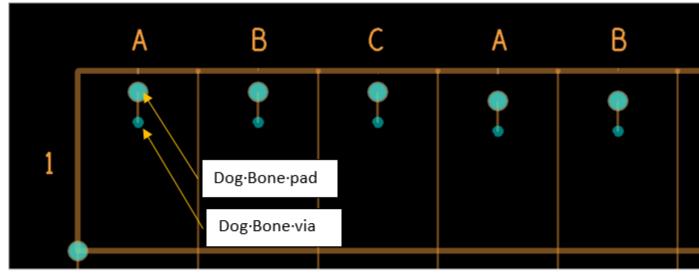
- Provide corrosion points at the
 - Copper plated via holes
 - Copper ground pads
 - Solder mask interfaces

$Figure {\bf \cdot 11} {\bf \cdot - Dog} {\bf \cdot Bone} {\bf \cdot \underline{Via}} {\bf \cdot Ground} {\bf \cdot Plane} {\bf \cdot Connection}$

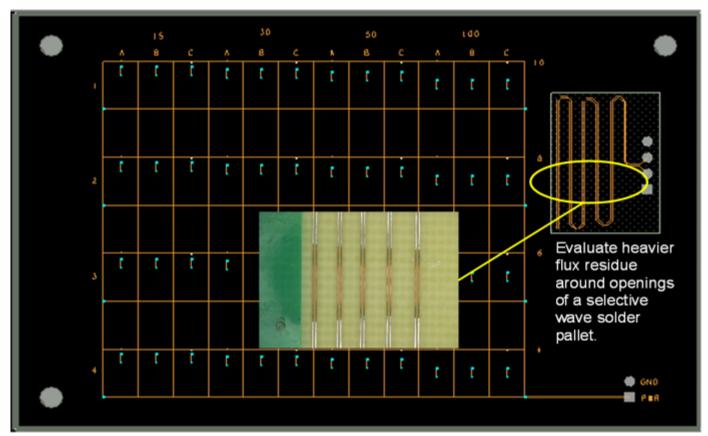
• Designed to test flux resistance

$Figure \cdot 12 \cdot - \cdot Flux \cdot Residue \cdot Comb \cdot Pattern \cdot Test \cdot Site \cdot$

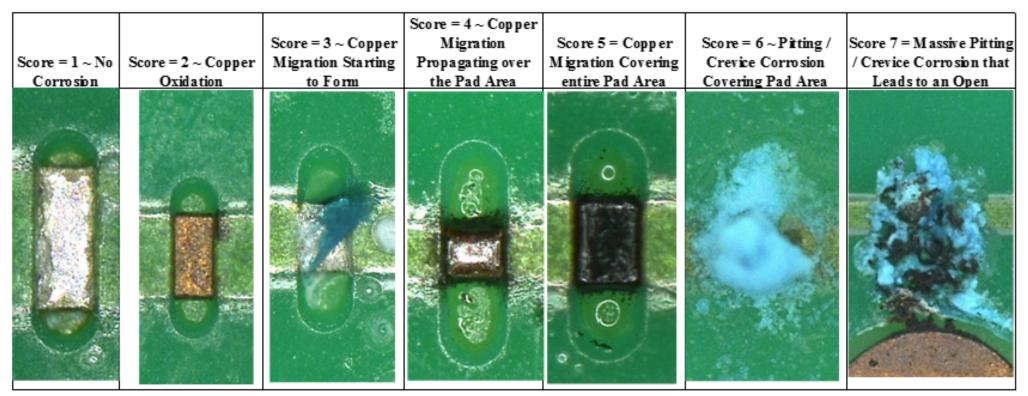
• Corrosion on boards was placed into a grading scale

Figure 17 -- Grading Scale Following Environmental Testing
