Does Thermal Cycling Impact the Electrical Reliability of a No-Clean Solder Paste Flux Residue

Eric Bastow
Indium Corporation
Clinton, New York

No-clean solder pastes are widely used in a number of applications that are exposed to wide variations in temperature during the life of the assembled electronics device. Some have observed that cracks can and do form in flux residue and have postulated that this is the result of or exacerbated by temperature cycling. Furthermore, the potential exists for the flux residue to soften or liquefy at elevated temperatures, and even flow if orientated parallel to gravity. In situations, such as in automotive electronics, where significant temperature cycling is a reality and high reliability is a must, concern sometimes exists that the cracking and possible softening or liquefying of the residue may have a deleterious effect on the electrical reliability of the flux residue. This paper will attempt to address this concern.

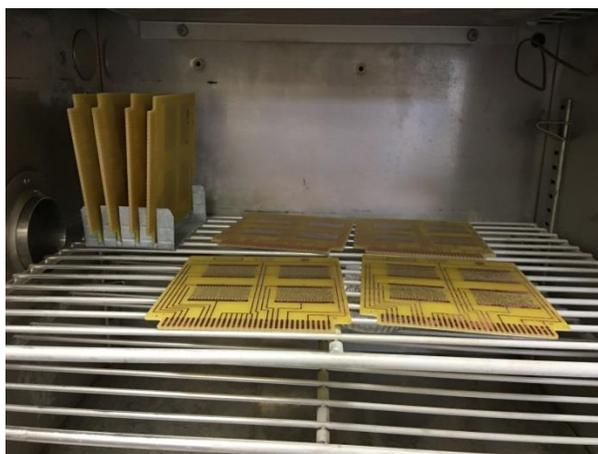
Figure 2 shows the orientation of the boards in the -40°C to +125°C chamber as photographed at the completion of the temperature cycling. The vertically-orientated boards can be seen in the metal rack on the left. The rack was orientated so that the flow of air could pass between the boards.

Figure 2 - Orientation of the Boards in the -40°C to +125°C Chamber

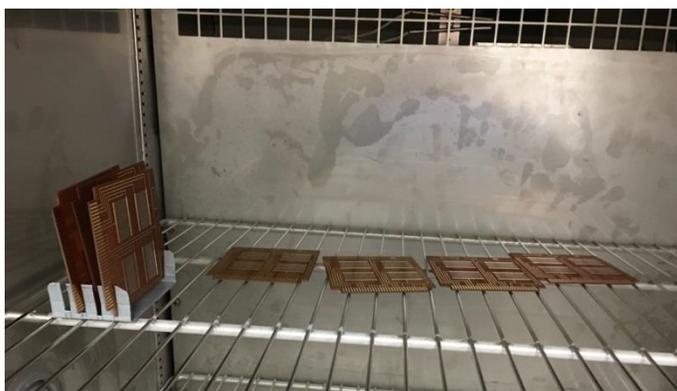
Figure 3 shows the orientation of the boards in the -55°C to +175°C chamber as photographed at the completion of the temperature cycling. The vertically-orientated boards can be seen in the metal rack on the left. The rack was orientated so that the flow of air could pass between the boards.

Figure 3 - Orientation of the Boards in the -55°C to +175°C Chamber

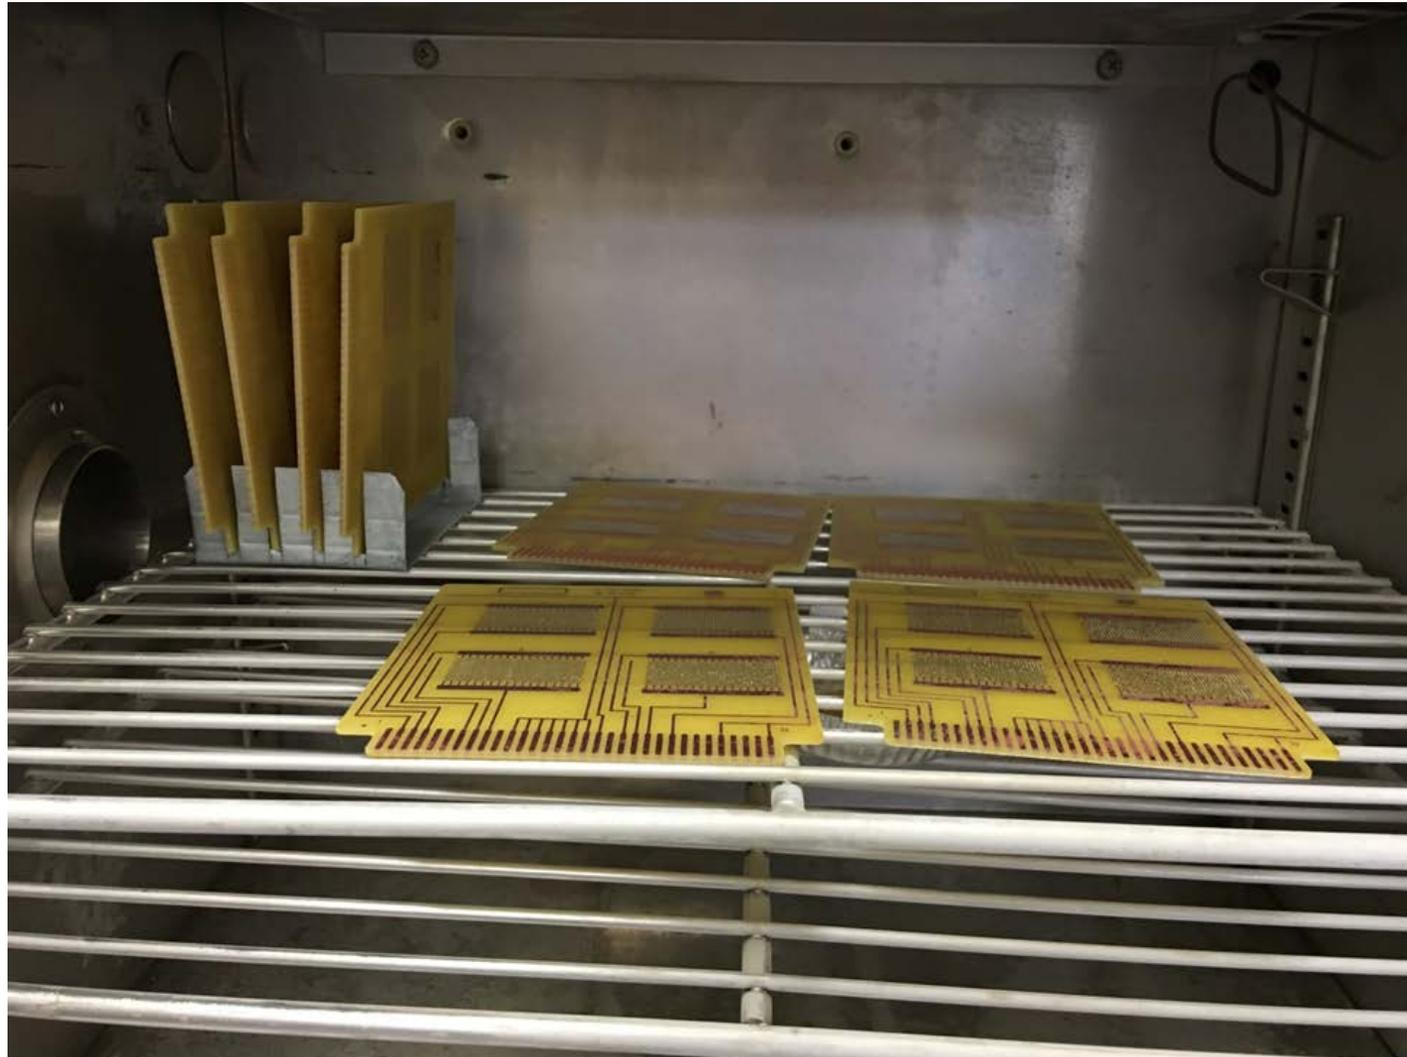
Orientation of the Boards in the -40C to +125C Chamber

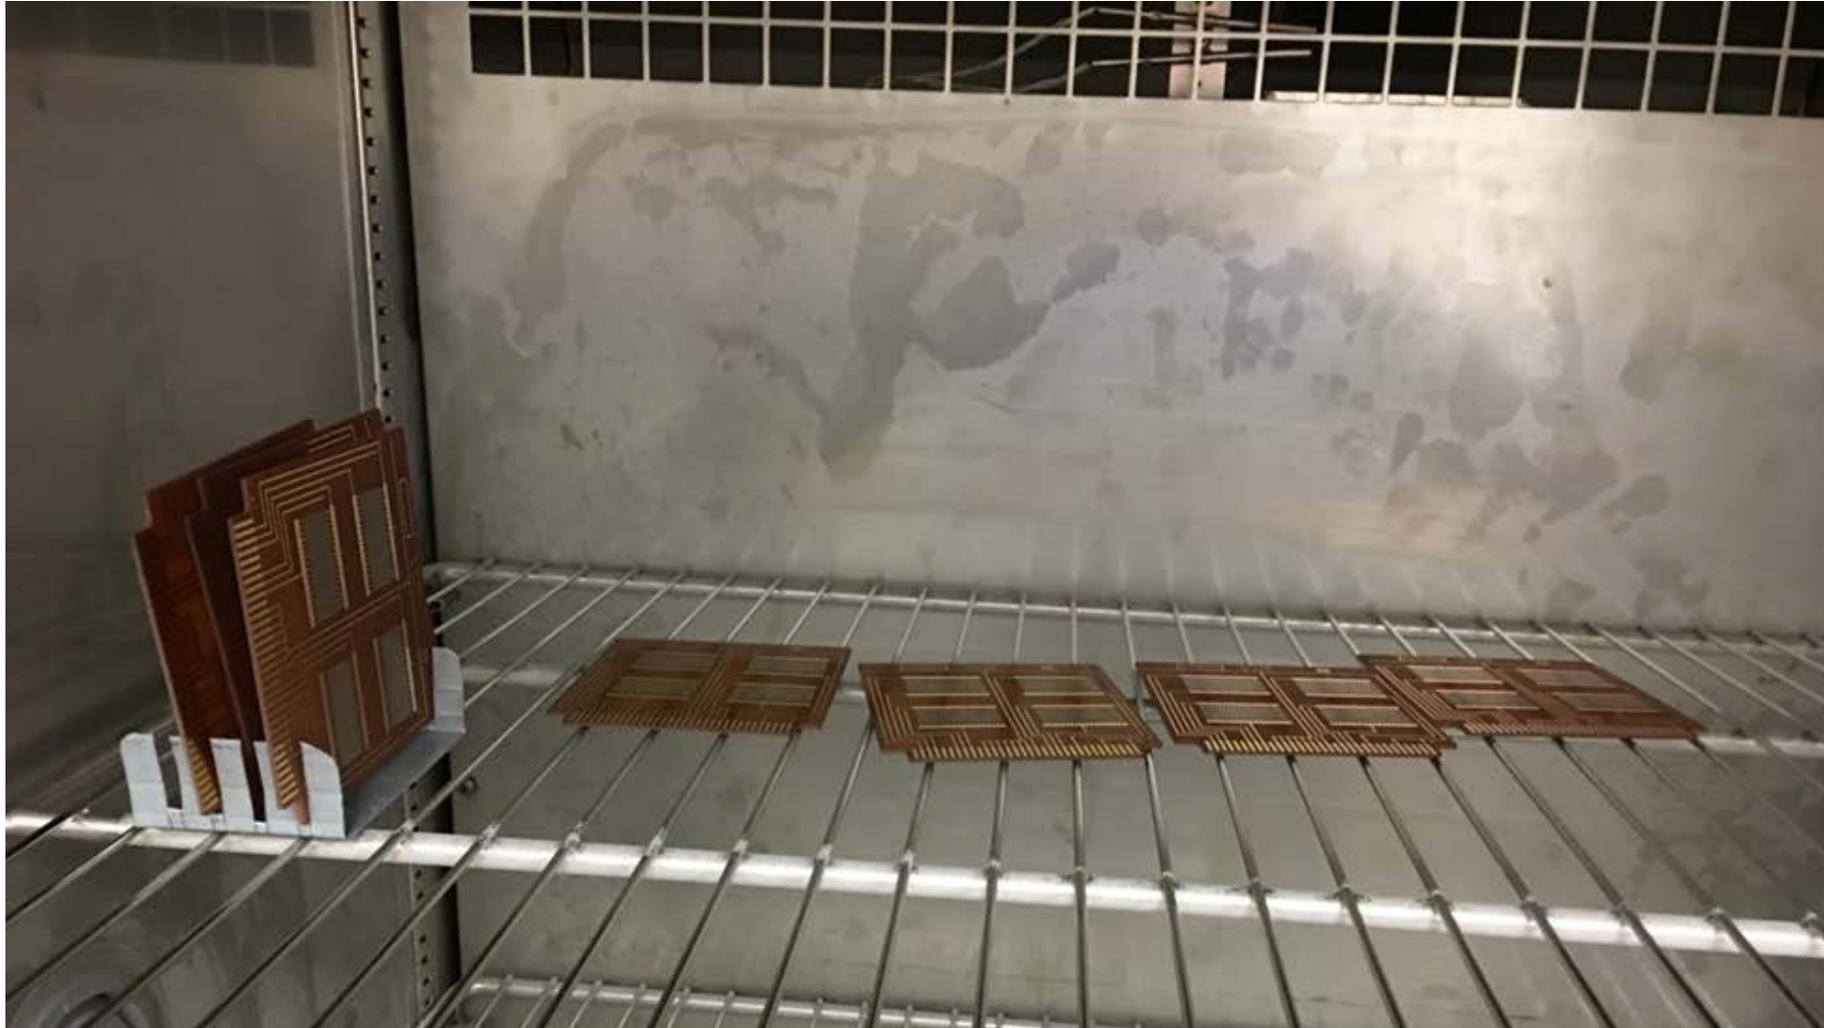
Orientation of the Boards in the -55C to +175C Chamber

Orientating the boards so that they were parallel to gravity did not seem to cause any substantial “flow” of the flux residue when the thermal cycle exceeded the softening point of the rosin. Any “flow” that did occur seemed to be more of a wetting or wicking action of the flux across the surface of the board. Keep in mind that there is no solder mask on the SIR test boards. They are bare FR4.
