# SIR Test Vehicles – Comparison from a Cleaning Perspective

Naveen Ravindran, Umut Tosun  
ZESTRON Americas  
Manassas, VA

There are numerous test vehicle options available to the industry for conducting SIR analysis. This study was designed to compare different SIR test vehicles, from a cleaning perspective, in order to determine which, test vehicle is tougher to clean and therefore challenge the cleaning process.

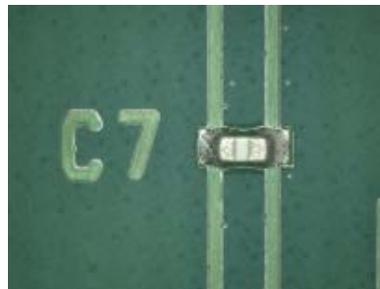
1. IPC-B-52 Rev B populated with:
  - a. QFP160
  - b. 0402SMC
  - c. 0603SMC
  - d. 0805SMC
  - e. 1206SMC

**Figure 1. IPC-B-52**

The SIR test vehicles used were the IPC-B-52 (Figures 1-3), IPC-B-36 (Figures 4-6) and the SMTA Saber (Figure 7). Each vehicle was screened using lead-free water soluble solder paste, 6 mil thick stencil and reflowed per the manufacturer’s recommendation. Figures 2 and 3 are representative pictures of low standoff chip cap components. For the SIR evaluation, each coupon type was populated as follows:

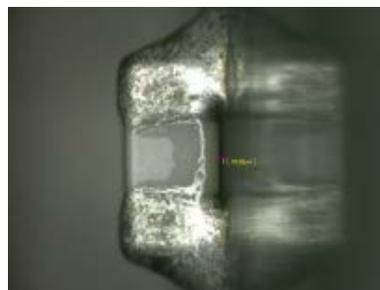
**Figure 2. 0402 component**

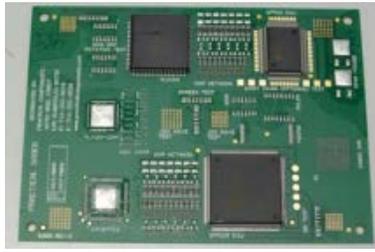
3. SMTA Saber Test board (Rev E) populated with:
- a. QFP208
  - b. QFP100
  - c. 0402SMR
  - d. 0603SMR
  - e. 0805SMR
  - f. 1206SMR
  - g. PLCC68

**Figure 7. SMTA Saber Test Board**

Standoff measurements could not be made on the SMTA Saber board due to the orientation of the chip components.

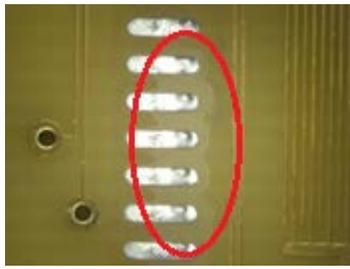
Representative pictures of the residues noticed in Trial 4 on all the board types are below:

Figure 11. IPC-B-36 Boards

- The IPC-B-36 board is the most difficult to clean. Thus, 100% cleanliness could not be achieved even at the reduced conveyor belt speed of 1 ft/min with just DI-water. Additionally, residues could be seen on the surface at the faster belt speeds.

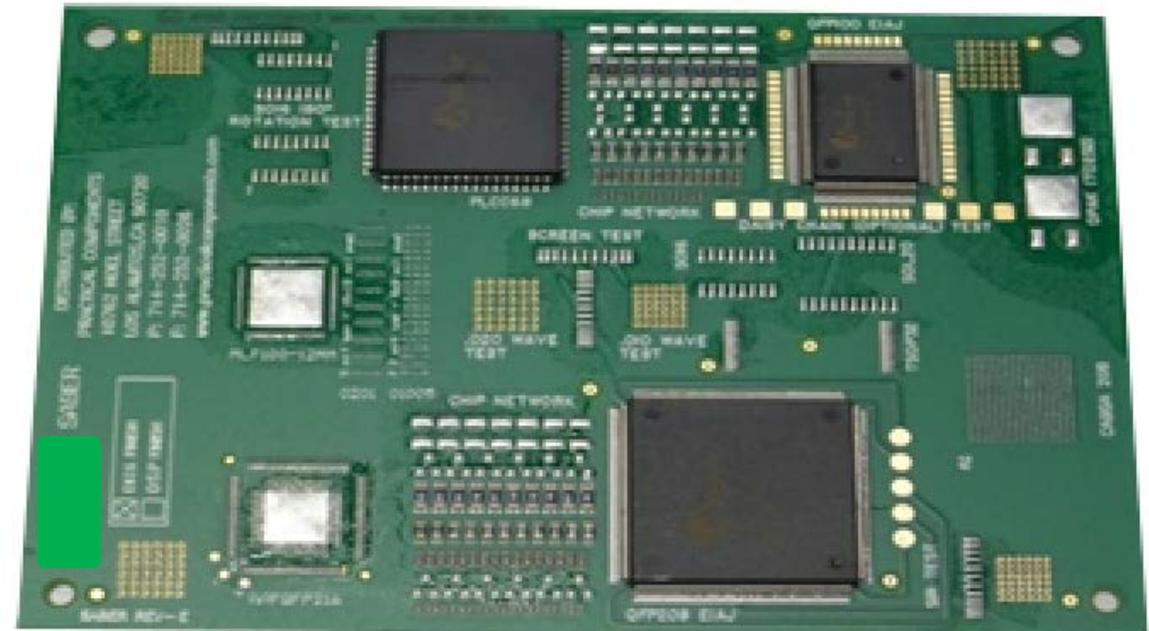
- SMTA Saber test board (Rev E) populated with
  - QFP208
  - QFP100
  - 0402SMR
  - 0603SMR
  - 0805SMR
  - 1206SMR
  - PLCC68

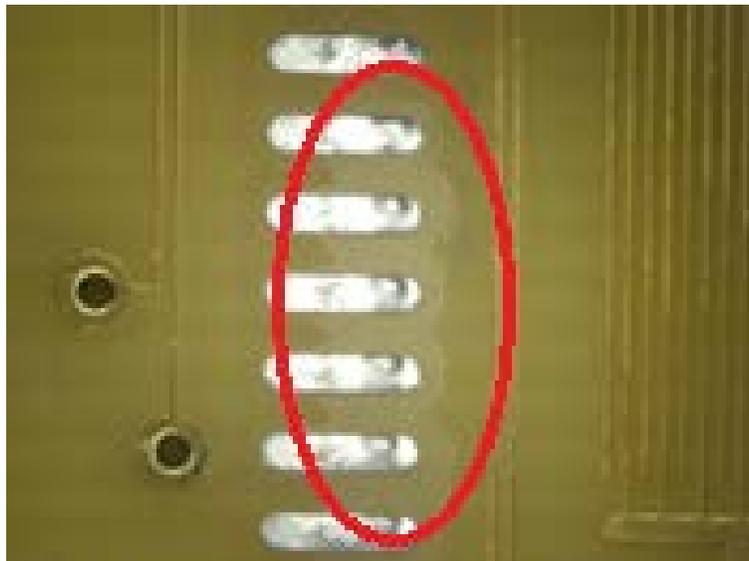
- IPC-B-36 Test Vehicles: Residues noticed in Trial 4
