AN INVESTIGATION INTO THE DURABILITY OF STENCIL COATING TECHNOLOGIES

Greg Smith and Tony Lentz
FCT Assembly
Greeley, CO, USA

ABSTRACT

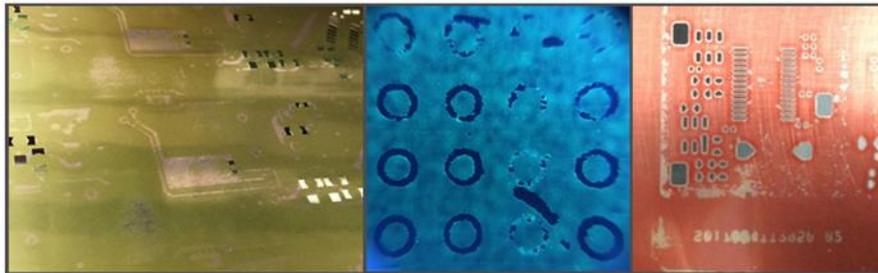
Figure 5: Damage to FPN Coatings

- When the sharp, thin edge of the squeegee pushes down against the stainless foil, over raised areas on the PWB, the friction between the coated side of the stencil and the uneven surface of the PWB eventually causes both types of coating to be worn away. In many instances this can be seen with PWB traces, venting patterns and even silkscreen rubbing off the coating in specific patterns as per the examples in Figure 5 below.

- In high volume applications, the coating chips or flakes off of the surface of the stencil around the apertures and in areas where there are no apertures. The amount of chipping or flaking varies depending on the process variables that are applied to the particular stencil. This can be seen below (Figure 5).

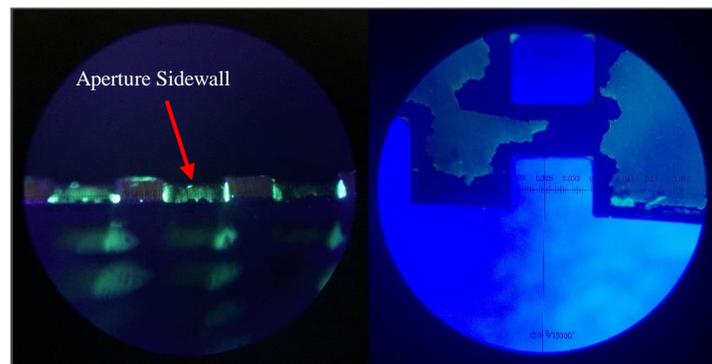
Figure 6: Cross Section and Surface Wear, 10,000 prints

Inspecting the retired stencil with 10,000 prints in the images above, the image on the right shows the coating has come off around the surface of the 15 mil apertures. After cross sectioning the same apertures, one can see the coating is still in the aperture walls (left image above). The UV tracer added to the coating fluoresces verifying the coating is still present.

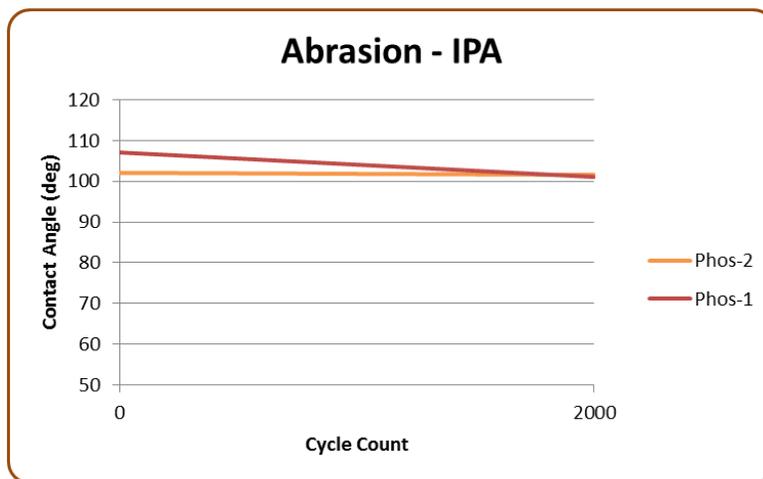
Figure 9: Contact Angle of Two Phosphonate Coatings Over 2000 Scrub Cycles with IPA

This test shows a slight decrease in contact angle for the Phos-1 coating while the contact angle for the Phos-2 coating did not change. Both coatings retained their hydrophobicity in this test. When running these type of abrasion / chemical resistance tests the data must be interpreted as a comparison of one technology to another within that particular test run. It is common for different batches / lots of monolayer phosphonate coatings to give slightly different contact angle results. Contact angles also change slightly from one stencil surface to another based on coating uniformity. Phosphonate coatings are applied manually which induces some variability in the uniformity of the coating.

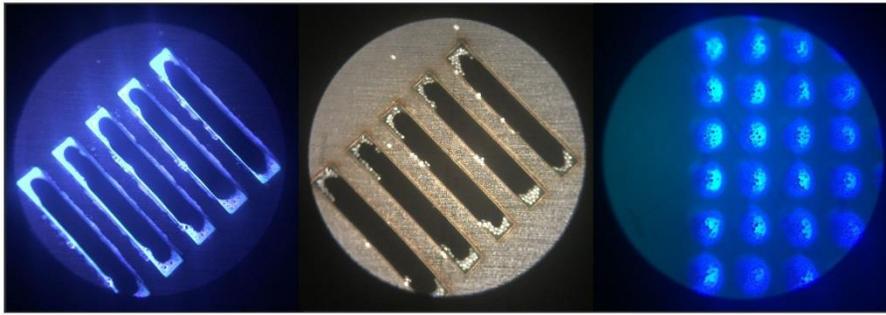
Figure 15: FPN Coating in Aperture Walls, Phosphonate on Board Side, 50 Prints, No Underside Clean

To test the effectiveness of the R & D stencil coating, 50 consecutive prints were completed with no underside wipes between the prints using the previous test vehicle and a solder paste including the UV dye in the flux. The images below (Figure 15) show the bottom of the stencil after 50 consecutive prints with no underside wipes along with images of the 0.4mm micro BGA prints onto copper clad.

Minimal flux and paste are visible on the underside of the stencil after 50 prints with no under stencil wipe and no bridging is present in the paste deposited on the copper clad. Durability studies were not done on this particular stencil in that the Phosphonate coating durability along with FPN durability findings in this study will apply here as well. This coating technology is currently under evaluation.

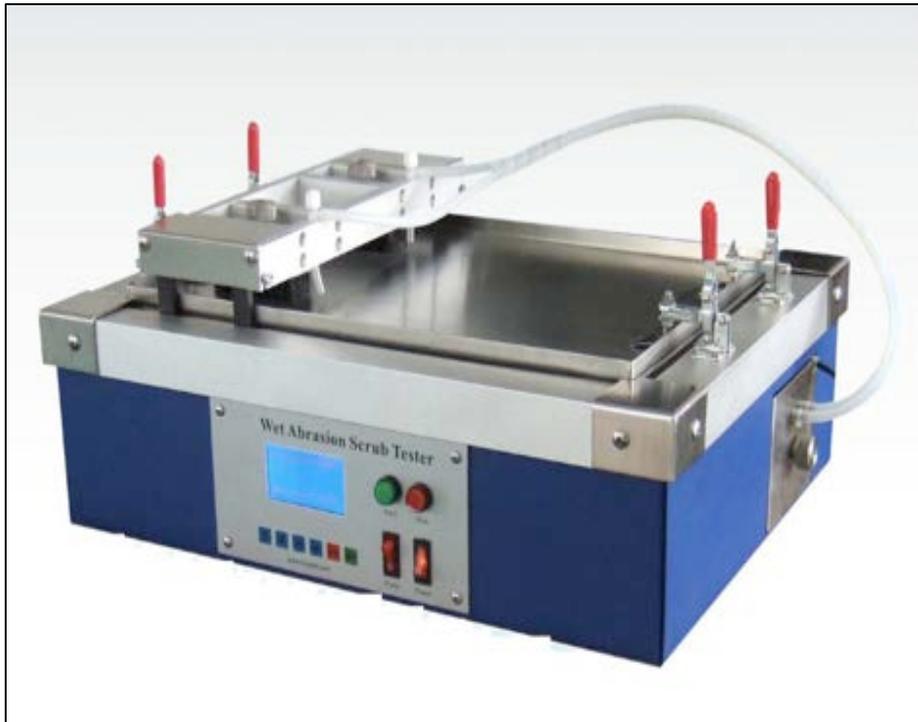
ASTM D2486 Wet Scrub Tester

- 2000 scrub cycles
- Dry and wet chemical scrub

Measured contact angle change
