Transient Solder Separation of BGA Solder Joint During Second Reflow Cycle

Steven Perng and Weidong Xie
Cisco Systems, Inc.
San Jose, CA

Transient Solder Separation of BGA Solder Joint During Second Reflow Cycle (Phase II)

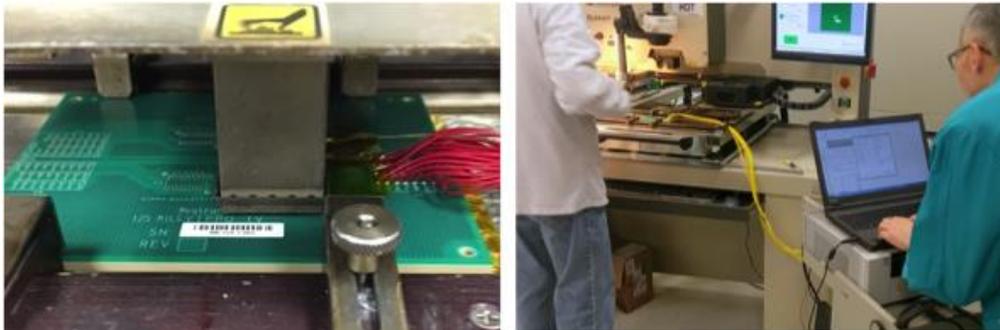
Figure 2 Experimental setup for the second reflow process

The test vehicles were assembled on a production SMT line. Then, they were reflowed again using a production rework station. Twenty-five daisy chains and two type-K thermocouples were wired to a data logger for real time data monitoring and recording.

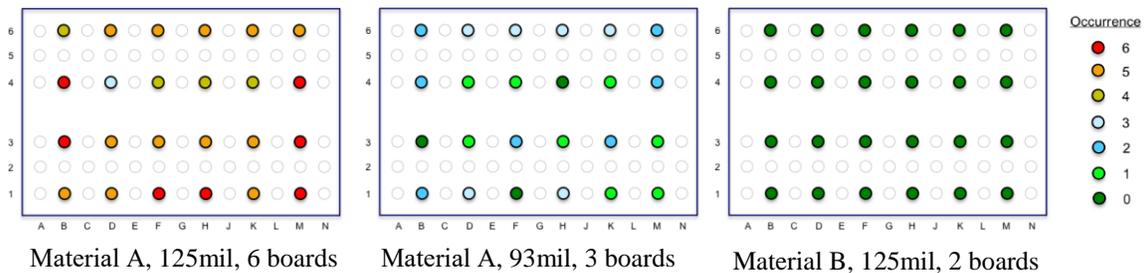
Figure 3 Frequency of Separated Solder Joint Location Analysis

The location analysis depicting the frequency of separated solder joints are shown in Figure 3. Please note that the total number of boards are different. As shown in Table 2, there are 6 boards for 125mil Material A, 3 boards for 93mil Material A, and 2 boards for 125mil Material B.

The pin mapping illustrating the frequency of separation was to determine if there is any significant failing trends on corner versus edge or inner pins. For the 125mil Material A boards, all 7 pins with 100% failing rate (6 out of 6) were all edge pins. A similar trend occurs with the 93mil Material A boards: all 6 pins with 100% failing rate (3 out of 3) were all edge pins. However, corner pins fail less frequently in both thicknesses. This may be an indication that the CTE mismatch (between VIPPO and dog-bone pad design) inducing the local stress (or warpage) is dominating the thermal stress inducing the global warpage during the reflow cycle. In other words, the typical thermal Moiré warpage measurement may not serve as an effective control gate for alerting of solder separation.

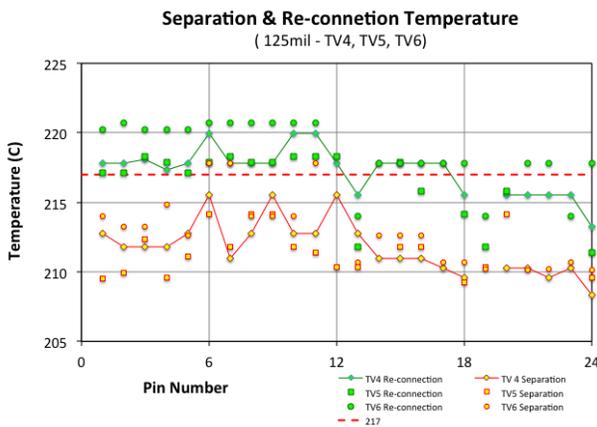
Figure 4 Separation and Re-Connection Temperature

Since each daisy chain has only one VIPPO pad, the separation and reconnection temperature can be detected when the resistance value changes abruptly. A sample analysis using 125mil TV4, TV5, and TV6 is shown in Figure 4. Out of the 71 VIPPO joints on these three boards, 63 separated. All 63 separated VIPPO joints re-connected in a short period of time.

The majority of the VIPPO solder joint separation initiated between 210°C and 215°C and re-connected just above 217°C. It indicates the VIPPO solder joint separates from substrate in solid state, just before melting. Therefore, the failure mechanism is similar to the brittle crack along the IMC line.

Meanwhile, most of the VIPPO solder joints re-connected just after becoming molten solder. It may be due to the shape change driven by surface tension. Once the solder becomes liquid, the donut shape solder joint is reformed into a more spherical shape, which fills the separation gap and re-connects the electrical path.

The low re-connection temperature pins are in the same area as the non-separated pin area. For example, Pin 13, 16, 18, 19, 20, and 24 of TV5 are reconnected below 217°C. While on the same 4th and 6th row area, Pin 14, 17, 21, 22, and 23 did not separate during the 2nd reflow, which leaves only Pin 17 experiencing separation.

Due to the differences of thermocouple installation, the temperature reading of the reflow simulator is higher than the rework thermocouple readings by 7~10°C. After adjusting with liquidus temperature and synchronization with the data logger, the separation is initiated at 211~214°C and reconnects at 215~218°C. This is consistent with the resistance-temperature measurement from the data logger (Figure 4).

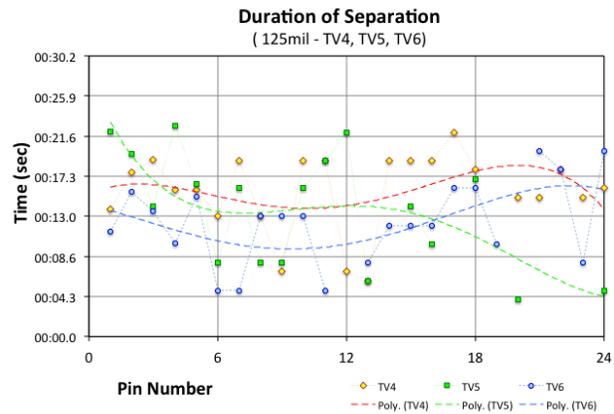
Figure 5 Duration of Separation

The duration of separation is defined as the time when the resistance value changes abruptly to a value that is less than 10 Ohms. As shown in Figure 5, the duration is in the range of 4 ~ 22 sec. The overall trend is between 9 ~ 18sec.

and component substrate, when the solder is in solid state. The solder joint starts to melt at 2:42 (222°C). As the surface reflection pattern changes, the solder joint becomes fully liquidus at around 2:50 (224°C). The solder joint re-connects at 2:53 (225°C). The duration of separation is about 18 seconds, which is consistent with the data from resistance value measurements in Figure 5.

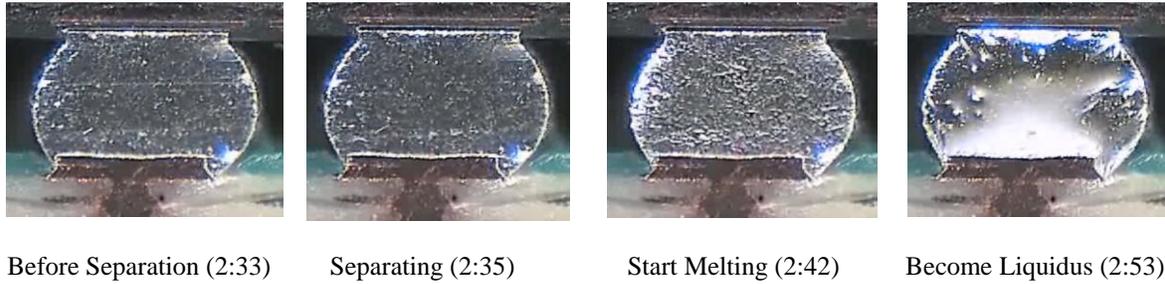
Figure 6 Solder Joint Images from Reflow Simulator

In Figure 6, the four images are from the same VIPPO joint at different time of the reflow cycle. Comparing to the image on the very left (2:33), the VIPPO joint in the middle left at time code 2:35 (221°C) exhibits a separation between the solder ball

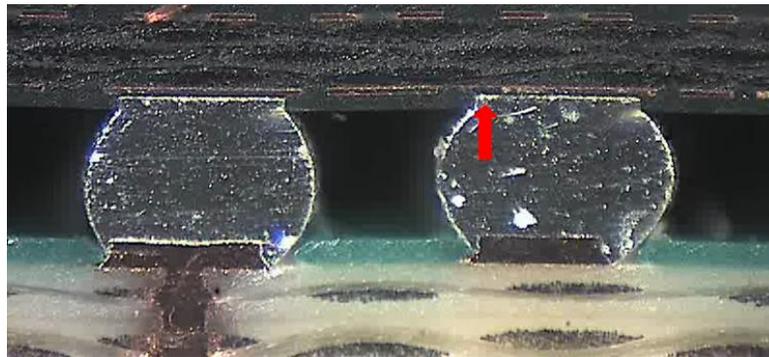
Figure 7 Solder joint image prior to separation, the dog-bone joint at the right side showed an upward pushing

By reviewing the video, it is observed that the dog-bone joints showed upward pushing as the reflow temperature increases, due to the excessive out-of-plane thermal expansion of the PCB material (as the red arrow indicates in Figure 7). The VIPPO joint separates before solder liquidus at the interface between solder and IMC of the component side; a small magnitude of pop-up of VIPPO joint at such an interface has been observed along with the sign of relief of upward pushing of the nearby dog-bone joint (Figure 8).

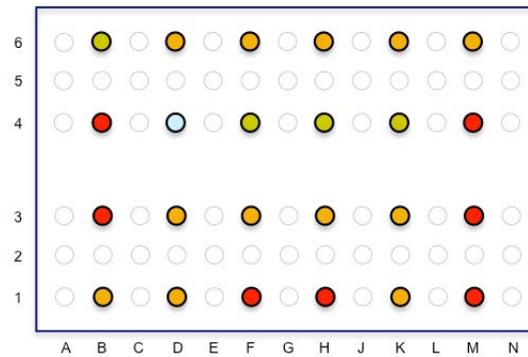
Material A, 125mil, 6 boards

- **84%** VIPPO joints separated (120 out of 143)
- **7 out of 24** joints consistently failed on all 6 boards. All seven joints are on **peripheral**.
- Each of the joints failed at least on 3 out of the 6 boards.

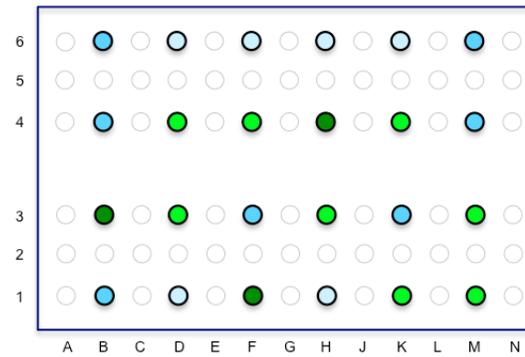
Material A, 93mil, 3 boards

- **58%** VIPPO joints separated (40 out of 69)
- **6 out of 24** joints consistently failed on all 3 boards, all six joints are on **peripheral**.
- 3 joints didn't separate for all three boards.

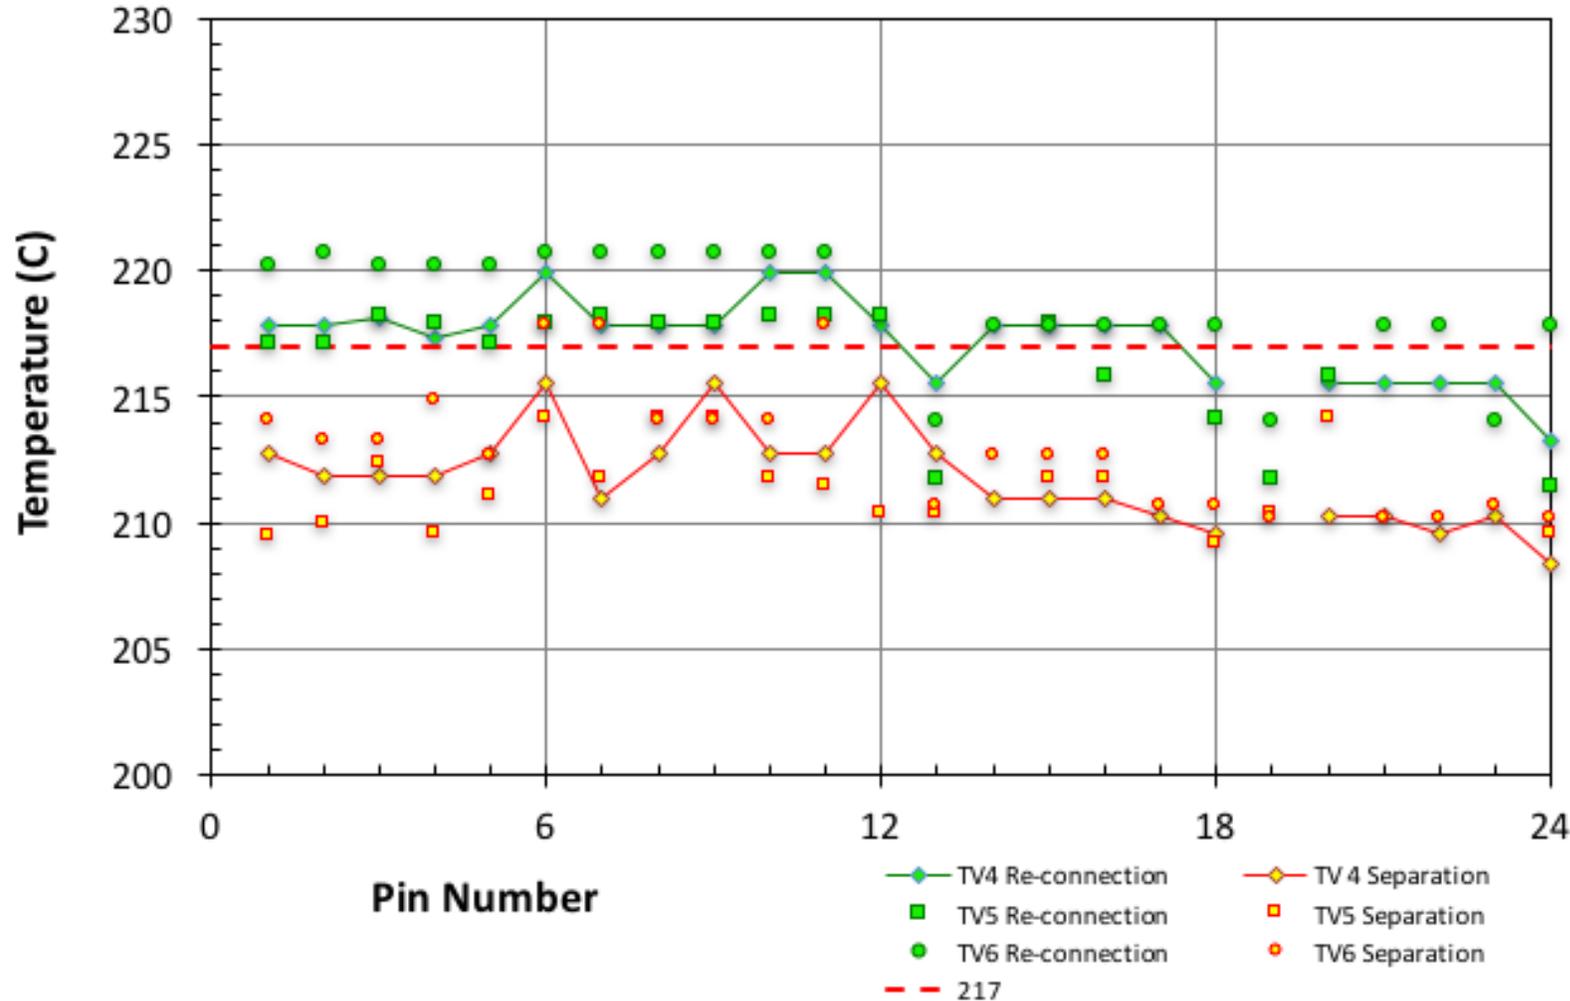
Separation & Re-connection Temperature

TV4, TV5, and TV6 of 125mil Material A are selected for analysis.

Pin 1~5 are in Data Logger 1; while Pin 6~24 are in Data Logger 2.

Pin 1~12 are toward the edge of the nozzle; while Pin 13~24 are in the center of the nozzle. Minor temperature difference is possible.

In general, the separation occurred around 210~215C, during the solid phase (before melted).

The re-connection occurred around 215~220C, either in solid phase or in liquid phase (after melting).

All the separated solder joints were re-connected.

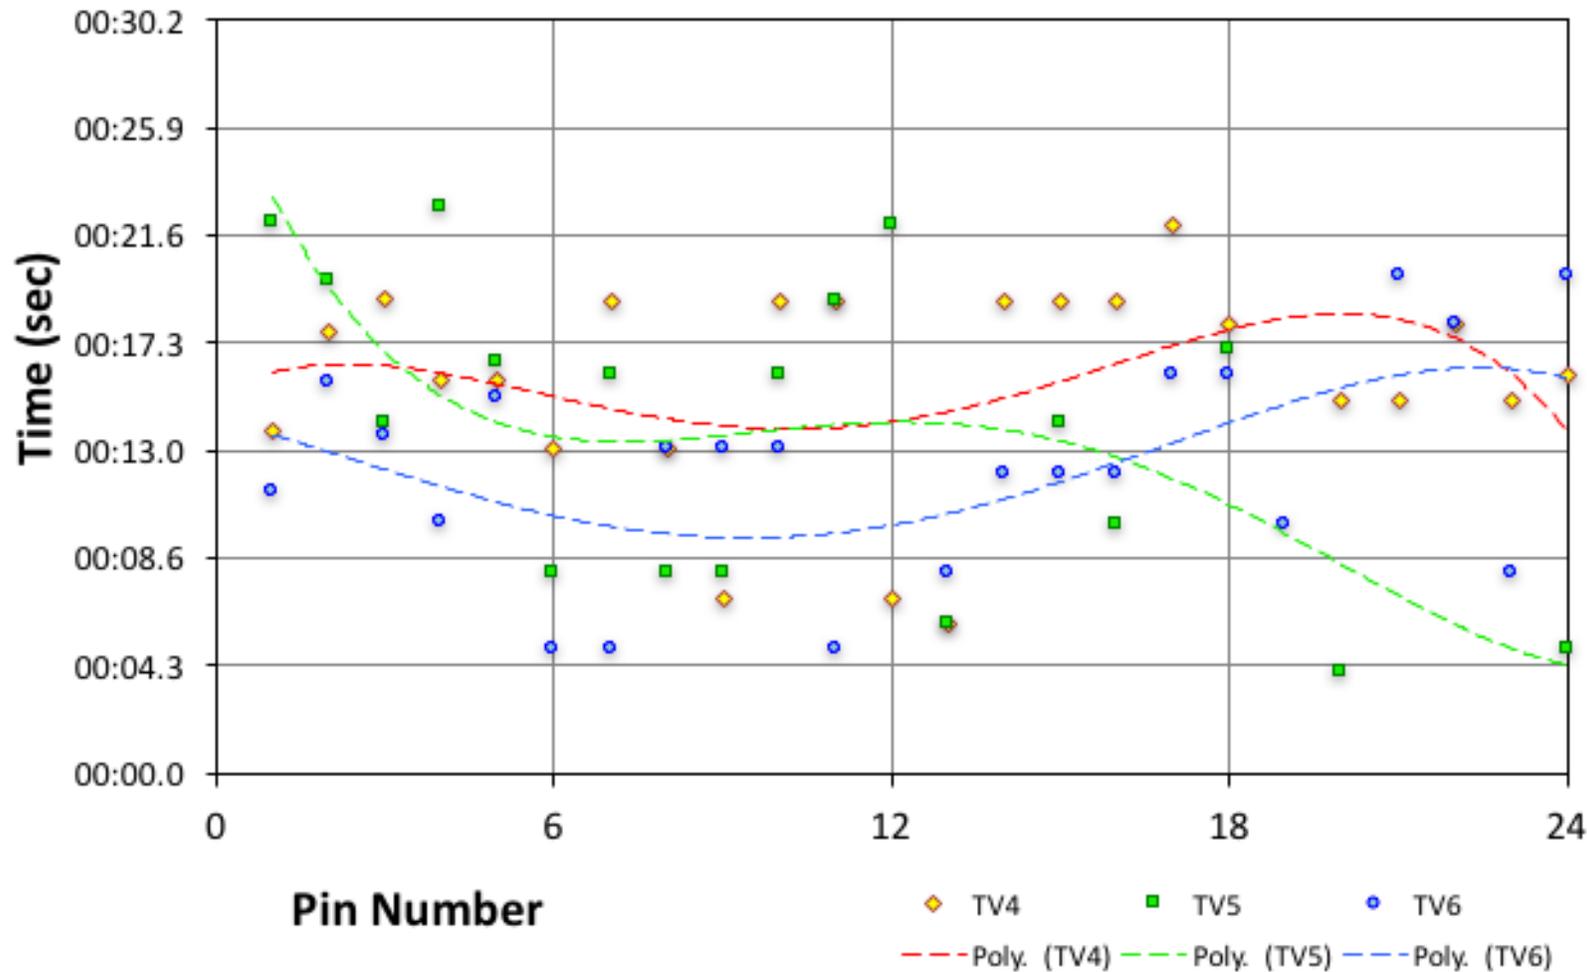
Duration of Separation
(125mil - TV4, TV5, TV6)

- The duration of separation is around 4~20 sec.
- TV5 has only 2 out of 6 joints separated, which may skew the trend.
- Majority of separation duration are around 12~18 sec.

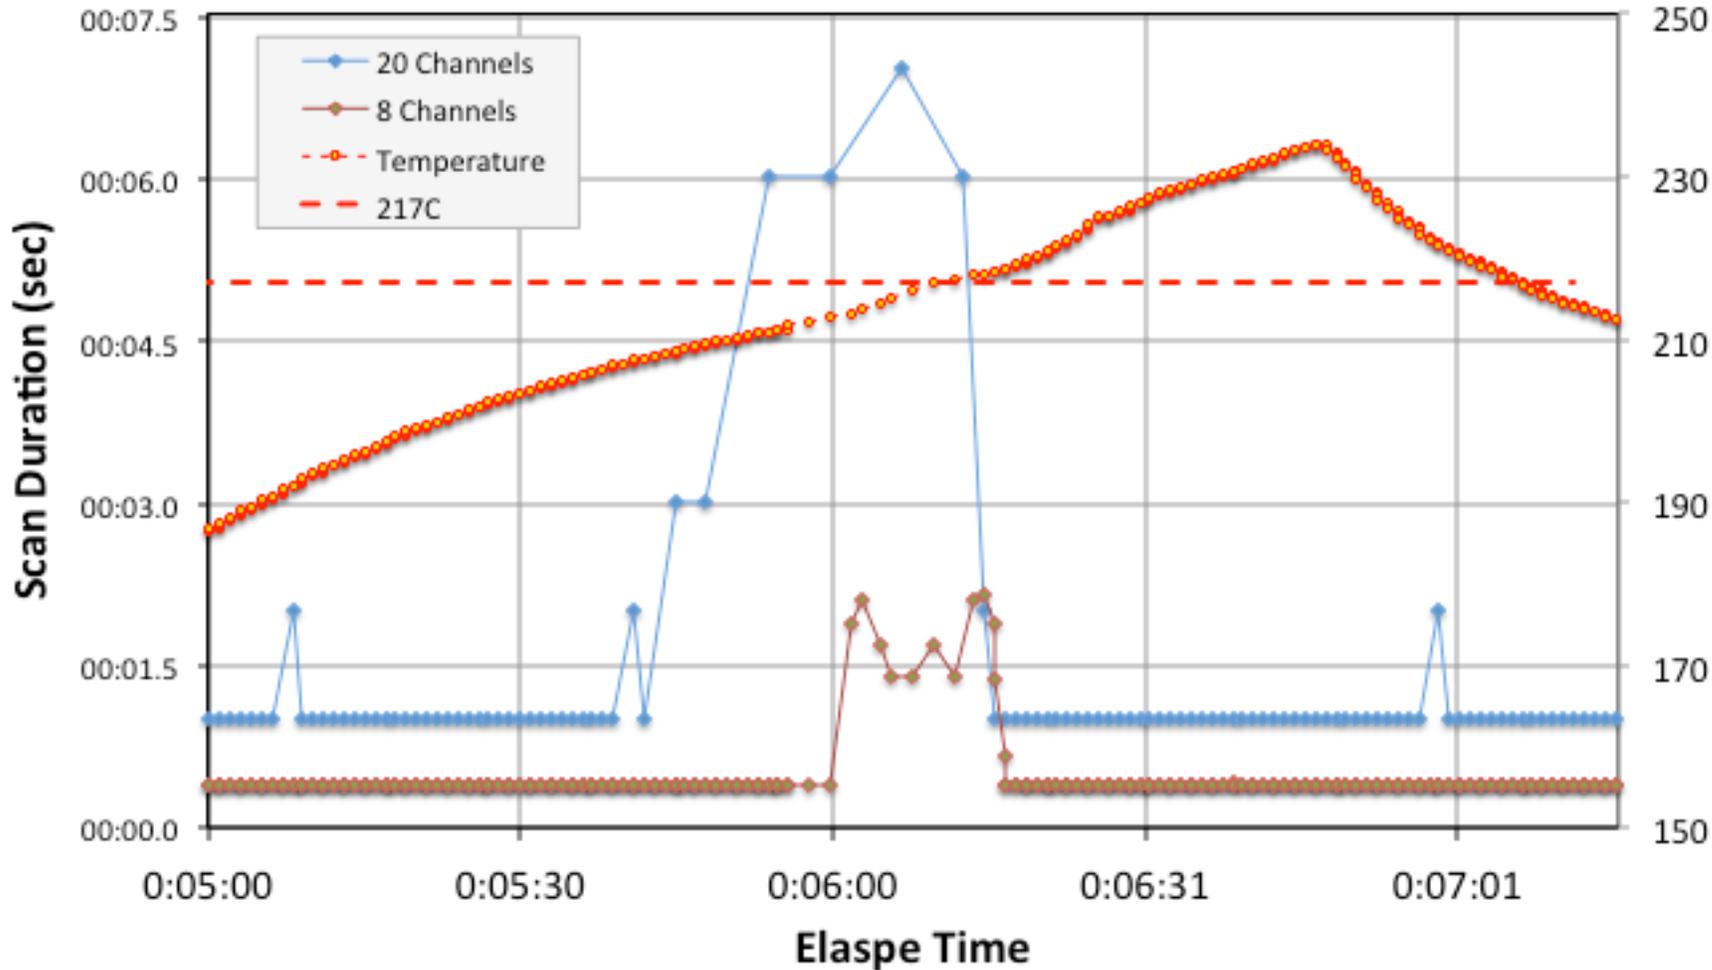
Scan Rate Analysis of One And Two Data Loggers Mode (TV4a vs. TV4b)

- All resistance and temperature measurements are routed to the data logger.
- The typical scan rate is 0.4 sec and 1 sec for 8- and 20- channel, respectively.
- However, when the measurement data is toward the MAX detection value and eventually Out-Of-Range, the scan rate increases to 2 sec and 7 sec for 8- and 20-channel, respectively.

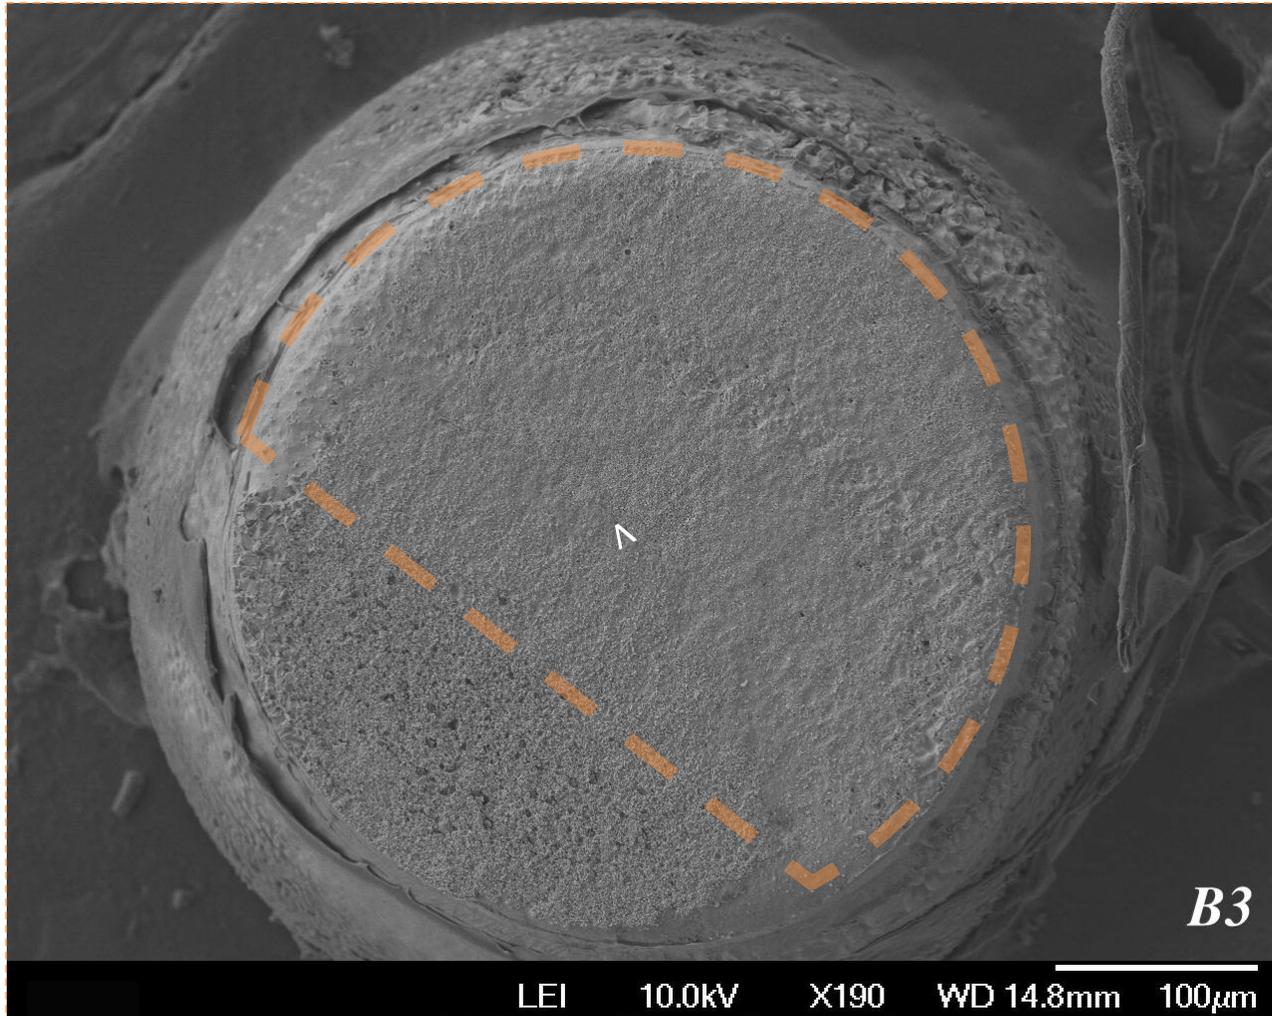
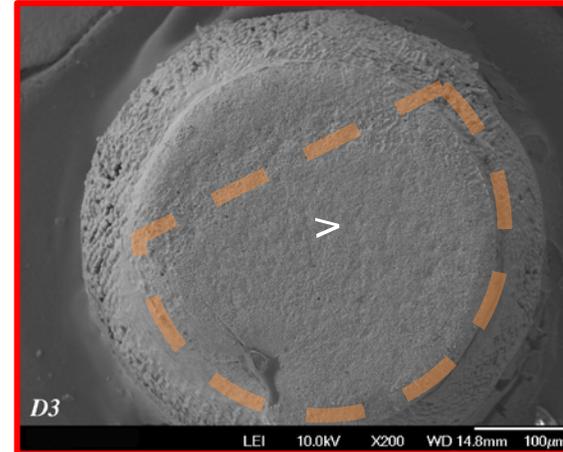
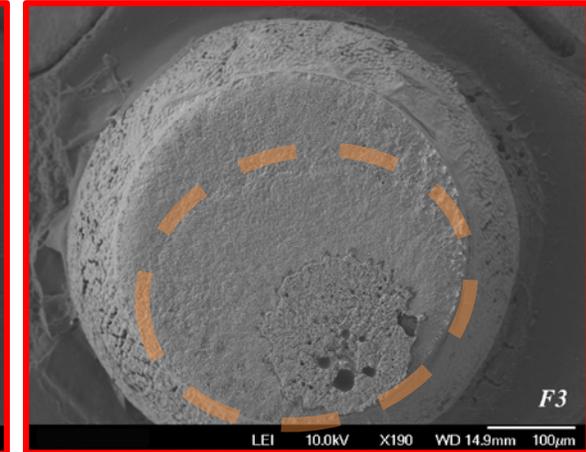
SEM of the Separated Surface (VIPPO, Top of BGA Ball, Inner Rows)

- The highlighted areas denote connected interface, as a regular solder joint.
- The exposed areas are the separated areas.

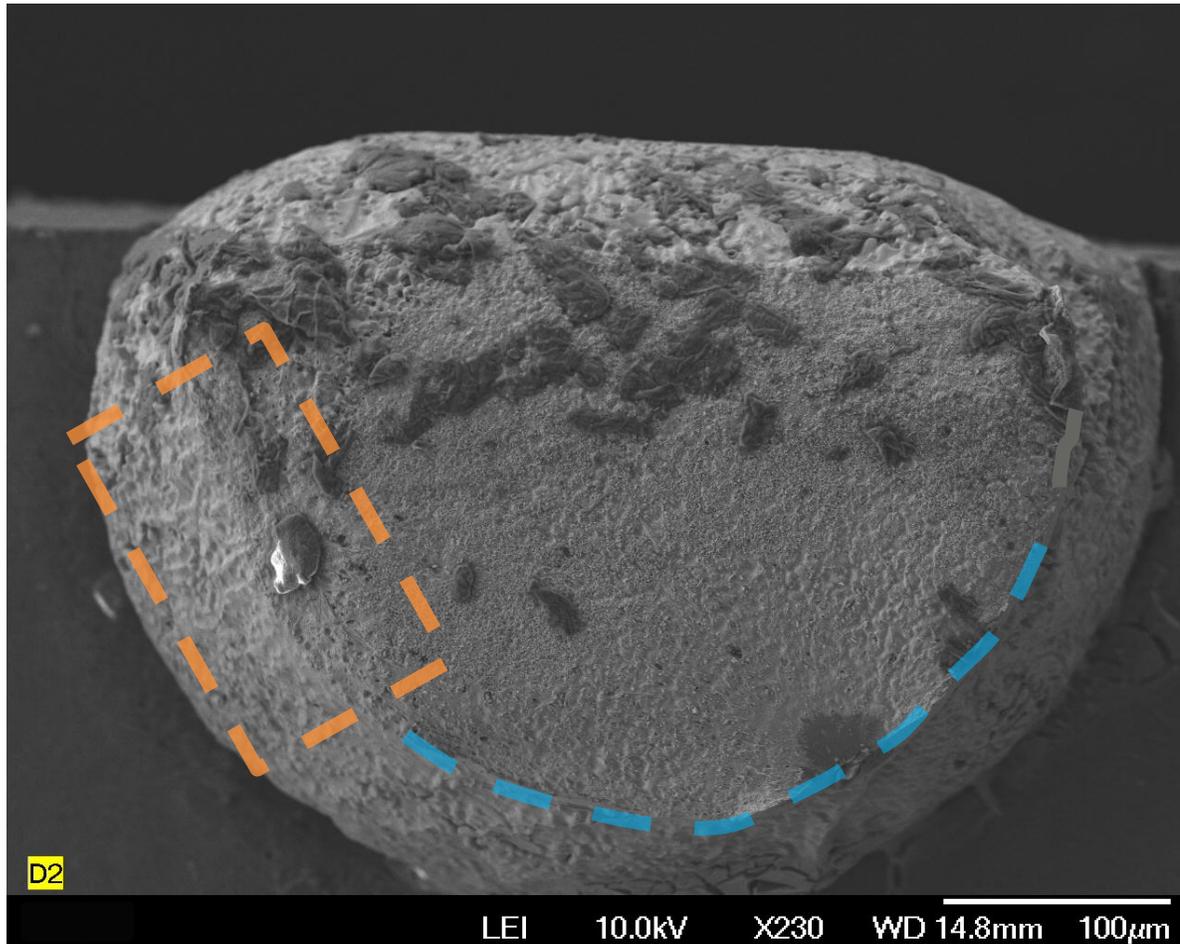
SEM of the Separated Surface (VIPPO, Top of BGA Ball, Edge Ball)

- An SEM image of the edge ball, which has been polished to 1/3 of the ball.
- The “ring” is the mark of component side pad.
- The dark black stuff may come from flux or the polishing process.
- The continuous structure in the dashed line area may be an indication of the separation.

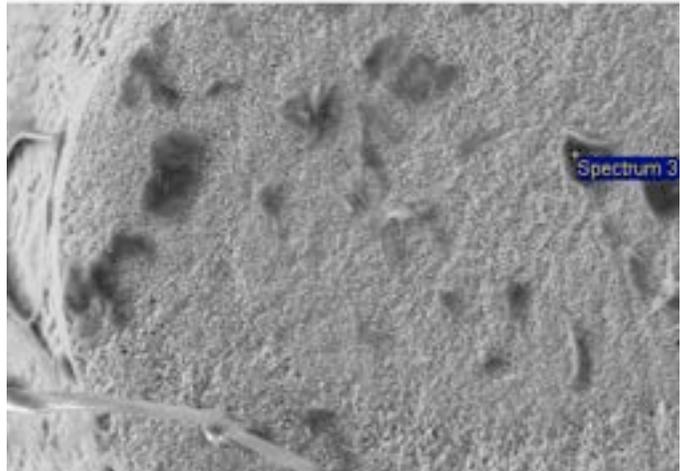
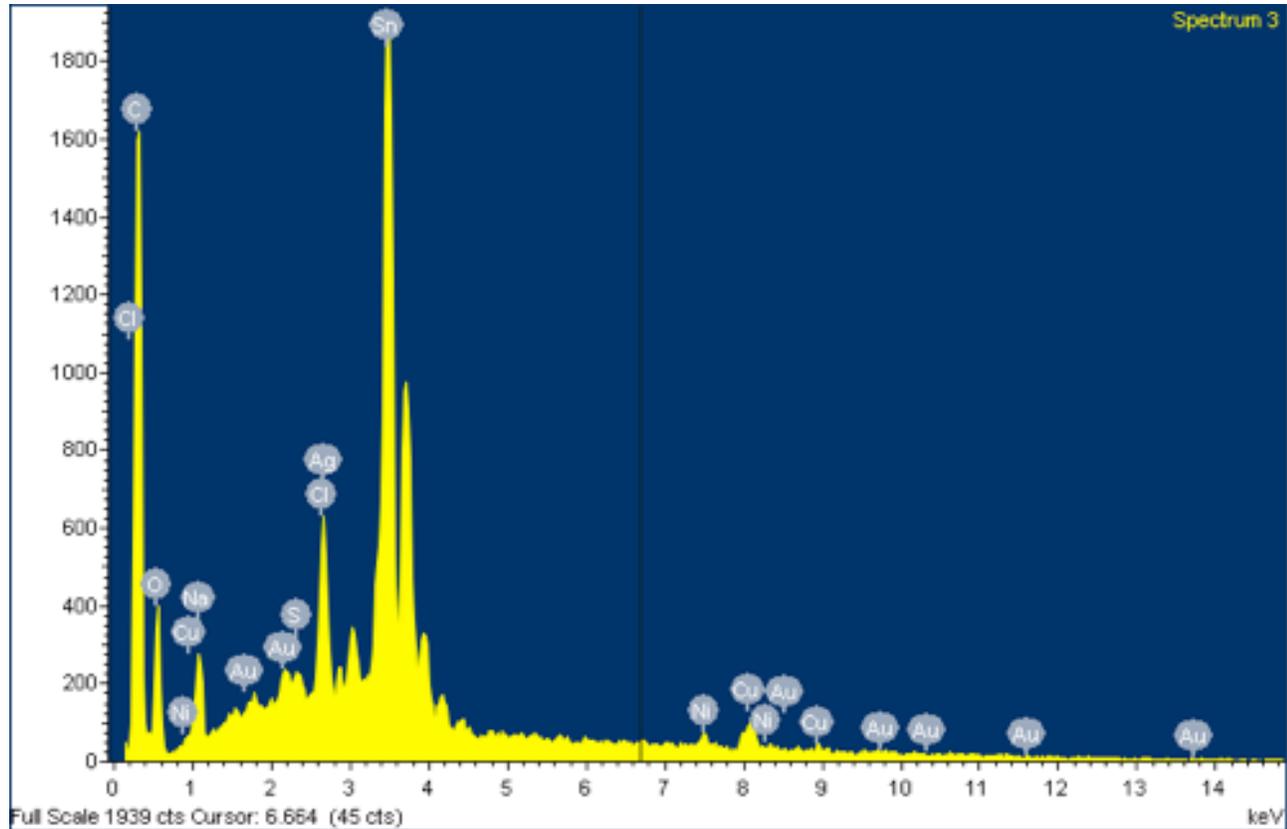
EDX of the Separated Surface (VIPPO, Ball Side)

Element	Weight%	Atomic%
C K	39.72	67.93
O K	16.19	20.79
Na K	2.51	2.24
S K	0.45	0.29
Cl K	2.94	1.70
Ni K	0.68	0.24
Cu K	2.64	0.85
Ag L	1.85	0.35
Sn L	31.54	5.46
Au M	1.49	0.16
