RoHS: 10 Years Later – IT Equipment Corrosion Issues Remain

Christopher Muller
Purafil Inc.,
Doraville, GA

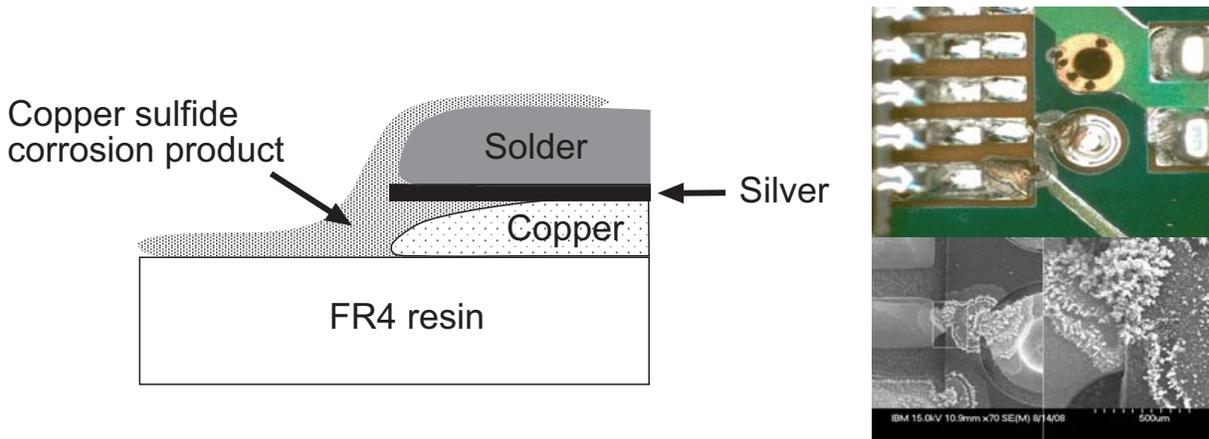
Figure 1: Schematic showing creep corrosion in cross section. Creep corrosion picture in color is at top right and a scanning electron micrograph is at the bottom right[11].

Amongst the various failure modes, creep corrosion has been the dominant corrosion-related failure mechanism since the implementation of ROHS in 2006. The restriction of lead metal in PCBs has forced the use of surface finishes, such as organic solderability preservative (OSP), immersion silver (ImAg), electroless nickel immersion gold (ENIG), immersion tin (ImSn) and various other finishes to enhance PCB solderability. Some of these finishes have made the PCBs susceptible to creep corrosion failures in corrosive environments high in sulfur-bearing contaminations [4-7]. Creep corrosion, shown in Figure 1, is a mass transport phenomenon in which solid corrosion products (typically sulfides and chlorides) migrate over a surface without the influence of an electric field and short circuit neighboring features on PCBs. Creep corrosion is highly surface sensitive and only occurs on surfaces when two prerequisites are met: a site for generating corrosion product and a surface for supporting the creep of the generated corrosion product [8-10].

For instance, for PCBs with ImAg finish, both Cu and Ag will corrode readily to form sulfides on ImAg plated Cu pads. However, if the surrounding surface (such as clean FR-4 and solder mask surface) does not support creep of sulfides, the corrosion product will stay on the pad where it was generated. No creep corrosion will occur. On the other hand, if the surrounding surface is contaminated solder mask, creep corrosion may occur. It was generally believed that high relative humidity will increase the propensity to creep corrosion just as it increases corrosion of most metals. But the iNEMI task force on creep corrosion on PCBs conducted tests on the effect of relative humidity and showed that creep corrosion can occur at relative humidity levels as low as 15% for some ImAg finished PCBs. On the other hand, in these test runs, ENIG finished PCBs suffered creep corrosion at high humidity in the 74-80% range and OSP finished boards suffered no creep corrosion at any humidity [11,12]. Data center administrators cannot just simply lower the relative humidity to alleviate creep corrosion without having to take the costly step of gas-phase filtering the air in the data center to remove the sulfur-bearing gaseous contamination. So, the solution to the creep corrosion problem is to use a finish that is resistant to creep corrosion such as OSP and ImSn (immersion tin), and to ensure that the data center air falls within the G1 severity level of ANSI/ISA 71.04-2013 [13]. Acceptable air quality must be such that the copper and silver corrosion rates are less than 300Å and 200Å/month, respectively.

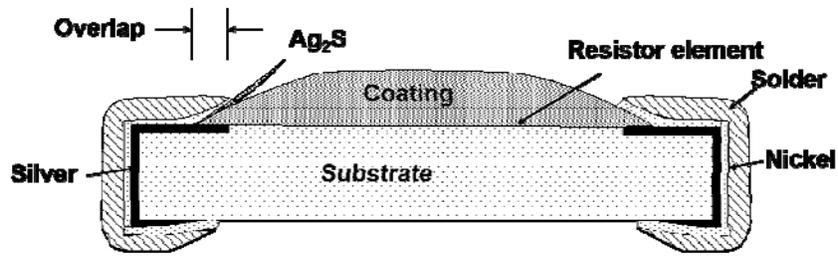
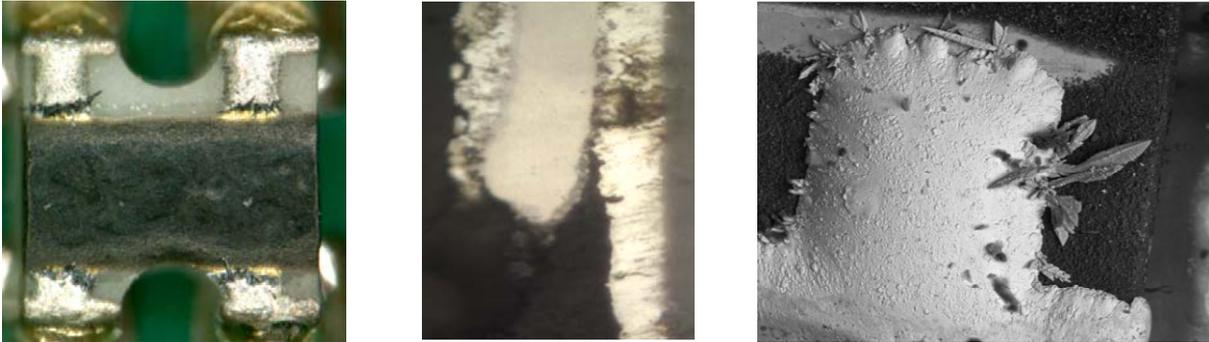
Figure 2: (Top) Schematic of a surface mount resistor in cross section. (Bottom left) Top view of a corroded resistor pack; (Bottom middle) Corroded surface mount resistor in cross section; (Bottom right) Corroded resistor showing the silver sulfide needles growing out of the resistor.

Another failure mechanism dominant in the last decade was the electrical open circuiting of surface-mount resistors due to the corrosion of the silver terminations in environments high in sulfur-bearing gaseous contamination. Surface mount resistors, shown in Figure 2, are bonded assemblies of materials with very differing temperature coefficients of expansions (TCE). Temperature changes mechanically stress the resistors weakening and cracking open the assemblies at the material boundaries through which sulfur-bearing gases can ingress and attack the silver terminations. The silver sulfide thus formed has higher volume than the silver it came from. The resulting internal mechanical stress further stresses and opens the cracks between materials increasing the rate of ingress of sulfur bearing gases. Thus, a corrosion positive feedback takes effect leading to the localized consumption of the silver termination resulting in an electrical open. Failures can be avoided using resistors that have multiple passivation layers protecting the underlying silver metallization at the terminals. In addition, data center air quality can be kept with the G1 severity level of the ANSI/ISA 71.04-2013 standard.

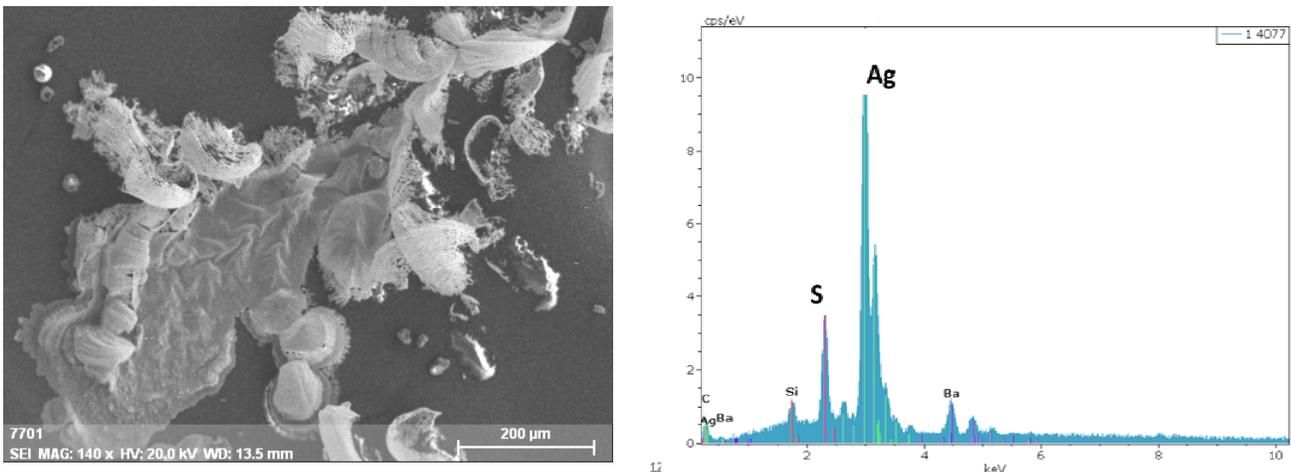
Figure 3: Silver dendrites growing between silver pads on a PCB. The X-ray elemental dispersive analysis to the right shows that the silver dendrites are growing in the presence of a sulfur-containing contamination.

Ion Migration [14,15]. Under high relative humidity condition, well above the ASHRAE recommended 60%, moisture can be adsorbed on PCB surfaces forming electrolytic bridges between closely spaced silver metallization on PCBs. Silver from the positive pad of the PCB can form ions which can drift under the influence of an electric field and deposit on the negative pad. The deposits can take on a dendritic morphology bridging and thus short circuiting the gap between the two silver-plated pads. Figure 3 shows an example of silver dendrites growing between pads. The dendrites also contain sulfur-bearing contamination that probably aided in the silver migration hastening the phenomenon.

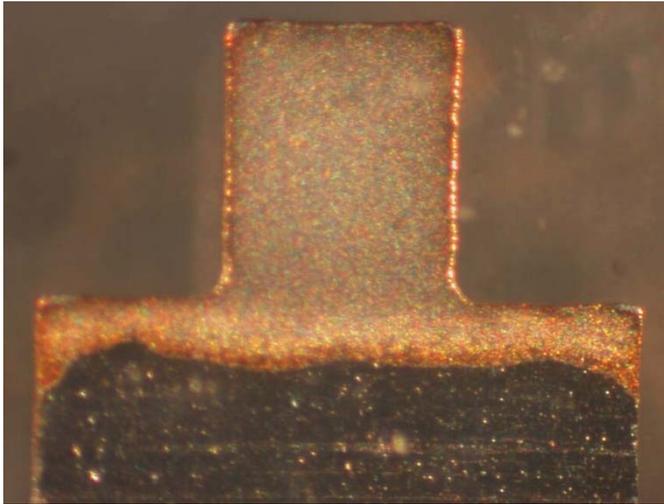
Figure 4. Leadframe connector showing visible corrosion on the copper-silver junction.

This facility is in an industrial park with significant vehicular traffic and is across the street from a recycling plant. Production personnel had reported evidence of corrosion based on visual discoloration of the silver on leadframes they were producing. Internal inspection and QC testing showed increased failure rates caused by what was identified as a “black oxide.”

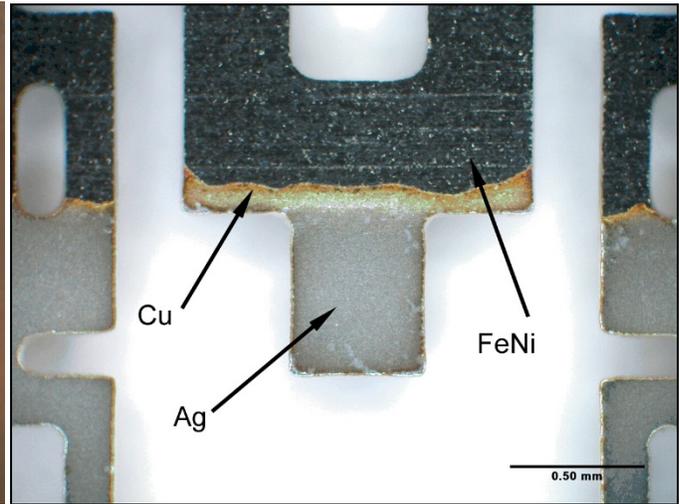
Figure 5. Magnified view of leadframe connector showing different metal layers.

The leadframe substrate appeared to be an iron-nickel (FeNi) alloy. Figure 5 shows a reflected light darkfield image showing the iron-nickel substrate as a dark grey. The lead ends are coated with a fine-grained silver with a thin copper layer beneath (probably to promote adhesion of the silver to the FeNi substrate).

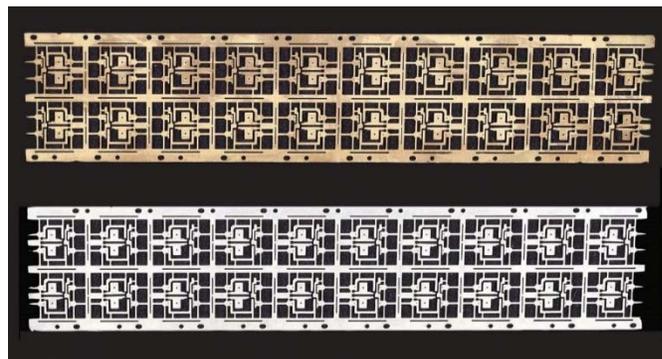
Figure 6. Leadframes taken from in-production material exhibiting corrosion (top) and without corrosion (bottom).

The Facility Manager discussed that they continually experienced silver corrosion problems on leadframes and legs of ICs. In fact, workers routinely discard 1-2 layers of leadframes from a roll before starting production because the silver had “turned black” overnight (Figure 6) and using those leadframes could have resulted in failure of finished devices that may not be discovered during final inspection.

The lack of proper environmental control resulted in higher contamination and corrosion rates inside the production areas. CCC monitoring indicated average copper and silver corrosion rates at more than 10-15x higher than the prescribed ISA G1 severity level, with evidence of both sulfur oxide and inorganic chlorine contamination.

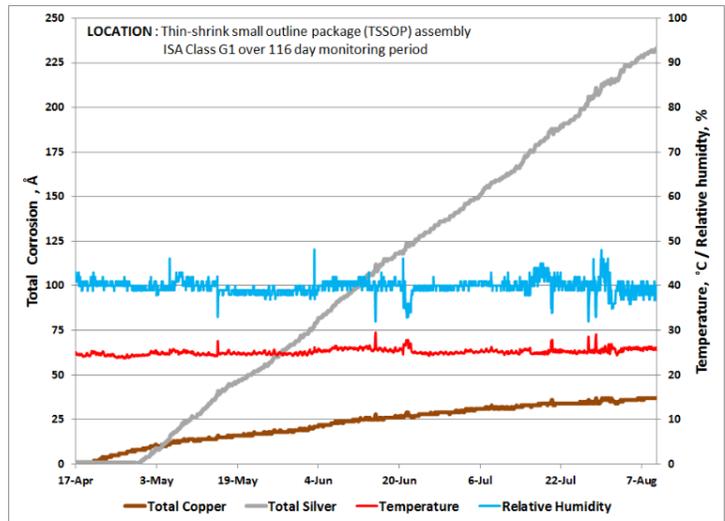
Figure 7. ACM monitoring data from TSSOP production area.

This facility purchased 6 ACMs to provide real-time monitoring in the production areas and the results confirmed the initial CCC assessment. The data indicates generally higher than acceptable (silver) corrosion rates, with some areas generally meeting ISA Class G1 (Figure 7). The company is having internal discussions to determine whether ISA Class G1 should be their acceptance criteria or whether Class G2 would be acceptable with their production requirements.

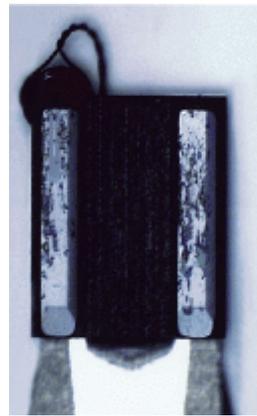
Figure 8. Hard disk read/write head showing corrosion.

Since the implementation of RoHS, this firm was experiencing a higher than expected failure rate of head stack assemblies (HSAs) due to corrosion. Even for those HSAs that did not fail, more than 60% of these showed some evidence of corrosion (Figures 8, 9). Almost all the corrosion identified by failure analysis was due to sulfur creep corrosion. It was suspected that this contamination was being introduced into the manufacturing areas by the makeup (outdoor) air handling systems.

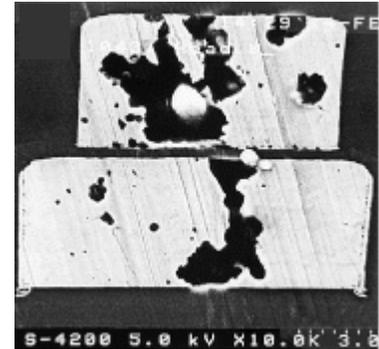
Figure 9. Hard disk head slider showing corrosion.

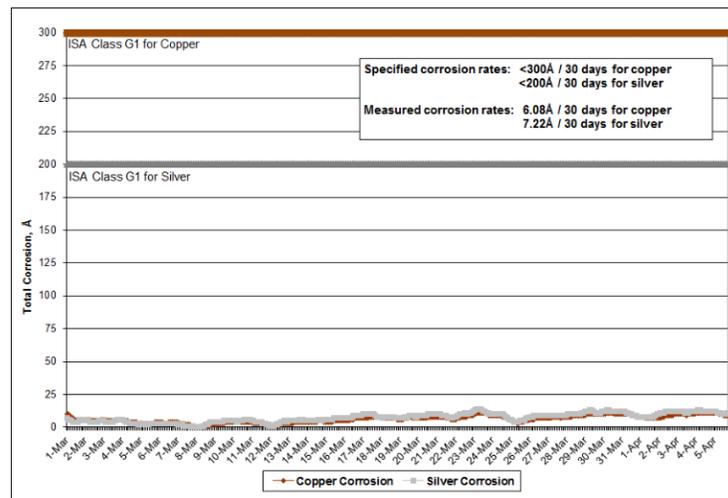
Figure 10. Reactivity monitoring data from ACM showing reduction in corrosion rates after installation of chemical filters. Acceptable ISA Class G1 levels for copper and silver are shown as solid bars at 300Å and 200Å, respectively.

Gas-phase air filters were installed in each of the makeup air handlers to remove the sulfur oxide and chlorine contaminants and in the recirculation air handlers to provide an additional level of air cleaning. These filters employed an extruded carbon composite media with enhanced capacity for acid gases. Within a few days after installation, data from the ACM indicated that the contamination had been effectively removed and the corrosion rate dropped to the specified ISA Class G1 (Figure10).

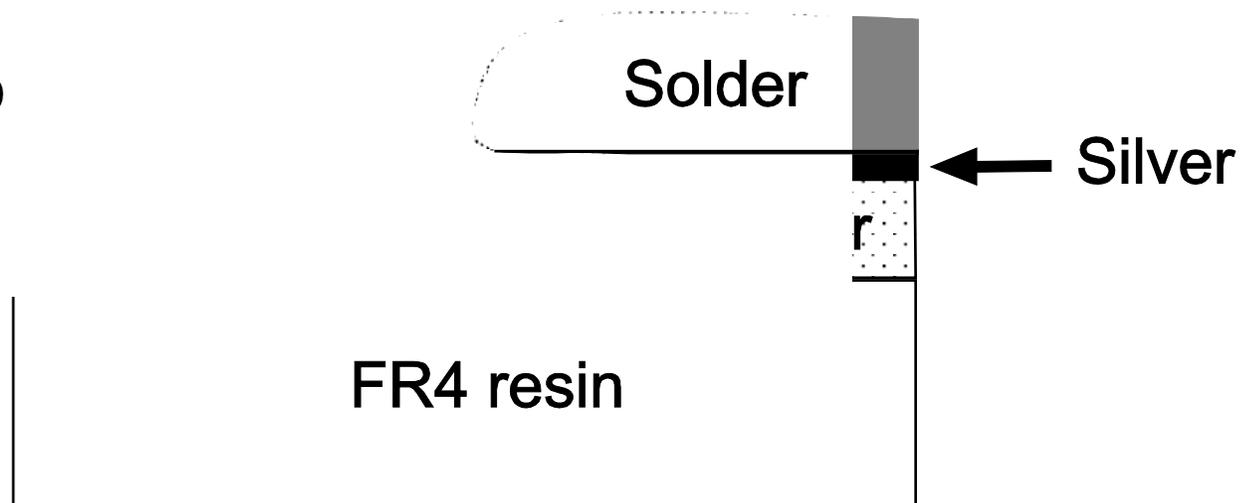
Schematic showing creep corrosion in cross section. Creep corrosion picture in color is at top right and a scanning electron micrograph is at the bottom right

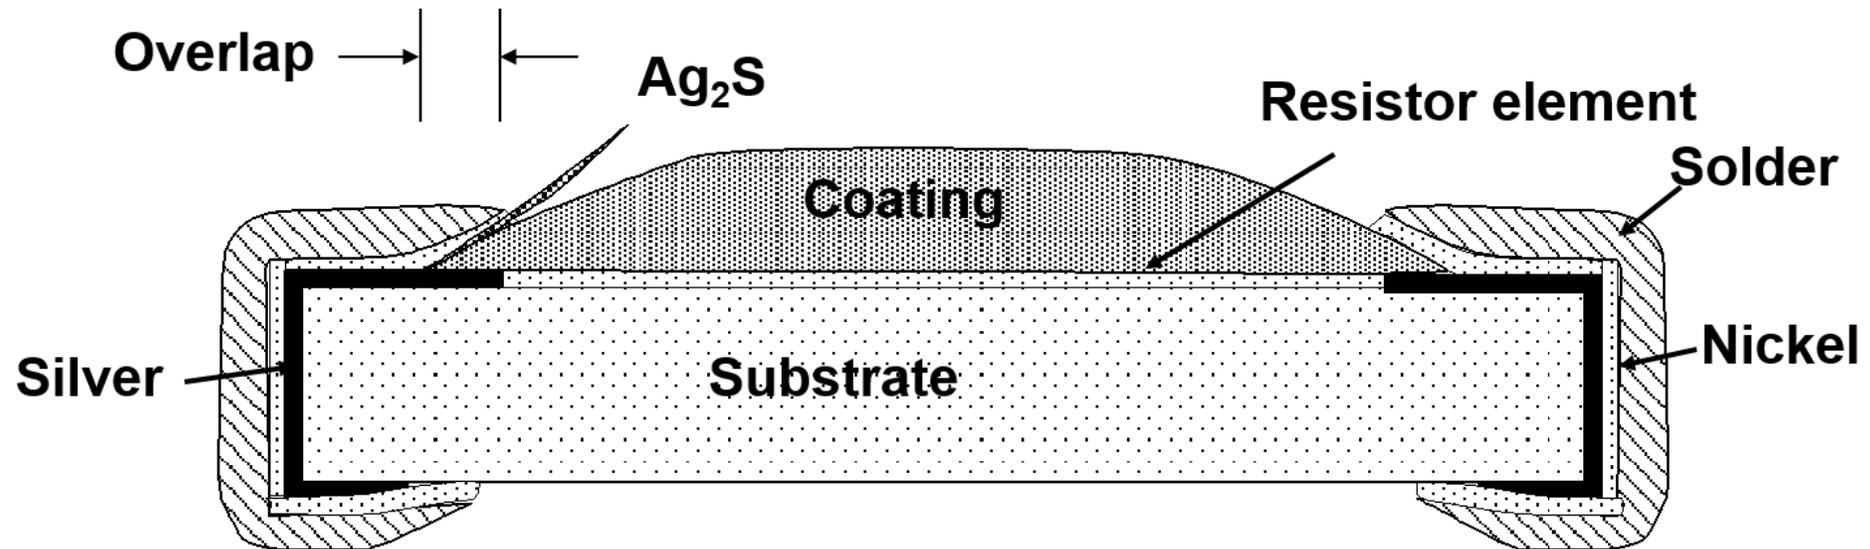
Schematic of a surface mount resistor in cross section.

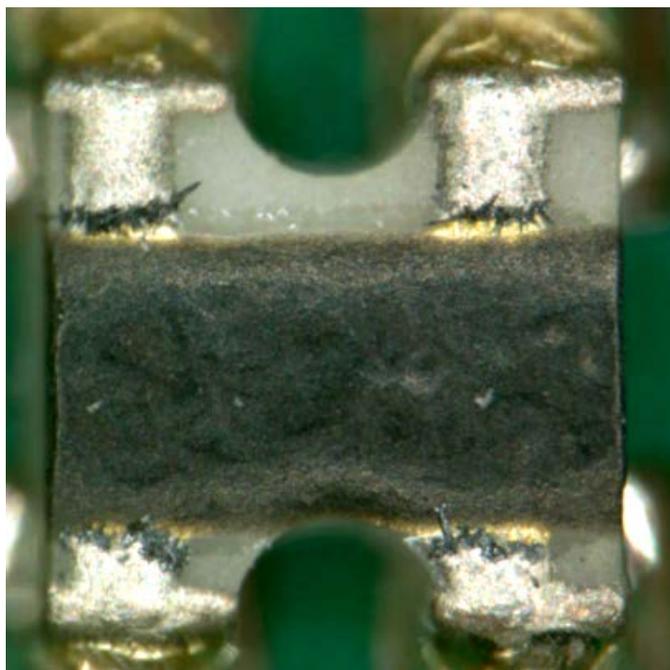
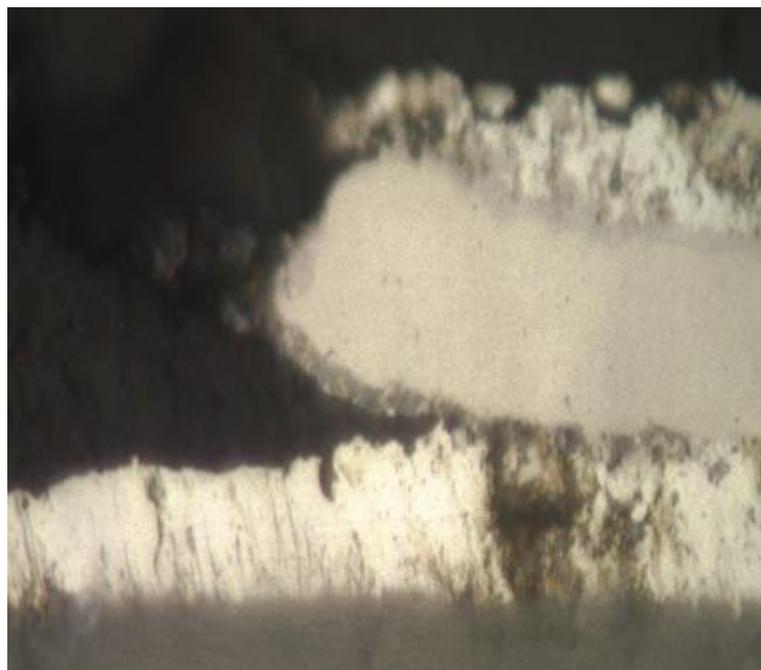
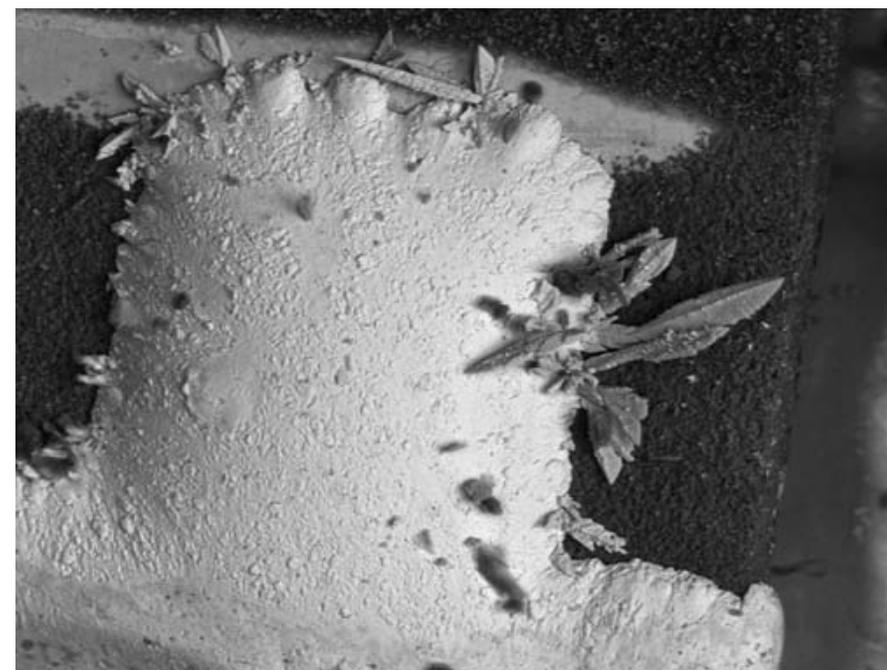
(Left) Top view of a corroded resistor pack; (Middle) Corroded surface mount resistor in cross section; (Right) Corroded resistor showing the silver sulfide needles growing out of the resistor.

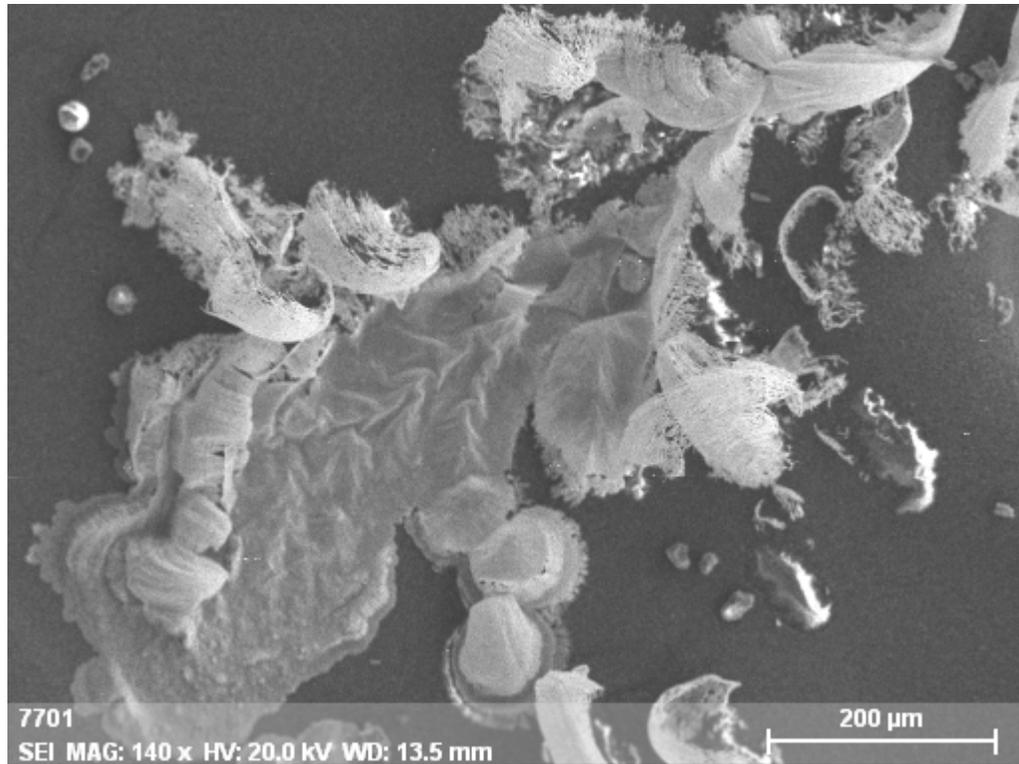
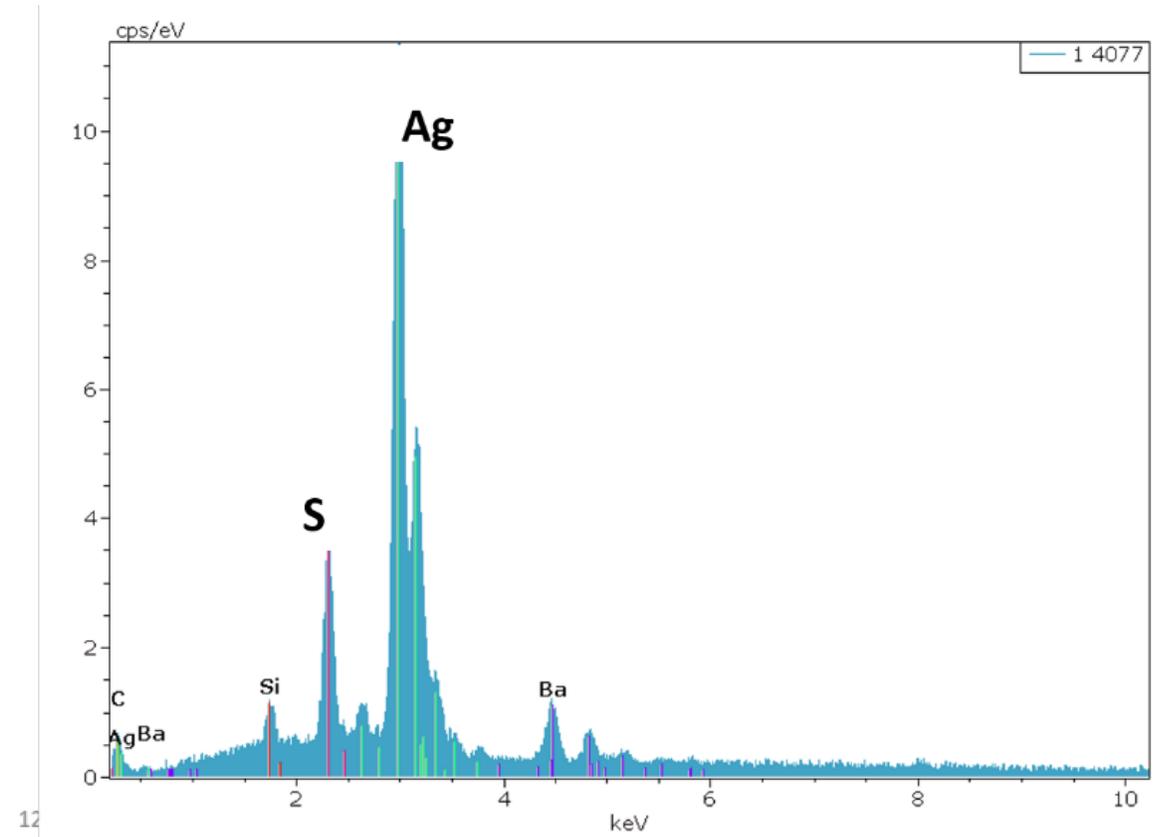
Silver dendrites growing between silver pads on a PCB. The X-ray elemental dispersive analysis to the right shows that the silver dendrites are growing in the presence of a sulfur-containing contamination.

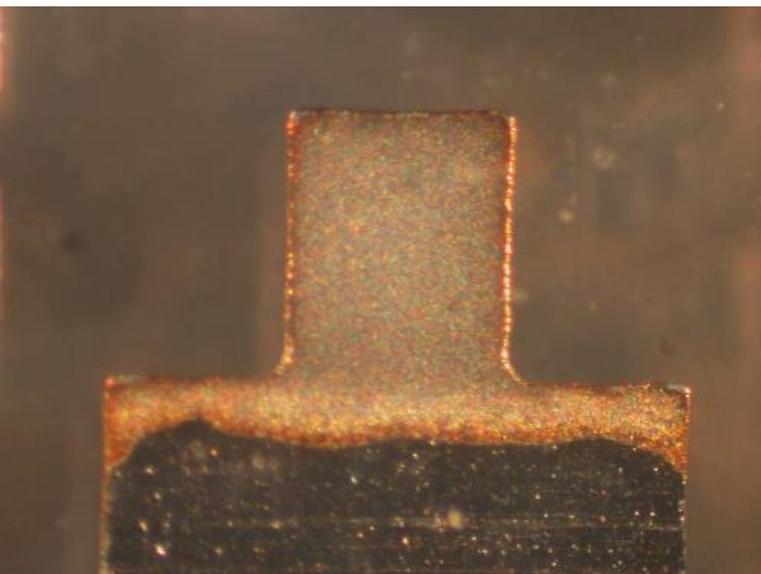
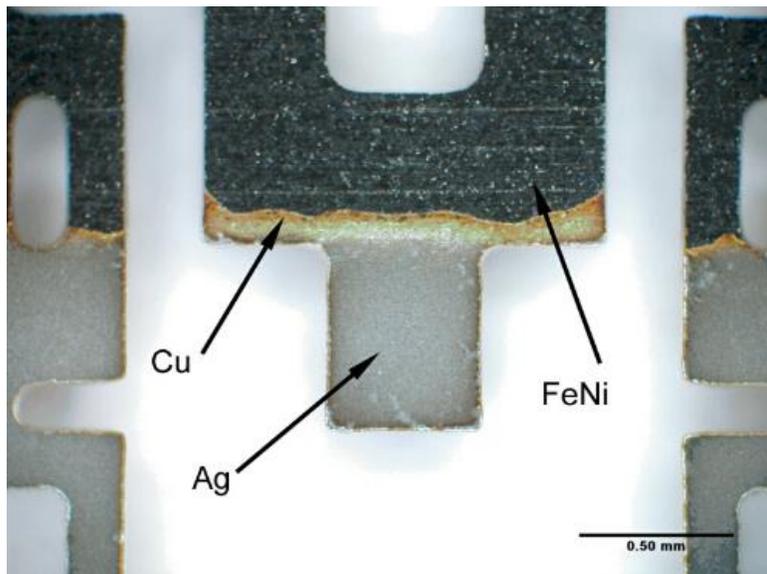
Leadframe Manufacturer

- Analyzed using scanning electron microscopy with energy-dispersive x-ray spectroscopy (SEM-EDS).
 - *Trace amounts of sulfur were found on the silver layer.*
- Environmental analysis was performed.
 - *Outdoor air and air in the production areas would be classified as ISA Class GX and G3, respectively.*
 - Greatly exceeds the general acceptance criteria of Class G1.
 - Active sulfur compounds, sulfur oxides, and inorganic chlorine were detected.
- Wet scrubbers installed in makeup air handlers.
 - *Removal efficiency for acid gases averaged <35%.*
- Gas-phase air filtration systems were installed in place of wet scrubbers in makeup air handlers.
 - *Air quality in all manufacturing areas met ISA Class G1.*

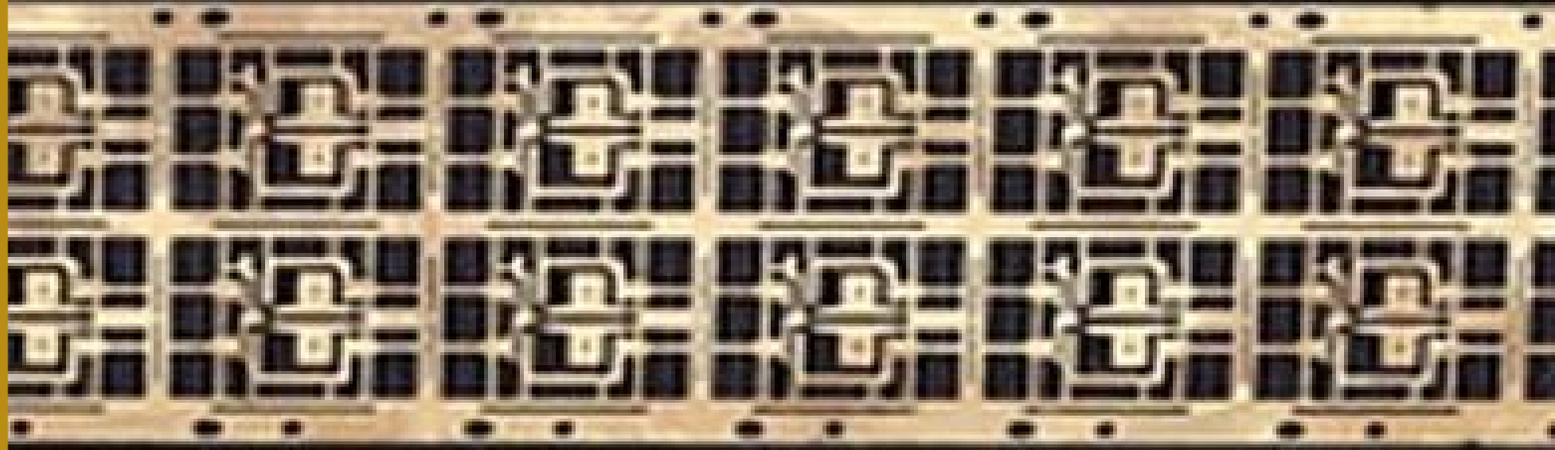
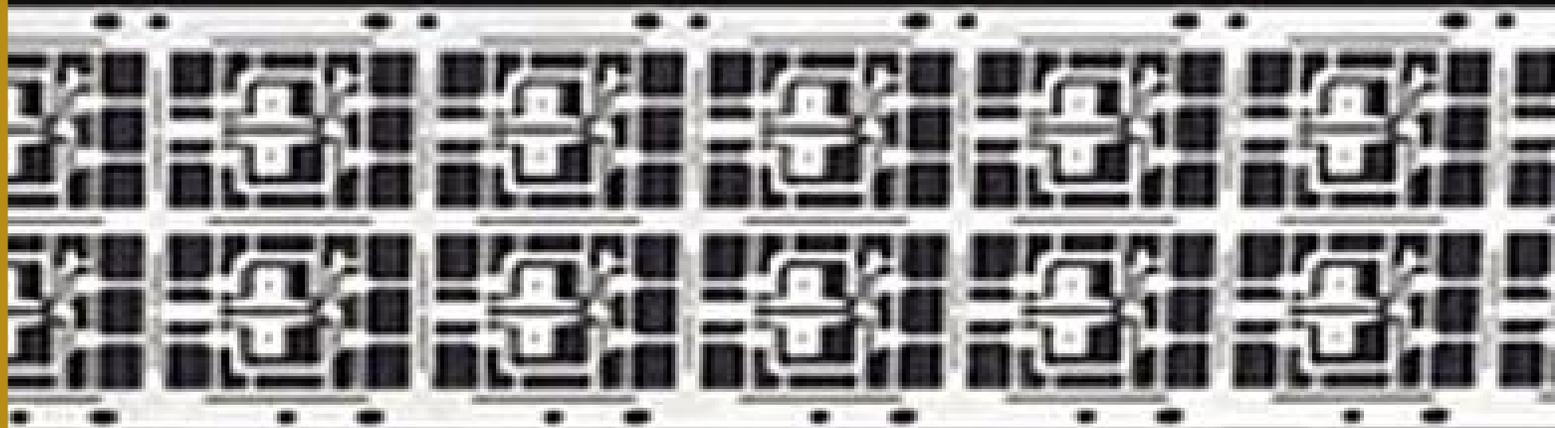
- Leadframes taken from in-production material exhibiting corrosion (top) and without corrosion (bottom).
- Lack of environmental control resulted in corrosion rates more than 10-15x higher than the ISA G1 severity level.
 - *Sulfur oxide and inorganic chlorine contamination.*
- Purchased real-time corrosion monitors for production areas.

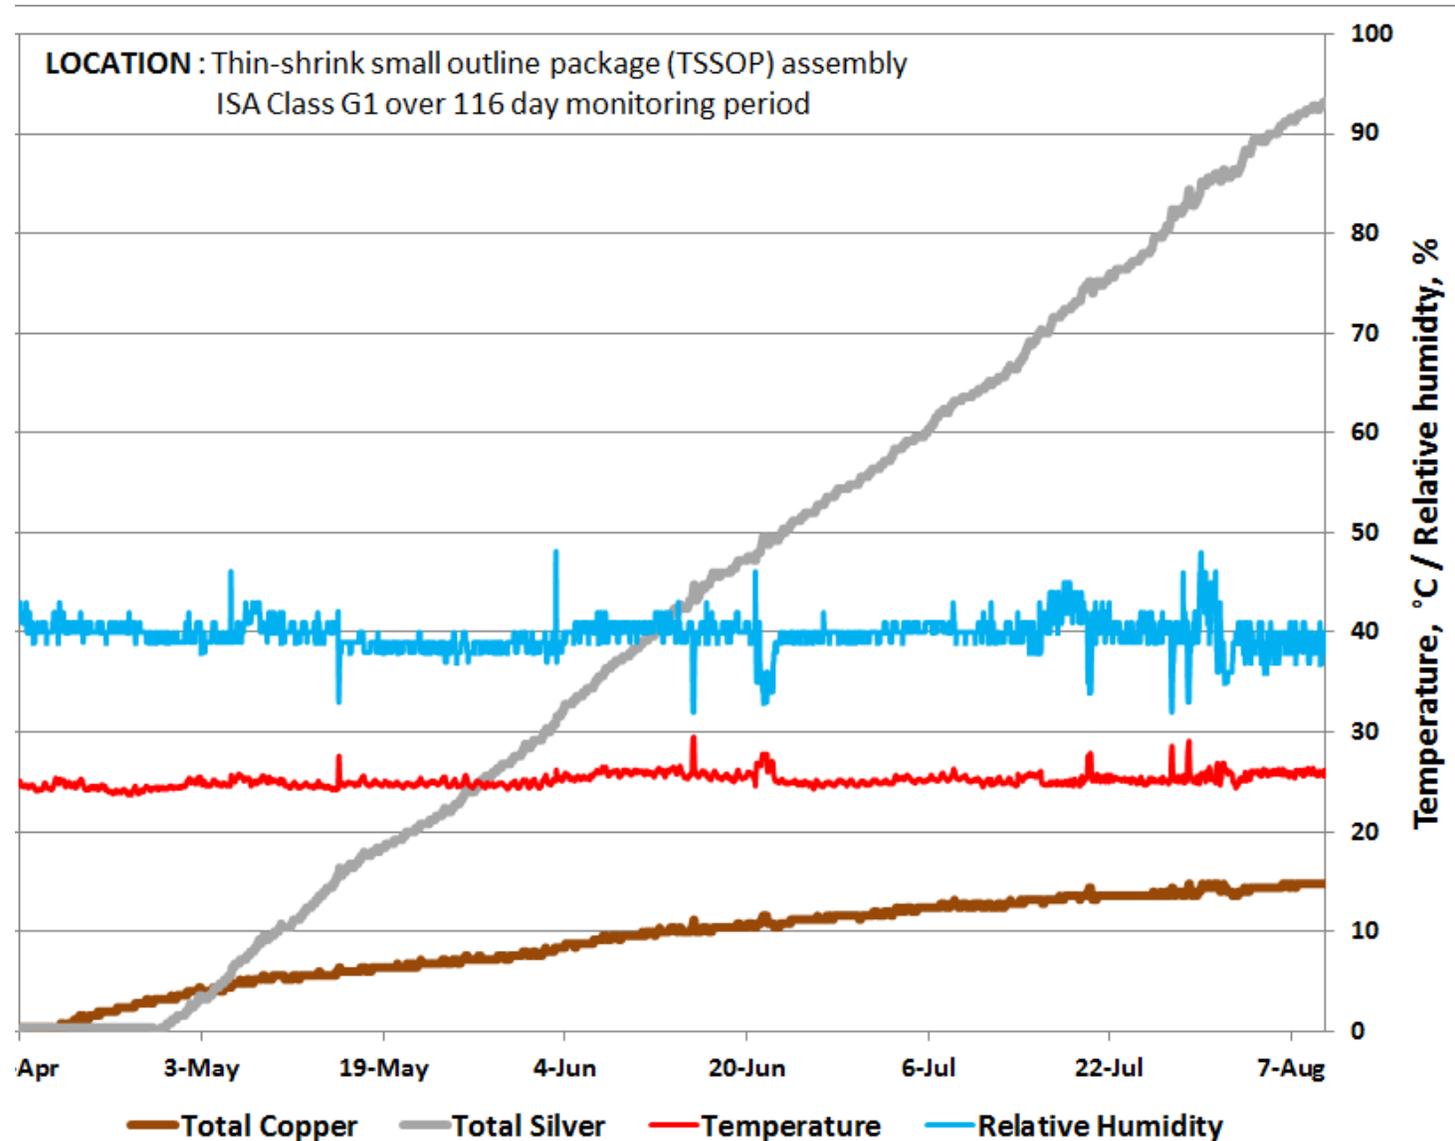
Monitoring Data From TSSOP Production Area

- Data shows higher than acceptable (silver) corrosion rates.
 - *Some areas generally meeting ISA Class G1.*
- Company is deciding whether production areas should be ISA Class G1.
 - *Class G2 may be acceptable with their production requirements.*

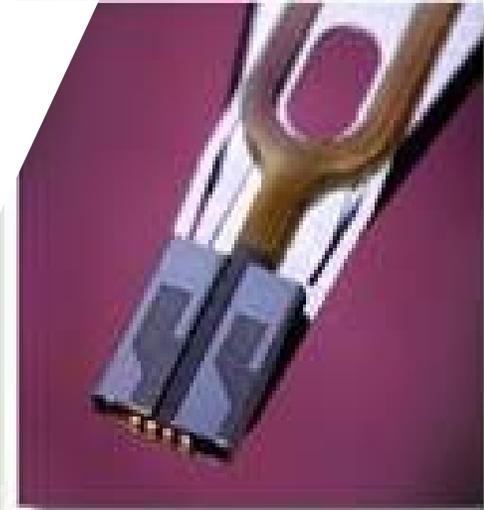
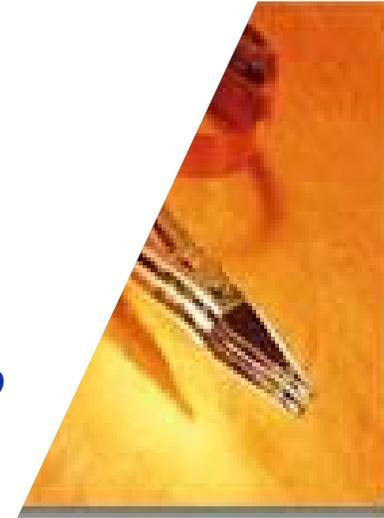
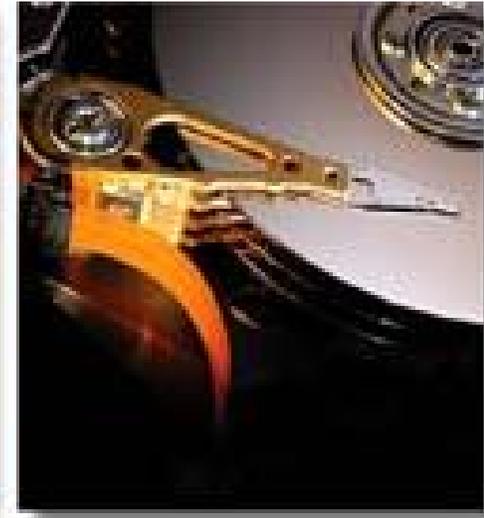
HARD DISK READ/WRITE HEAD SHOWING CORROSION

- Company specializes in designing, developing & manufacturing suspension assemblies for the hard disk drive (HDD) industry.
 - *Suspension assemblies position read/write heads above the data on the disk surface.*
 - *Critical components to the reliability and performance of HDDs.*
- RoHS-compliant head stack assemblies (HSAs) were experiencing high failure rates due to corrosion.
 - *For HSAs that did not fail, >60% showed some evidence of corrosion.*
- Almost all corrosion was sulfur creep corrosion.
 - *This contamination was being brought in through the makeup (outdoor) air handling systems.*

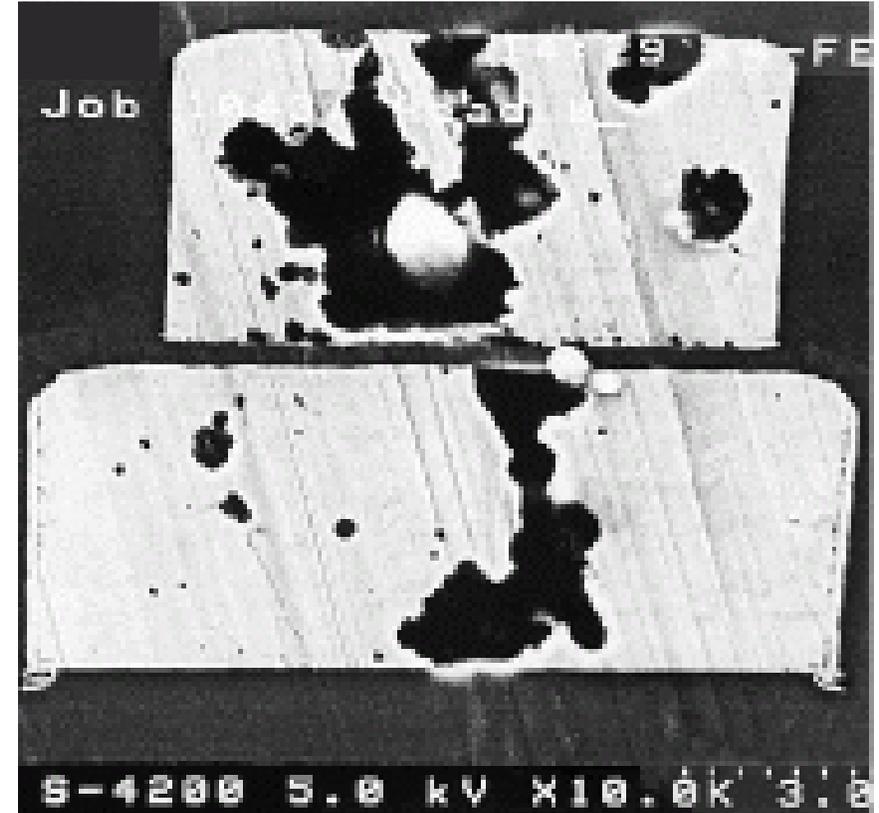
HARD DISK HEAD SLIDER SHOWING CORROSION

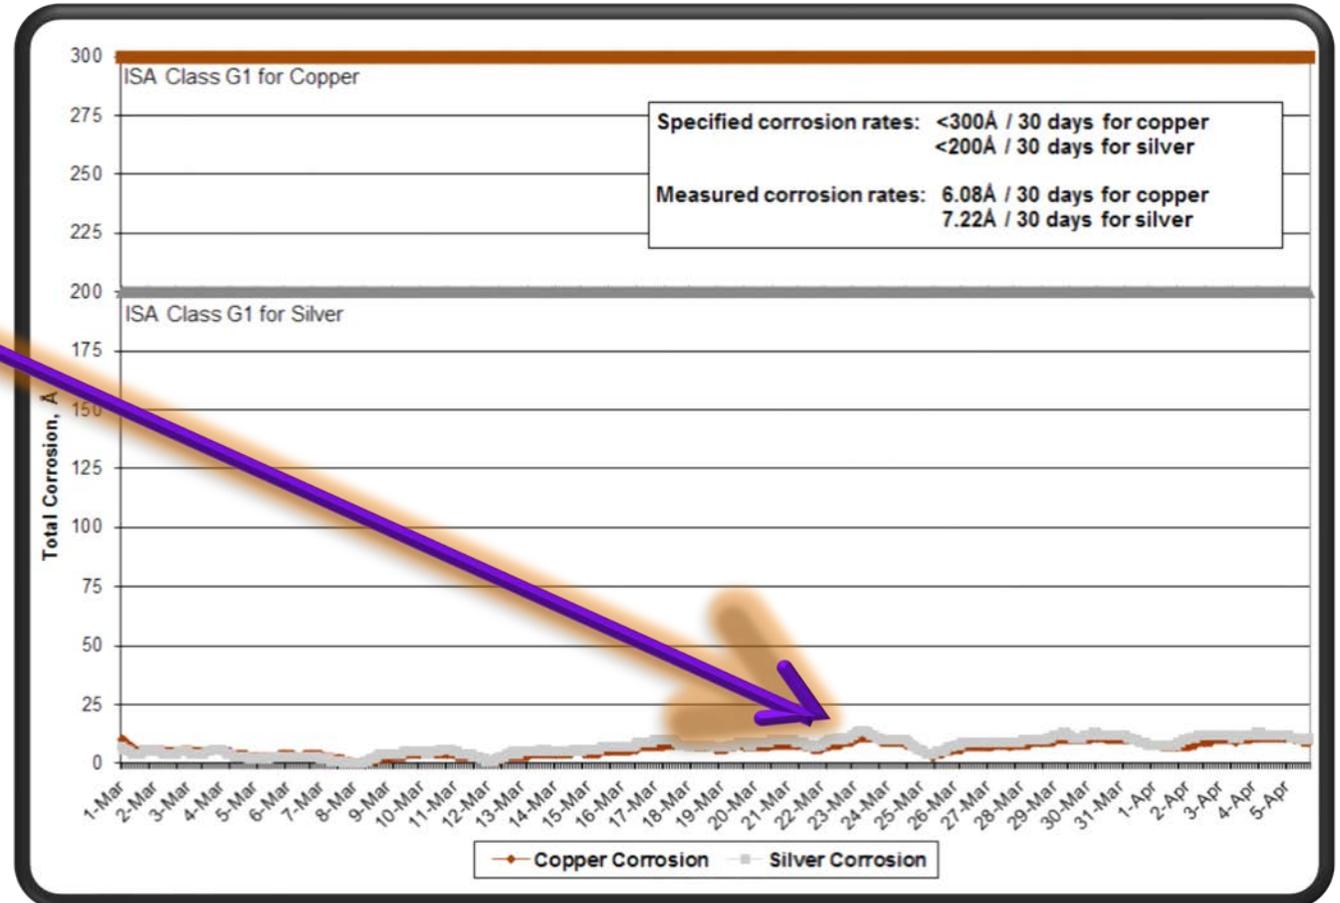
- Reactivity monitoring data from real-time corrosion monitor showing reduction in corrosion rates after installation of chemical filters.
- Acceptable ISA class G1 levels for copper and silver are shown as solid bars at 300Å and 200Å, respectively.
