SURVIVING 3K THERMAL CYCLES WITH VARIABLE VOID LEVELS (-40°C TO 125°C)

Rafael Padilla*, Derek Daily, Tokuro Yamaki, Tomoyasu Yoshikawa and Masato Shimamura
Senju Comtek Corporation
Santa Clara, CA, USA (*former-Senju)

ABSTRACT

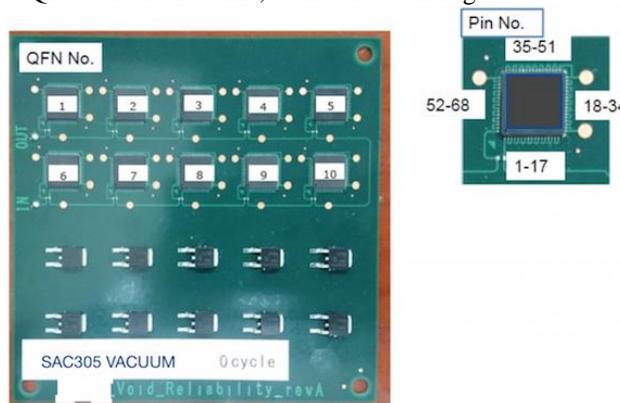
Figure 4 Example of QFN/DPAK circuit board daisy chain and pin numbers for the QFN inputs/outputs (I/Os).

The TV-2 board layout contains 10 QFNs and 10 DPAKs, as illustrated in Figure 4.

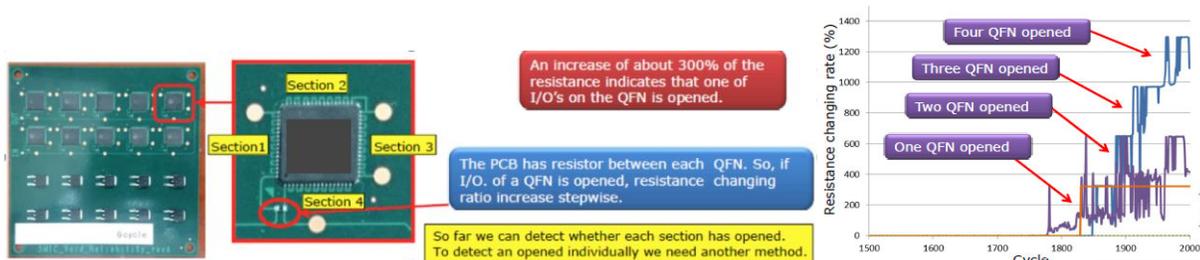
Figure 5 Example of QFN/DPAK circuit board daisy chain, used to detect cracks in the QFN I/Os via electrical resistance changes, with example of expected value changes and how they correlate to cracking in the I/Os.

It is also important to note, that the QFNs on the Test Vehicle-2 boards are powered by a daisy chain with ground pads and a chip resistor per QFN component, so significant cracks in the I/Os can be detected via electrical resistance changes, so even if the resistor cracks there is still a step/incremental difference between QFN components.

An example of how this is detected is illustrated below in Figure 5.

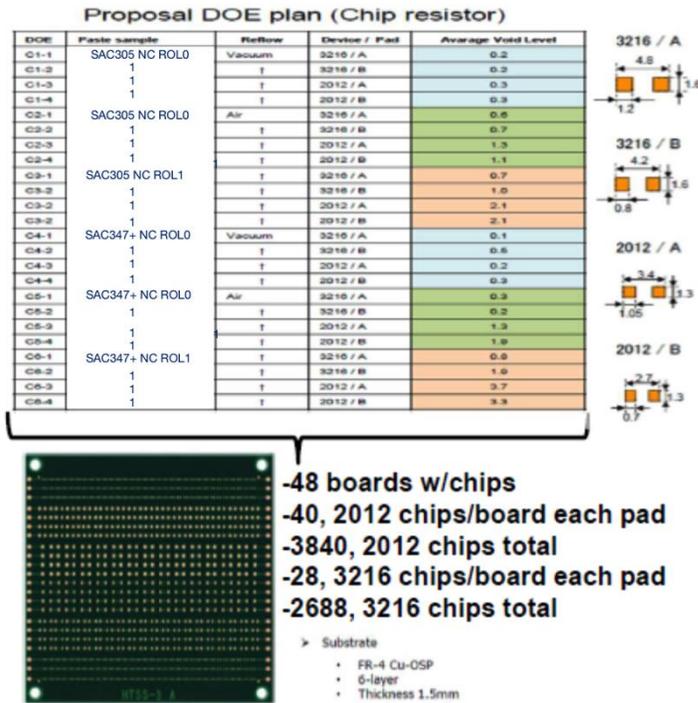
Figure 17 Chip component DOE test matrix, for alloy comparison testing, showing average level of voiding for all legs is below 3%, regardless of reflow environment or pad geometry tested

Figure 17 shows the DOE test matrix for the chip components.

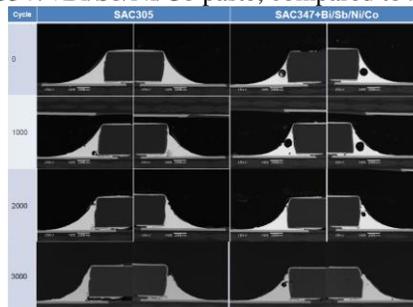
Figure 22: 3216-Chip Resistor cross sectional analysis for initial and 500, 1000, 1500, 2000 and 3000 thermal cycles.

As seen in Figure 22, through cross sectional analysis, it was confirmed that after 3000 cycles the chip resistors crack length and crack rate was shortened by using SAC347+Bi/Sb/Ni/Co paste, compared to SAC305.

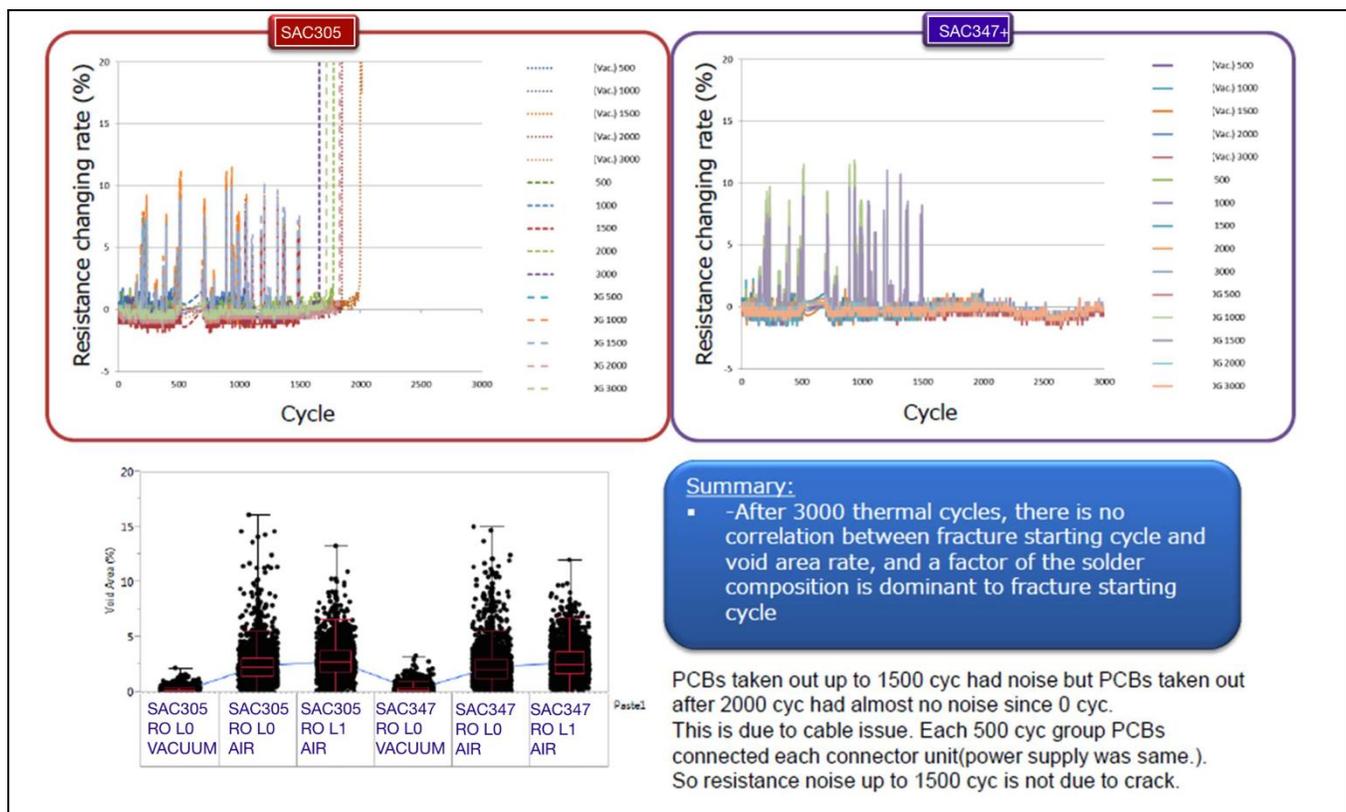
Figure 23 Electrical resistance results for the 6 SAC305 boards, and 6 SAC347+Bi/Sb/Ni/Co boards pulled from the chamber after 2000 thermal cycles.

This means, theoretically, up to 1500 thermal cycles, for all of the DOE legs, there are no large cracks occurring in the QFN solder joint I/Os which would cause a significant change in the electrical resistance (i.e. above 300%). However prior to 2000 cycles, we begin to detect large spikes in the electrical resistance with all the SAC305 boards. Figure 23, for example, clearly shows the results for six SAC305 boards pulled from the chamber after 2000 cycles. Resistance spikes are first detected in the SAC305, No-Clean (ROLO) boards with medium level voiding (5-20%) at 1770 thermal cycles.

Shortly thereafter a spike was detected in the SAC305 boards with 25-35% voiding at 1830 thermal cycles, and then almost immediately after that the SAC305 vacuum reflowed boards begin spiking at 1848 thermal cycles.

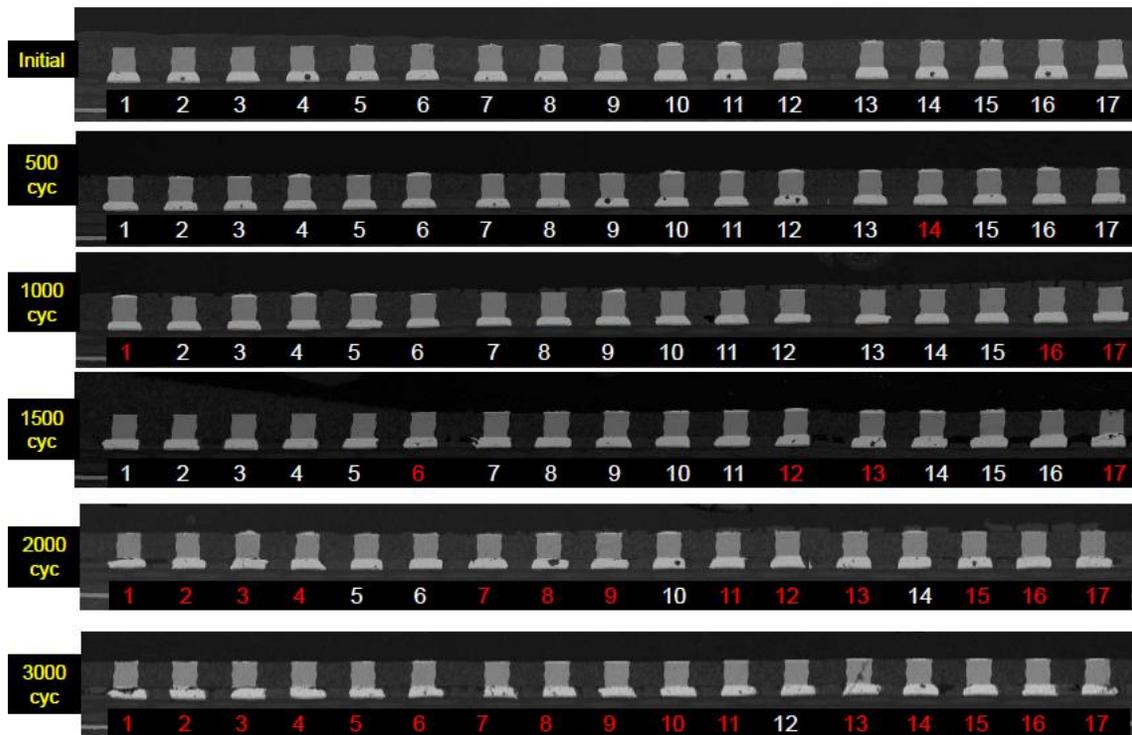
Figure 24 Example of QFN I/O row 1-17, CS analysis results of the SAC305, No-Clean (ROL0) convection air

As illustrated in Figure 24, CS analysis of I/Os 1-17 of the QFNs confirmed fully cracked joints (i.e. over 50% of the solder joint axis) does not occur with the SAC305 boards in any of the QFN I/Os until around or slightly after 1500 cycles are reached.

However, we do see the beginning of cracks appearing after 500 cycles with all the SAC305 convection air reflowed boards, but not until 1000 cycles with SAC305 vacuum reflowed boards, nonetheless fully open joints (>50%) of the QFN I/Os, regardless of reflow environment or initial void level, are all occurring around the same time (in between 1500-2000 thermal cycles).

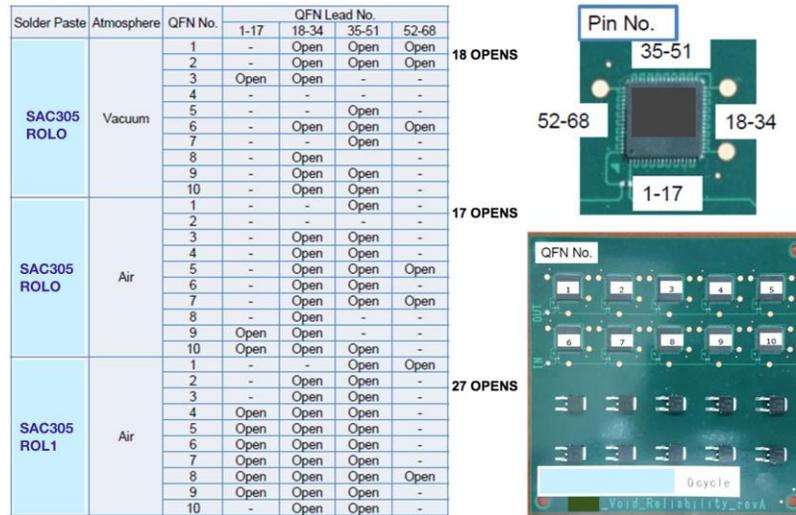
Figure 27 After 2000 cycles, electrical resistance spikes were detected in all SAC305 boards, with the SAC305 vacuum reflowed boards having the most events of 7, compared to the SAC305 boards which were reflowed in air, and had below 2 events.

When reviewing the event detection results for the QFN I/Os after 2000 thermal cycles, as illustrated in Figure 27, in combination with the CS analysis results for all the boards removed from the chamber (Figures 24 – 26), we can see *no direct correlation between void percentage levels and thermal cycle reliability*.

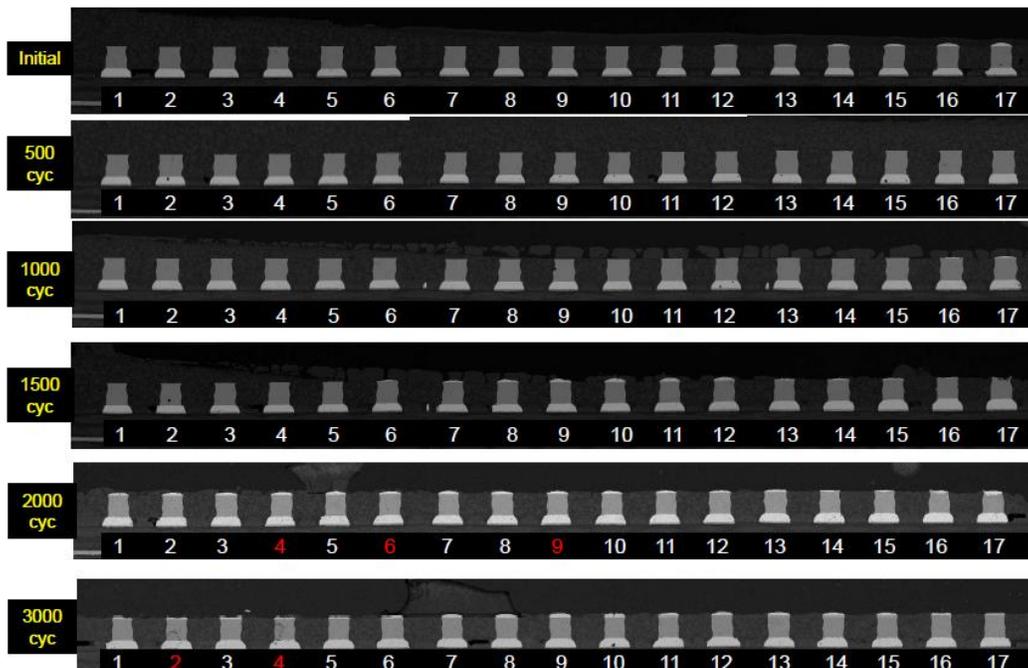
Figure 28 QFN input-output, CS analysis results of the SAC347+Bi/Sb/Ni/Co, No-Clean (ROL0) vacuum reflowed boards.

As illustrated in Figures 28 through 31, CS analysis confirmed no significant cracking beyond 50% as having occurred up to 3000 cycles for the SAC347+Bi/Sb/Ni/Co.

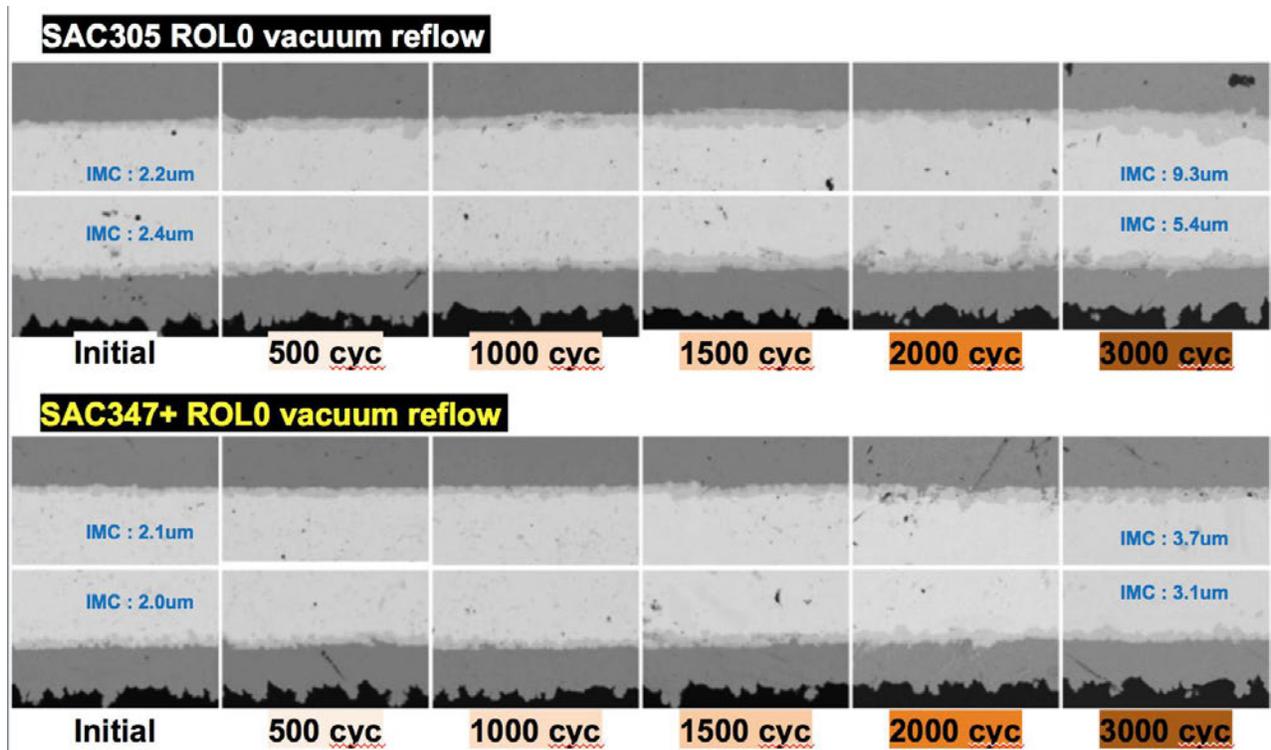
Figure 33 Comparison between initial, 500, 1000, 1500, 2000 and 3000 thermal cycles CS analysis images showing IMC thickness of the QFN I/Os from row 1-17.

When reviewing the DOE results, it is difficult to make any true correlation with regards to voiding and thermal cycle reliability. Differences within each assembly were statistically insignificant and CS analysis of the intermetallic compounds (IMC) formed between the SAC305 alloy and SAC347+Bi/Sb/Ni/Co, which can be seen in Figure 33, show that the initial IMC layer began at similar thicknesses for both alloys.

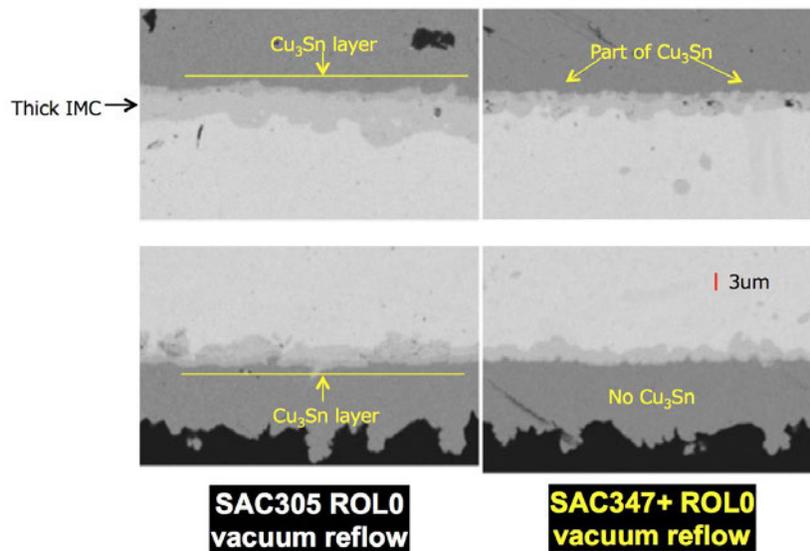
Figure 34 Comparison of IMC structure between SAC305 and SAC347+Bi/Sb/Ni/Co after 3,000 thermal cycles from -40°C to 125°C.

However, after 3000 thermal cycles it is clear that the IMC thicknesses of the SAC305 solder joints are growing at a faster rate than those of SAC347+Bi/Sb/Ni/Co alloy. As seen in Figure 34, when one compares the IMC structures after 3000 cycles of the SAC305 and SAC347+Bi/Sb/Ni/Co alloy, the SAC305 alloy not only has a larger IMC thickness, but a greater amount of Cu3Sn intermetallic formed in comparison to the solder joint with SAC347+Bi/Sb/Ni/Co paste, making the SAC305 solder joint more susceptible to cracking.

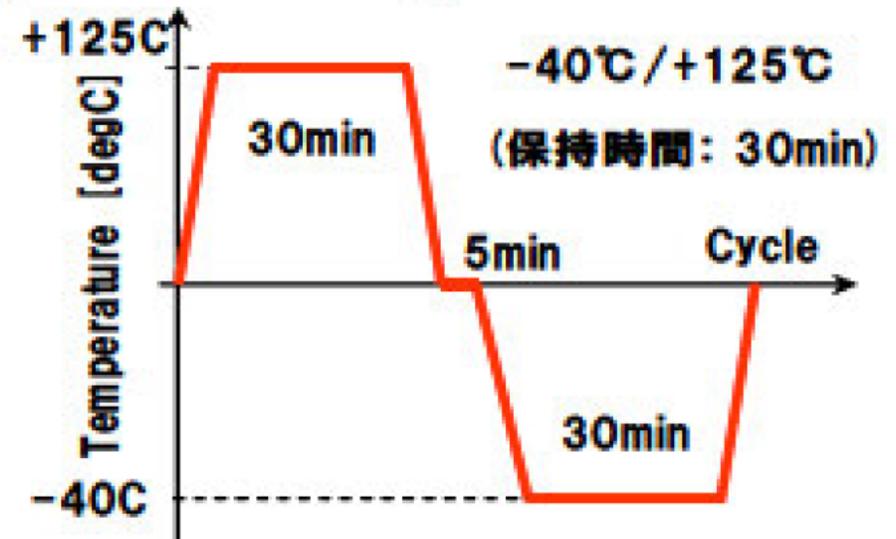
【TCT Profile】

- The Assembled TVs were to be subjected to a -40C/+125C TCT
- 30min dwell
- 5min ramps
- TVs are to be reviewed for initial characteristics (void, IMC) and observed throughout the test each 500 cycles up until 3,000 completed cycles.

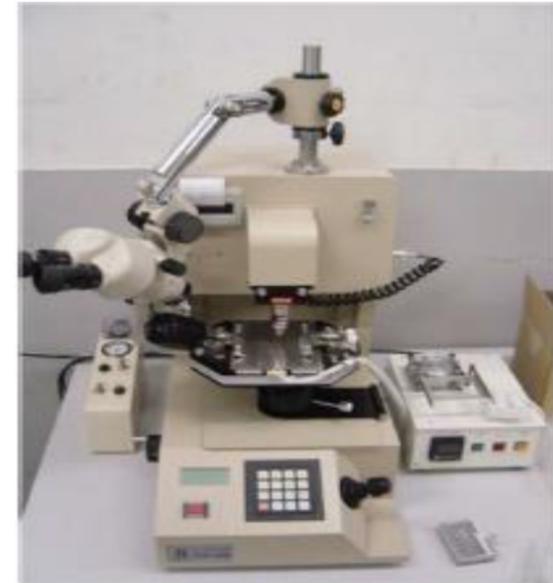
3216 Shear Results

- Again, although the variation in void levels was not ideal to meet the targeted Low, Medium and High void levels, we could measure some variation due to materials and process.
- Shear Speed: 6mm/sec.

- Upper Chart: Shear Values (N)
- Lower Chart: Void Area

The results indicate a significant increase in initial and final shear strength before and after thermal cycling is observed for the SAC347+Bi/Sb/Ni/Co paste alloy when compared to the base SAC305 alloy results.

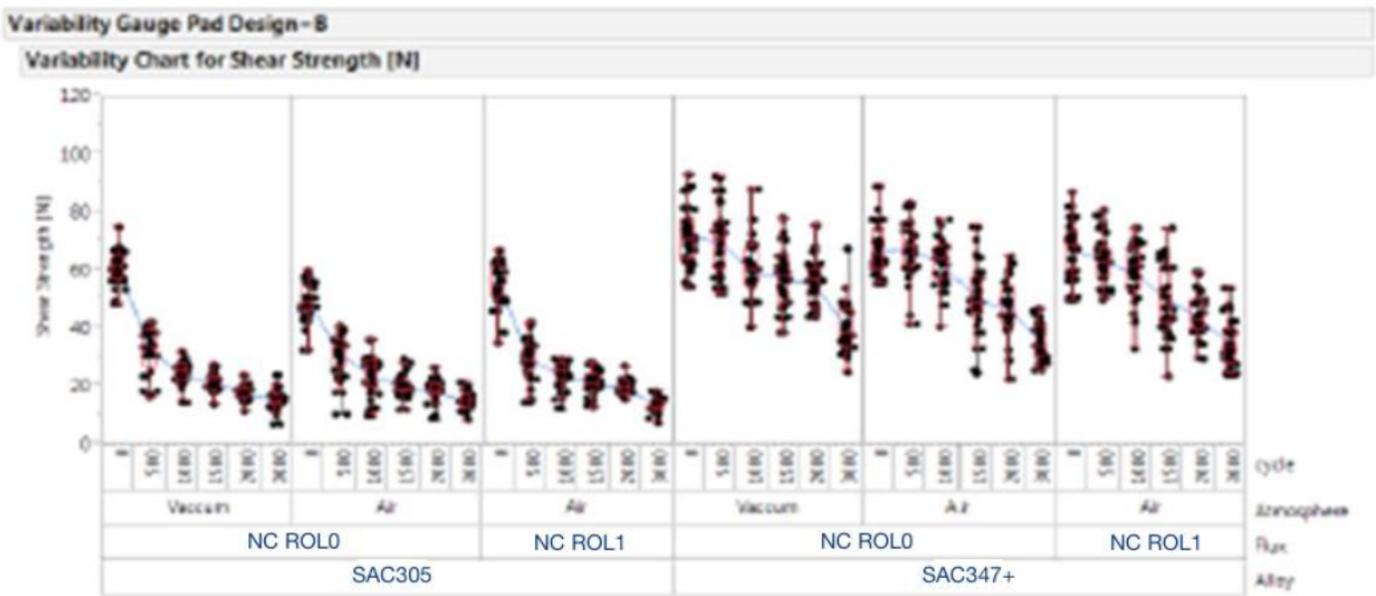
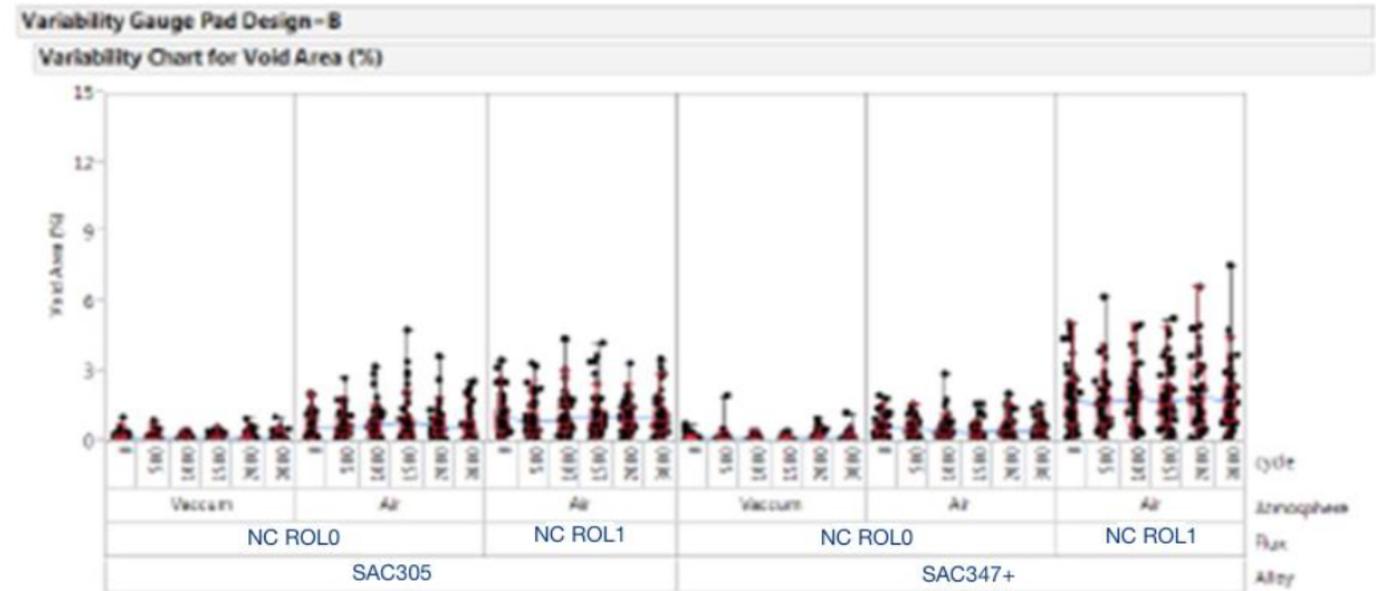
- NOTES:
 - SAC347+ initial values much greater than SAC305
 - Regardless of void level, SAC347+ with similar result and consistently higher value versus SAC305 post 3000 cycles.

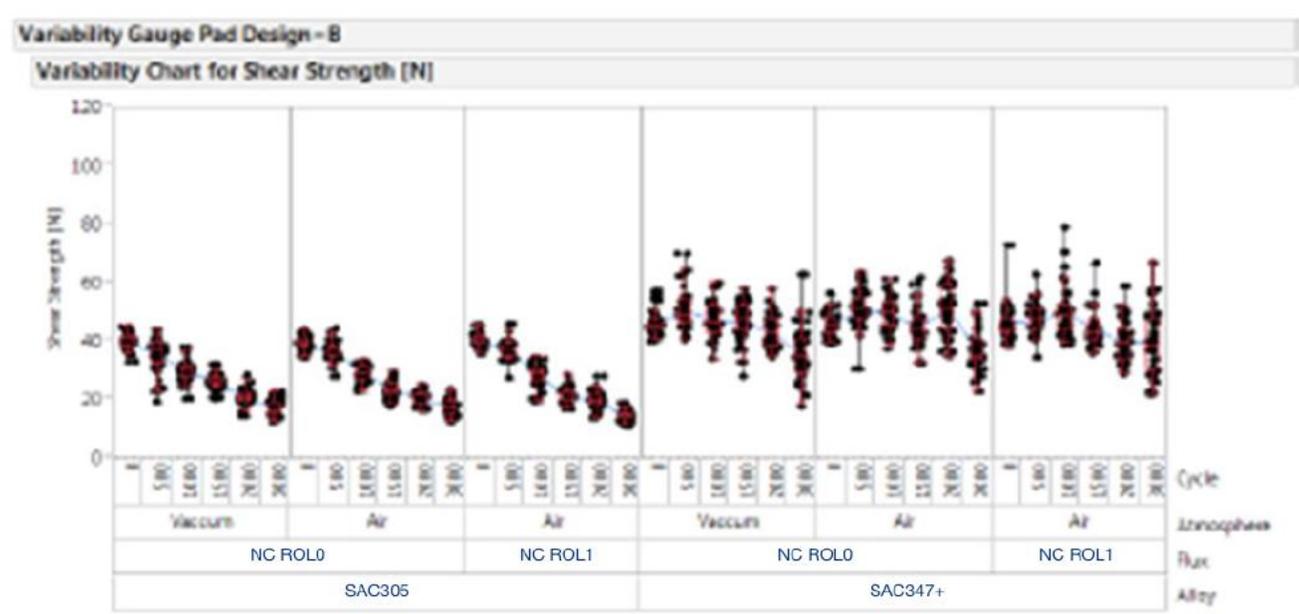
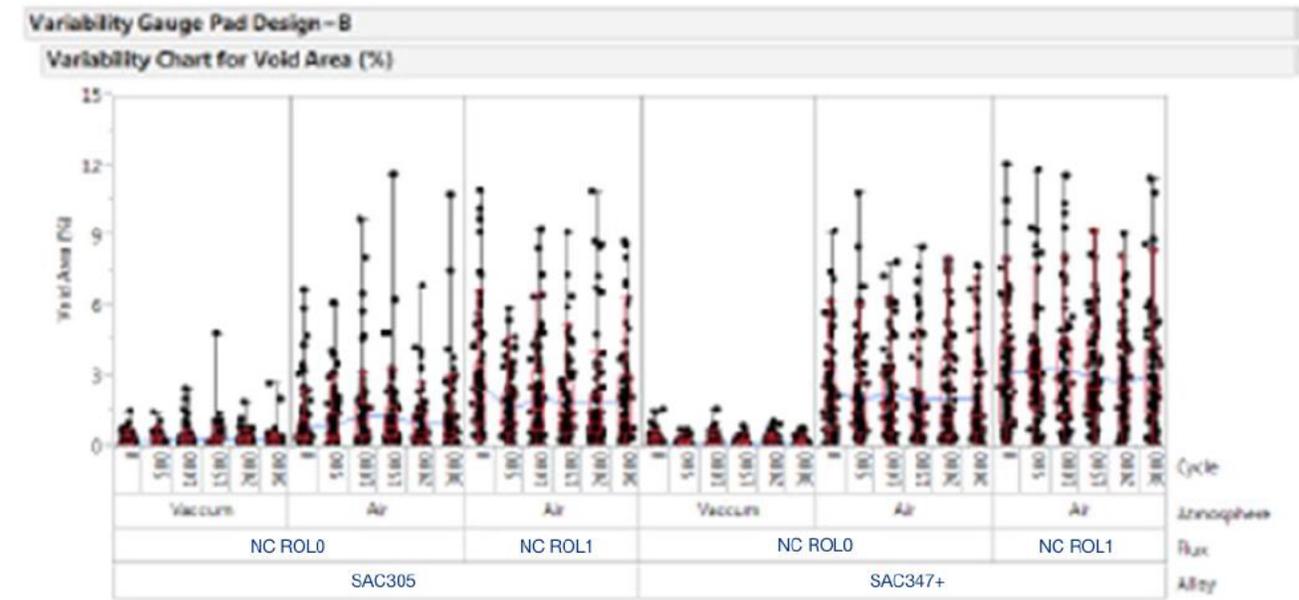
2012 Shear Results

- NOTES:
 - Greater void variation from 3216 results.
 - But LESSER variation in shear force readings from initial through 3000 cycles.

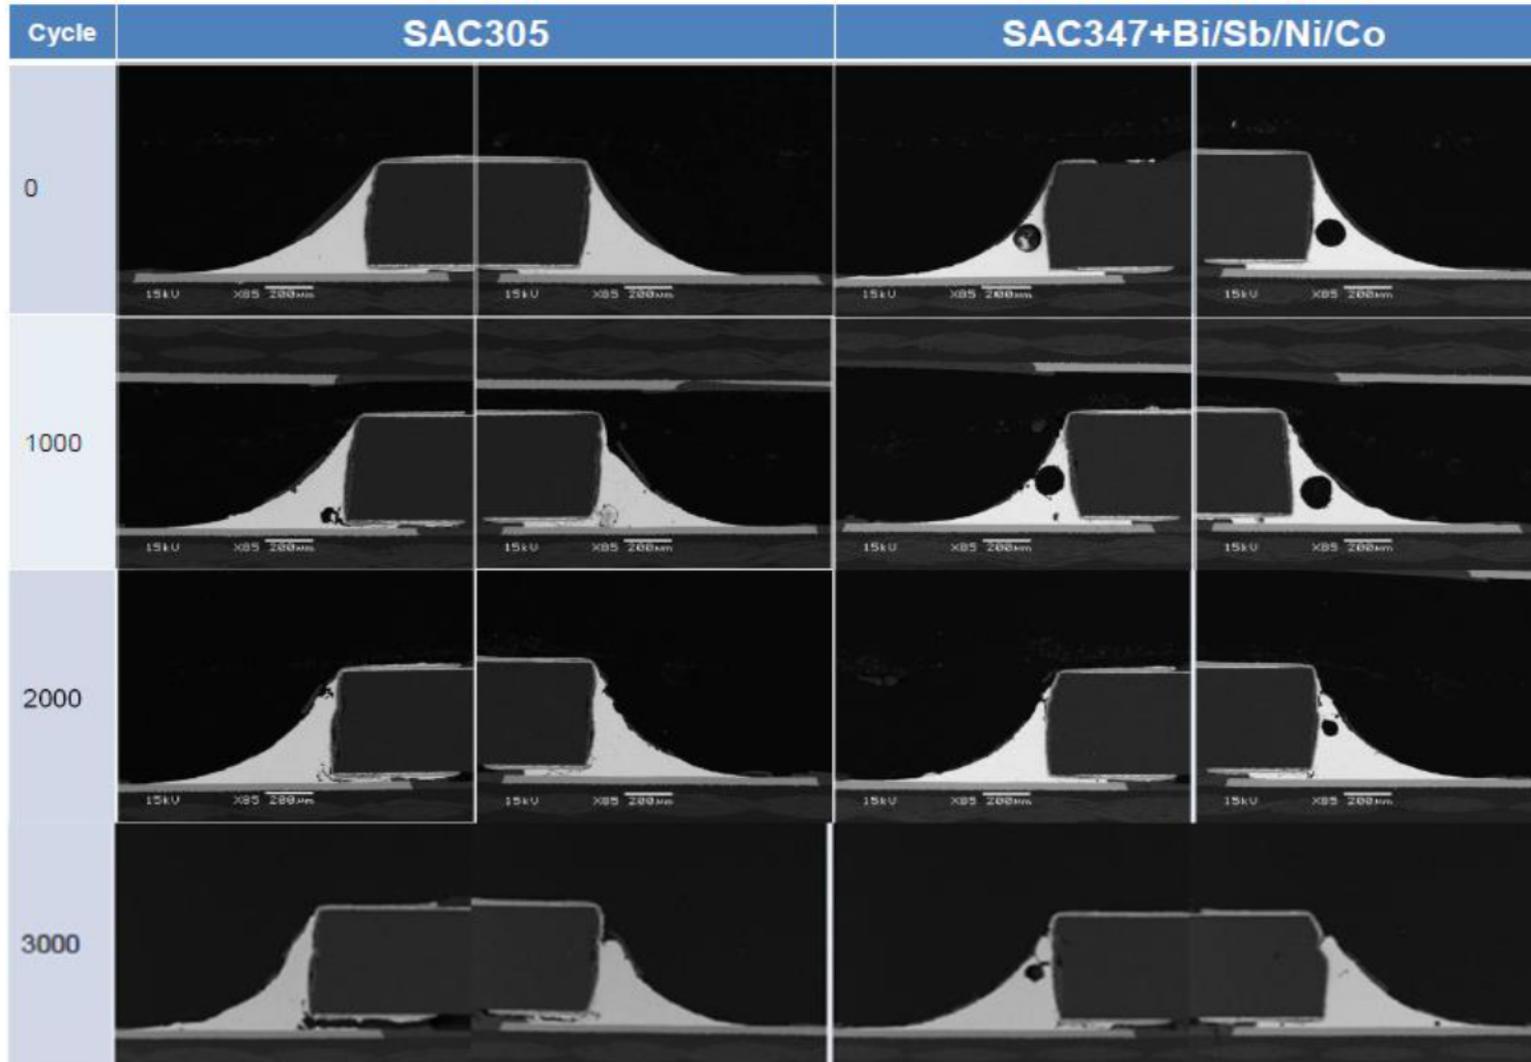
Chip Resistor Representative X-Ray

- Left Side: SAC305
- Right Side: SAC347+
- NOTES:
 - *Top: T0*
 - *Bottom: T3000*
 - *SAC347 larger voiding*
 - *But as TCT progresses, the crack propagates throughout the SAC305 underside and termination.*
 - *SAC347+ crack growth is limited.*
 - *This is typical of other joints observed.*

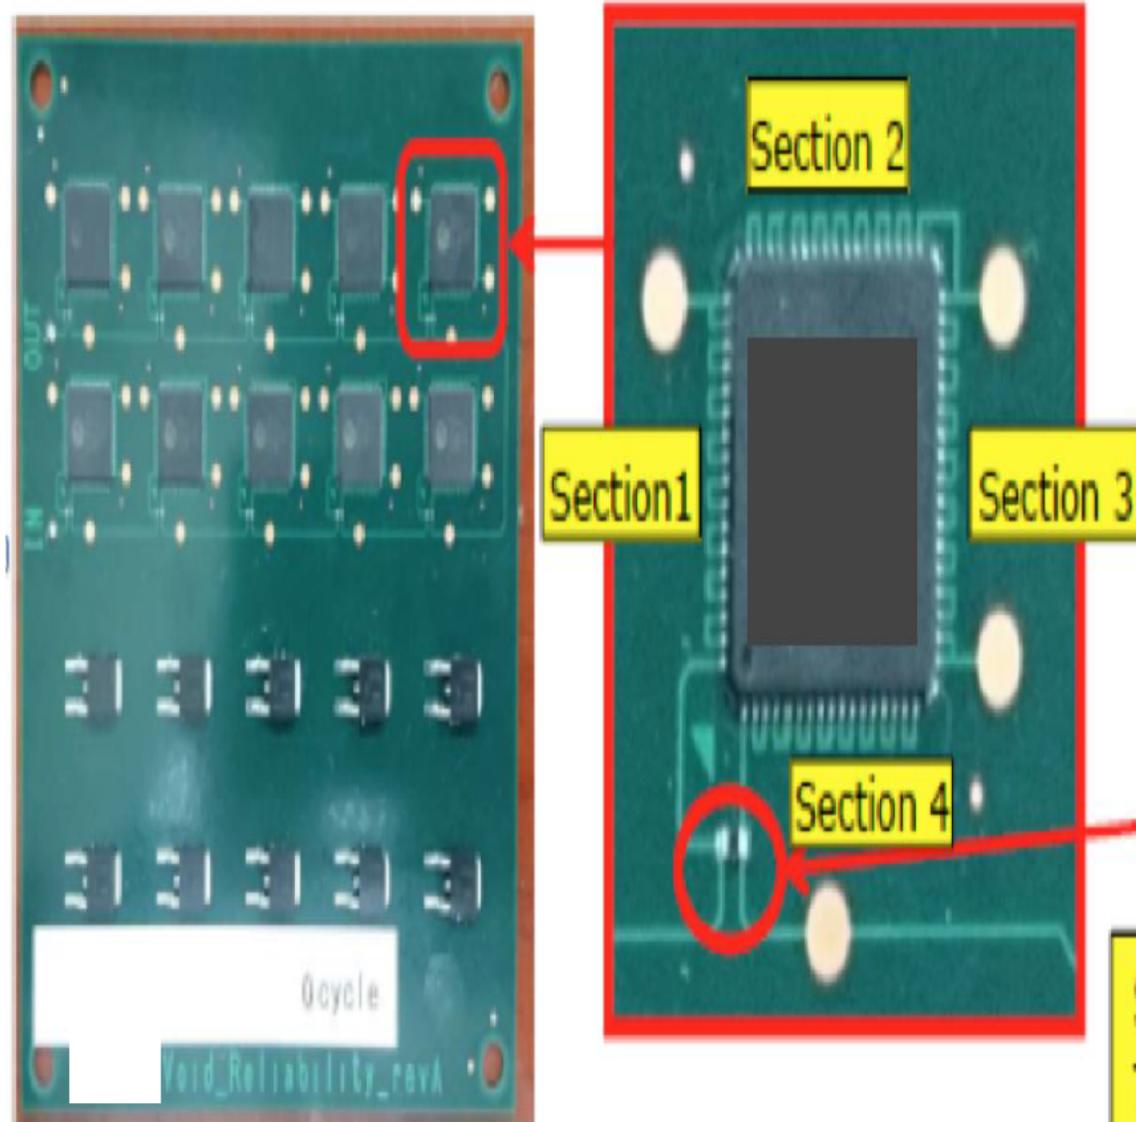
- QFNs are connected via daisy chain and resistance is measured.
- Should a section or side of the QFN leads suffer a failure, the resistance measured will increase by a factor of ~3X.
- Individual lead failure detection is not possible with this process.
- DPAK are also mounted for the purpose of relative voiding and crack propagation comparisons.

An increase of about 300% of the resistance indicates that one of I/O's on the QFN is opened.

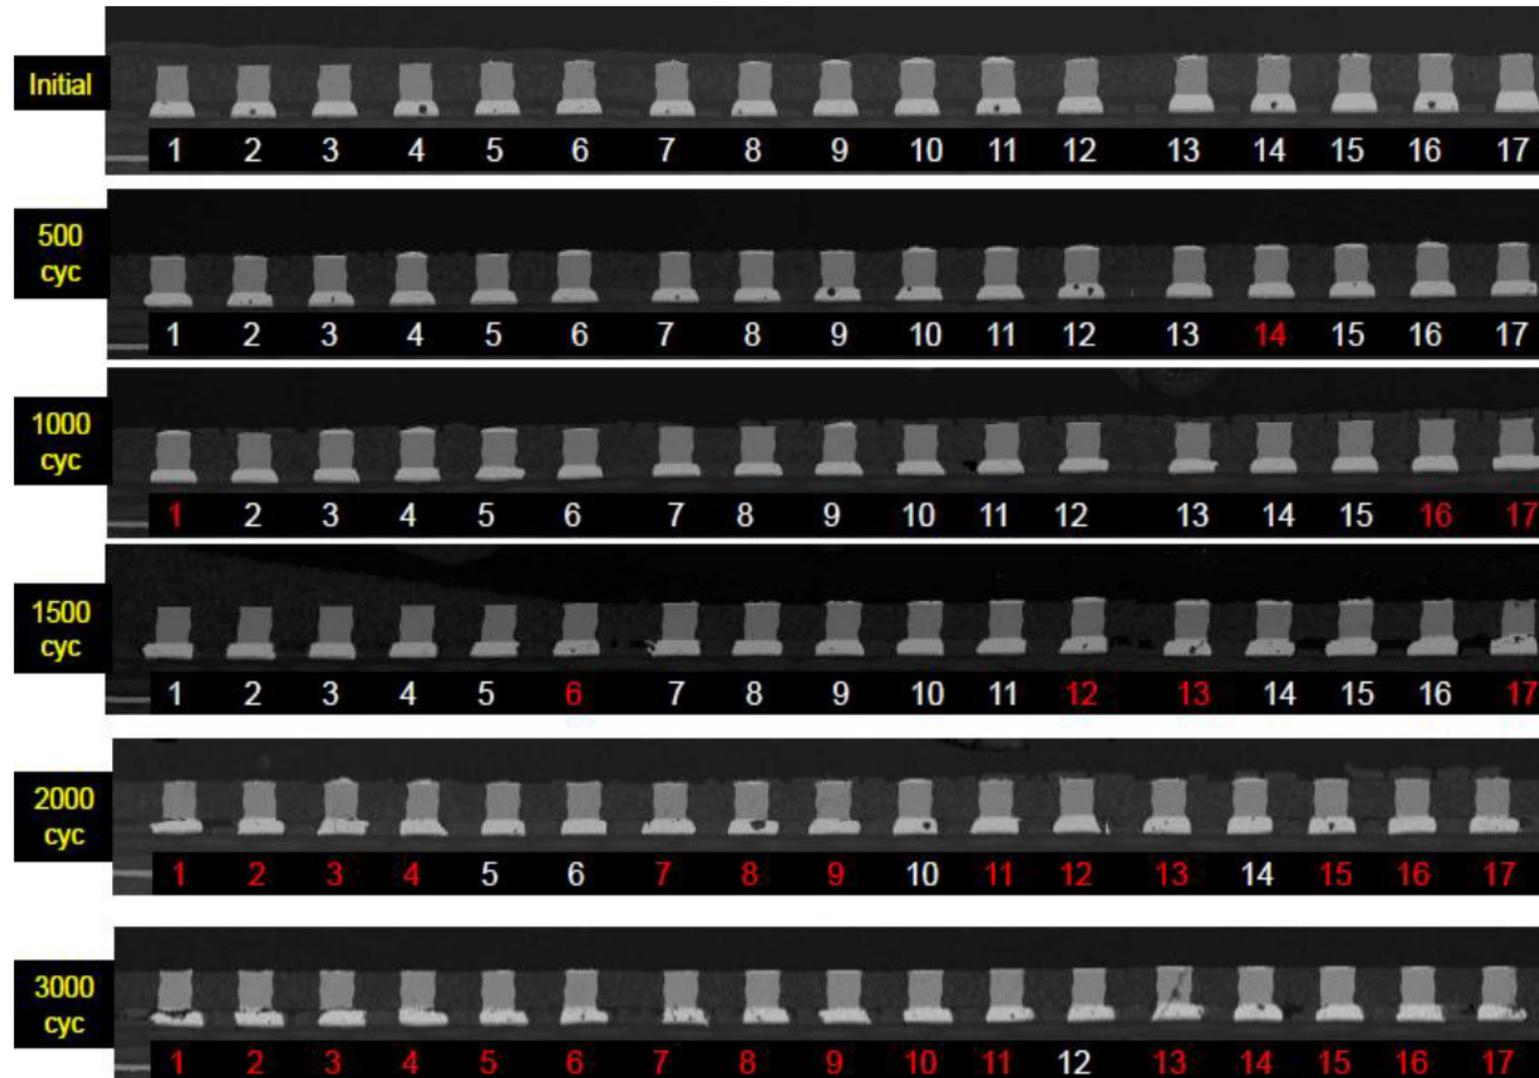
Example of FA

- Here QFN rows are analyzed for crack initiation and length.
- In this case, a SAC305 with relatively lower voiding had still a significant number of failures.
- CS could find significant (yellow) and major (red) cracks.

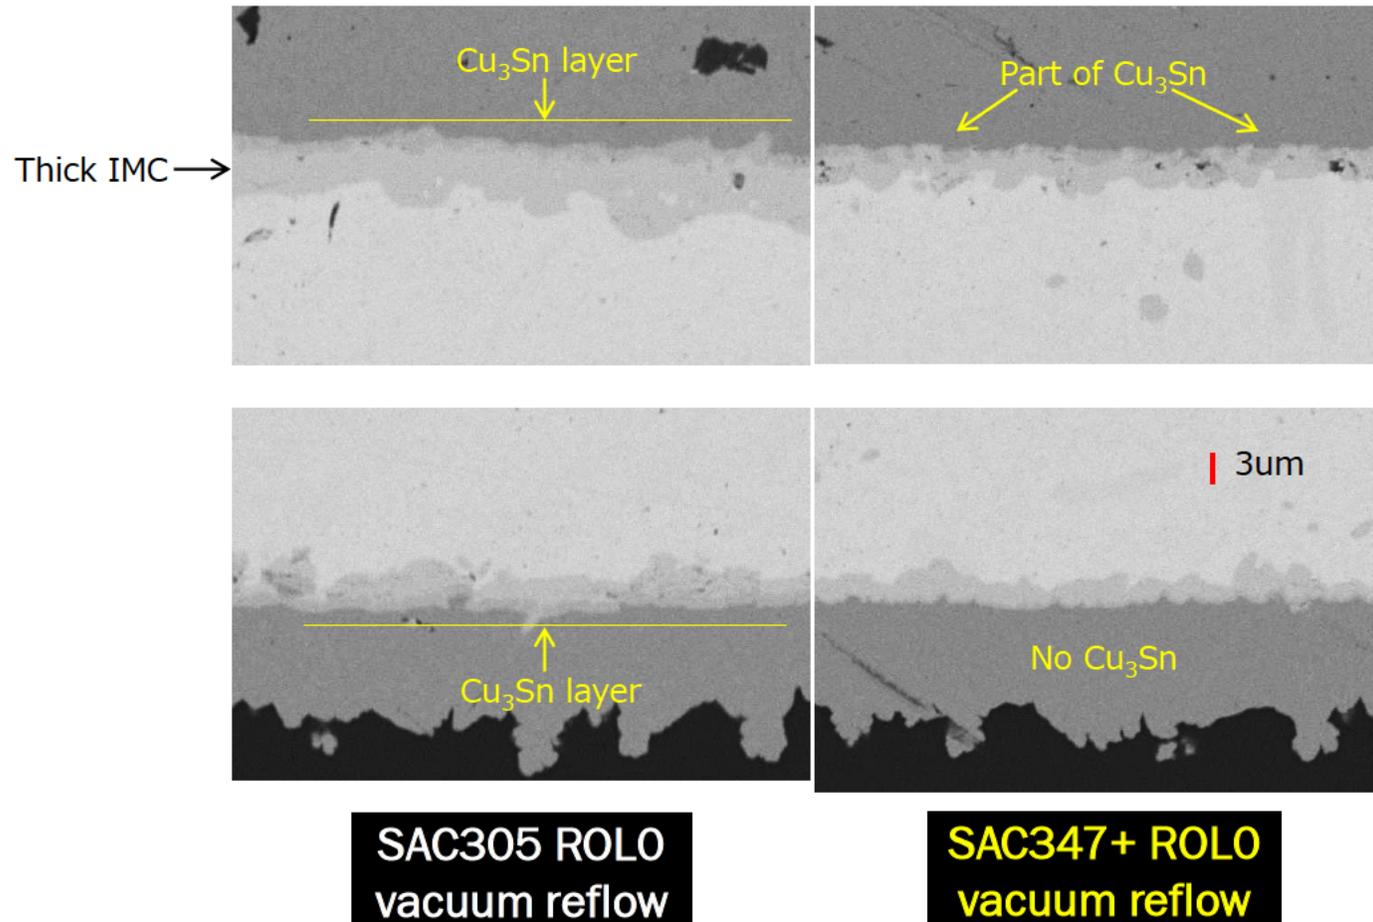
IMC thickness closeup w/ Cu_3Sn growth for SAC305

SAC305 IMC growth is faster than SAC347+. Especially Cu_3Sn growth is clear in SAC305
