# Sn3.2Ag0.7Cu5.5Sb Solder Alloy with High Reliability Performance up to 175°C

Indium Corporation

A novel lead-free solder alloy 90.6Sn3.2Ag0.7Cu5.5Sb (SACSB), was developed targeted for high reliability with a wide service temperature capability. The alloy exhibited a melting temperature range of 223 to 232°C, reflowable at profile with peak temperature 245°C and 255°C, with ambient temperature Yield Stress 60MPa, UTS 77 MPa, and ductility 28%, and a higher stress than both SAC305 and 90.9Sn3.8Ag0.7Cu3Bi1.45Sb0.15Ni (SACBSbN), the latter two alloys were used as controls. When tested at 140°C and 165°C, the die shear stress of SACSB was comparable with SACBSbN but higher than SAC305, and the ductility was higher than both SACBSbN and SAC305, with SACBSbN exhibiting distinct brittle behavior. When aged at 125°C and 175°C, the die shear strength of SACSB was comparable or higher than both controls. When pretreated with a harsh condition, a temperature-shock test (-55°C/155°C) for 3000 cycles, the die shear strength of SACSB was 8 times of that of SACBSbN and SAC305. When pre-conditioned using a temperature-cycling test (-40°C/175°C) for 3000 cycles, the die shear strength of SACSB

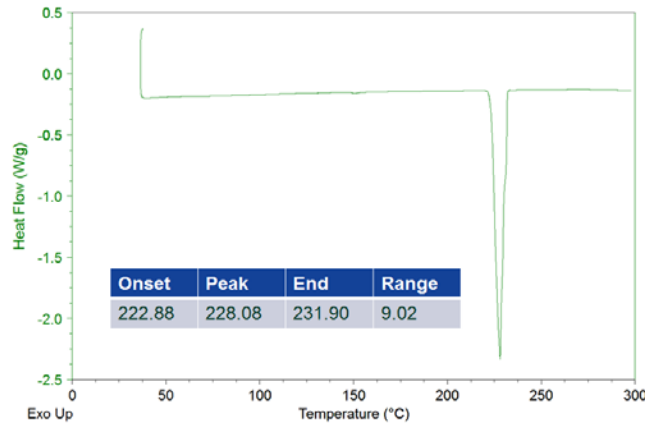
The melting behavior of SACSB measured by Differential Scanning Calorimetry (DSC) was shown in Figure 1.

**Figure 1 DSC thermograph of solder alloy SACSb**

The melting temperature of SACSb is about 11°C higher than SACBSbN, as shown in Table 1.

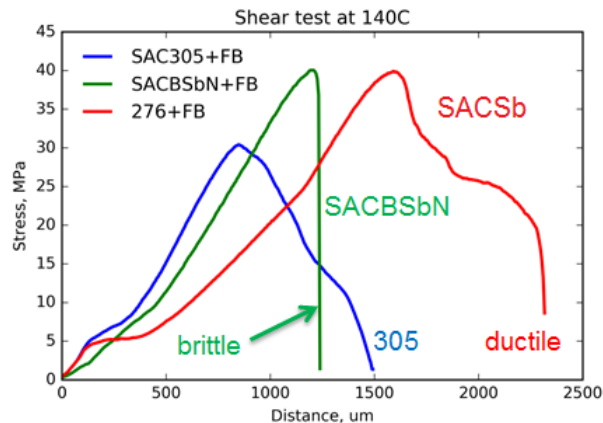
**Figure 2 Shear test curves for solder joints of Cu die (3mm x 3mm) attached onto Alloy42 substrate measured at 140°C**

As shown in Table 3 and Figure 2 and Figure 3, both SACBSbN and SACSb exhibit higher yield stress and UTS (Ultimate tensile stress) than SAC305. SACBSbN has the lowest ductility, and the rapid drop in stress failure pattern shown in Figure 2 and Figure 3 indicated brittle failure. SAC305 exhibited higher ductility than SACSb at ambient temperature. But, the relative ranking reversed at elevated temperature, 140°C and 165°C, with SACSb being more ductile than SAC305, as shown in Figure 2 and Figure 3.

As shown in Figure 2 and 3, both SACSb and SACBSbN showed a higher maximum stress than SAC305. This suggests that both alloys may deform to a less extent than SAC305 under a typical stressed condition, hence may promise a better joint integrity under mild conditions.

However, there is a significant difference between SACSb and SACBSbN. SACSb is rigid and ductile, while SACBSbN is rigid but brittle, as shown in Figure 2 and Figure 3. Under the harsh test condition where  $\Delta T$  was high, the dimension mismatch between parts and substrate became very significant due to CTE mismatch. This significant dimension mismatch would cause a brittle joint to crack quickly, as seen on SACBSbN. The challenge was more tolerable for a more ductile joint, as shown by SACSb. Accordingly SACSb showed a much better reliability than SACBSbN under harsh conditions, including high testing temperature and large  $\Delta T$ .

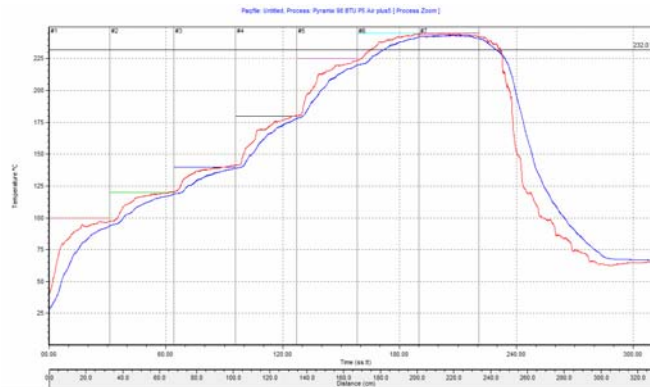
**Figure 4** Reflow profile with a peak temperature of 245°C.

Two reflow profiles under air atmosphere were used in this study, as shown in Figure 4 with a peak temperature of 245°C and Figure 5 with a peak temperature of 255°C. Unless otherwise specified, the 255°C peak temperature profile was used.

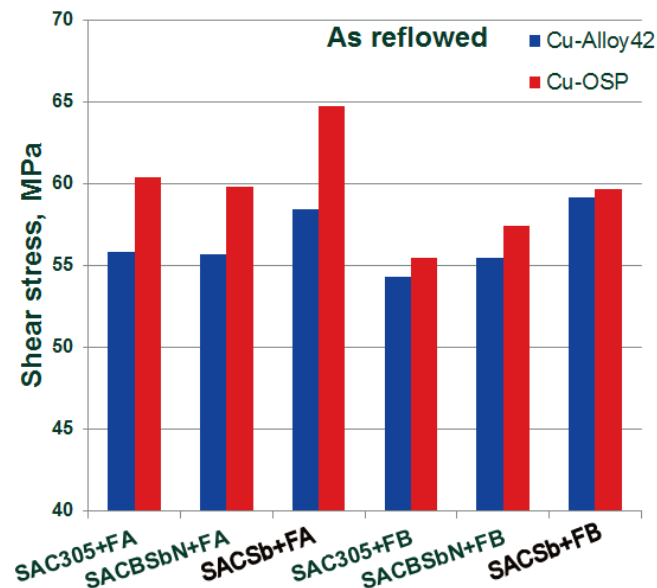
The shear strength of as-reflowed solder joints measured at room temperature for various combinations of materials and solder alloys are shown in Figure 7. All solder pastes were reflowed with a 255C Peak profile.

Several trends were observed. First, Cu-Cu resulted in higher shear strength than Cu-Alloy42, presumably due to better wetting on Cu than on Alloy42. Secondly, SACSb showed a higher shear strength than both SAC305 and SACBSbN. Thirdly, Flux A (FA) showed a higher strength than Flux B (FB). However, the relative ranking of flux on shear strength could not be observed in Figure 8 to be discussed next, suggesting a possible data scattering effect.

**Figure 7 The shear strength measured at room temperature for various combination of materials and solder alloys reflowed with Peak255 profile**

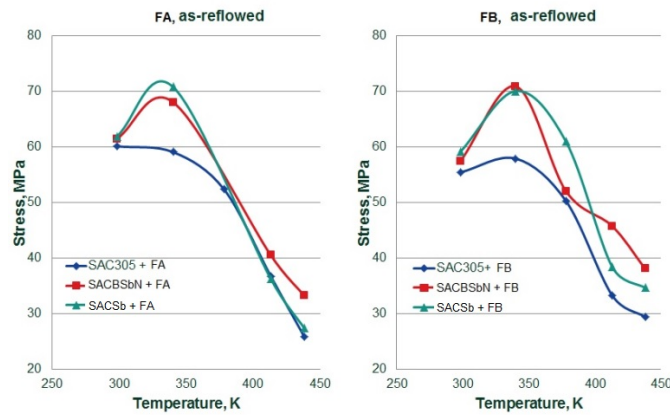
The shear strength of as-reflowed solder joints measured at 25°C, 65°C, 105°C, 140°C, and 170°C were shown in Figure 8.

**Figure 8 The shear strength of as-reflowed solder joints measured at various temperatures**

In general, the shear strength decreased with increasing temperature, except for the initial increase in shear strength at 65°C. The latter could be attributed to annealing or stress relaxation effect. The shear strength of SACSb and SACBSbN were comparable, and both were higher than SAC305. The effect of flux type was unclear, suggesting an insignificant effect on shear strength.

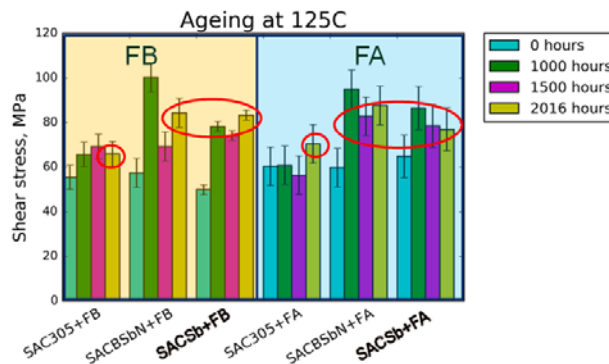
Figure 9 showed solder joint shear strength measured at room temperature after the mild TA (thermal aging) at 125°C up to 2016 hours.

**Figure 9 Solder joint shear strength measured at room temperature after TA at 125°C up to 2016 hours.**

For automotive applications, 125°C aging condition is considered a mild condition. Under this condition, SACSb is comparable with SACBSbN in shear strength, and the two alloys are equivalent or superior to SAC305. Here the flux factor also is insignificant.

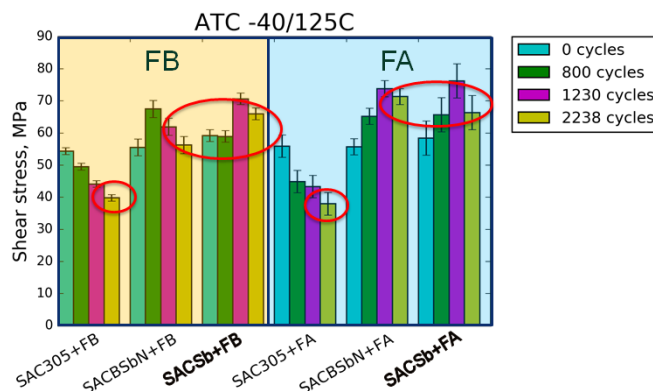
For the mild TCT (-40/125°C) condition, the shear strength against cycling number is shown in Figure 11. After 2238 cycles, the shear strength of SACSb is comparable with SACBSbN, and both of them are higher than SAC305.

**Figure 11 Solder joint shear strength measured at room temperature after TCT (-40°C/125°C) up to 2238 cycles.**

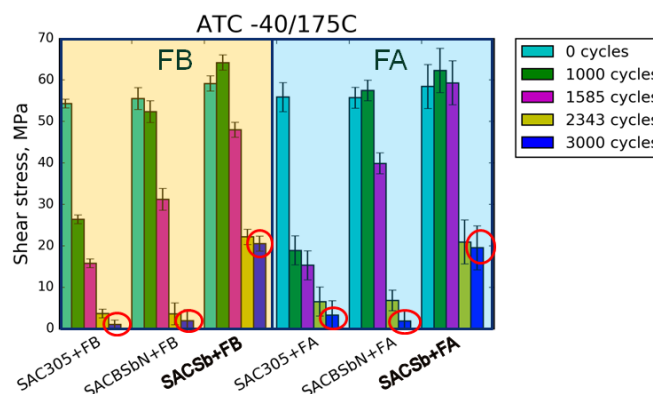
For harsh TCT (-40°C/175°C) condition, SAC305 dropped to less than 50% of initial strength after 1000 cycles. SACBSbN and SAC305 exhibited a shear strength about 1/20-1/11 of SACSb, as shown in Figure 12. Flux-wise, FA is comparable with FB.

**Figure 12 Solder joint shear strength measured at room temperature after TCT (-40°C/175°C) up to 3000 cycles.**

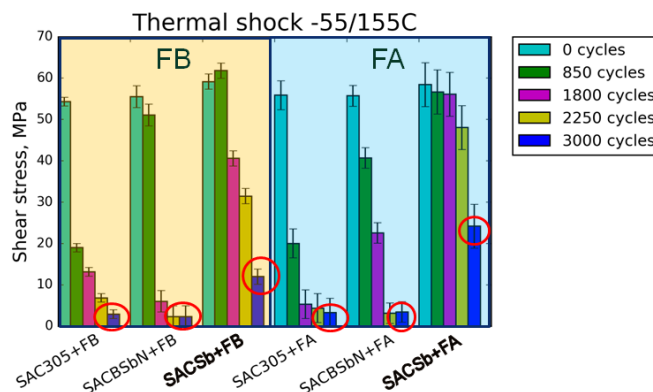
For the harsh TST conducted at -55°C/155°C, the results are shown in Figure 13. The cycling detail was 10 min dwell time, ~24 min per cycle.

**Figure 13 Solder joint shear strength measured at room temperature after TST (-55°C/155°C) up to 3000 cycles.**

With increasing TST cycling number, SACSb retained strength very well, followed by SACBSbN, with SAC305 declining most rapidly. After 3000 cycles, the shear strength of SACSb is about 8 times of SACBSbN and SAC305. Joints with FA showed slightly higher shear strength than those of FB.

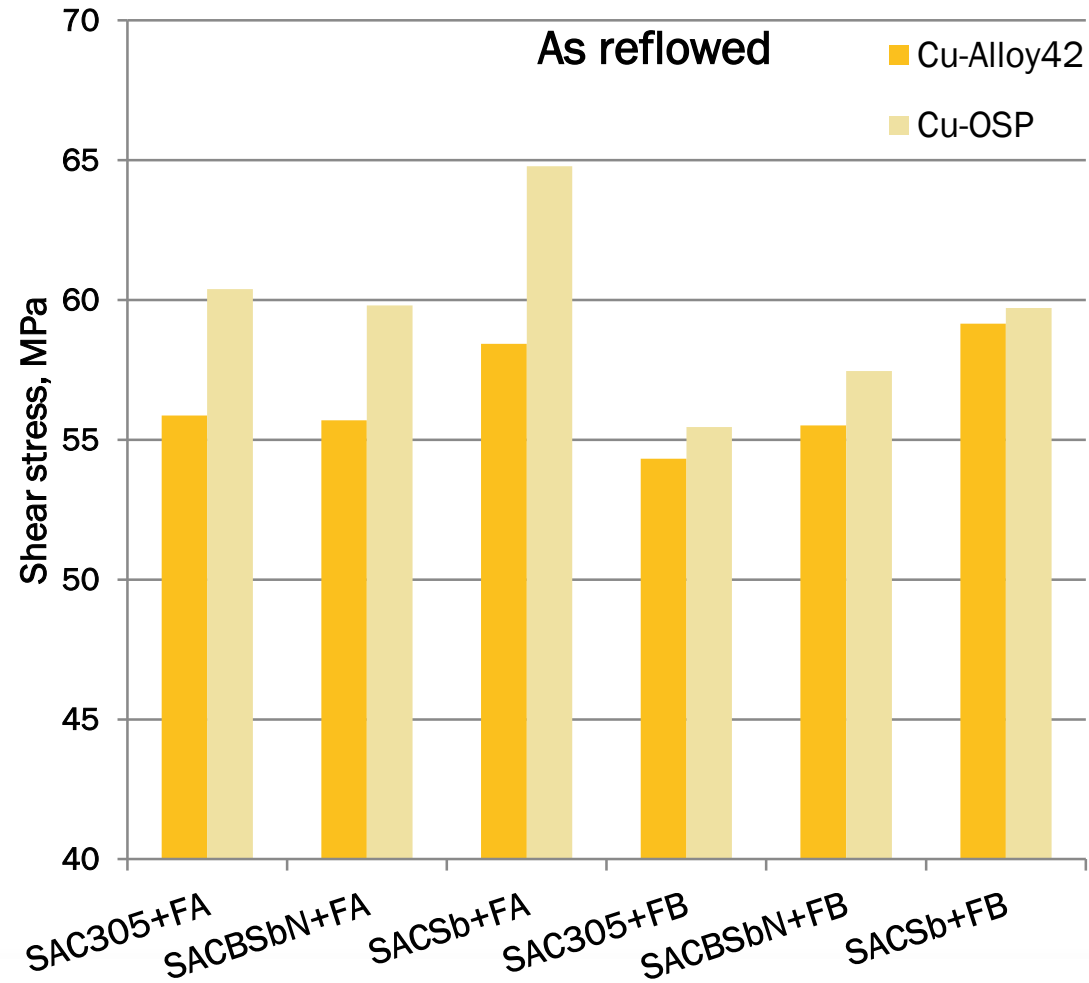
Shear stress at RT, as-reflowed

RT Shear Strength

SACSb  
> SACBSbN & 305

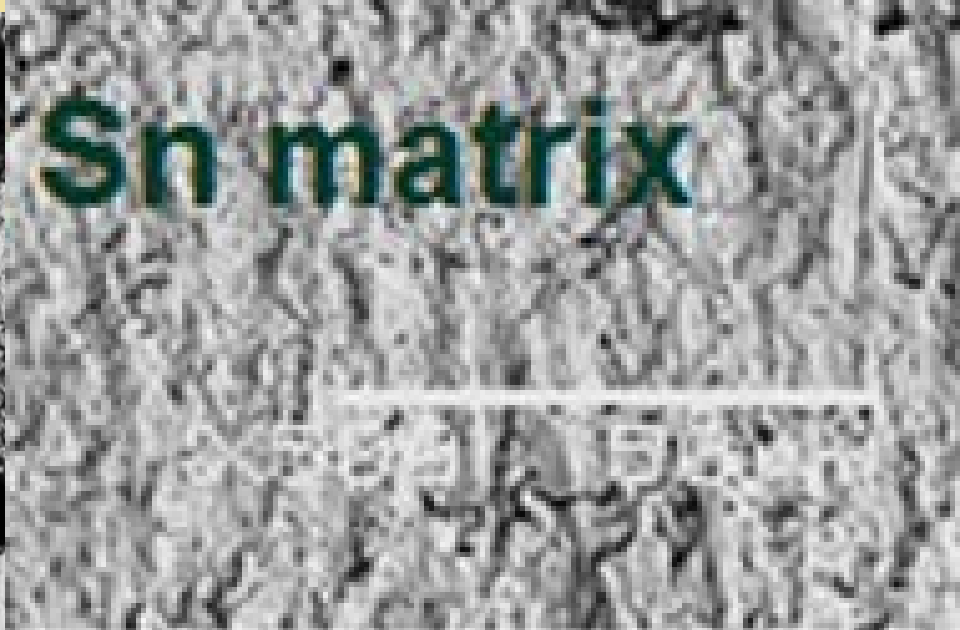
Fractured die back surface of as-reflowed SACBSbN joints (500X)

No sign of ductile texture  
can be discerned

Ni-K	Cu-K	Ag-L	Sn-L	Bi-M
1	2.25	55.38		42.37	
2		8.51	1.22	88.68	1.60
3			63.65	36.35
