# Acoustic Detection of Pad Craters in Mechanical Shock and Transient Bend Tests

Julie Silk<sup>1</sup>, W. Carter Ralph<sup>2</sup>, Gregory Morscher<sup>3</sup>, Elizabeth Benedetto<sup>4</sup>, Douglas Olney<sup>1</sup>  
<sup>1</sup>Keysight Technologies, <sup>2</sup>Southern Research Institute, <sup>3</sup>University of Akron, <sup>4</sup>HP Inc

# **Acoustic Detection of Pad Craters in Mechanical Shock and Transient Bend Tests**

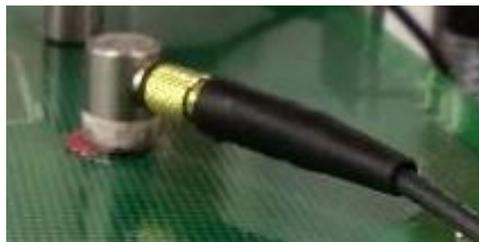
**Figure 3 - Acoustic transducer mounted to a PCB with accelerometer wax**

The acoustic emission tests employed the use of wide-band transducers that are sensitive to at least 100 and up to 700 kHz or higher with a flat frequency response. A sampling rate of 10 MHz or higher was used for all experiments. A 20dB preamplifier was used to amplify the signal. Better results were achieved by setting the amplification such that the waveform responses of interest were just at the point of saturation, then setting the trigger to be slightly above the noise generated by the test frame. In some tests, additional amplification is needed. An example of a transducer mounted to a PCB is shown in Figure 3. Vacuum grease was used as a coupling agent to enhance the sound wave into the sensor. Other couplants are petroleum jelly or other viscous materials. Transducers can be attached to the board with a mechanical clamp or cyanoacrylate; a thin layer of accelerometer wax, as shown in Figure 3, gave comparable results with easier application and removal, so was used in the majority of this testing.

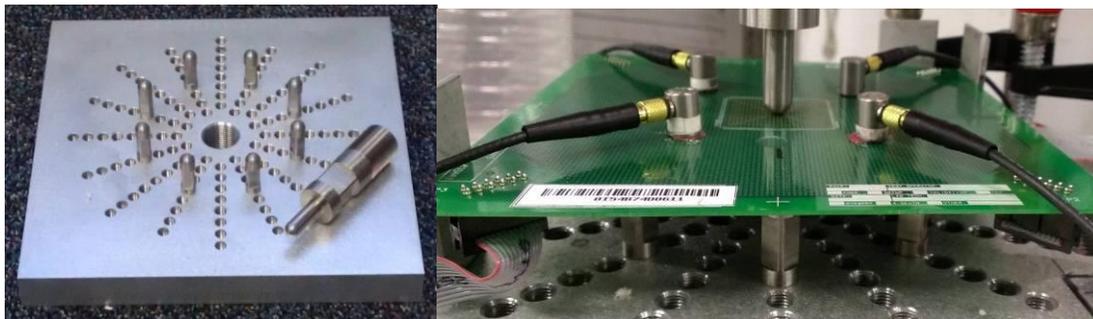
**Figure 8 - Spherical bend test fixture and setup**

locations of the eight supporting points and an array of pins at each corner that connect to the strain gage leads and daisy chains. The spherical bend test fixture is shown in Figure 8, along with a photograph of a test article mounted on the fixture ready to test. The aluminum angle brackets at the front left and back right corners of the PCA are alignment fixtures that are spaced a paper's width from each edge so that they do not make contact during the test. Four acoustic emission transducers were placed on each test article, typically 38mm from the center of the BGA along the diagonals (near the corners).

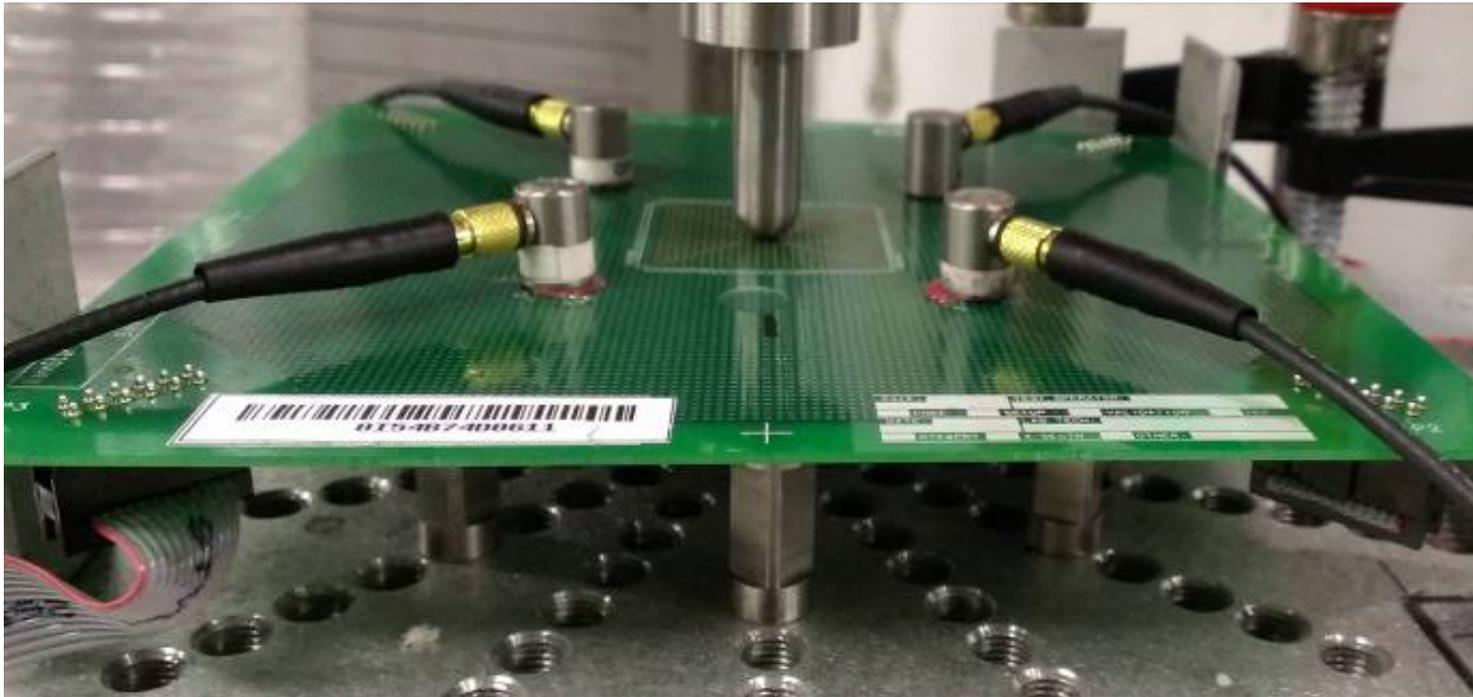
## Example of test vehicle with transducers attached

Transducers can be attached with several choices of couplants and attachment methods.

Wide-band transducers used: sensitive to at least 100 kHz and up to 700 kHz, flat frequency response  
Test vehicle parameters: 35x35 mm PBGA package, 1 mm pitch SAC305 solder balls, non-solder mask defined pads, 1.6 mm thick, 203x203 mm board
