# Head-on-Pillow Defect Detection – X-ray Inspection Limitations

Lars Bruno and Benny Gustafson  
Ericsson AB, Stockholm, Sweden

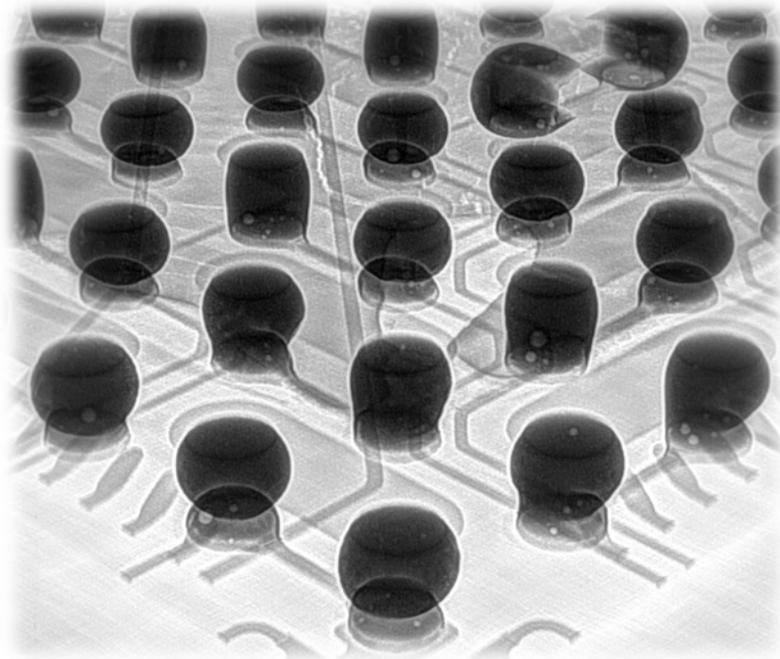
Figure 1 – X-ray image from HoP defect analysis<sup>1</sup>.

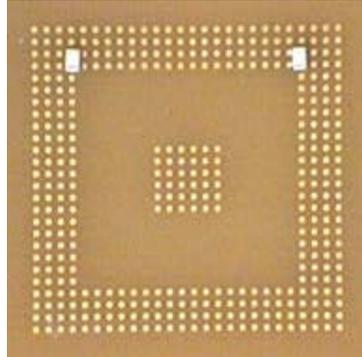
**Figure 2 – Example of chip components placed on a solder paste screen printed BGA pad site<sup>2</sup>.**

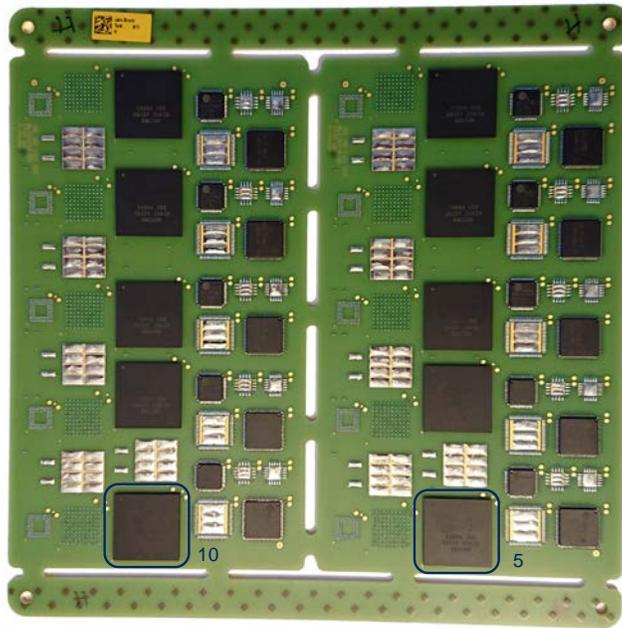
**Figure 11 – Test board panel with encircled HoP defect BGA test components.**

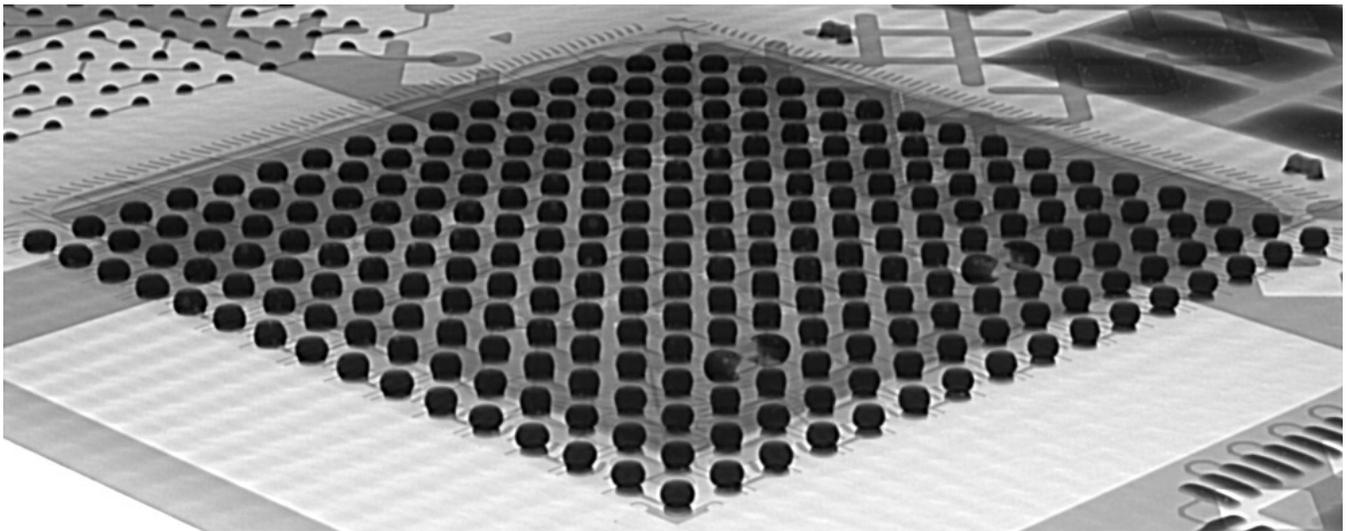
**Figure 14 – X-ray inspection – detector view angle 70°, sample rotation 45°.**

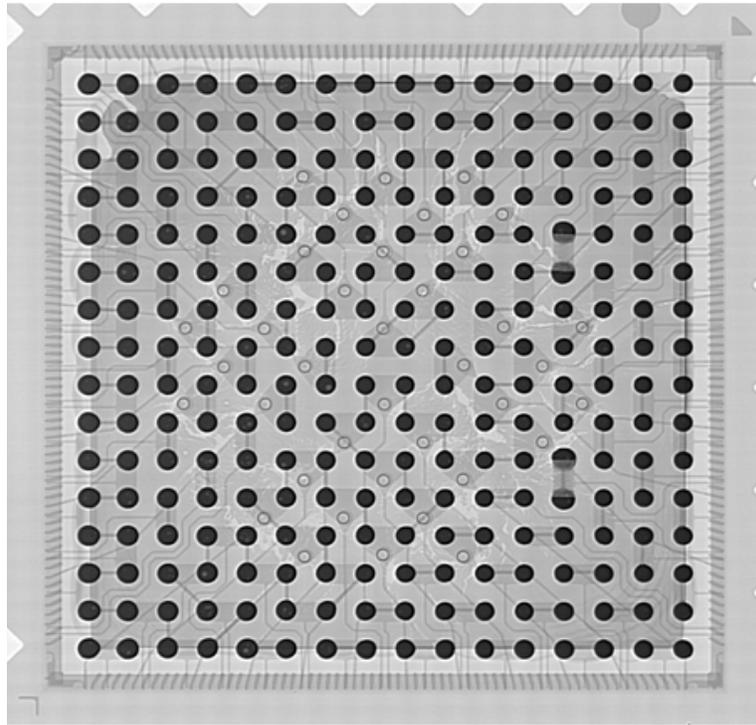
**Figure 15 – X-ray inspection – top view (0° tilt).**

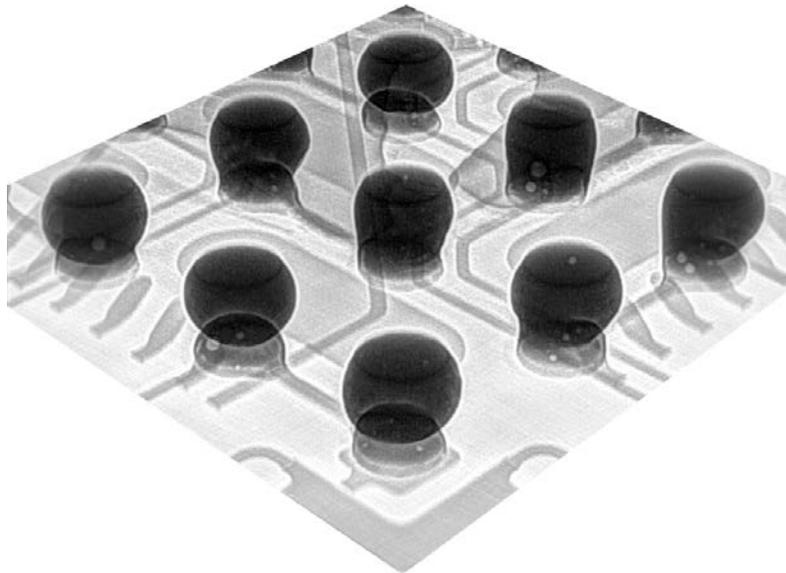
**Figure 16 – BGA solder joints - all regarded as HoP in this x-ray inspection.**

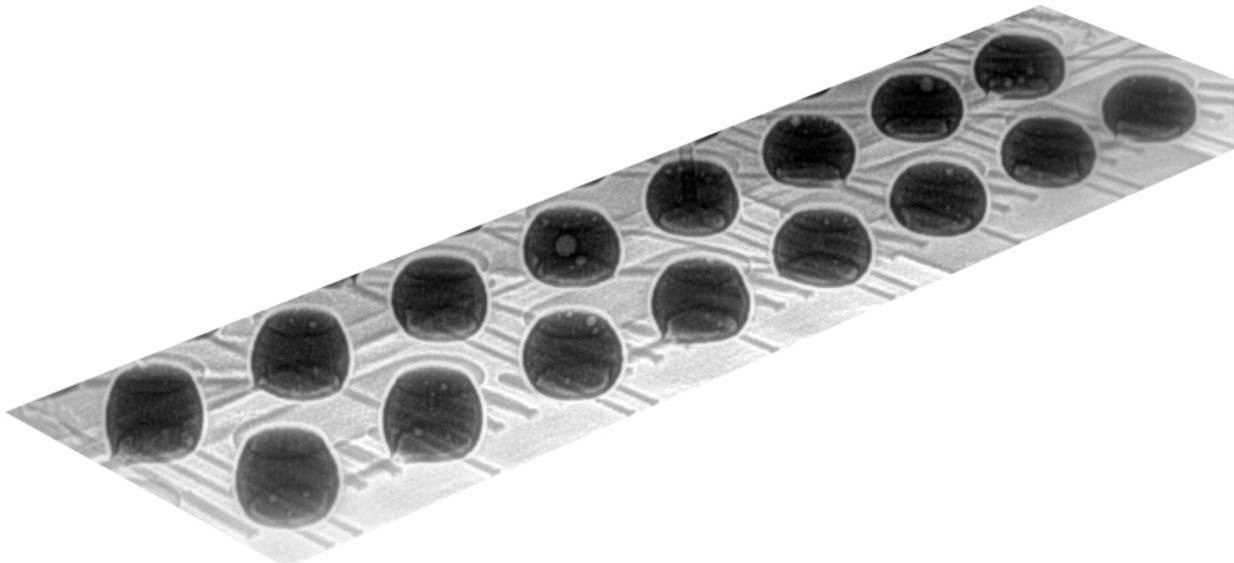
**Figure 17 – X-ray image of good solder joints - regarding HoP.**

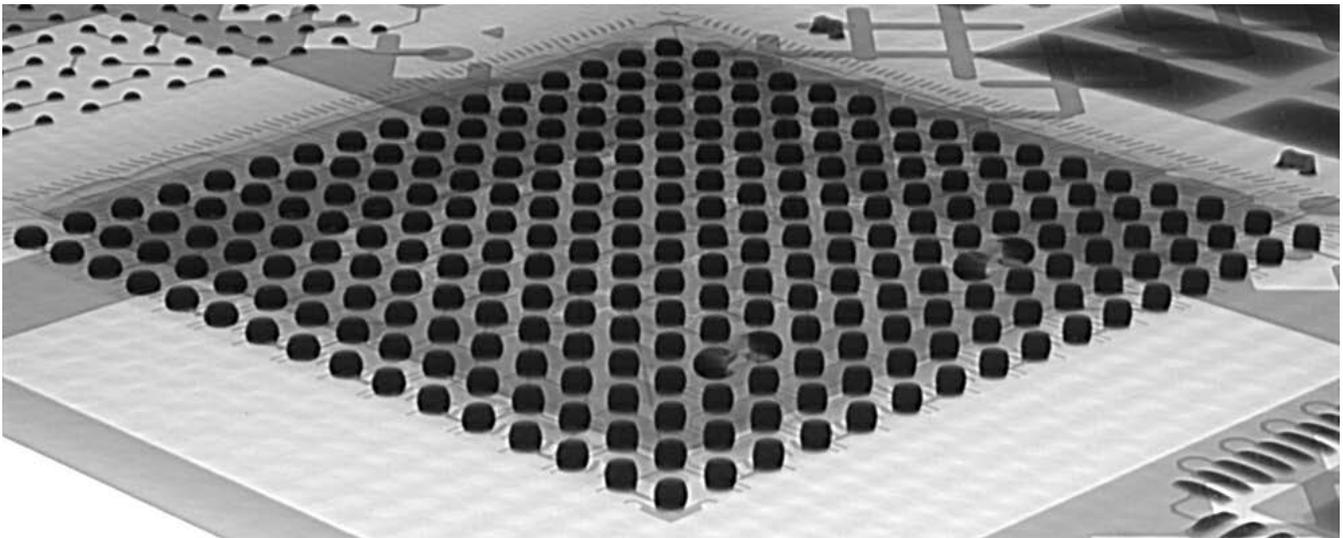
**Figure 18 – X-ray image of the best performing solder paste's solder joints.**

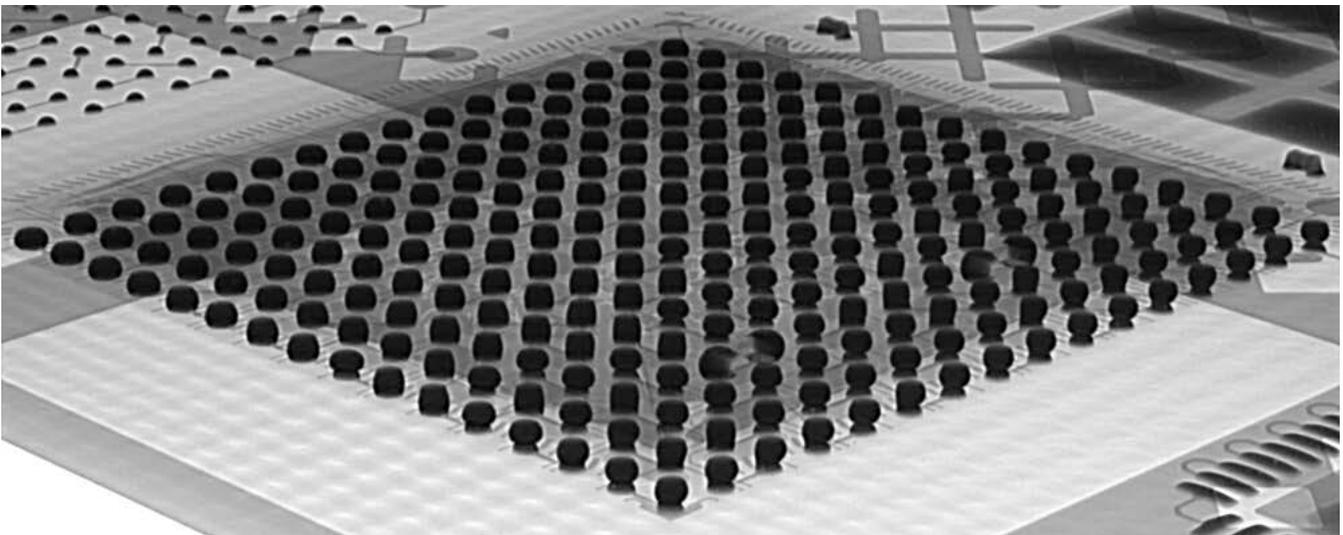
**Figure 19 – X-ray image of solder joints created with a solder paste with poor HoP mitigation properties.**

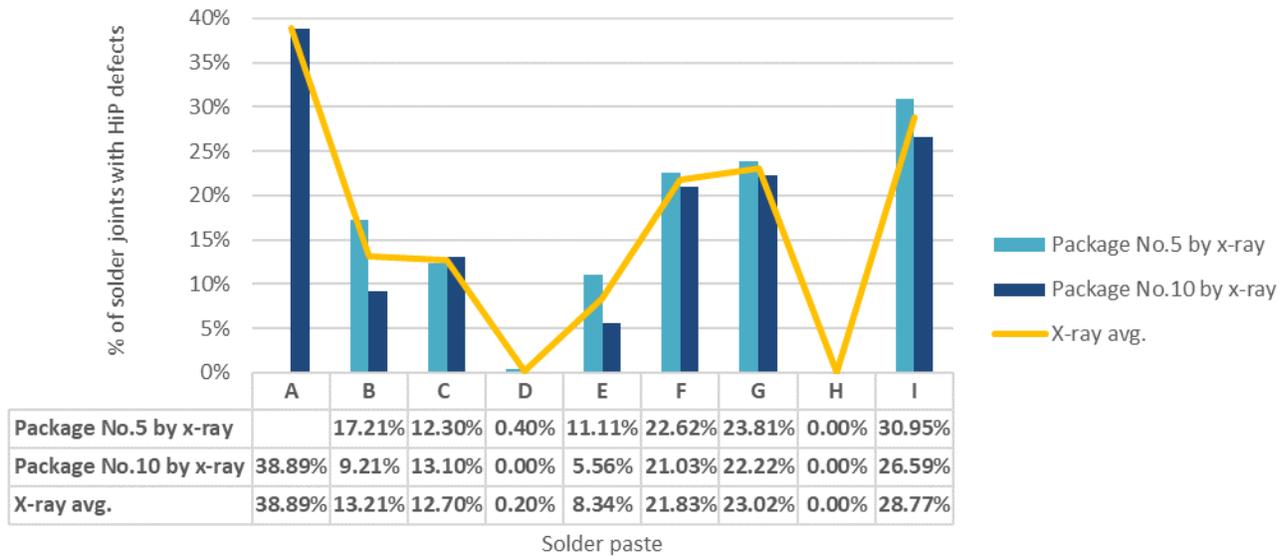
**Figure 20 – Solder paste HoP defect rates for nine different solder pastes – BGA256.**

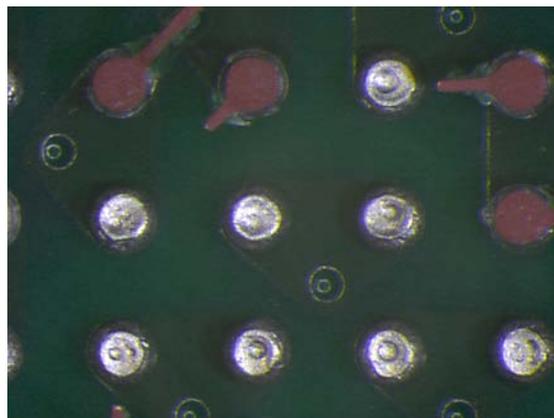
**Figure 21 – Eight HoP defects verified after prying-off a test BGA.**

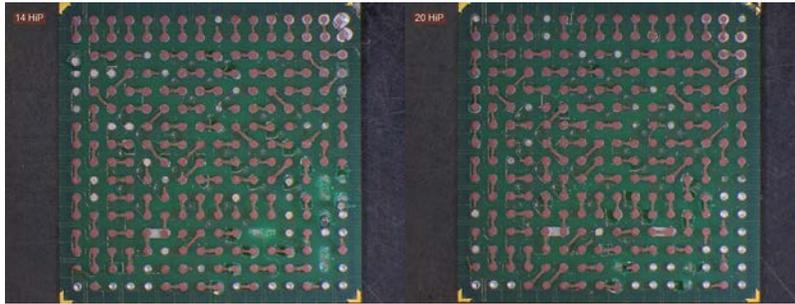
**Figure 22 – HoP defects verified after prying-off two test BGAs -solder paste I.**

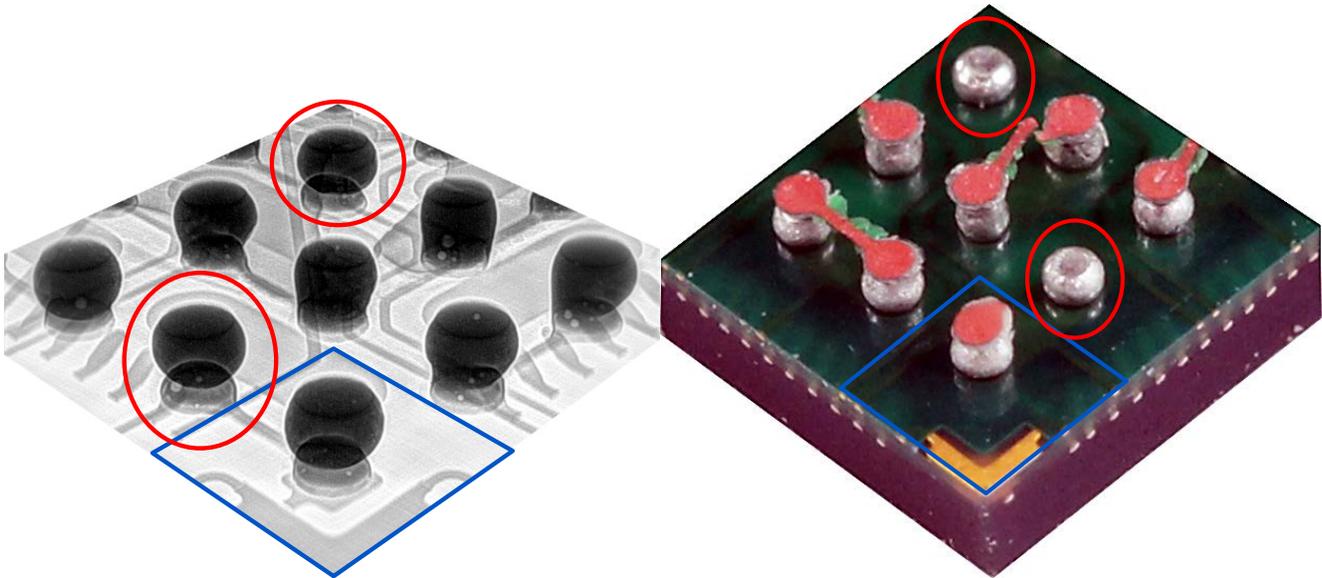
**Figure 24 – Comparison of x-ray image (left) and pried component (right) –red encircles show verified HoP defects.**

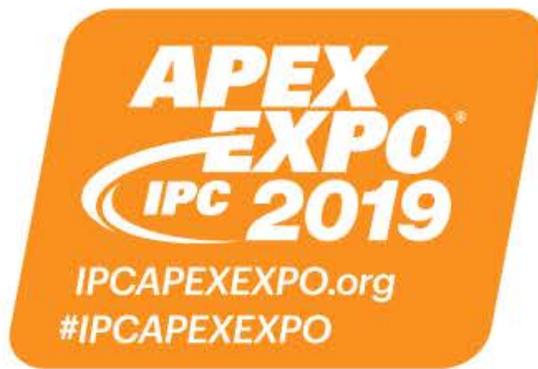
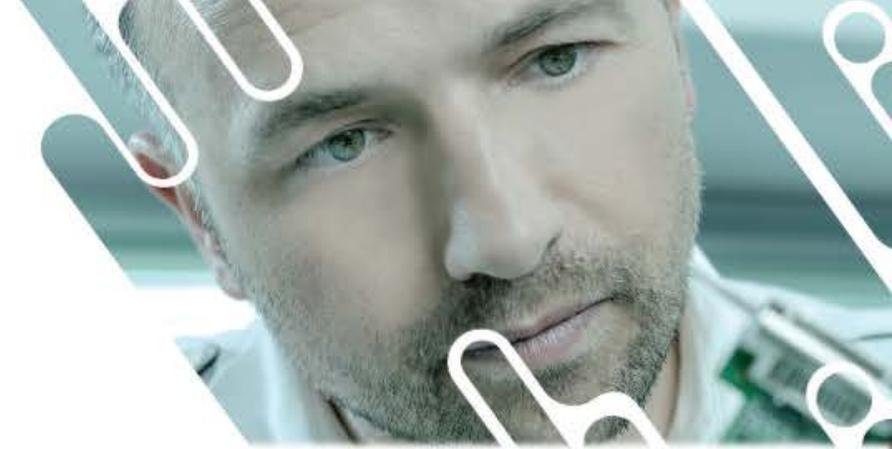
# Head-on-Pillow Defect Detection – X-ray Inspection Limitations

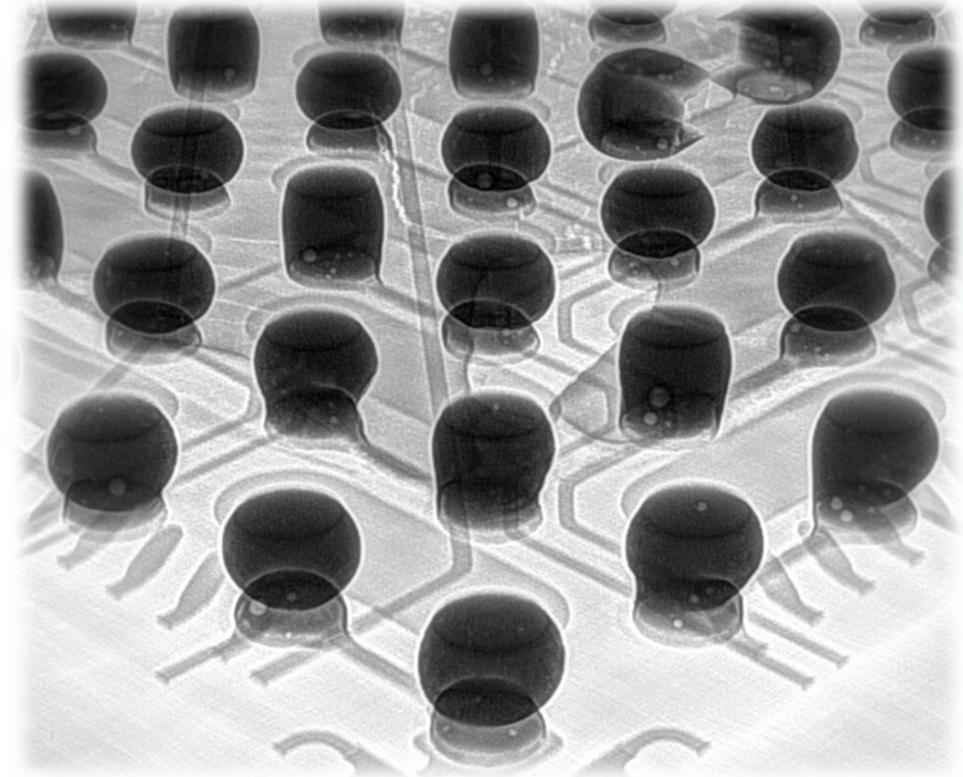
Lars Bruno and Benny Gustafson  
Ericsson AB, Stockholm, Sweden

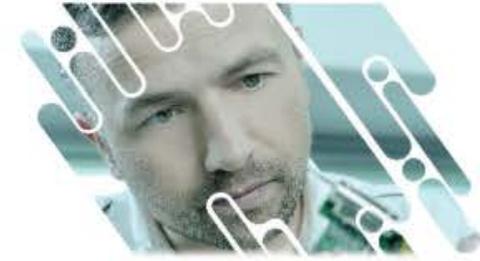
**MEETINGS AND COURSES:** JANUARY 26–31, 2019  
**CONFERENCE AND EXHIBITION:** JANUARY 29–31, 2019

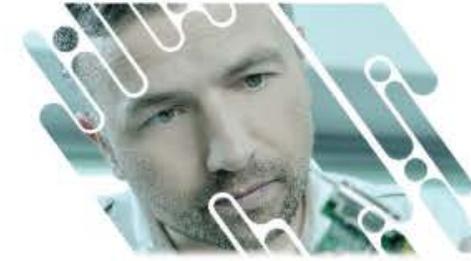
- Background
- Purpose
- Methodology
- Test material
- Assembly
- X-ray inspection
- Pry-off
- Discussion
- Conclusion & recommendations
- Acknowledgements
- Q & A

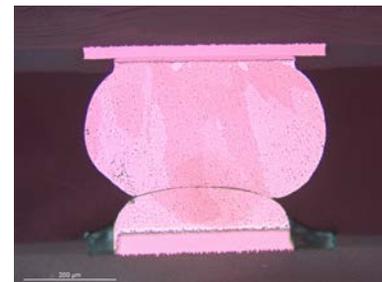
- BGAs of different variants and sizes more and more common.
  - *Ranging from a few mm die size Wafer Level Packages (WLPs) with low ball count up to large multi-die System-in-Package (SiP) BGAs with 60-70 mm side lengths and thousands of I/Os.*
- Sensitive to package and board warpage during soldering that could lead to:
  - *Solder balls losing contact with the solder paste and its flux.*
  - *This may result in solder joints with two distinct structures and poor, or no, coalescence between the added solder and the BGA balls.*
  - *This defect is called Head-on-Pillow (HoP).*
- HoP defects are difficult to detect, even with most modern x-ray equipment.

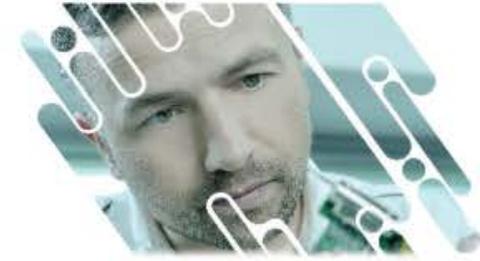
MEETINGS AND COURSES: JANUARY 26-31, 2019  
CONFERENCE AND EXHIBITION: JANUARY 29-31, 2019

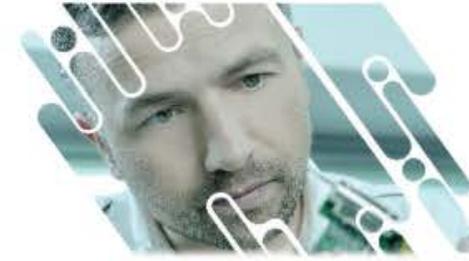
- Many different wetting evaluations were performed during a solder paste qualification that aimed at finding a low, or zero, halide classified solder paste that could replace a higher halide content one.
  - *One of these wetting evaluations was a HoP defect test.*
- When analyzing the solder joints in this HoP defect test, remarkable differences between x-ray inspection and pry-off of the components were found that clearly show how difficult it is to determine this failure type.
  - *New x-ray inspection criteria for IPC-A-610 is therefore suggested.*

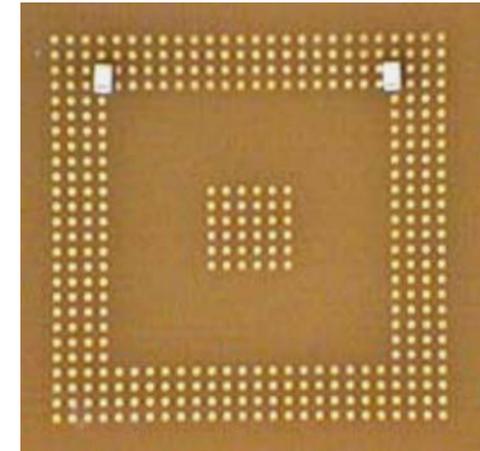
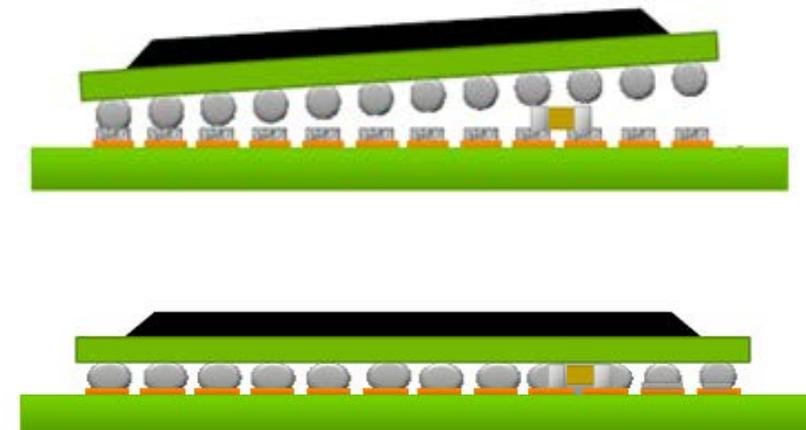
- Measurements of components and boards.
- Preparation of stencil, SMT-program, reflow profile etc.
- Screen printing of test boards.
- SPI measurements of the screen printed solder paste deposits.
- Placement of two chip resistors on each test BGA site.
- Placement of BGA on the sites with the two chip resistors.
- Convection reflow soldering in air atmosphere.
- X-ray inspection and analysis.
- Prying off the BGAs and analysis of results.
- Comparison of the results from the x-ray and the prying analyzes.

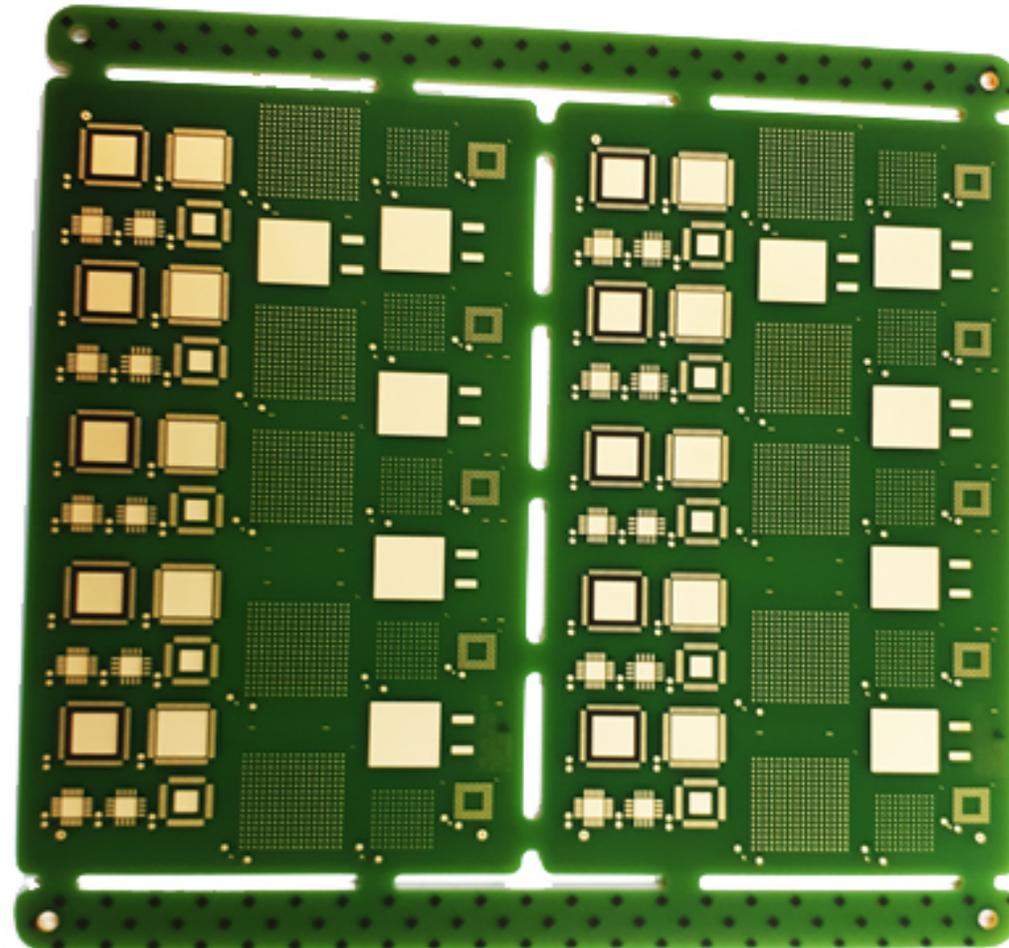
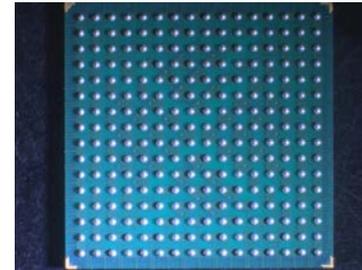
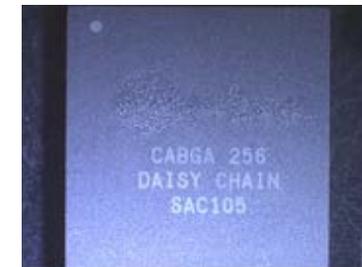
- Board:
  - 2 layer, 2.1 mm thick, 0.41 mm diameter NSMD pads, ENIG pad finish.
  - 2 boards per panel.
- BGA:
  - 256 balls, SAC105, 1.0 mm pitch, 0.36-0.39 mm ball height before soldering.
- Chip resistor:
  - 0402, heights 0.29-0.32 mm.

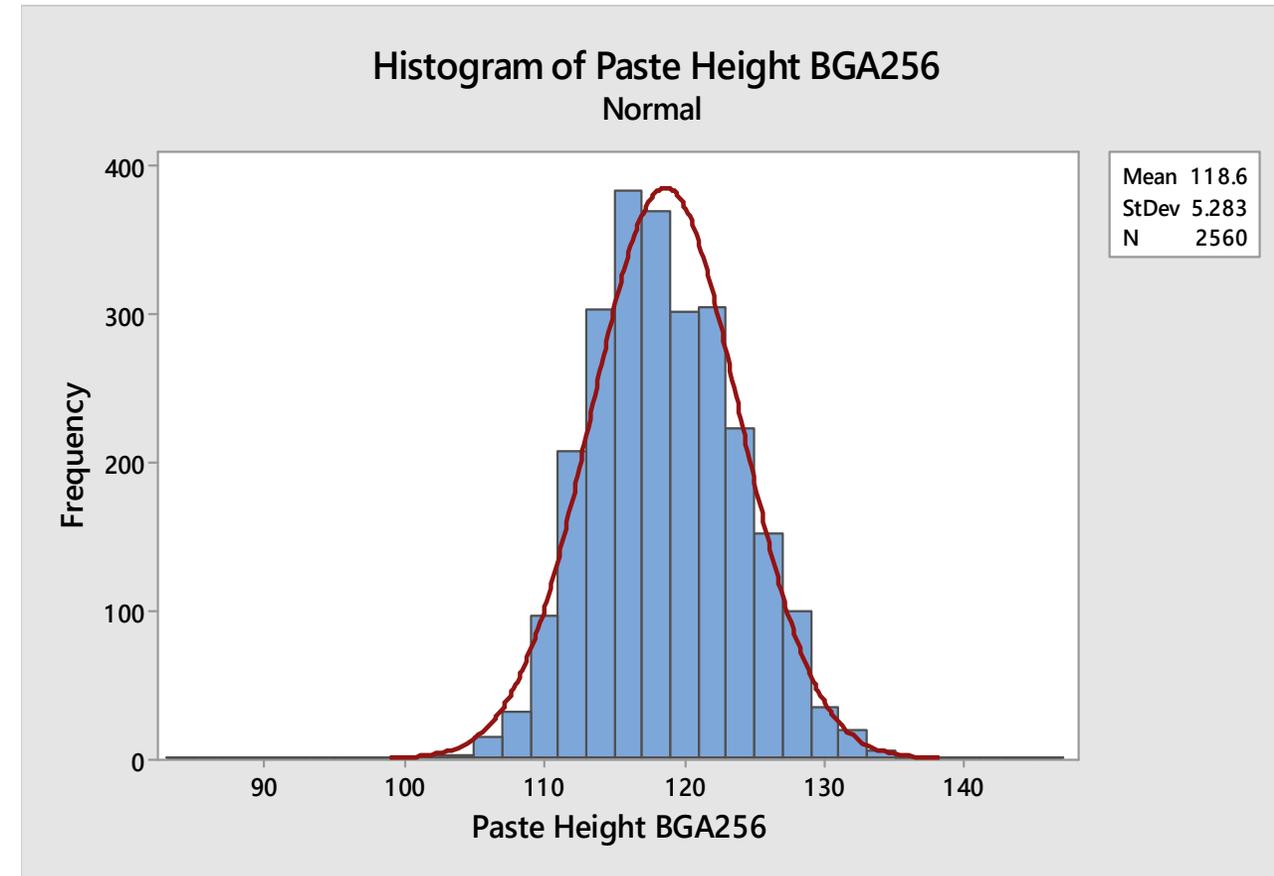
Typical solder deposit heights

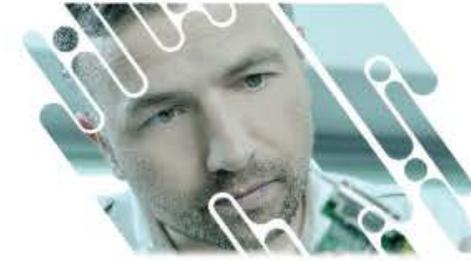
# X-ray inspection Summary

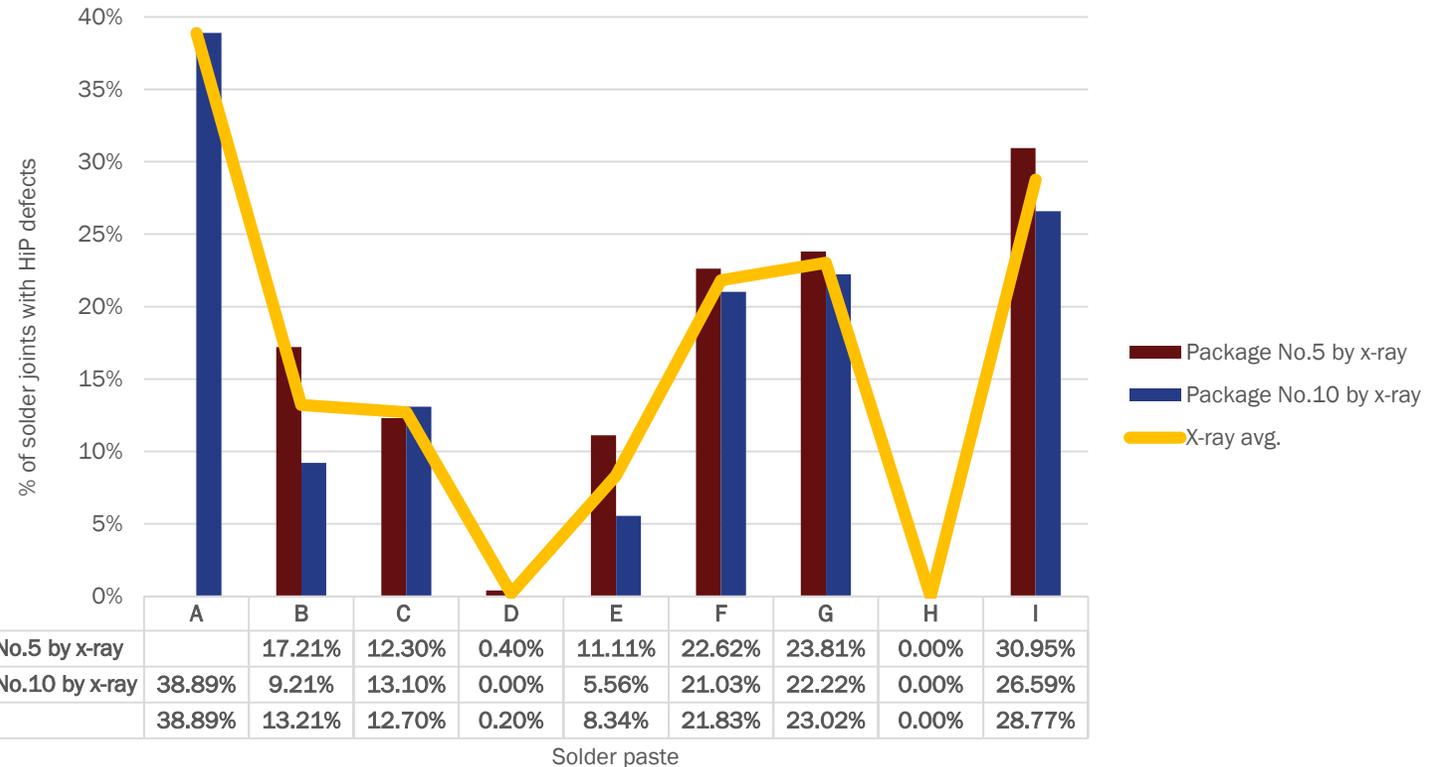
- Paste D and paste H are HoP defect free (or close to).
- Paste A and paste I worst performance.

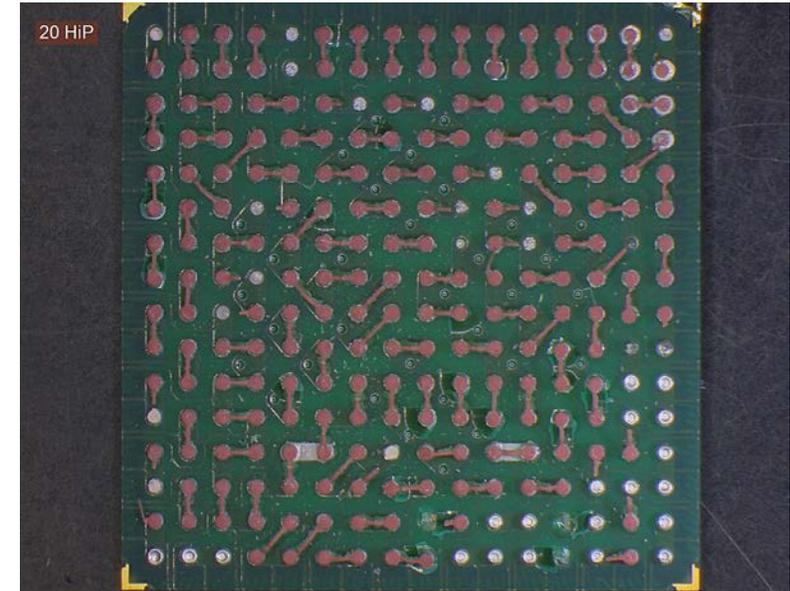
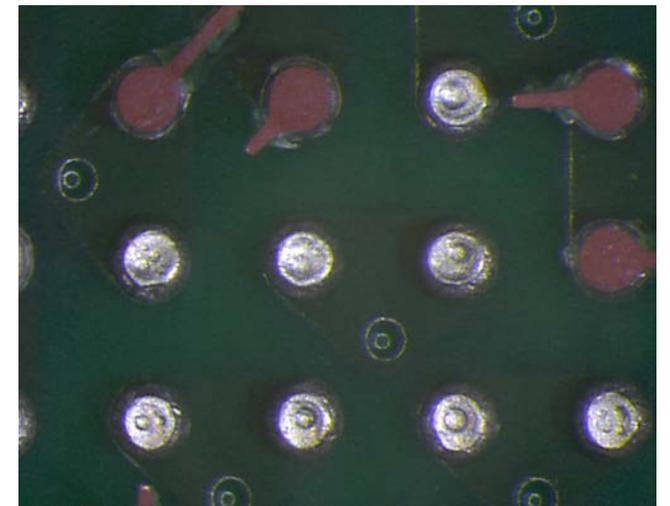
- HoP solder joints:
  - *Dimple in balls.*
  - *Smooth ball edges around dimple.*
  - *No cracked areas.*
- Non-HoP solder joints:
  - *Balls removed together with pad, either from board or from package.*
  - *Cracked solder joints.*

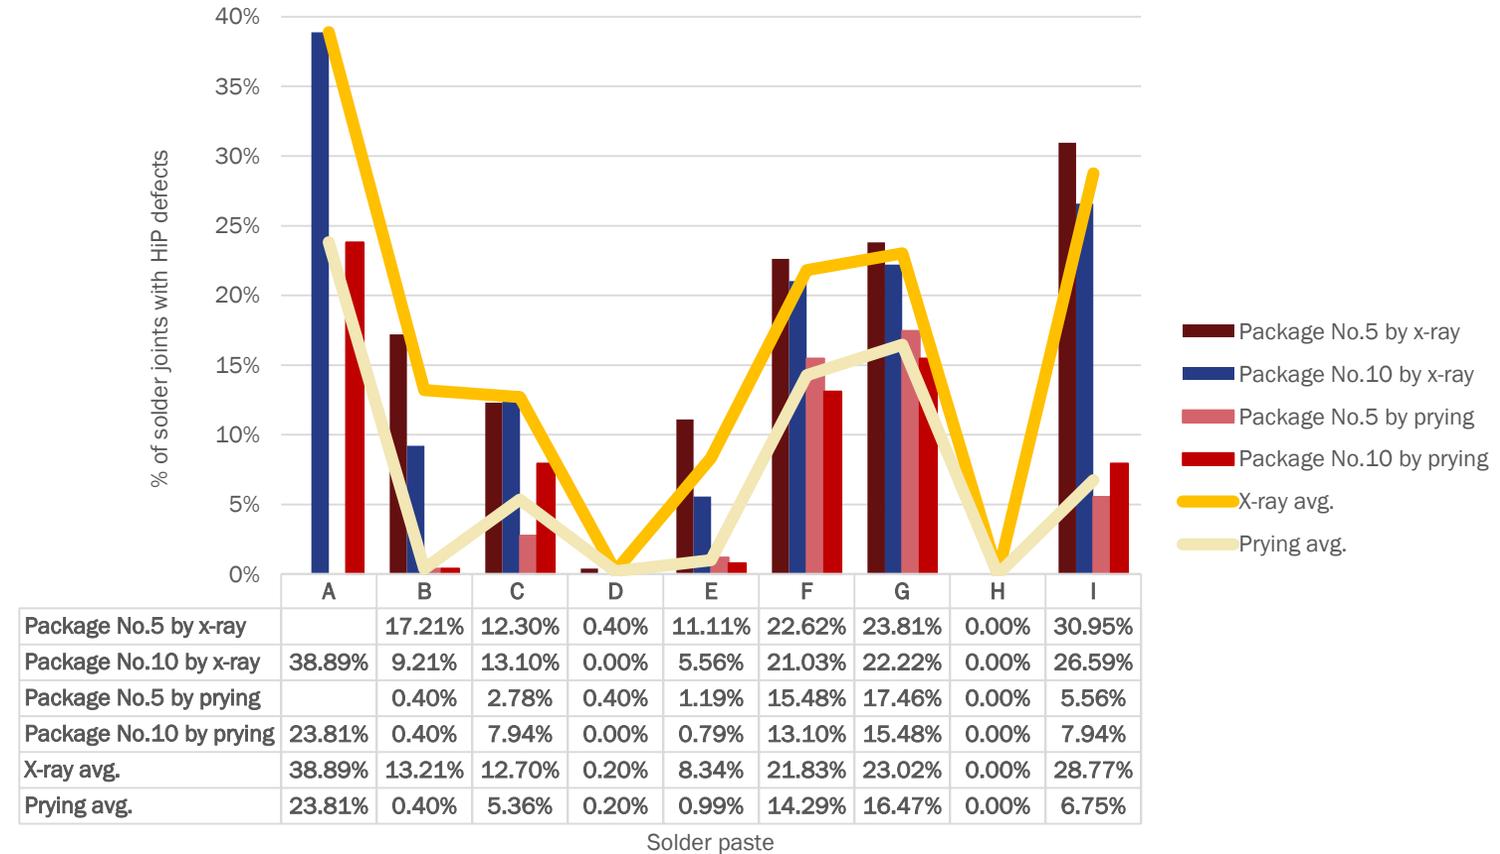
- Difference between x-ray inspection and pry-off could be vast.
- *Many solder joints that look like HoP in x-ray are, in reality, no HoP defects.*

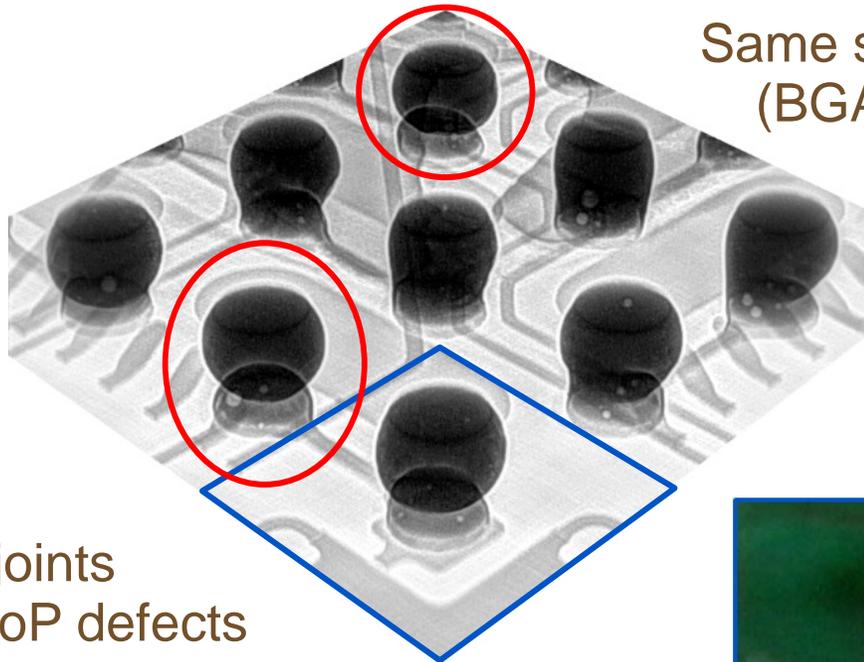
All 9 solder joints  
judged as HoP defects  
in x-ray.

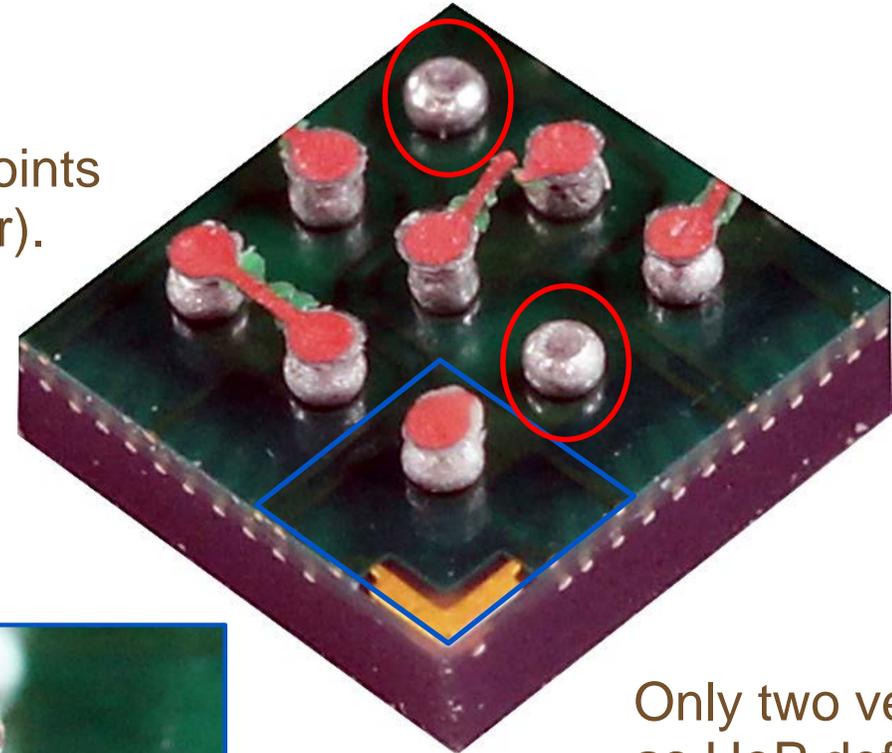
Only two verified  
as HoP defects  
after pry-off.

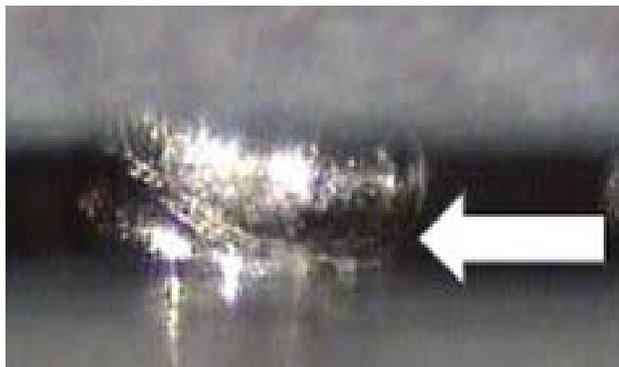
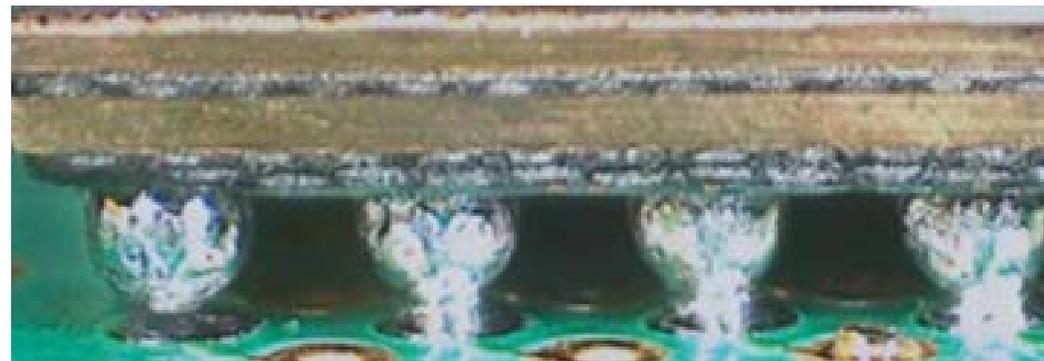
"Waist" in BGA  
solder connection

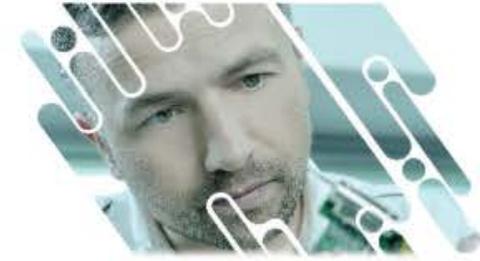
## Conclusions and Recommendations
