# Design and Construction Affects on PWB Reliability

Paul Reid

## PWB Interconnect Solutions

The reliability, as tested by thermal cycling, of printed wire boards (PWB) are established by three variables; copper quality, material robustness and design. The copper quality was most influential and could be evaluated pretty accurately by microsectioning methods to determine the general quality of the board. Next in the hierarchy of influence came the robustness of material, and the tertiary influence was design. With the advent of Removal of Hazardous Substances (RoHS) causing lead to be removed from solder and the increase in thermal excursions for assembly and rework to 260C, materials tend to be as much a problem as copper quality in the robustness of PWBs. At the new lead free assembly temperatures the materials tend to break down adding to the failure modes caused by lead free assembly. Both the copper quality and material robustness are improving and now PWB designs are beginning to become more influential in the ability to provide a robust board in a lead-free environment. In this paper we will review the general trends in design like the use of non-functional pads, or nicke

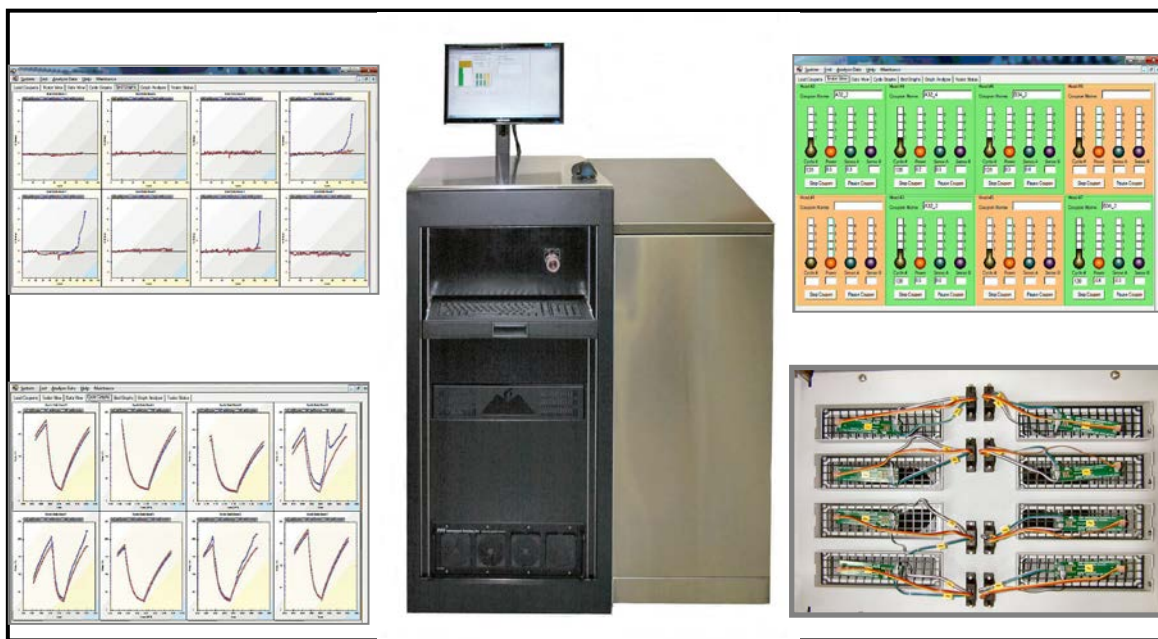
Figure 2 is the latest IST tester which automatically sets up and thermal cycles individual IST coupons to specific temperatures, monitoring the coupons for changes in resistance. The equipment can precondition to simulate assembly and rework and then proceed with thermal cycles to failure. The equipment monitors and records the cycles to failure data for review.

Figure 2 –IST Tester, Eight Head with Coupons, Three Screen Shots

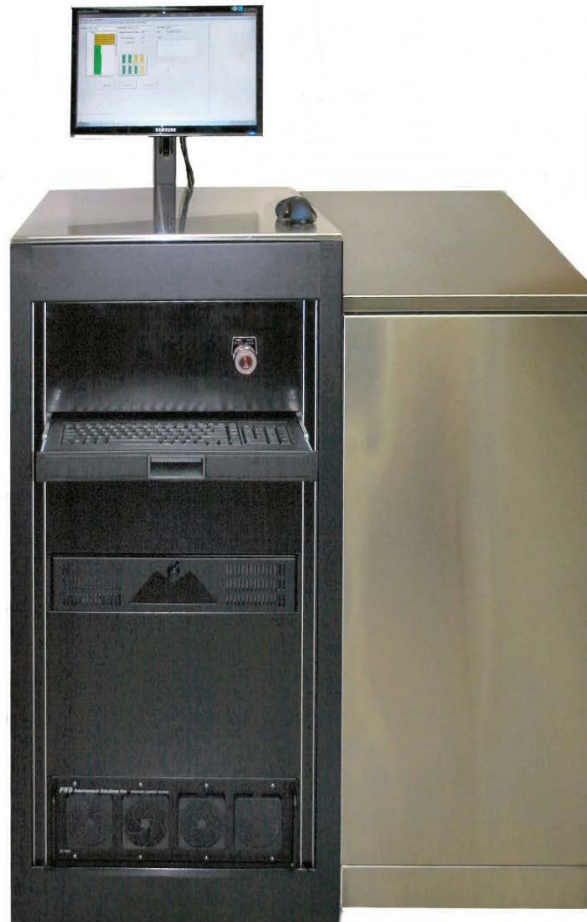
# IST Hardware “High Capacity” HC

- *IST = Interconnect Stress Testing*
- *Thermal Cycles by Electrically Heating a Test Coupon*
- *Continuously Measures Resistance of Circuits During Heating*
- *10% Increase in Resistance is a Failure – Stressing Stops.....*
