The Effects of Partially Activated No-Clean Flux Residues under Component Bodies and No-Clean Flux Residues Entrapped Under RF Cans on Electrical Reliability

Eric Bastow
Indium Corporation
Clinton, NY, USA

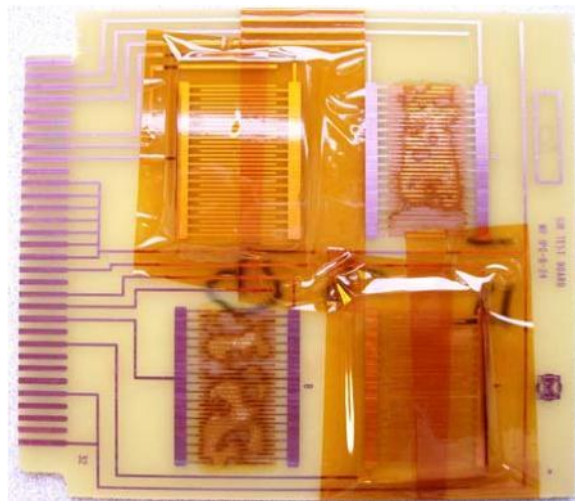
Figure 1 - Example of reflowed SIR board with glass slides secured in place with Kapton tape

In order to mimic flux being entrapped under a component body, ~1.5” long standard microscope slides were used to cover the flux on two opposing corner patterns of the SIR boards. Two SIR boards were prepared for each flux vehicle. Kapton tape was used to secure the slides in place and created somewhat of a seal along the periphery of the glass slide. The slides were secured in place with the tape throughout the duration of reflow and SIR testing. (See Figure 1 for an example.) Glass slides were chosen because glass allows for easy inspection of the flux (dendrites) without disturbing the flux. Also, glass has a propensity to attract and hold moisture, further adding to the “worst case scenario” conditions, specifically, promotion of electrochemical migration.

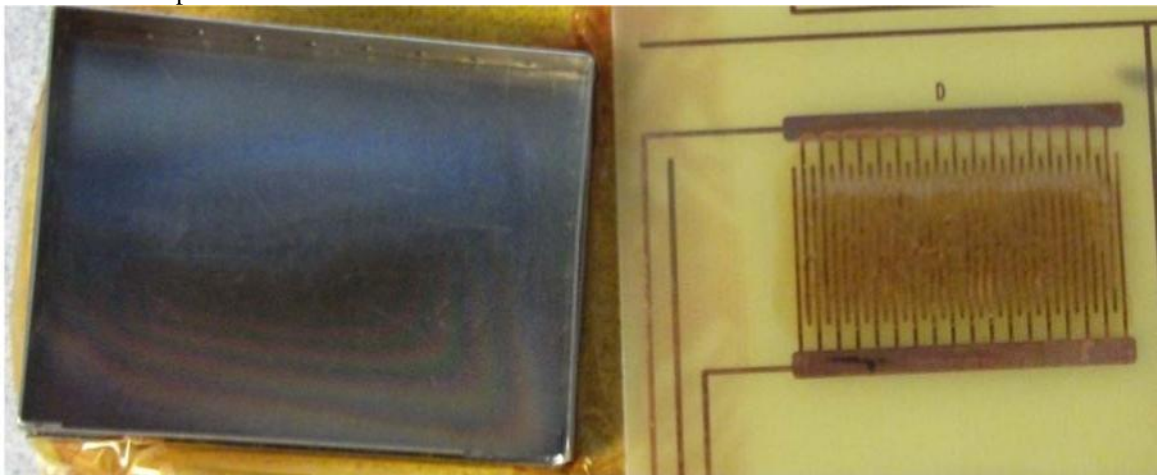
Figure 2 - Example showing RF shield and relative location of electrical traces on SIR board near pattern "D"

In the case of the RF shield scenario, an RF shield was affixed over the upper left SIR pattern (pattern “D”). This was the only location that allowed for placement of the RF shield with minimal risk of contact and shorting to the electrical traces. A little bit of the RF shield had to be removed for the reason of avoiding contact with the electrical traces running down the left side of the SIR boards (Figure 2).

The RF shield was held in place during reflow and SIR testing with Kapton tape creating

somewhat of a seal around the RF shield. Due to a limited quantity of appropriately sized RF shields, only one board was prepared for each solder past flux vehicle.

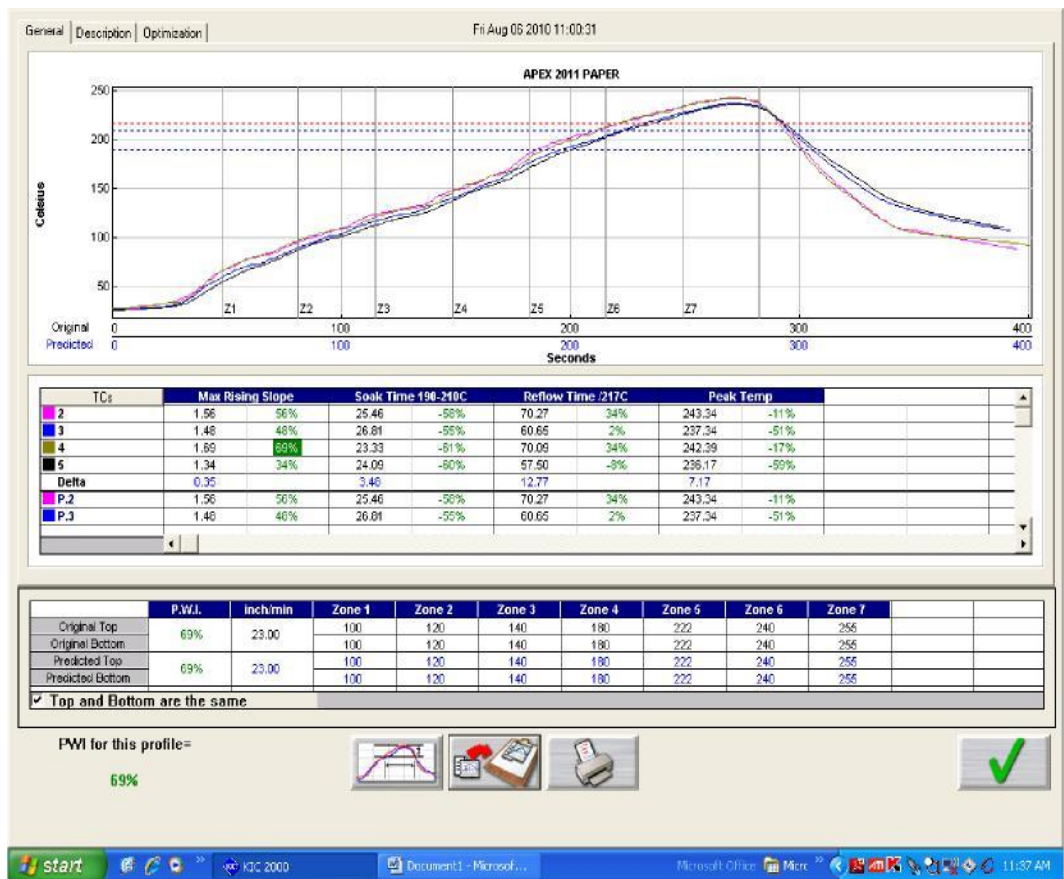
Figure 3 - Reflow profile used for Pb-free fluxed SIR boards with glass slides attached

The SIR boards prepared with Pb-free no-clean solder paste flux vehicles were reflowed with the following profiles (Figures 3 and 4). On the SIR boards prepared with the glass slides, the bare SIR patterns achieved a peak temperature of -243°C and the patterns with the glass sides achieved a peak temperature of -237°C. On the SIR boards prepared with the RF shield, the bare SIR patterns achieved a peak temperature of -245°C and the pattern with the RF shield achieved a peak temperature of -234°C. The placement of the thermal couples can be seen in Figures 5, 6, and 7.

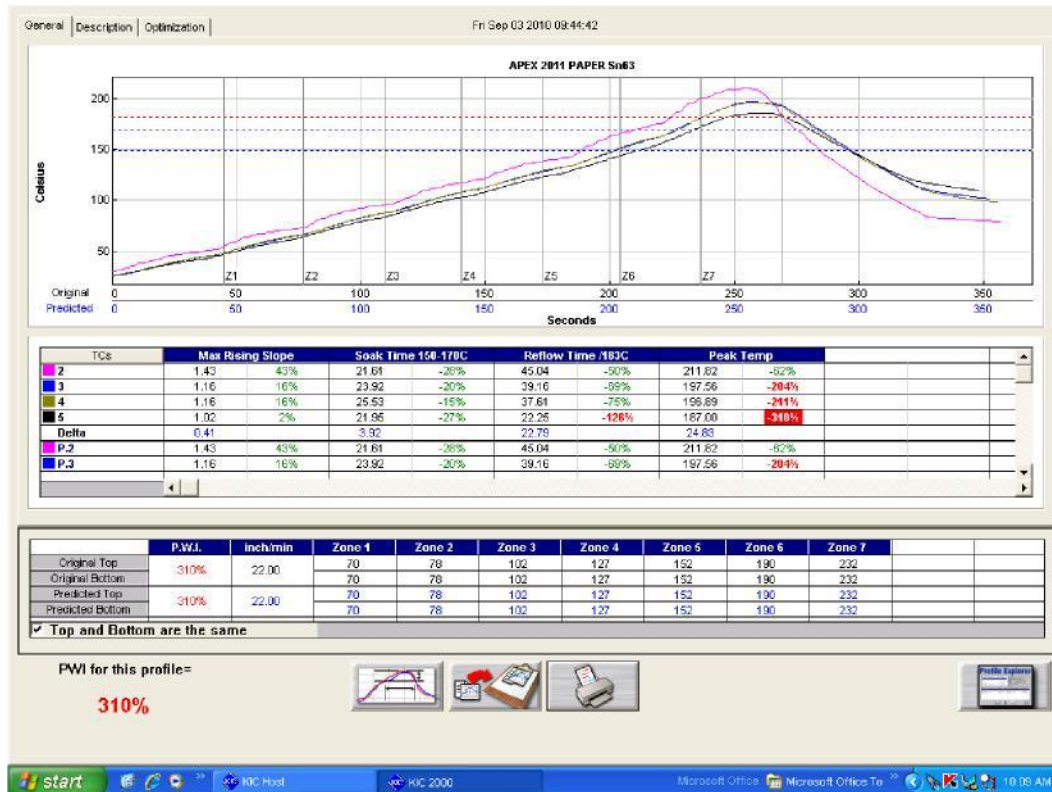
Figure 8 - Reflow profile used for the SnPb fluxed SIR boards with glass slides and RF shield attached

The SIR boards prepared with SnPb no-clean solder paste flux vehicle were reflowed with the following profile (Figure 8). One board was used for profiling with the upper left pattern covered with the RF shield and two opposite corner patterns covered with glass slides. The bare pattern achieved a peak temperature of $\sim 212^{\circ}\text{C}$, the glass slide patterns achieved a peak temperature of $\sim 197^{\circ}\text{C}$, and the RF shield pattern achieved a peak temperature of 187°C .

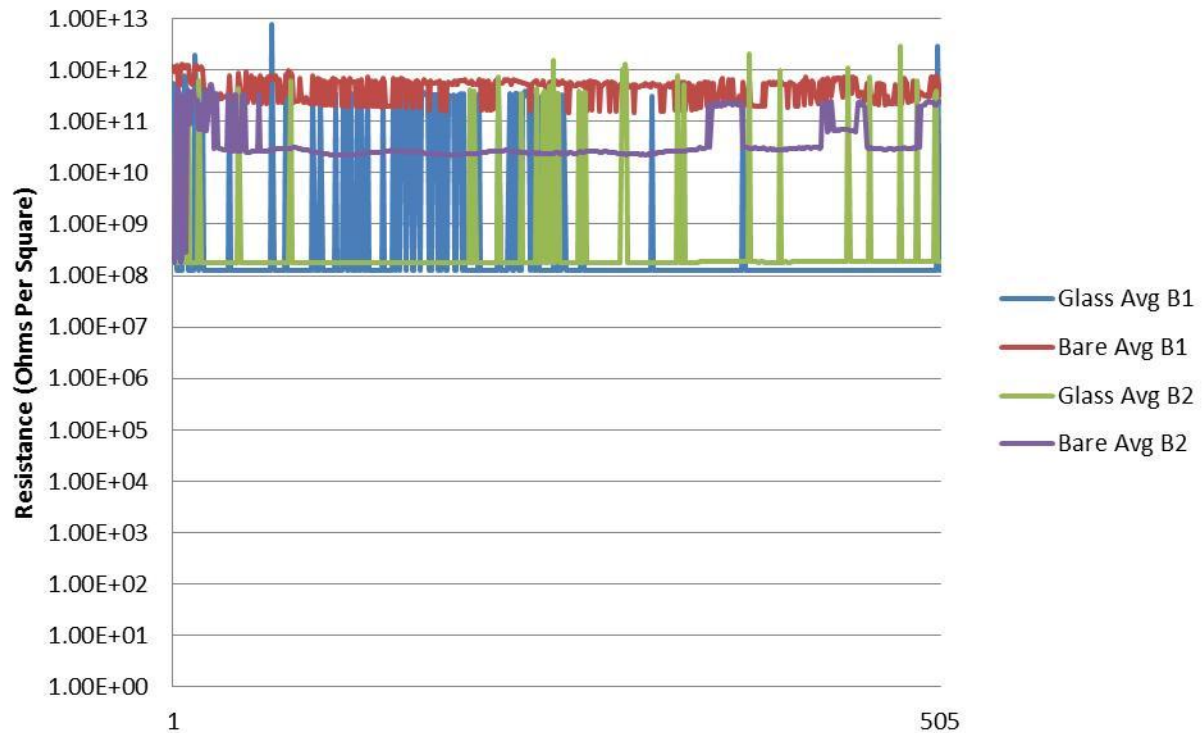
Pb-Free, Halogen Free, Pin Probe-able Residue, Glass Slide

Both the bare patterns and the patterns covered with the glass slides produced passing SIR values. However, the patterns covered with the glass slides exhibit lower SIR performance.

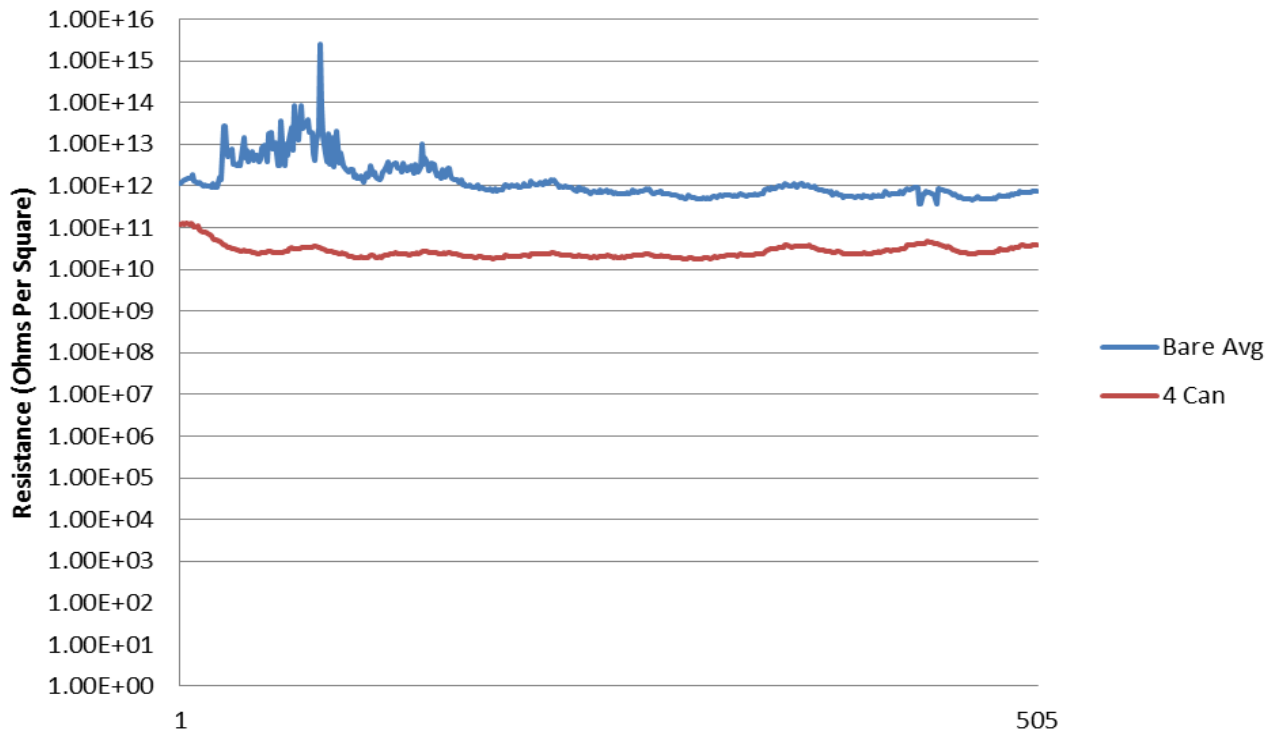
Pb-Free No-Clean, Halogen Free, Pin Probe-able Residue, RF Can

Both the bare patterns and the pattern covered with the RF shield produced passing SIR values. However, the pattern covered with the RF shield exhibits slightly lower SIR performance.

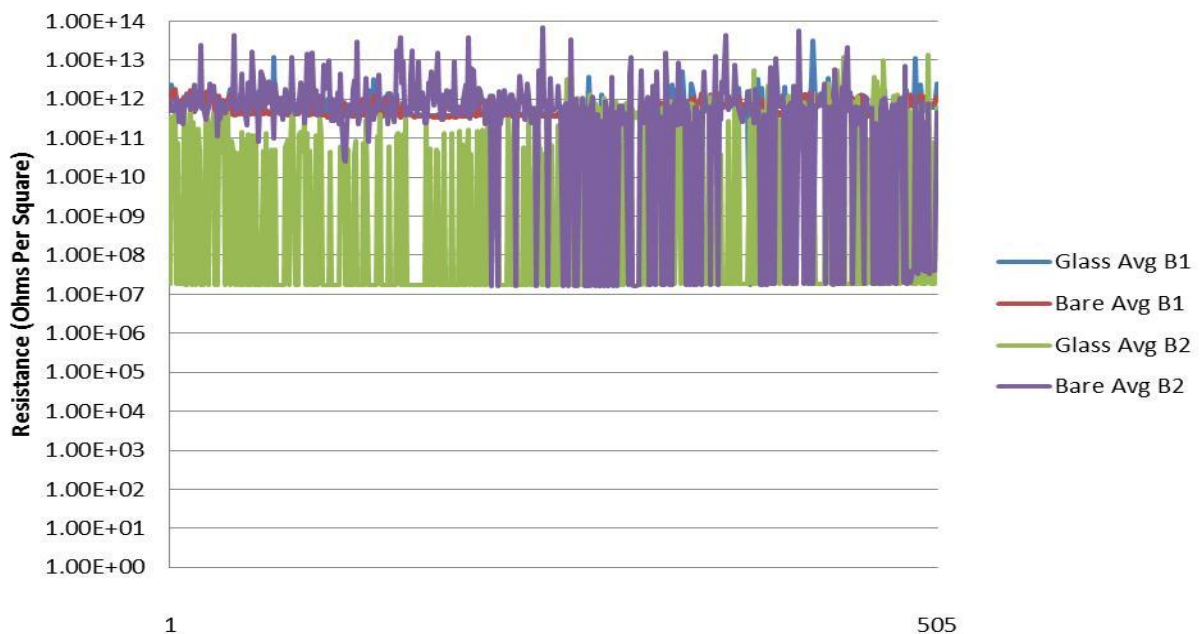
Pb-Free No-Clean, Halogen Free, Standard Residue, Glass Slide

The author was not able to ascertain any meaningful trend from the data produced from these two boards. There seemed to be no rhyme or reason to it. Possible explanations for the aberrant data include condensation, improper wiring, loose connections, etc. Therefore, the author selected data sets that seemed to be in agreement with the typical SIR trend of bare and glass covered patterns. That data is in the following graph.

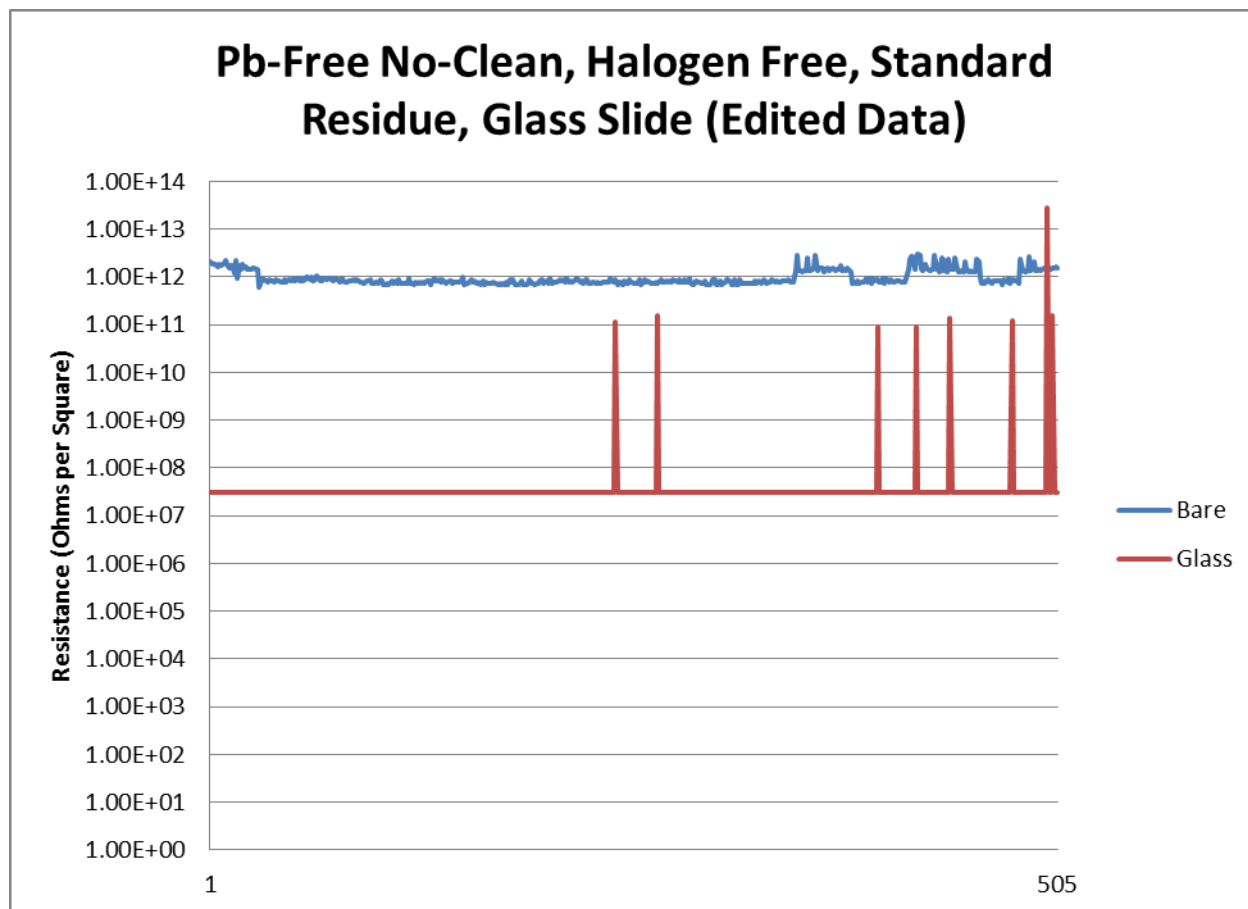
The bare patterns exhibit passing SIR values; whereas, the glass slide covered patterns exhibit lower and failing SIR values.

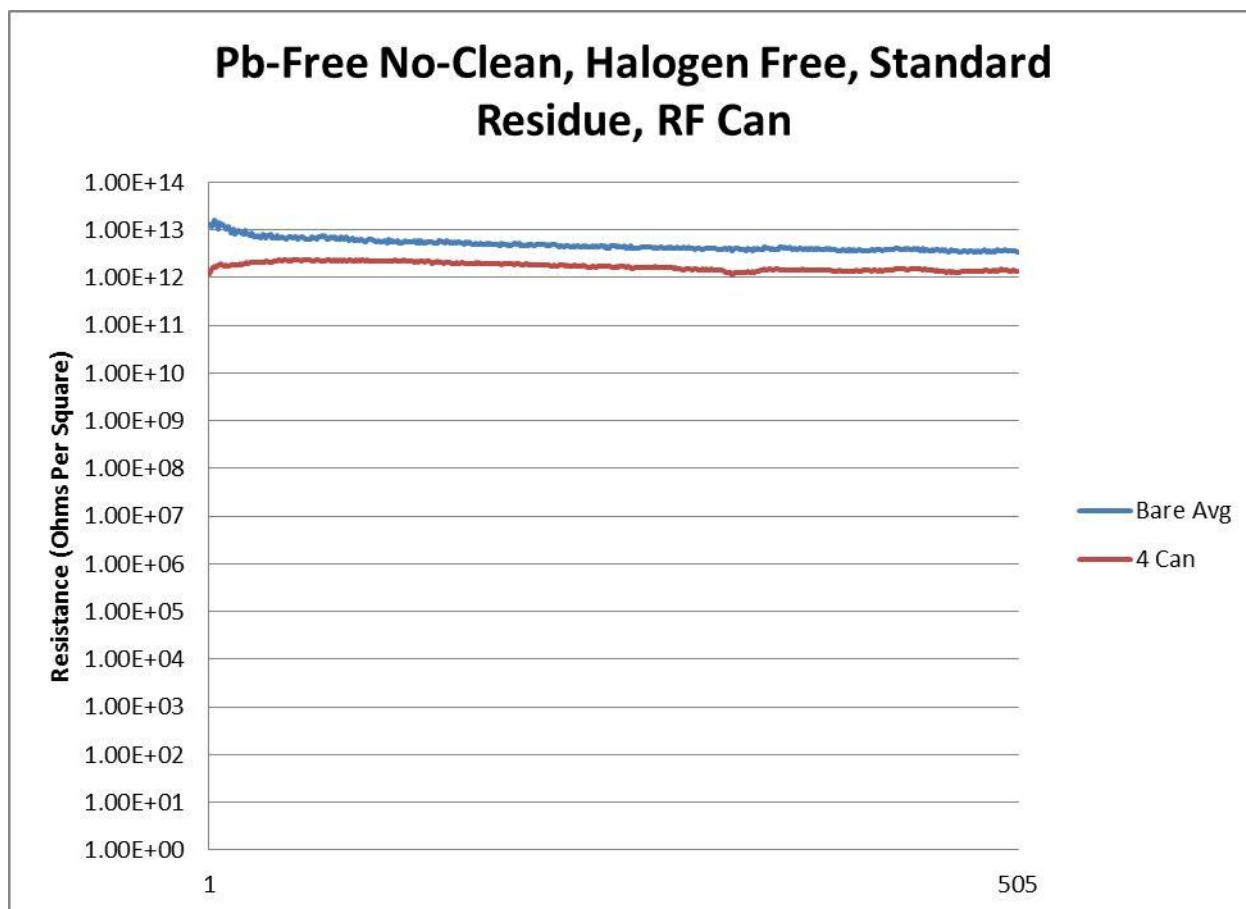
Both the bare patterns and the pattern covered with the RF shield produced passing SIR values. However, the pattern covered with the RF shield exhibits slightly lower SIR performance.

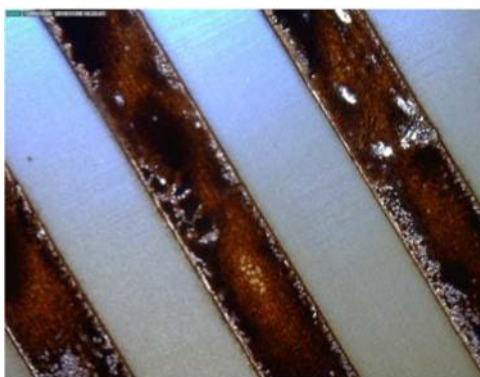
Upon completion of the SIR testing the residues were inspected. No dendritic type growth was observed. However, some patterns had notable visual anomalies (Figures 9 – 11). (The bluish coloration is a result of blue LED backlighting.)

Figure 9 - Pb-free, halide-containing, standard residue, SIR pattern under RF shield

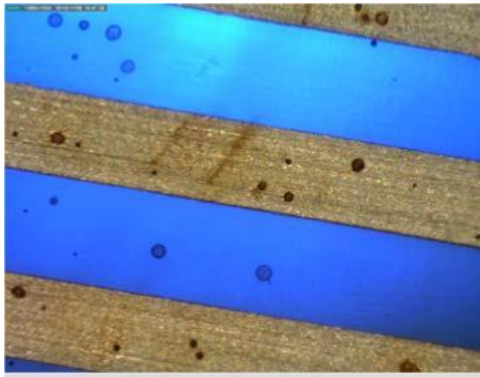
Figure 10 - Pb-free, halogen-free, pin-probeable residue, SIR pattern under RF shield

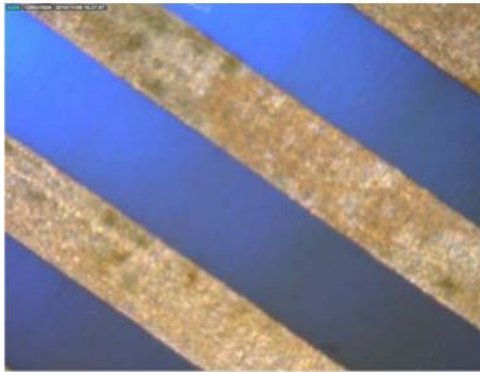
Figure 11 - Pb-free, halogen-free, standard residue, SIR pattern under RF shield

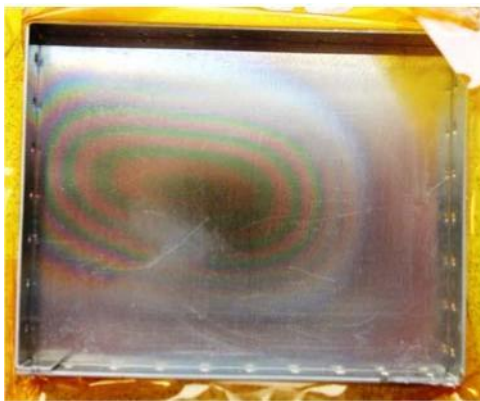
All RF shields exhibited discoloration on their undersides (Figure 12). No noticeable discoloration was detected on any other surfaces of the RF shields. This discoloration was virtually unaffected by wiping with a cotton swab and isopropyl alcohol. It appears to be the result of some sort of chemical interaction between the flux vapors and the metal of the shield.

Figure 12 - Discoloration of the RF Shield

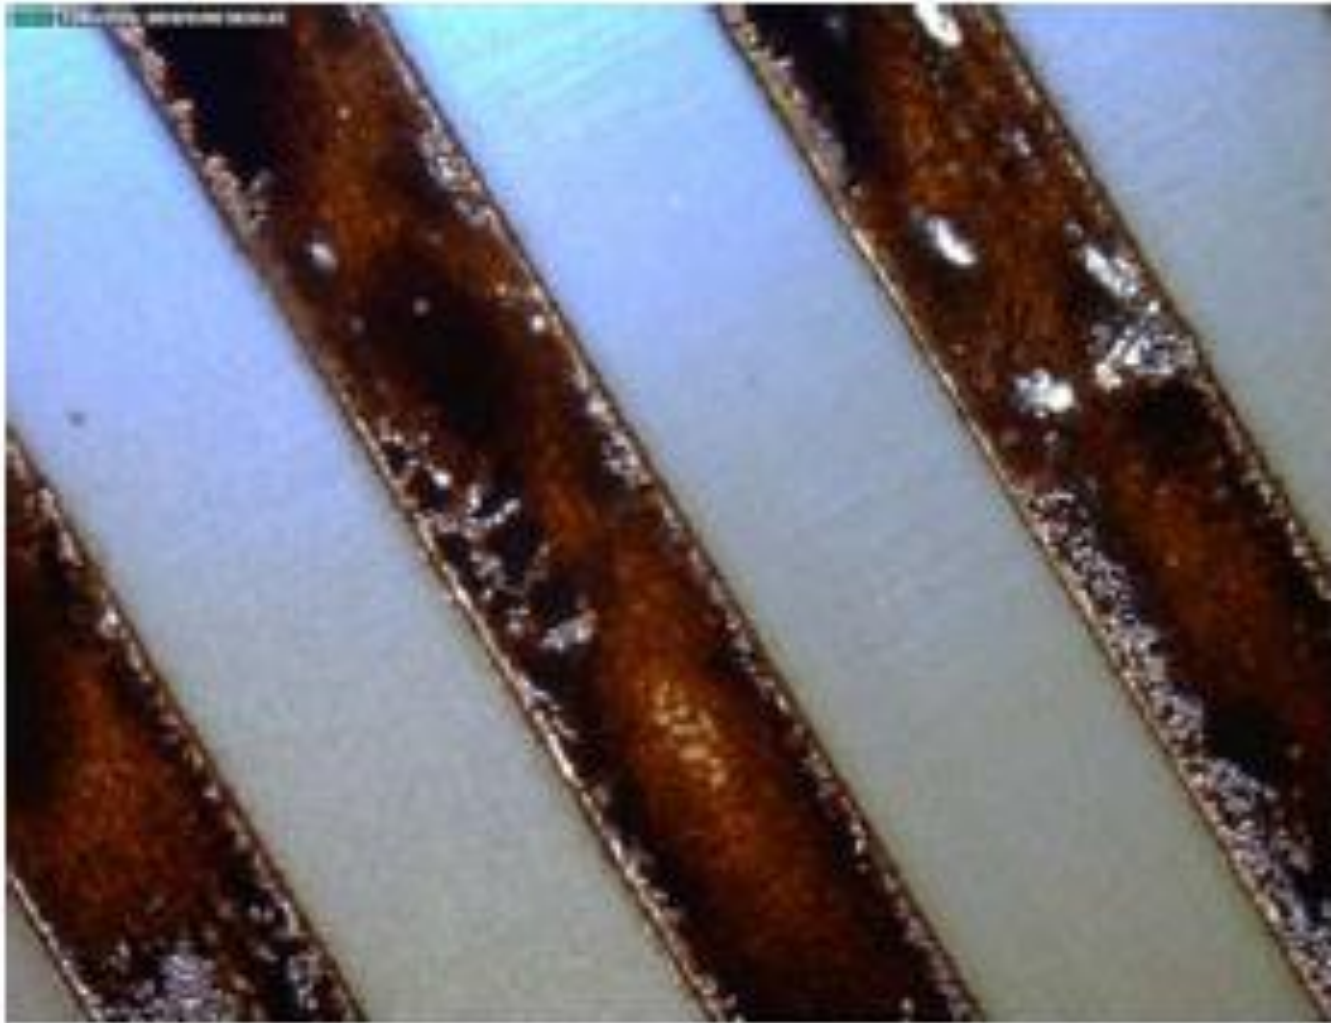
Pb-free, halide-containing, standard residue, SIR pattern under RF shield

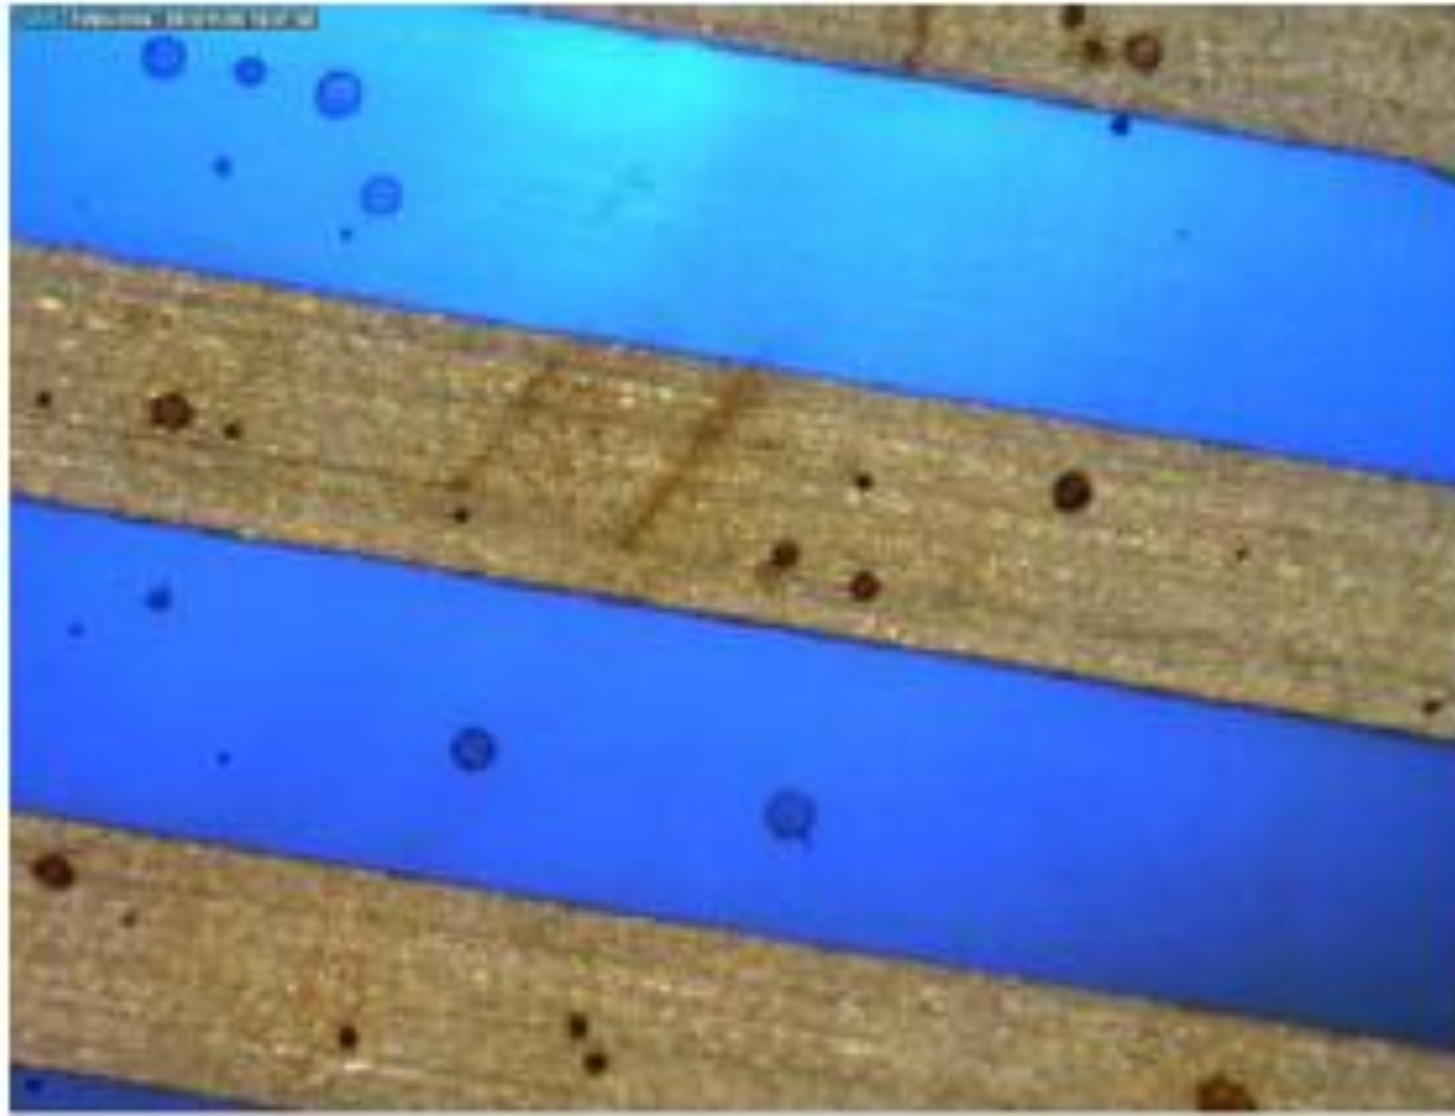
Pb-free, halogen-free, pin-probeable residue, SIR pattern under RF shield

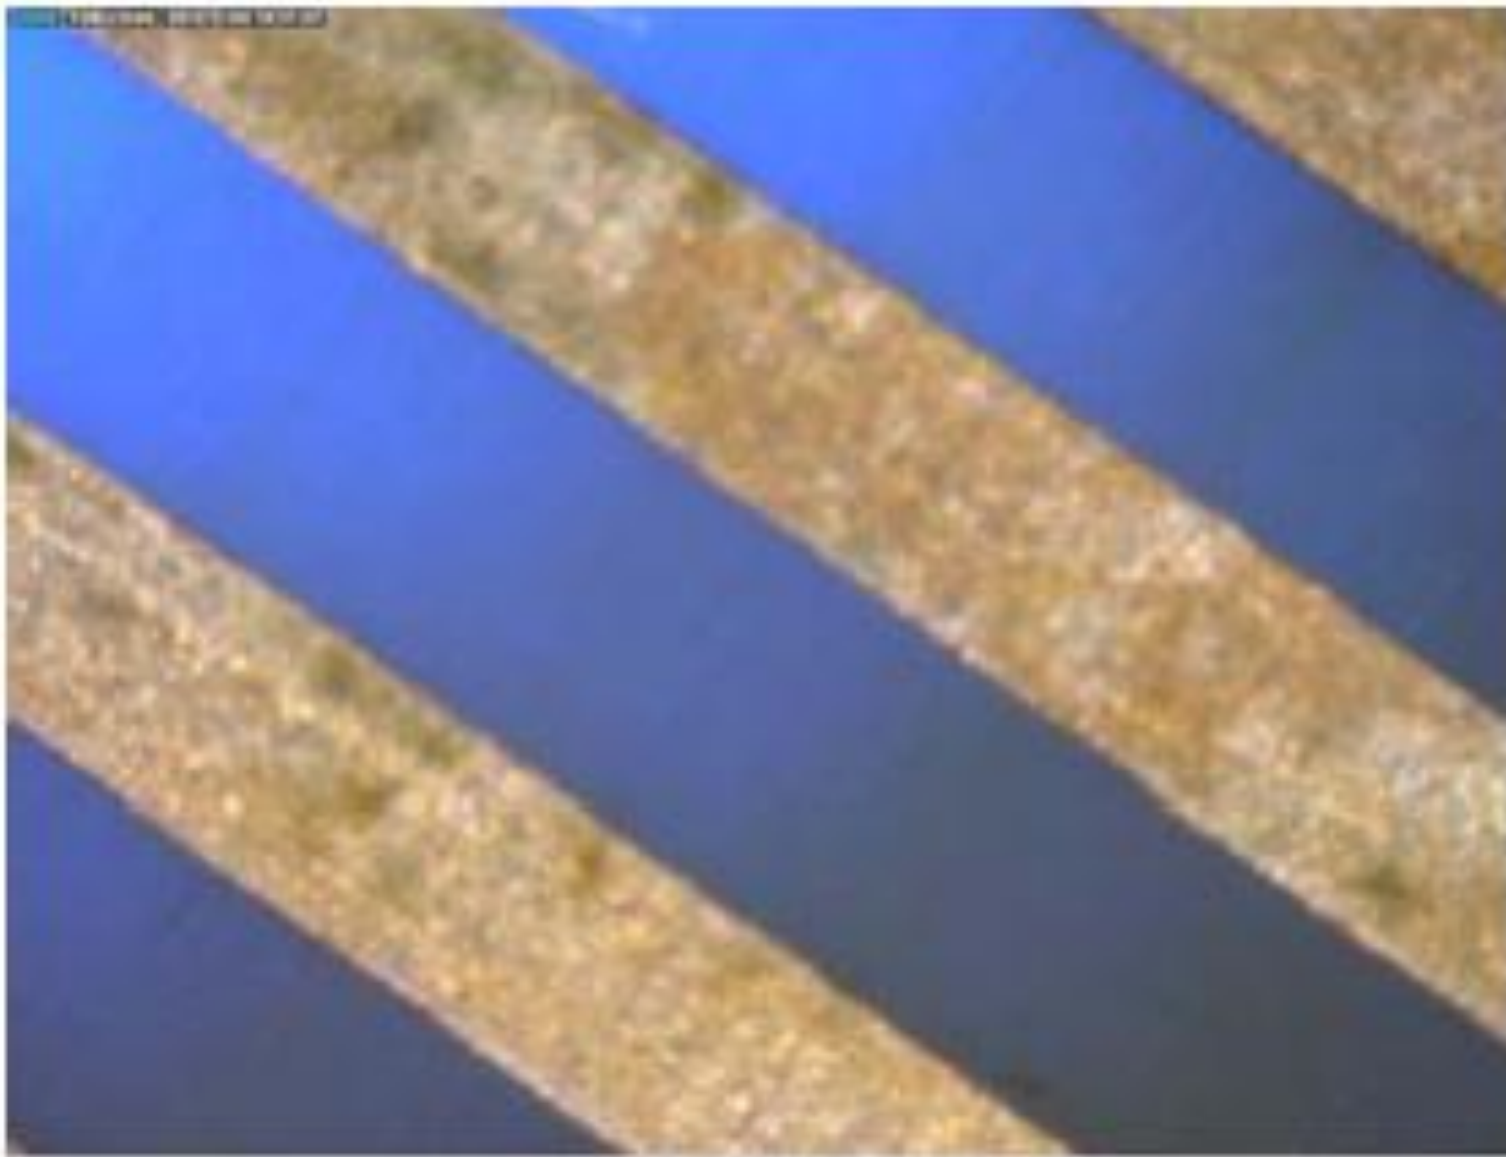
Pb-free, halogen-free, standard residue, SIR pattern under RF shield

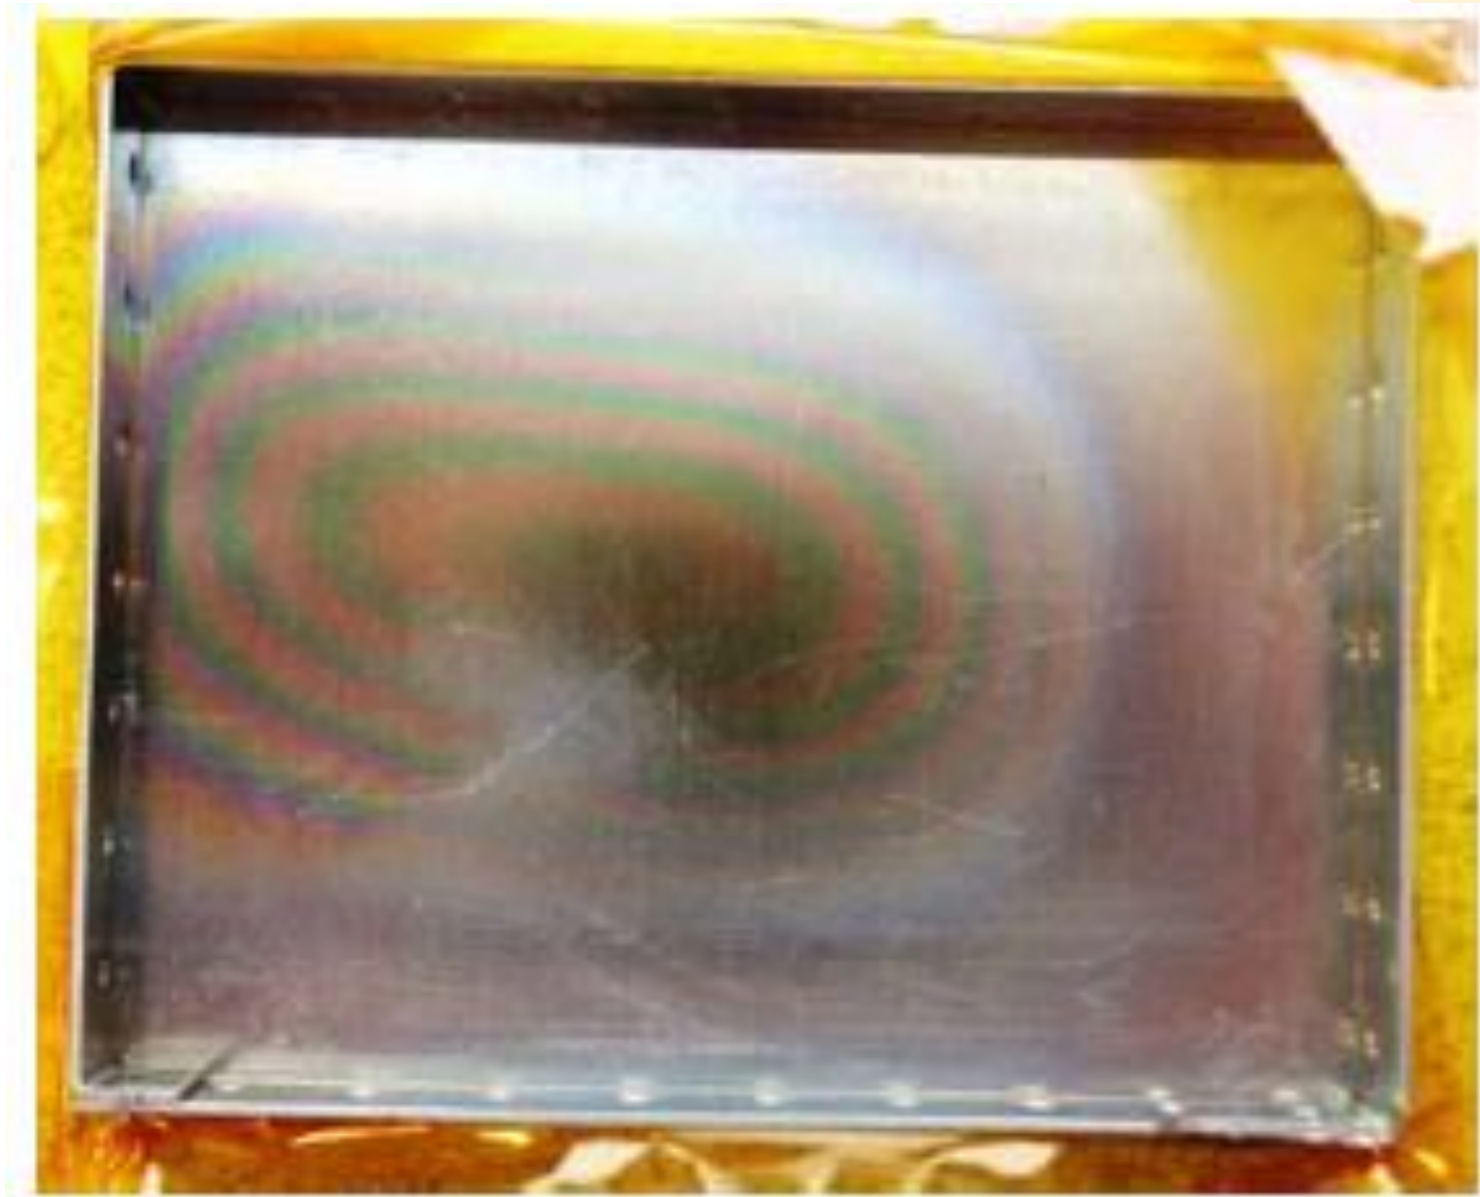
Discoloration of the RF Shield
