Reliability Testing of PWB Plated through Holes in Air-to-Air Thermal Cycling and Interconnect Stress Testing after Pb-free Reflow Preconditioning

Joe Smetana, Alcatel-Lucent, Plano, TX
Bill Birch, PWB Interconnect Solutions, Ottawa, Canada
Thilo Sack, Celestica, Toronto, Canada
Kim Morton, Viasystems, China
Marie Yu, Multek, China
Chris Katzko, TTM (Meadville), China
Erkko Helminen, TTM (Meadville), China
Laura Luo, Cisco, San Jose, CA

The High Density Packaging Users Group Consortium investigated plated through hole reliability of printed wiring board test vehicles constructed with 20 different Pb-free capable printed wiring board materials. The study contained a total of 27 different constructions built by three PWB manufacturers. The materials were tested using both air-to-air thermal cycling and Interconnect Stress Testing (IST) methodologies. The test vehicles combined both via reliability and materials analysis testing capabilities, using two specially designed IST coupons with via to via spacing of both 0.040" (1mm) and 0.032" (0.8mm). All products were constructed with 20 layers, laminated to an average thickness of 0.115" (2.92mm), and drilled with 0.010" (0.254mm) vias

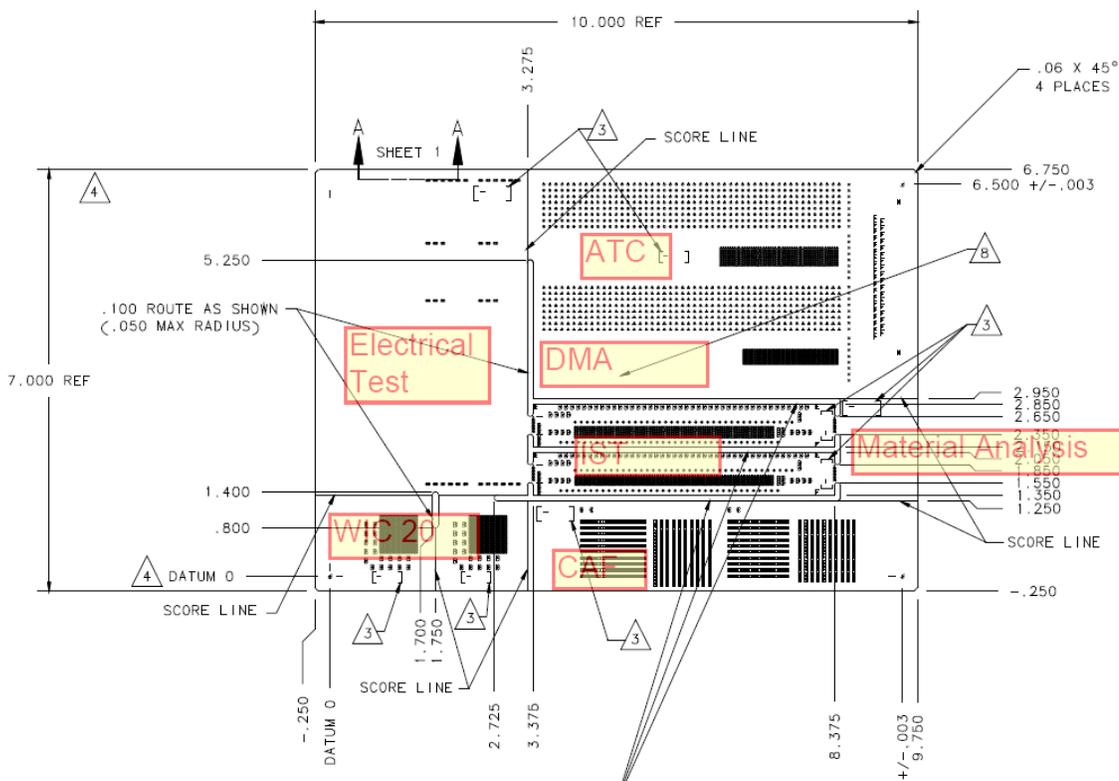
Figure 1: MRT 3 Test Board

The printed circuit board design used for this study is shown in Figures 1 and 2. The two IST coupons are specifically designed material analysis coupons (PWB Interconnect part numbers MAT20006A-32 and MAT20005A-40) having 0.25mm (.010 inch) diameter drilled via holes. One coupon has 1mm (.040 inch) via to via spacing and the other has a 0.8mm (.032 inch) via to via spacing. The air-to-air thermal cycling section has four sets of vias arranged in eight chains of 50 vias each. The first three sets of eight chains of 50 vias have 0.25mm (.010 inch) drilled via holes with via spacing of 2.54mm (.100 inch), 1mm (.040 inch), and 0.8mm (.032 inch) respectively. The fourth set of eight chains uses a 0.66 mm (.026 inch) drilled hole size on a 2.54 mm (.100 inch) via to via spacing. The via chains on 1mm and 0.8mm pitch in both the IST and air-to-air thermal cycling sections are designed identically such that they use the same hole sizes, including the use of non-functional pads, etc. Complete design details are reported separately [11].

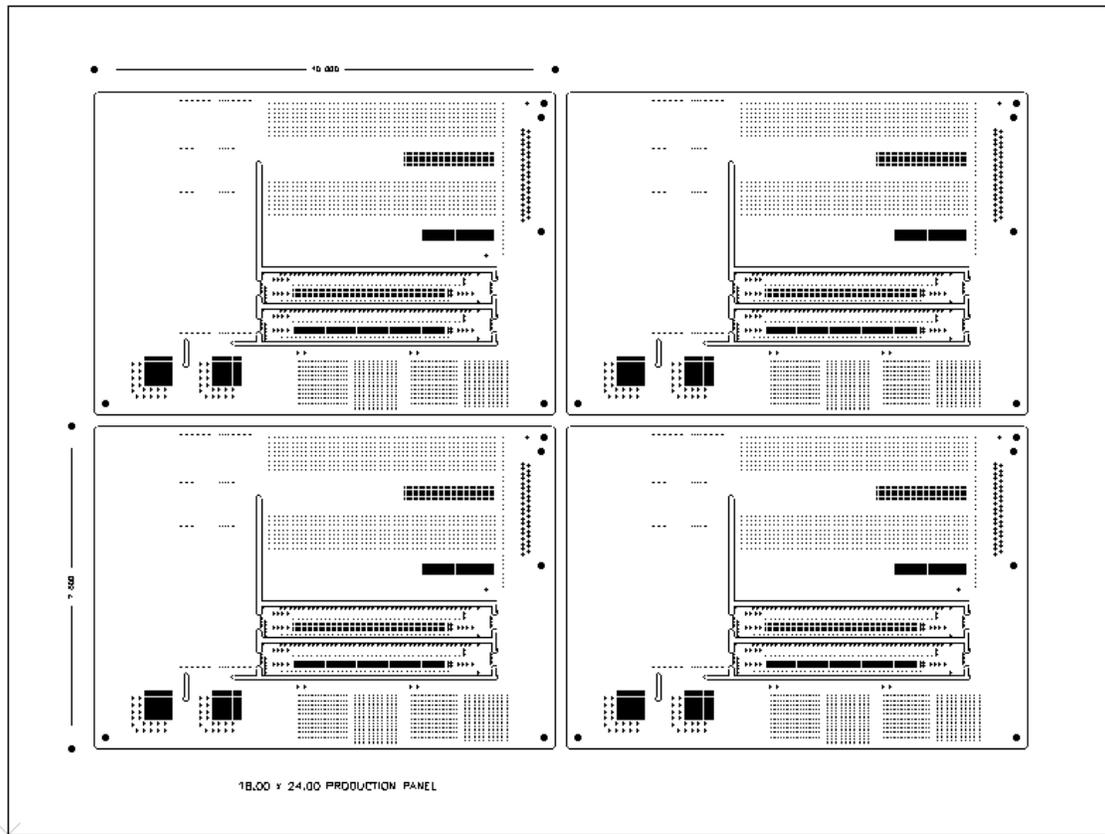
Figure 2: PWB Fabricator Production Panel

The MRT-3 test board was stepped and repeated 4 times (2 by 2) onto a 24" (610mm) x 18" (457mm) production panel, see Figure 2 for production panel lay-out. For this study a minimum quantity of six production panels were produced for each material, resulting in a minimum of 24 boards of each material type. Subsequent testing was carried out on 12 non-stressed (as received) and 12 stressed (6x 260°C Reflow) boards, this effectively results in 12 "coupons" of each type for each test condition. For the purposes of increased statistical confidence a higher number of coupons (18+) is recommended, the lower quantity was determined by considering a compromise between statistical validity and containing the escalating costs associated to all types and levels of testing.

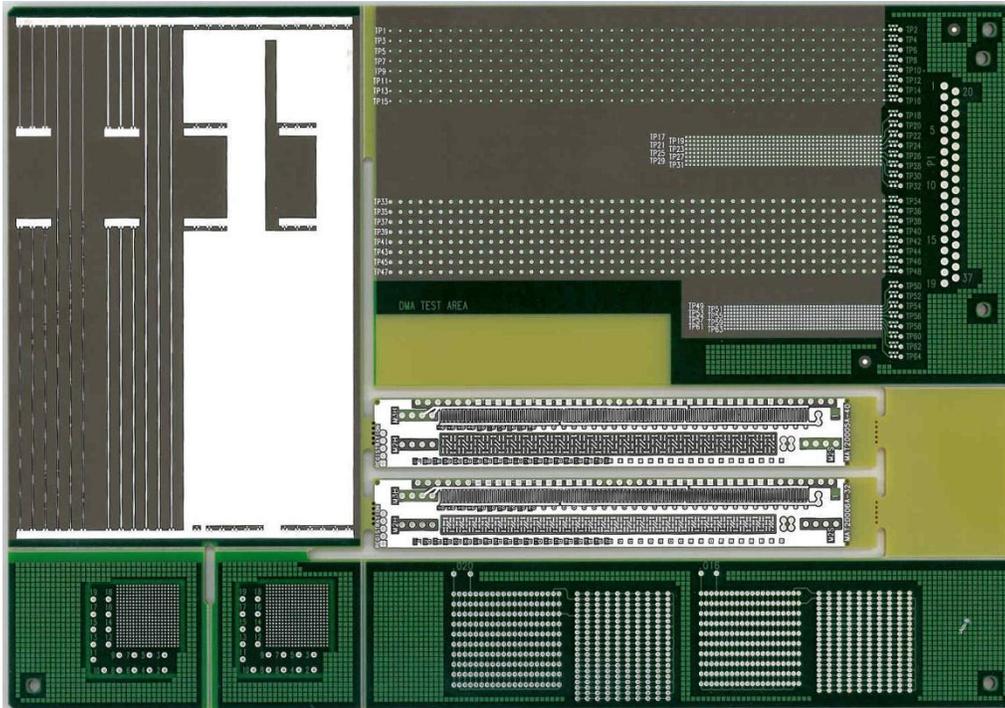
Figure 3: Picture of an actual MRT-3 test board

Following the production of panels for each of the 27 different material types the production panels were pre-routed and scored to enable easier removal (singulation) of certain coupon types and then profile routed into individual 254mm (10.00 inch) x 178mm (7 inch) test boards. Figure 3 shows a pre-routed and scored individual test board.

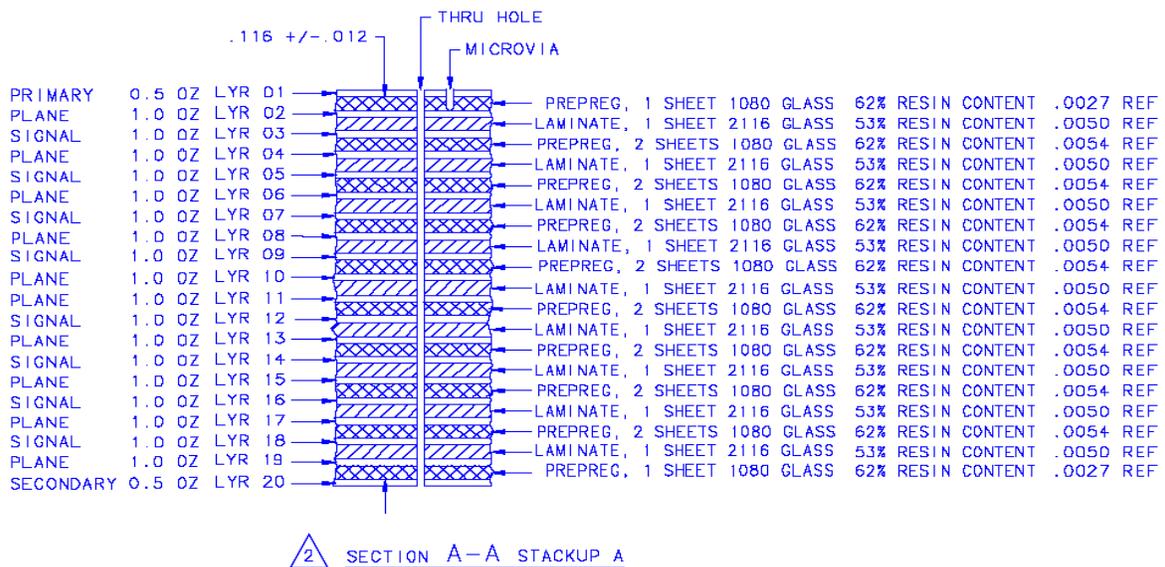
Figure 4: 20 layer standard stack-up, 58% resin content

All material types tested used the same material stack-ups with the same glass styles and resin contents for each given stack-up, regardless of material supplier. This enables the materials to be directly compared to one another. For the 20 layer constructions, both the standard and high resin content constructions are essentially the same in overall thickness, measuring 2.95 mm (0.116 inches) and 3.0mm (0.118 inches) thick respectively. Using similar constructions enables the ability to compare the effect of resin content independently of layer count and board thickness. The standard 20 layer construction was designed with an overall resin content of 58% and is considered typical for a board of this thickness, as shown in Figure 4. The high resin content construction has an overall resin content of 69% and represents very complex and worst case constructions that would typically have higher layer counts (such as 26 or 28 layers) in a similar thickness. This 69% resin content stack-up is detailed in Figure 5.

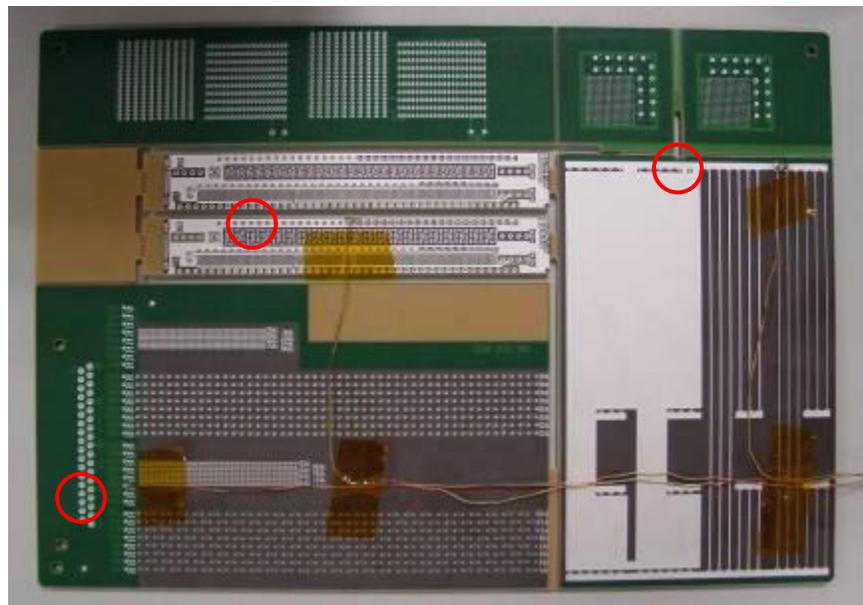
Figure 6: Reflow Oven Profile Board

One single profile card was generated for both stack-up configurations. A picture of the profile board, with three thermocouple attachment locations is shown in Figure 6 and the resulting profile is shown in Figure 7.

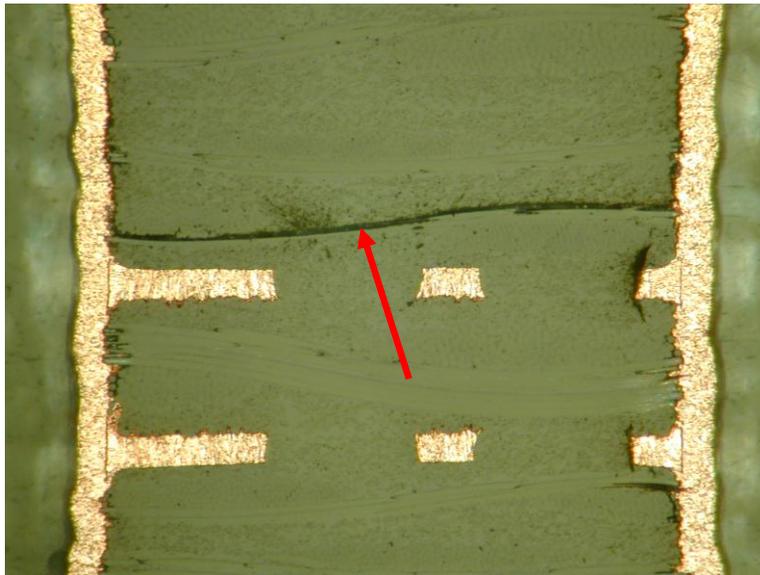
Figure 10: Example of Eyebrowing

The authors of this paper believe that, at least in the specific cross-sections examined, eye-browning is an actual separation of the glass to resin bond and is not caused by the pulling out of a glass fiber during sample preparation. Other damage identified, highlighted as yellow, is significant material degradation that may or may not be rejectable per IPC criteria. Examples of this include medium “cigar” voids as shown in Figure 11 or other zone “A” degradation or damage. Hole wall separation that exceeds 20%, though not an IPC defect, is also highlighted as yellow and specifically noted as “HWS”, when no other defects or degradation are noted in the cross sections.

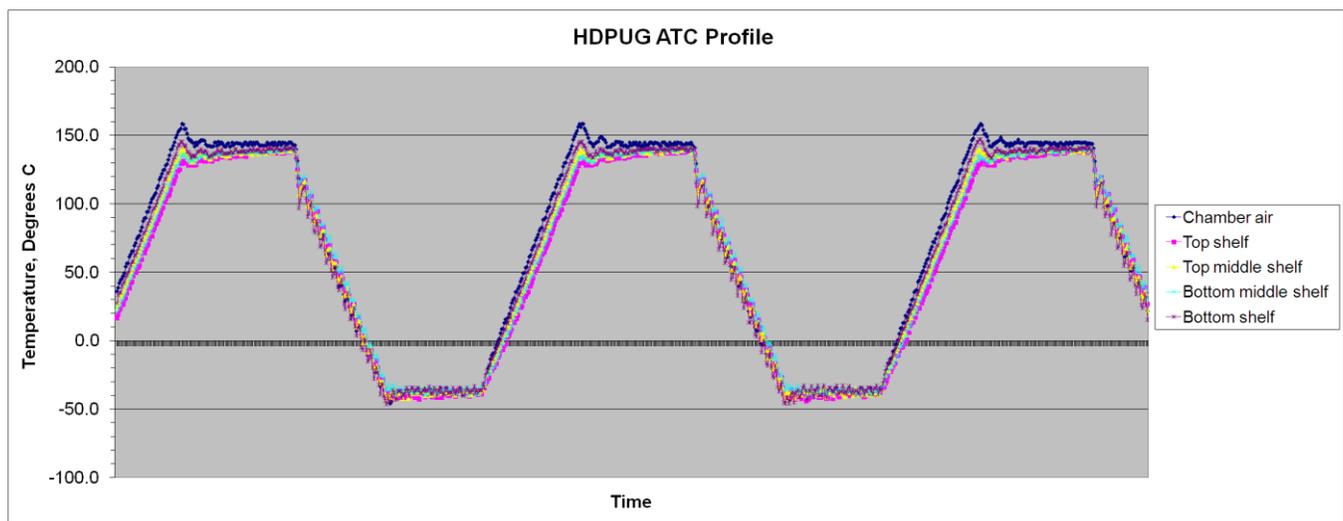
Figure 12: Air-to-Air Thermal Cycle Profile

For the air-to-air thermal cycling a failure was defined as a measured circuit bulk resistance threshold of 11 ohms (virtually open). This was based on previous testing that identified this threshold to give the cleanest Weibull plots on this test circuit [4].

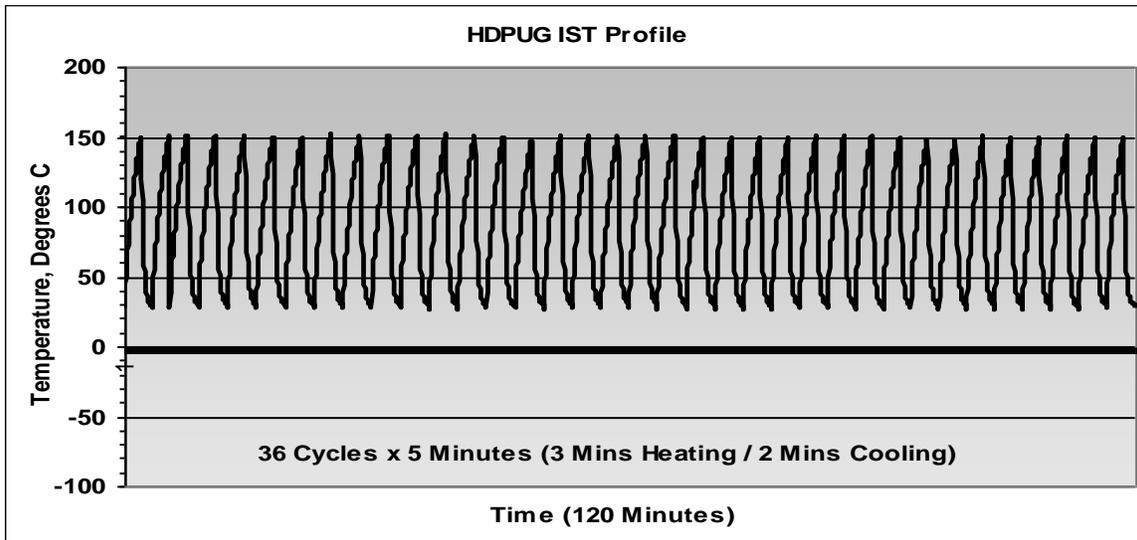
Figure 13: IST Thermal Cycle Profile

The IST coupons were cycled per the IPC-TM-650 Method 2.6.26 using single sense testing, heating from ambient to 150°C in 3 minutes, and cooling back to ambient in 2 minutes. The failure criteria used for IST is that the coupon testing stops at 10% increase in resistance (as per IPC Standards). This capability identifies a further advantage of the IST methodology in the fact that each coupon is individually stopped during testing, permitting precise understanding of the damage accumulation when the product reaches a point of elevated resistance, usually caused by a cylindrical barrel crack. This greatly enhances the ability to determine the root cause during the failure analysis stage because “non-relevant” damage that can commonly confound the ability to understand premature product failures is not present.

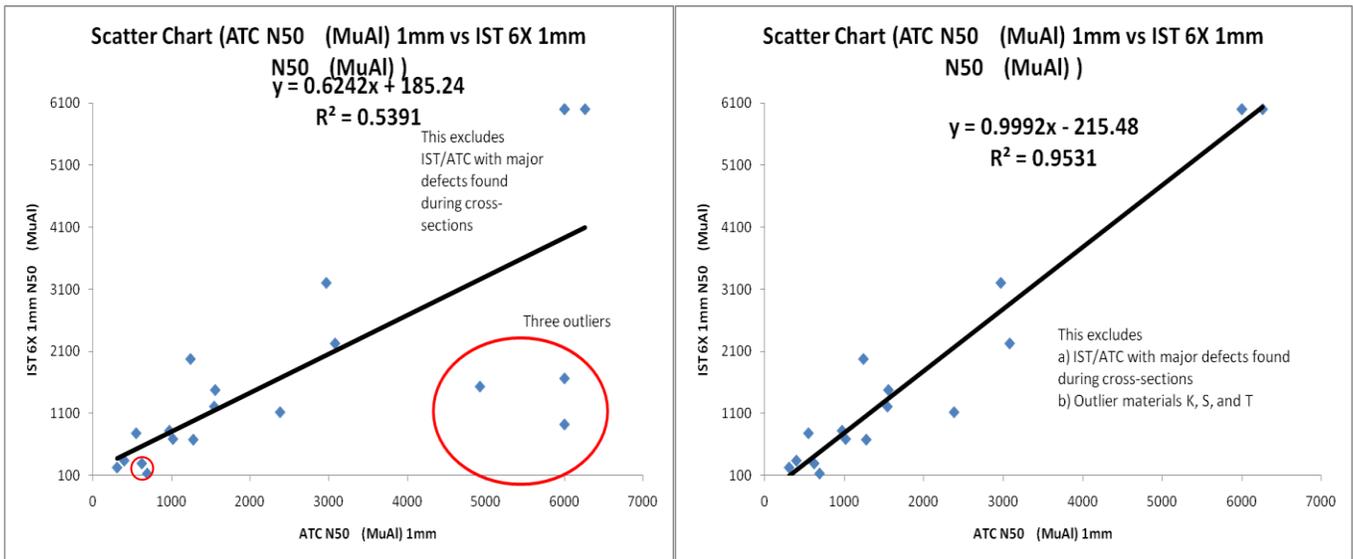
Figure 14a (left) and b (right): IST vs. ATC after 6X reflow. a) includes all data without major laminate defects in the samples b) same data with the 3 outliers removed. This data is from the 50% failure rate (N50, MuAl) as defined by the log normal distribution.

Air-to-air thermal cycle results were compared to IST thermal cycle results after the 6X assembly reflow using regression analysis (Figures 14a and b). To ensure that this was a valid comparison, only the 1mm pitch results from each test were compared. Additionally, any materials that were found to have major delamination defects in the cross-sections detailed above in the 1mm ATC and IST sections were excluded from this data, as major defects could produce misleading results.

The data for coupons without failures through 6000 ATC or IST cycles was entered as N50=6000 for this correlation analysis. As noted in the introduction, significant changes were made in the design of the IST coupons to more evenly distribute the heat in these coupons compared to previous similar testing [1] with the expectation that this would allow for a good correlation between these two tests. With the exception of the three outliers circled in Figure 14a, material K at 58% resin content, and material S and T at both resin contents, this goal has been achieved. When these three outliers are removed, the correlation coefficient between ATC and IST is greater than 0.95 as shown in Figure 14b. Even with the outliers removed, there is still a significant amount of scatter in the data around the best fit line. Some scatter is expected due to the smaller sample size of the IST coupons and the resulting variation in the spread of the data, plus normal variability associated with different locations of the boards on the fabrication panels.

The three outliers are unique in that these are three of five materials in this data set with the Tg by DMA storage modulus, at approximately 150°C or lower as measured on the multilayer board after 6X reflow. ATC testing peak temperature is 135°C compared to the 150°C peak temperature of IST. Thus the IST testing for these materials is at or above the Tg. All others have a Tg significantly higher than 150°C. The other two materials in this data set with a Tg by DMA storage modulus of 150°C or lower are also circled in Figure 14a. Though not obviously noted as outliers the materials O and Q had a similar result where ATC significantly outperformed IST by more than a 2:1 ratio. Figure 15 is the regression analysis and plot with all of these materials removed. Since the IST peak temperature is 150°C and is at or above the Tg by DMA storage modulus, this data suggests that for long term reliability testing, the peak temperature of the IST testing should be reduced to below the Tg of the finished multilayer board (10°C reduction in the peak test temperature appears to be an adequate reduction based on the data). Otherwise, the plating reliability will be judged to be much lower than it actually is for typical applications where the operating temperature does not approach the Tg of the material. For applications with high peak operating temperatures, such as some automotive applications, the Tg (DMA Storage Modulus) appears to be a critical material parameter affecting long term plating reliability and higher Tg materials may be required.

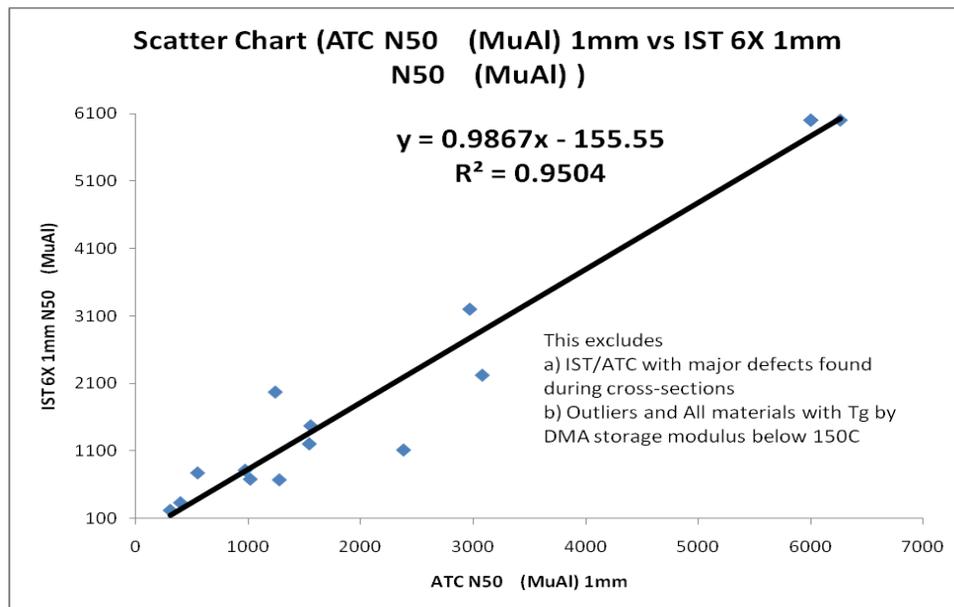
Figure 15: IST vs. ATC after 6X reflow after removing major defects and outliers with Tg by DMA storage modulus below 150°C.

In summary, after accounting for the issues noted above associated with the Tg of the material, IST testing using these newly designed IST material analysis coupons with distributed internal heaters, correlates well to ATC testing and can be used for long term reliability estimates.

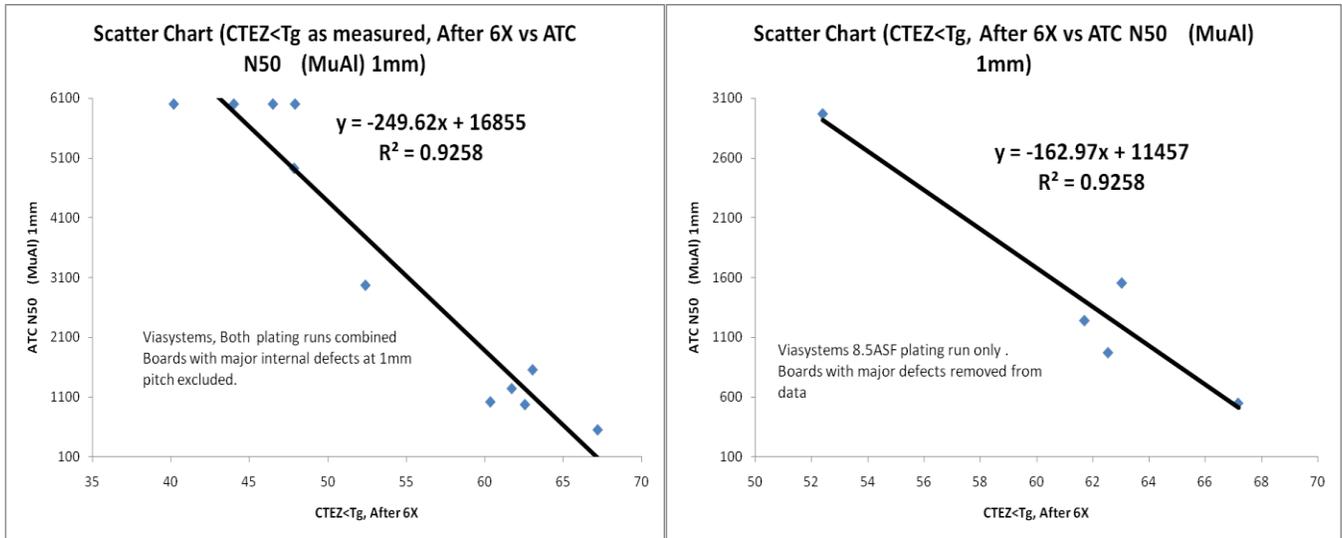
Figure 16 a and b: Comparison of ATC performance to Z-axis CTE as measured on the multilayer board, a) Left, all boards plated at Viasystems b) Right, Single plating run at Viasystems (8 Amperes/square foot current density) only.

Previous work [1] showed the correlation of ATC performance to the Z-axis coefficient of thermal expansion (CTE) below the glass transition temperature (Tg) as measured on the finished multilayer printed circuit boards (not the bare laminates). In this work, with three different fabricators and multiple plating runs, there are challenges in replicating the correlation due to plating differences among suppliers and plating runs. After eliminating any data from boards with internal laminate damage, there were sufficient boards fabricated at Viasystems for this correlation study. There were two separate plating runs at Viasystems, with a different plating current density in each one (6.1 Amperes/square foot (ASF) for 240 minutes and 8.5 amperes/square foot for 180 minutes). Figure 16a is the plot and regression analysis for the two plating runs combined. For this analysis, the materials with no failures after 6000 cycles were entered as having an N50 failure rate of 6000 which makes the regression somewhat inaccurate. Even with this entry, the correlation coefficient is 0.93. Figure 16b reduces the sample set to the 8.5 ASF plating run only. In this run, there were no materials that did not fail before 6000 cycles. The correlation coefficient is identical to the combined data set, but as expected the equation describing the fit is different as it is not influenced by suspensions. This data confirms the direct relationship of the Z-axis CTE below the Tg (α_1) as measured on the finished multilayer printed circuit board and the plated through hole reliability in thermal cycling. Given this information, once a fabricator's plating reliability has been qualified, the effect on thermal cycle reliability of changes to the board materials can be estimated by the resulting change in the Z-axis CTE. This can be extended across multiple designs.

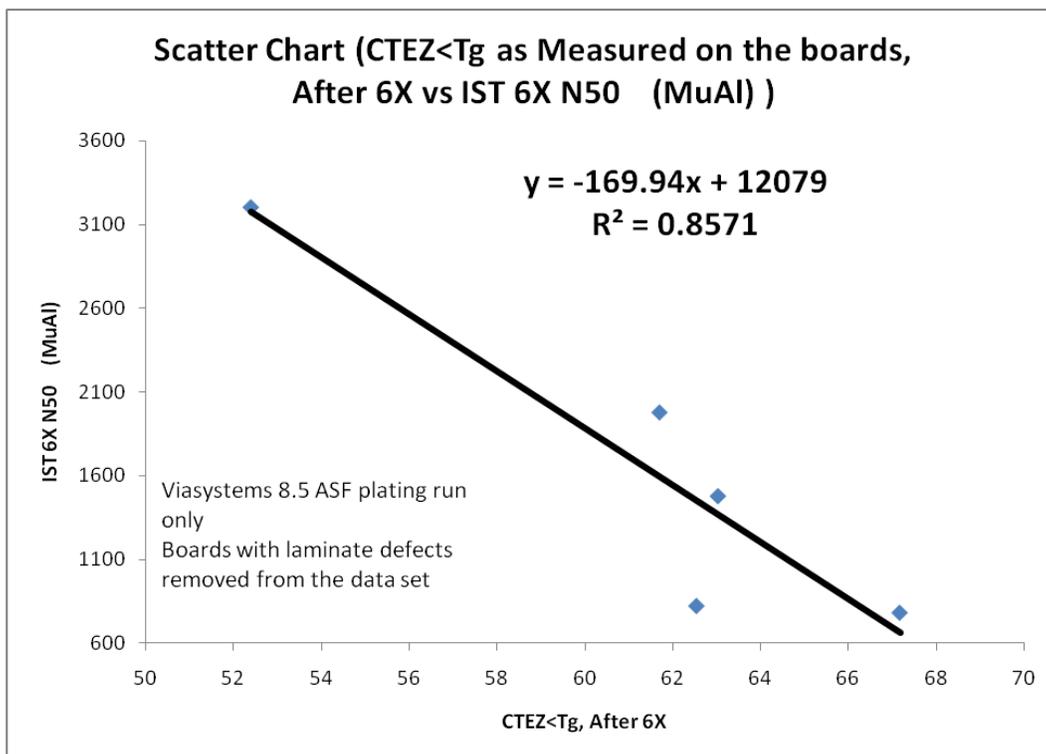
Figure 17: Comparison of IST performance to Z-axis CTE as measured on the multilayer board

A regression analysis similar to that done for the ATC case was completed comparing IST results to the Z-axis CTE prior to Tg for the Viasystems boards with the results as shown in Figure 17. The results obtained by combined both plating run results (not shown) had very poor correlation. This was driven by the materials that had a Tg as measured by DMA Storage Modulus at or below 150°C as discussed above in the ATC to IST comparison. When only the 8.5ASF plating run data is used, which did not include any of these materials, the correlation coefficient is 0.86 and the results are very comparable to ATC. This confirms that IST testing using these specially design material analysis IST test coupons in addition to ATC can also be used for plating qualification and the affects of material changes on plating reliability can be assessed by changes in the Z-axis CTE of the finished printed wiring board.

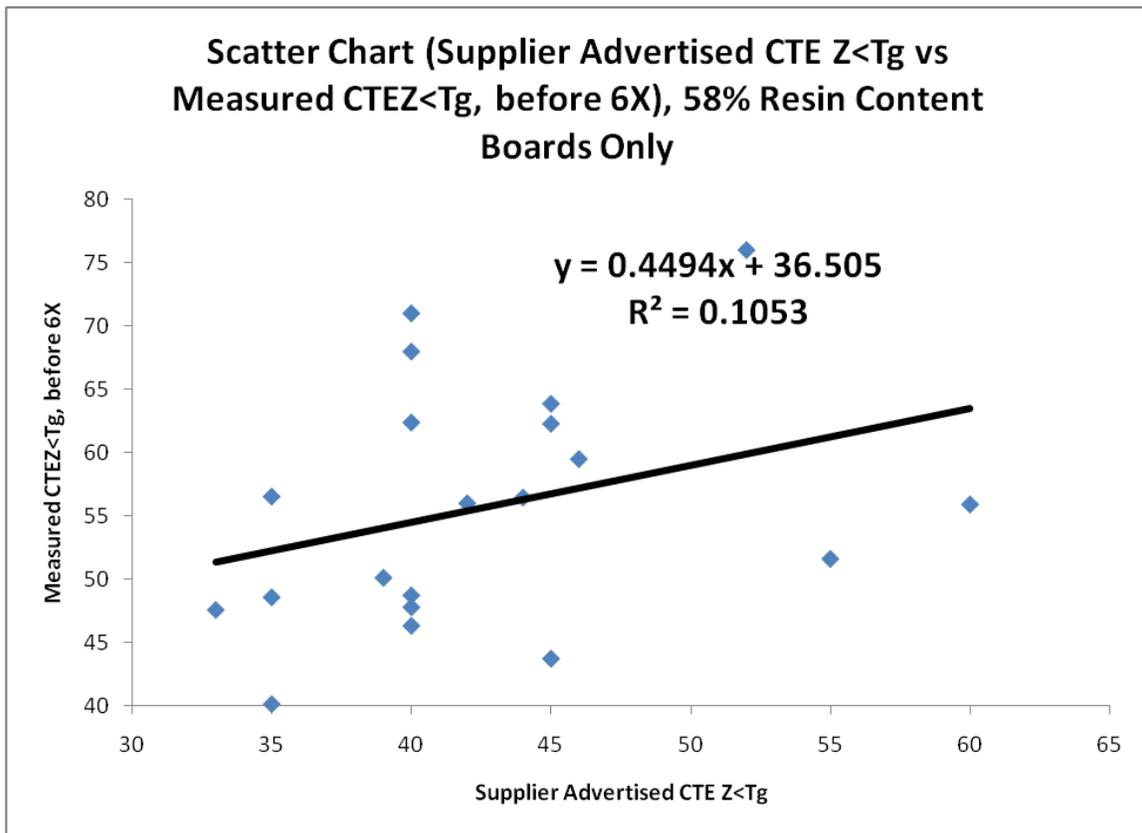
Figure 18: Comparison of Supplier Advertised Z-axis CTE below Tg to Measured Z-Axis CTE below Tg as built on the 58% resin content constructions.

As can be seen in Figure 18, the correlation between suppliers advertised data and data on actual boards is nearly non-existent. Also, the supplier data in many cases is quantized to the nearest five parts per million. This is a major flaw in many supplier data sheets. The observed lack of correlation can only be due to suppliers' inconsistent sample selection for this testing or inconsistent measuring techniques confounded by rounding the data to the nearest five parts per million. Another possibility is that some suppliers may overstate the capability of their products for marketing purposes. Considering the importance of this data to the reliability of end user products, industry standards need to be reviewed to ensure that the methods for sample selection (including thickness, glass style and resin content), preparation and measurement are clear, and reporting requirements need to be to the nearest part per million and not rounded.

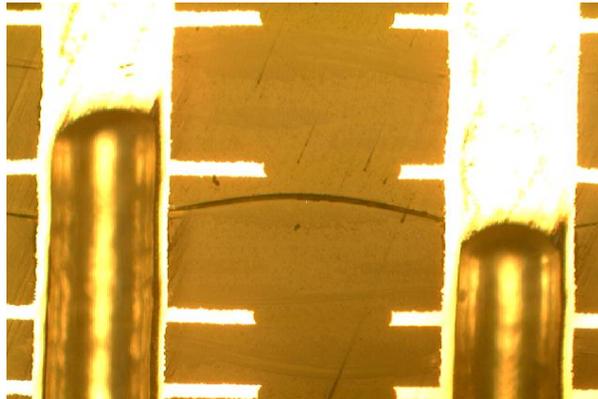
Figure 20: Example Eyebrow Crack

After completion of ATC and IST, cross-sections were done to determine the failure modes and to help in identification of any anomalous results. All the failures identified were barrel cracks as shown in the example in Figure 19. Also noted in the cross-sections after ATC was that there was a significant increase in eyebrow cracks compared to the after 6X reflow cross-sections as shown in Figure 20.

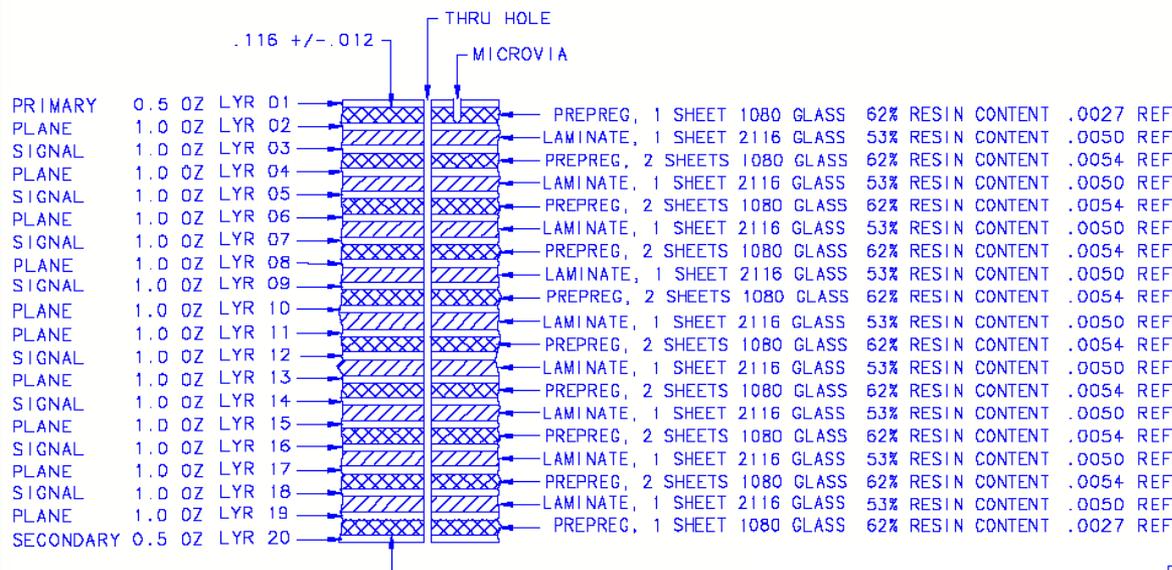
SECTION A-A STACKUP A

Stackup A: 20L, 58% RC, .116" thick

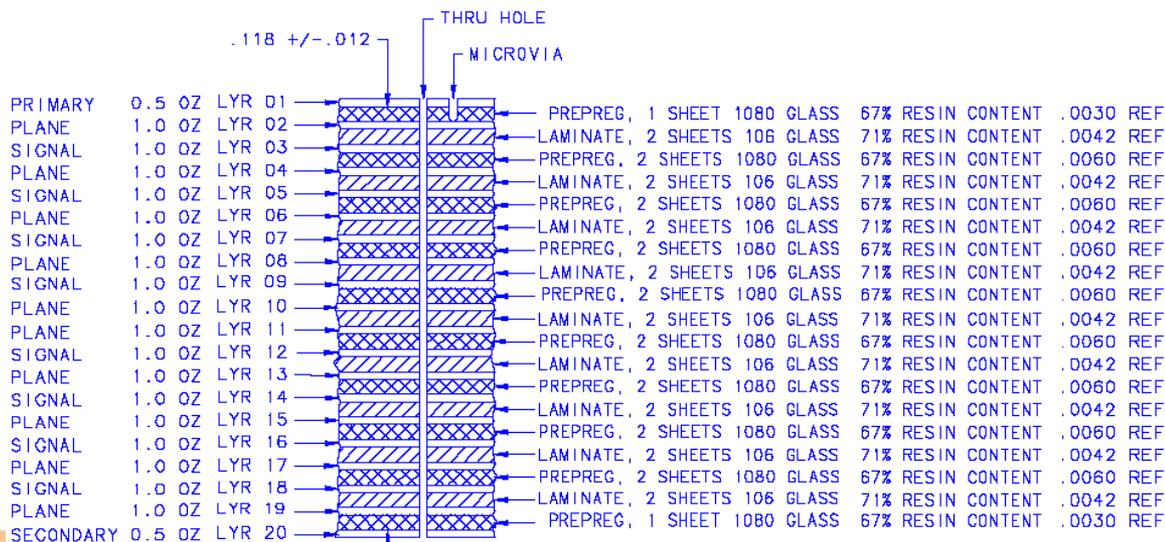
SECTION A-A STACKUP B

Stackup B: 20L, 69% RC, .118" thick (represents Higher Layer count in same thickness)

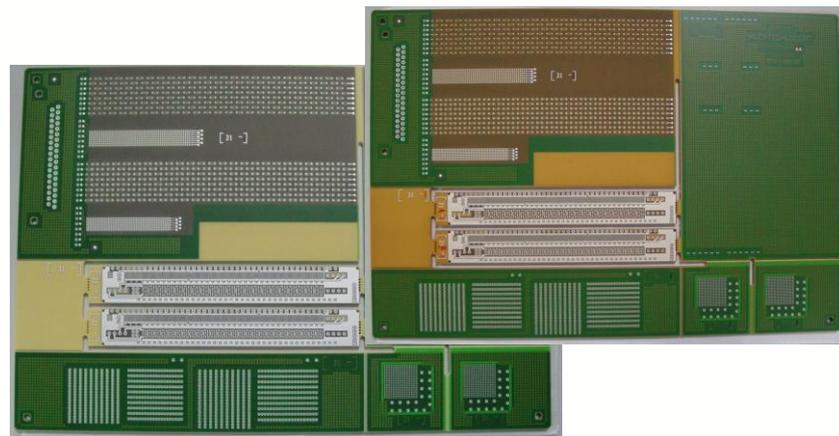
Color changes (oxidation)
typical after reflow

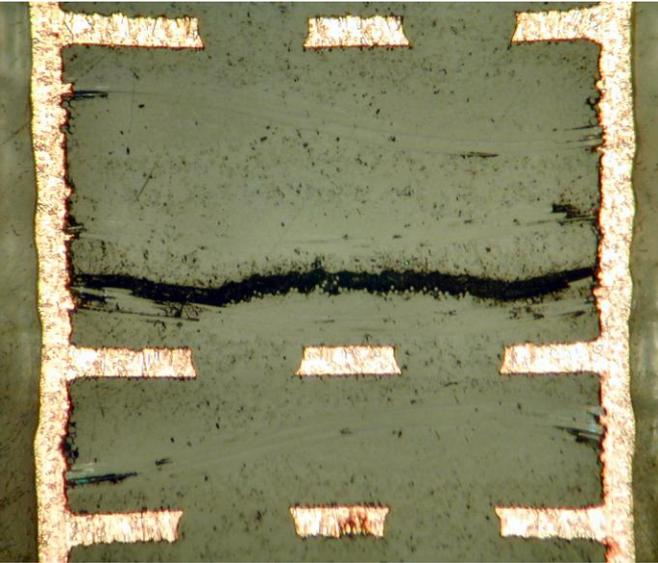
Longitudinal cohesive delamination

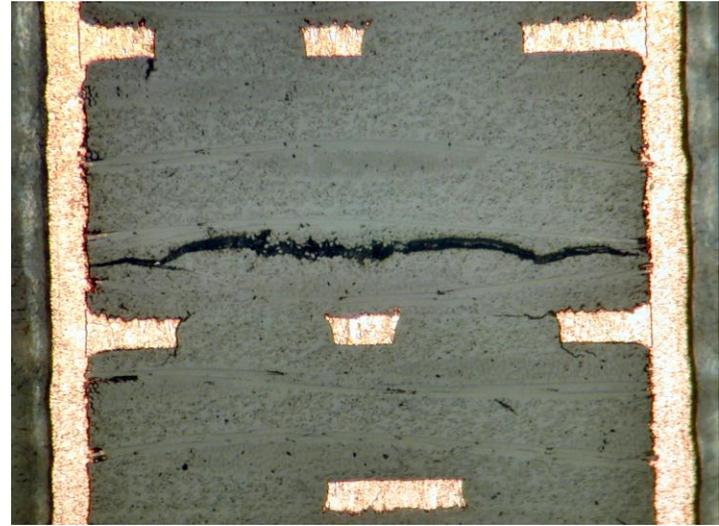
Snake Delamination (Partially in resin, partially along glass)

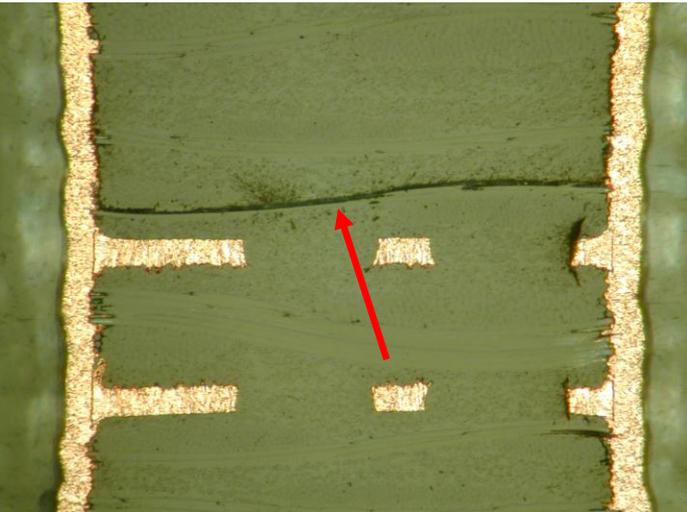
Eyebrowing (separation along glass)

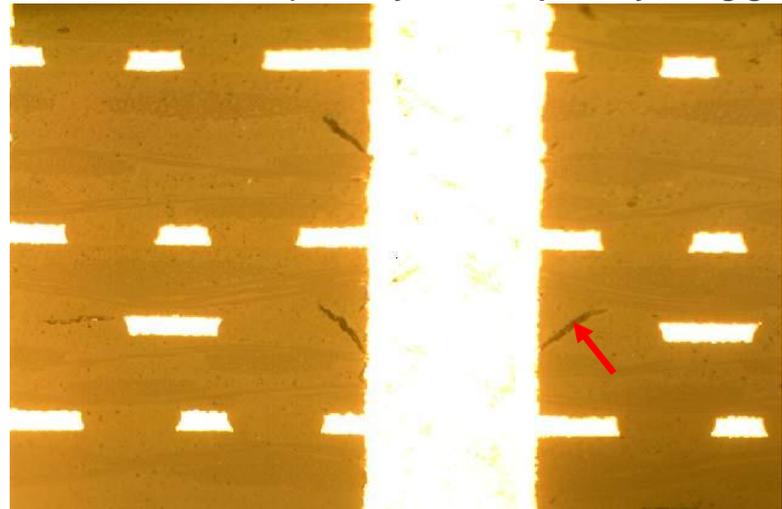
Cigar voids

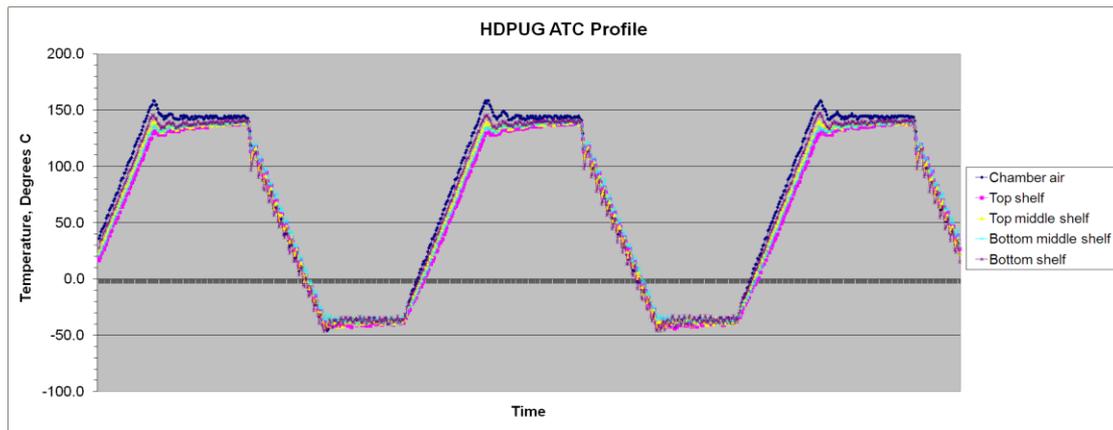
-40 to +135°C, 10 min ramps and dwells

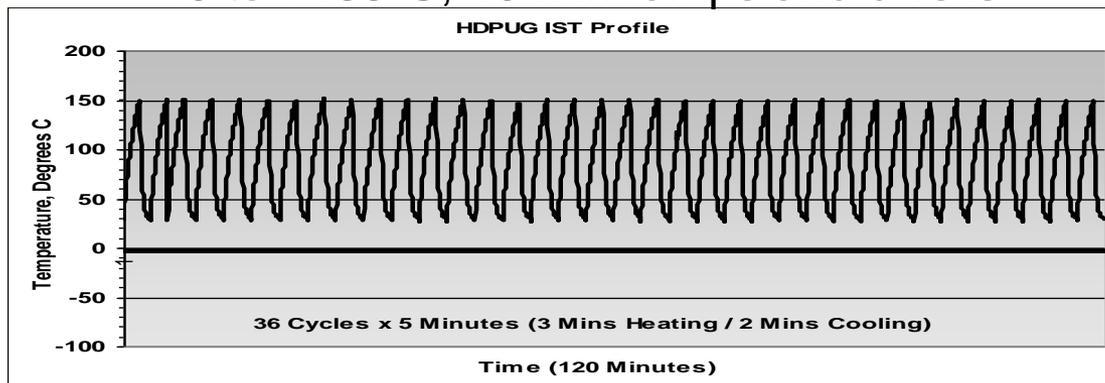
25 to 150°C, 3min heating, 2 min cooling, no dwell

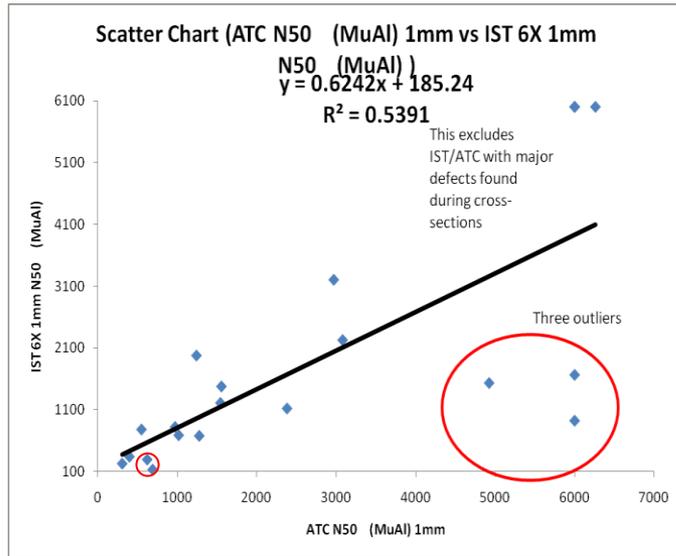
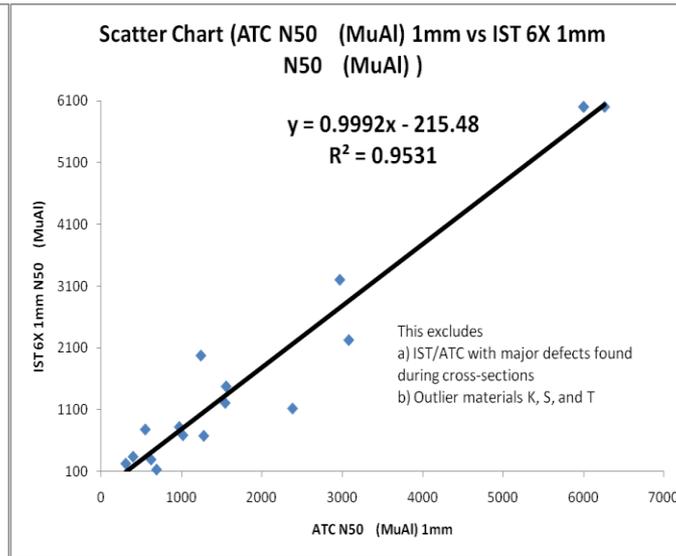
Comparison of ATC to IST (6X Reflow, 1mm pitch)

Scatter believed primarily due to smaller IST sample size

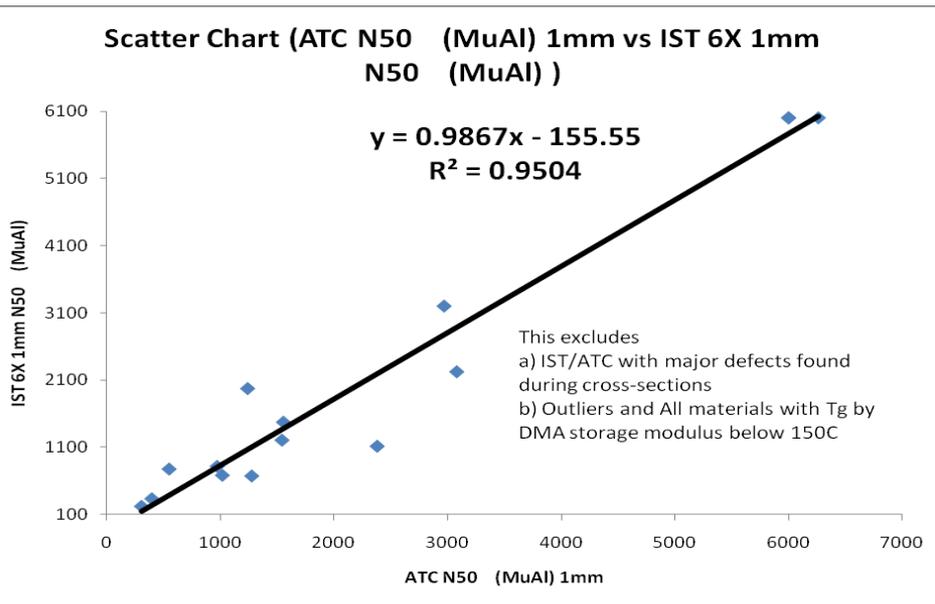
Outliers: Actually 5. Where ATC >> IST (>2:1 ratio) → Tg by DMA storage modulus or lower → Affect IST (peak temp 150°C) but not ATC (peak temp 135°C)

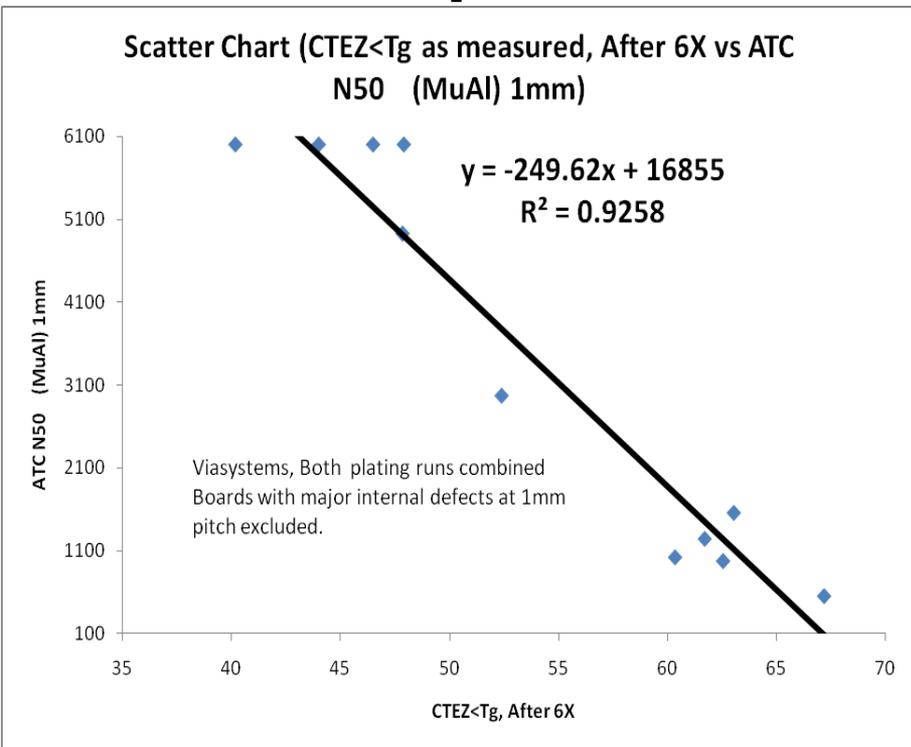
All boards plated at Viasystems

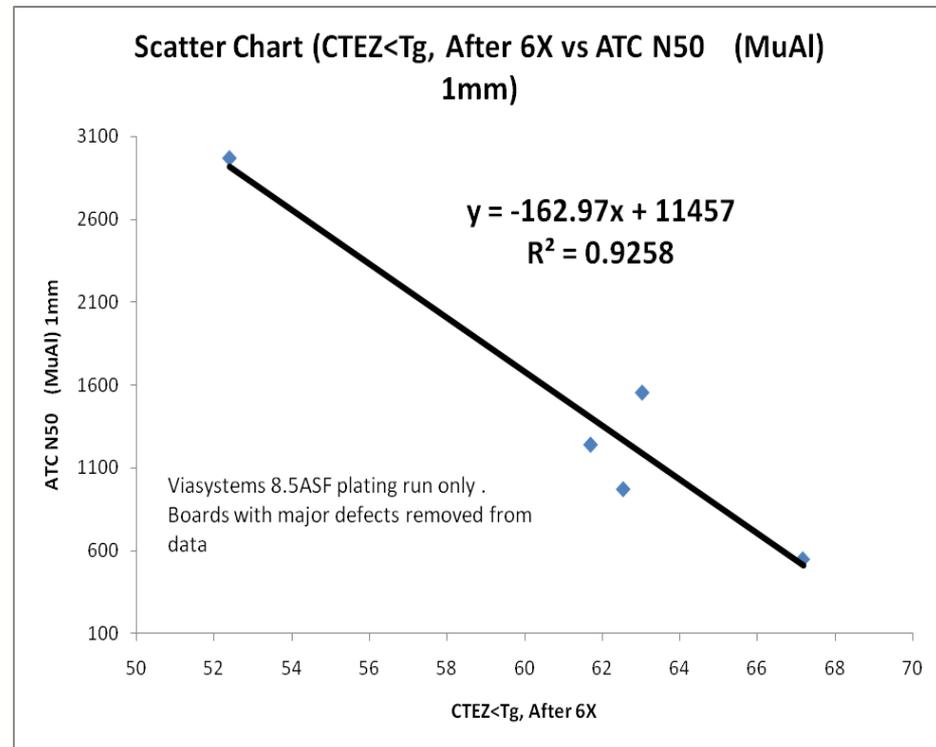
Single plating run at Viasystems(8 ASF)

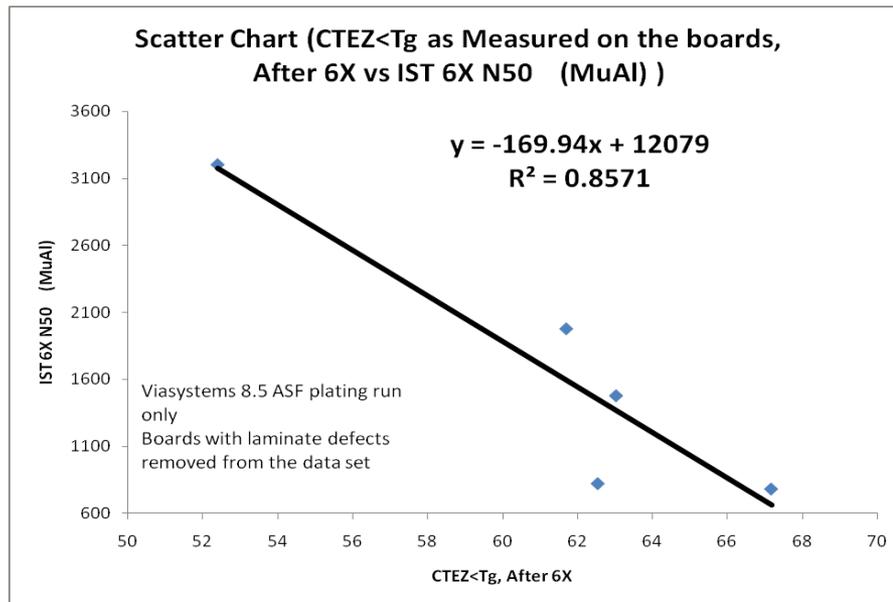
Comparison of IST to CTE Z

- Good correlation only occurs when you remove materials with $T_g \leq 150^\circ\text{C}$
 - Same issue comparing ATC vs. IST
 - Confirms IST testing using these specially design material analysis IST test coupons in addition to ATC can also be used for plating qualification and the affects of material changes on plating reliability can be assessed by changes in the Z-axis CTE of the finished printed wiring board.

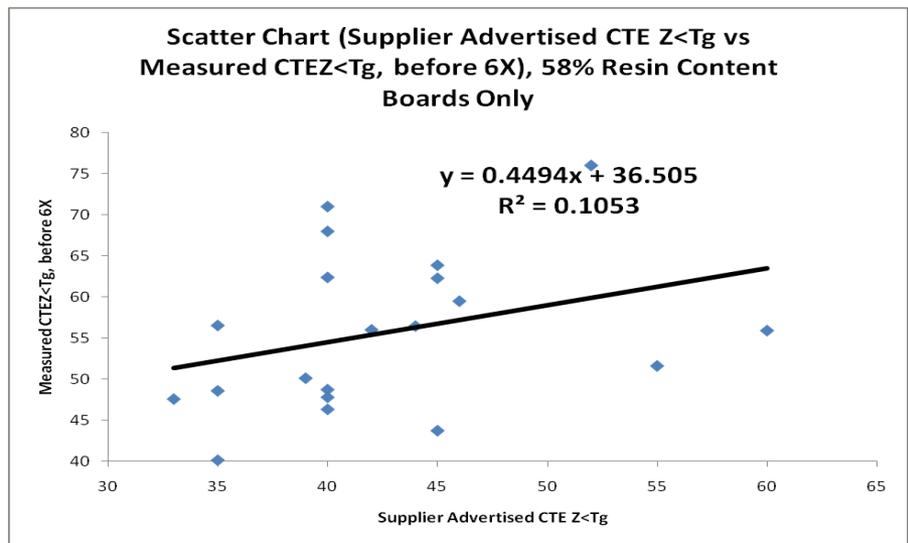
Comparison of Supplier CTE Z to Measured CTE Z

- Supplier Advertised data at 50% RC vs. Measured on identical 58% RC boards
 - Should be a difference, but should correlate → **Clearly Does NOT!**
 - Can only be due to suppliers’ inconsistent sample selection for this testing or inconsistent measuring techniques confounded by rounding the data to the nearest five parts per million (or supplier “advertising”)
- Considering the importance of this data to the reliability → industry standards need to be reviewed to ensure that the methods for sample selection (including thickness, glass style and resin content), preparation and measurement are clear, and reporting requirements need to be to the nearest part per million and not rounded.

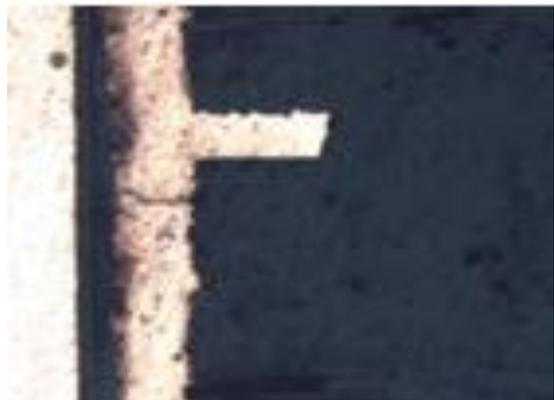
Typical Fatigue Crack

- All failures were barrel cracks
- Also noted in the cross-sections after ATC → significant increase in eyebrow cracks compared to the after 6X reflow cross-sections (no ATC).
