The Effects of Non-filled Microvia in Pad on Pb-free Solder Joint Reliability of BGA and QFN Packages in Accelerated Thermal Cycling

Joe Smetana, Alcatel-Lucent, Plano, TX
Thilo Sack, Celestica, Toronto, Canada
David Love, Oracle, Santa Clara, CA
Chris Katzko, TTM (Meadville), China

IPC/APEX, April 2011, Las Vegas, NV

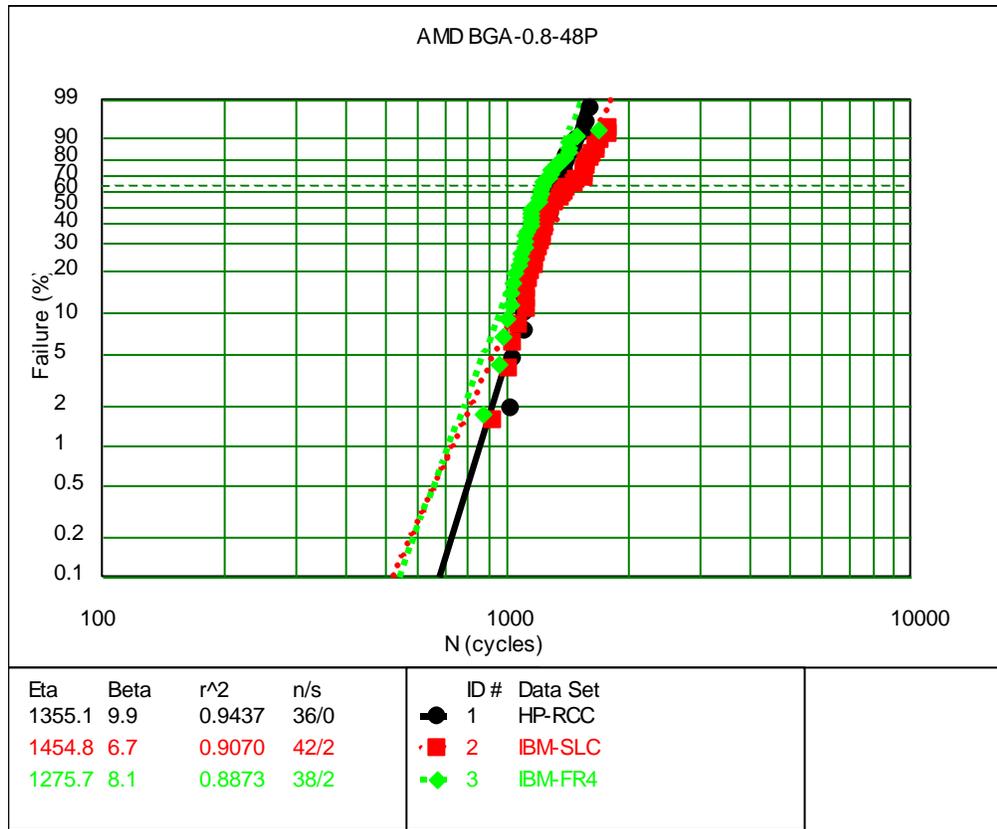
Figure 1: Weibull Plots of air-air thermal cycle results on a 0.8mm pitch 48IO BGA from 3 nearly identical artwork boards with minor differences in construction of outer layers assembled at the same time with SnPb solders. Two of these constructions (SLC and RCC) had microvia in pad (conformal). The all FR4 construction did not.

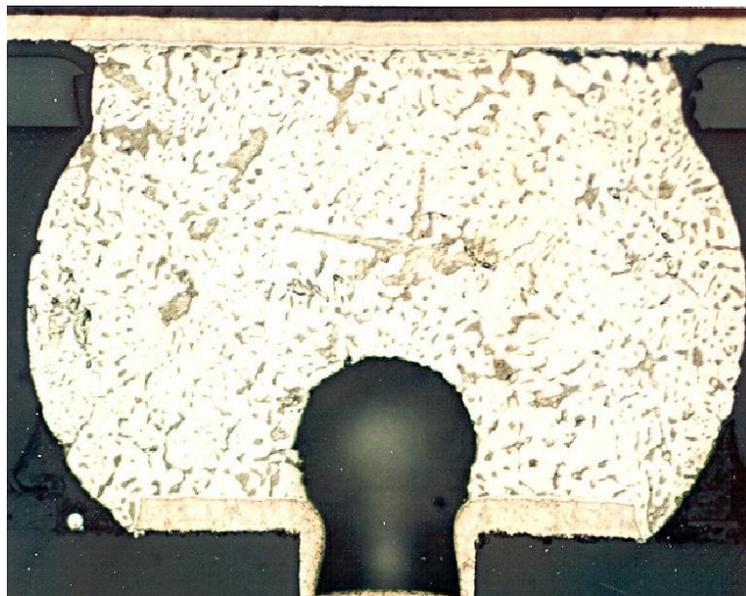
Figure 2: Example of a conformal microvia in pad and associated void in a SnPb assembly after thermal cycling. Fatigue crack is away from the void.

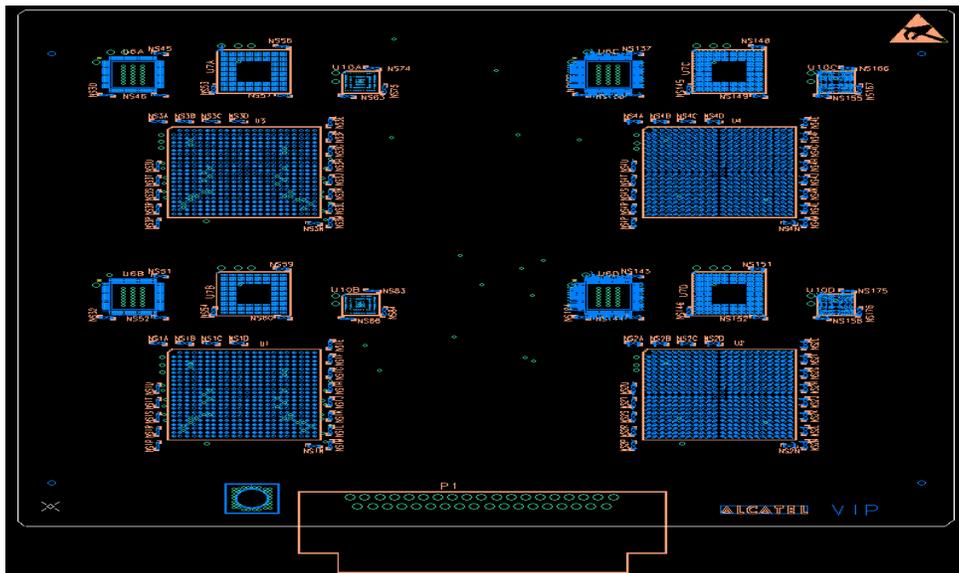
Figure 3: Test Vehicle design. 2 sets of components on the left side have microvia-in-pad. 2 sets of components on the right side do not have microvia-in-pad.

The bare board is a 6 layer, 0.125 inch (3.175mm) thick, 7.0 x 6.5 inch (177.8 x 165.1 mm) design using a high Tg filled phenolic FR4 material and immersion silver surface finish. The prepregs between layers 1-2 and 5-6 were 2113 glass for a nominal thickness of approximately 3.3 mils and the laser drilled vias were drilled at a nominal dimension of 6 mils. This thickness and hole size combination was selected to represent the worst case hole size and thickness typically found in a conformal microvia-in-pad construction and thus represent the worst case voiding from a microvia-in-pad at assembly.

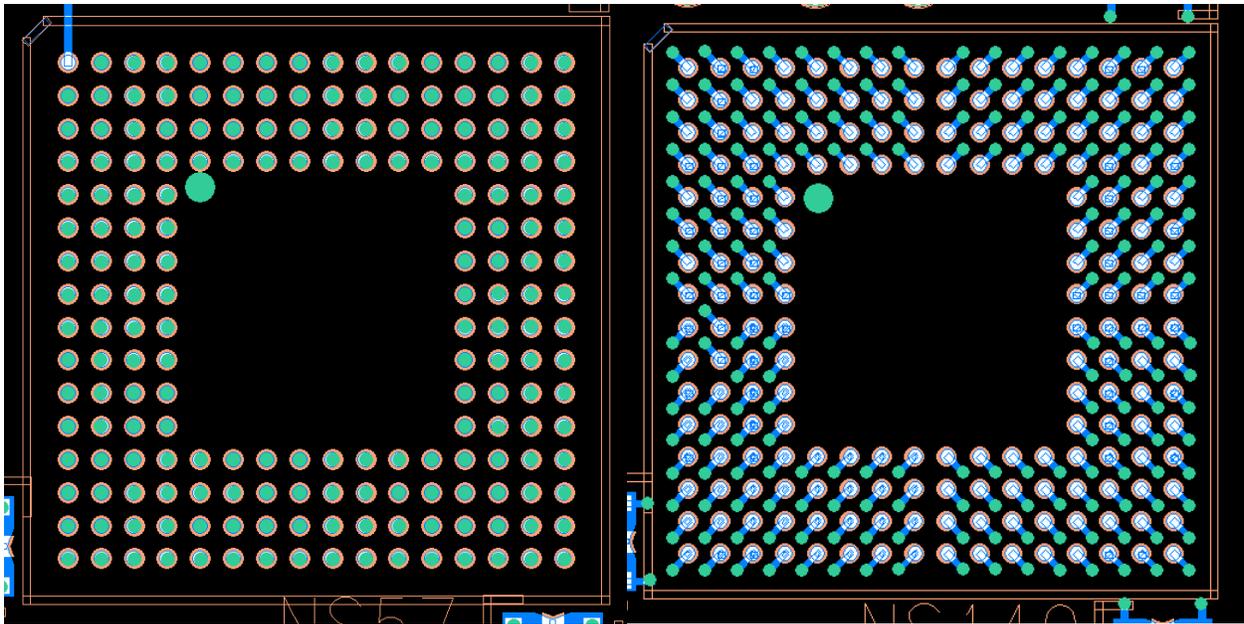
Figure 4: BGA192 – Left with Microvia in pad, Right, with fan out, no microvia in pad.

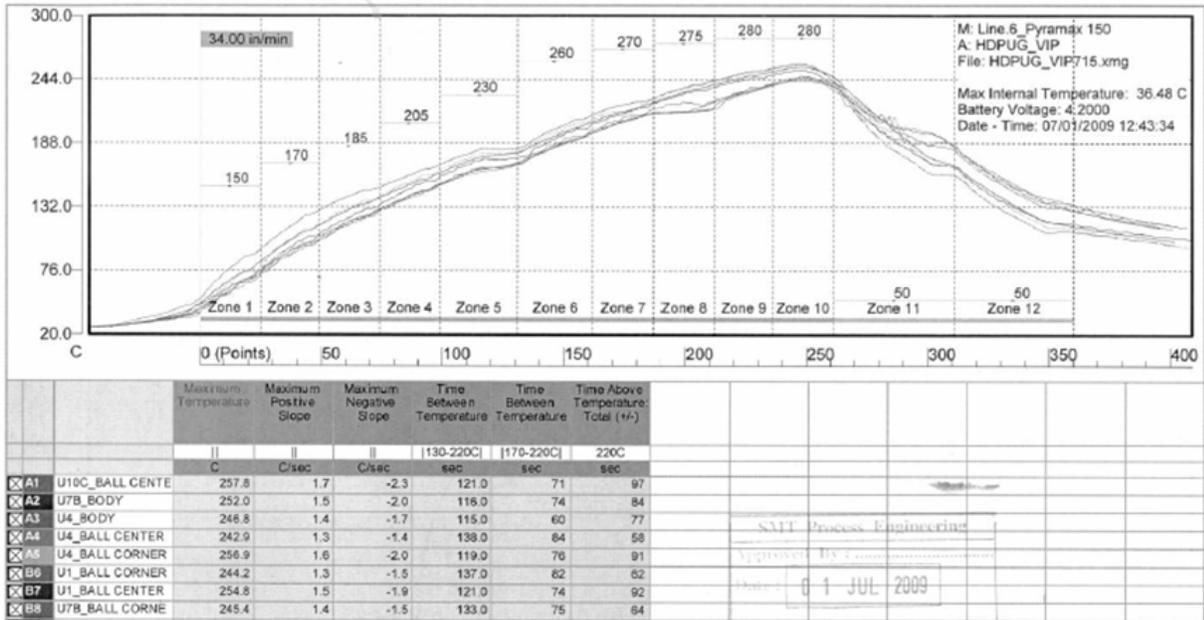
Figure 6: SMT Reflow Profile

Assembly was performed at Celestica Thailand with a typical Pb-free SMT process using SAC 305 solder paste and the reflow profile shown in Figure 6. 40 boards were built in total (16 boards for ATC testing, 10 for the Micro-structure evolution project and the remaining for spares and additional testing and a setup board). After assembly, boards were tested electrically for continuity and X-rayed for voids using 5DX 3-D X-ray laminography. Two boards failed electrical testing. The root cause of both of these was broken internal wire bonds on the QFN72 packages. In X-ray, 21 boards out of 40 failed to meet the IPC-7095A Class 2 requirements for voiding in BGA solder balls (Reject class 2 if void size is greater than 45% of ball diameter or 20% of ball area). Six of these rejects were in locations with no microvia-in-pad, 15 of these were in locations with microvia-in-pad. The voiding found in the components without microvia-in-pad was attributable to voiding in the solder balls of the BGAs as received (see Figure 7). No doubt a portion of the rejects for voiding in the microvia-in-pad locations were also associated with voids in as-received BGAs. Nevertheless, there was a clear impact from the microvias on the existence of voids larger than the IPC criteria. Figure 8 shows the assembled test vehicle.

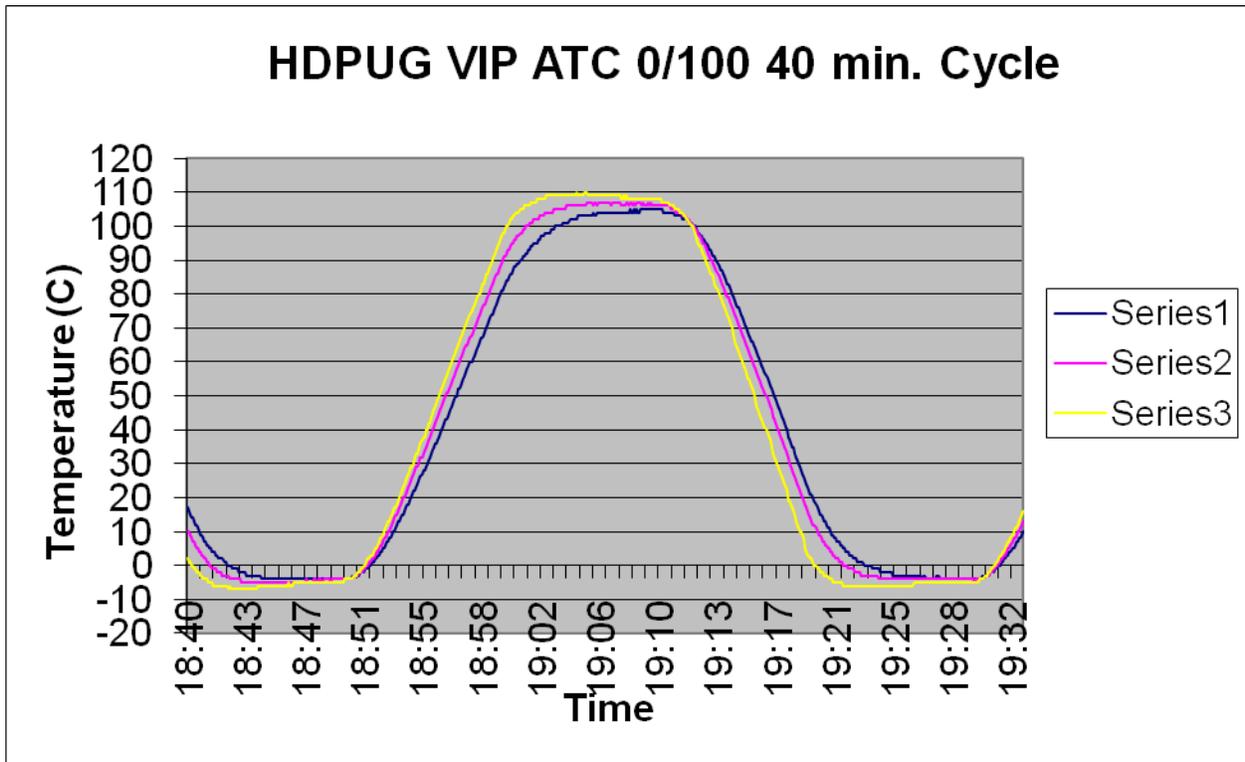
Figure 9: Air-Air Thermal Cycle Profile

The finished assemblies were thermal cycled from 0-100°C with 10 minute ramps and 10 minute dwells at the temperature extremes. Cycling was stopped after 4279 cycles. See figure 9 for the actual thermal cycle.

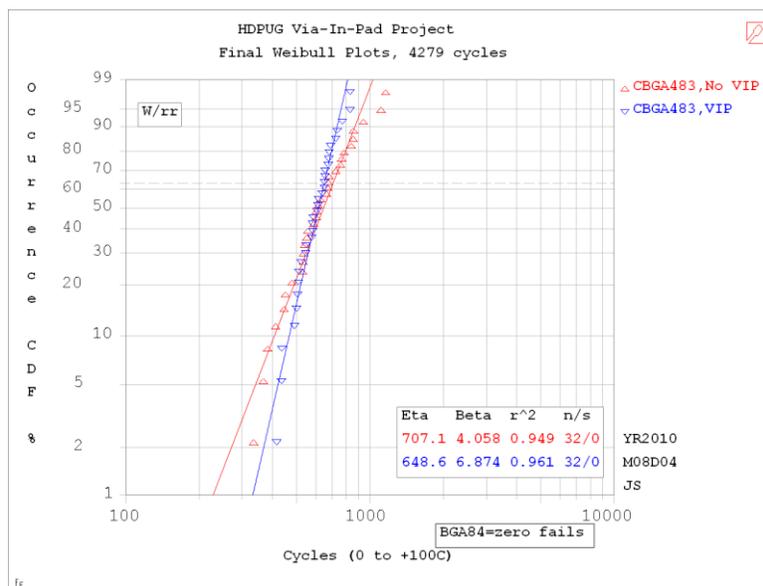
Figure 10: Weibull Plots of the CBGA483 failure data

Extensive Weibull and regression analysis was completed on the failure data. The BGA84 had no failures through the entire 4279 thermal cycles. Figure 10 shows the Weibull plots for the CBGA 483. Statistically, these failure distributions are different at greater than 99% confidence. This data shows a 9% increase in the characteristic life without the microvia-in-pad, compared to the via-in-pad condition, and it also shows a statistically significant difference in the slope (Beta) of the distribution, such that the first failures for the microvia-in-pad components occur after the first failures for the no microvia-in-pad case. Weibull plots are shown, but the lognormal distribution is actually a better fit for these data sets. When combined into a single data set, the fit to a lognormal distribution is still excellent, though not as good statistically as either of the individual data sets. Given this, and the relatively small differences between the data sets, it can be stated the impact of the voids from a microvia-in-pad on this component is minor, and in practical application can generally be ignored. This may be due to the large solder ball size of this component.

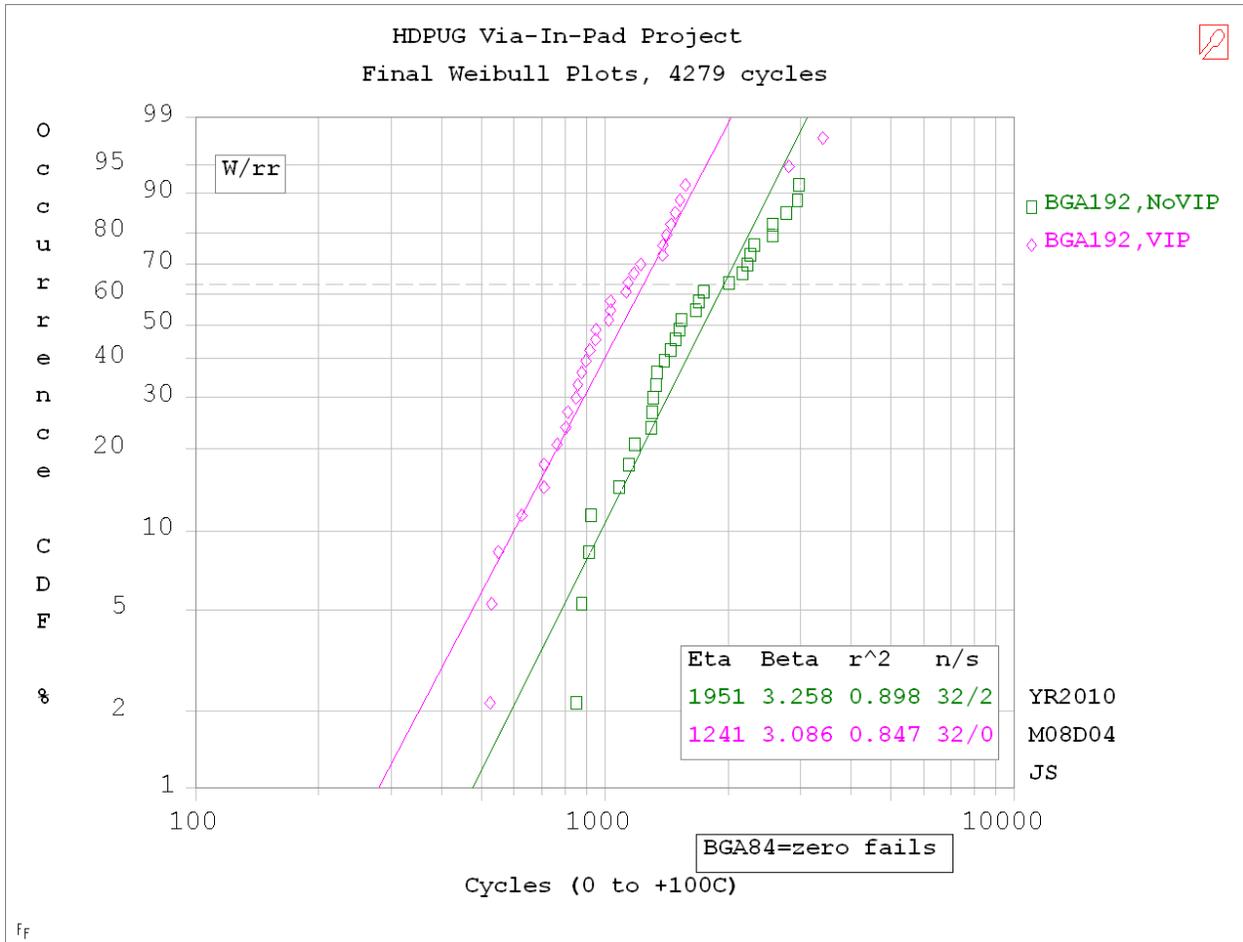
Figure 11: Weibull Plots of the BGA192 failure data

Figure 11 shows the Weibull plots for the BGA192 components. The characteristic life of the no microvia-in-pad construction is 57% better than that of the same component with microvia in pad. The slopes (beta) of the 2 different distributions are not statistically different. The distributions are again best fit to the log normal distribution (not shown), but the conclusions are the same either way; the microvia-in-pad construction has a significant negative impact on the BGA solder joint reliability in accelerated thermal cycling for this component and solder ball size.

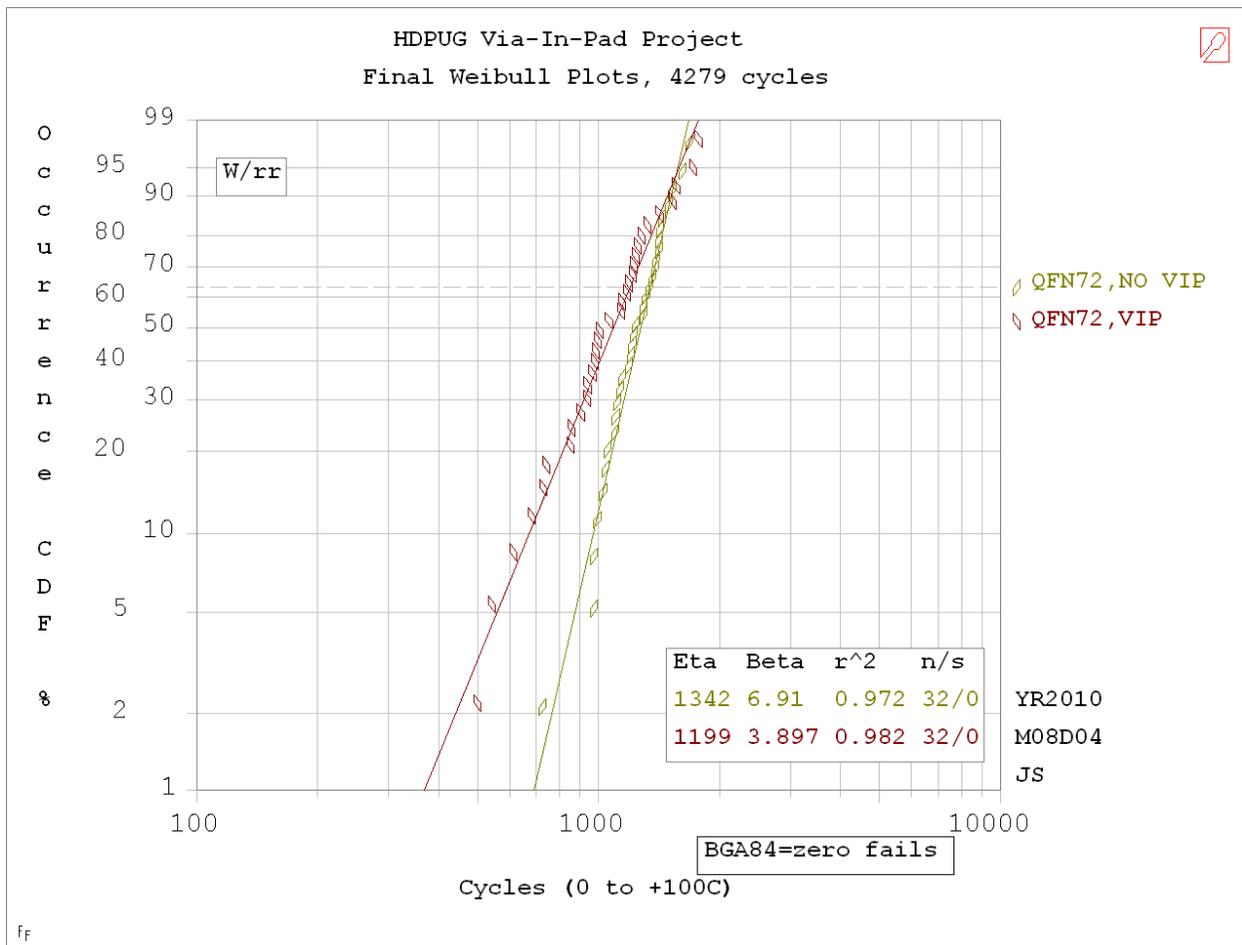
Figure 12: Weibull Plots of the QFN72 failure data

Figure 12 shows the Weibull plots for the QFN72 components. The characteristic life of the no microvia-in-pad construction is 12% better than the characteristic life of the microvia-in-pad construction. Additionally the slope (beta) of the distributions is larger for the no microvia-in-pad construction such that the time to first failure is significantly better also. These distributions both fit well to Weibull as plotted. In summary, the microvia-in-pad construction has a significant negative impact in the solder joint reliability of the QFN72 in this test.

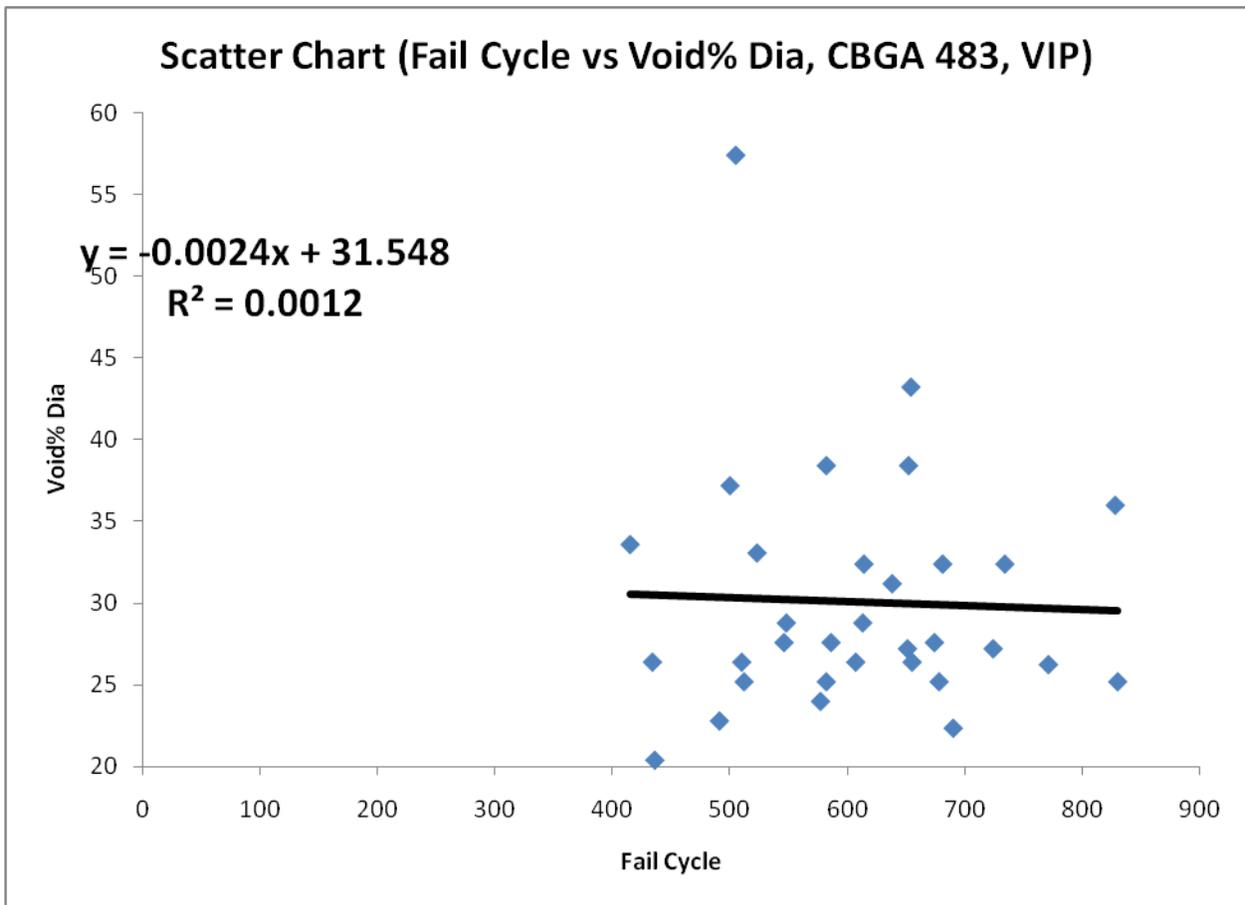
Figure 13: Scatter Chart showing the void percentage in %diameter in the corner or adjacent solder balls versus the failure cycle for the CBGA 483 component with microvia-in-pad.

Table 2 gives a summary of the voiding on these components in the corner and adjacent solder balls. For the CBGA483, where the impact of VIP is minimal on the thermal cycle performance, every component had some voiding on either the corner or adjacent solder balls, regardless of whether there was VIP or not. The average void percentage in both area and diameter was significantly greater for the VIP construction, and the maximum void percentage exceeded 50% (both diameter and area) for the VIP and 30% and 10%, diameter and area respectively, for the no VIP construction. The VIP construction clearly has an impact on the amount of voiding. However, a study was done to determine if the voiding could be correlated to the failure cycle. In all cases, the correlation coefficient is less than .01. Figure 13 provides just one example of the lack of correlation between void percentage and failure. The component with the highest voiding percentage (area and diameter) in the corner or adjacent solder balls, with over 50% was not the first part to fail, but rather the sixth, and a component with 20% (diameter) and 3% (area) voiding failed before it. The voiding percentage in the corner and adjacent solder balls, where the failure is expected, does not correlate to the performance of the CBGA 483 component in accelerated thermal cycling.

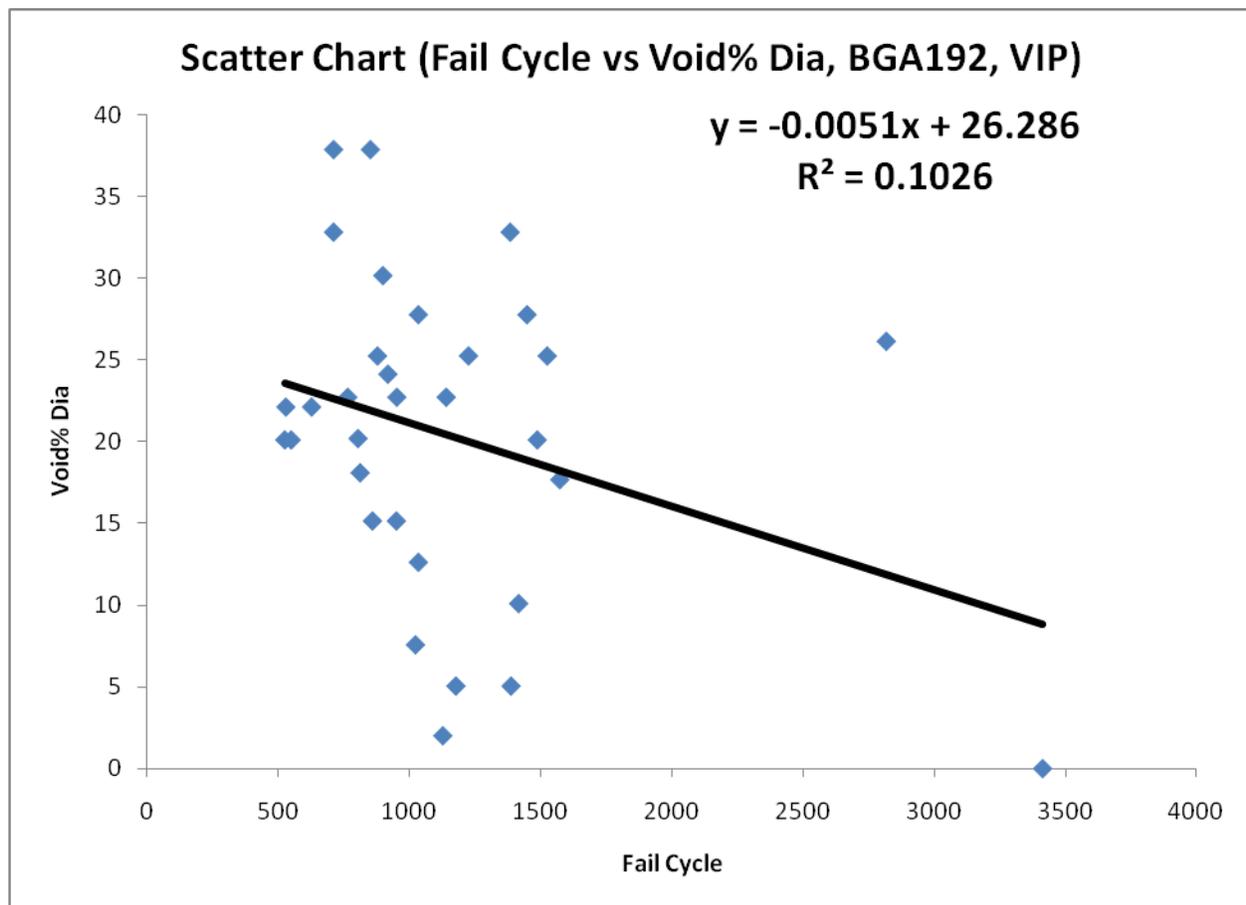
Figure 14: Scatter Chart showing the void percentage in %diameter in the corner or adjacent solder balls versus the failure cycle for the BGA 192 component with microvia-in-pad.

solder balls with VIP than without (97% vs. 25%). The maximum void percentages on this component were not dramatically different, however (37% vs. 30% in diameter, 14% vs. 9% in area). As with the CBGA analysis, there was no correlation between the failure cycle in thermal cycling vs. the void percentage in area or diameter. Figure 14 provides an example.

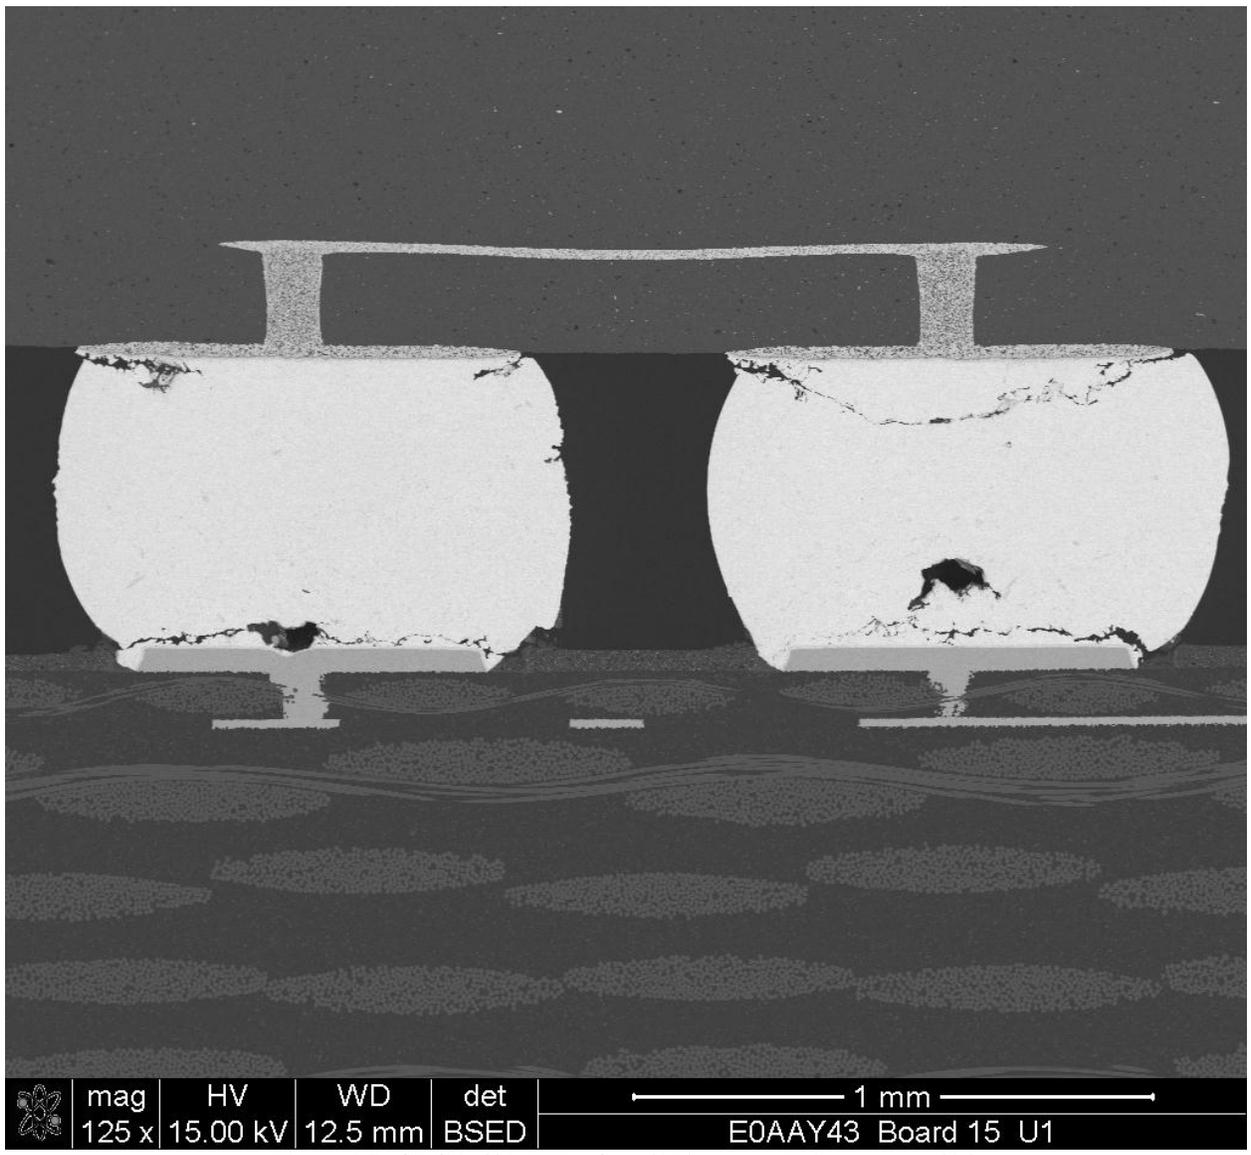
Figure 15: CBGA 483 VIP, after 4279 cycles. Failure cycle 434.

Figures 15 and 16 are representative cross-sections of the CBGA 483 with and without microvia-in-pad respectively. Both of these show that the failure locations could be either on the board or on the component side with this component. Though the void associated with the microvia in pad could be in the crack path, the influence of this void does not appear to have a major impact on the crack path. This is in agreement with the relatively small differences between the data sets as seen in the Weibull plots of the failure data for these components earlier.

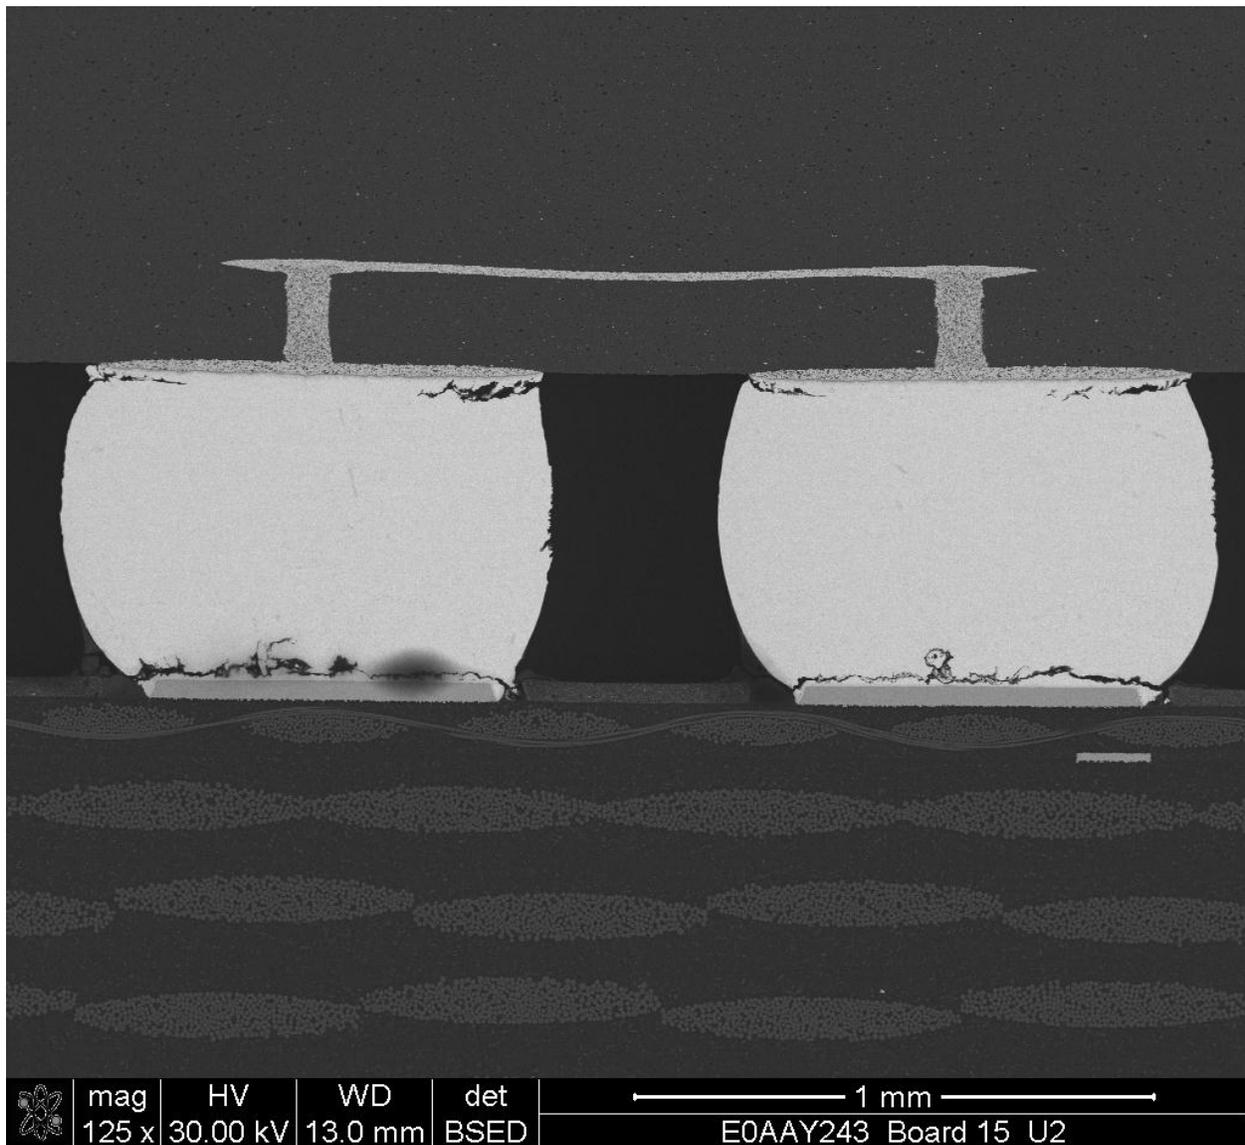
Figure 16: CBGA 483, No VIP, after 4279 thermal cycles. Failure cycle 334.

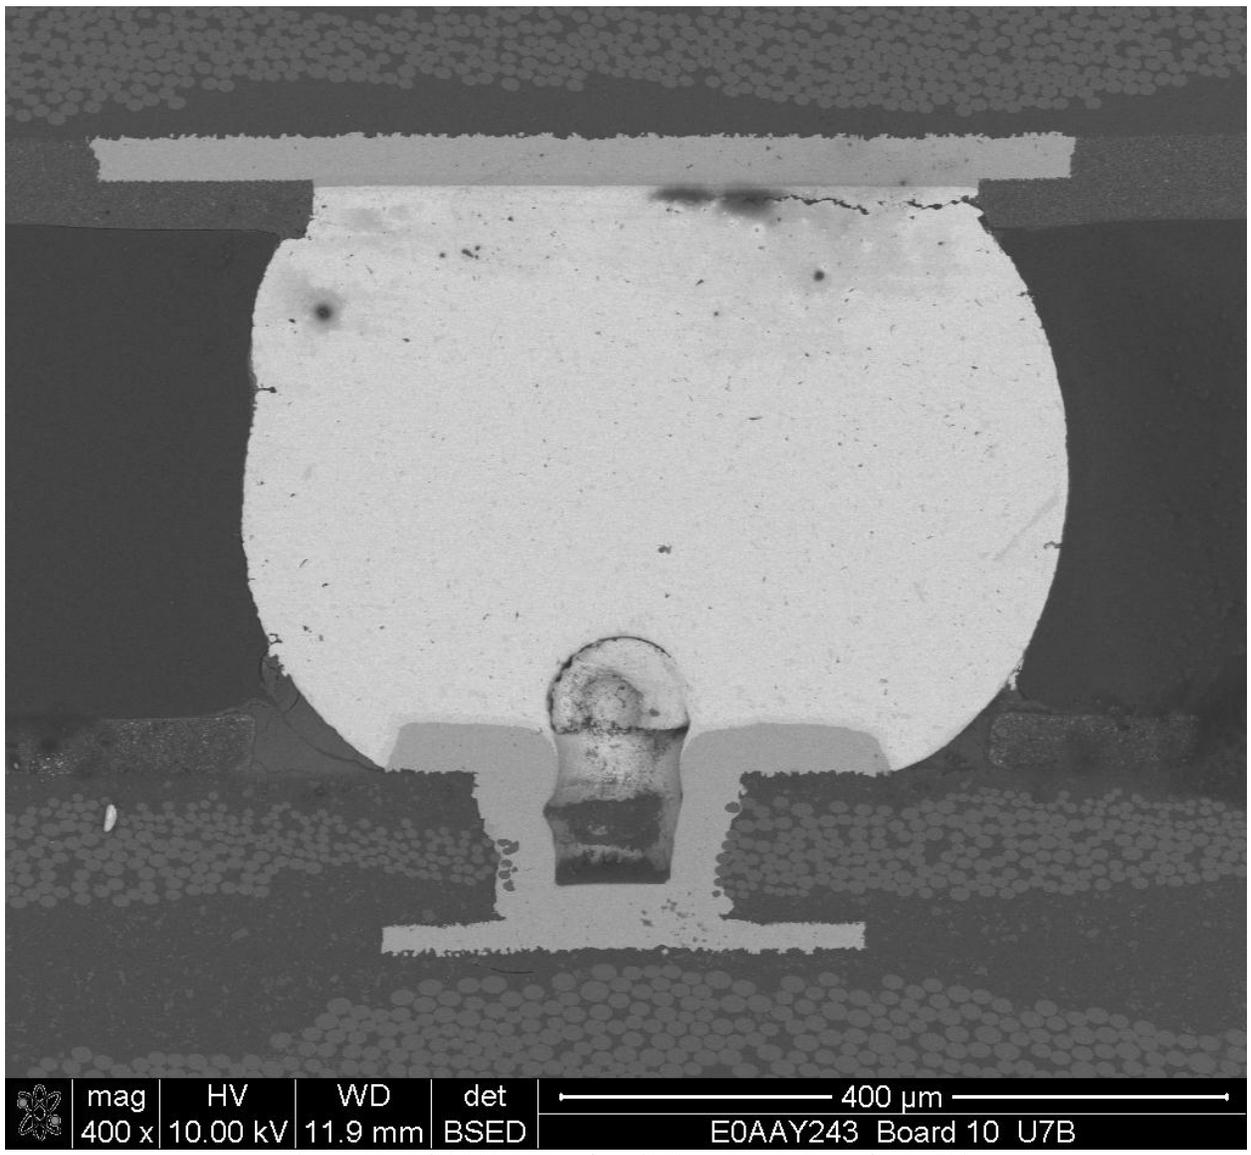
Figure 17: BGA192, VIP, after 4279 cycles. Failure Cycle 529

Figures 17 and 18 are representative cross-sections of the BGA 192 with and without microvia-in-pad respectively. In these samples, the crack path for the microvia-in-pad construction is on the component side away from the void from the microvia-in-pad. The crack path for the no microvia-in-pad construction, on the other hand, is on the board side (through the bulk solder adjacent to the intermetallic). If there had been a void here (potentially associated with the microvia-in pad), it would have influenced the crack path and likely reduced the life of the component (as the via size is 6 mils diameter vs. a board pad size of 14 mils diameter). This failure analysis is not conclusive, but suggests that the microvia in pad could negatively impact the life of the component in thermal cycling as was seen in the Weibull plots for these components previously.

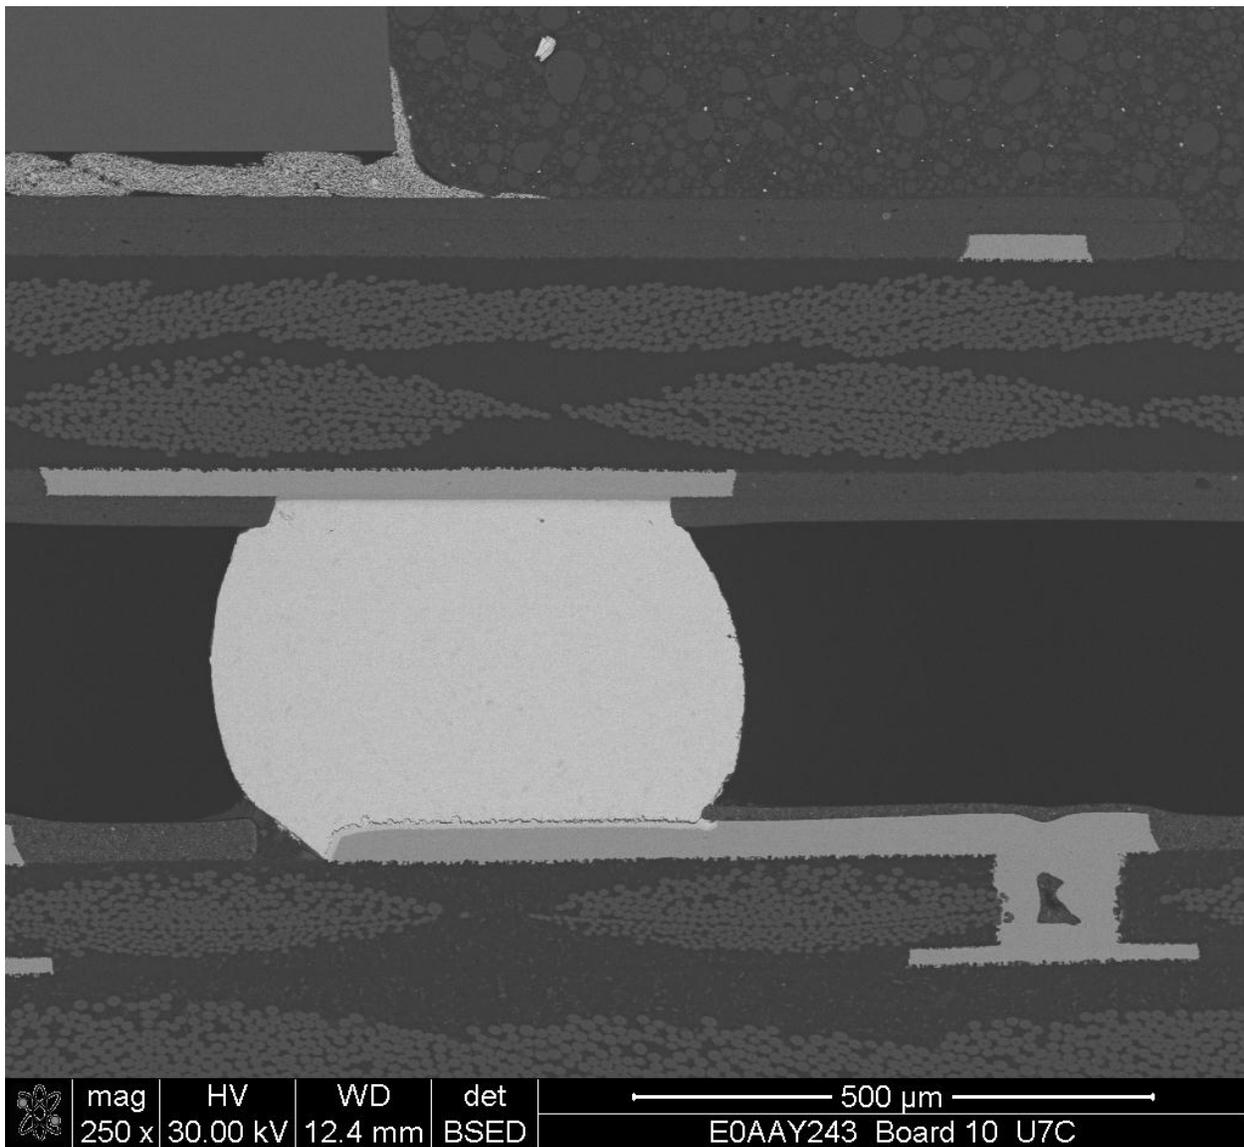
Figure 18: BGA 192, No VIP, after 4279 cycles. Failure Cycle 854

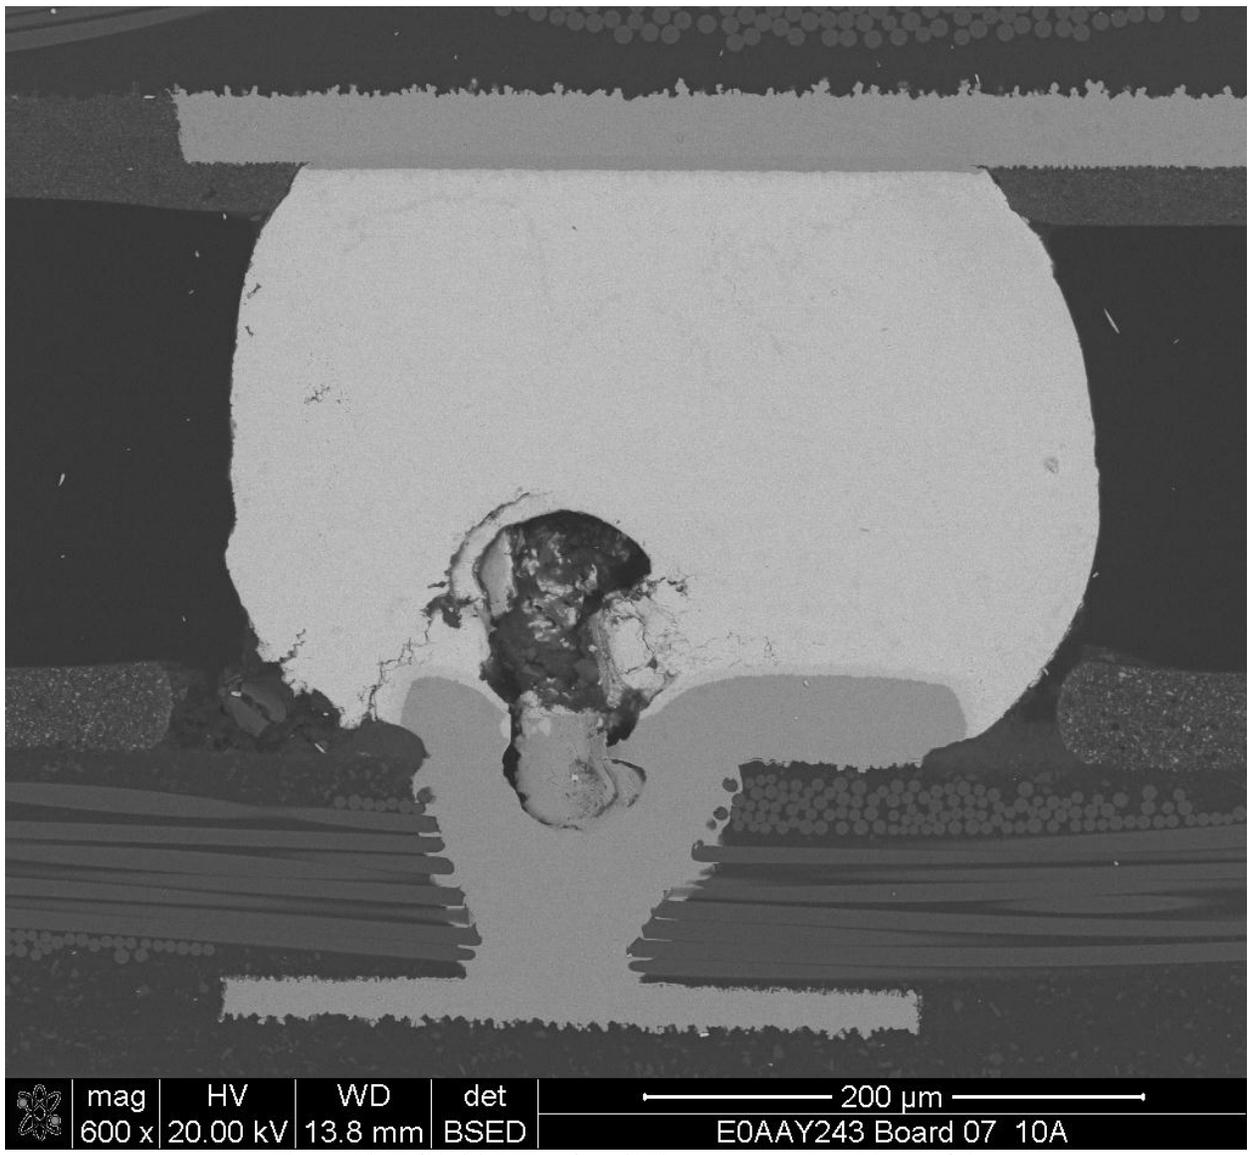
Figure 19: BGA 84, VIP, after 4279 thermal cycles. Did not fail

Figures 19 and 20 are representative cross-sections of the BGA 84 with and without microvia-in-pad respectively. Neither of these had failed after 4279 thermal cycles. Both of them have voids in the solder ball. In both cases, the crack paths are influenced by the void. In both cases the crack paths are near the board side, which is also near where the void is. Other cross-sections, not shown, without obvious voids in the cross-sections, show the beginnings of cracks on both the board side in one cross-section and on the component side in another cross-section. Another cross-section (not shown) that is in a solder ball without a microvia-in-pad, but has a similar size void, shows a fatigue crack from the center of the solder ball to the nearby void. This clearly shows that the solder void affects the crack path in this BGA solder ball. It does not however, conclusively show that the voiding would necessarily make the failure earlier.

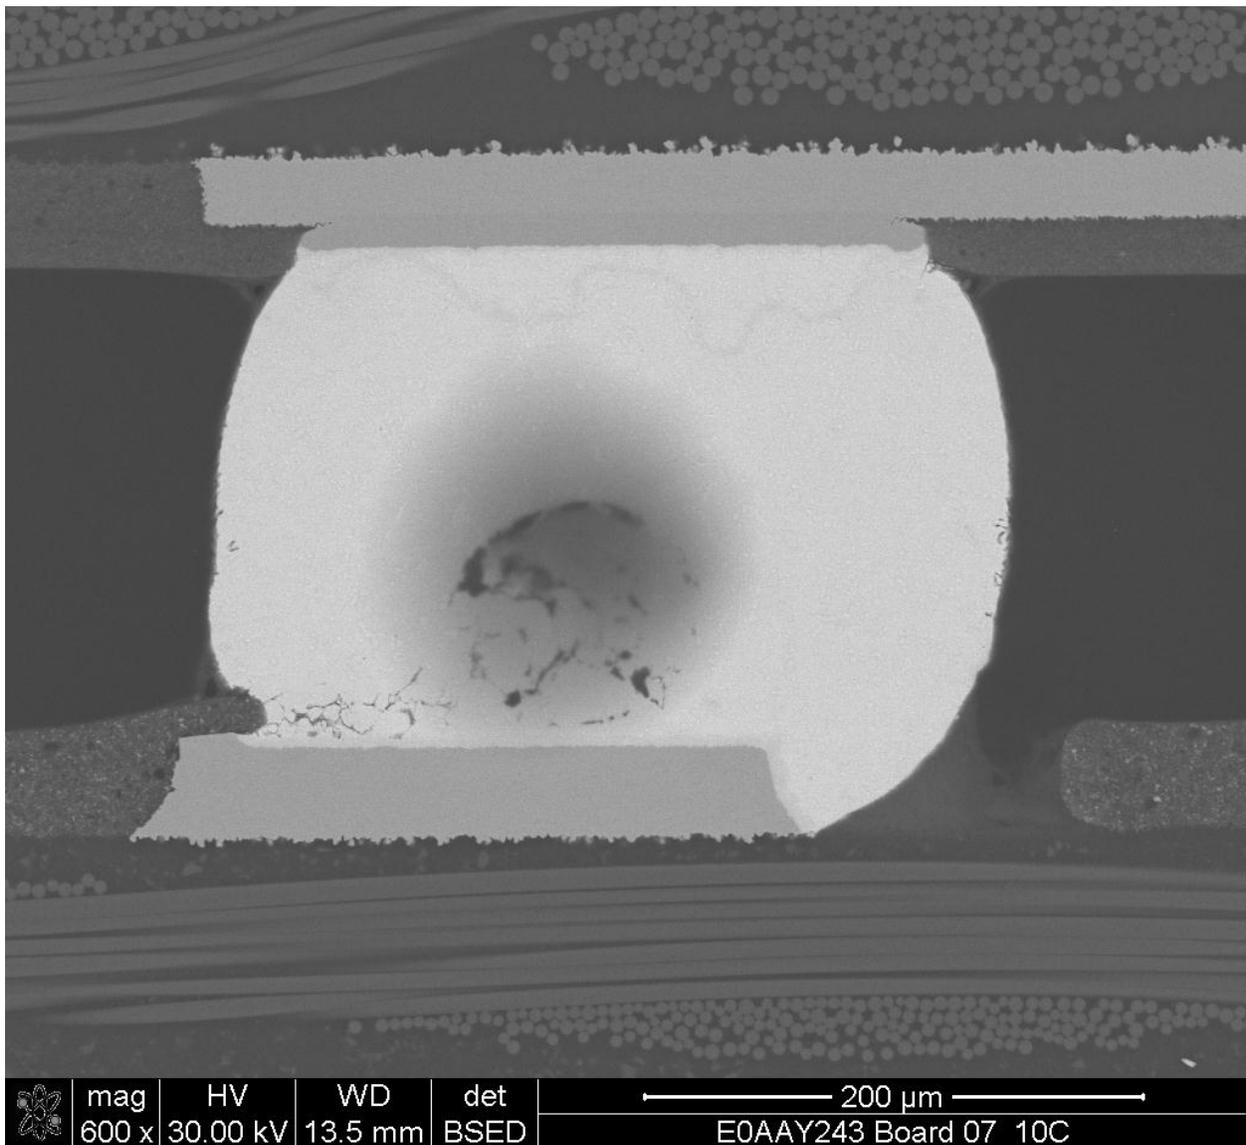
Figure 20: BGA 84, No VIP. After 4279 cycles. Did not fail.

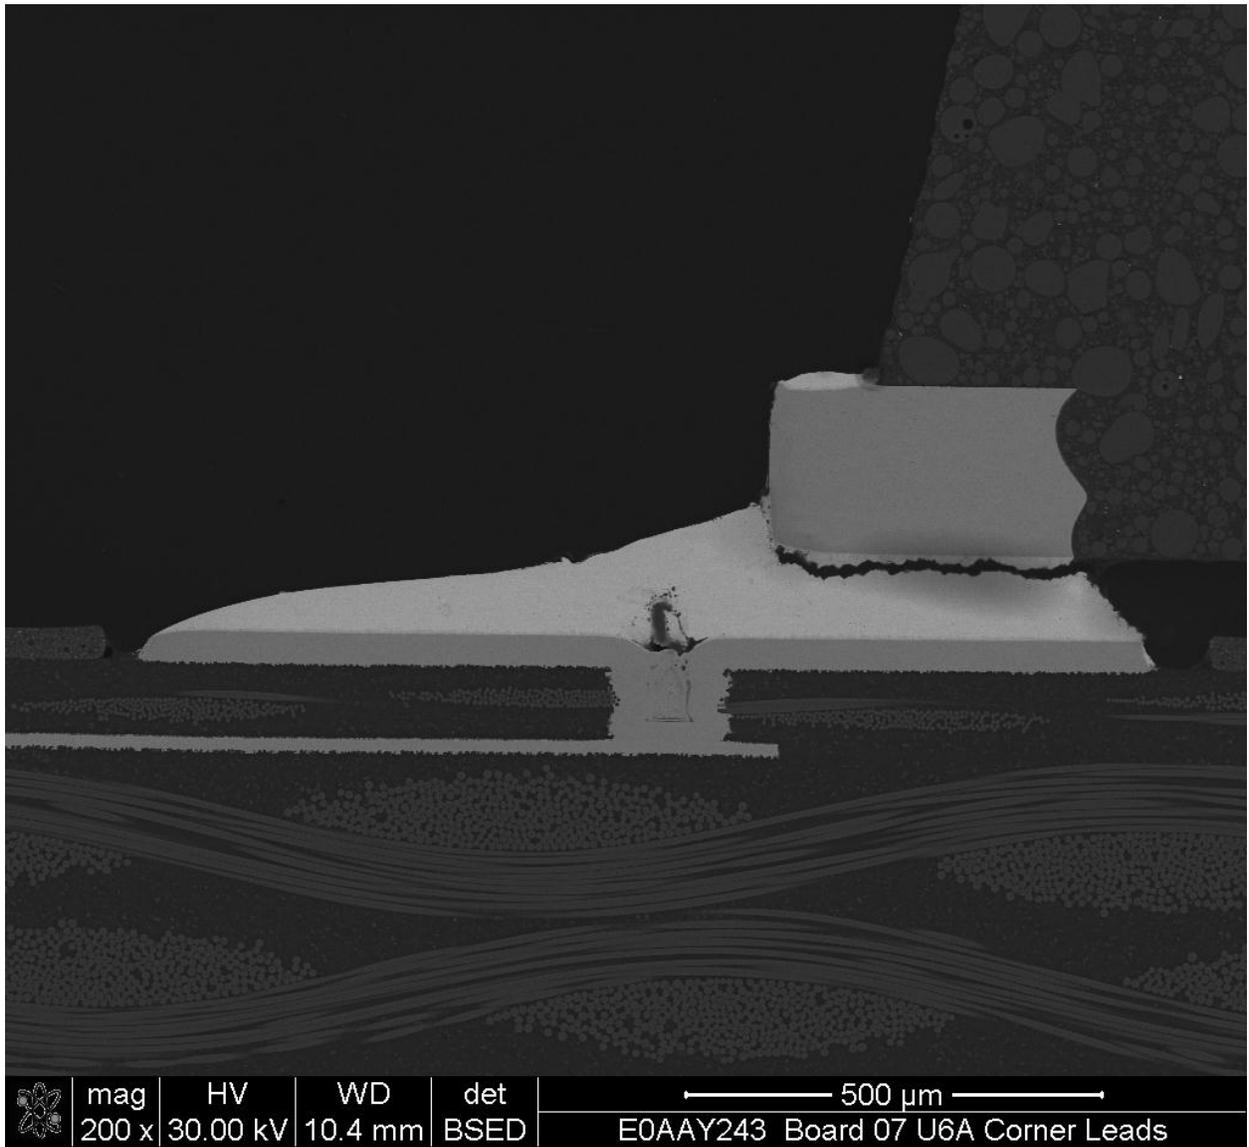
Figure 21: QFN72, VIP, after 4279 cycles, Failure Cycle 504

Figures 21 and 22 are representative cross-sections of the QFN 72 with and without microvia-in-pad respectively. There is nothing obvious in these cross-sections that the small void associated with the microvia-in-pad has anything to do with the crack path or failure cycle. In fact, as can be seen from the cross-section, the microvia location is actually external to the crack path, and beyond the edge of the component. This does not correspond to the Weibull data and is unexplainable at this time.
