The Effects of Non-filled Microvia in Pad on Pb-free Solder Joint Reliability of BGA and QFN Packages in Accelerated Thermal Cycling

Joe Smetana, Alcatel-Lucent, Plano, TX
Thilo Sack, Celestica, Toronto, Canada
David Love, Oracle, Santa Clara, CA
Chris Katzko, TTM (Meadville), China

IPC/APEX, April 2011, Las Vegas, NV

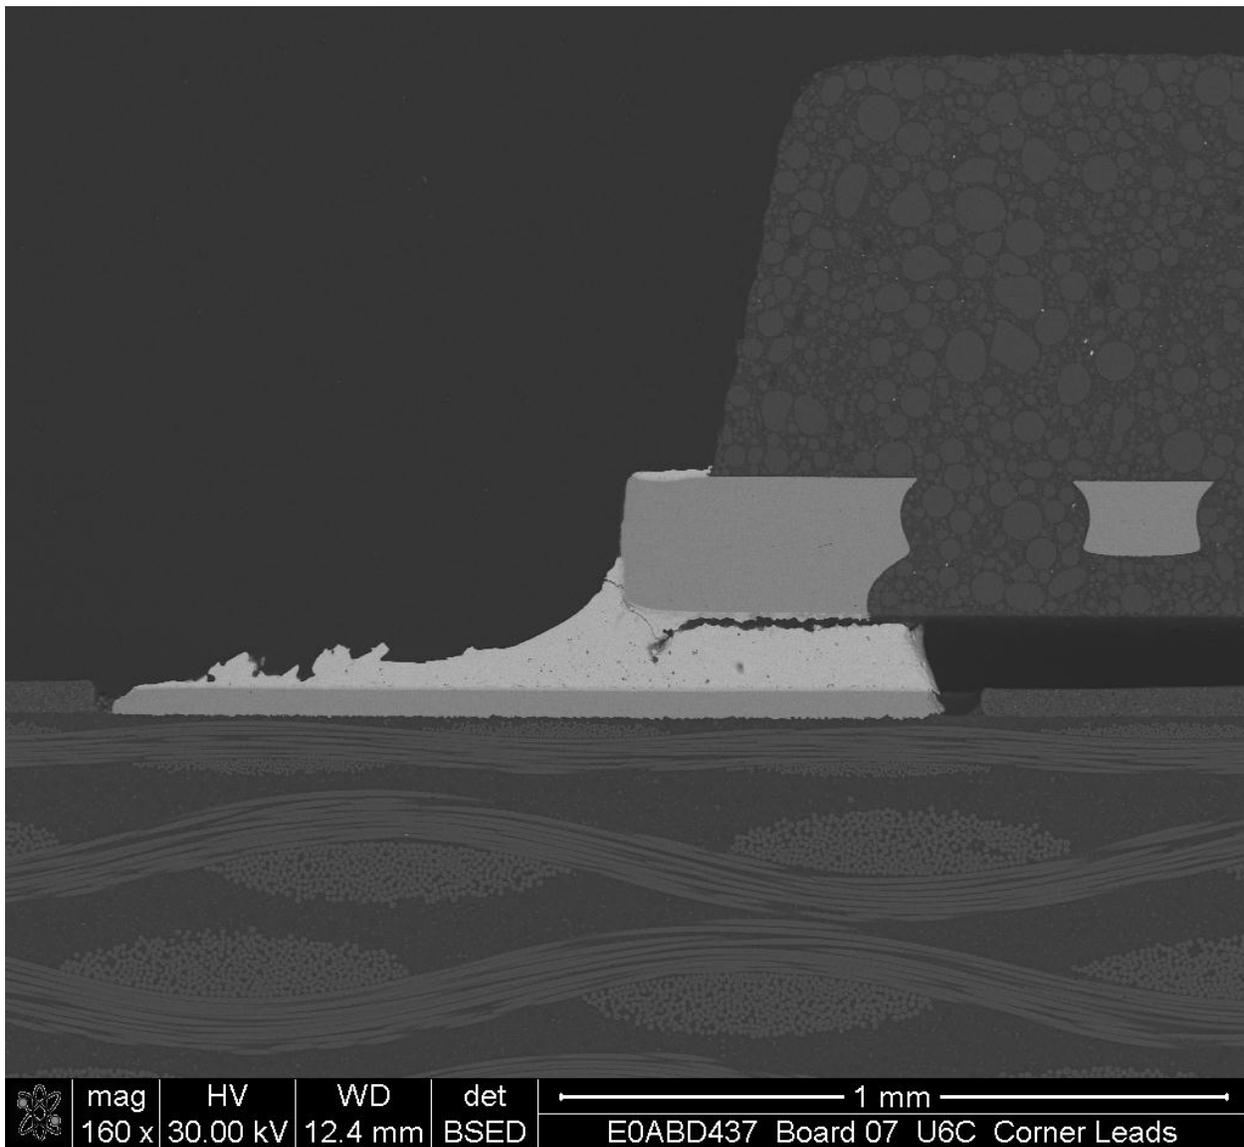
Figure 22: QFN72, No VIP, after 4279 cycles, Failure Cycle 982

Figures 21 and 22 are representative cross-sections of the QFN 72 with and without microvia-in-pad respectively. There is nothing obvious in these cross-sections that the small void associated with the microvia-in-pad has anything to do with the crack path or failure cycle. In fact, as can be seen from the cross-section, the microvia location is actually external to the crack path, and beyond the edge of the component. This does not correspond to the Weibull data and is unexplainable at this time.

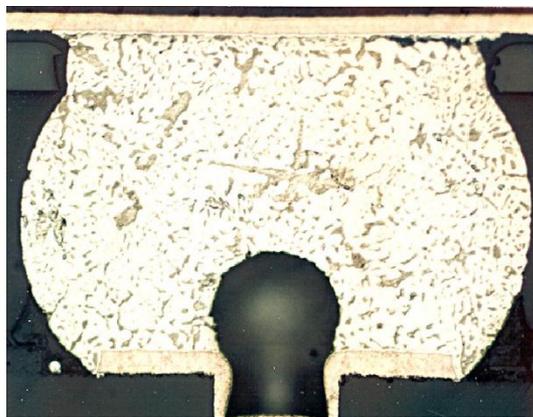
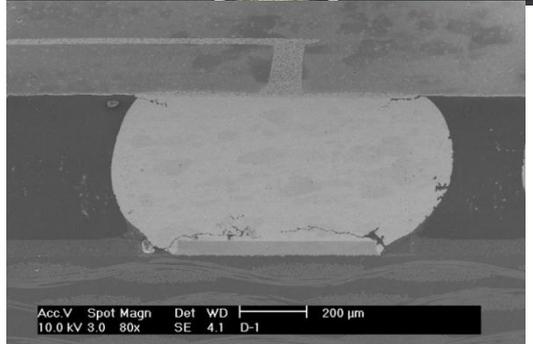
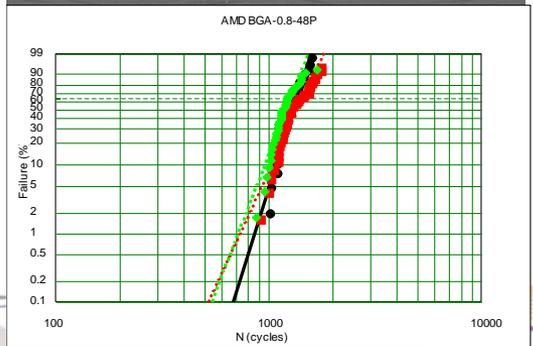
- With SnPb soldering – microvia in pad constructions (and associated small voids) have no impact on BGA thermal cycle reliability (lower left)
 - The failure location is virtually always on the package side of the component, away from the small void formed above the microvia (Top Left)
 - (This is not to say the voiding doesn't or can't affect SnPb solder joint reliability)
- With Pb-free SAC soldering, the failure location can be on either the component side or the board side of the solder ball (Bottom Left)
 - More likely with ceramic parts and waferscale parts.
 - The solder is stiffer than SnPb, and stresses are distributed differently in the solder joints.
 - Does the void associated with a microvia in pad negatively affect thermal cycle reliability?

ETA	Beta	r ²	n/s	ID #	Data Set
1355.1	9.9	0.9437	36/0	1	HP-RCC
1454.8	6.7	0.9070	42/2	2	IBM-SLC
1275.7	8.1	0.8873	38/2	3	IBM-FR4

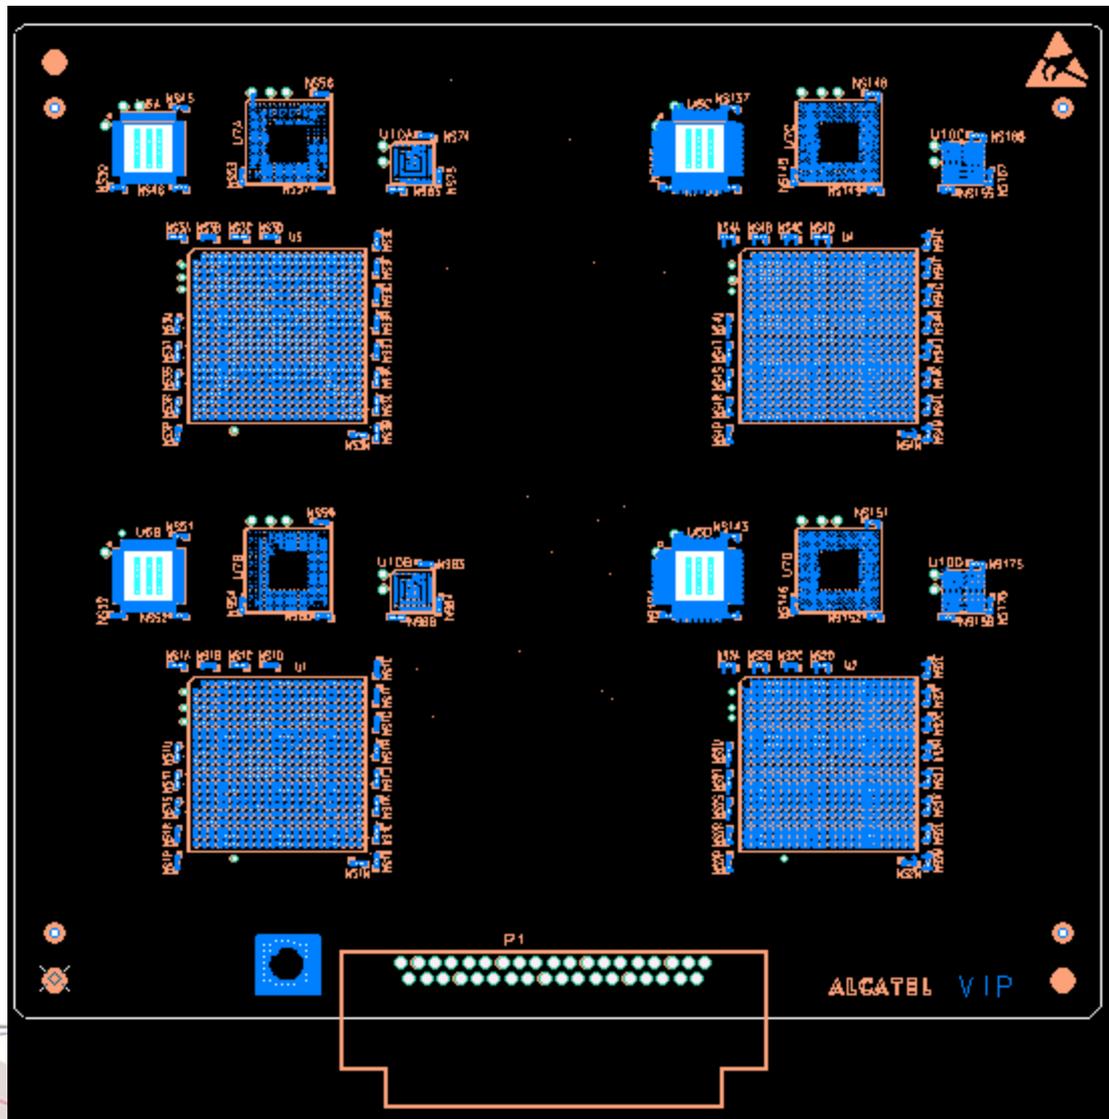
VIP Test Board

- 4 each of 4 component types per board
 - 2 sets on left – Via in Pad
 - 2 sets on right – No vias in pad
- Test Board Size: 6.5" x 7" x .125" thick
- Connector not populated – for wiring only
- Extra ground lug point added

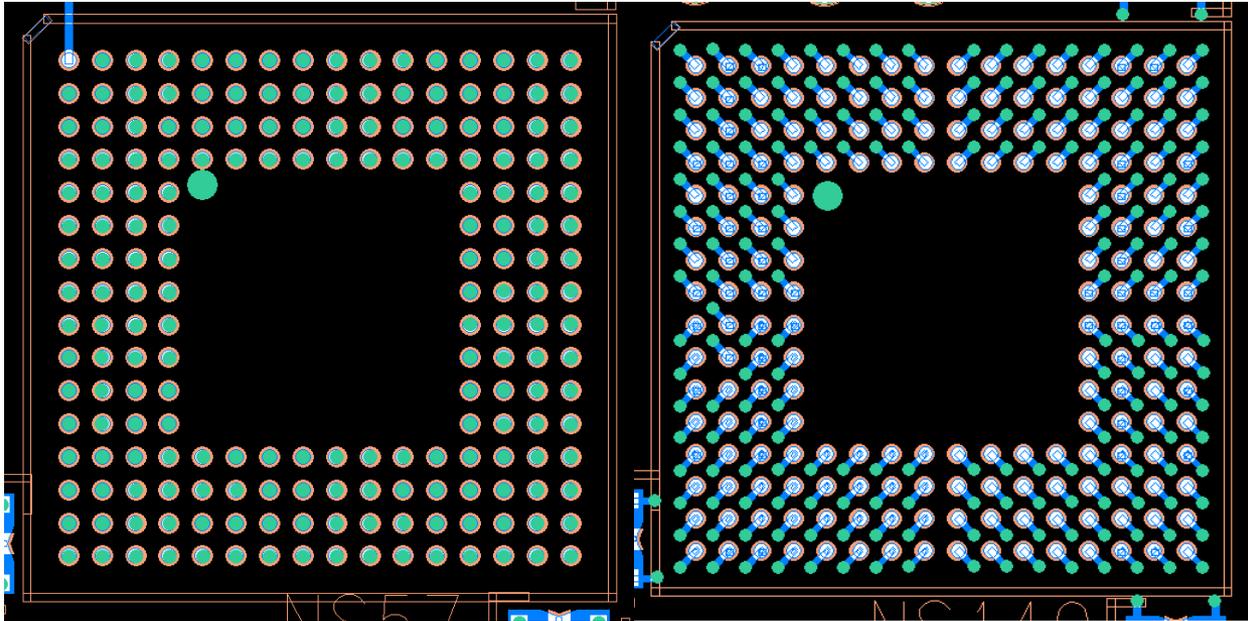
BGA192 – Left with Microvia in pad,
Right, with fan out, no microvia in pad

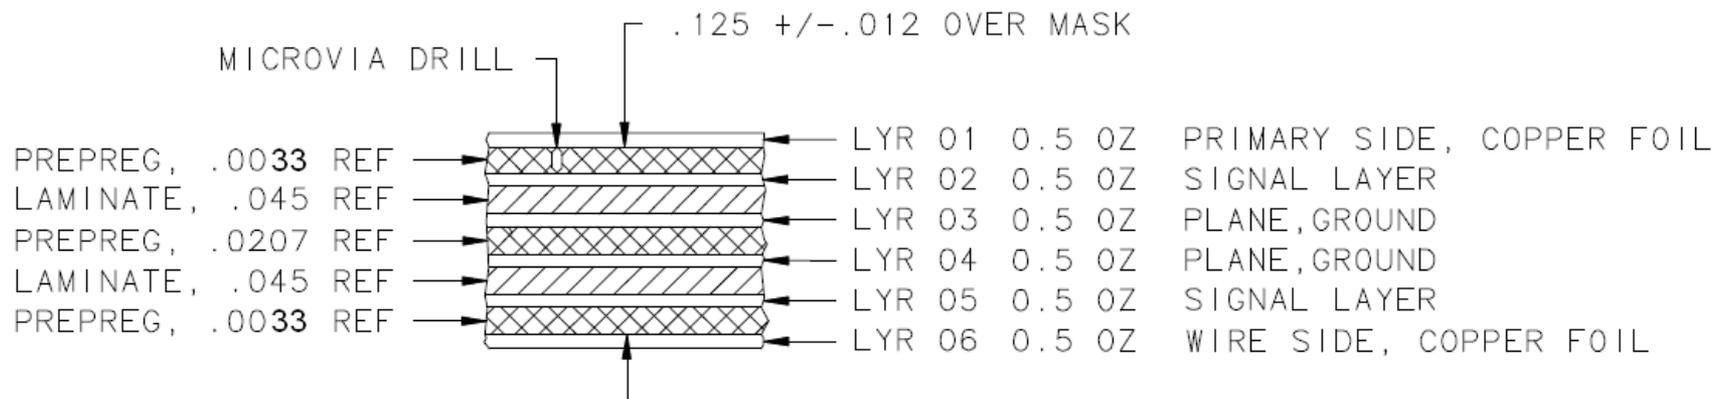
Test Board Stackup

- Most routing on Layer 2
- Layers 3 and 4 are planes
- Open areas on L2 and 5 are thieved
- L1-L2 (and L5-6) were built with 2113 glass style
 - To better represent the worst case thickness.
 - Nominal microvia laser drill size prior to plating was 6 mils

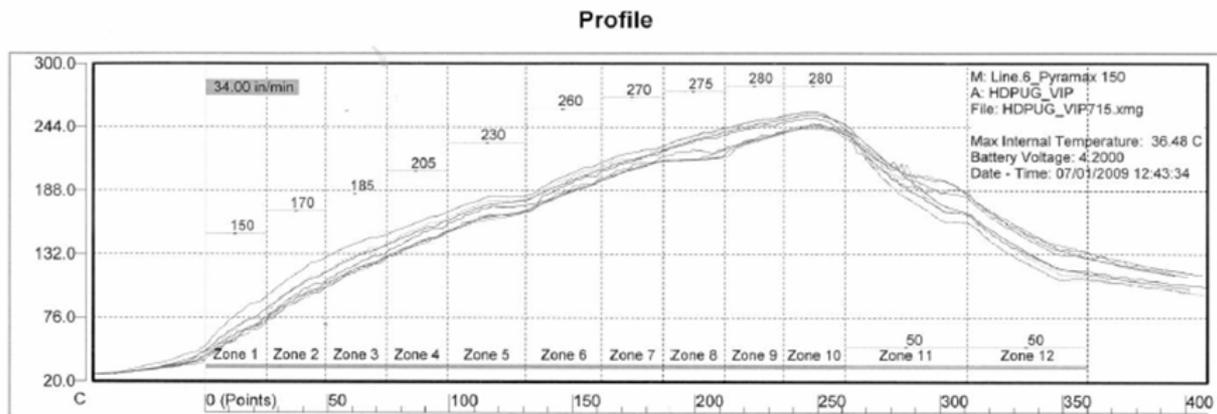
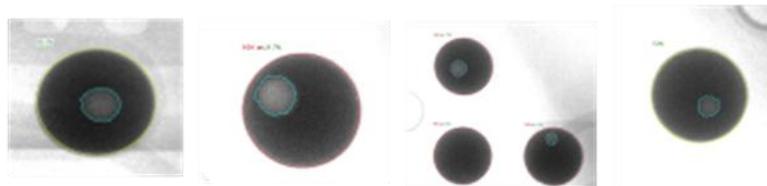
Standard SMT Reflow Profile

Some of the voiding attributable to voids in components as received.

In X-ray, 21 of 40 failed to meet the IPC-7095A Class 2 requirements for voiding in BGA solder balls (Reject class 2 if void size > 45% of ball diameter or 20% of ball area). Six of these rejects were with No VIP, 15 of these were with VIP

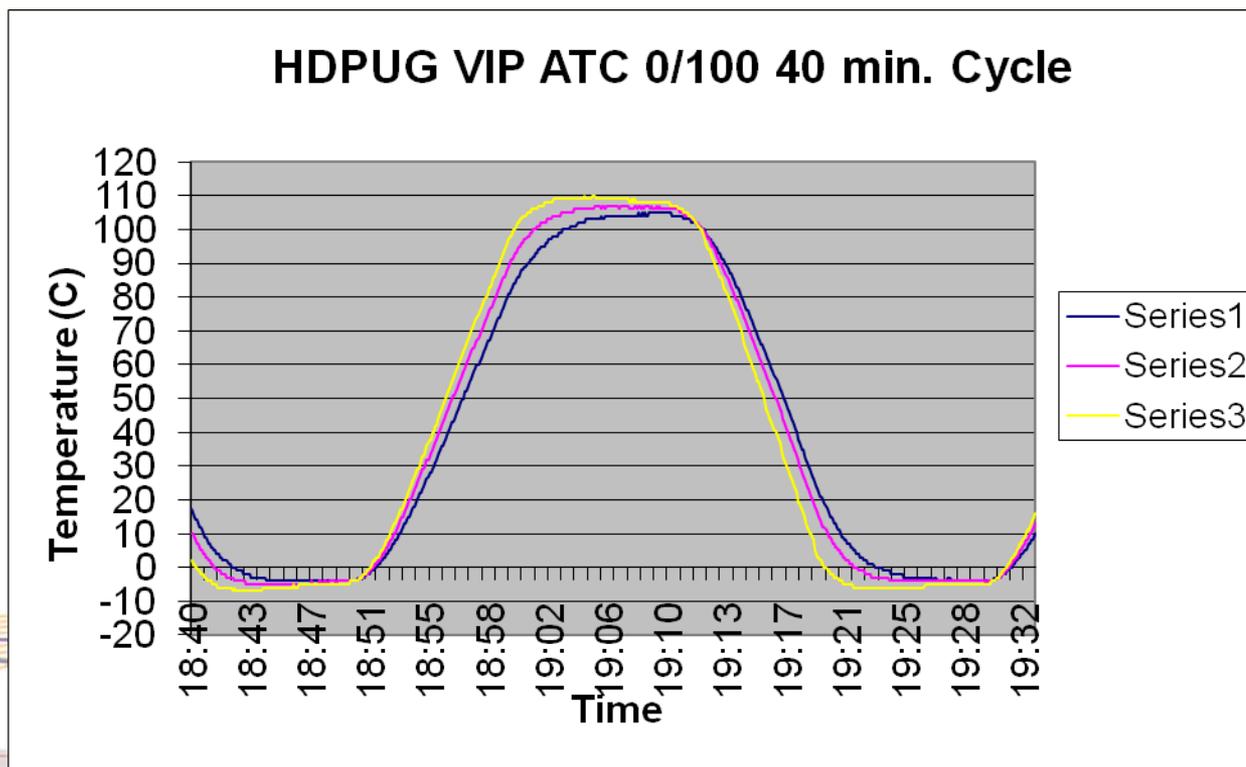
- 0 to +100°C at Freescale Semiconductor
 - Completed 4279 cycles

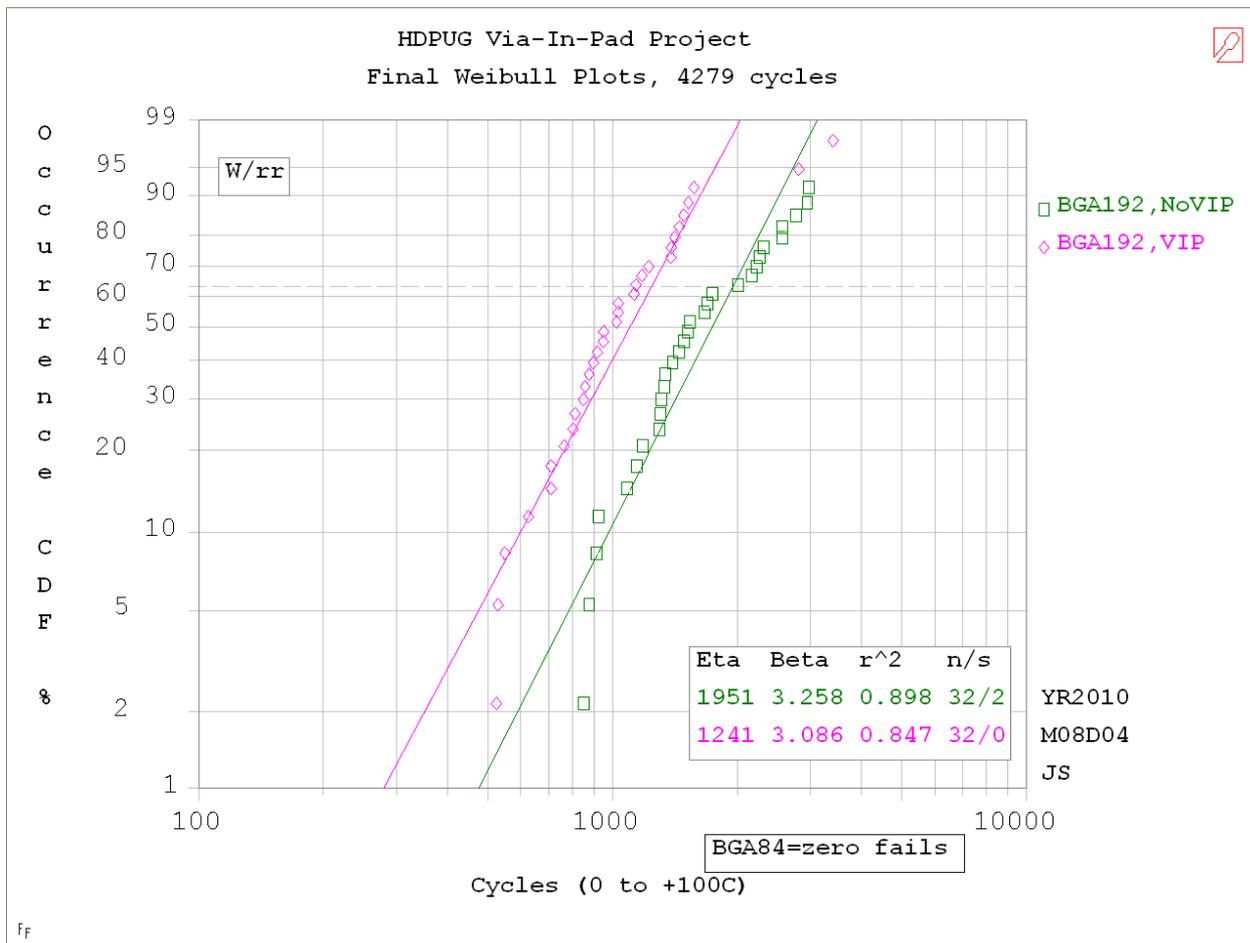
BGA192

The characteristic life of the no microvia-in-pad construction is 57% better than that of the same component with microvia in pad

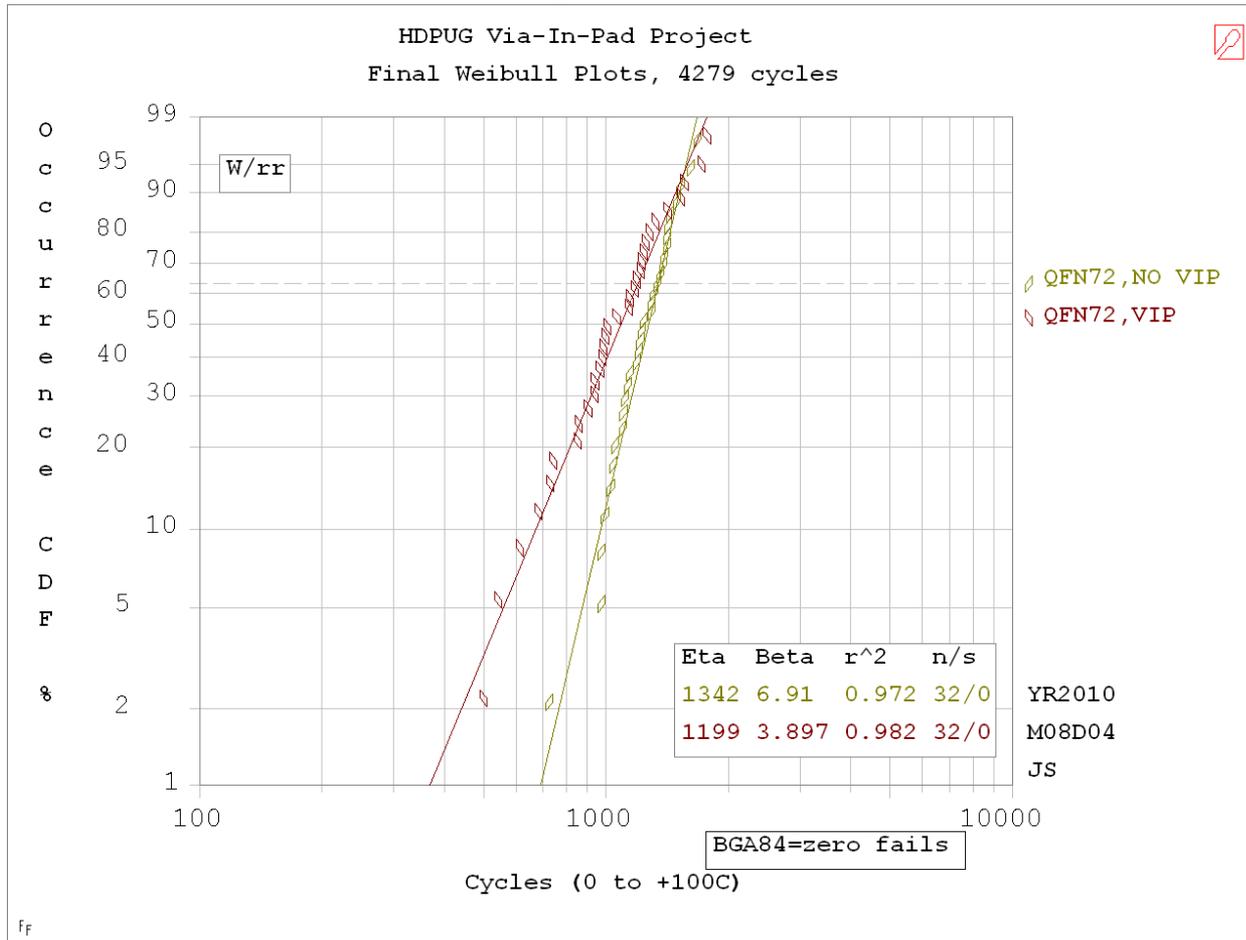
QFN72

Characteristic life of the no VIP construction is 12% > than VIP construction. Slope (beta) of the distributions is larger for the No VIP construction → time to first failure is significantly better also

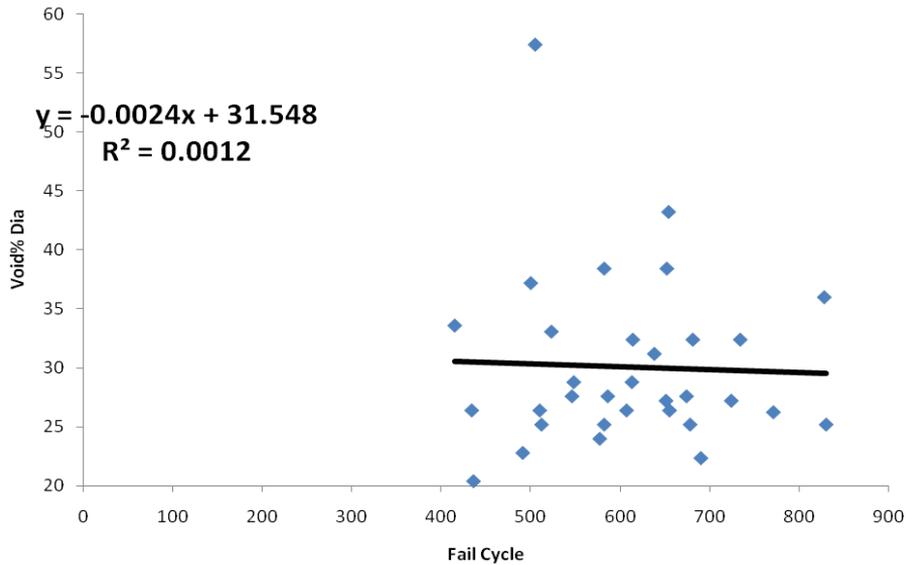
Scatter Chart (Fail Cycle vs Void% Dia, CBGA 483, VIP)

No Correlation

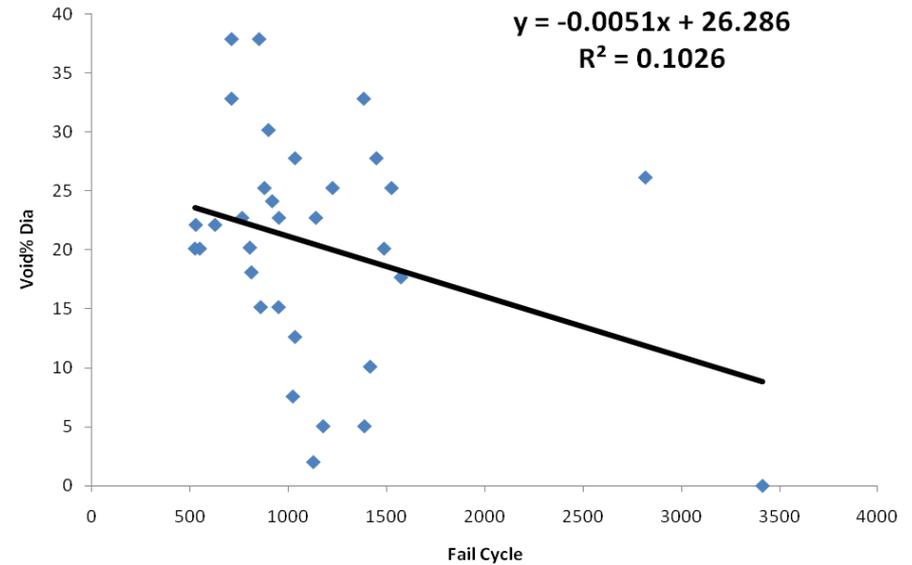
Scatter Chart (Fail Cycle vs Void% Dia, BGA192, VIP)

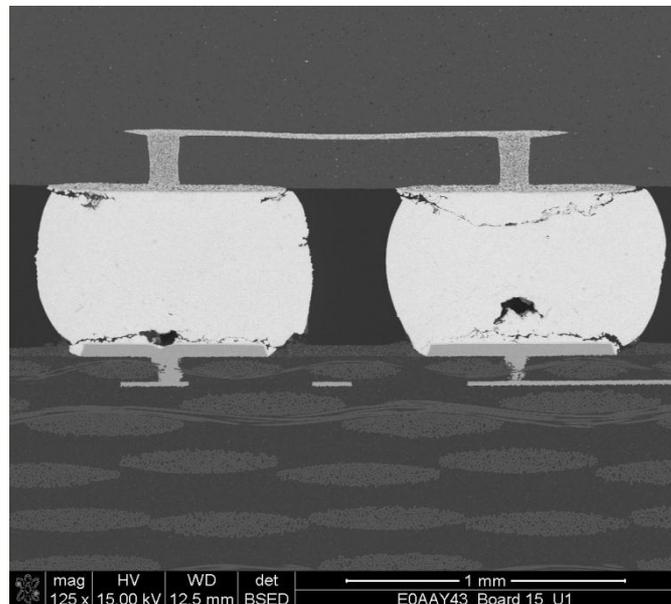
CBGA 483 VIP, after 4279 cycles.

Failure cycle 434.

- Failure locations could be board or component side.
- The influence of this void does not appear to have a major impact on the crack path.
- In agreement with the relatively small differences between the data sets as seen in the Weibull plots components earlier.

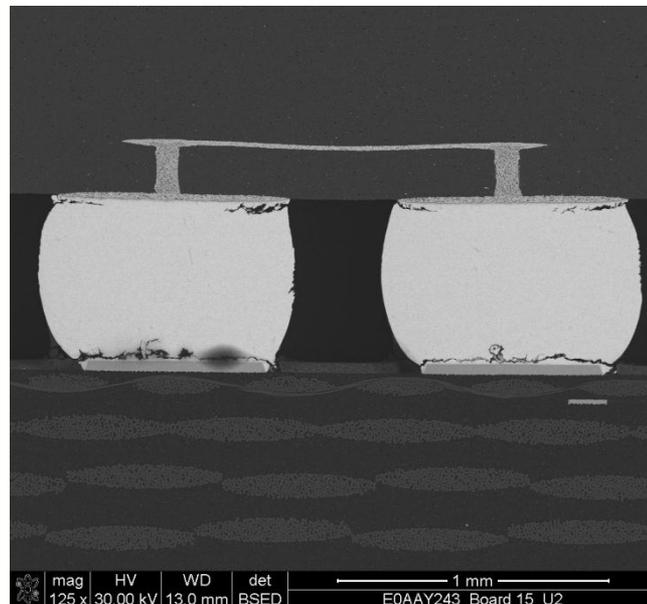
CBGA 483, No VIP, after 4279

thermal cycles. Failure cycle 334.

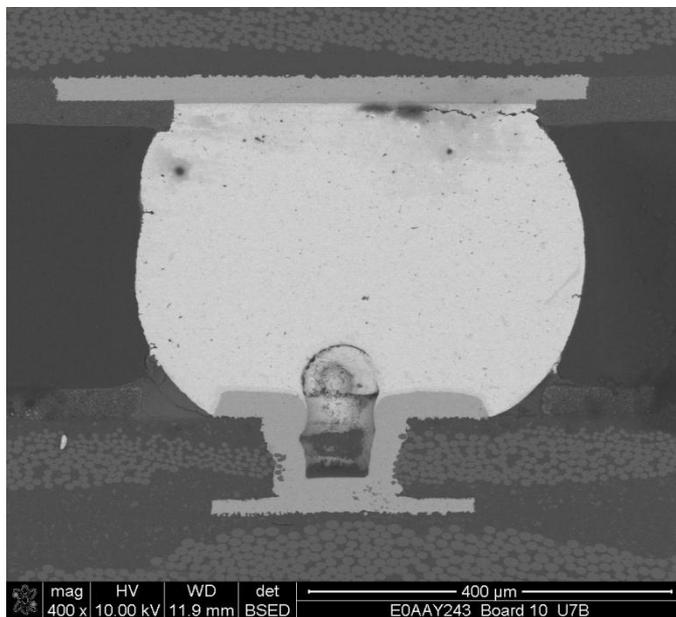
BGA192, VIP, after 4279 cycles.
Failure Cycle 529

Crack path VIP → component side away from the void
Crack path No VIP → on the board side (through the bulk solder)
If there had been a void here it would have influenced the crack path and likely reduced the life.
FA not conclusive, suggests VIP could negatively impact the life as seen in the Weibull plots

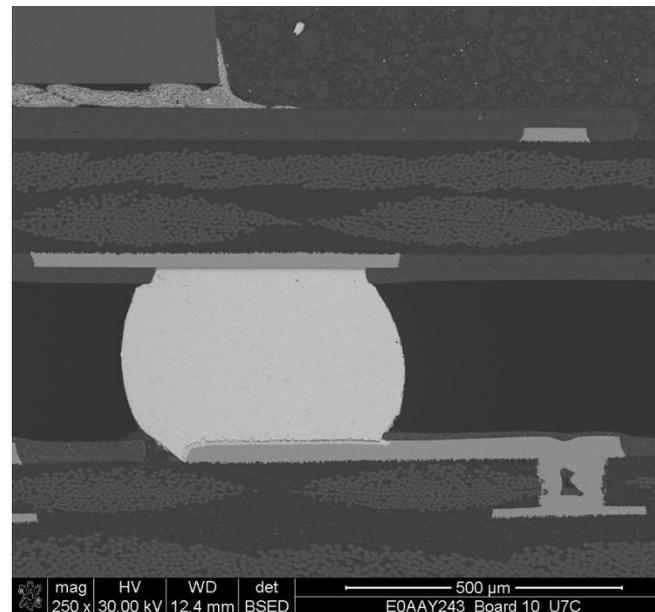
BGA 192, No VIP, after 4279
cycles. Failure Cycle 854

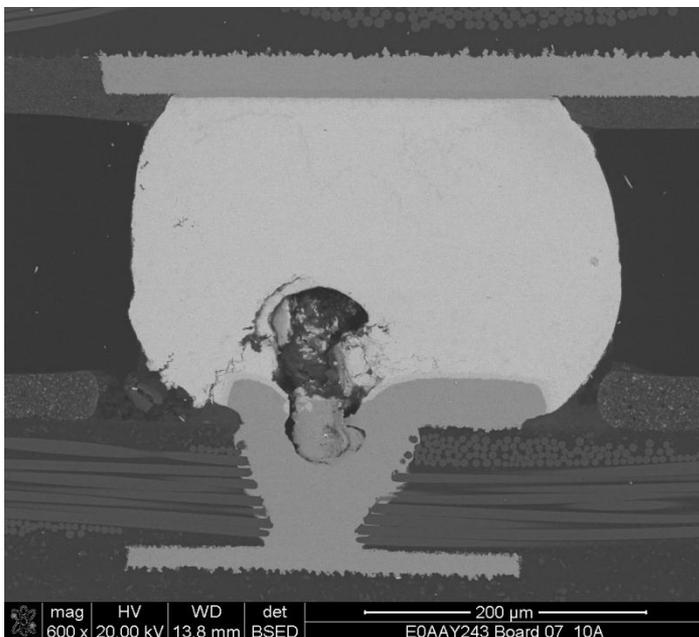
BGA 84, VIP, after 4279 thermal cycles. Did not fail

Both have voids → crack paths are influenced by the void.

Crack paths are near the board side, which is also near where the void is.

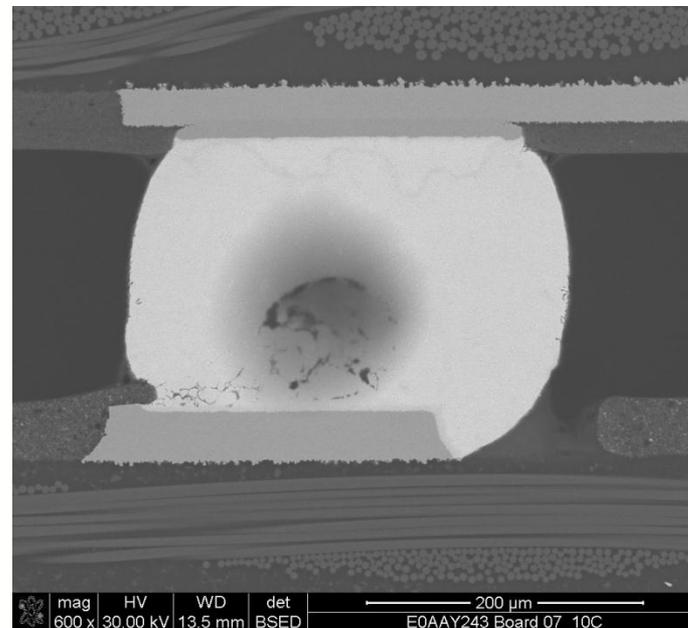
BGA 84, No VIP. After 4279 cycles. Did not fail

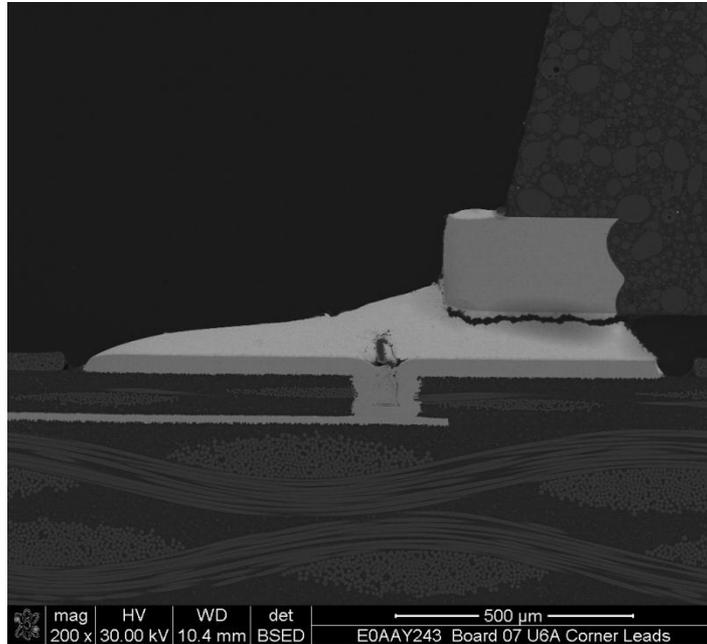
QFN72, VIP, after 4279
cycles, Failure Cycle 504

Nothing obvious that the small void associated with the VIP has anything to do with the crack path or failure cycle.

Microvia location is external to the crack path, and beyond the edge of the component.

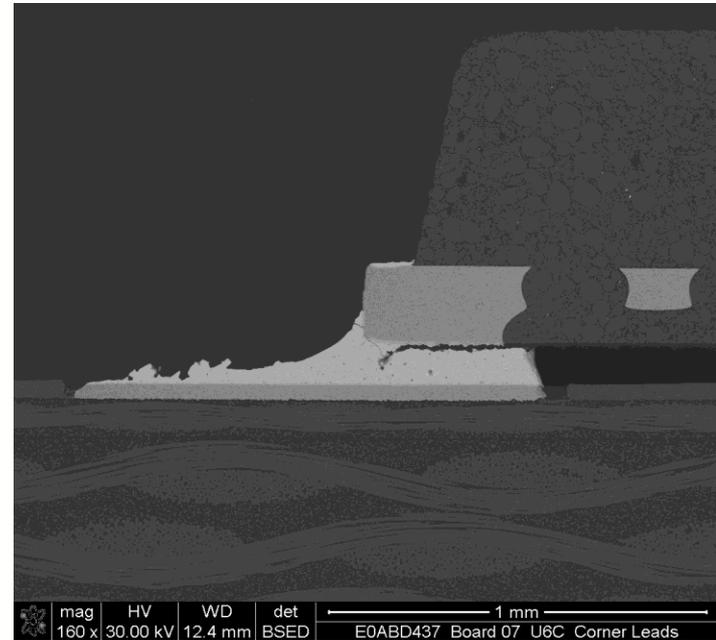
QFN72, No VIP, after 4279
cycles, Failure Cycle 982

Does not correspond to the Weibull data → unexplainable at this time.
