Thermal Cycling Reliability Screening of Multiple Pb-free Solder Ball Alloys

ABSTRACT

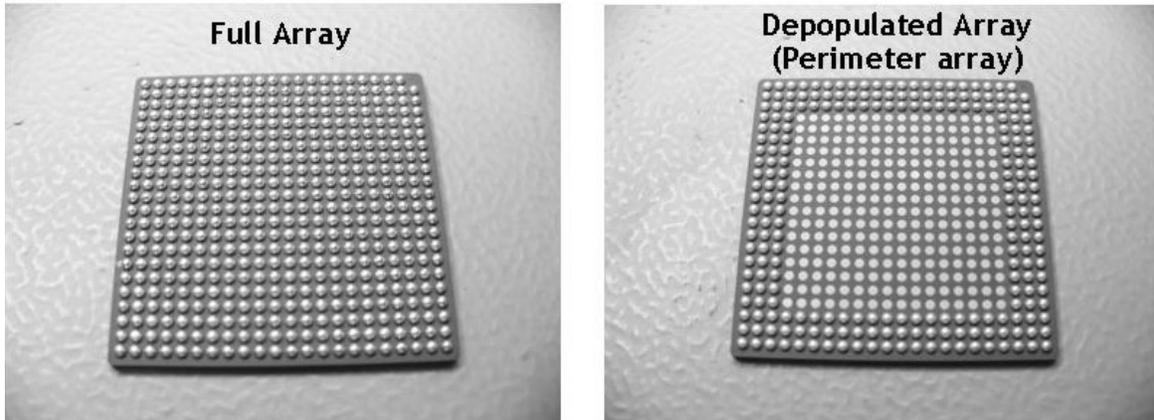
The component used for this testing is based on Freescale Semiconductor ceramic ball grid array (CBGA) daisy chain test component. The ceramic substrate measures 27 mm x 27 mm and is purchased as a land grid array (LGA). Balls are attached afterwards to create either a full or a perimeter array BGA. The full array has 483 I/O with one corner ball depopulated and the depopulated or perimeter array has only the outer 3 rows populated, with the center of the array left depopulated. Figure 1 shows a photograph of the full and depopulated component arrays in the “dead bug” position.

Figure 1. The CBGA component shown with fully populated array (left) and depopulated or perimeter array (right).

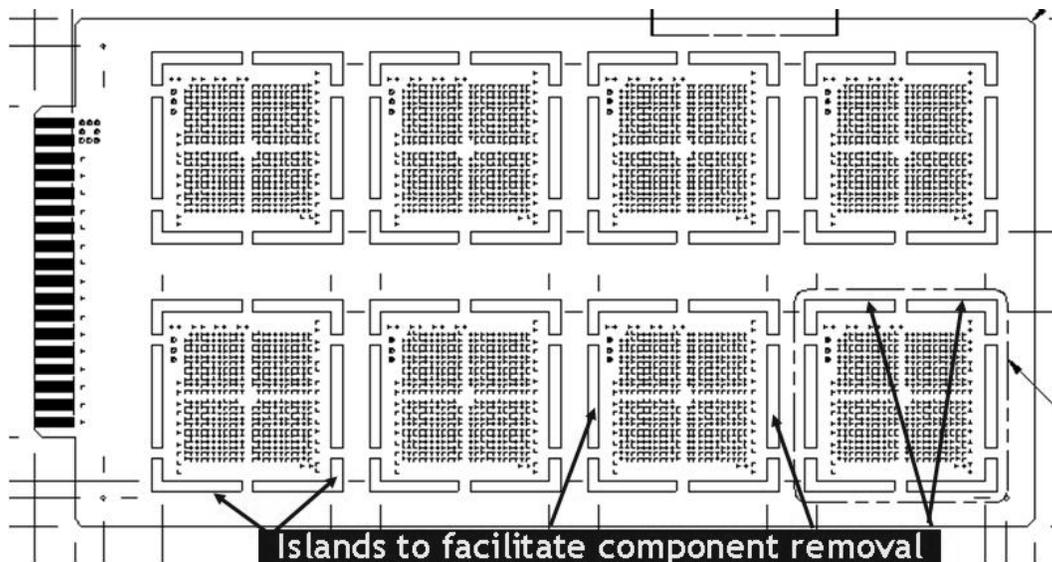
The schematic of the test board is shown in Figure 2. It is a 6 layer board with dimensions of 4.5 x 8.9 x 0.093 inches and has individual islands for each of the 8 component locations to facilitate component removal. The gold finger edge connector at one end of this board is specifically designed to mate with the event detector cable used for resistance monitoring during thermal cycle testing. The material used in PCB fabrication was Isola 370HR, a filled phenolic Pb-free compatible FR4. The board finish is immersion silver.

Figure 2. Schematic drawing of the 8-up daisy chained test board.

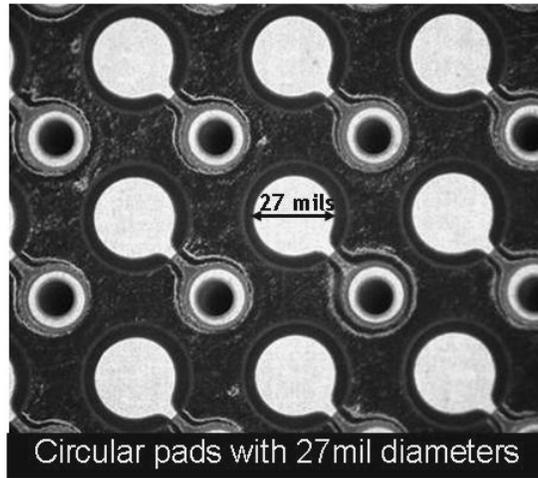
Figure 3. Typical circular CBGA assembly pad sites with 27 mil diameters.

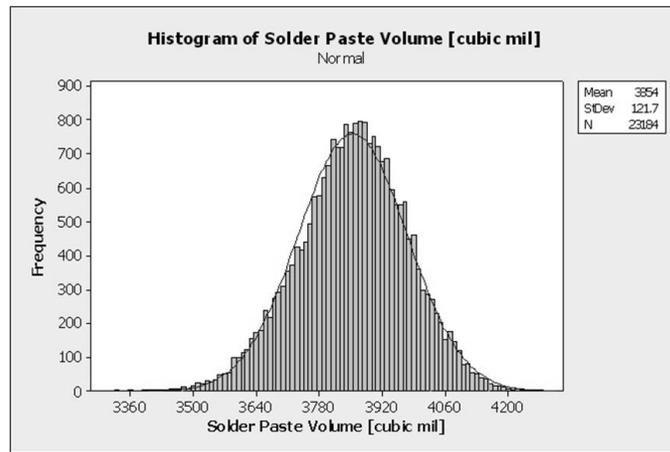
Figure 4. Histogram of measured solder paste volumes.

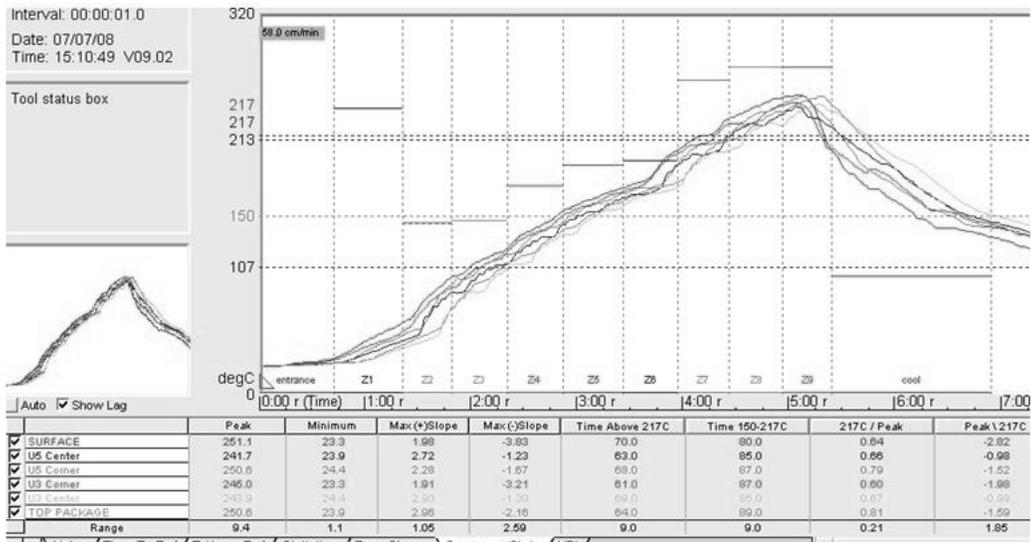
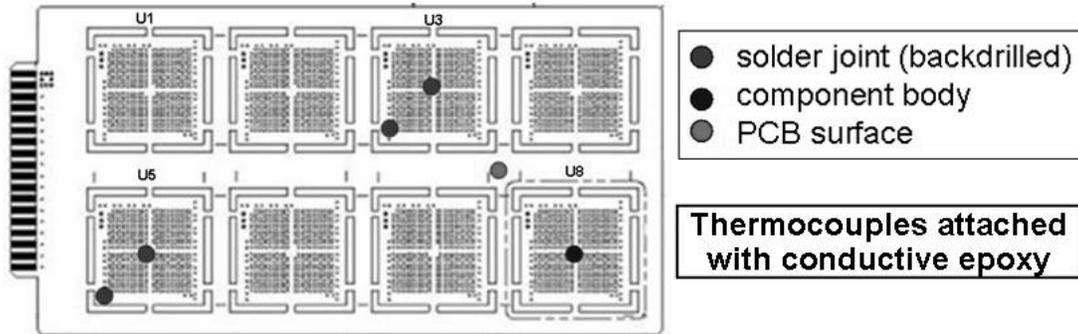
Figure 5. Pb free assembly reflow profile and thermocouple attachment locations.

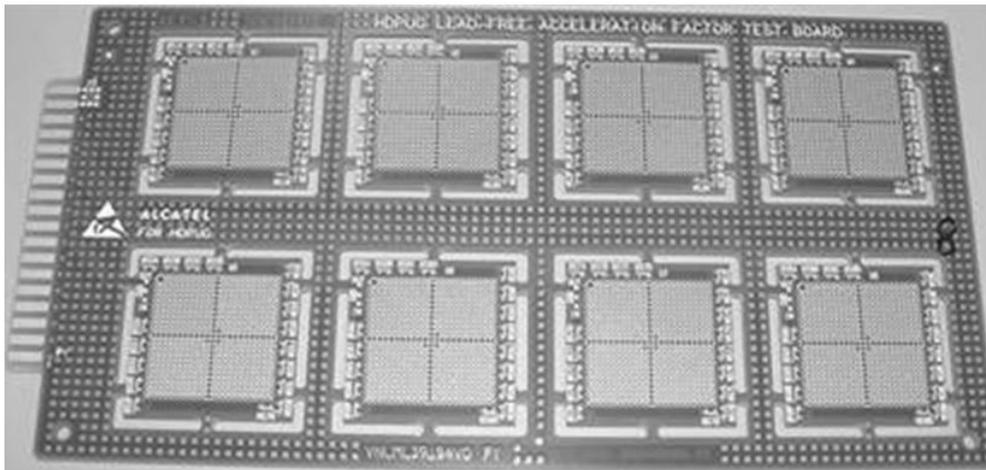
Figure 6. Photograph of finished PCB test vehicle assembly.

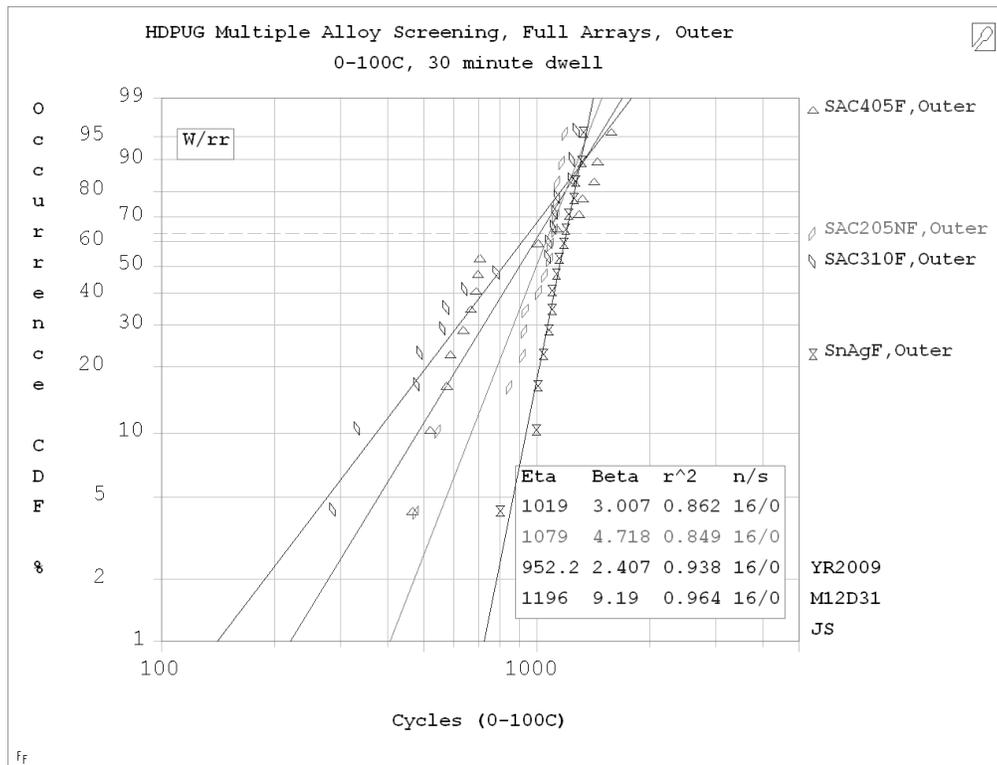
Extensive Weibull and regression analysis was completed on the failure data. Figures 7 and 8 show the Weibull plots for the full arrays and figures 9 and 10 show the Weibull plots for the depopulated arrays respectively. For clarity these have been separated into high silver alloys (2% or greater Ag) and lower silver alloys (less than 2% silver). The data also are summarized in Table 5. See the appendix for individual Weibull plots by specific alloy. These individual plots also separate early from late failures. Inner row failures on the full arrays were also monitored, but are not shown here as they are of limited value and are clearly affected by the outer row failures. For the full arrays, there is an anomaly in the data in roughly the 700-900 cycle range where there are very few failures on any of the alloys. There were no chamber events to explain this anomaly and extensive failure analysis, detailed later, was done in an attempt to understand this data. Two separate failure modes were identified. As a result the Weibull beta values for the full arrays are in general lower than what would normally be expected. For the depopulated arrays, this anomaly is not seen and the Weibull beta values were much more as expected. The depopulated components failed considerably faster than the full arrays. However, failure analysis showed that many of these failures were also not typical fatigue failures.

Figure 7. Weibull plot of the high silver alloy CBGA Full Arrays

Several anomalies in the experimental data were discussed in the previous section entitled **Weibull and Regression Analysis**. The data from the Weibull plots presented previously in Figures 7 and 8 are summarized again in a modified version of Table 5. The shaded areas indicate test cells selected for metallographic failure analysis. Viewing the data in tabular format facilitates anomaly recognition and the test cell comparisons. Anomalous behavior includes: 1) the performance of some alloys differs significantly between full and depopulated arrays, 2) many of the test cells are characterized by atypically low Weibull slopes ($\beta < 3.0$), and 3) some lower Ag alloys appear to outperform the higher Ag alloys. This third anomaly

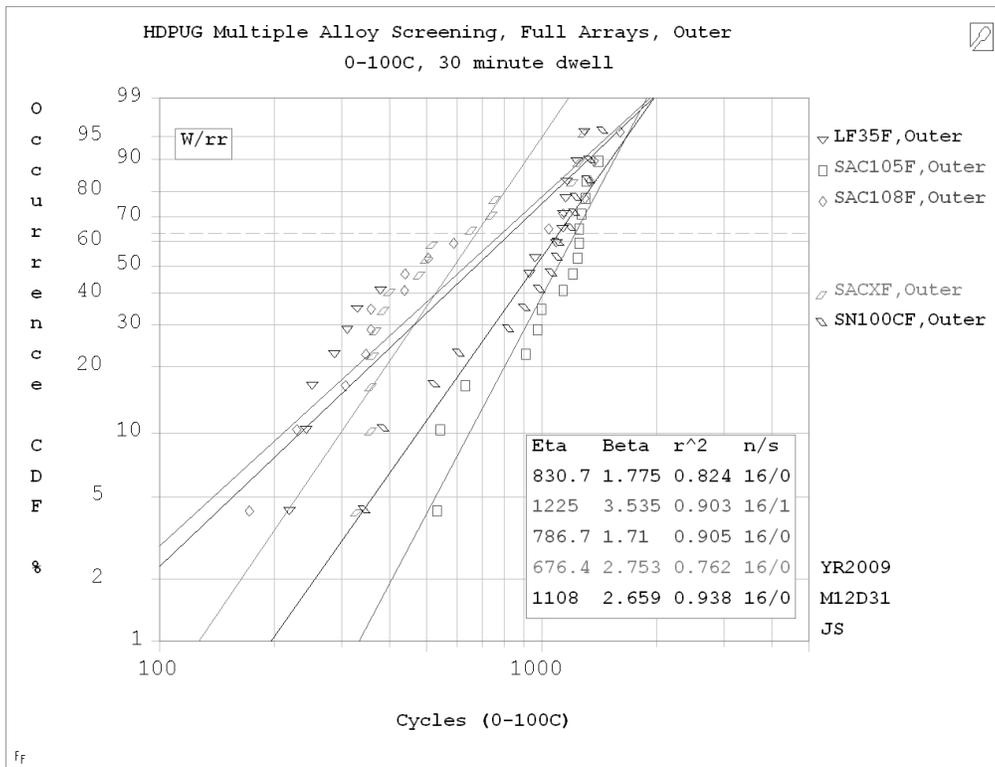
Figure 8. Weibull plot of the low silver alloy CBGA full arrays.

A close examination of the Weibull plots for these alloys (Figures 8 and 10) shows some early failures as well as indications of multiple failure modes within the distributions. These data sets also are characterized by inconsistent Weibull slopes (β), which is indicative of some deviation from a single mode of fatigue failure. Failure analysis was performed on samples of SAC105 and SAC105 in an attempt to resolve these anomalies.

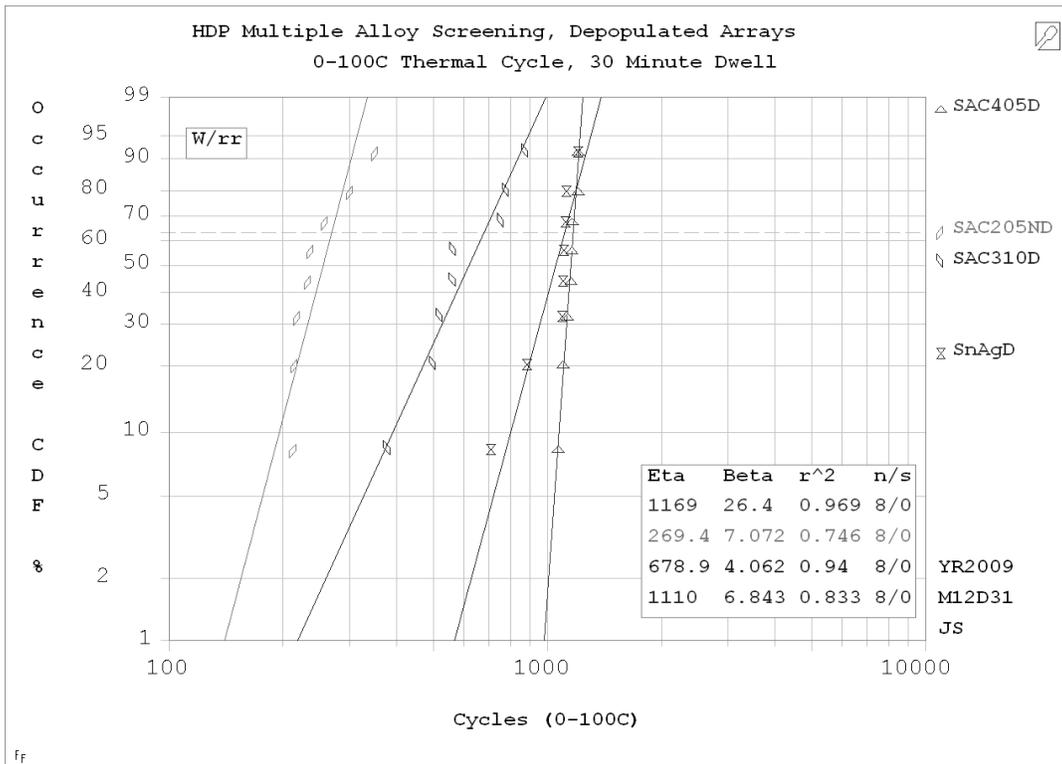
Figure 9. Weibull plot of the high silver alloy CBGA Depopulated Arrays

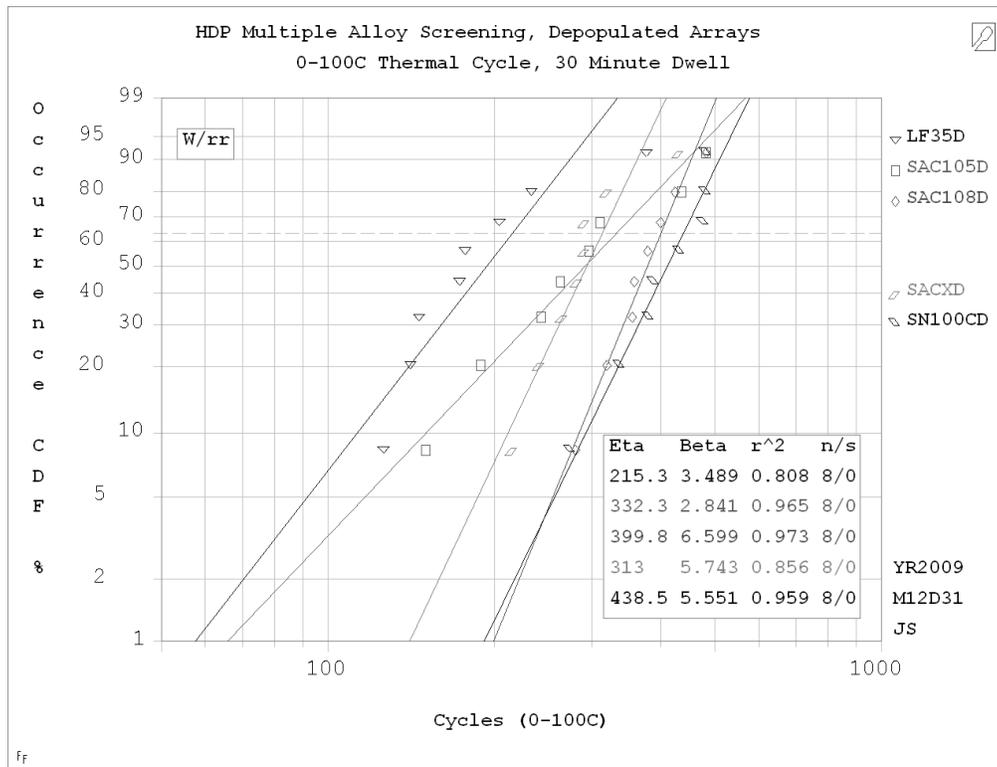
Figure 10. Weibull plot of the low silver alloy CBGA Depopulated Arrays.

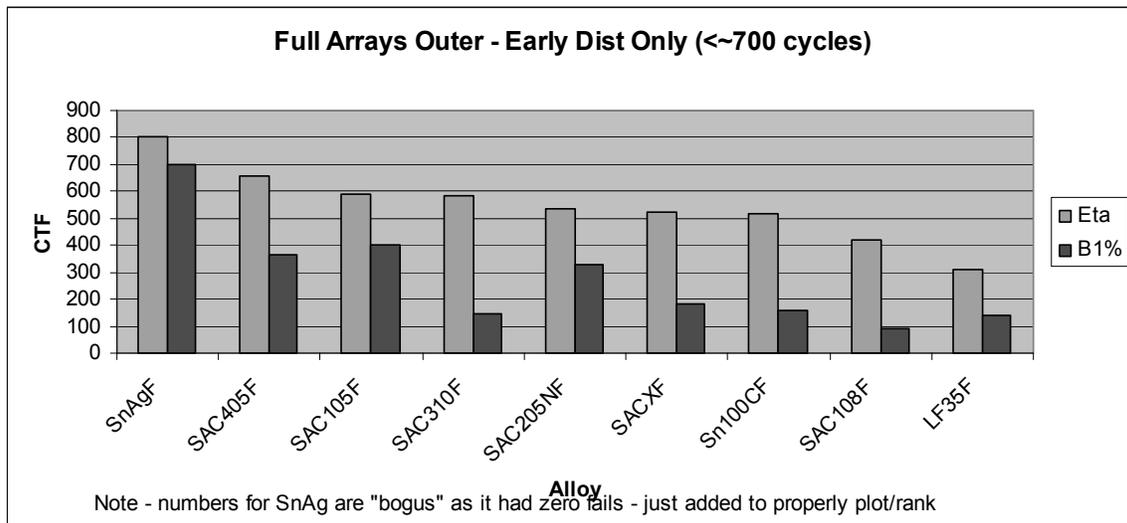
Figures 11 and 12 show the rankings of the full and depopulated arrays. For the full arrays, the ranking shown here is based only on the failures from the early group of failures. In all cases the blue bars represent eta (characteristic life) and the burgundy bars represent the 1% failure rate based on the Weibull data.

Figure 11: Ranking of the performance of the full arrays by alloy. This data includes only the failures before approximately 700 cycles.

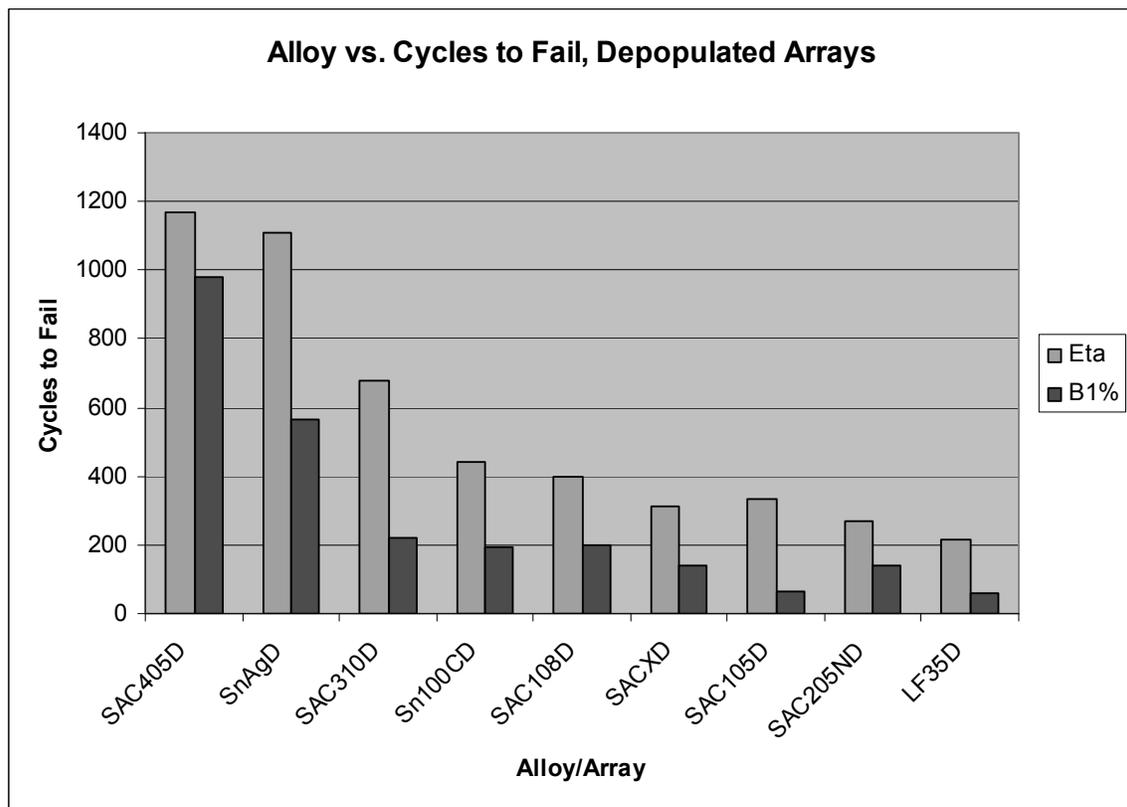
Figure 12. Ranking of the Weibull performance of the Depopulated Arrays

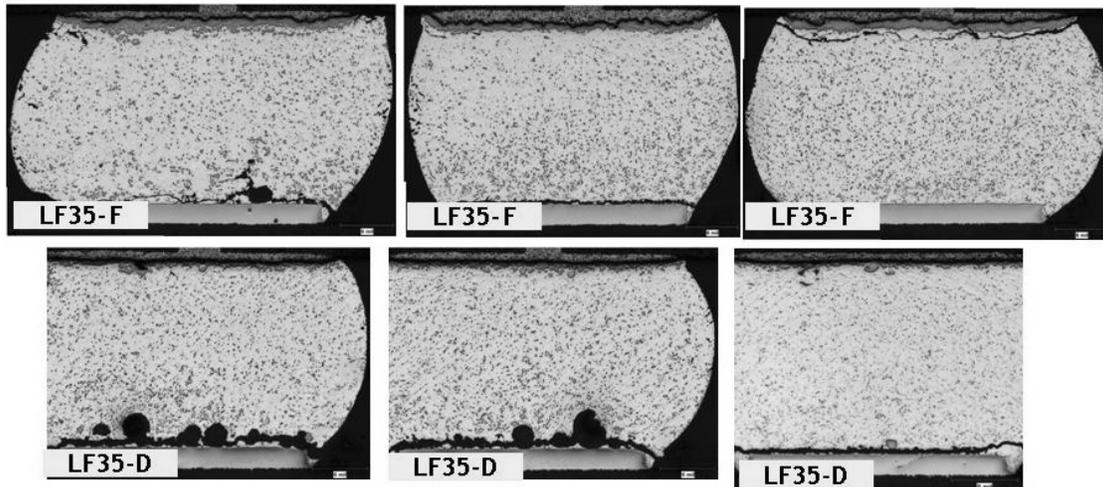
Figure 13 shows photomicrographs for failed samples of alloy LF35 for both full and depopulated array test vehicles. The LF35 alloy was analyzed because: 1) the LF35-F cell has an atypically low Weibull slope, with $\beta=1.8$, and 2) the LF35-D cell has an extremely low characteristic lifetime ($\eta=215$ cycles) as well as indications of several premature failures. These photomicrographs show that the fractures are not always the typical solder fatigue fractures at the package side of the solder joints. Some of the failures are mixed mode fractures consisting of solder fatigue, void-assisted fatigue and interfacial or near-interfacial fractures. Additional analyses that are too detailed to present here, reveal that the probable 1st fail sites occur at the PCB side, with minimal solder fatigue damage at the package side of those failed joints. The LF35 test results appear to be compromised by the mixed mode failures and multiple failure locations. This result is qualitatively consistent with the low Weibull slopes, particularly for the LF35-D ($\beta=1.8$) and might account for the low characteristic lifetime and early failures. There is however, no evidence that these mixed failure modes are a direct consequence of the LF35 alloy composition.

Figure 13. Photomicrographs for failed samples of alloy LF35 showing examples of solder fatigue, void-assisted solder fatigue and interfacial type fractures.

- The data for alloy LF35 is severely compromised by mixed mode failures. Void-assisted fatigue fracture located at the PCB side appears to be a major contributor to early failures in this test cell. Calculations of characteristic fatigue lifetime for LF35 are corrupted by the atypical failure modes.

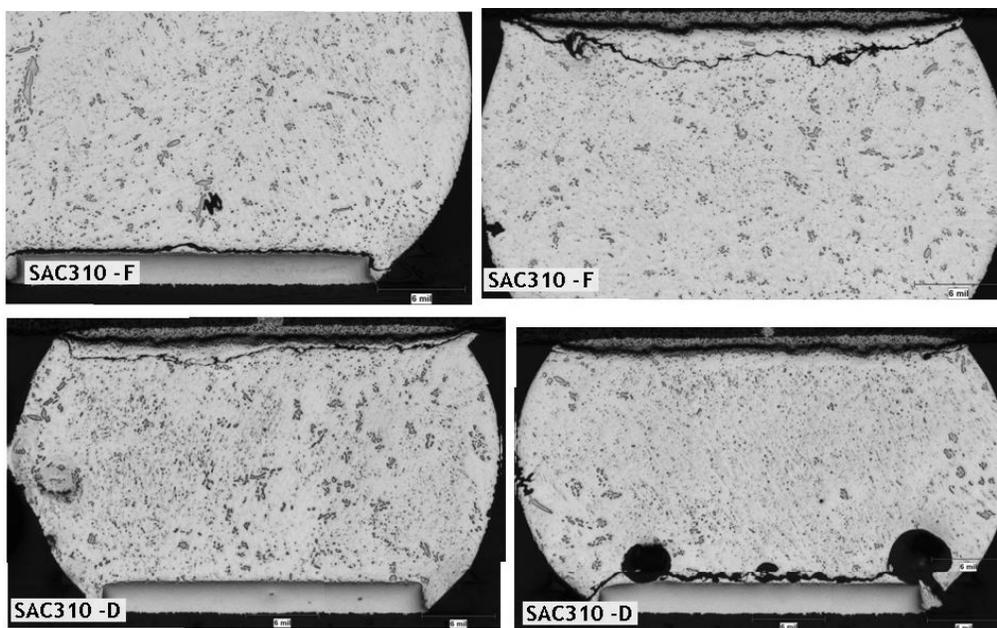
Figure 14 shows photomicrographs of failed SAC310 alloy samples in both full and depopulated arrays. SAC310 was selected for analysis primarily because the SAC310-D cell has a characteristic lifetime, $\eta=679$ cycles, that is lower than expected compared to the other high Ag alloys such as SAC405 and Sn3.5Ag. The SAC310-F test cell also has a relatively low Weibull slope, with $\beta=2.4$. The analysis of the SAC310 fractures shows PCB side mixed mode failures with void-assisted fatigue and near-interfacial fractures. Figure 15 shows two examples of interfacial or near-interfacial fractures in SAC310 at higher magnification. These photomicrographs illustrate that it is very difficult to determine if the fracture path is through the solder adjacent to the intermetallic layer (near-interfacial) or between the solder and the intermetallic layer (interfacial).

Examination of multiple solder joints showed that the voiding was relatively severe in the case of 310-D and is likely responsible for low observed characteristic lifetime. Even though these photomicrographs are limited to a single sample, the data indicate that there is a strong possibility that the characteristic lifetime and slope are compromised by the presence of multiple and mixed mode failures. Qualitatively, the observed deviation from the pure fatigue failure mode seems greater for 310-D than 310-F.

Figure 14. Photomicrographs for failed samples of alloy SAC310 showing examples of solder fatigue, void-assisted solder fatigue and interfacial type fractures.

- Mixed mode failures occur in SAC310, with the effect more pronounced in SAC310-D. The failure analysis indicates a strong possibility that both the characteristic lifetime and slope for SAC310-D are compromised by the presence of multiple and mixed mode failures. Mixed mode, early failures are likely responsible for the low slope in SAC310-F data and the low characteristic lifetime for SAC310-D.

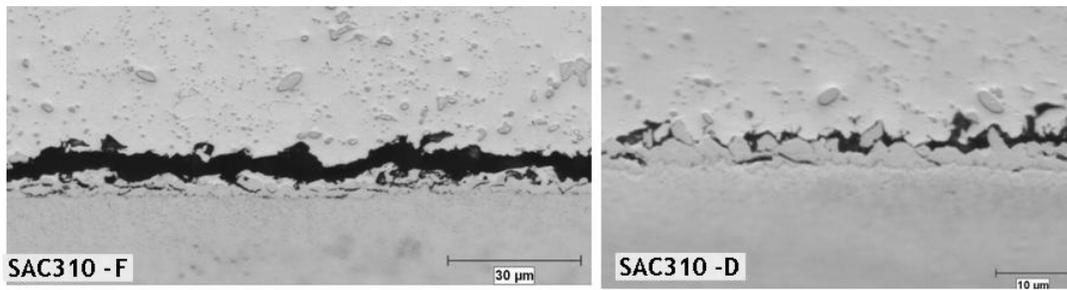
Figure 15. This figure shows higher magnification photomicrographs for interfacial or near-interfacial fractures in alloy SAC310.

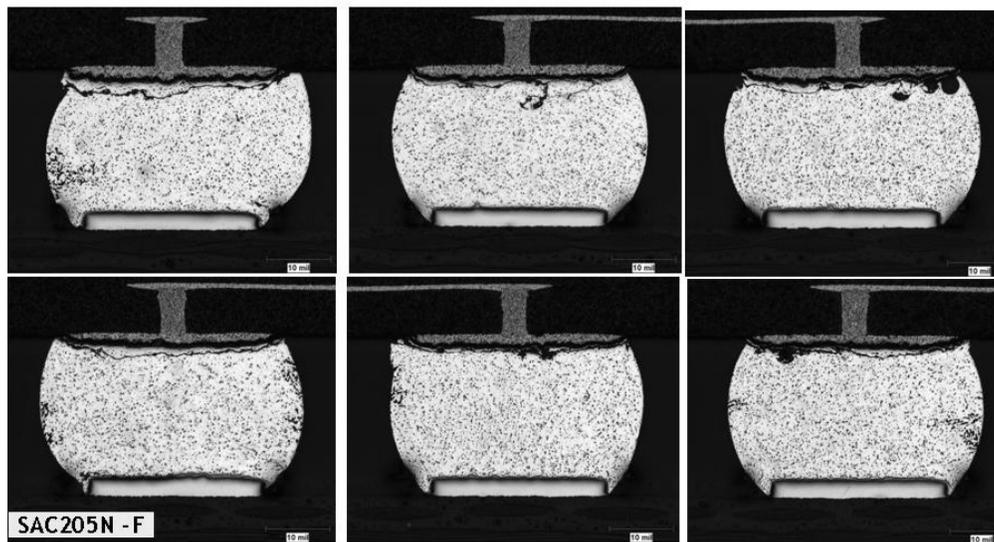
Figure 16 shows photomicrographs for six failed BGA sites for alloy SAC205N in the full array configuration. SAC205N was chosen for analysis because of a relatively high characteristic lifetime ($\eta=1079$ cycles), and good β (4.7), which is indicative of a single failure mode such as solder fatigue. The SAC205N analysis shows that all the fractures in the outer rows of this particular component were due to solder fatigue at the package side. The Weibull plot for SAC205N (Figure 18) shows only two early, lower-cycle data points in the failure distribution (between 500 and 600 cycles), with the remainder of the failures above 900 cycles. These observations tend to support the conclusion that the SAC205N failure distribution is dominated by solder fatigue, with the possibility of a few early, mixed mode failures.

Figure 16. Photomicrographs for failed samples of alloy SAC205N showing only solder fatigue fractures.

- The analyses of the SAC205N and SAC405 samples show only fatigue cracking at the package side of the solder joints. The samples chosen for analysis failed at relatively high cycle counts in testing, which is consistent with fatigue failure. However, it must be noted that the Weibull plots for both of these alloys contain early failure data points or evidence of bimodal distributions, which is symptomatic of non-fatigue failures. The presence of mixed mode failures, particularly in SAC405-F could account for the low β in that test cell.

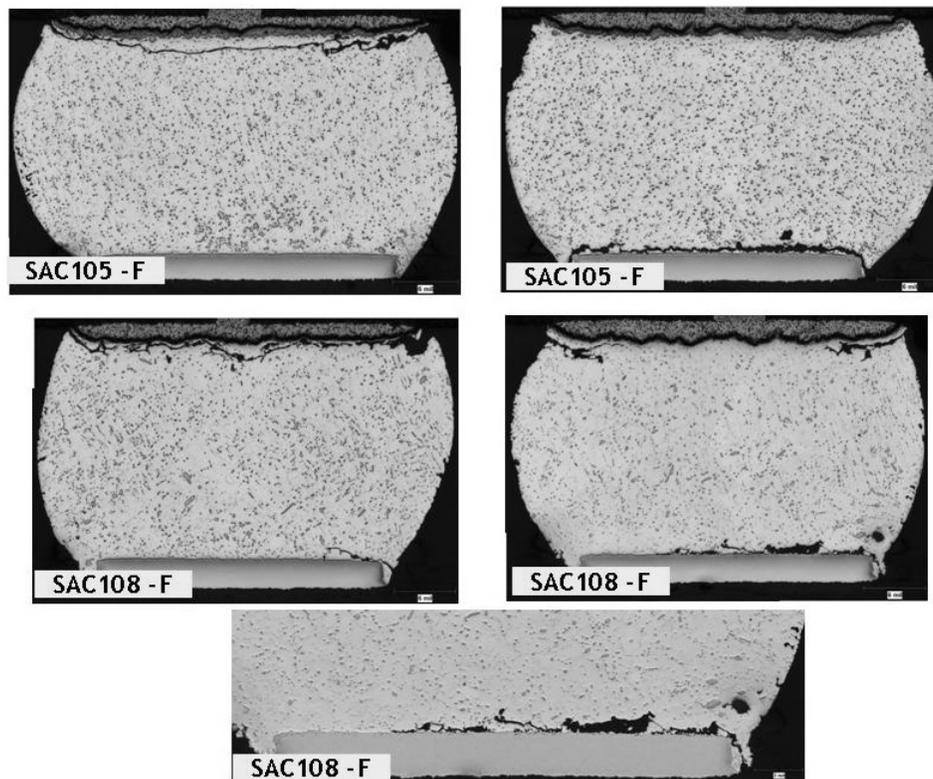
The series of photomicrographs in Figures 17-19 show clear evidence of the type of mixed mode solder joint fractures detected in the SAC310 and LF35 alloys. In general, the depopulated array samples seemed to have a greater tendency for anomalous failures than the full arrays, which is consistent with the results for the other alloys. This physical data, combined with the anomalies that exist in the Weibull plots, provide compelling evidence that the test data for SAC105 and 108 are compromised to a certain extent by non-fatigue type failure modes.

Figure 17. Photomicrographs showing both package and PCB side failures in SAC105 and SAC108 full array samples.

- The test results for SAC105 and 108 are compromised to a certain extent by non-fatigue type failure modes. The physical analysis and the anomalies in the Weibull plots, indicate that the apparent statistical distinction between the two alloys is an artifact introduced by atypical, non-fatigue failures.

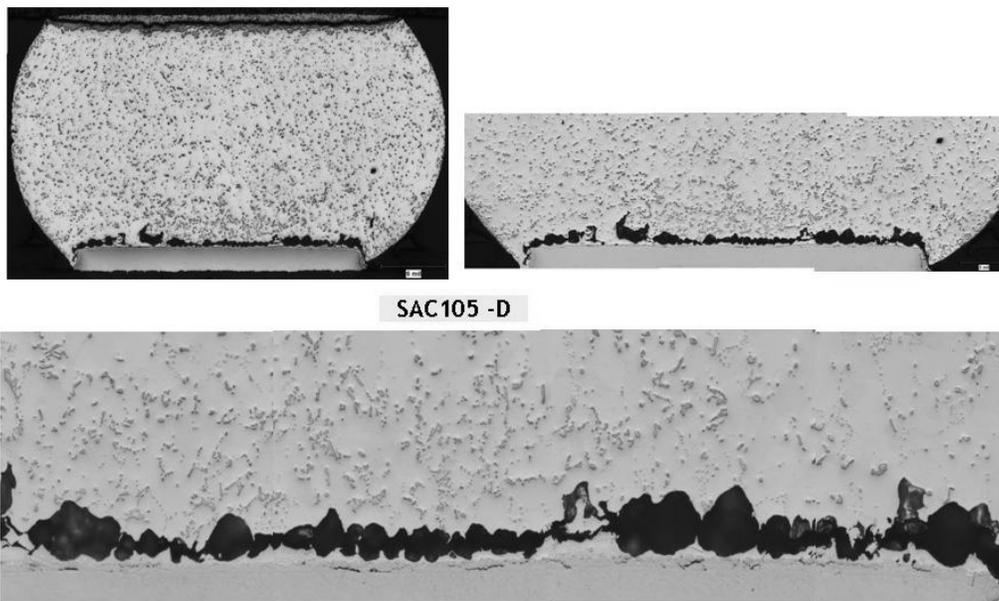
Figure 18. Photomicrographs showing void-assisted fracture in SAC105 in a depopulated array test sample.

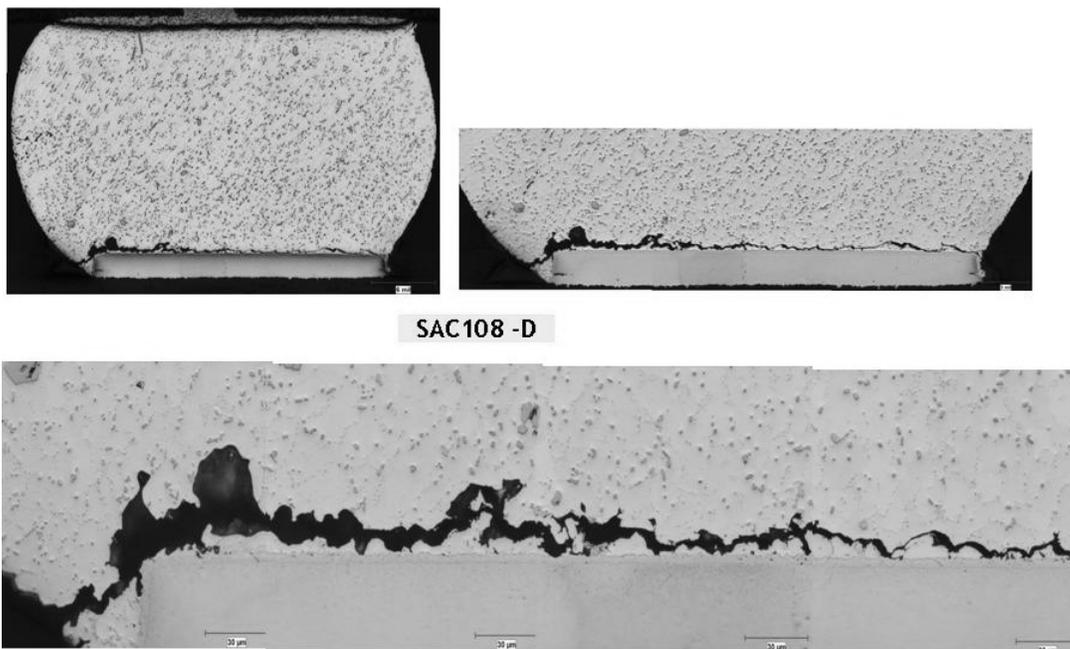
Figure 19. Photomicrographs showing multiple failure modes including void-assisted fracture and solder fatigue in a SAC108 depopulated array test sample.

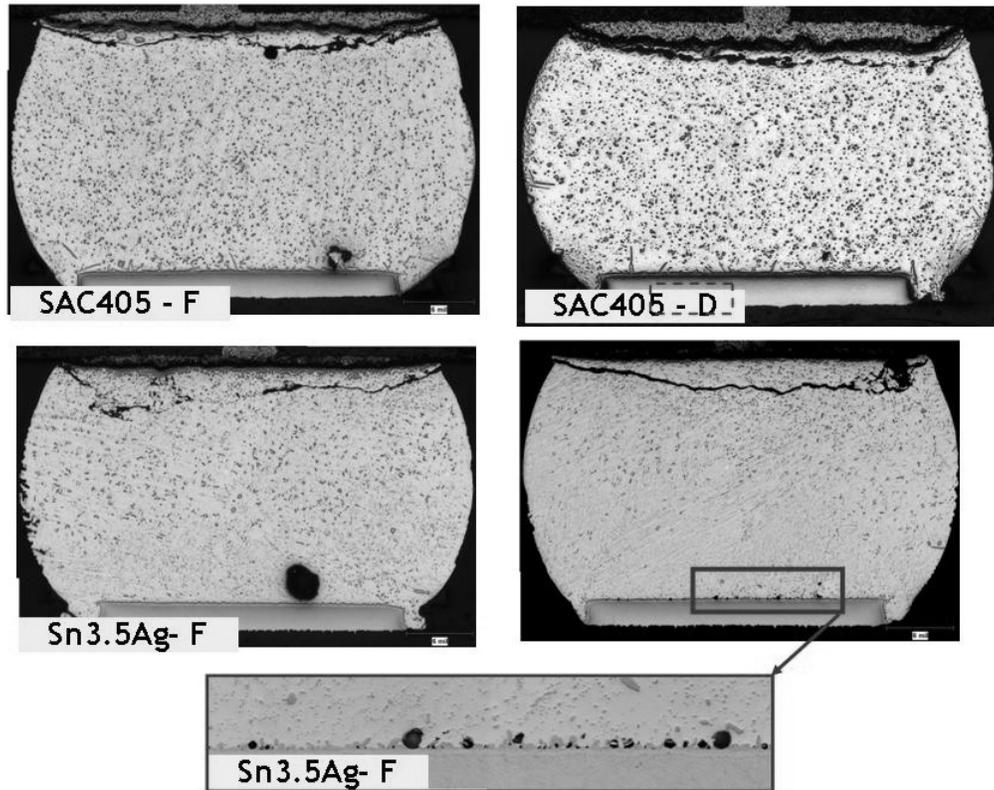
Unfortunately, the failure analyses on the SAC405 test vehicles did not resolve the anomalies or provide any further clarification of the test data. The photomicrographs of the SAC405-F and SAC405-D test vehicles in Figure 20 show that these two samples failed exclusively in solder fatigue at the package sides of the solder joints. Both the full and depopulated arrays selected for analysis failed at over 1000 cycles, which is completely consistent with the observed solder fatigue failure mechanism. It is conceivable that mixed mode failures could exist in some of the SAC405-F samples that failed at much

lower cycle counts. The presence of a few mixed mode failures in the distribution could lower the Weibull slope (β) without causing a significant drop in the characteristic lifetime. It would require substantial additional failure analysis in order to identify mixed mode failures, and that is beyond the scope of the current work. At this time, the authors are unable to offer an explanation for the extremely high $\beta=26.4$ for the SAC405-D.

The Sn3.5Ag-F sample also failed exclusively in solder fatigue at the package sides of the solder joints. It is interesting to note that some voiding is detected at the PCB side of the solder joint. The voiding in the Sn3.5Ag sample is not as severe compared to the other test cells and it is not a factor in the solder joint failure. However, this is further evidence of solder anomalies, even in a sample exhibiting acceptable performance in temperature cycling.

Figure 20. Photomicrographs for failed samples of alloy SAC405-F, SAC405- D and Sn3.5Ag-F showing only solder fatigue fractures at the package sides of the solder joints. There is voiding present at the PCB interface in the Sn3.5Ag but there no cracking has initiated at that location.

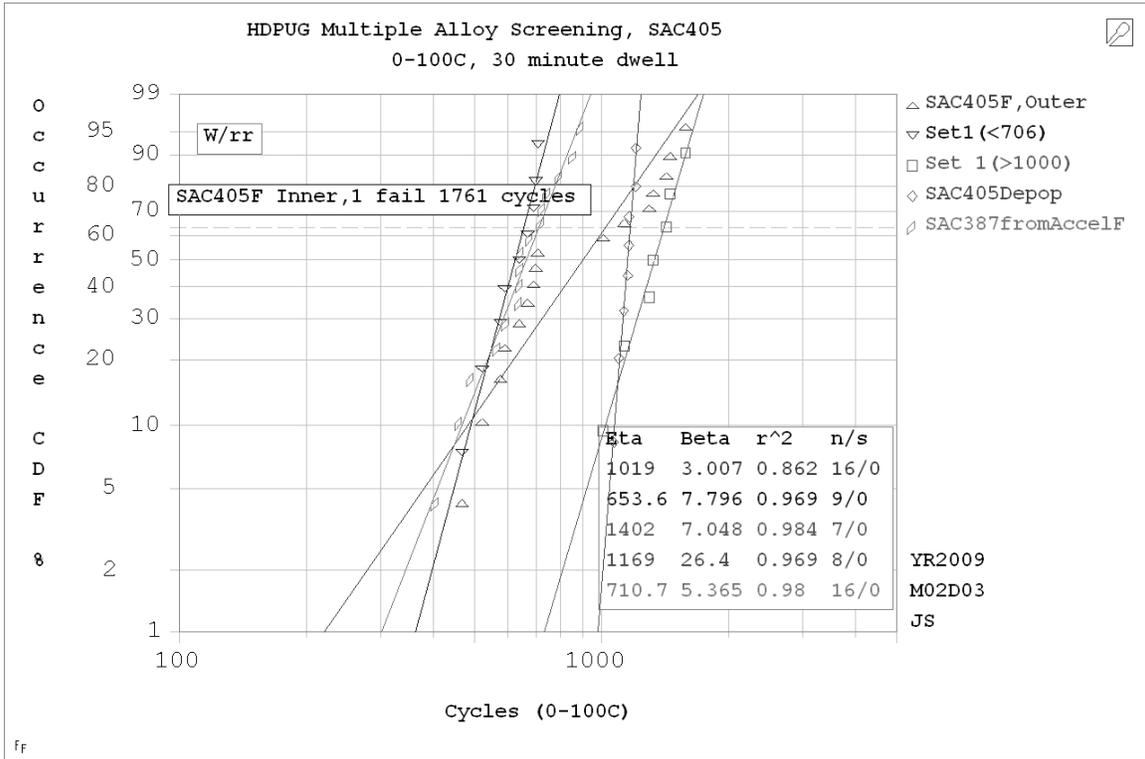
Figure A1: SAC405 Weibull plots including the comparable Weibull plot on the same component used in the HDPUG acceleration factors test.

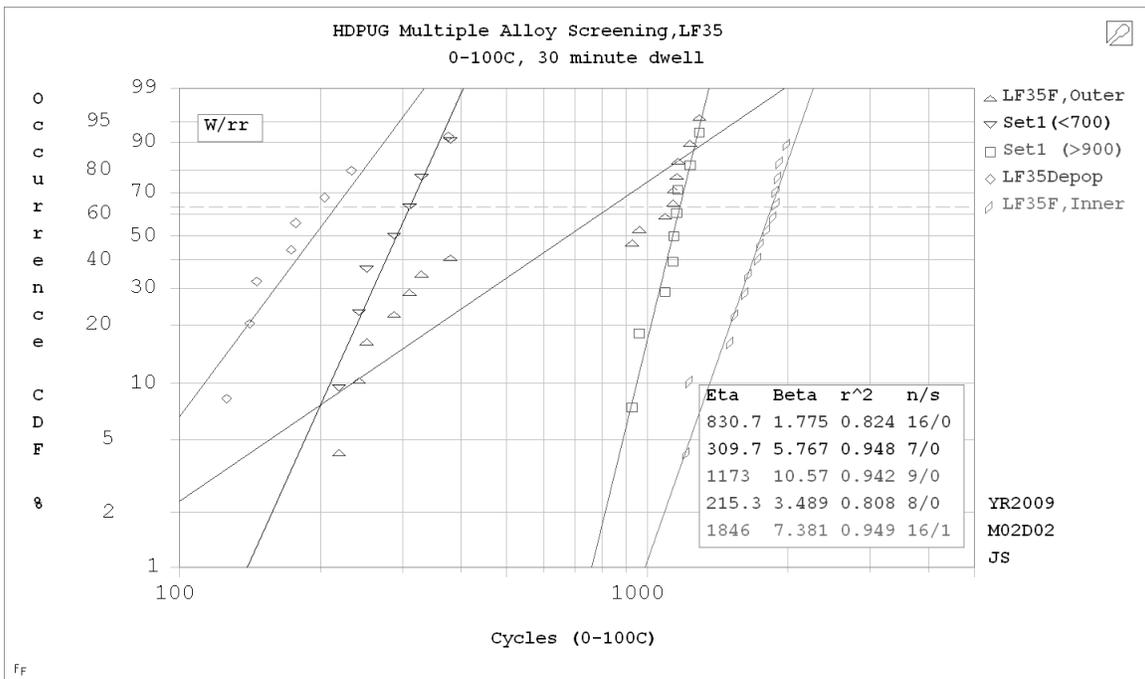
Figure A2: LF35 Weibull plots

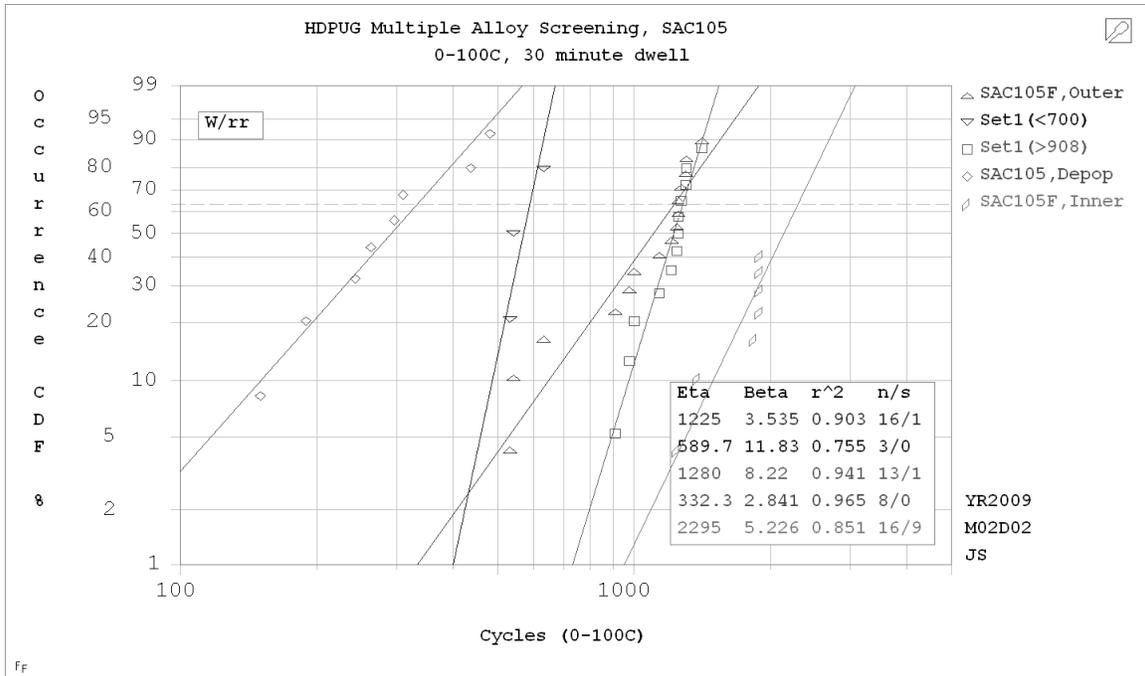
Figure A3: SAC 105 Weibull plots

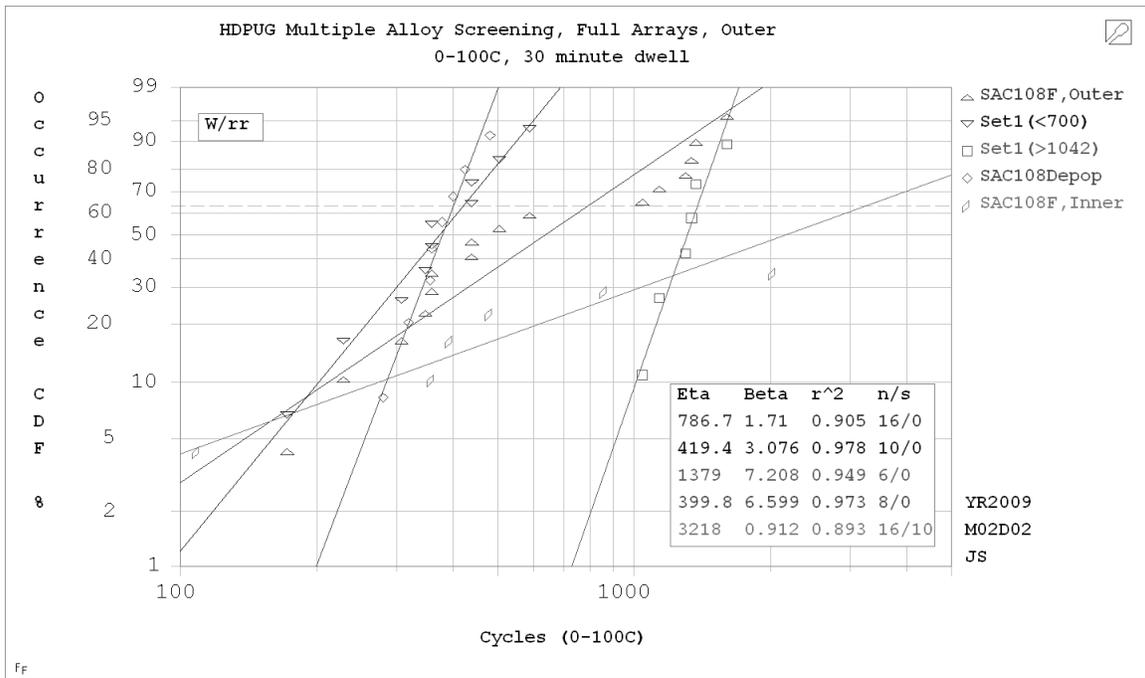
Figure A4: SAC108 Weibull plots

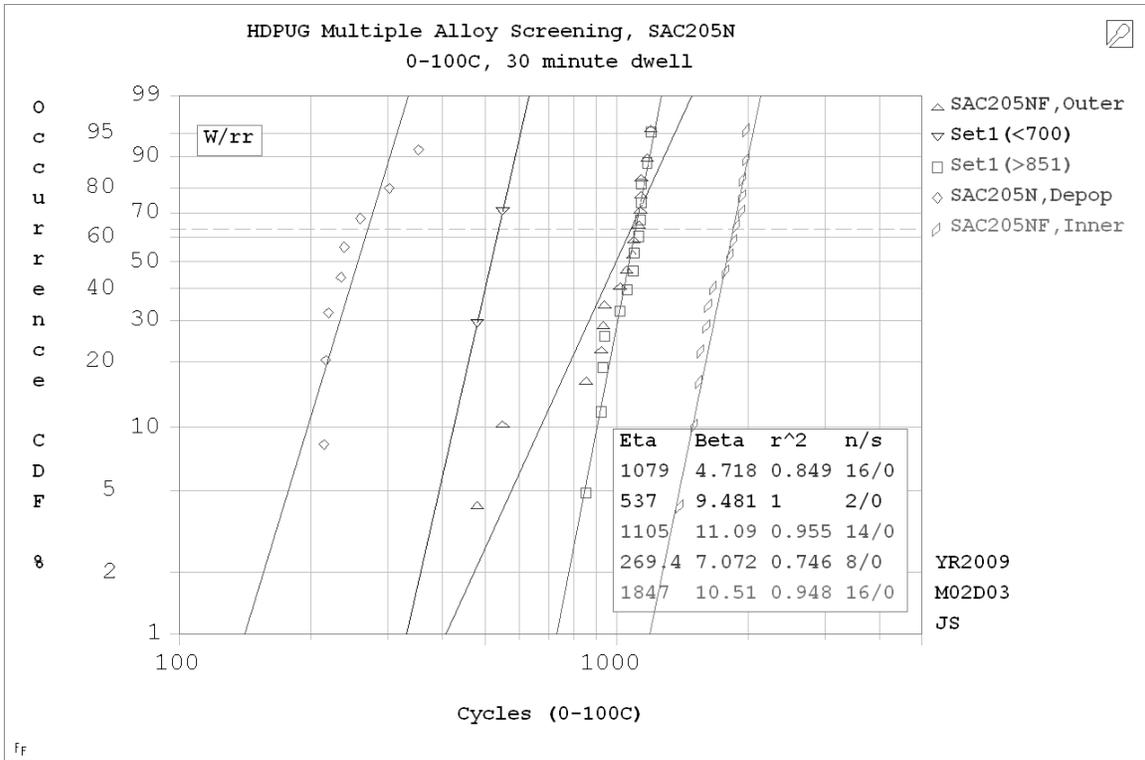
Figure A5: SAC205N Weibull plots

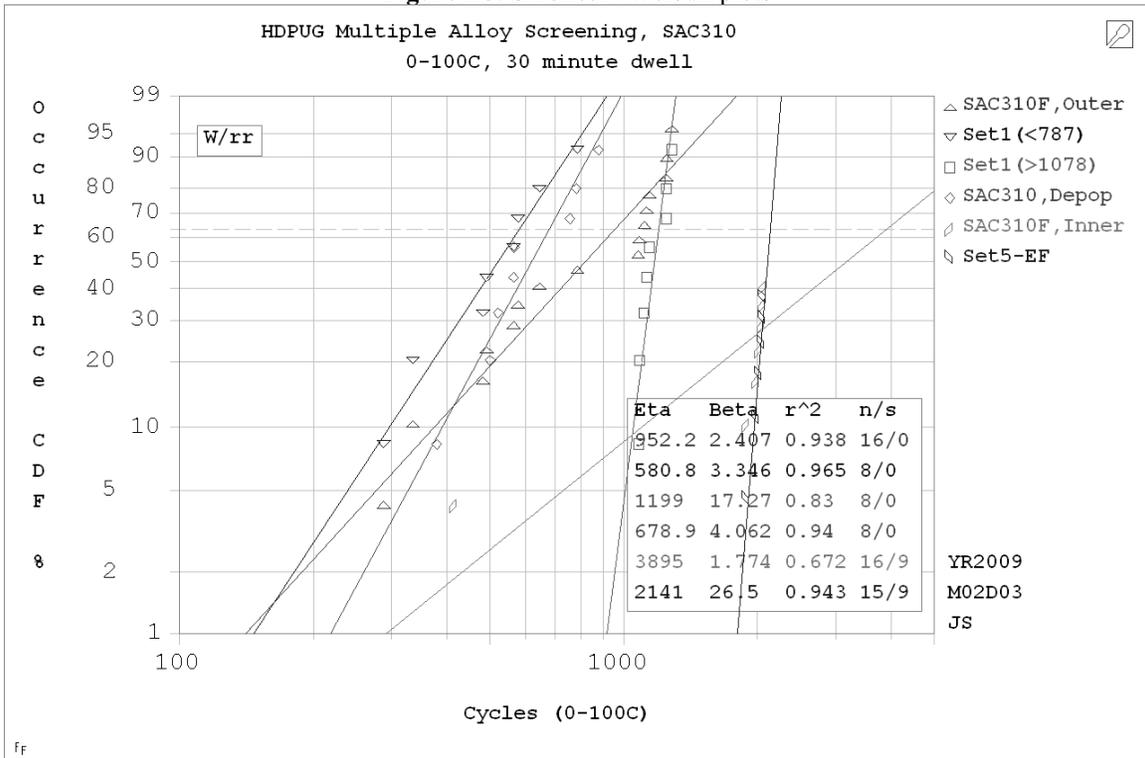
Figure A6: SAC 310 Weibull plots

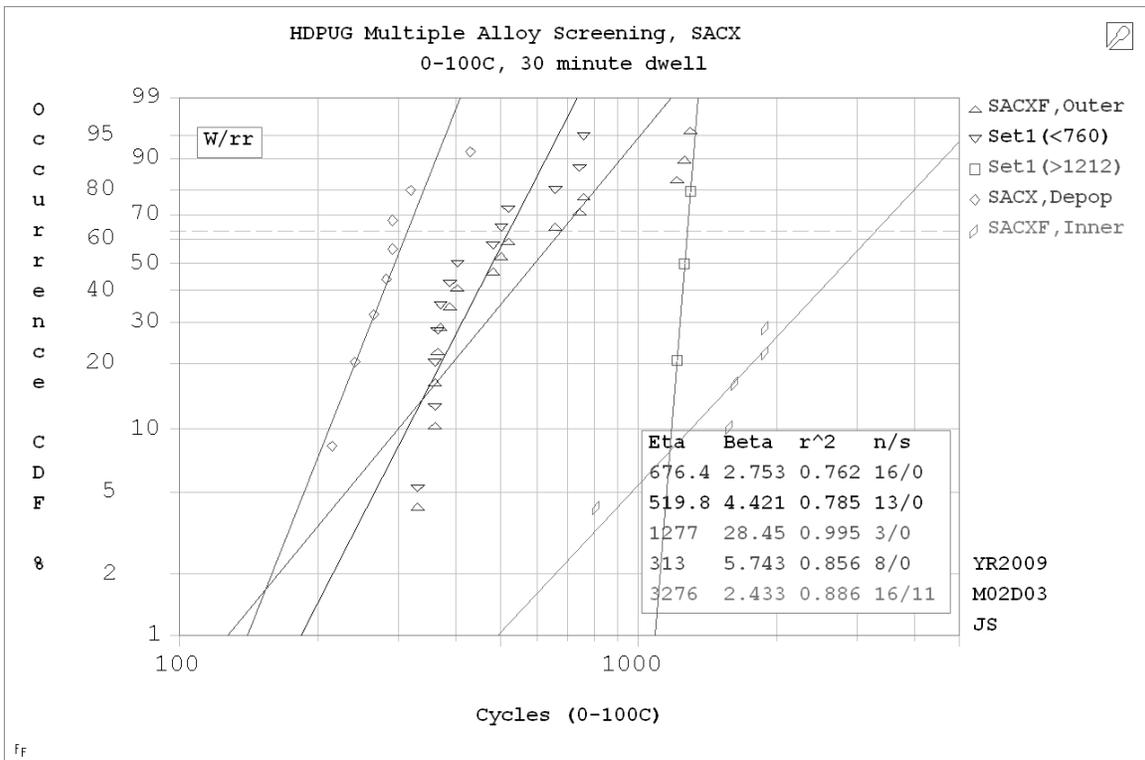
Figure A7: SACX Weibull Plots

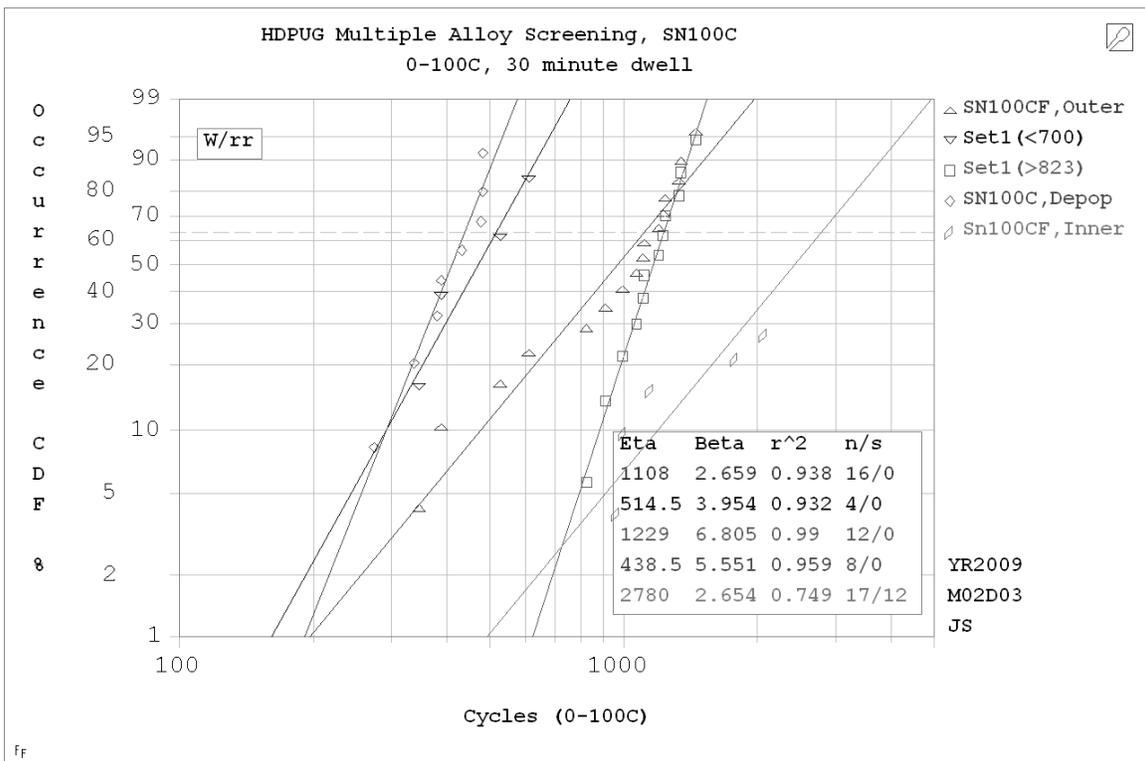
Figure A8: SN100C Weibull Plots
