Thermal Cycling Reliability Screening of Multiple Pb-free Solder Ball Alloys

ABSTRACT

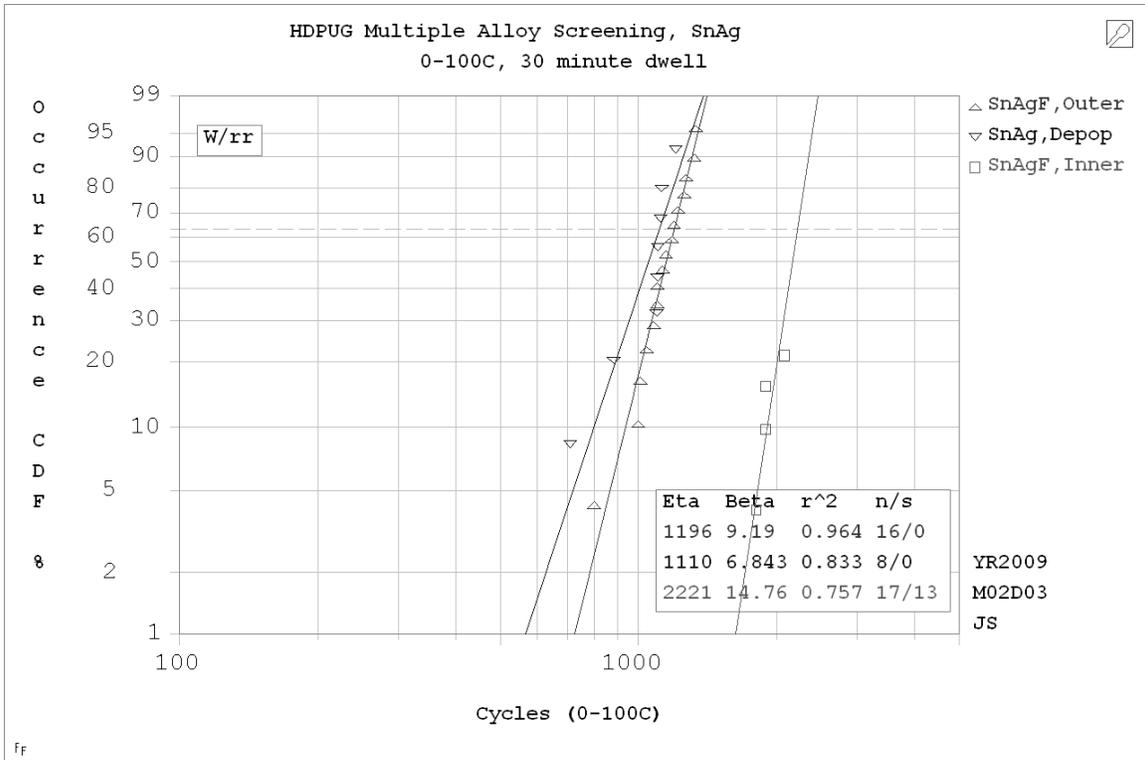
Figure A9: SnAg Weibull Plots

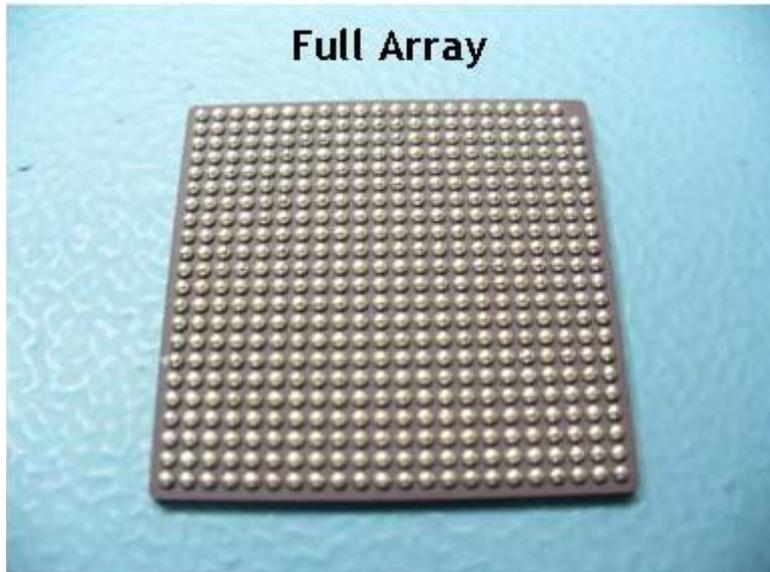
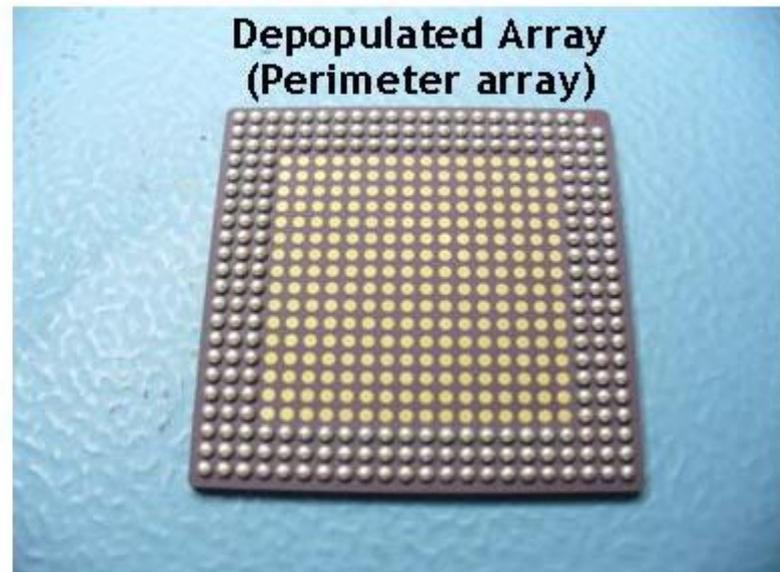
Component Evaluated

- Freescale Semiconductor ceramic ball grid array (CBGA) daisy chain test component.
- 27 mm x 27 mm
 - 483 I/O full array (one corner ball is depopulated).
 - Depopulated or perimeter array has only the outer 3 rows populated, with the center of the array left depopulated.

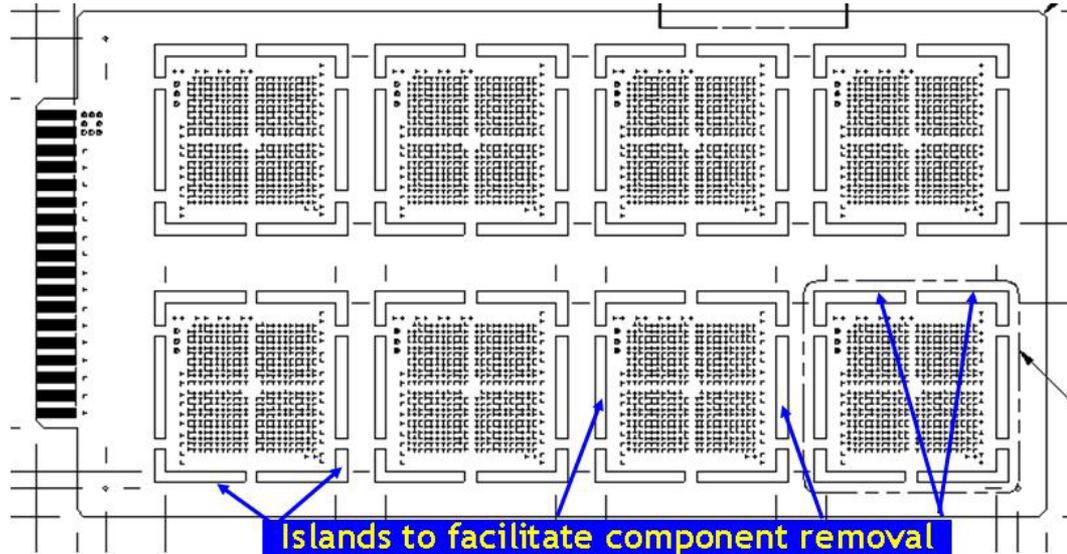
Overview of TV Board Design

6 Layer board, 4.5 x 8.9 x 0.093 inches

Material: Isola 370HR, Immersion Silver finish

Key Benefit: Board and component previously used for Hi-Ag alloy studies.
Produces failures rapidly.

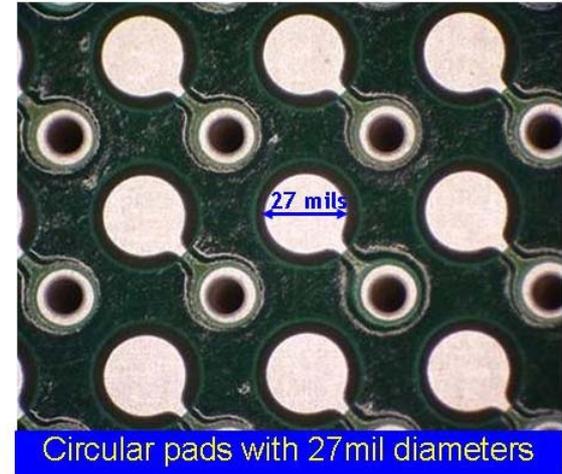
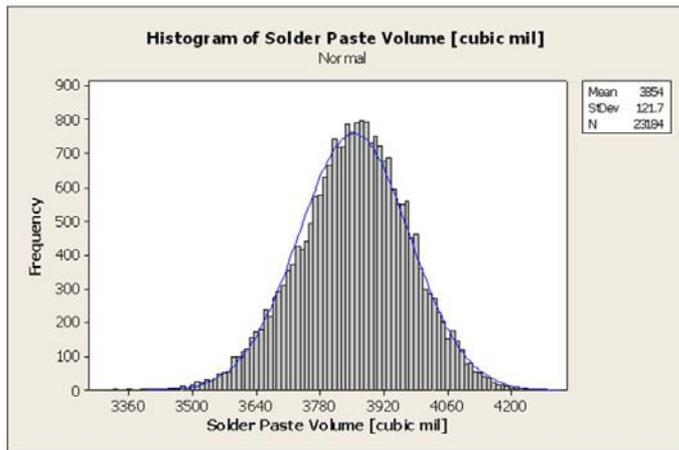
- 6 mil thick laser cut stencil with 27 mil round aperture openings - to match the pad size on the bare board
- Theoretical solder paste volume of 3435 cubic mils.
- Type 3, no-clean solder paste with an alloy composition of 96.5Sn3Ag0.5Cu and a metal percentage of 89%

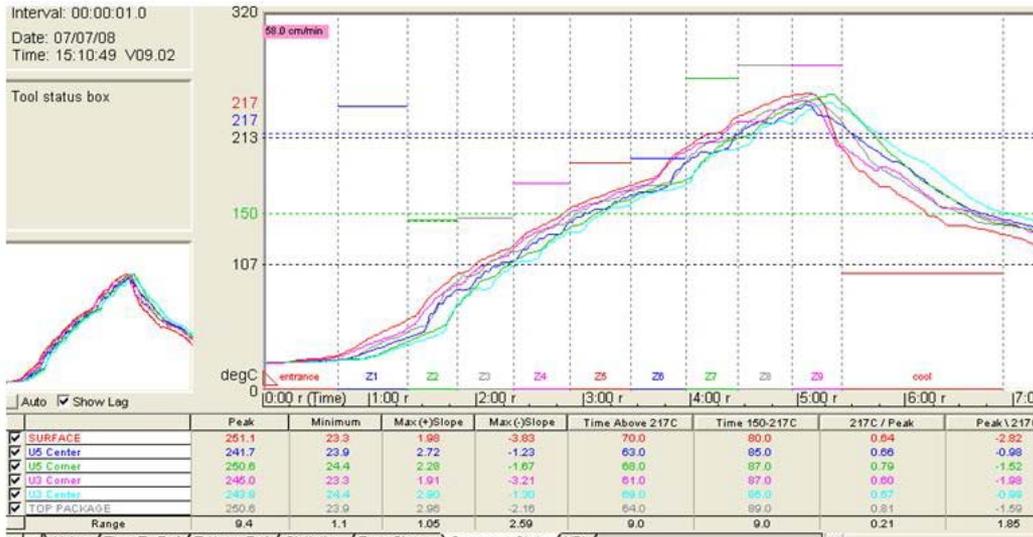
Assembly Profile and Thermocouple locations

Peak
Temperatures of
241-251°C

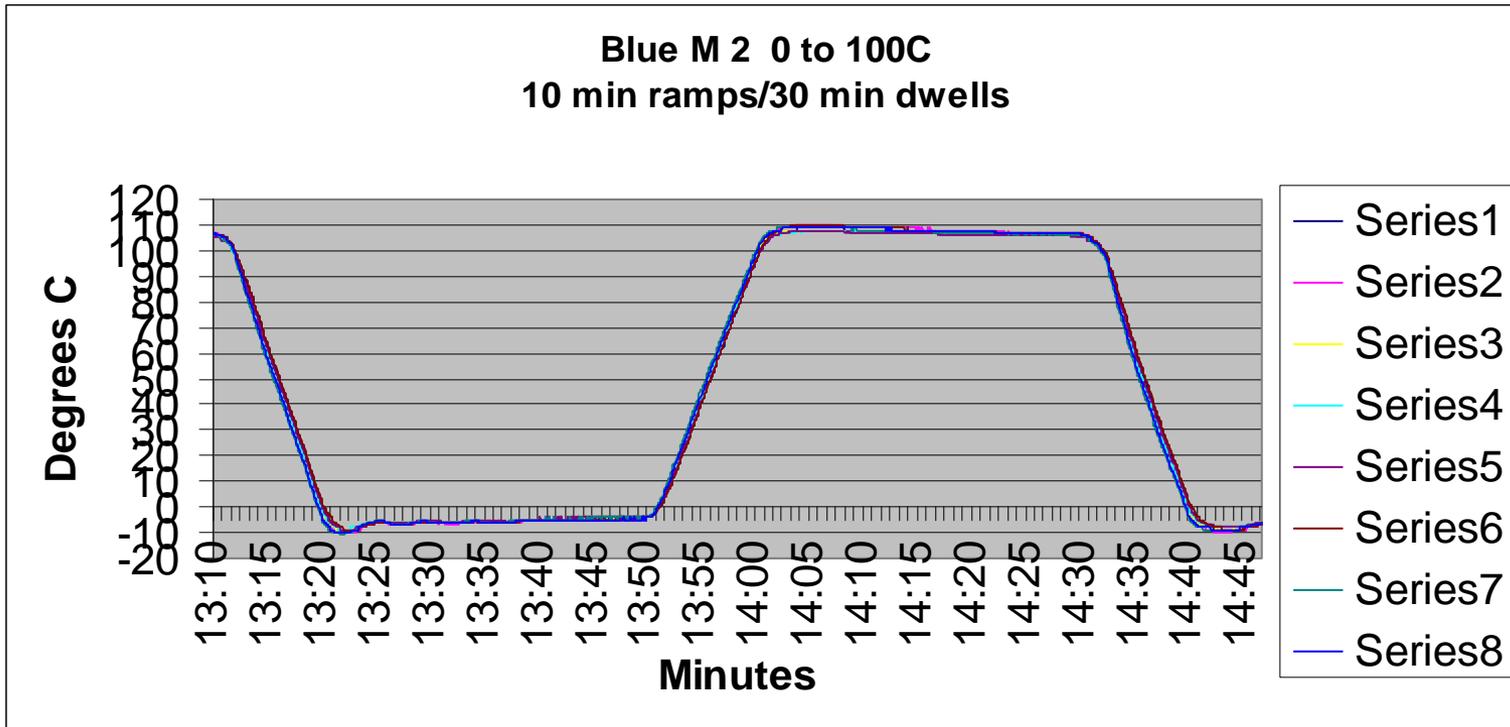
Thermal Cycle Profile

0 °C to 100 °C with 10 minute ramps, 30 minute dwells IAW IPC-9701A industry test standard

Monitored by Event Detector

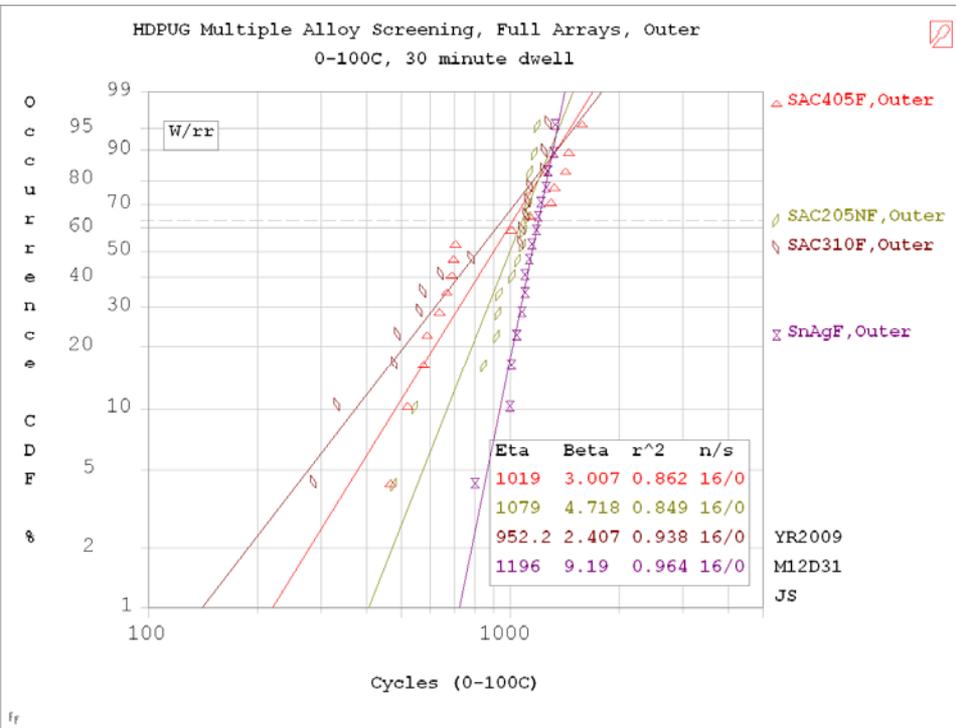
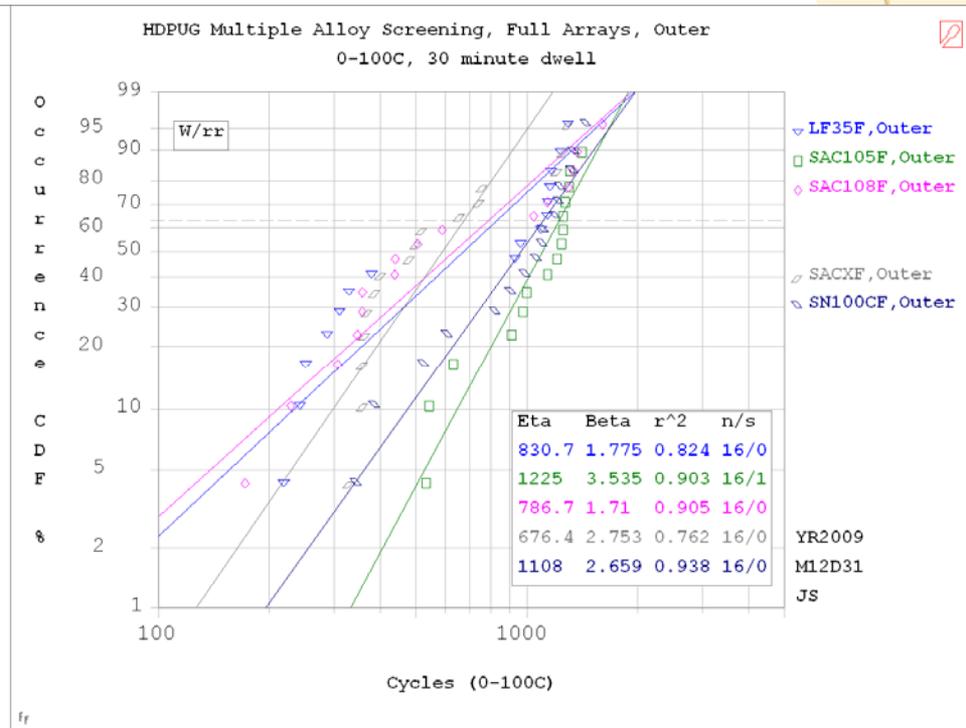
Weibull Analysis

High Ag

Low Ag

Anomaly in the data – 2 separate failure modes

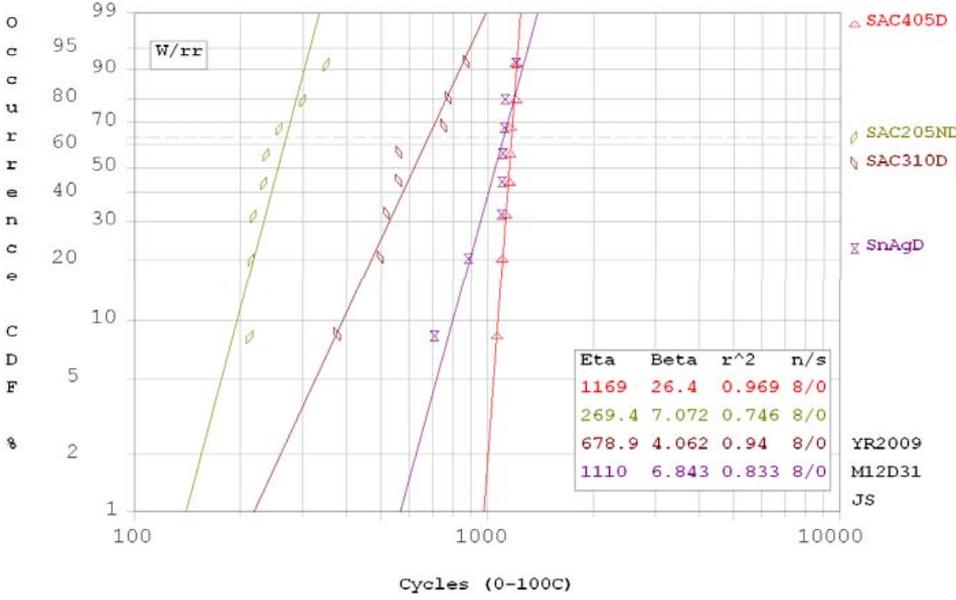
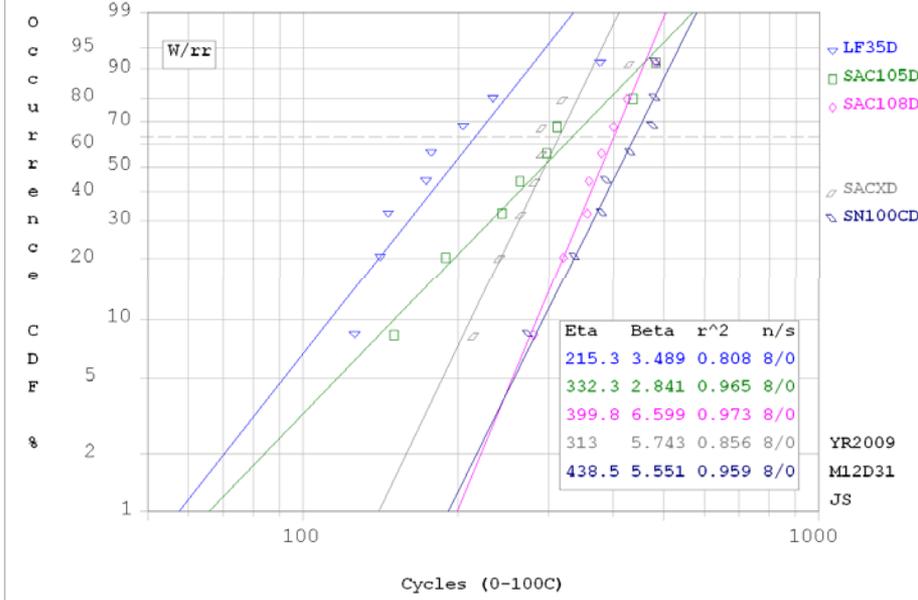
HDP Multiple Alloy Screening, Depopulated Arrays
0-100C Thermal Cycle, 30 Minute Dwell

High Ag

Low Ag

Depopulated Arrays

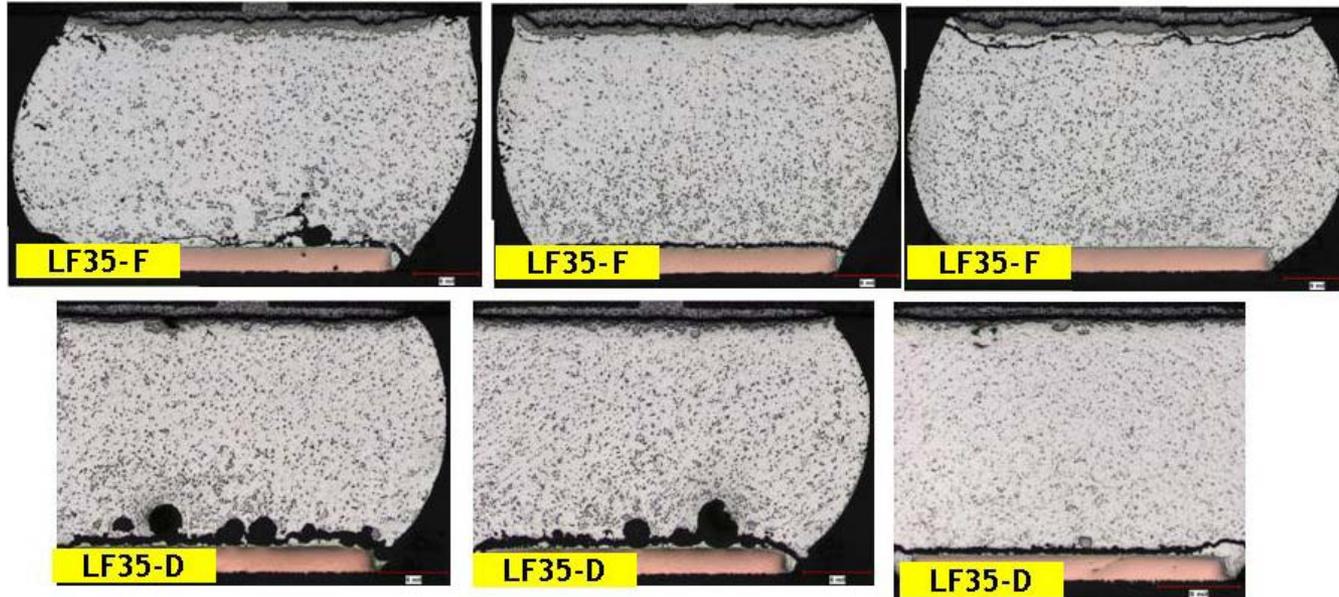
Failure Analysis, Optical Metallography – LF-35

Atypically low Weibull slope, with $\beta=1.8$, and 2) the LF35-D cell has an extremely low characteristic lifetime ($\eta=215$ cycles) as well as indications of several premature failures.

- Not always the typical solder fatigue fractures at the package side of the solder joints.
 - Mixed mode fractures consisting of solder fatigue, void-assisted fatigue and interfacial or near-interfacial fractures.
 - Probable 1st fail sites occur at the PCB side, with minimal solder fatigue damage at the package side of those failed joints.

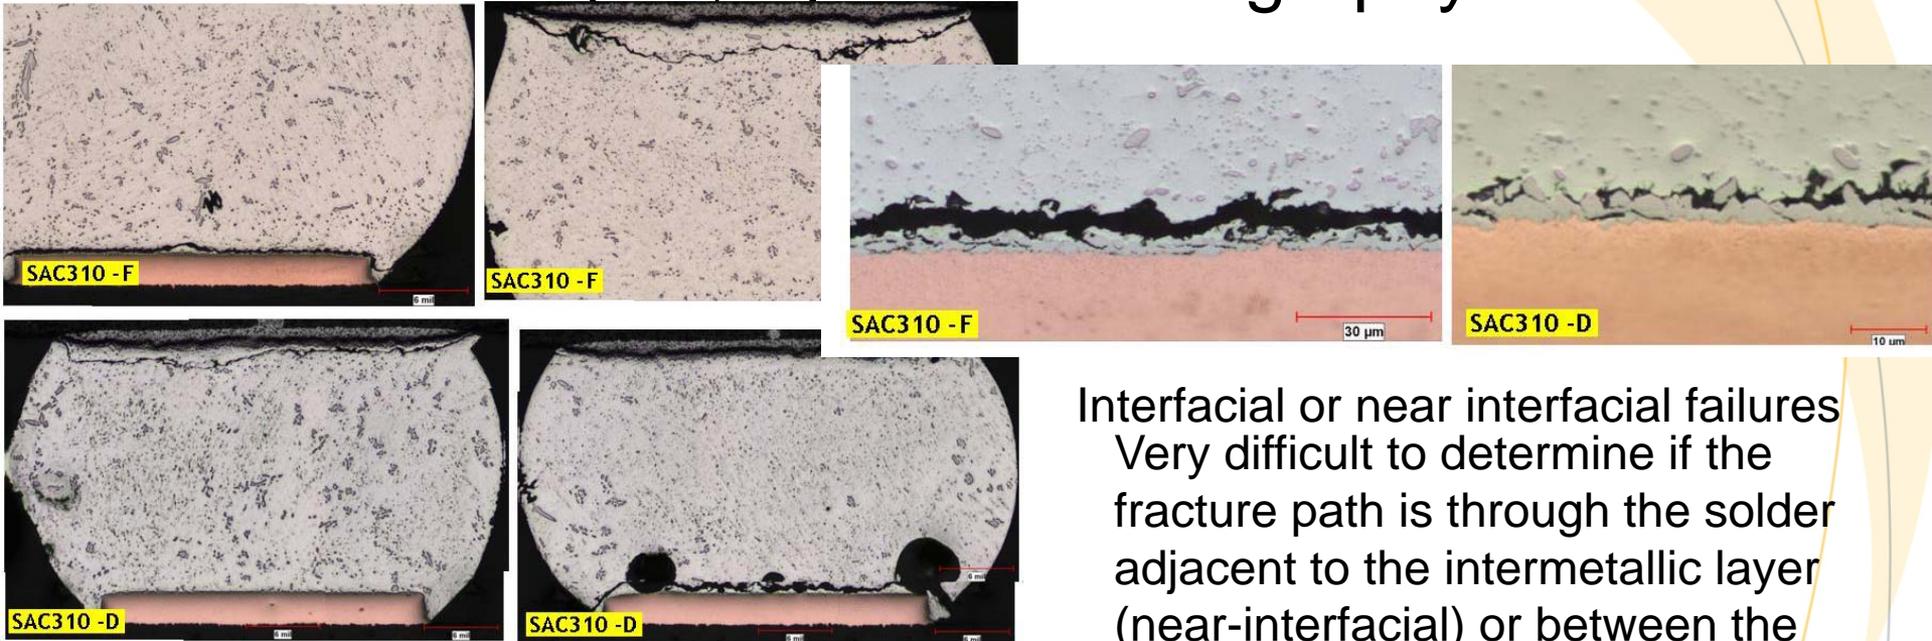
Failure Analysis, Optical Metallography – SAC310

Interfacial or near interfacial failures
 Very difficult to determine if the fracture path is through the solder adjacent to the intermetallic layer (near-interfacial) or between the solder and the intermetallic layer (interfacial).

Characteristic lifetime, $\eta=679$ cycles, lower than expected compared to the other high Ag alloys, Also has a relatively low Weibull slope, with $\beta=2.4$.

- Mixed mode failures with void-assisted fatigue and near-interfacial fractures.

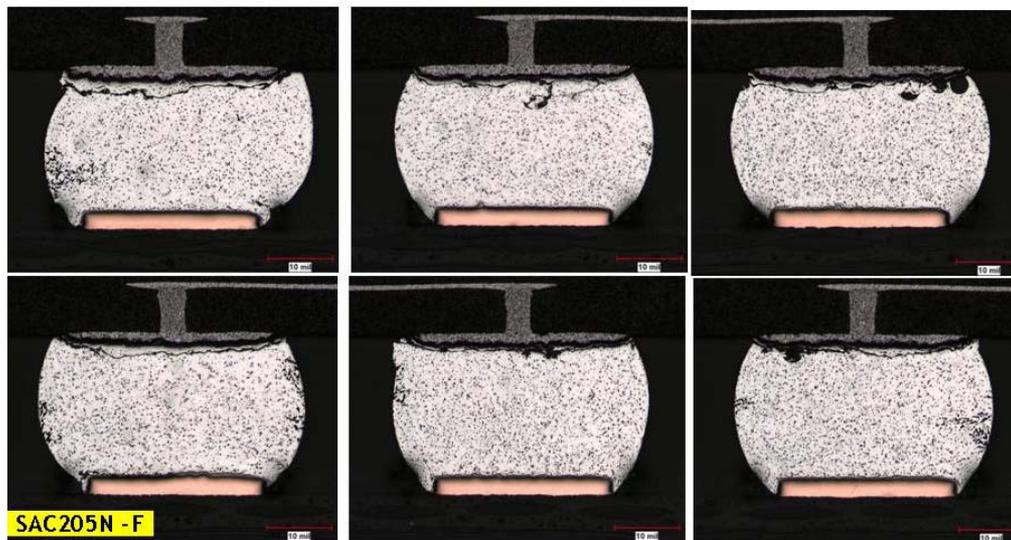
Failure Analysis, Optical Metallography – SAC205N

Relatively high characteristic lifetime ($\eta=1079$ cycles), and good β (4.7)

- Indicative of a single failure mode such as solder fatigue.
- Analysis shows all the fractures in the outer rows of this particular component were due to solder fatigue at the package side.
- Weibull plot - two early, lower-cycle data points in the failure distribution - remainder of the failures above 900 cycles.
- Observations tend to support the conclusion that the failure distribution is dominated by solder fatigue, with the possibility of a few early, mixed mode failures.

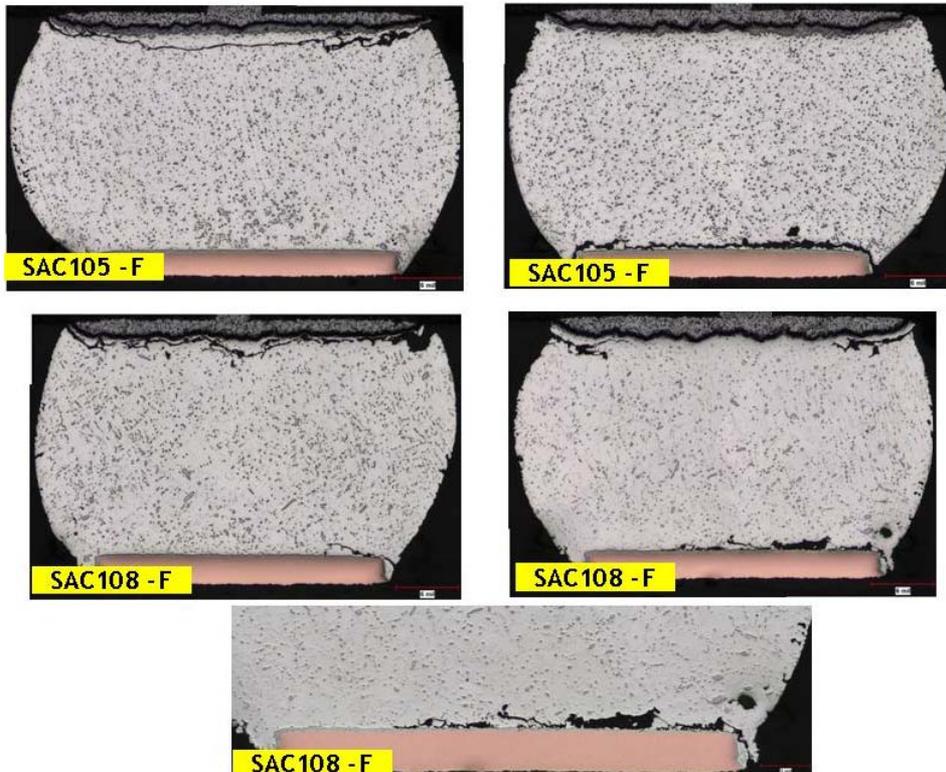
Failure Analysis, Optical Metallography – SAC105 and 108

- Expected to have very similar thermal fatigue performance.
- Expected to have much lower fatigue resistance than the higher Ag alloys.
- Weibull data does not confirm these expectations.
 - SAC105 Eta >> SAC108 with the full array
 - SAC108 Eta > SAC105 with depopulated array.
 - For full array, SAC105 Eta ~ comparable to both SAC405 and Sn3.5Ag.

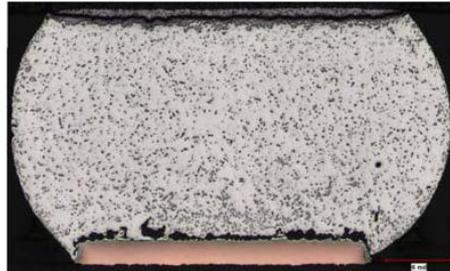
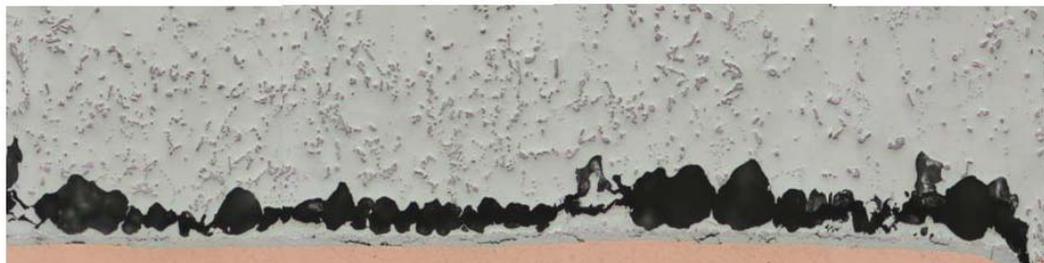
SAC105 -D

Early failures & multiple failure modes
Inconsistent Weibull slopes (β), \rightarrow deviation from a single mode of fatigue failure.

- Clear evidence of the type of mixed mode solder joint fractures detected in other alloys.

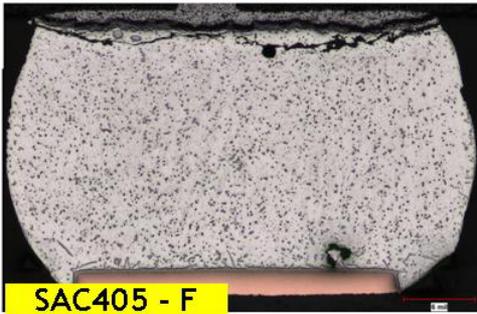
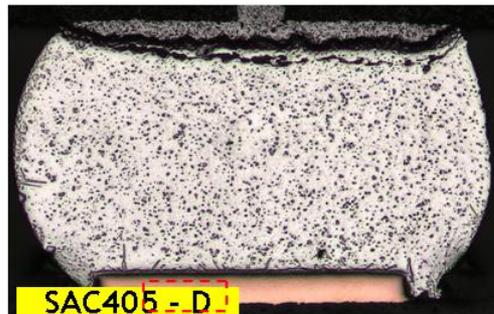
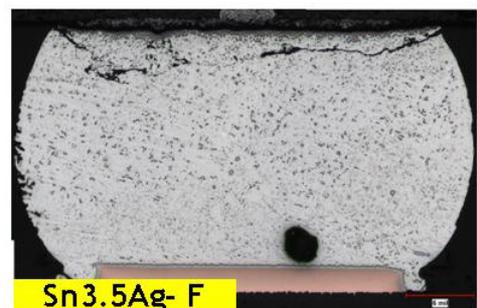
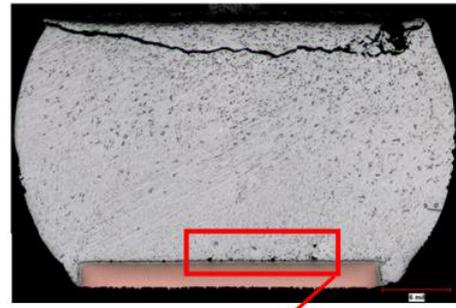
Failure Analysis. Optical Metallography – SAC405 and Sn3.5Ag

FA did not resolve the anomalies in SAC405 data

FA samples failed exclusively by solder fatigue on package side (samples were over 1000 cycles to failure)

Voiding is seen on board side of SnAg samples – but did not have any cracks

The Sn3.5Ag has Weibull characteristic of single mode, thermal fatigue failures.
