Creep Corrosion of OSP and ImAg PWB Finishes

C. Xu, W. Reents, J. Franey, J. Yaemsiri and J. Devaney
Alcatel-Lucent
Murray Hill, NJ and Raleigh, NC, USA

Abstract

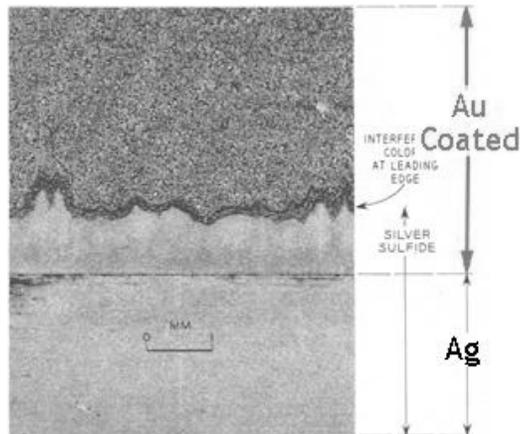
Figure 1 – Creep corrosion of silver sulfide on Au surface [2]

Creep corrosion is the mass transport process in which solid corrosion products (typically sulfide and chloride) migrate over a surface without the influence of an electric field. It was first reported by Egan and Mendizza for Ag_2S on an Au surface [2]. In their experiment, a silver substrate was used and one half of the Ag surface was coated with a thick Au layer (see figure 1). When the sample was exposed to a sulfur containing environment, silver sulfide was formed on exposed Ag. Furthermore, it was also observed that silver sulfide spilled over onto the Au surface and migrated away from the Ag-Au interface. This migration was called creep corrosion [2]. In figure 1, one can clearly see the leading edge of the creeping silver sulfide. Interestingly, when the experiment was repeated with a Ag-Rh or Ag-Pd interface, Ag_2S did not creep onto either the Rh or the Pd surface, even though heavy silver sulfide was formed on the exposed silver surface in both cases. Apparently, Ag_2S creep corrosion is highly surface specific and only happens on the Au surface but not on the Rh and Pd surfaces. This is a very important characteristic of creep corrosion. First, a site is required for creating corrosion product, for example an exposed Ag substrate in this case. Additionally, a surface is needed to support the creep of corrosion products. In this case, it is the Au surface. Rh and Pd, on the other hand, would not support the creep of silver sulfide.

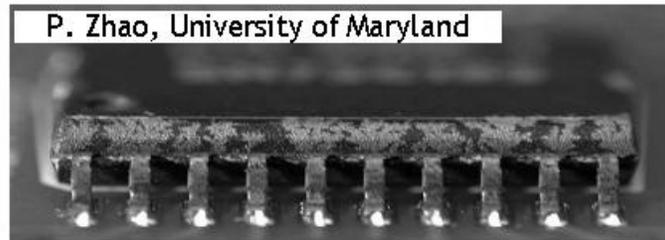
Figure 2 – Creep corrosion on molding compound for a DIP component [3]

Creep corrosion is not only limited to metallic surfaces. It has also been observed on the plastic molding compound used for IC packages. In this case, the corrosion first takes place on the exposed lead-frame (Cu alloy) and the corrosion product (typically copper sulfide) migrates on to the adjacent encapsulated surface of the component and causes an electrical short circuit between the adjacent leads (see Fig.2) and product failures in the field. Zhao [3] has systematically studied creep corrosion on plastic encapsulated microcircuit packages with noble metal pre-plated lead-frames and found that Telcordia outdoor MFG testing is effective in producing creep corrosion on the plastic molding compound. As little as 5-day Telcordia outdoor MFG testing can induce creep corrosion over the mold compound. Battelle Class III testing is less effective but still

capable of producing creep corrosion over the mold compound surface. Telcordia Indoor MFG testing, on the other hand, did not induce creep corrosion within the 30-day exposure.

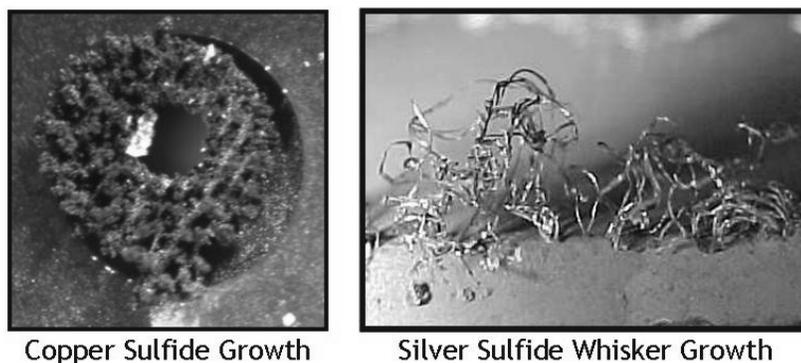
Figure 4 – Dendritic growth and whisker formation [8] driven by compressive stress

Creep corrosion has a very different mechanism from that of whisker formation and dendritic growth. The latter two are driven by the compressive stress in the coating. Dendritic growth of corrosion products such as copper sulfide and silver sulfide is a consequence of the much lower density and higher specific volume of the corrosion products relative to their metal counterparts. When Cu or Ag are corroded to form copper sulfide or silver sulfide, there is a volume expansion in the original Cu or Ag metal films, leading to a compressive stress build up. As corrosion is typically not uniform and occurs preferentially at defect sites such as a grain boundary or porosity, this compressive stress can not be easily released and therefore initiates/drives the whisker formation and dendritic vertical growth of corrosion products out of the coating films. Fig. 4 shows typical images of corrosion product dendritic vertical growth (left) and whisker formation (right). Unlike creep corrosion, surface properties of areas surrounding the corroding sites are not important for whisker formation and dendritic growth.

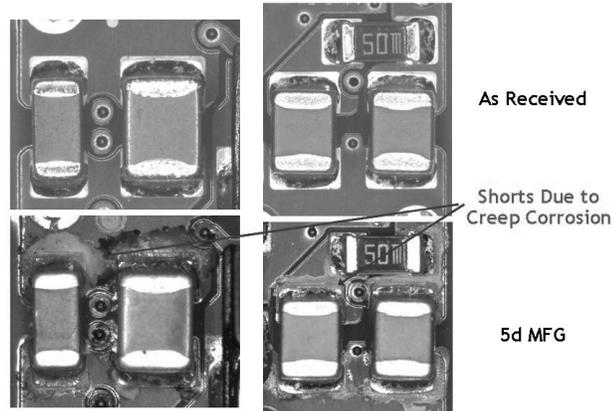
Figure 5 – Optical images of samples before and after 5 days MFG test

Fig.5 compares optical images of circuit boards before (top two images) and after 5 days MFG test (bottom two images). As the two top images show, OSP-coated pads were not completely covered by the solder after reflow and the edges of the pads

are exposed. This is more clearly seen in Fig.6, where SEM image of a pad and EDS analysis results at two locations are summarized. The left-upper corner in the top image is the end termination of the component. Most of the area of the Cu pad is covered by the solder and flux residues, as the EDS result on the left side shows. However, no solder is found on the edge of the pad (right-bottom). The EDS analysis on the edge of the pad (right side) shows a large Cu peak and two small O and C peaks, indicating an exposed Cu pad with OSP and possibly also some flux residues. When this sample is exposed to MFG, corrosion products will form on the exposed OSP/Cu edge. Furthermore, corrosion products creep on to the adjacent solder mask surface and causes short circuits between the adjacent components, as clearly shown in Fig.5.

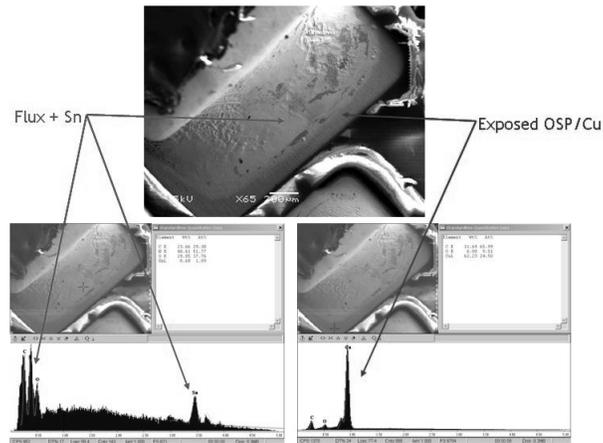
Figure 6 – ESD Analysis of OSP coated Cu pads after reflow soldering

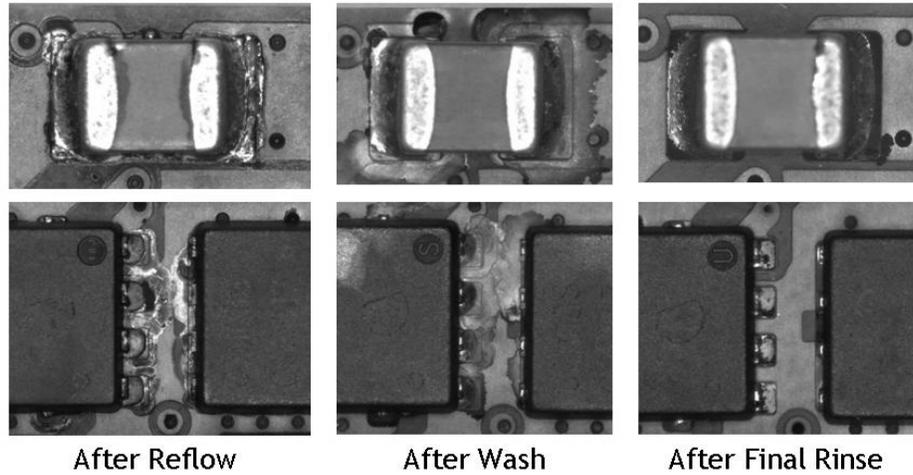
Figure 7 – Effect of post-reflow cleaning on creep corrosion

All the samples were then subjected to 5 days MFG test. Fig. 7 shows images taken at two identical locations for the three circuit boards after 5 days MFG testing.

Severe corrosion was seen for all three samples. The two images on the left were from the sample removed immediately after reflow. In addition to corrosion, creep of corrosion products was also observed. However, creep of corrosion products is rather localized and extends only just beyond the perimeters of the Cu pads. The two images in the middle were from the sample removed after going through the first wash section but without rinsing. Interestingly, the creep of corrosion products in this case is significantly more extensive than the sample removed immediately after reflow. The wash seems to help flux residues spread further onto the solder mask surface, which creates a larger creepable surface around the Cu pads, hence more extensive creep corrosion on this sample. The two images on the right were from the sample removed after going through the

entire cleaning process (reflow, wash, rinse and final rinse). Only minor creep corrosion was observed at one location (bottom right corner in the top image). Most of the creep promoting flux residues seem to be removed in this case during the standard cleaning. However, the presence of creep corrosion indicates that there is still some flux residue left on the surface, even though the surface cleanliness measurement using the Alpha Metals Ionograph 500M showed a typical reading of $\sim 1\mu\text{g}/\text{sqin}$, well below the $10\mu\text{g}/\text{sqin}$ IPC limit. Clearly, a PWB surface, which is clean enough for preventing electrochemical migration, may not be adequate for preventing creep corrosion. This could be due to the fact that creep corrosion is more sensitive to the flux residues than ECM. The alternative explanation is that creep corrosion is promoted by species other than ionic residues, which are responsible for ECM and analyzed using the standard ionograph.

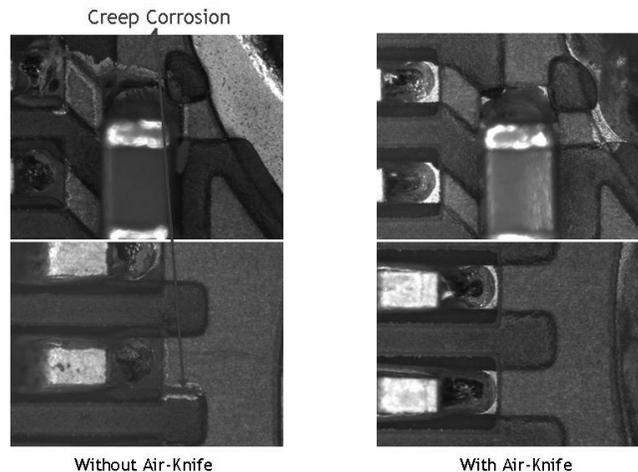
Figure 8 – Comparison between standard and improved cleaning processes

In order to further minimize creep corrosion, the standard cleaning process needs to be improved. As the first wash tank is highly contaminated with flux residues, the drag-in of solution from wash tank to the first rinse tank would contaminate the first rinse tank with flux residues and compromise the cleaning operation. To minimize the drag-in, an air knife was installed

between the wash section and the first rinse section to blow off trapped solution on the circuit boards after the wash. Samples for MFG testing were then collected from both the standard operation and the improved operation. In Fig.8, results after 7 days MFG test are summarized. The two images on the left are from the sample cleaned using the standard process and show some creep corrosion. The two images on the right are from the sample cleaned using the improved cleaning process and show no creep corrosion.

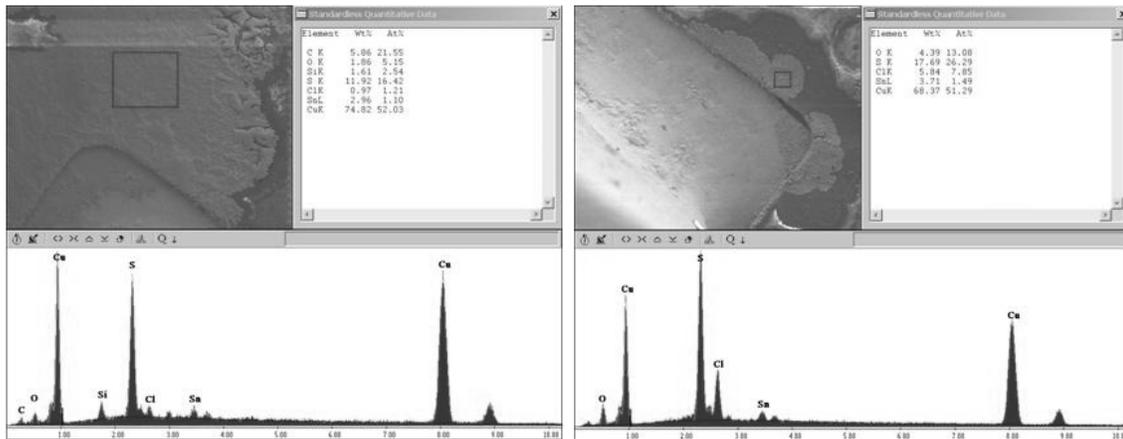
Figure 9 – Composition of creeping corrosion products

The chemical composition of the creeping species was also determined using EDS analysis and results are summarized in Fig.9. The image on the left side of Fig.9 shows that the creeping species is mostly copper sulfide, with a small peak due to chlorine. This is very typical for most areas analyzed. However, in some of the areas a rather large Cl peak is also observed in addition to copper sulfide, as the image on the right side of Fig.9 shows. A small oxygen peak is also observed in both cases and is most likely due to the substrate (solder mask coated FR-4). This is consistent with the fact that copper sulfide is highly mobile and creeps readily on many surfaces, while copper oxide typically does not creep.

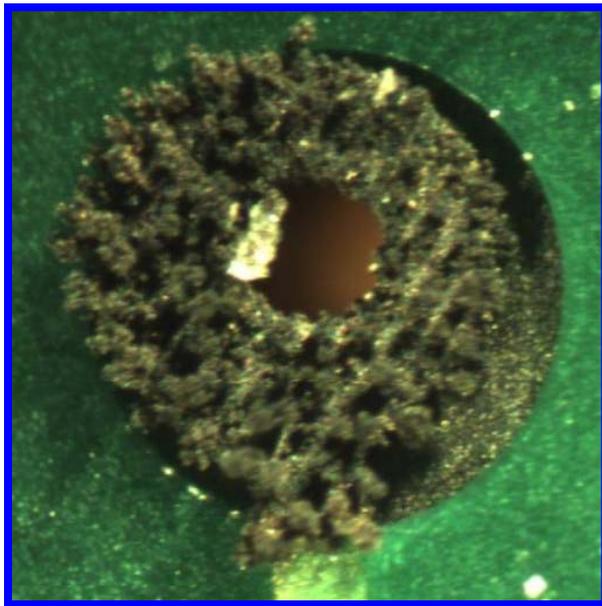
Dendrite Growth

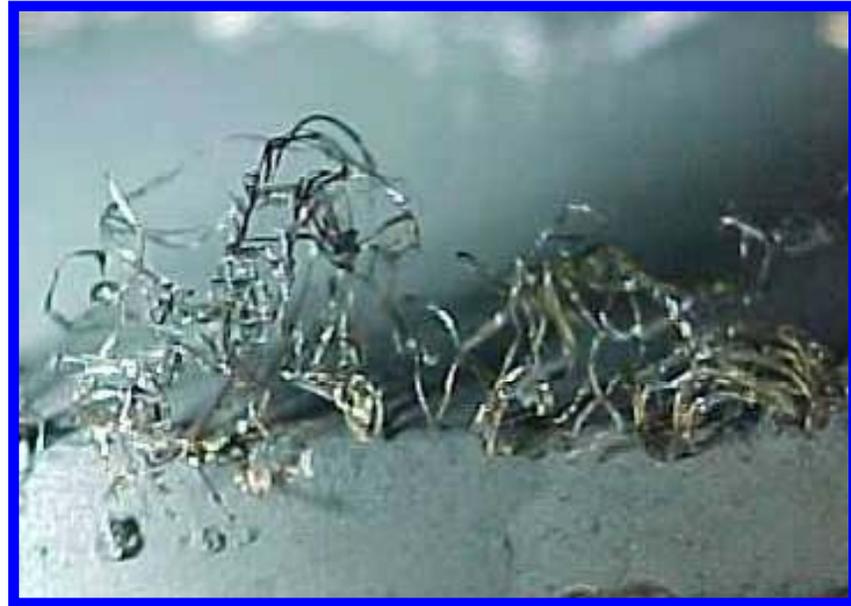
Silver Sulfide Whisker Growth

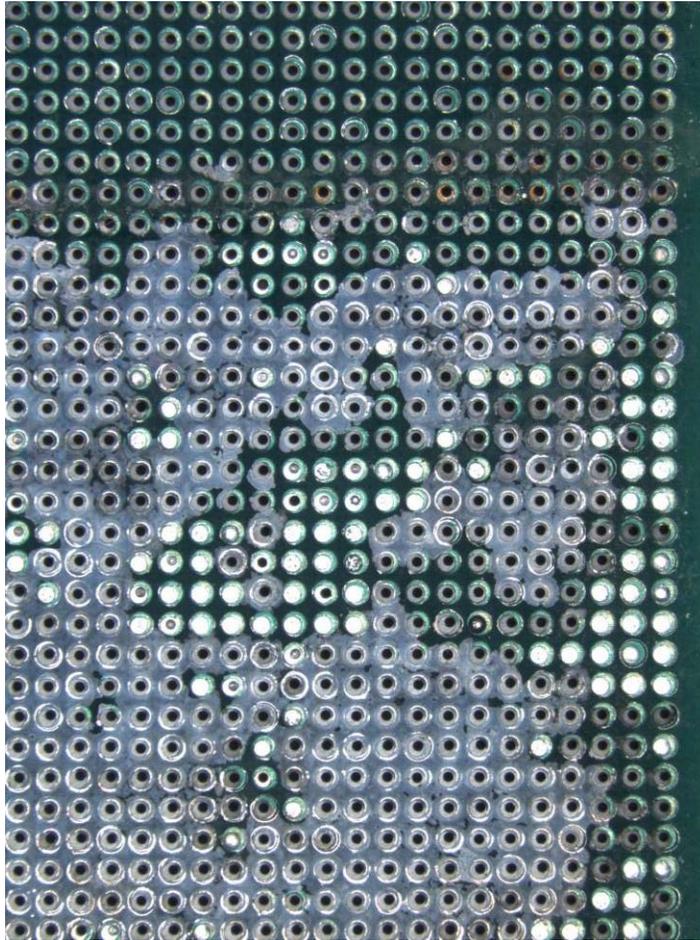
Assembled with ORLO Flux

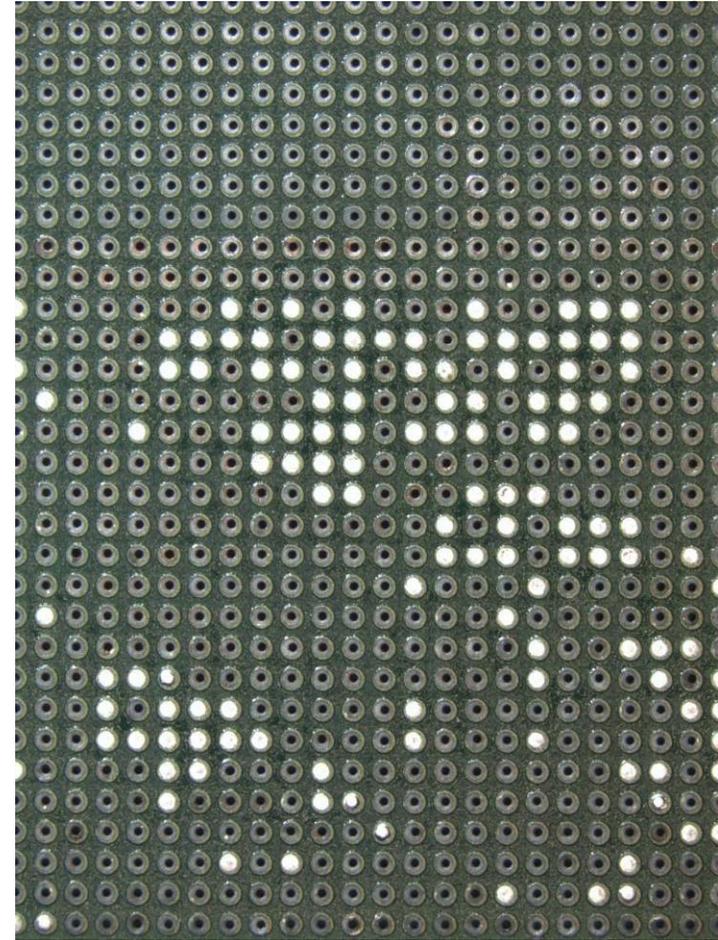
Assembled with ROL0 Flux

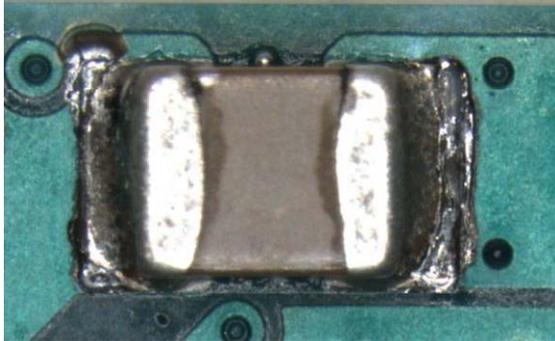
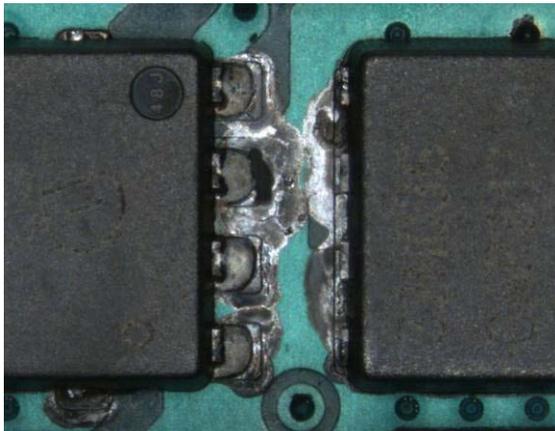
Sample 1

After Reflow

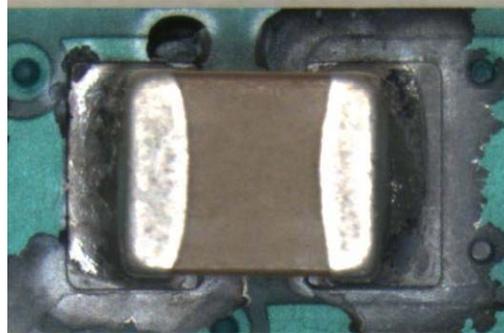
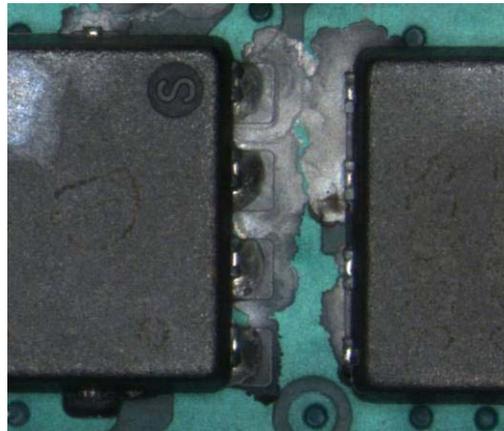
Sample 2

After Wash

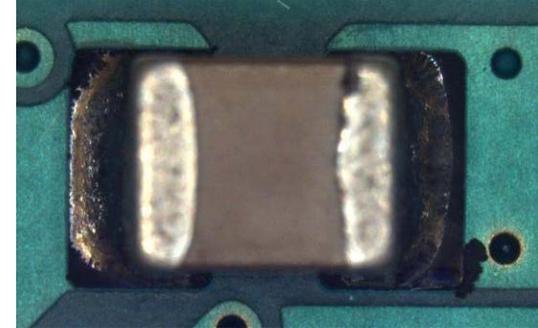
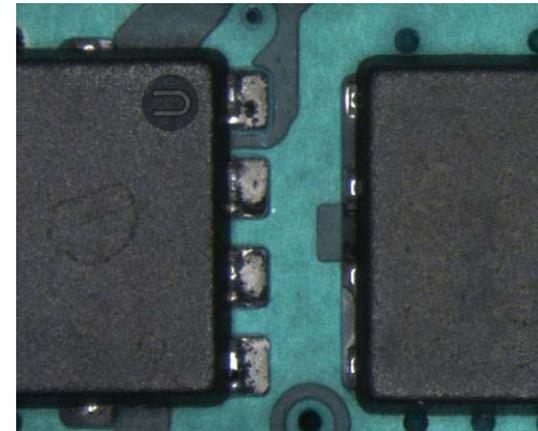
Sample 3

After Final Rinse

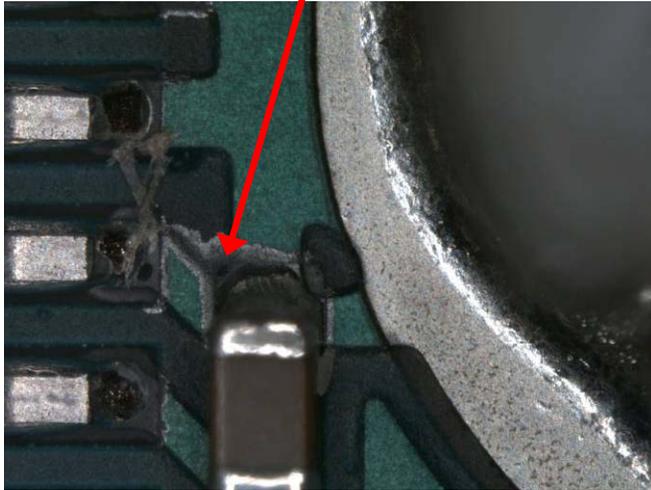
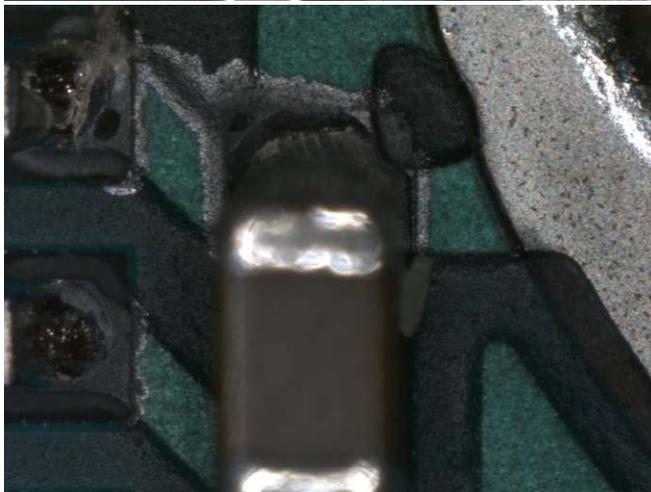
Without Air-Knife

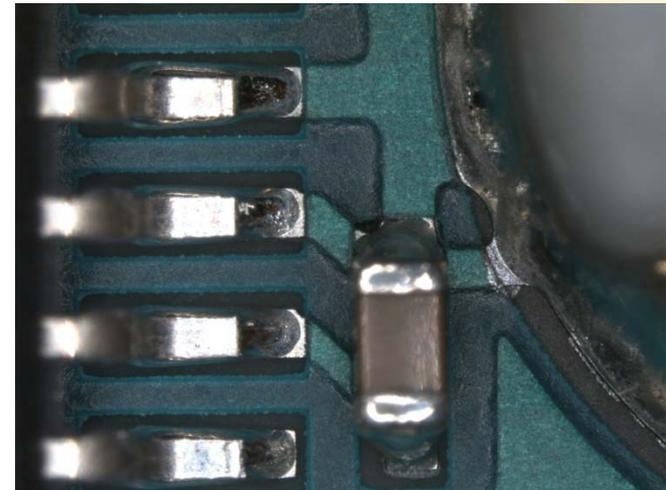
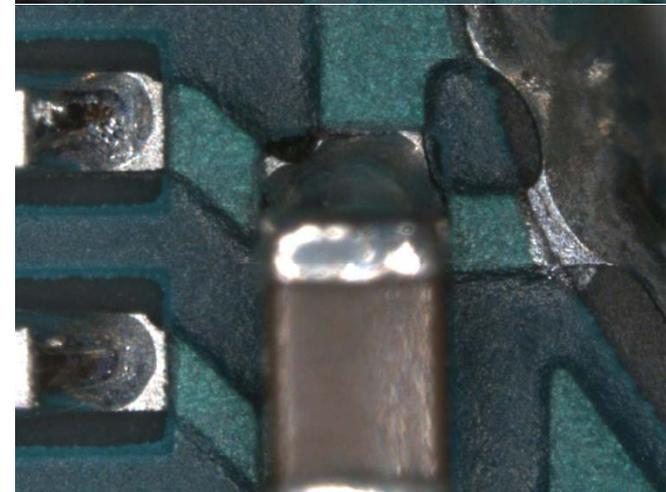
With Air-Knife

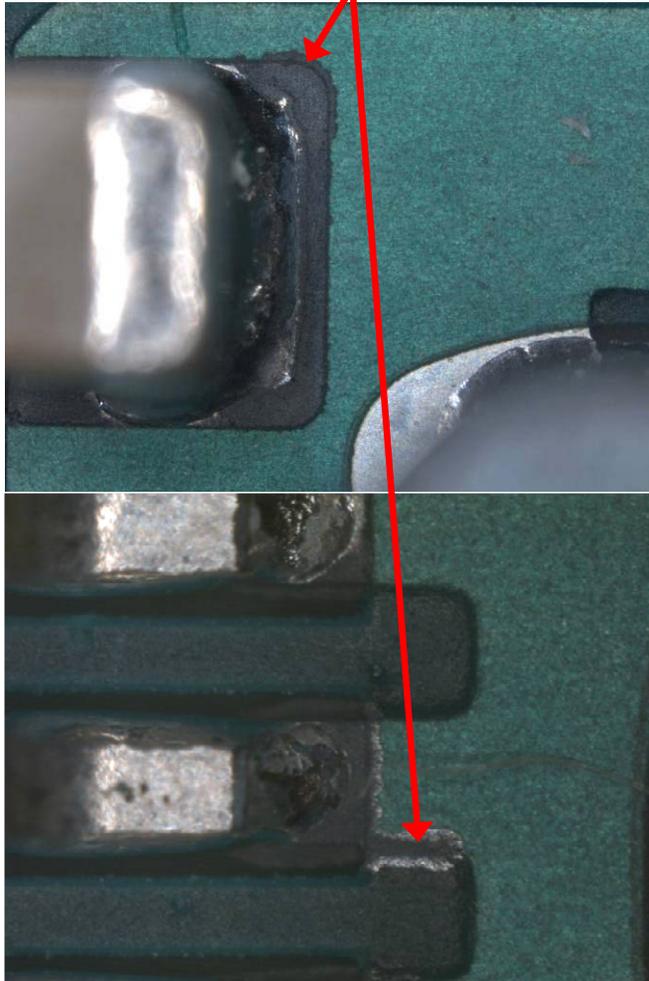
Without Air-Knife

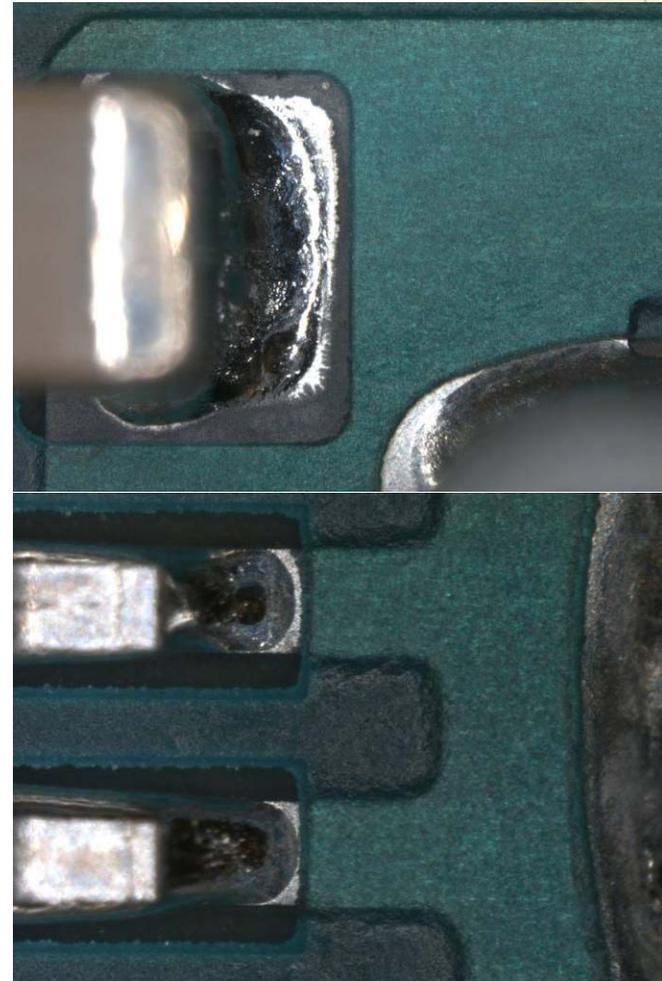
With Air-Knife
