# **An Investigation into Hand Sanitizers and Hand Lotions and Potential Risks to High Performance Electronics**

Douglas Pauls  
Michael Vosatka  
Rockwell Collins  
Cedar Rapids, IA

## **Abstract**

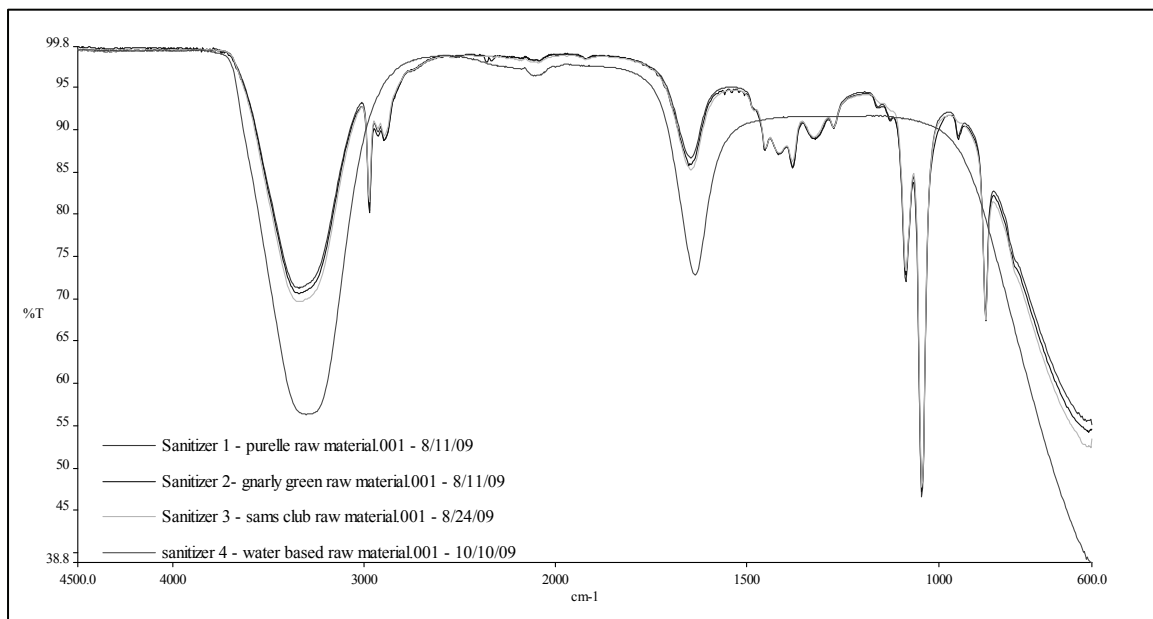
**Figure 2. FTIR Spectra of Alcohol Based Sanitizers**

The ethanol-based sanitizer materials all had nearly identical infrared fingerprints, correlating strongly to alcohol. The X3 sanitizer, which was not alcohol based, had a different IR fingerprint. Figure 2 shows the composite FTIR scan.

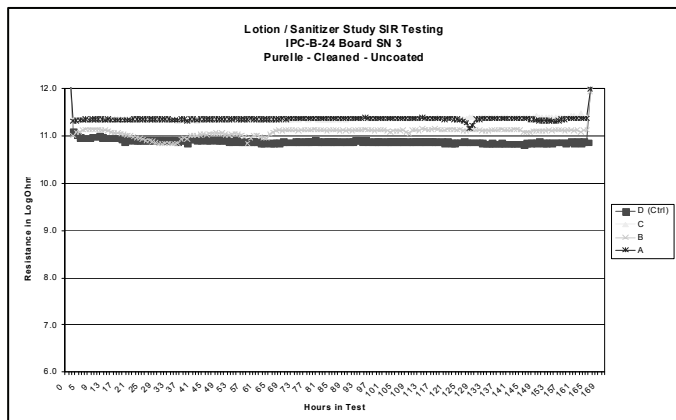
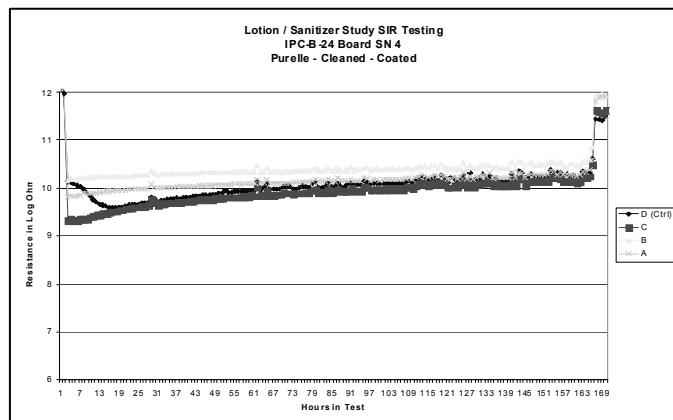
1. Figures 9 through 12 show the results for the Purell material.

- For the samples handled with Purell treated hands, all of the measured results were above the 8.0 LogOhm criteria.
- For all of the Purell combinations, there was not a great deal of variation between the control pattern (D) and the handled patterns. In most cases, the uncoated control pattern was higher in SIR level than for the handled patterns, but not dramatically so. While all of the SIR values were above the 8.0 LogOhm level, it is clear that handling the patterns has some degradation on SIR performance, though minor in this case. The two best SIR performances came from the cleaned boards and the two poorest (though still acceptable) came from the uncleaned boards.

- In the post-SIR visual examination, performed at 4-10X magnification, no indication of corrosion or electrochemical migration (dendritic growth) was found.

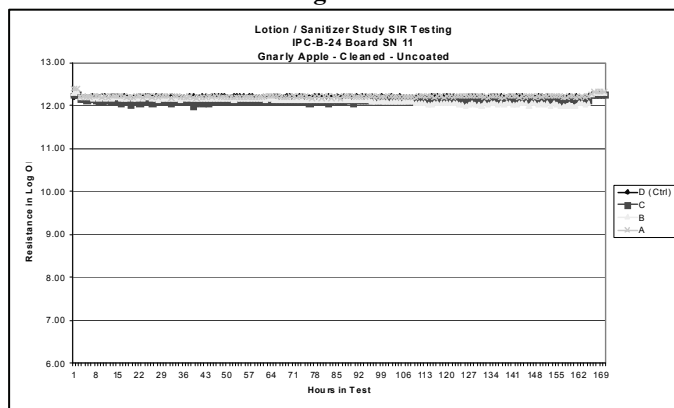
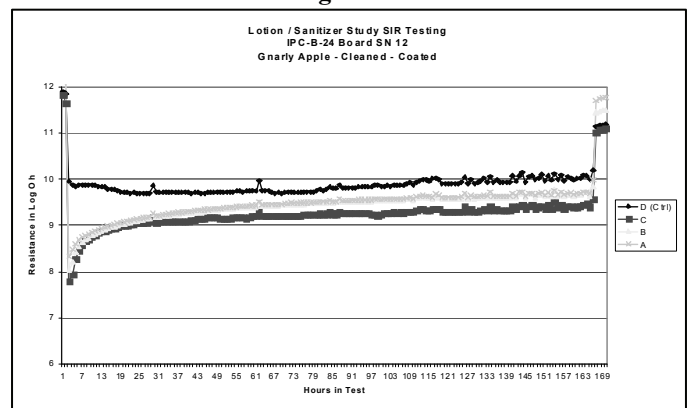
1. Figures 17 through 20 show the results for the Germ-X Gnarly Green material.

- For the samples handled with Gnarly Green treated hands, the SIR levels were above the 8.0 LogOhm level, with the possible exception of the first initial measurements at the hot and humid test conditions.

- In general, most SIR test methods do not consider the first data points taken at elevated conditions to be valid, as the system is still coming to equilibrium. The SIR testing in this evaluation was also done with a more frequent measurement interval than most SIR test methods, so the first initial data points were not given much weight.

- Using the remaining data for analysis, there was a noticeable difference between the control patterns (D) and the treated patterns (A-C), though not as great as noted for the Sam's Club material. As with the Sam's Club sanitizer, the data suggests that the Gnarly Green material does leave a form of residue that can still impact SIR performance, even after exposure to an optimized aqueous wash process. However, as the values were above the 8.0 LogOhm level, the impact would not be considered as harmful.

- The post-SIR visual examination showed no signs of corrosion or metal migration.

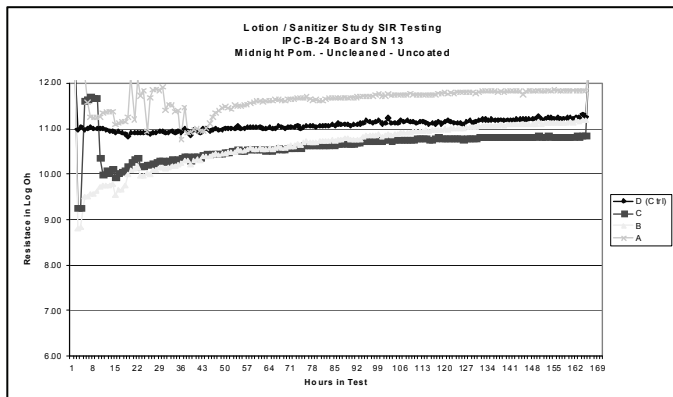
1. Figures 21 through 24 show the results for the Midnight Pomegranate material.

2. For the samples handled with Midnight Pomegranate treated hands, all of the measured results were above the 8.0 LogOhm criteria.
3. The data for Figure 21 suggests that for the uncleaned and uncoated boards, there was an interaction between the lotion residues and humidity, taking several days to come to an equilibrium condition. The data in Figure 22 (cleaned/uncoated) shows that the cleaning process removed the residues.
4. The variability in the SIR performance in Figure 24 (cleaned / coated) is unexplained. The most likely cause is variability in the applied coating, which was applied by hand.
5. The post-SIR visual examination showed no signs of corrosion or metal migration.

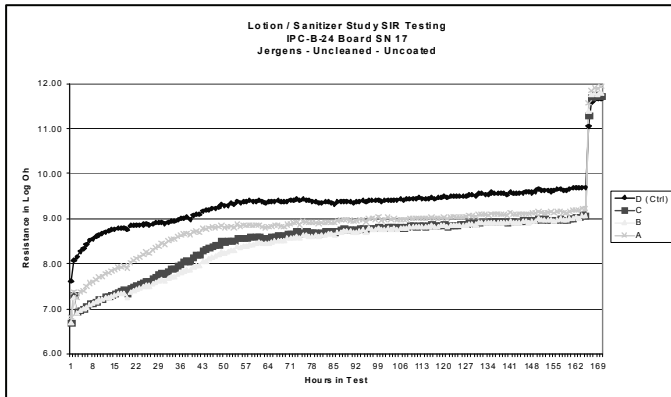
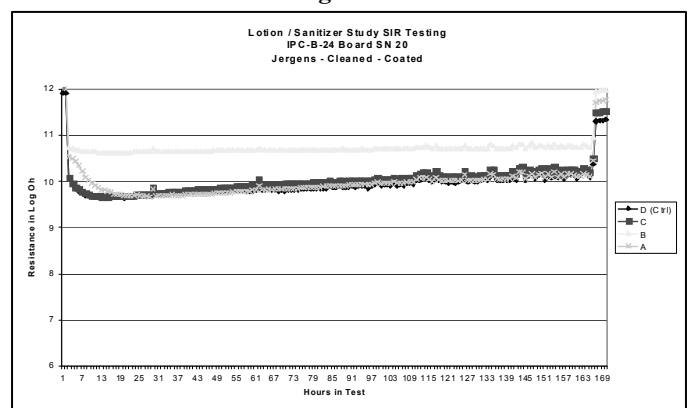
1. Figures 25 through 28 show the results for the Jergens material.

- The SIR performance for the Jergens' material was significantly poor than for the other lotions or sanitizers examined. The values for the first two days of testing in Figure 25 were consistently below the 8.0 LogOhm criteria. This suggests that the residues from the Jergens lotion was more persistent and hydrophilic (water attracting). The poor performance of the control pattern suggests that the residues may be mobile. It may also be that this test board had lotion residues inadvertently applied to the control pattern.

- The data in Figure 27 suggests that the lotion residue, even when coated over with conformal coating, can combine with moisture to degrade insulation resistance. The difference in performance between the different treated patterns (A-C) suggests that there may be some threshold value for the residues, where enough residue was present on pattern C to show poor performance, whereas patterns A and B did not exhibit the same performance.

- The data for Figures 26 and 28 showed desirable SIR performance, well above the 8.0 LogOhm criteria, with consistent performance from all patterns. This indicates that whatever the residue was that caused the poor performance, it was fully removed by the aqueous wash process.

- As with the other materials, there was no evidence of corrosion or metal migration on any of the test patterns.

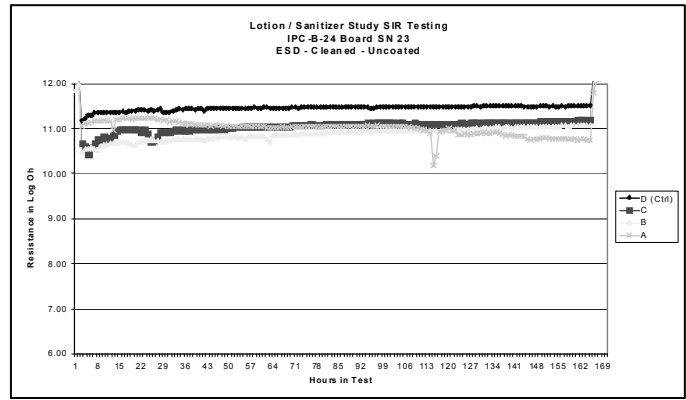
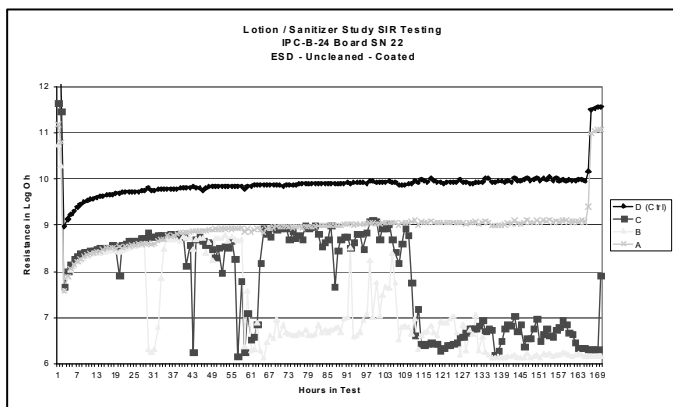
1. Figures 29 through 32 show the results for the Chemtronics material.

2. As with the other lotion materials, the SIR performance dipped below the 8.0 LogOhm metric initially, recovering to higher levels later in the test.

3. The data for the two uncleaned cases (Figures 29, 31) showed a decade of difference between the untreated control pattern (D) and the treated patterns (A-C). Figure 29 shows that the samples that were uncleaned and uncoated had consistent performance throughout the test. Figure 31 shows highly variable results for the uncleaned but coated condition. The two affected patterns (B and C) had some level of coating delamination noted in the post-SIR visual examination, indicating that the residues could interfere or interact negatively with conformal coating, leading to poor SIR performance. No corrosion or metal migration was noted for these affected patterns.

4. The data from Figures 30 and 32 shows that whatever residue remained was removed by the aqueous cleaning process.
5. No corrosion or metal migration was noted for any of the other test patterns.
