# Rework Process Window and Microstructural Analysis for Lead-Free Mirrored Bga Design Points

Matthew Kelly, Mitchell Ferrill  
IBM Corporation

Polina Snugovsky, Rupen Trivedi, Gaby Dinca, Chris Achong, Zohreh Bagheri  
Celestica International Inc.

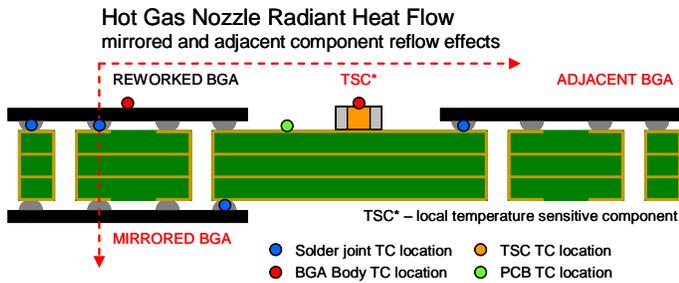
As shown in Figure 1, a mirrored BGA design construction consists of a BGA device on the top side of the printed circuit board assembly, with another BGA device on the bottom side of the assembly – directly under the top side device. The more rigid double sided construction is consequently more process sensitive and may exhibit lower thermo-mechanical reliability performance if specific material and process details are not carefully monitored and controlled.

Figure 1. Mirrored, Adjacent, PCB, and TSC Heat Effects (not to scale)

Firstly, as shown in Figures 1 and 2, during hot gas rework of a mirrored BGA device it is important to thermally monitor the rework site of interest as well as the local PCB temperature, mirrored BGA solder joints under the rework site, any adjacent (same side) BGA solder joints, and any local temperature sensitive component (TSC) body temperatures.

The number of thermocouples used to monitor the mirrored lead-free BGA rework process was increased. Thermocouples should be placed in the following locations to ensure that the various components of the PCBA are sufficiently monitored and controlled (see Figure 1):

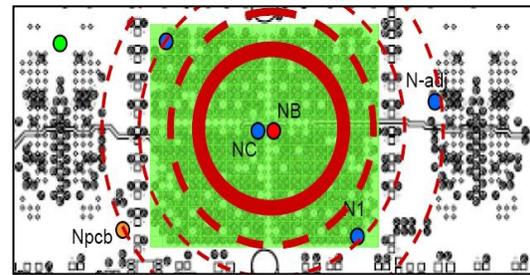
Figure 2. Hot Gas Nozzle Radial Heat Flow

Secondly, as shown in Figure 2 with the concentric red circles, there is an increased thermal radius from the rework nozzle location due to the elevated melting point of the SnAgCu alloy. With higher processing temperatures there is greater heat transfer from the top to bottom side of the assembly, and there is a larger thermal radius affecting adjacent components near the repair location. Since the heat transfer through the PCB is substantial, shielding the mirrored BGA from secondary reflow is of greater difficulty. Likewise, with a larger thermal radius, more adjacent BGAs and local TSCs will be affected, and must also be shielded to avoid partial reflow conditions. These highlighted issues are especially of concern for thinner card cross sections ranging nominally from 0.050" to 0.062" (1.2 to 1.6mm).

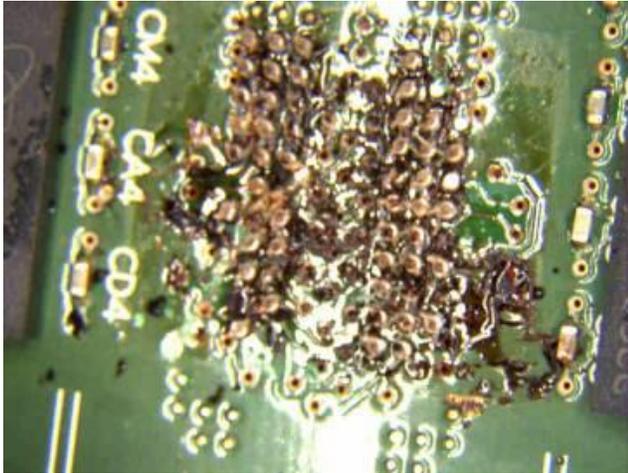
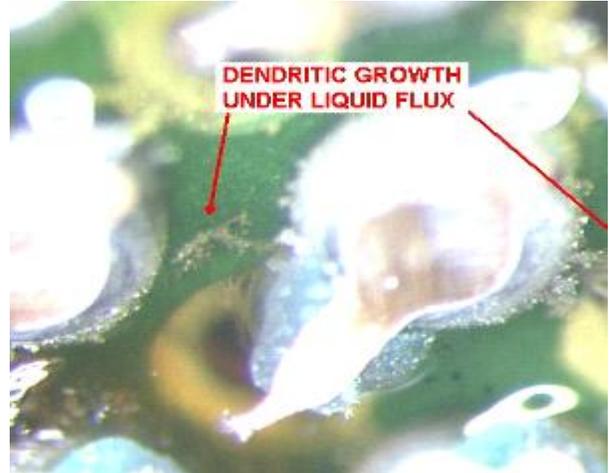
Dendritic growth, leading to conductor shorting, was observed under *mirrored* SAC305  $\mu$ BGA test devices, after hot gas rework processing was conducted on a *topside* SAC305 BGA and  $\mu$ BGA locations. The mirrored BGA device was originally not allowed to reflow and a no-clean, halide bearing (L1 type) tack flux was used for the hot gas rework process. The results are shown below in Figures 3 and 4. Figure 3 shows the mirrored  $\mu$ BGA device location after the device was removed. Under the mirrored location, excessive flux pooling and charring was observed. Figure 4 shows upon closer examination that dendritic growth between via and pad structures on the PCB surface had occurred, ultimately resulting in device failure.

**Figure 3 (left). Figure 4 (right).** Dendritic Growth photos under a Mirrored  $\mu$ BGA Rework Location

Failure analysis determined that the root cause of the test failure could be attributed to the flux chemistry used, the flux application method used, and inadequate thermal activation of the flux during the hot gas rework process.

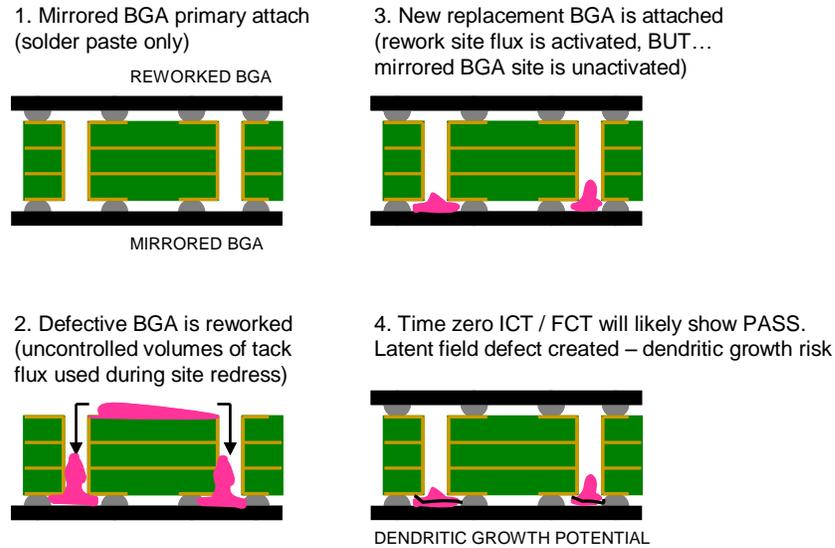
1. Halide bearing, no-clean tack flux was smeared into top side vias during the site redress process step, and was not removed before the reflow process.
2. As the replacement top side BGA and  $\mu$ BGA devices were being soldered, the excess tack flux, through capillary action and heat, wicked down the open via structures associated with the mirrored  $\mu$ BGA construction and pooled between the bottom side of the PCB and the backside  $\mu$ BGA device.
3. Traditional hot gas rework techniques were originally used to ensure that the mirrored  $\mu$ BGA solder joints did not undergo secondary reflow.
4. Partially un-activated halide bearing flux (only partially cured) pooled under the mirrored  $\mu$ BGA device.
5. No final wash step was used.
6. Over time, under electrical bias and ambient humidity, dendritic growth occurred.

Below in Figure 5, the failure mechanism is outlined graphically step by step.

**Figure 5.** Mirrored  $\mu$ BGA Rework Dendritic Growth Pathway

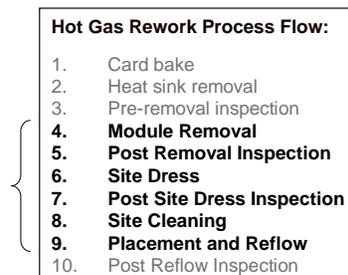
In combination with assembly material selection activities, an end-to-end review was conducted on the existing mirrored BGA hot gas rework process to examine opportunities for improvement and risk mitigation. Figure 6 shows the conventional process flow, along with highlighted steps (4 through 9) that were modified during process development activities.

**Figure 6. Process Development Areas**

Changes were made in the module removal, inspection, site redress, cleaning, and reflow processes. Of these process changes, the most significant development activities involved final hot gas reflow.

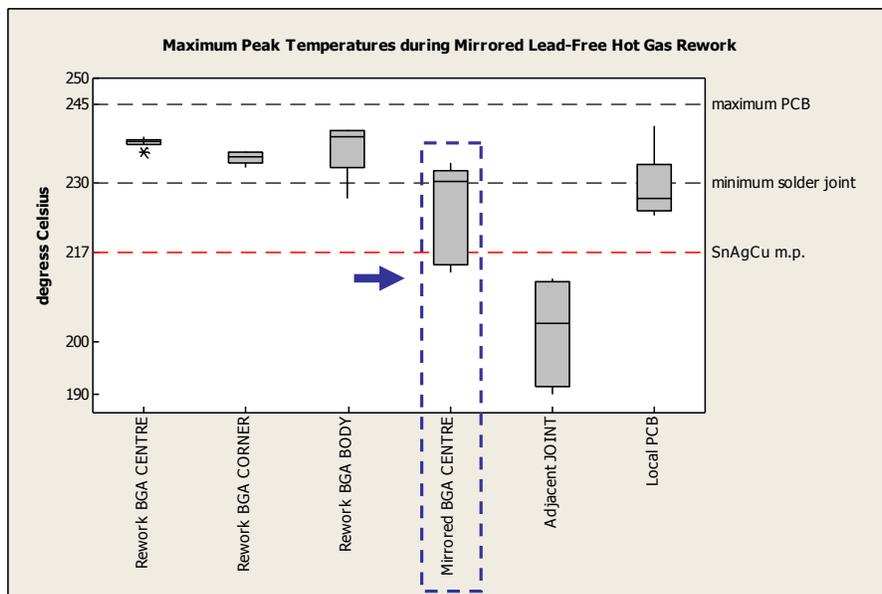
Figure 7 shows the same data graphically. Depending upon the design configuration, mirrored BGA solder joints may remain above 230°C (desired condition), may reflow within the pasty range of the solder, or may remain below 217°C and not reflow.

**Figure 7. Maximum Peak Temperature Ranges for Mirrored BGAs**

As will be discussed further in the following sections, significant rework process development activities have highlighted that lead-free mirrored solder joint temperatures during rework should be processed avoiding the alloy’s pasty range; allowing mirrored joints to fully reflow if they cannot be sufficiently shielded and remain below the melting point of the alloy.

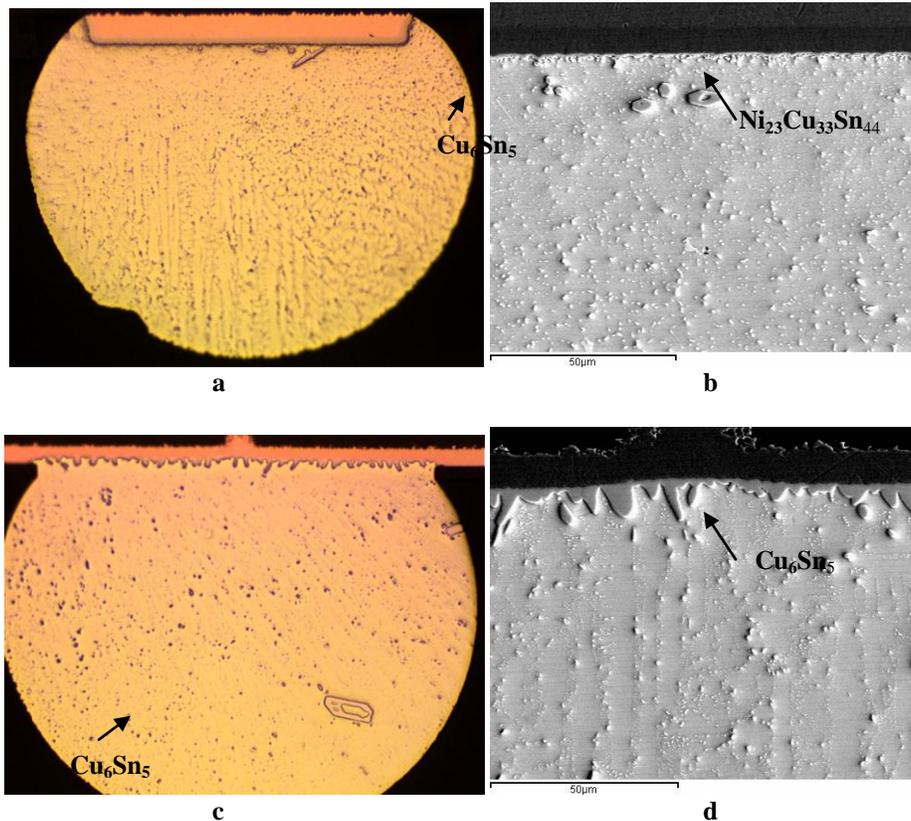
The microstructures of as-received BGA components are shown in Figures 8a through 8d. Although both the  $\mu$ BGA and PBGA had SAC305 solder balls, the microstructure, composition, and intermetallic types after ball attachment were quite different.

**Figure 8. Microstructure of As-Received  $\mu$ BGA (a, b) and PBGA (c, d): a: 200X; b: SEM 1000X; c: 200X; d: SEM 1000X**

The intermetallic reaction layer formed between ENIG finished pads of the  $\mu$ BGA and the SnAgCu solder ball contained 25.1 at. % Ni, 33.1 at. % Cu, and 41.9 at. % Sn (Table 3) and was found to be a ternary compound. The existence of this compound in a SnNiCu system was shown by Obendorff in 2001 [5] and was confirmed by L. Snugovsky et al [6] in 2005. As shown in [6], this ternary compound corresponds to the formula  $\text{Ni}_{23}\text{Cu}_{33}\text{Sn}_{44}$ . The intermetallic reaction layer was thin and did not exceed 1  $\mu\text{m}$  (Table 3).

The intermetallic layer of the PBGAs at the copper substrate pad was much thicker (Figure 8) with an average thickness of 5  $\mu\text{m}$ . It had a cellular structure with some spikes protruding into the bulk solder up to 8  $\mu\text{m}$ . The composition is shown in Table 3 and corresponds to the  $\text{Cu}_6\text{Sn}_5$  formulation.

The microstructure of both the  $\mu$ BGA and PBGA (Figure 8) contained primary-like Sn dendrites and Sn+ $\text{Ag}_3\text{Sn}$ + $\text{Cu}_6\text{Sn}_5$  eutectic within the interdendritic spaces. The primary  $\text{Cu}_6\text{Sn}_5$  hexagons (which are hollow) were also present in both components. In the case of the PBGA, there were more  $\text{Cu}_6\text{Sn}_5$  particles and they were larger in size. This indicated a higher Cu content within the PBGA solder ball. The EDX analysis showed that  $\mu$ BGA balls contained 2.99%Ag and 0.55%Cu, which corresponded with a SAC305 sphere composition. The PBGA balls contained 3.1%Ag and 1.0%Cu that was a result of Cu dissolution during sphere attachment. The reduction of Cu pad thickness is also visible in Figure 8c.

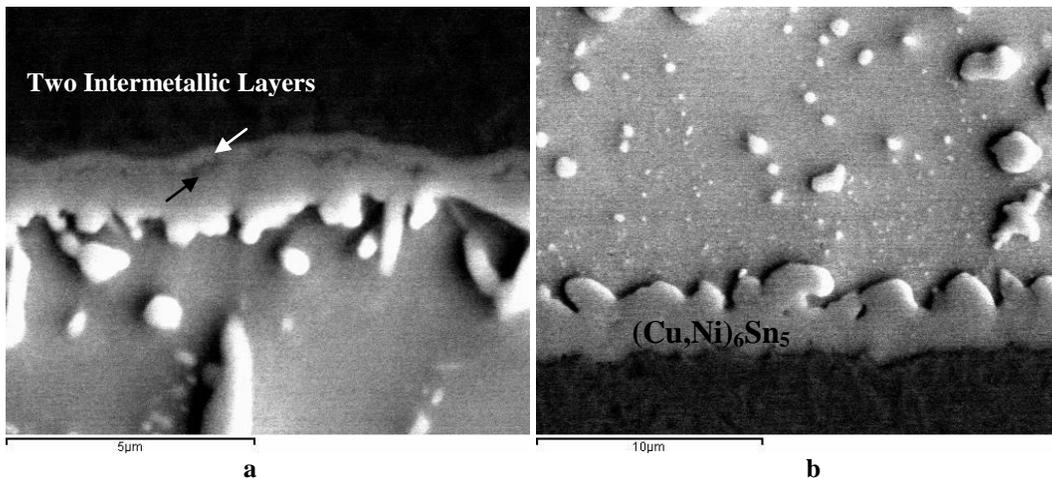
When assembled to the copper/OSP surface finish board during SMT primary attachment reflow processing, the  $\mu\text{BGA}$  microstructure underwent some changes. Two layers of intermetallic on the component side were visible under SEM at high magnification (Figure 9a). Also, long spikes grew from the previously flat intermetallic interface (Figure 9b). The composition of the two intermetallic layers was the same and similar to the as-received component (Table 3). The two layered structure may be explained by partial intermetallic dissolution during reflow followed by precipitation at the cooling stage, which resulted in a boundary formation in the intermetallic layer. The board side intermetallic was a  $\text{Cu}_6\text{Sn}_5$  type with some Cu atoms substituted by Ni (Table 3).

**Figure 9. Microstructure of SMT Primary Attached  $\mu\text{BGA}$ , SEM: a – Component Side; b –Board side**

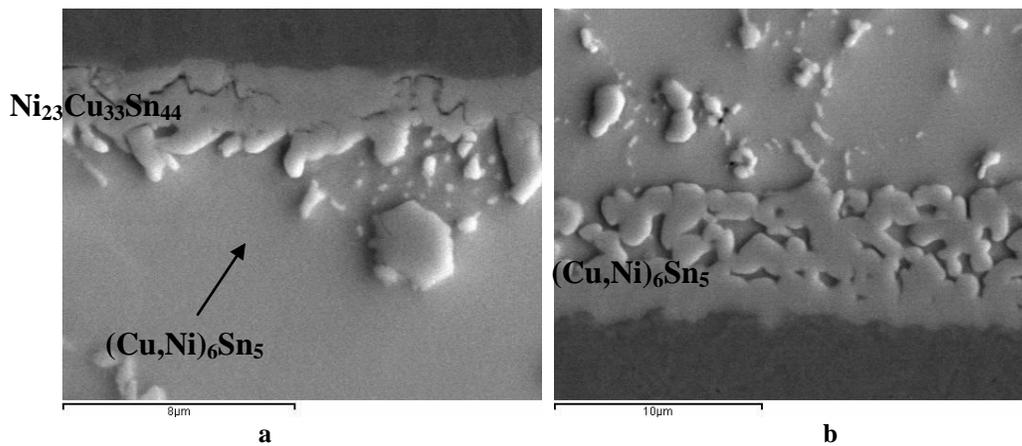
Reworked  $\mu$ BGA joints showed different intermetallic morphology, thickness and solder microstructure (Figure 10) than that of as-assembled joints. The intermetallic formed at the component side was slightly thicker than in primary attachment reflowed joints (1.0  $\mu\text{m}$ , 1.2 $\mu\text{m}$ , and 1.7  $\mu\text{m}$ , respectively) as shown in Table 3. Similar to the primary attached joints, two layers of intermetallic were detectable at the component side. Both were the  $\text{Ni}_{23}\text{Cu}_{33}\text{Sn}_{44}$  type.

The board side intermetallic layer of reworked  $\mu$ BGAs was more than two times thicker than in primary attachment  $\mu$ BGAs (Table 3). It was determined to be a  $\text{Cu}_6\text{Sn}_5$  type with some Ni atoms incorporated within the structure. Solid at the base on the Cu pad, the intermetallic layer turned into the lace-like structure closely resembling the bulk solder (Figure 10b). This intermetallic layer morphology was common for reworked BGA solder joints integrating NiAu on the component side and Cu on the PCB side (made available from surface finishes like OSP, Immersion Ag, or Immersion Sn).

Figure 10. Microstructure of Reworked  $\mu$ BGA, SEM: a – component side, b –board side

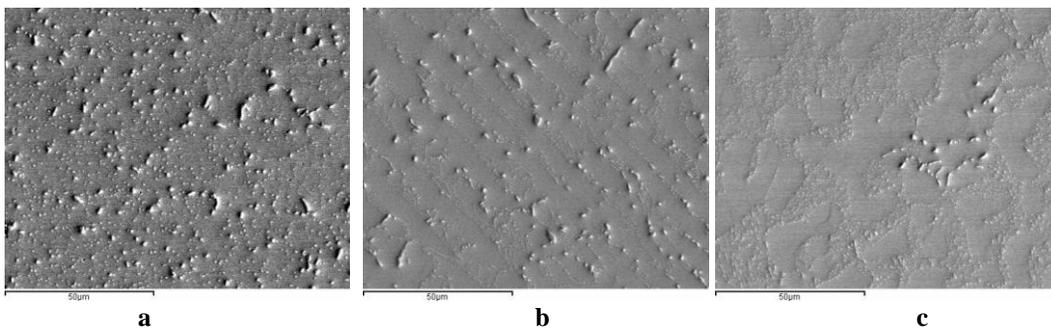
The bulk solder joint microstructure of reworked  $\mu$ BGAs was also different from primary attachment top side and double reflowed bottom side joints (Figure 11). The microstructure also consisted of primary-like Sn dendrites and Sn+Ag<sub>3</sub>Sn+Cu<sub>6</sub>Sn<sub>5</sub> eutectic within the interdendritic spaces, but with Sn dendrites having a defined orientation and the larger dendritic arms. There were primary Cu<sub>6</sub>Sn<sub>5</sub> particles that were often attached and were close to the component side intermetallic layer (Figure 10a). The content of Cu in the bulk solder exceeded that of an as-received component by a factor of 2.6 (Figure 12) as a result of the Cu dissolution from the board side Cu pad. The Ag content was also slightly higher and will be discussed later in this paper.

Figure 11. Microstructure of a Centre Ball from a Primary Attached  $\mu$ BGA (a), a Reworked  $\mu$ BGA

(b), and Reworked PBGA, (c) SEM 1000X

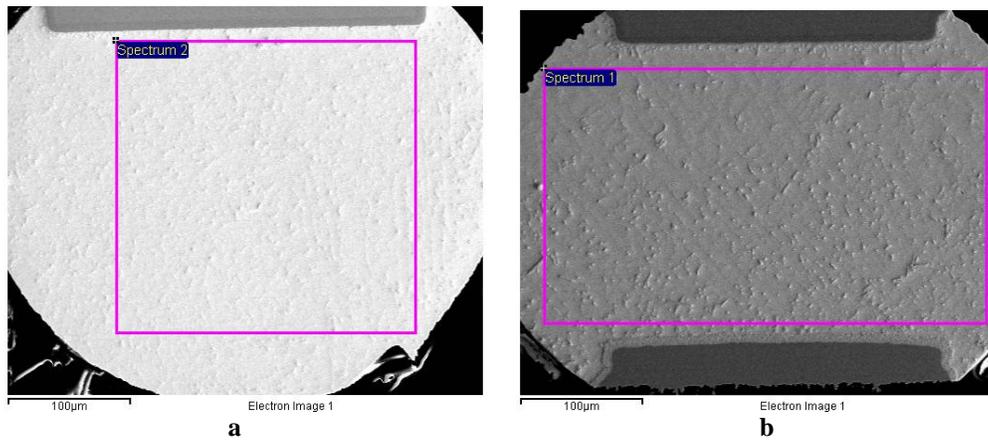
**Figure 12.** Microstructure and Composition of an Unassembled (a) and reworked (b)  $\mu$ BGA, SEM, 300X

Virgin $\mu$ BGA			Reworked $\mu$ BGA		
Element	Weight %	Atomic %	Element	Weight %	Atomic %
Cu	0.55	1.01	Cu	1.42	2.61
Ag	2.99	3.27	Ag	3.17	3.44
Sn	96.46	95.72	Sn	95.41	93.96

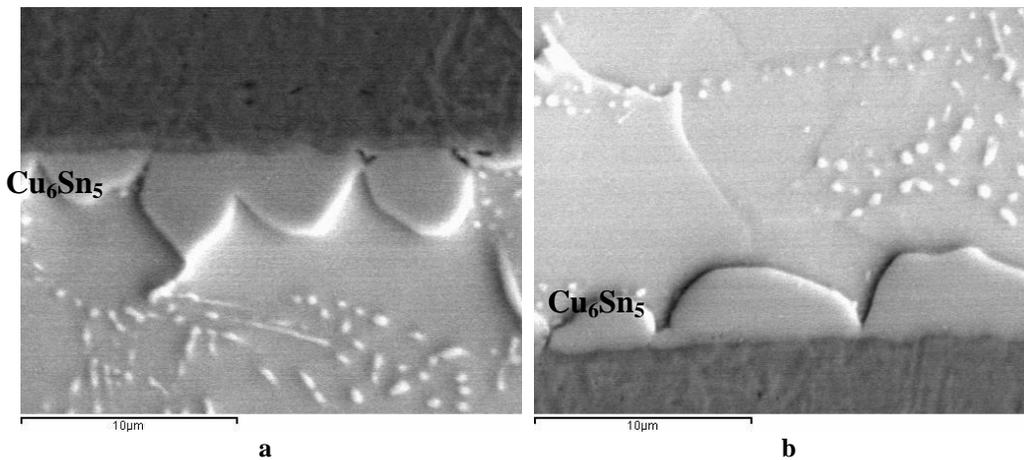
The intermetallic characteristics and microstructure of the reworked PBGA is shown in Table 3 and Figure 13. The  $\text{Cu}_6\text{Sn}_5$  type with the same composition, microstructure, and thicknesses was formed on the component and board sides. The morphology of both component and board layers were completely different from those found within the  $\mu$ BGAs (Figure 10). The intermetallic layers found within the reworked PBGAs did not have a lace-like or layered structure. Instead, they were dense and had a cellular structure. This difference indicates different behaviour of the  $\text{Ni}_{23}\text{Cu}_{33}\text{Sn}_{44}$  and  $(\text{Cu},\text{Ni})_6\text{Sn}_5$  when compared to  $\text{Cu}_6\text{Sn}_5$  during dissolution followed by precipitation during the rework process. As shown in Figure 11, the bulk solder joint microstructure of PBGAs was coarser and the proportion of eutectic was higher than found within the  $\mu$ BGAs.

**Figure 13.** Microstructure of reworked PBGA, SEM, 5000X: a – component side; b –board side

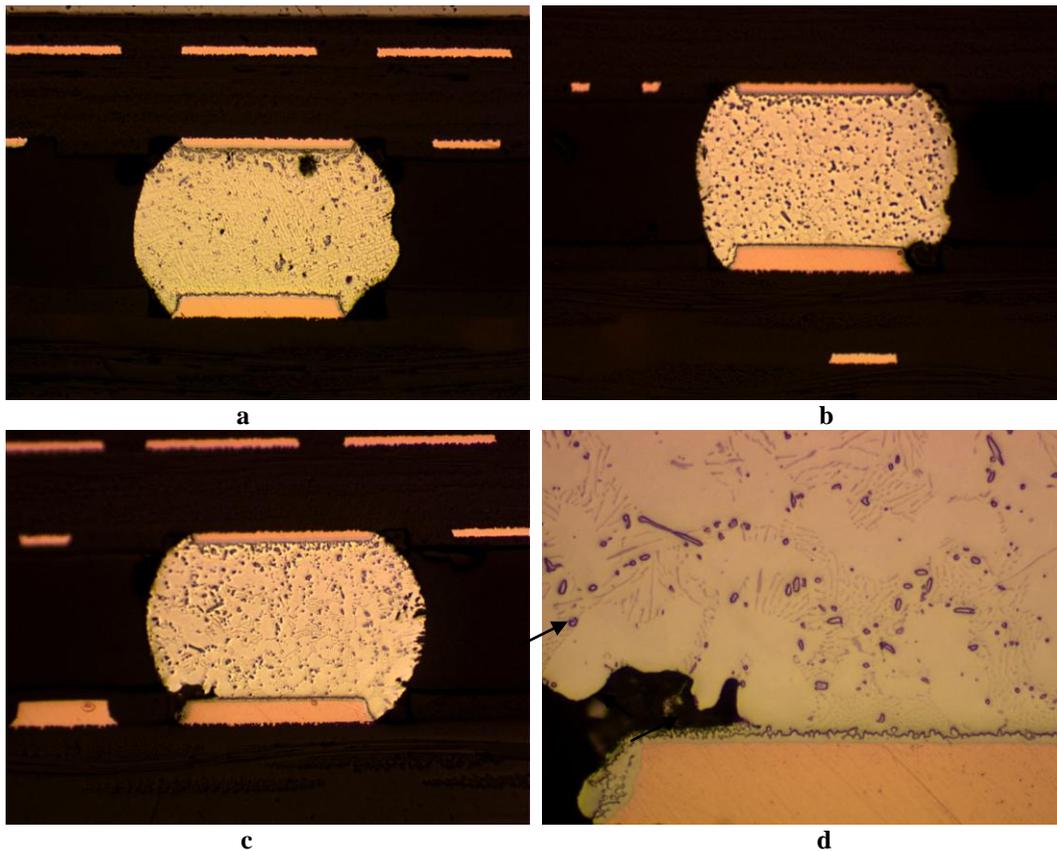
The defects found within mirrored solder joints detected *prior to process optimization* are shown below in Figure 14. The mirrored solder joints often had irregular shapes (Figure 14a, b). Also, voids or partial separation between the solder and the intermetallic layer were present in mirrored BGAs located under the reworked location (Figure 14c, d). These defects were not observed in SnPb solder control samples. Detailed analysis revealed that the separation propagated through the SnAgCu ternary eutectic phases accumulating at the board side. The separation had a dendritic shape. As shown in Figure 14d, it follows the eutectic boundary between the board surface and dendritic arms. The alloy's pasty range was determined to be the reason for this separation and irregular shape.

During cooling of SnAgCu alloys after reflow, solidification began with the formation of primary  $\text{Ag}_3\text{Sn}$  or  $\text{Cu}_6\text{Sn}_5$  depending on solder composition. Next, Sn nucleation occurred. The Sn phase grew in a dendritic shape towards the hot board side. Finally, the liquid crystallized as a binary system ( $\text{Sn}+\text{Ag}_3\text{Sn}$  or  $\text{Sn}+\text{Cu}_6\text{Sn}_5$ ) and then ternary eutectic ( $\text{Sn}+\text{Ag}_3\text{Sn}+\text{Cu}_6\text{Sn}_5$ ) within interdendritic spaces. The last portion of liquid with the lowest melting temperature solidified at the board side. The melting temperature of the ternary eutectic in SnAgCu solder alloys was approximately  $217^\circ\text{C}$ . Any additional constituents resulting from dissolution of the substrate material, such as Au in the joints with NiAu finished components, segregated in the last liquid to freeze and reduce the eutectic temperature even further. The presence of a quaternary  $\text{Sn}+\text{Ag}_3\text{Sn}+(\text{Cu},\text{Ni})_6\text{Sn}_5+\text{AuSn}_4$  eutectic was detected within the analyzed assemblies (Figure 15a). The DSC curve of an as-assembled solder joint is shown in Figure 15b. It revealed that melting may begin at a temperature as low as  $212.5^\circ\text{C}$ . Narrow liquid layers form between the Sn dendrites and the intermetallic layer /solder interface at the board side. Sliding and opening between the Sn grains and the intermetallic layer / solder interface under internal stresses help to explain the observed irregular solder joint shapes, voids, and separations.

**Figure 14.** Defects of Mirrored  $\mu\text{BGAs}$  after Topside Rework: a, b, c – 100X; d – 400X

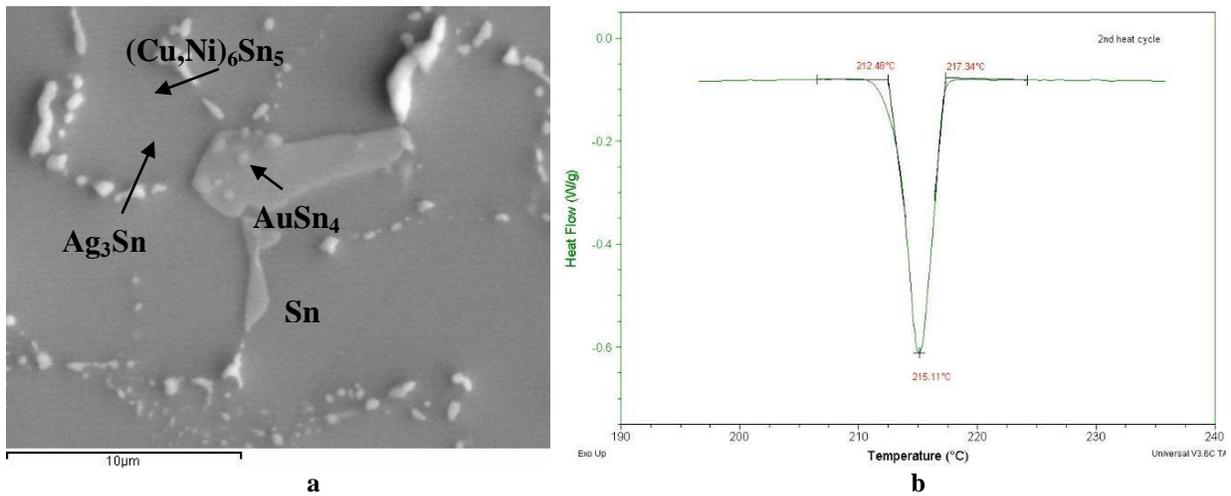
**Figure 15.** Microstructure of the Low Melting Eutectic (a) and DSC characterisation of melting  $\mu\text{BGA}$  joints

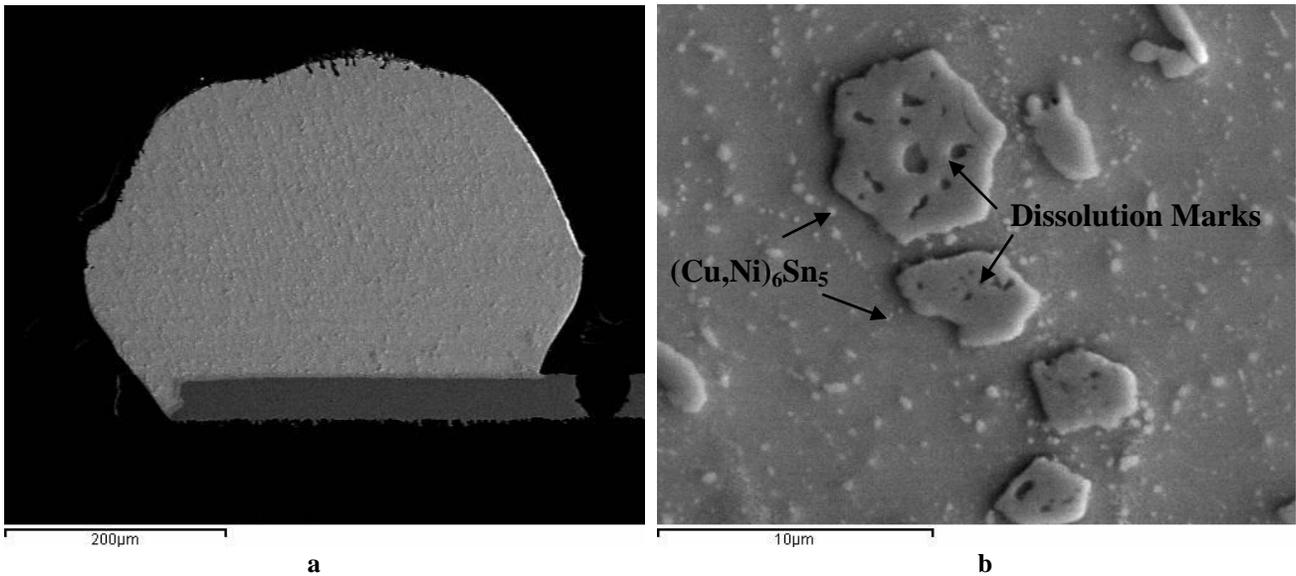
To further understand the final microstructure of mirrored BGA solder joints after top side rework operations, metallurgical analysis after each process step was performed. During component removal the bulk solder melted. The intermetallic layer at the board side as well as single primary intermetallic  $\text{Cu}_6\text{Sn}_5$  particles started dissolving into the liquid solder. This resulted in intermetallic thickness reduction (Table 4) and the changing of the shape of the primary crystals. A significant amount of solder was still attached to the board pad after original component removal (Figure 16).

**Figure 16.**  $\mu$ BGA location after component removal: a – 200X; b - Microstructure of partially dissolved  $\text{Cu}_6\text{Sn}_5$  particles

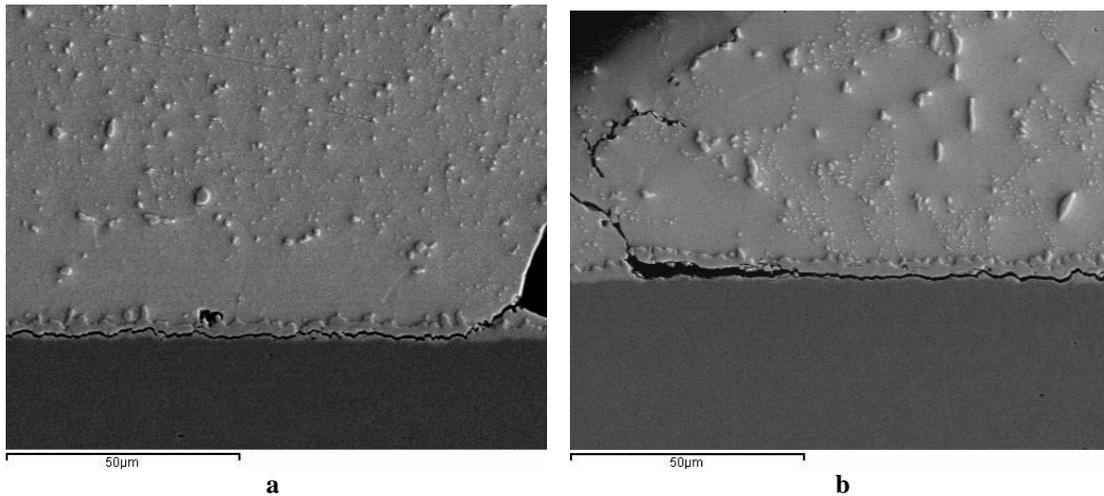
Component removal caused the most significant changes in microstructure of mirrored BGAs. The area of the mirrored solder joint closest to the board was shown to surpass the alloy's melting temperature. In a semi melted stage, microstructure coarsening and separation occurred. The separation propagated through the solder grain boundaries between the intermetallic layer and the bulk solder. This observation may occur through the intermetallic layer because of the greatly reduced strength of the intermetallic at the temperature near the melting point and increased internal stresses. This defect is quite dangerous because it may be aggravated during thermal cycle exposures (Figure 17). The thickness of the intermetallic layers at both the component and board sides were not affected and were similar to SMT reflowed primary attachment joints.

**Figure 17.** Mirror  $\mu$ BGA under removed component, SEM, 1000x: a – after component removal; b – ATC

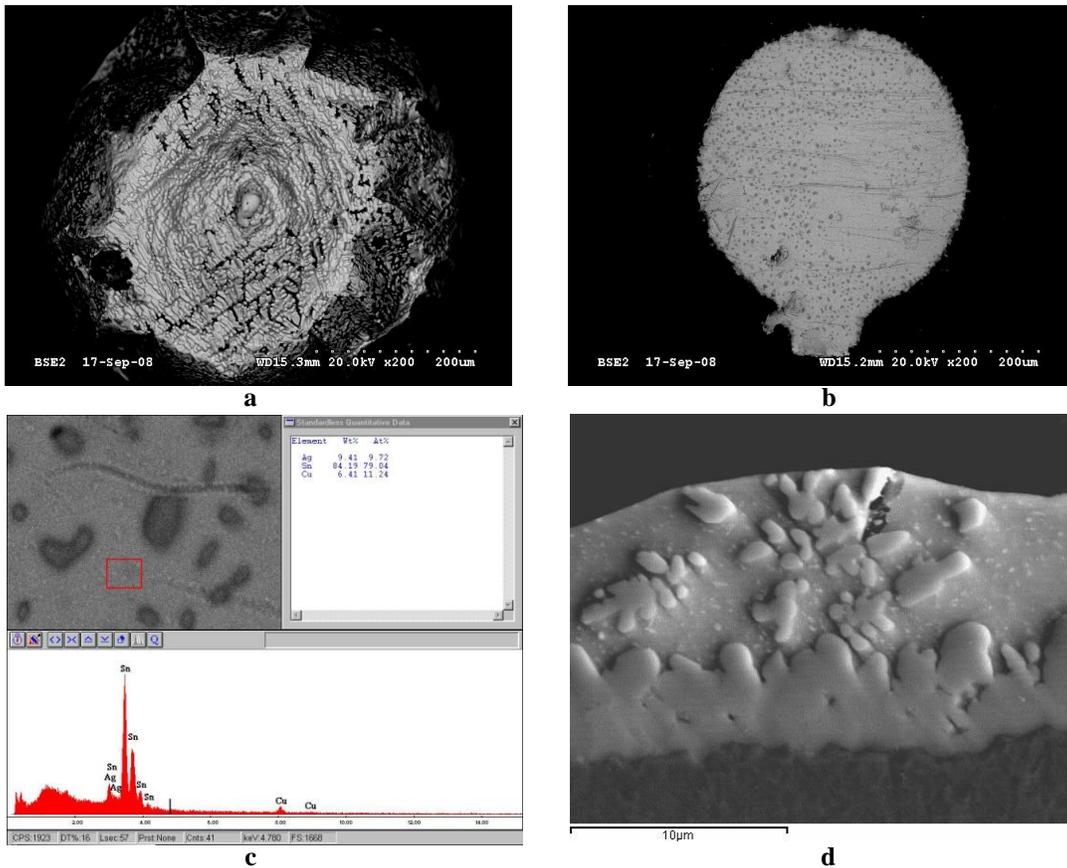
During the redress step, most of the solder left after component removal was consumed by using Cu solder wick. The top view under the SEM is shown in Figure 18. The pads look flat compared to the previous component removal stage of rework (Figure 18a, b). EDX analysis indicated that in addition to the  $\text{Cu}_6\text{Sn}_5$  area - black spots (solder with very high Ag content – 8.8 to 18%) were present. The microstructure of a cross-sectioned pad after site redressing is shown in Figure 8d. Some solder still remained on top of the intermetallic layer. This solder contained many  $\text{Ag}_3\text{Sn}$  intermetallic particles that caused a shift in its composition from the near eutectic to off-eutectic. This accumulation of the  $\text{Ag}_3\text{Sn}$  intermetallic particles resulted in higher Ag content within reworked solder joints, as previously discussed. There was no change observed in intermetallic thickness after this process step.

**Figure 18.** SEM Photos of Pads after Component Removal (a) after Removal and Redressing, (b) Residual Solder Composition, (c) Cross Sectional Composition, (d) Final Microstructure

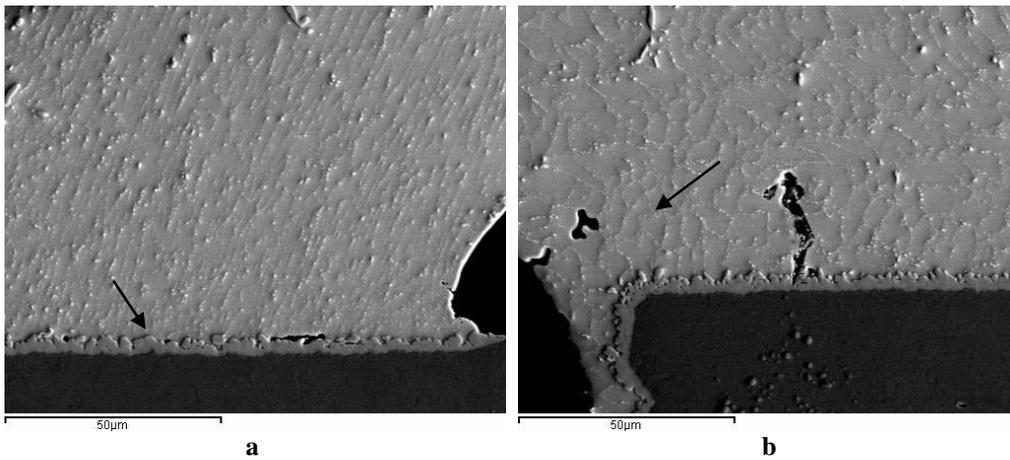
Mirrored components, after redressing the rework site, demonstrated similar separation and shrinkage defects that were shown before in the samples after component removal. These defects may be inherited from the previous stage of rework, or created additionally (Figure 19).

**Figure 19.** Mirrored µBGA under reworked component, separations caused by partial melting, SEM, 1000x

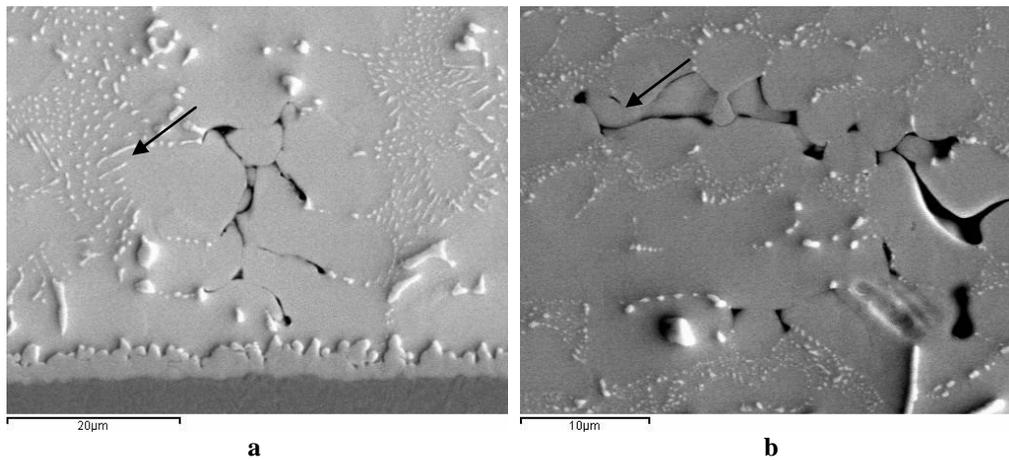
As discussed, option (a) which prevents the melting of mirrored BGA solder joints may not provide sufficient heat to thermally activate flux that has wicked under mirrored BGAs. Option (b) which allows partial melting may aggravate the defects from the removal and redressing rework process steps discussed within this paper. If partial melting of the Sn occurs near the intermetallic layer / bulk solder interface, defects that look like tiny cracks may be produced as shown in Figure 20.

**Figure 20.** Mirrored  $\mu$ BGA under Reworked (a)  $\mu$ BGA and (b) PBGA, separations caused by partial melting, SEM: A – 2000X: b – 3000X

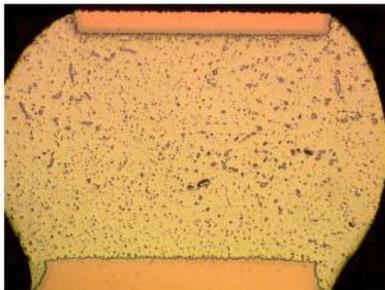
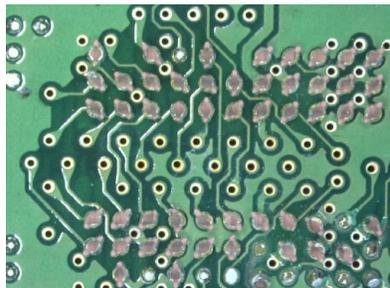
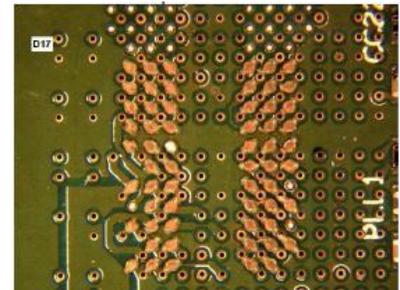
Construction analysis showed that resultant mirrored BGAs had excellent bulk solder joint collapse and had well-formed IMC layers at the PCB and component side interfaces. In addition to the excellent metallurgical structure observed, significant process improvements reduced flux residue and the amount of flux pooling down via structures; reducing the risk of dendritic growth shorting. Example final structures are shown in Figure 21.

Well formed joints; good IMC

Die & Pry performed well

Reduction in flux pooling

**Figure 21.** Backside Flux Pooling eliminated with Excellent Solder Joint Formation and Collapse

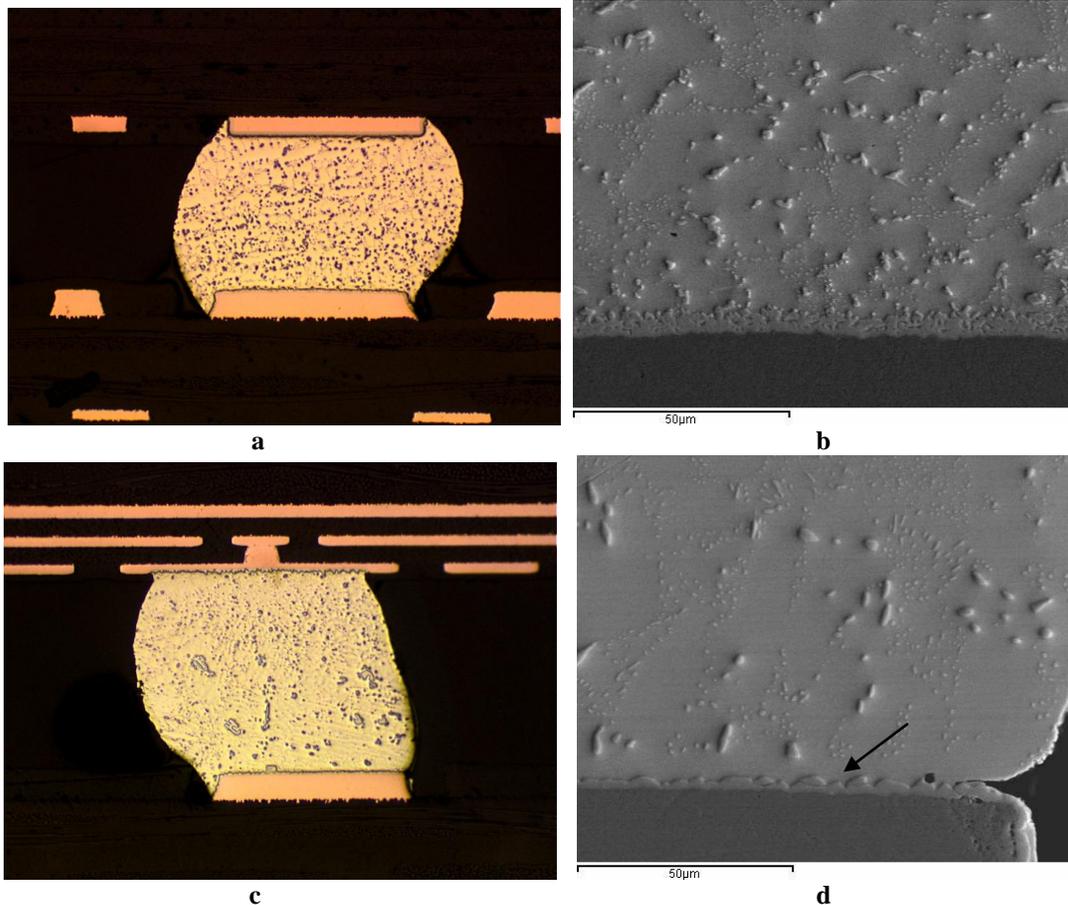
In order to evaluate the thermal mechanical reliability, the test cards with reworked  $\mu$ BGA and PBGA using optimized rework profiles were thermal cycled at 0°C to 100°C. The ATC profile had a dwell time of about 15 minutes at both high and low temperatures, with 15 minutes ramps up and down. The test duration was 1200 cycles. All cards passed the test without any failures. The microstructure after cross-section is shown in Figure 22. It was slightly coarser than before ATC. The maximum damage that was found after 1200 cycles was a small crack in the PBGA (Figure 22d). The crack was initiated at the board side and penetrated into the solder joint along the intermetallic/solder interface for about 15 $\mu$ m.

The microstructure of mirrored joints after ATC was also slightly coarsened and the intermetallic thickness was increased to 4 $\mu$ m and 1.4 $\mu$ m at the board and component sides, respectively. Again, there were no cracks found in mirrored joints.

**Figure 22.** Reworked (a, b)  $\mu$ BGA and (d, c) PBGA after ATC: a – 100; b – SEM, 1000X; c – 100X; d – SEM, 1000X
