Pb-Free Reflow, PCB Degradation, and the Influence of Moisture Absorption

Kerin O'Toole, Bob Esser, Seth Binfield, and Craig Hillman, DfR Solutions, College Park, MD
Joe Beers, Gold Circuits,

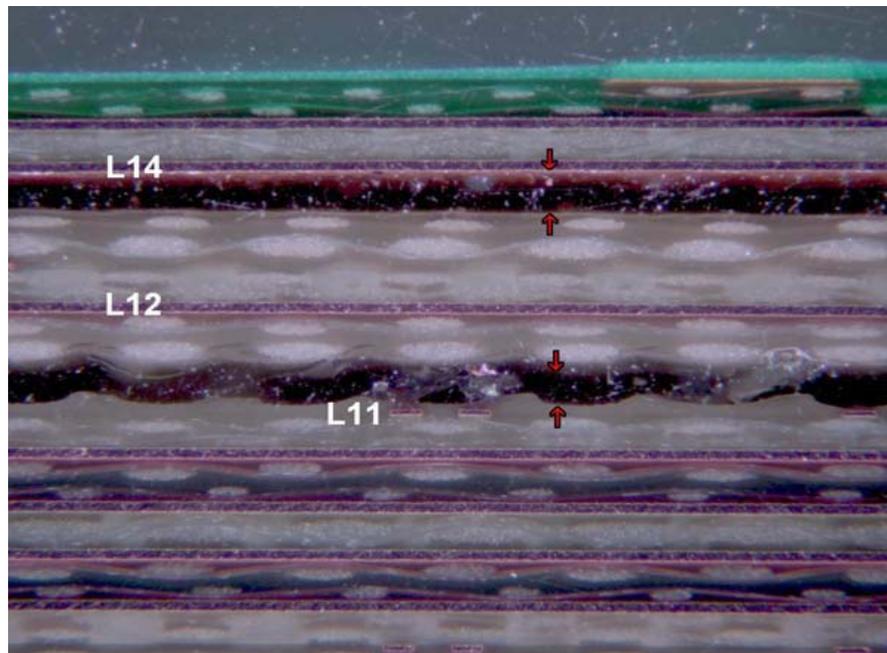
Figure 1: Optical micrograph of cross-sectioned 16 layer PCB that experienced delamination during reflow.

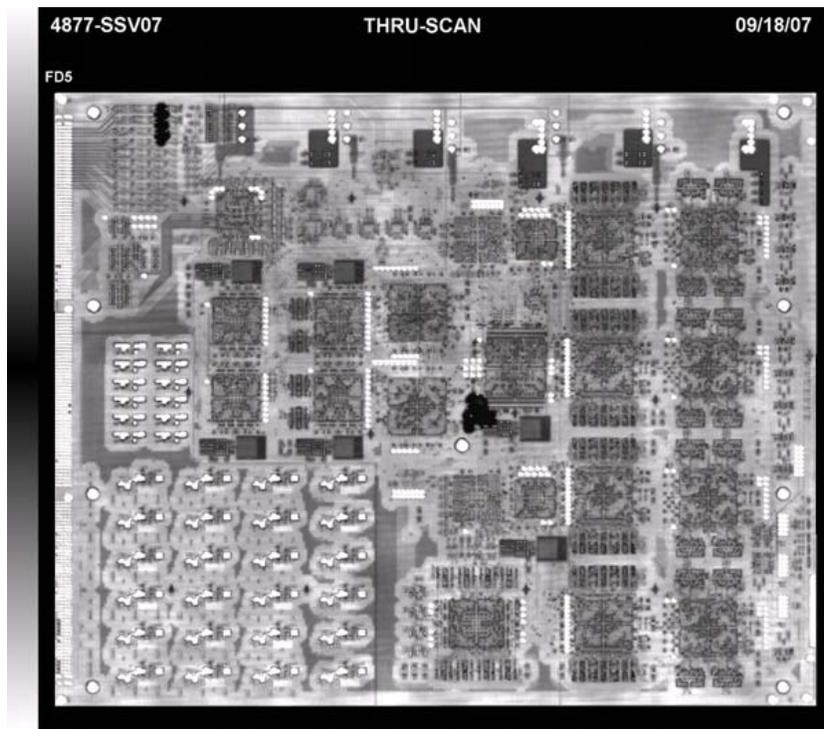
An example of the complexity and uncertainty of the drivers for this phenomenon can be found in a case study involving a contract manufacturer. As seen by the acoustic image in Figure 2, the CM was experiencing pervasive delamination after exposing a circuit card assembly (CCA) to Pb-free reflow. The CCA was 14 x 18 inches and 90 mil thick and was fabricated with laminate material with a Tg of approximately 180C. Cracking or delamination during reflow tends to be an overstress mechanism and can therefore be described as a stress vs. strength phenomenon. That is, either the environmental stress was higher than expected or the material strength was lower than expected.

Figure 2: Through scan acoustic image of printed circuit board. The delaminations are highlighted in red

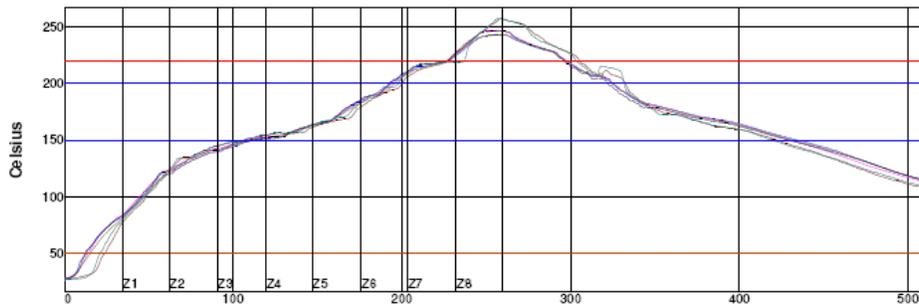
Figure 3

The environmental stress during reflow would be driven by either the temperature profile (ramp rate, maximum temperature, time above liquidus) or the presence of volatiles within the printed board stack up. The reflow profile is displayed in Figure 3. The primary parameters of the reflow profile were within nominal ranges, including:

- Ramp rates between 2 to 3°C per second
- Time above liquidus between 45 to 90 seconds
- Peak temperature below 260°C.

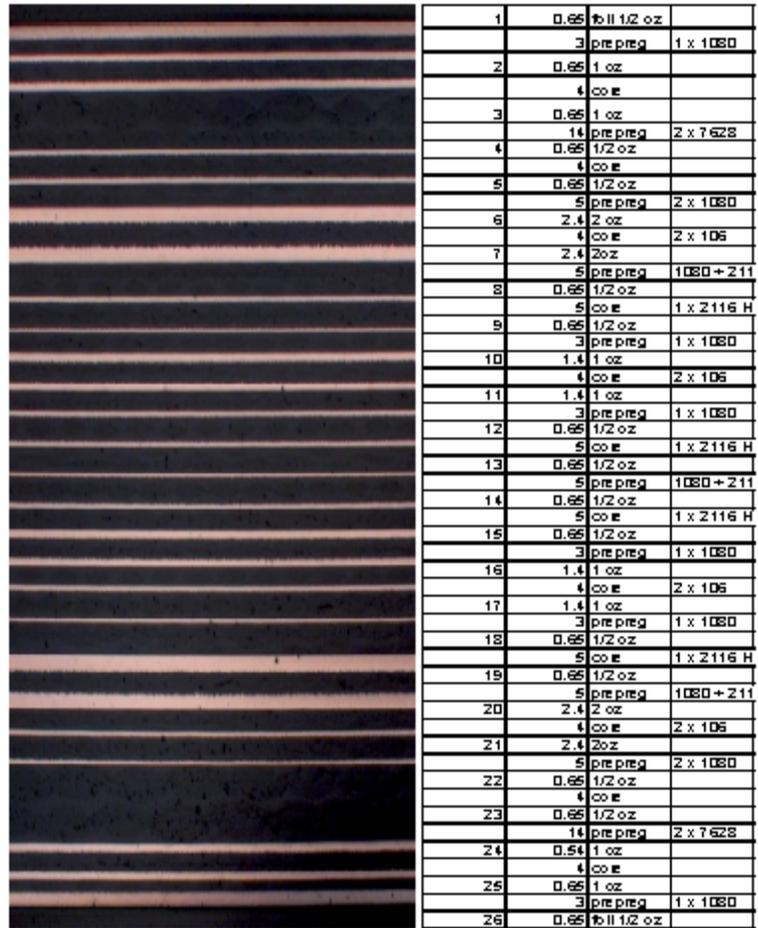
Figure 4: Representation of coupon stack-up and physical parameters of the different layers.

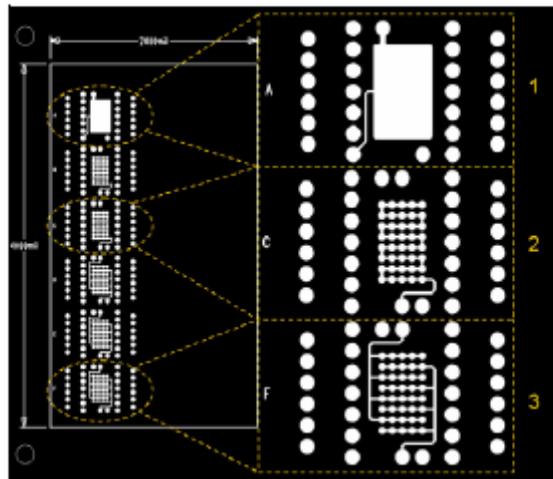
Each coupon contained three sections and a total of six test structures were incorporated into the design, as pictured in Figure 5. The three sections of the PCBs all consisted of the basic shield-over-shield copper plane design; however, they differed in their content of plated through holes (PTHs) and non-functional pads. Section 1 contained only copper planes, which resulted in the largest shield-over-shield capacitance measurements and facilitated observation of clear trends for this data. Section 2 contained copper planes, PTHs and nonfunctional pads on every layer, allowing capacitance measurements to be made for both shield-over-shield and PTH-shield trends on the same coupon. Lastly, section 3 contained copper plains, PTHs and nonfunctional pads on every other layer. This design can be utilized for conductive anodic filament (CAF) testing; however, this data has not yet been obtained and will be the focus of future studies.

Figure 5: Schematic representation of the PCB coupons. Test structures are labeled A-F and a representative coupon from each of the three sections is displayed to the right of the image.

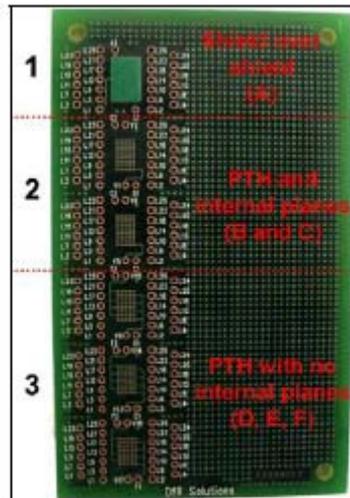
In addition to the three sections of the PCBs, six test structures were present on each coupon and their layout is shown in Figure 6. Test structure A, located on section 1 of the PCB, contained only the basic shield-over-shield design for both the standard and advanced coupons. Test structures B and C, located on section 2 of each PCB; contained PTHs and internal planes that varied slightly in their dimensions depending on the coupon type. On the standard coupon, the pads had a 27-mil diameter, a 78-mil pitch, a 15-mil drill diameter and a clearance of drill+10mil. The advanced coupon design differed with respect to test structures B and C in only the drill diameter and clearance parameters, which had a value of 12 mil and drill+7mil respectively. Test structures D, E and F, present on section 3 of the coupons; consisted of PTHs with no internal

Figure 6: Image of tested PCB coupons with the three sections and corresponding test structure location labeled.

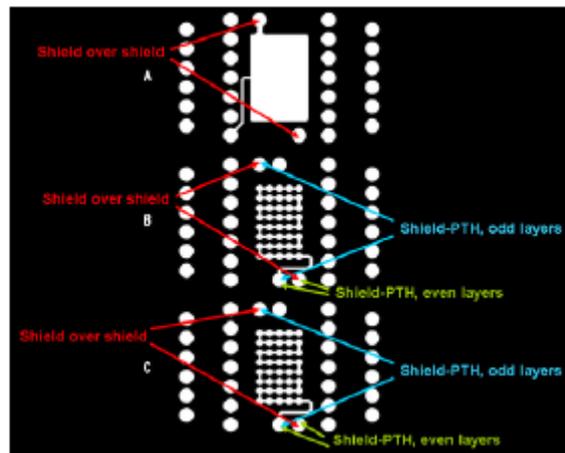
The current design of these PCBs allowed for the measurement of capacitance across the internal planes and between PTHs and internal planes as diagramed in Figure 7. The different dimensions of the test structures present on the standard and advanced coupons allowed investigation into how the size of the PTHs can affect the degradation of the board manifested through changes in capacitance and physical board mutations. Limitations arose during this experiment because test structures A, B and C all have their layers shorted together through the nets A1-A2, B1-B2 and C1-C2, respectively. This design allowed for the measurement of capacitance across all layers as a whole but not across individual layers. Therefore, although we had the ability to detect the presence of shorts, cracking and delamination, we were not necessarily able to determine the exact location of the failure.

Figure 7: Schematic depicting how the capacitance measurements were obtained

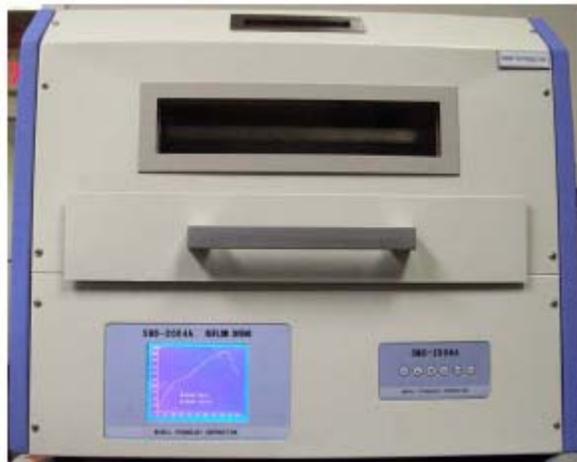
The oven was utilized during the study to simulate reflow cycling on the PCBs. To do this, two different reflow profiles were created which differed only in their peak temperature. The first reflow profile consisted of a peak temperature of 260°C (Figure 9) while the second profile consisted of a peak temperature of 280°C (Figure 10).

Figure 8: Benchtop reflow oven

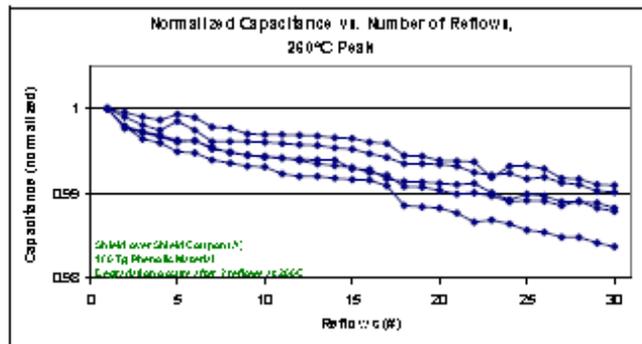
Figure 12: The relationship between the normalized capacitance and increasing reflow cycles, repeated 30 times with a peak temperature of 260°C preformed on 5 advanced coupons.

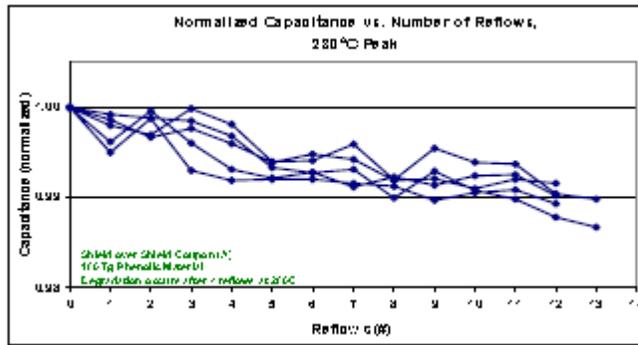
When the peak temperature of the reflow cycle was increased to a value of 280°C, the same general trend was observed although the degradation occurred about fifty times faster (Figure 13). This was shown by the fact that only 12-13 reflow cycles of the second profile were needed to cause a comparable decrease in capacitance to what was previously observed in the first profile with 30 reflow cycles. The normalized capacitance of the 280°C profile showed a marked decrease after 4 reflows equal to about 0.5% on average, and then capacitance decreased gradually with each additional reflow cycle. The data from both tests of phase 1 suggests that an inverse relationship exists between these two variables and as the peak reflow temperature is increased within the range tested, the amount of reflows necessary to cause a comparable decrease in capacitance is reduced.

Figure 13: The relationship between the changes in the normalized capacitance as a result of 12 reflow cycles with a peak temperature of 280°C performed on 5 advanced coupons.

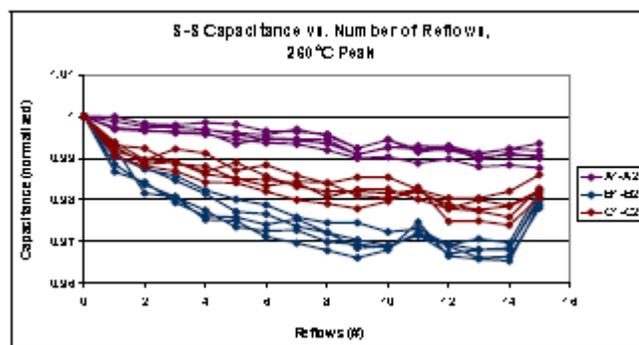
The results obtained showed that different test structures degrade at different rates as apparent in Figure 14. From these results, it is clear that test structure B degraded the most followed by test structure A and then test structure C. Test structure B had an average rate of degradation of almost five times that of test structure A, and test structure C had rate of degradation about three times that of test structure A. This suggests that some inherent difference with the design of these test structures resulted in differential rates of degradation.

Figure 14: The results of 5 standard boards through 15 reflow cycles with a peak temperature of 260°C. The shield over shield capacitance was measured before testing and after each cycle for test structures A, B and C.

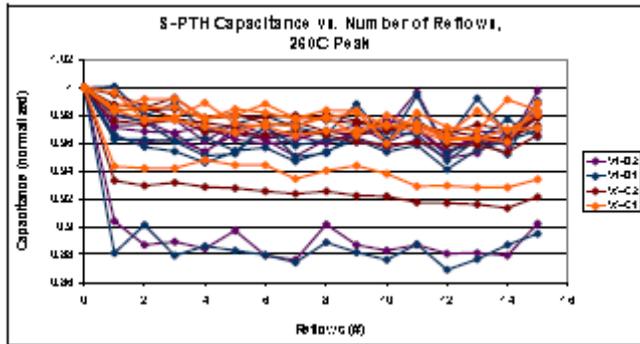
The overall changes in shield-PTH capacitance (Figure 15) were much greater than the shield-over-shield capacitance changes across all test structures (Figure 14). After just one reflow cycle, the degradation observed in the PTH-shield nets was comparable to the degradation observed in shield-over-shield capacitance nets after 15 reflow cycles. The PTH-shield capacitance also decreased most dramatically after 4 reflows and continued to decrease as the boards were subjected to an increasing number of reflow cycles. The data for the shield-PTH capacitance changes also appeared much more variable compared to the shield-over-shield data, with one board showing a much larger decrease in capacitance on all PTH-shield nets compared to the others.

Figure 15: The relationship between the measured Shield-PTH normalized capacitance changes that occurred after 15 reflow cycles at a peak temperature of 260°C.

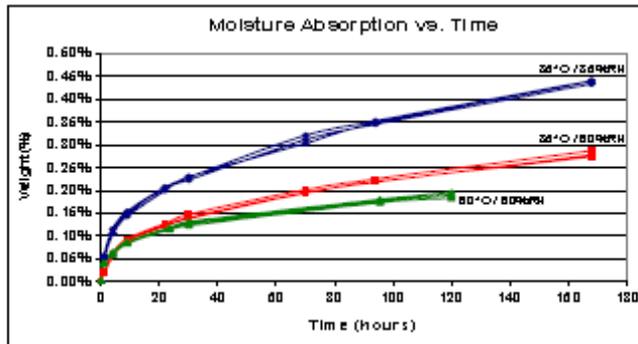
Moisture absorption was measured as the percent weight increase of the PCBs. This data was then used to measure the effect of increased moisture absorption on the capacitance of the test coupons after repeated reflows. Also, different moisture sensitivity profiles were utilized in order to observe which parameters would result in the greatest amount of moisture absorption. As shown in Figure 16, as either the relative humidity or temperature of the moisture sensitivity profile is increased, the percent weight gain by the PCBs is also increased. This is apparent because the PCBs subjected to the MSL1 profile had the largest percent weight gain of the three profiles. The MSL2 profile had a larger percent weight gain compared to MSL2a profile and since these profiles only differed by the temperature of the moisture sensitivity profile, it demonstrates that with increased temperature alone, more moisture absorption can be achieved. When subjected to any of the three conditions, the PCBs all behave the same way. There was a linear relationship between time of exposure and percent weight gain, but this began to level off as the PCBs became saturated, evident in Figure 16. Based on Figure 16, it is also clear that saturation of the PCBs began around 8 hours. When the data is represented as the percent weight gain versus the time in hours squared, a linear relationship appears as shown in Figure 17. This demonstrates that the percent weight gain is proportional to the square of the time in hours.

Figure 16: Representation of the relative moisture absorption of the boards subjected to different moisture sensitivity profiles. Increases in relative humidity and temperature both resulted in increased water absorption by the PCBs

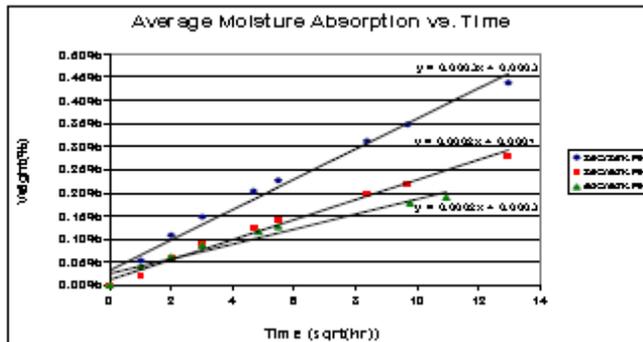
Figure 17: The plotted percent weight gain versus the time in hours squared, demonstrates that a linear relationship exists between these variables.

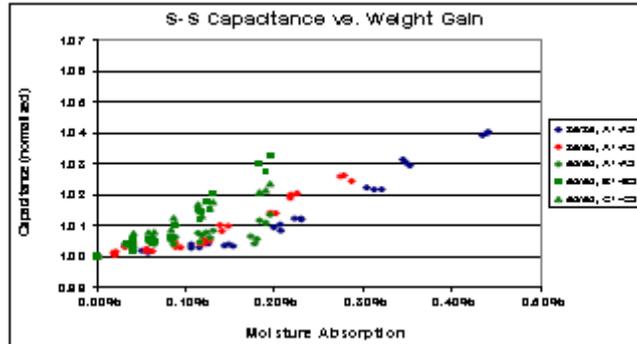
The three moisture sensitivity profiles resulted in similar changes in capacitance for all PCBs; however variation existed when comparing changes across individual test structures. The capacitance measurements of coupon sections containing only shield-over shield layers showed the smallest change with respect to moisture absorption. This relationship was observed by looking at the data from test structure A because up to approximately 0.15% weight gain, no significant changes in capacitance occurred. After this point however, the data appeared to linearize, and as percent moisture absorption increased, capacitance measurements also increased (Figure 18). The shield-over-shield capacitance in test structures B and C showed a larger increase in capacitance with respect to increased percent moisture absorption. This is apparent in Figure 19, where the 2 traces for capacitance measurements of net B1-B2 and C1-C2 show a much greater change at 0.20% moisture absorption compared to the test structure A. The PTH-shield results were much more variable and although it is apparent that a larger change in capacitance resulted relative to the percent of moisture absorption, no clear trend in the data for these test structures exists (Figure 19).

Figure 18: The normalized shield-over-shield capacitance is measured with the respect to the about of moisture absorption. As moisture absorption increases so does the increase in capacitance.

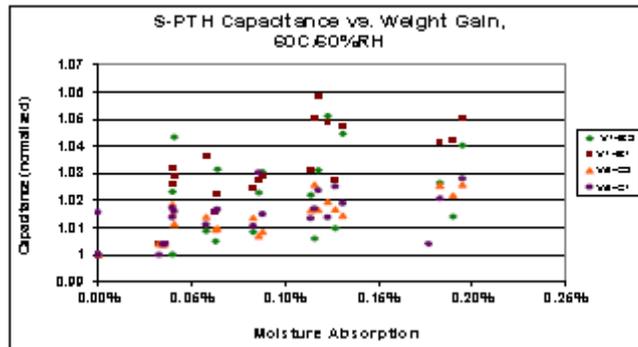
Figure 19: Normalized shield-PTH capacitance vs. weight gain for the MSL2 a moisture sensitivity profile. Capacitance measurements were obtained for both test structures B and C.

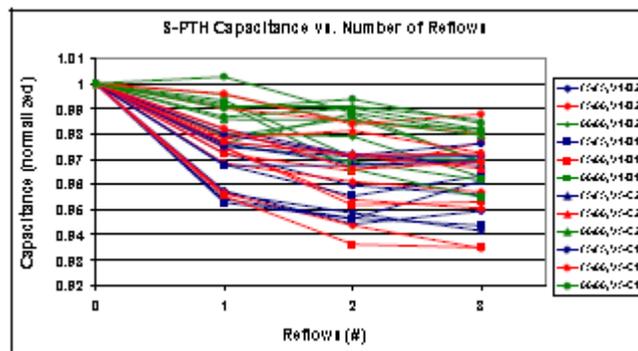
The normalized capacitance changes from phase 1 were noticeably less compared to the capacitance changes in the boards exposed to the moisture profiles in phase 2. This is true even when the boards were subjected to fewer reflow cycles. Within this subset of data, the same trends observed earlier regarding the different test structures were also observed. Test structure A showed the smallest change in capacitance measurements while test structure B had the greatest. This suggests that the presence of PTHs increases the rate of degradation and that shielded PTHs consistently perform worse than unshielded PTHs. This data also suggests that a difference in the capacitance changes exists because of the different moisture sensitivity profiles the PCBs were exposed to. The 60°C/60%RH profile had the smallest measured degradation and it was also the profile with the lowest temperature and RH value. The higher temperature profiles resulted in more moisture gain and a larger increase in capacitance before being subjected to reflow testing. However when this data was normalized, the PCBs also demonstrated a greater decrease in capacitance after repeated reflows (Figure 20). With all conditions, the PTH-shield capacitance measurements degraded quicker compared to shield-over-shield capacitance measurements (Figure 21). The same trend in the moisture sensitivity profiles was seen when testing shield-PTH capacitance, with MSL2a showing the least amount of degradation compared to the other two profiles. The data suggests that when PTHs are present the temperature of the profile becomes more of a factor in the amount of degradation that occurs.

Figure 20: Shield-over-shield capacitance vs. number of reflows after being subjected to the respective moisture sensitivity profiles including MSL1, MSL2 and MSL2a. Capacitance was measured for test structures A, B and C.

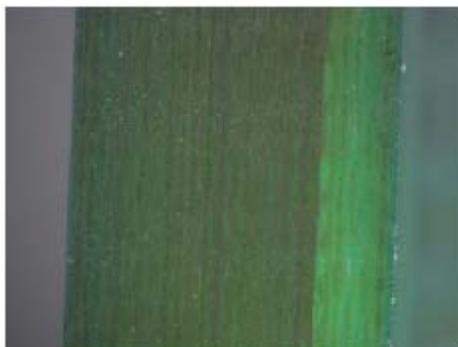
Besides the discussed changes in capacitance that occurred as a result of moisture exposure and repeated reflows, delamination was visible evidence for PCB degradation (Figure 22). Delamination was only observed in featureless areas (see Figure 23) and evidence for delamination was only observed in PCBs subjected to moisture sensitivity profile MSL1. This profile had both the highest temperature and highest relative humidity, resulting in the largest percent weight gain in the PCBs. No visible delamination occurred in the MSL2 or MSL2a profile nor in any of the “dry samples” from phase one, which suggests that increases in moisture content facilitates the process of delamination in these PCBs.

Figure 22: Delamination observed in cross-section of a test coupon subjected to MSL1 exposure (85°C/85RH) and subjected to 3 reflows at a peak temperature of 260°C

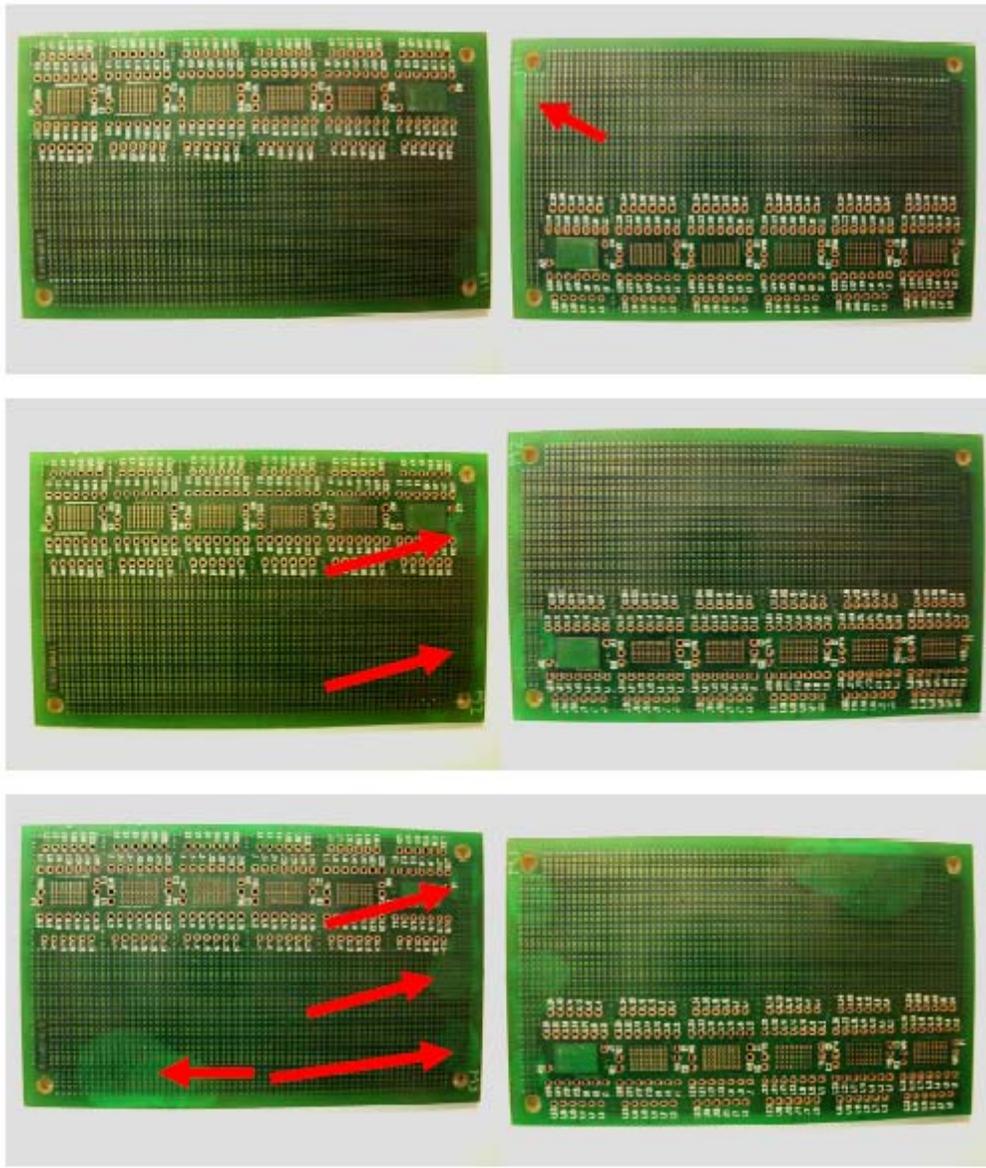
Figure 23: Photo documentation of delamination in PCB coupons subjected to MSL1 exposure (85°C/85%RH) and 3X reflow at peak temperature of 260°C. Delamination is highlighted by red arrows.

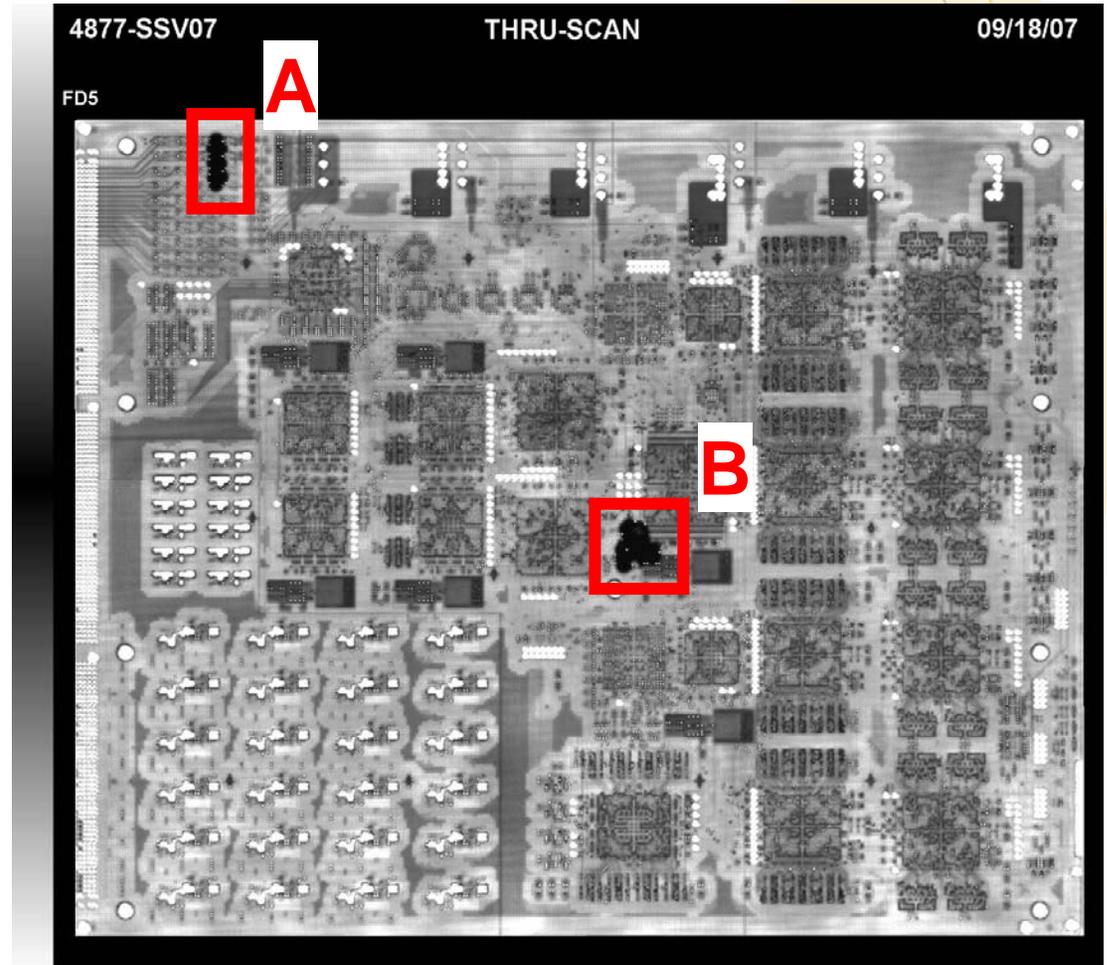
Acoustic Microscopy

- Delamination marked by red boxes
 - Scalloped shape is due to pinning at the plated through holes (PTHs)
- Results from acoustic microscopy confirmed observations from visual inspection
 - No additional delamination sites were identified

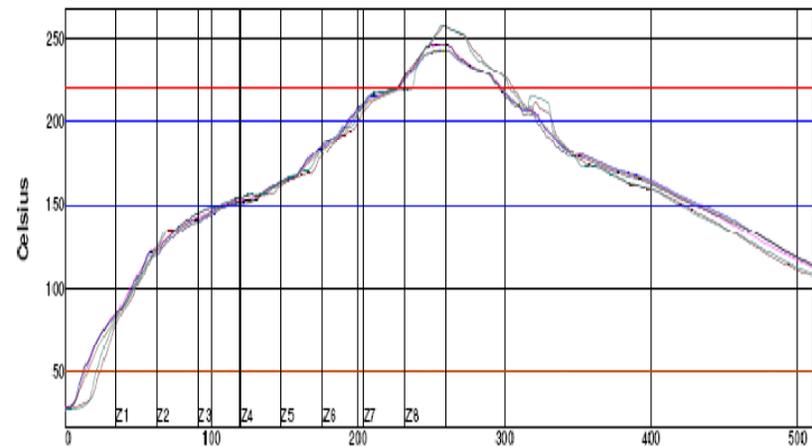
Temperature Profile

- A review of the reflow profile indicate that the temperatures experienced by the printed board were within the bounds of expectation for a Pb-free reflow profile on a large circuit card assembly (CCA)
- DfR definition of a large CCA
 - Thickness: 90 mil or greater
 - W x L: 14 x 18 or greater
- Expectations for Pb-free reflow of large CCA
 - Ramp rates: 2-3C/second
 - Time above liquidus: 45 to 90 seconds
 - Max. Temperature: 260C

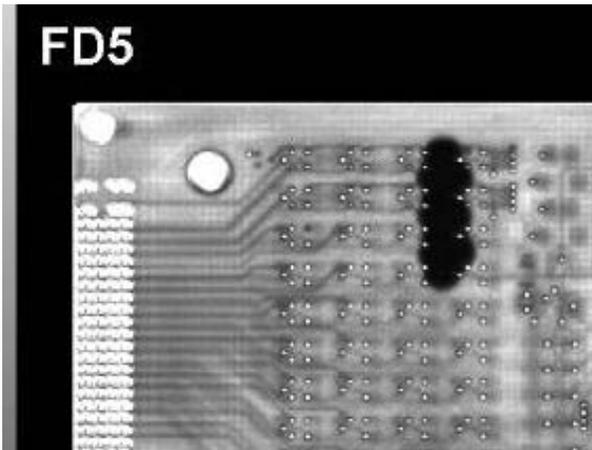
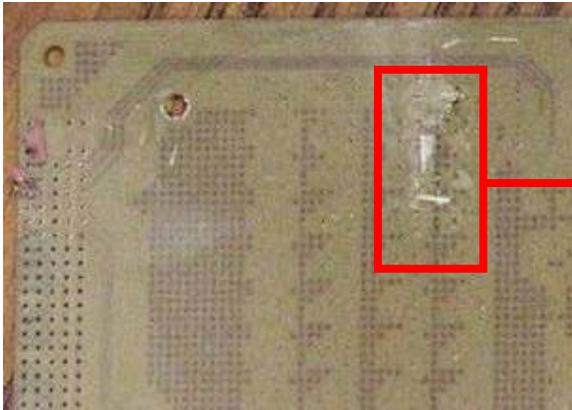
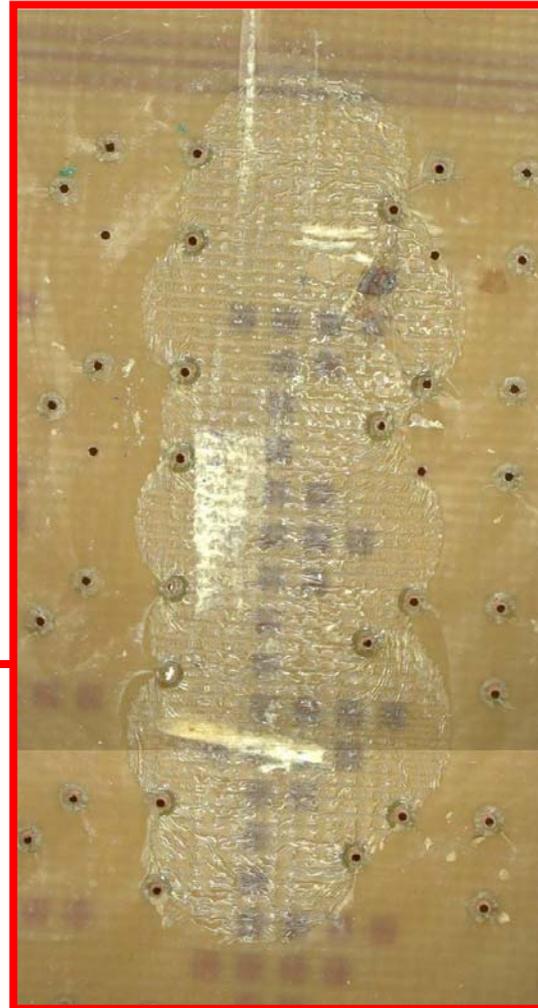
Corner Delamination

- Bubble is pinned in place by the plated through holes (PTH)
- Poor or no epoxy adhesion in delaminated area

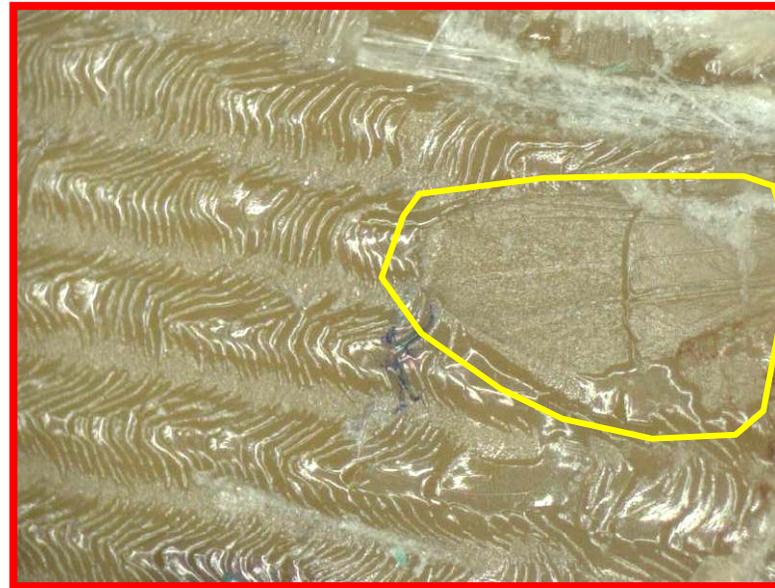
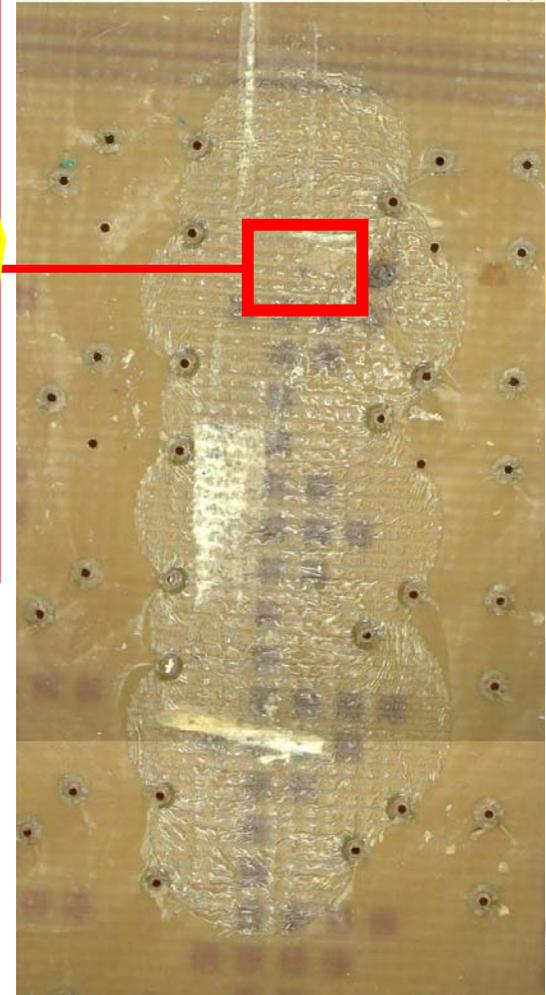
Corner Delamination (cont.)

- Lack of adhesion to glass fibers (yellow outline)
 - Could be initiation site
 - May suggest wetting issues

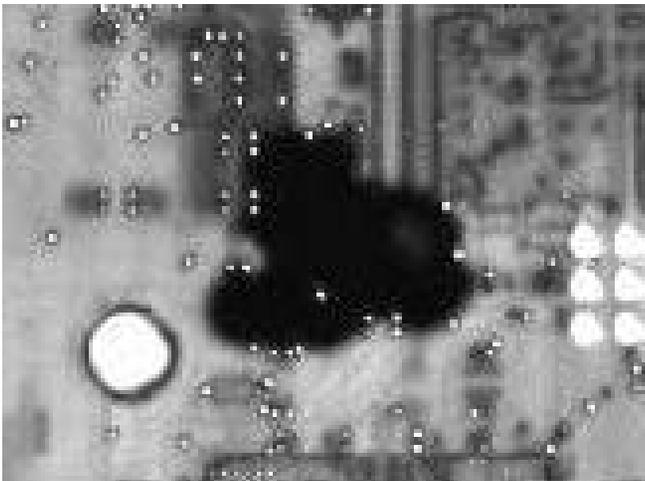
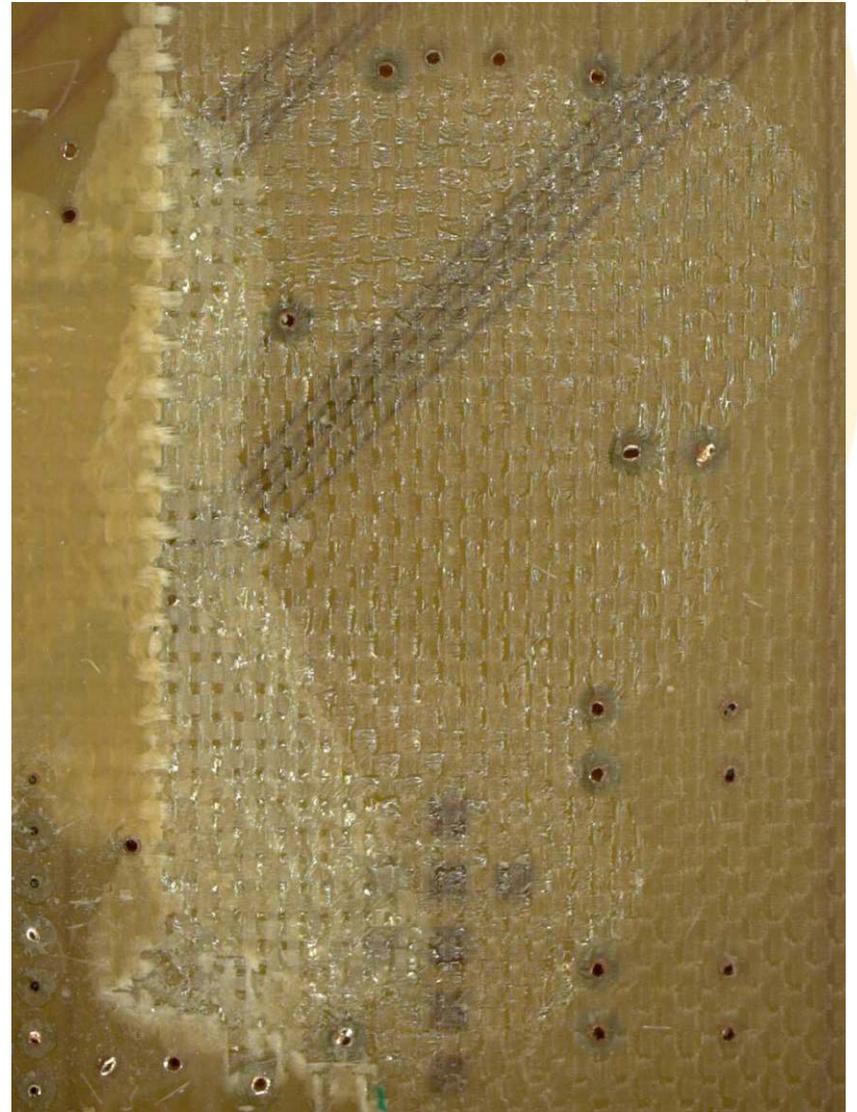
Central Delamination

- Delamination appears to span multiple layers
- Plated through holes pin the expansion of the delamination

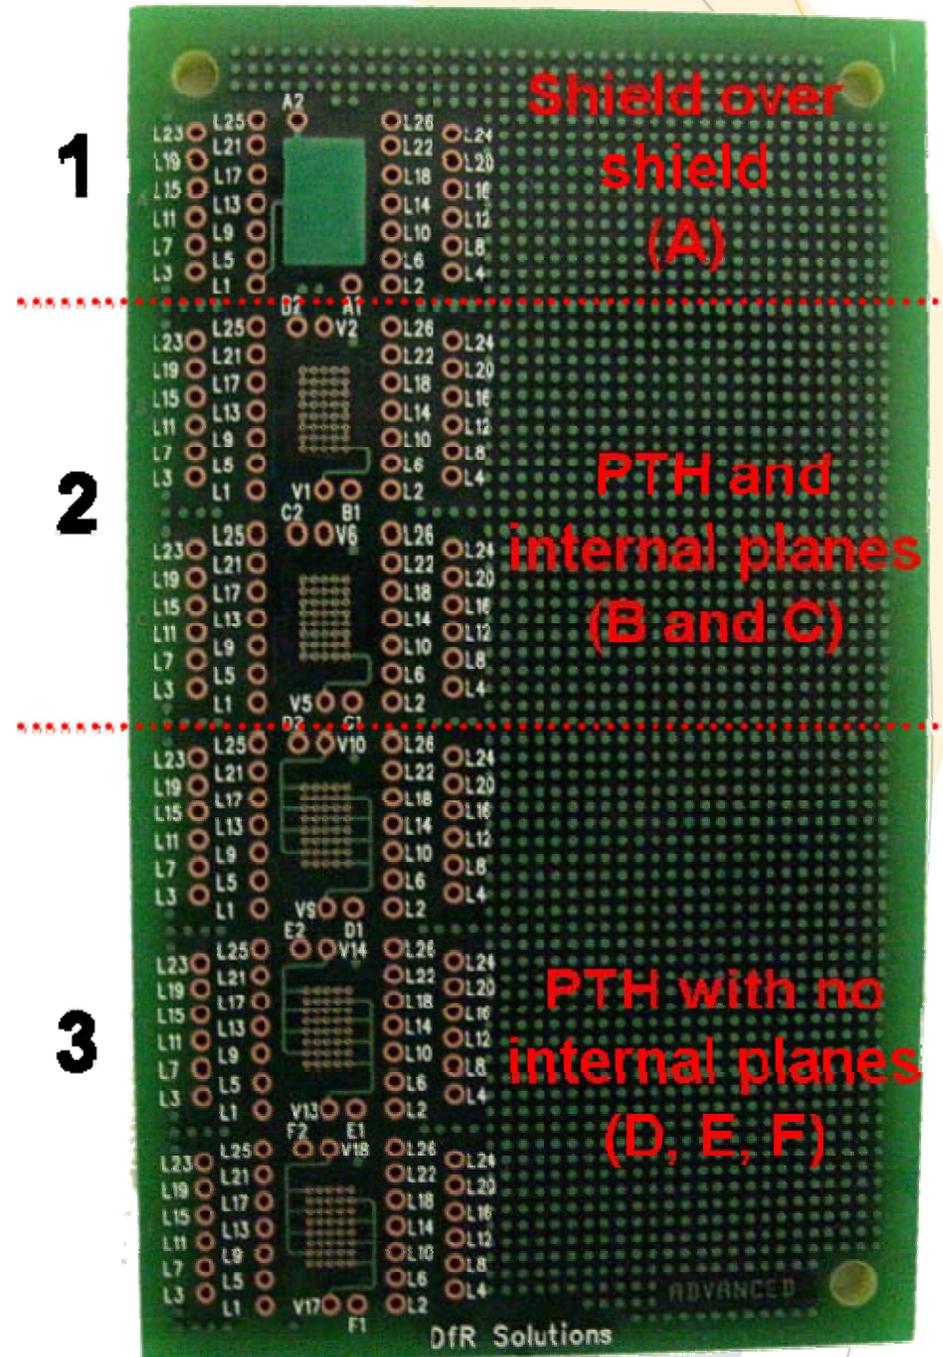
- Two coupon designs (Standard / Advanced)
 - Each coupon design has three sections and six test structures
- Section 1: 'Shield over shield' (Test Structure A)
 - Plane-to-plane spacing: See slide 4 (same for both standard and advanced designs)
- Section 2: PTH with internal planes (Test Structures B and C)
 - Plane-to-plane spacing: See slide 4 (same for both standard and advanced designs)
 - Drill diameter: Standard: 15 mil; Advanced: 12 mil
 - Clearance: Standard: Drill + 10 mil; Advanced: Drill + 7 mil
 - Pitch: 78 mil (same for both standard and advanced)
 - Pad diameter: 27 mil
- Section 3: PTH with no internal planes (Test Structures D, E, & F)
 - Drill diameter: Standard: 15 mil; Advanced: 12 mil
 - Pitch: Standard: 40 mil; Advanced: 32 mil
 - Pad diameter: 27 mil

- Photo-documentation of coupon design

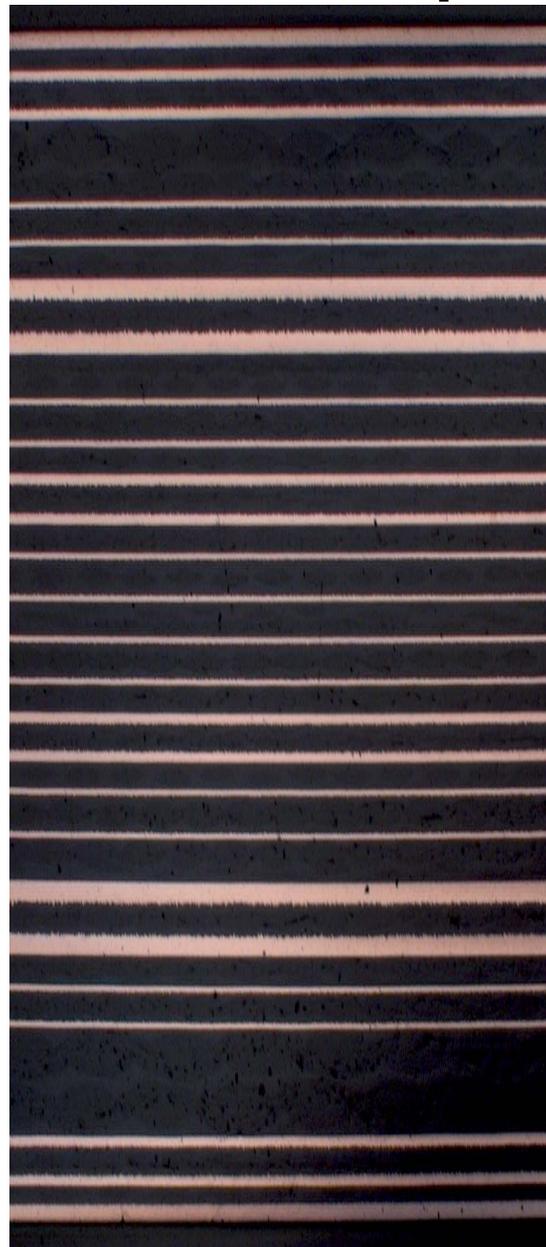
Coupon Stackup

- Board thickness
 - 150 mil (3.75 mm)
- Number of layers
 - 26
- Dielectric thickness
 - 3 mil (75 μm), 4 mil (100 μm), and 5 mil (125 μm)
- Glass fabric
 - 106, 1080, 7628, and 2116
- Copper foil thickness
 - 0.5 oz (17.5 μm), 1 oz (35 μm), and 2 oz (70 μm)

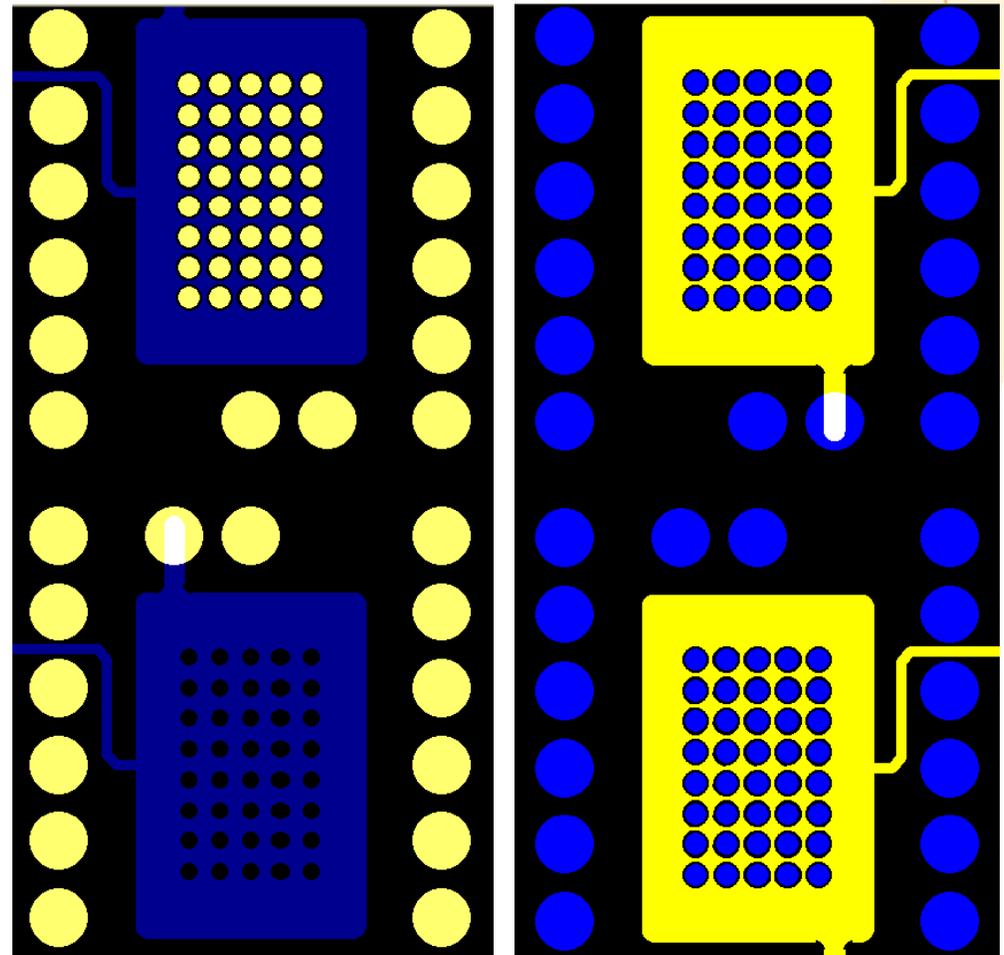
- Nets A1-A2, B1-B2, and C1-C2 allow measurement of capacitance between layers
- Nets V1-B1, V1-B2, V5-C1, and V5-C2 allow measurement of capacitance between PTHs and layers

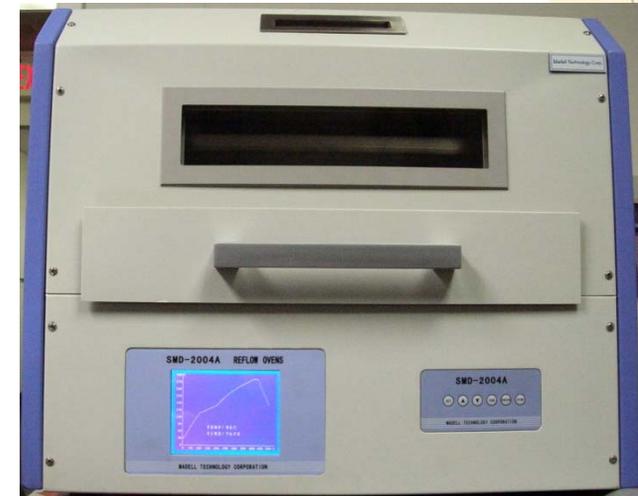
Equipment – Reflow Oven

- Madell Technology Corporation
 - SMD-2004A
- Calibration with an external thermocouple to verify the accuracy of the reflow profiles reported by the oven at 260°C and 280°C
 - The oven's thermocouple was taped onto the surface of the boards during each reflow, so the temperature of the board surfaces drives the ramp of the reflow profile
 - Ensures that the boards are reaching the desired peak temperatures

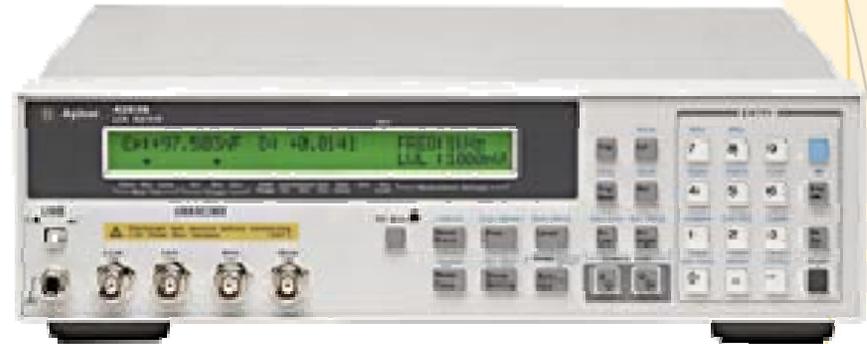
Equipment – Capacitance Meter

- Agilent Technologies
 - 4263B LCR meter
 - 0.1% basic accuracy
- All measurements taken at 100kHz
- Small capacitance measurements:
 - Calibration with 22pF NPO ceramic capacitor
 - C_s measured 22pF +/- 2%
 - C_p measured 22pF +/- 5%
 - Used C_s for all capacitance measurements

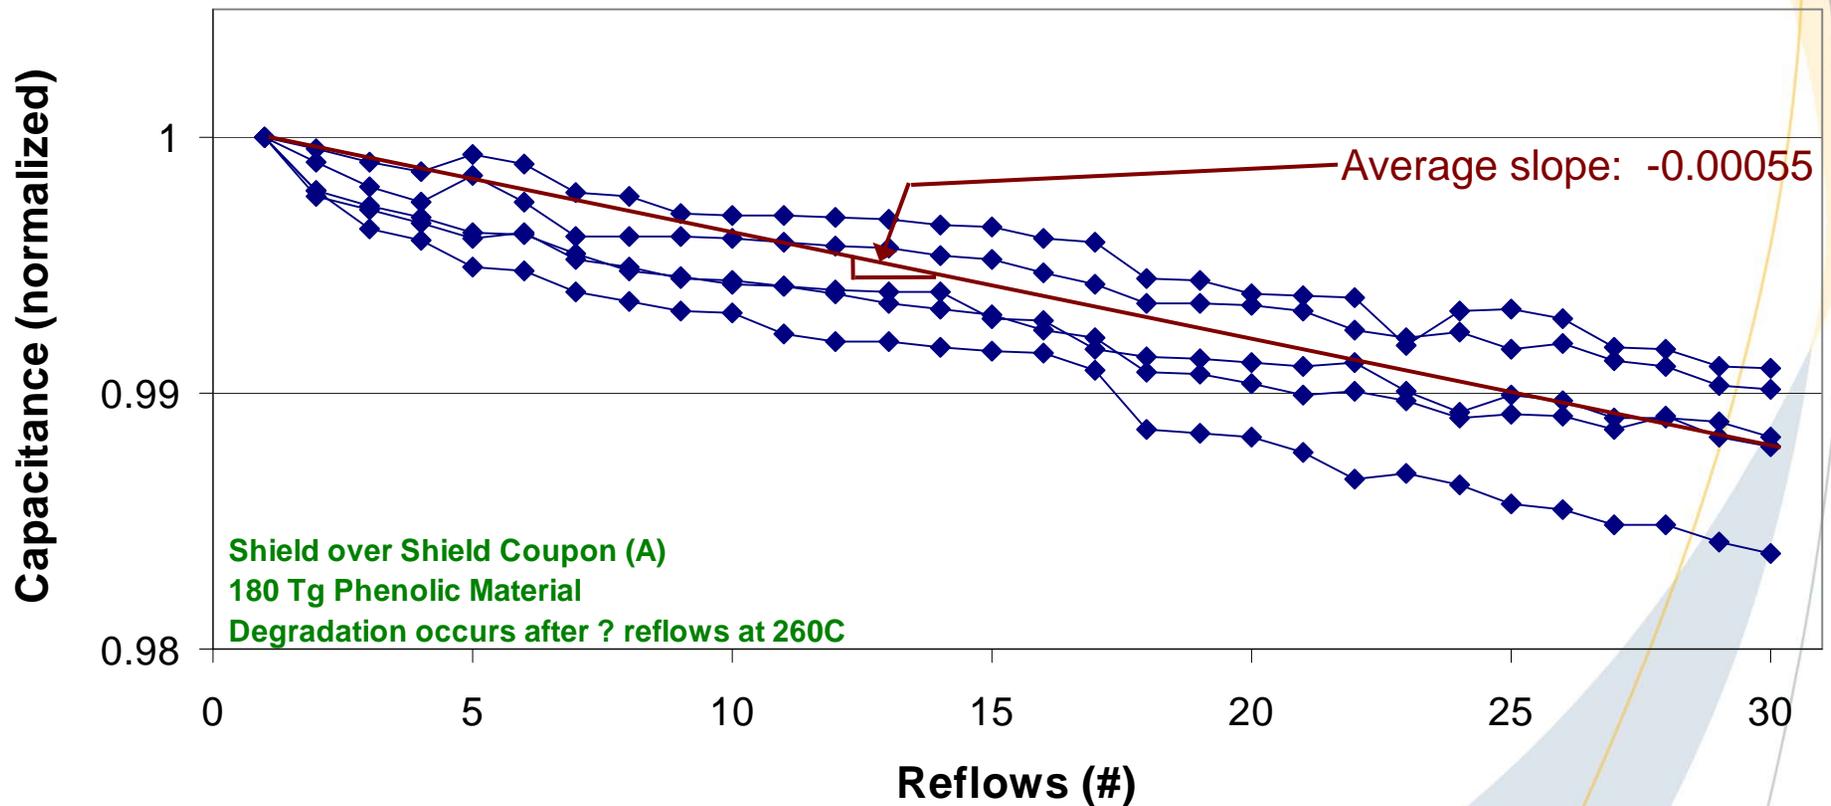
Normalized Capacitance vs. Number of Reflows,
260°C Peak

- Steady decrease in shield over shield (S-S) capacitance at 260°C, but no clear roll-off point
- Test structures A, B, and C degrade at different rates, with B showing the greatest change in capacitance
 - Test structure B has an average degradation rate almost 5X greater than that of test structure A
 - Test structure C has an average degradation rate almost 3X greater than that of test structure A
- 280°C samples show a stronger (~0.5% average) decrease in shield over shield capacitance after 4 reflows, but gradual degradation continues with each subsequent reflow cycle
 - Average degradation rate of the 280°C samples was approximately 50% greater than that of the 260°C samples
