Pb-Free Reflow, PCB Degradation, and the Influence of Moisture Absorption

Kerin O'Toole, Bob Esser, Seth Binfield, and Craig Hillman, DfR Solutions, College Park, MD
Joe Beers, Gold Circuits,

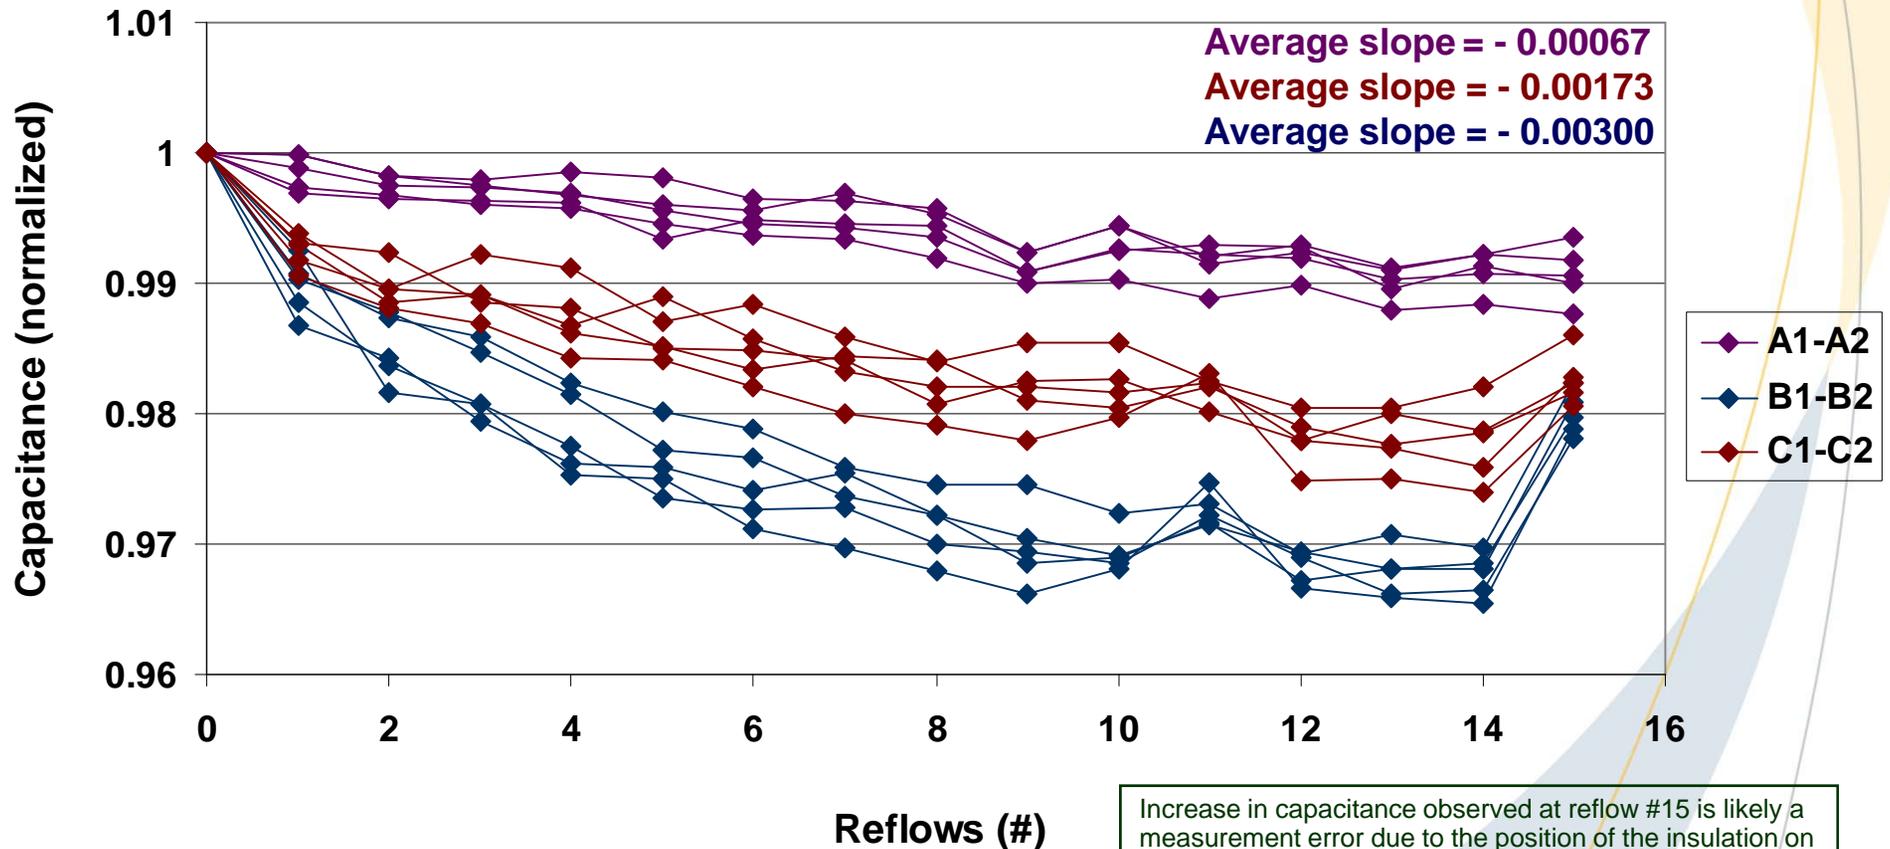
S-S Capacitance vs. Number of Reflows,
260°C Peak

- Steady decrease in shield over shield (S-S) capacitance at 260°C, but no clear roll-off point
- Test structures A, B, and C degrade at different rates, with B showing the greatest change in capacitance
 - Test structure B has an average degradation rate almost 5X greater than that of test structure A
 - Test structure C has an average degradation rate almost 3X greater than that of test structure A
- 280°C samples show a stronger (~0.5% average) decrease in shield over shield capacitance after 4 reflows, but gradual degradation continues with each subsequent reflow cycle
 - Average degradation rate of the 280°C samples was approximately 50% greater than that of the 260°C samples

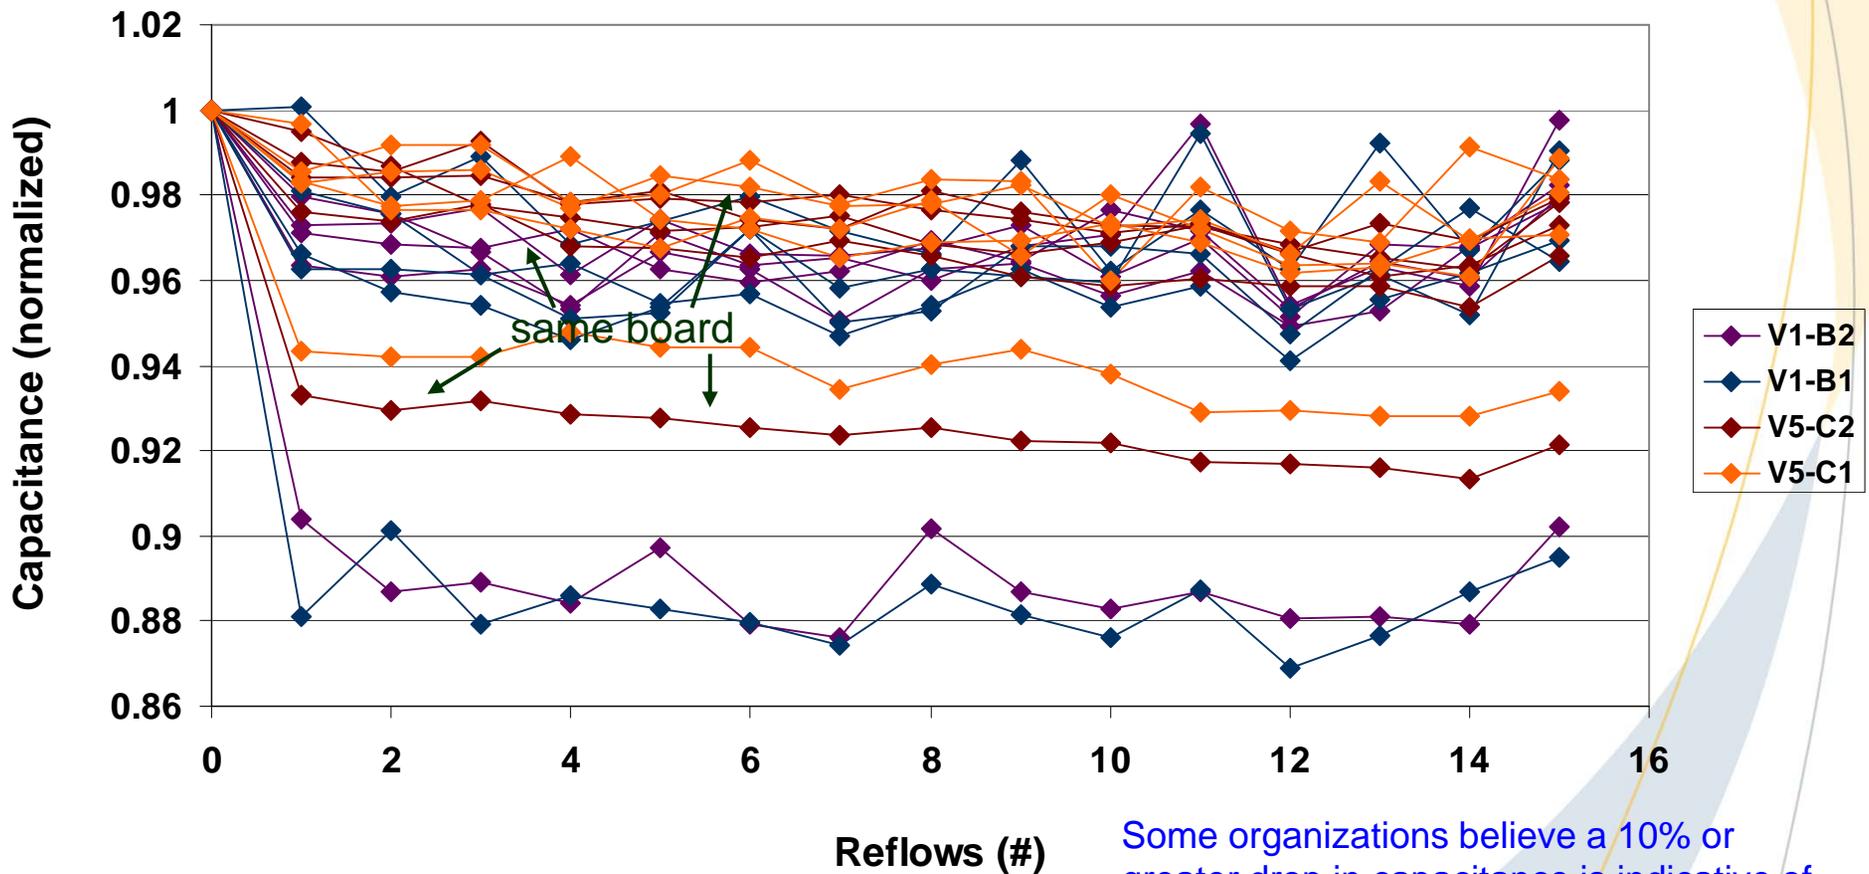
S-PTH Capacitance vs. Number of Reflows,
260C Peak

Some organizations believe a 10% or greater drop in capacitance is indicative of cracking or delamination

- Shield to PTH (S-PTH) capacitance:
 - A higher degree of degradation compared to shield over shield
 - After just one reflow cycle, the degradation in S-PTH capacitance is comparable to that of the S-S capacitance after 15 reflow cycles.
 - Very significant decrease in capacitance after 4 reflow cycles, followed by very gradual degradation with an extensive degree of variation
 - One board had a much larger decrease in capacitance on all S-PTH nets

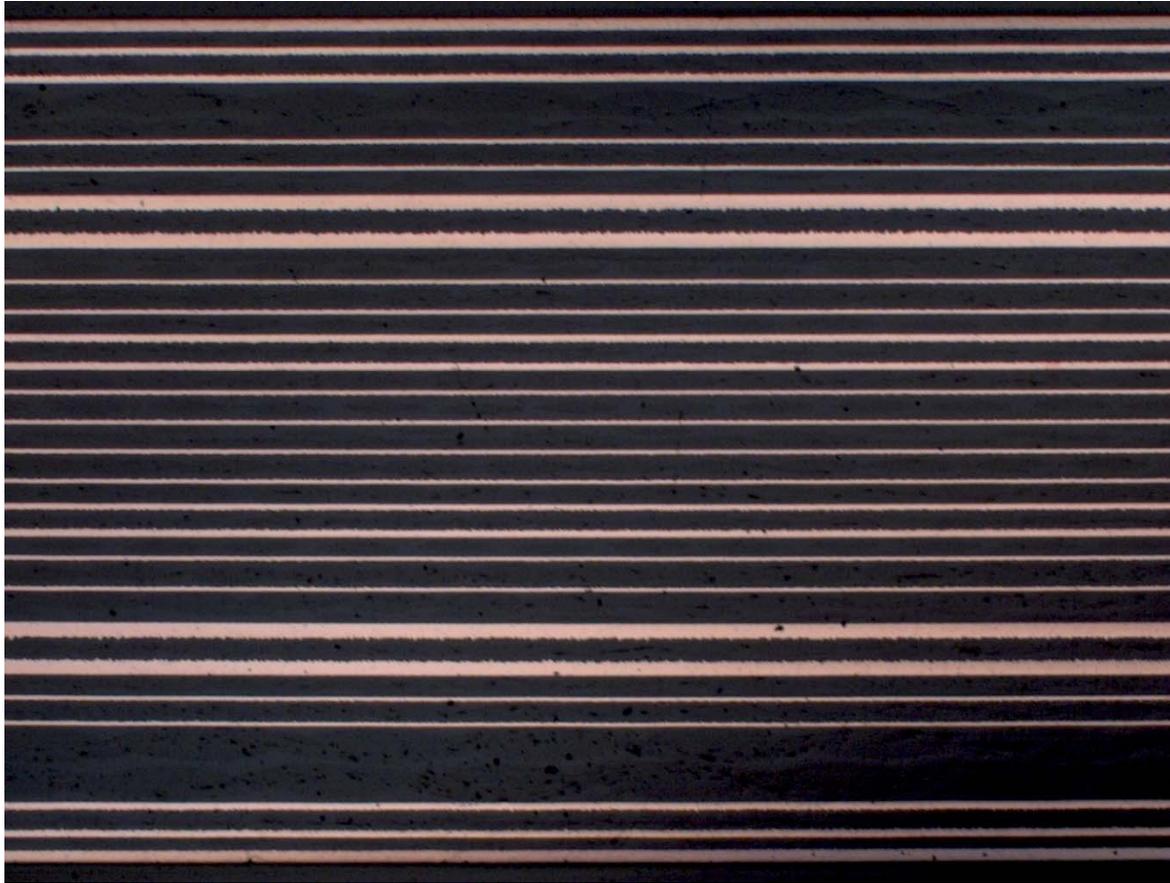
Phase 1, Part 1: Cross Section

- Cross section of sample after 33 reflows at 260°C peak
- Low magnification: no cracking observed

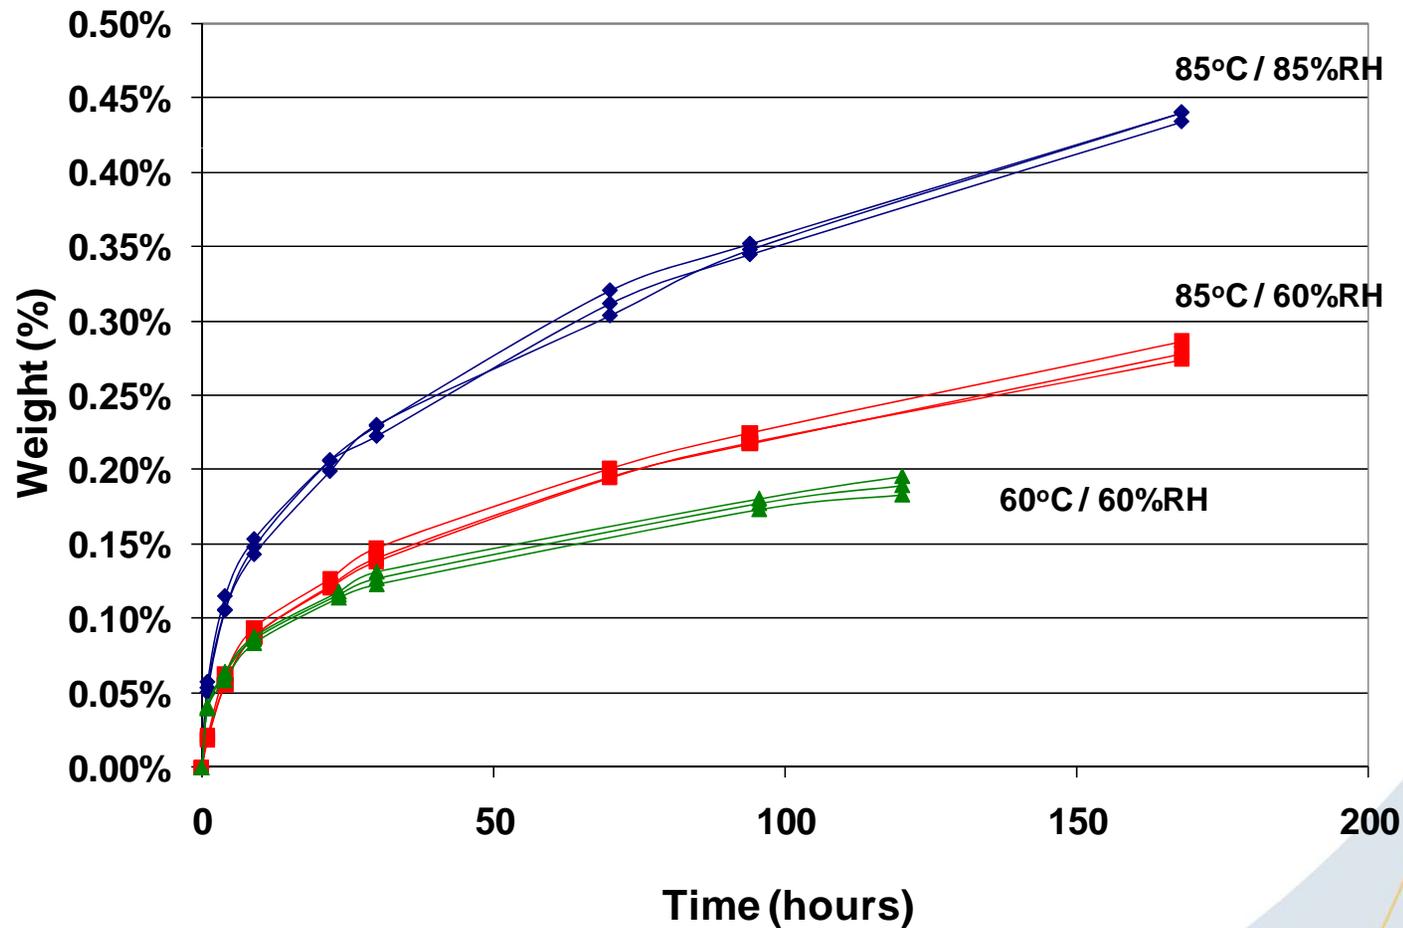
Moisture Absorption vs. Time

- The 85°C/85%RH samples showed the largest weight gain due to moisture absorption
- The 60°C/60%RH samples showed the smallest weight gain due to moisture absorption
- Higher temperature results in increased moisture absorption at 60%RH
- Moisture absorption is proportional to the square root of time in hours, as per Fick's law of diffusion
 - Deviation is observed as moisture saturation is approached
 - Saturation seems to initiate around 64 (8^2) hours

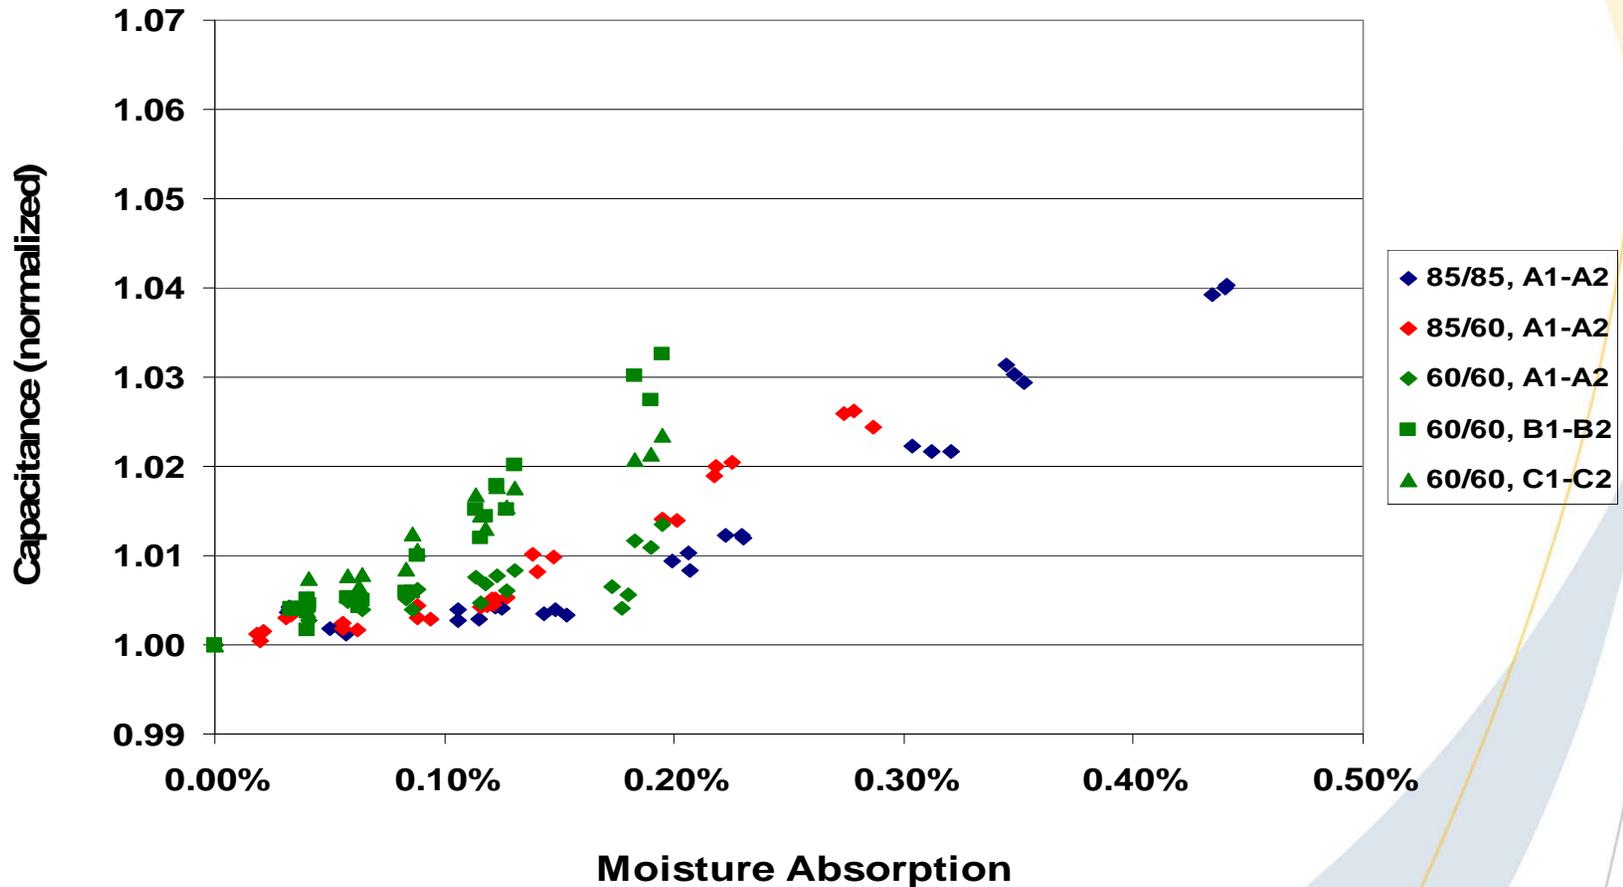
S-S Capacitance vs. Weight Gain

- Capacitance as a function of moisture absorption shows similar trends for all three environmental conditions
- Shield-over-shield with no PTHs showed minimal change up to 0.15%, followed by approximately linear behavior
- The shield-over-shield with PTHs showed a larger increase in capacitance relative to the amount of moisture absorbed
- Shield-to-PTH capacitance showed a larger increase in capacitance relative to amount of moisture absorbed, but no clear trend

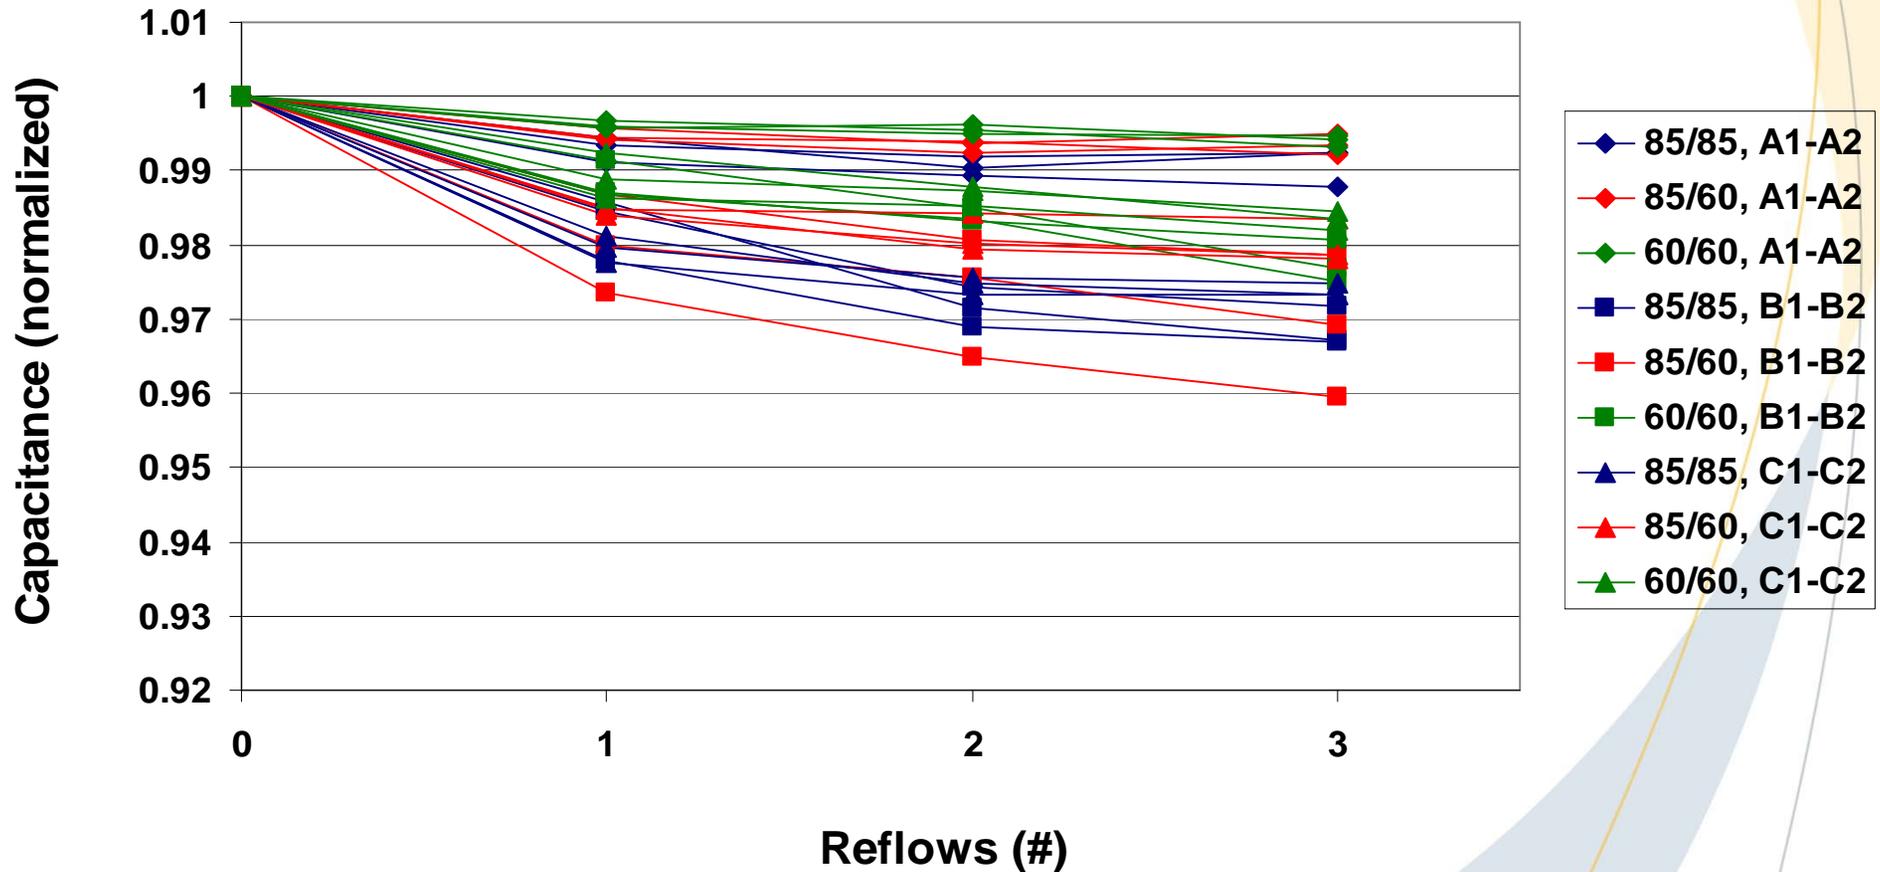
S-S Capacitance vs. Number of Reflows

- Capacitance degradation
 - Test structure B degrades more than test structure C, which degrades more than test structure A
 - Same as reflow without moisture preconditioning
 - 60°C/60%RH degrades the least, while 85°C/60%RH and 85°C/85%RH seem to show similar behavior
- Was capacitance degradation due to moisture desorption or damage accumulation within the coupon?
 - After 85°C/85%RH, 4% increase in capacitance
 - After 3 reflows, 4% decrease in capacitance
 - Is there moisture remaining after the first reflow?

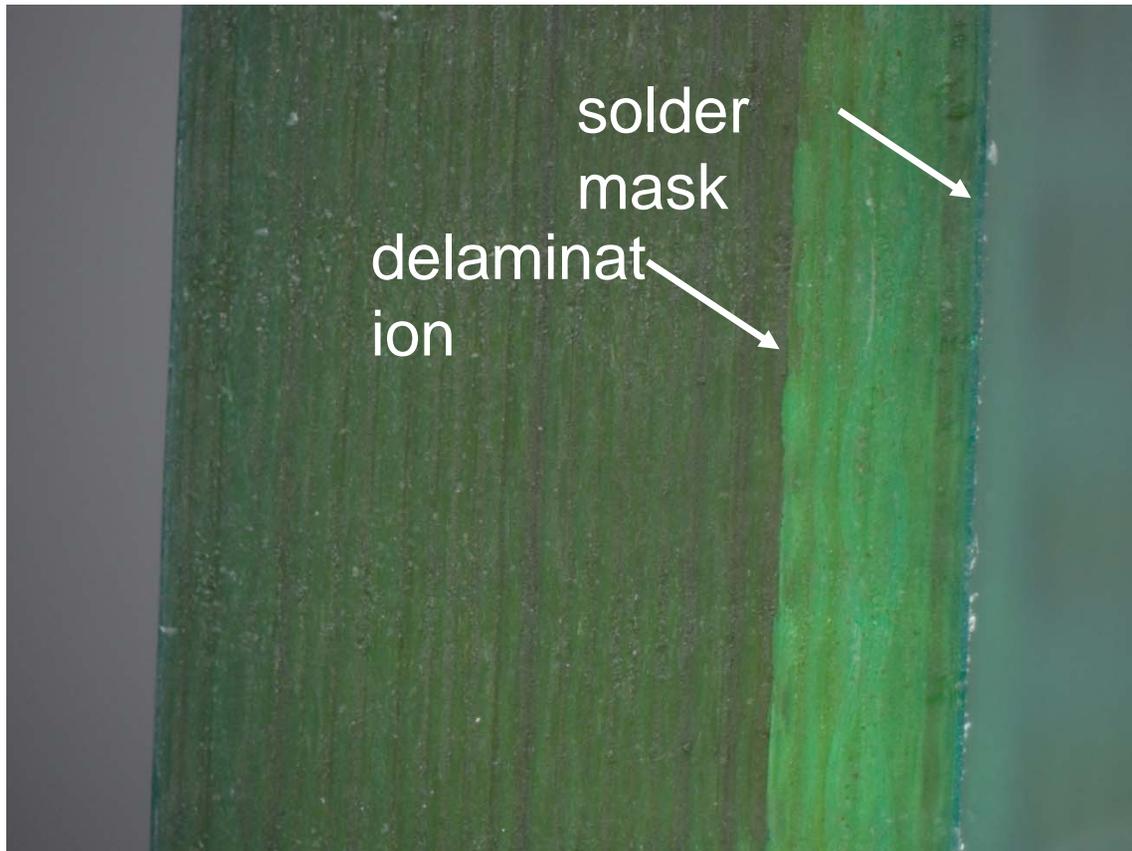
Delamination observed in 85°C/85%RH test boards

- Delamination occurred primarily in featureless areas
- Evidence of failures only in specimens tested as per MSL1 (85°C/85%RH, 168 hours)
 - These samples had the highest % weight gain
- No visible delamination in MSL2 (85°C/60%RH, 168 hours) and MSL2a (60°C/60%RH, 120 hours) samples
- No observable delamination in any “dry samples” from phase 1

2.5X side view of 85°C/85%RH board after 3
reflows at 260°C peak

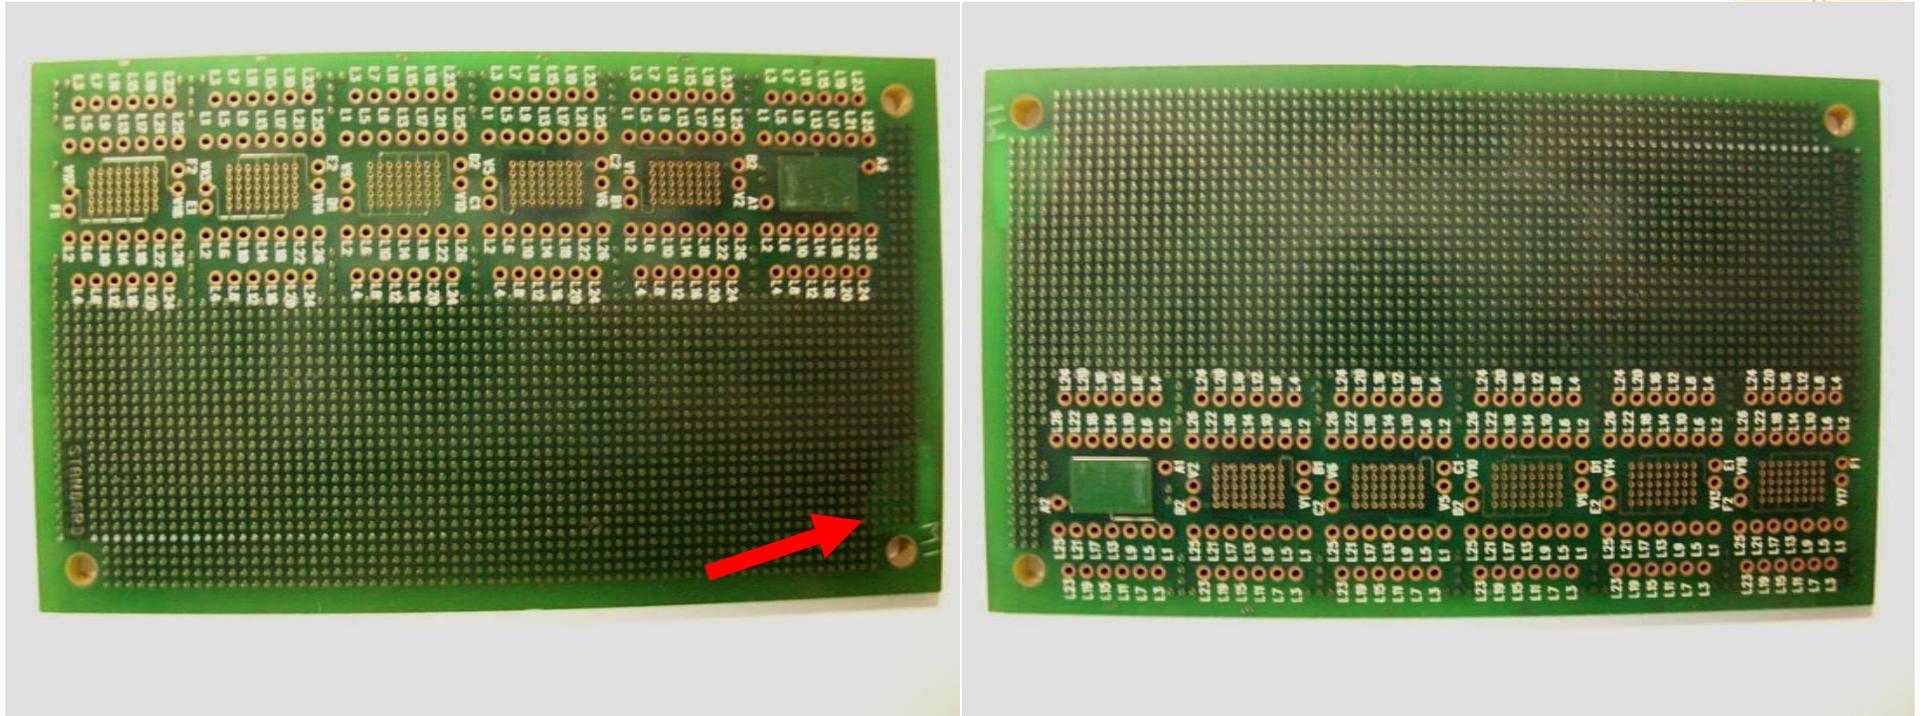
Coupons after 85C/85%RH + 3 Top Reflows Bottom

Red arrows mark internal delamination

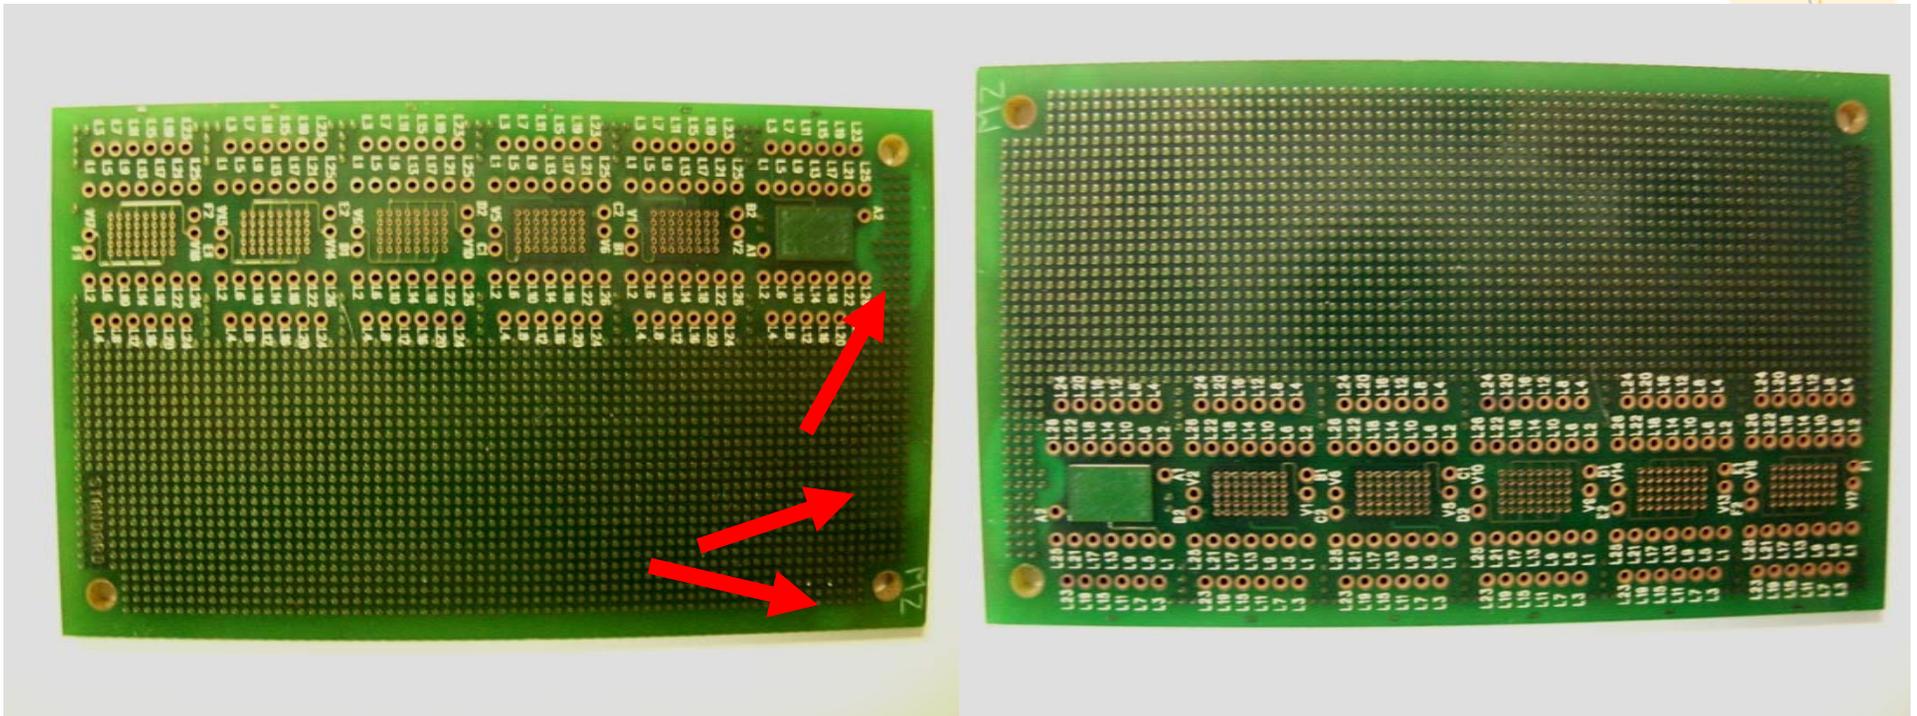
Coupons after 85C/85%RH + 3 Top Reflows Bottom

Red arrows mark internal delamination

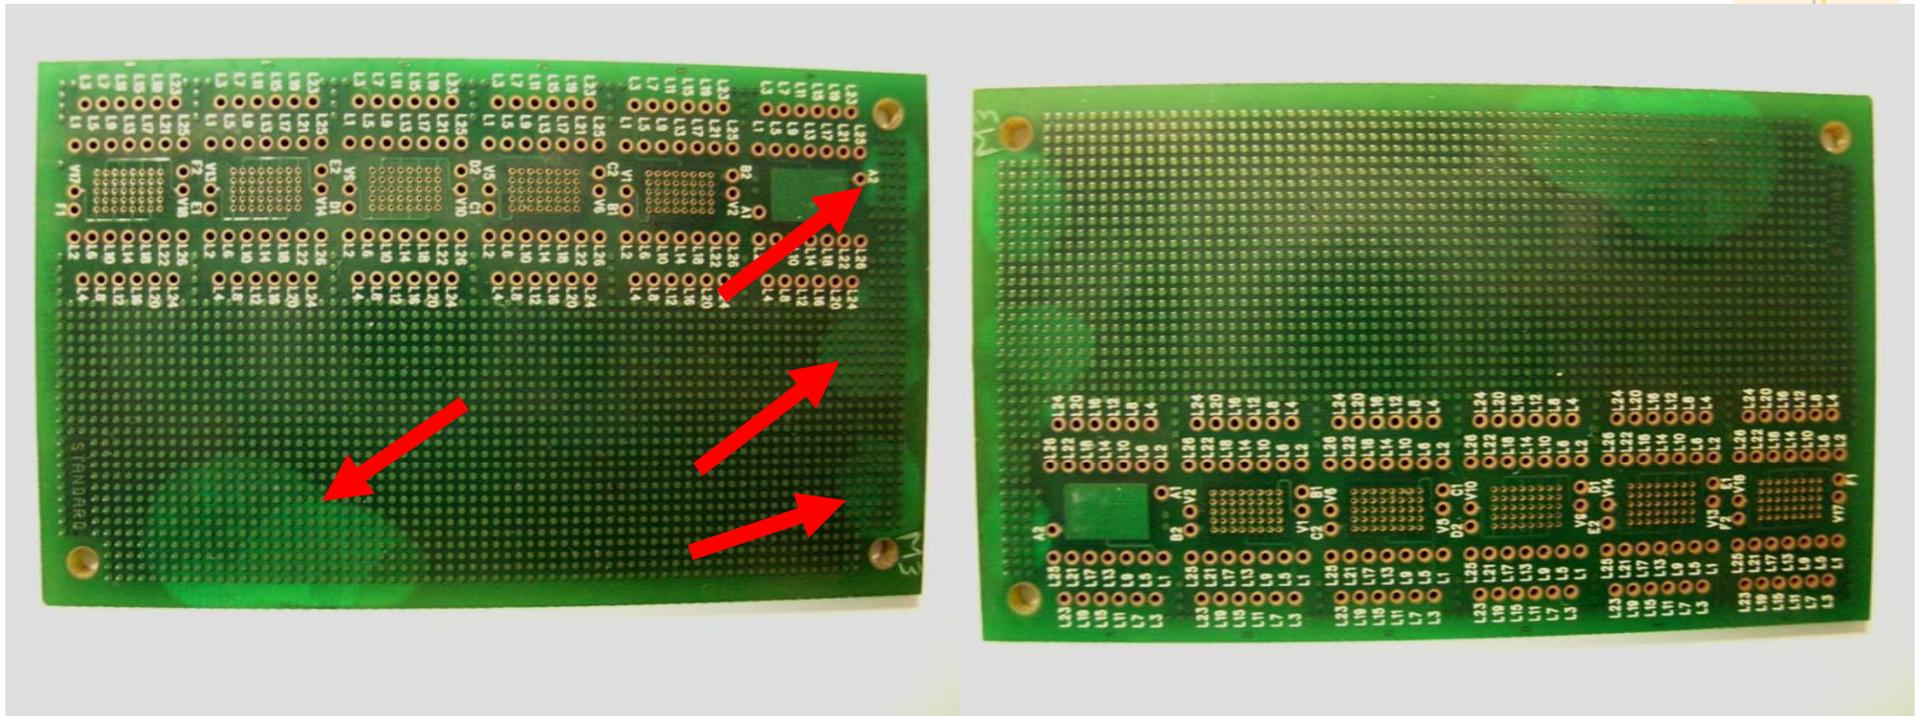
Coupons after 85C/85%RH + 3 Top Reflows Bottom

Red arrows mark internal delamination
