The Effect of Functional Pads and Pitch on Via Reliability using Thermal Cycling and Interconnect Stress Testing

Christopher Hunt and Martin Wickham
National Physical Laboratory
Teddington, UK
(www.npl.co.uk/ei)

Bill Birch and Jason Furlong
PWB Interconnect Solutions Inc.
Nepean, Canada
(www.pwbcorp.com)

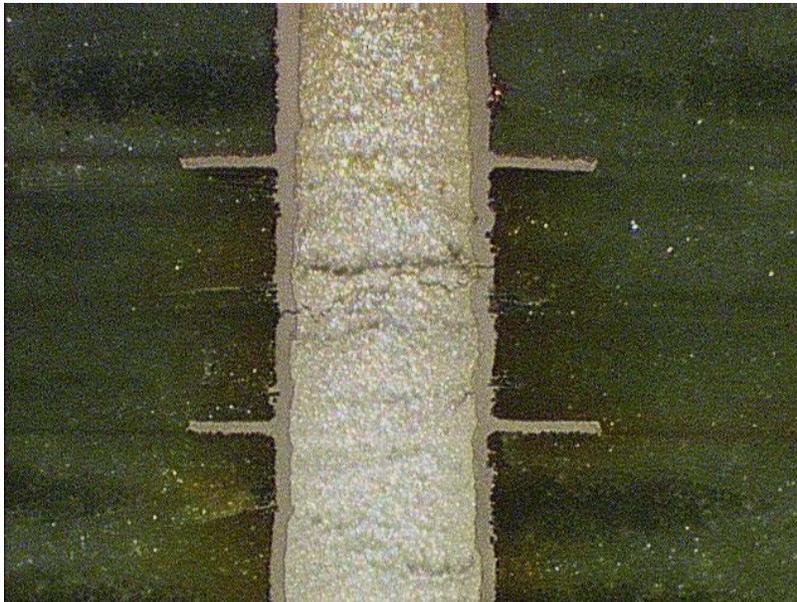
Figure 7: Micro section of via with failure in region where non-functional pads have been retained.

Reviewing micro-sections of failed vias indicates a high percentage of vias with non-functional pads included, have failed adjacent to the non-functional pads as shown in Figure 7 even though these are away from the central portion of the via, where failures would generally be expected to occur. These correlates well with other evaluations that have been undertaken by PWB (reference 4) and Kim et al (reference 5). It has been postulated that the inclusion of non-functional pads acted as stress concentrators, leading to the earlier failure.

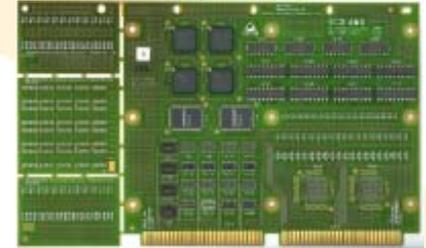
NPL Pb-contamination Studio

- Failures of vias in NPL project evaluating Pb contamination of LF
 - 5 assemblies per batch, 400 μ via in 1.6mm FR4

Reflow Solder	Wave Solder	No.of via failures at 2000 thermal cycles
SAC	SAC	7/310
SAC	None	4/310
SnPb	SnPb	1/310
SnPb	SnPb	2/310

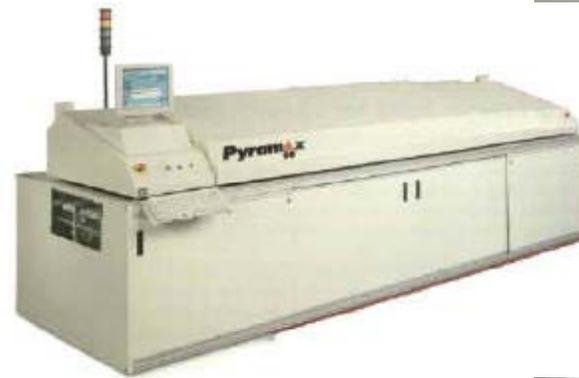
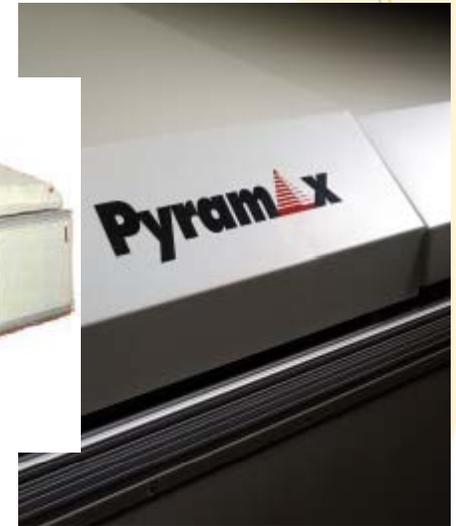
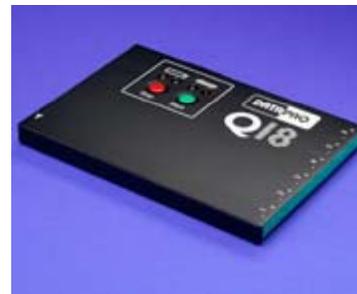
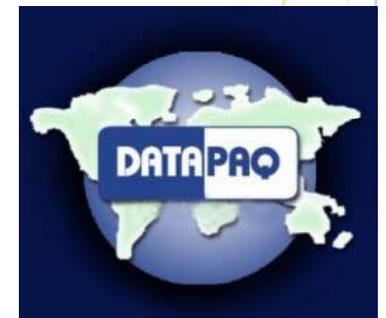
Reflow Profiling – 2.5mm

Paqfile: BTU 260 P2 B1_2_5, Process: BTU PCBrel P2 2_5 [User Zoom]

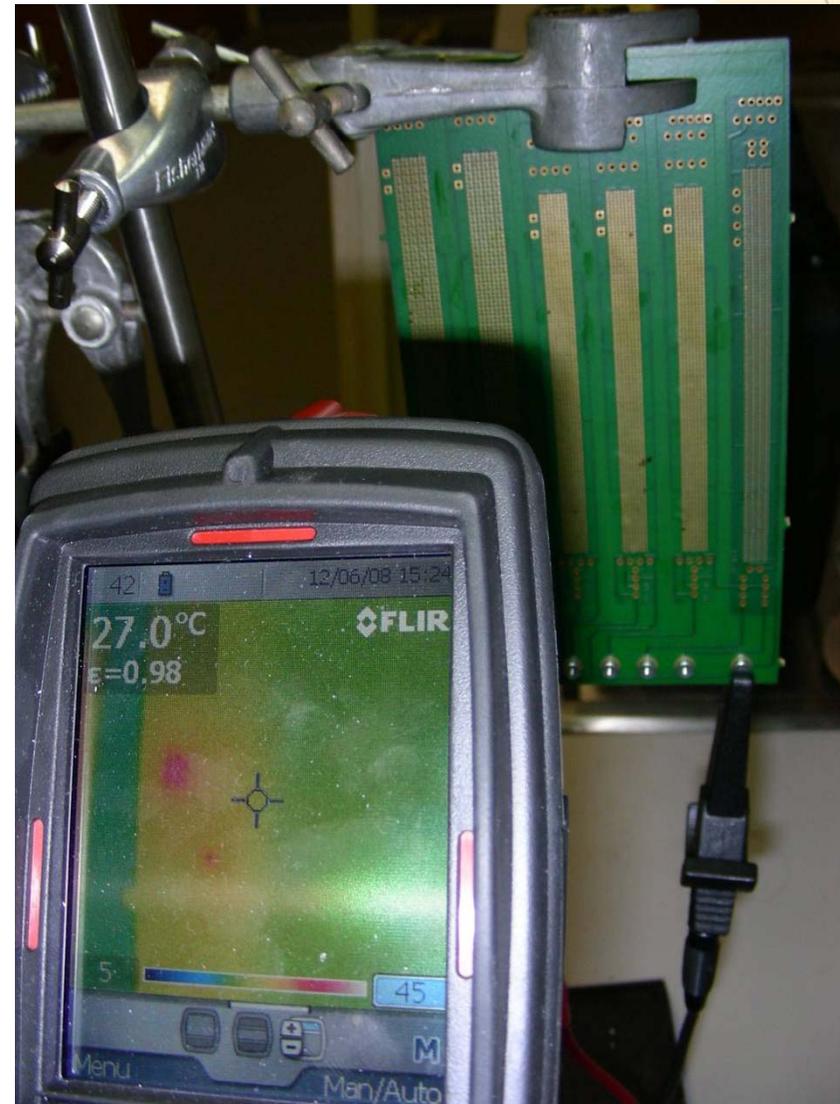
Failed Via Location

- Electrical test
- Thermal test for intermittents

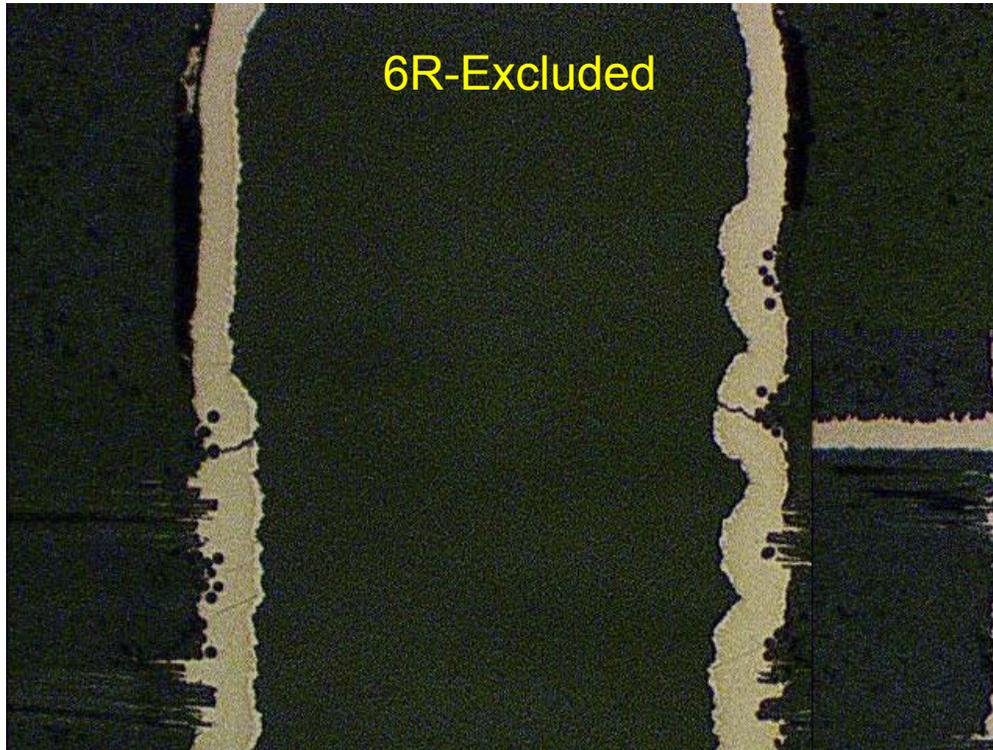
Comparison – 2.5mm Ag, 2000 cycles

- Micro-sections of failed vias showed high percentage of vias failed adjacent to the non-functional pads, even though these are away from the central portion of the via, where failures would normally occur.
- These correlates well with other evaluations that have been undertaken by PWB
- It has been postulated that the inclusion of non-functional pads acted as stress concentrators, leading to the earlier failure.

Failure 2.5mm Ag, 2000 cycles, NF Pads included
