Pockets of Contamination That Are Causing Field Failures and How to Avoid Them

Eric Camden
Foresite, Inc
Kokomo, IN

Abstract

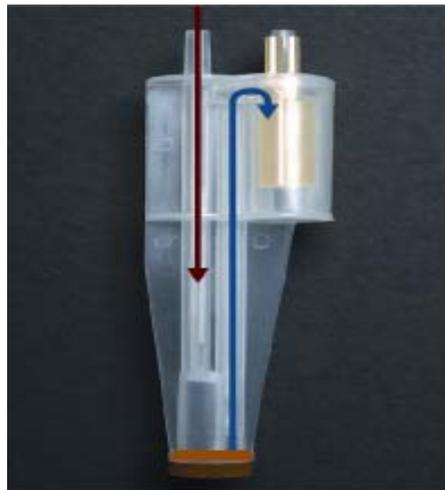
The designed system uses a deionized steam extraction system to collect a 2.2 ml sample from a 0.1 in² area of circuitry. The system produces a microburst of steam that is allowed to soak for 20 seconds, and is then aspirated into a collection cell. This steam is applied 5 times to achieve effective residue removal from the area of analysis. After 9 collection cycles, an electrical test is performed across a sacrificial y-pattern electrode to check for electrical leakage. 10v of electricity is applied, and the system makes a determination after 60 seconds as to whether or not the sample is 'clean' or 'dirty'. The current threshold for considering a sample clean is 500 μ A, and is based on 13 years of data collection through ionic analysis in failure analysis applications. The electrical test continues to run for two minutes after the cleanliness determination is made, and current readings are recorded in the testing program. The extracted sample can then be used for ion chromatography analysis to determine the exact type and quantity of the localized contamination.

Figure 1 Diagram of localized steam extraction test and collection cell

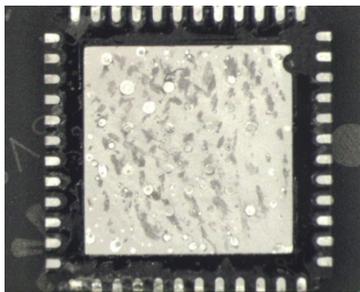
All of these elements combined and trapped under the PQFN package create a very high risk for conductive pathways to form. It was found that they used a nominal range profile for the reflow oven used with the no-clean paste. We tried modifying to a higher reflow profile, but there was still gooeey, non-complexed flux under the package. The reason for this phenomenon is that as the weight of the PQFN package collapses over the molten solder paste during reflow, flux from the outside is sinking over and becoming trapped underneath the package where it cannot be complexed and released. The PQFN, which sits atop solder paste at a 6 mil stencil thickness, is able to drop down to 3-4 mils, thus trapping the flux and blocking the solvent path of volatilization. The parts were sheared off of the assembly to perform the site specific extraction and further testing with ion chromatography, results are in Table 1, photo of underside of component with flux in figures 1&2.

Figure 2 Bottom of PQFN with Flux

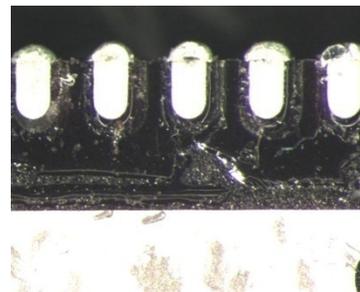
Figure 3 Close-up of same PQFN

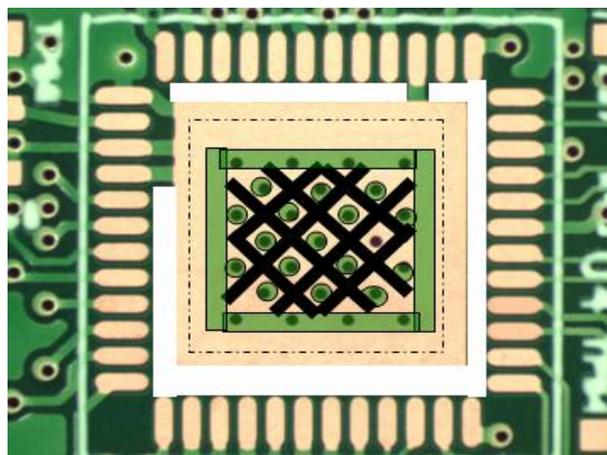
Figure 4- Depiction of PQFN recommended changes and details

1. Remove inside area soldermask (except on ground contact pads or attach the ground to the thermal vias on the other side and eliminate traces to ground pad)
2. Reduce Center pad by 15% on all sides
3. Plug all via's with mask and place
4. Solder mask in the mask defined area with diamonds (black)

We were asked to develop a corrective action plan to prevent future field failures, and recover the contaminated assemblies through rescue cleaning. This customer implemented several corrective actions suggested by Foresite in order to prevent the flux entrapment. The first recommended action was a design change suggested which was to remove some of the pads from underneath the PQFN components. Fewer pads mean lowered opportunities for contamination. The final design change

suggested was the widening of the gap between the power and the ground. This wider spacing decreases the risk of bridging. In addition to these design changes, also suggested was closer monitoring of solder paste deposition, and the use of less solder paste and to monitor the cleanliness levels of incoming bare boards as well as the components. To analyze whether or not these suggested changes were effective in eliminating the problem of goeey contamination under the PQFN parts, we analyzed additional samples manufactured with the original process, and compared them to assemblies manufactured with the suggested design changes. As seen in the analysis from table 2, the original process produced assemblies with high amounts of weak organic acid flux residues, and still exhibited a thick, goeey flux residue underneath the PQFN components. The assemblies built with the suggested design changes, including modified spacing and pad placement, showed acceptable low levels of weak organic acid residues. The flux residue was able to volatilize under these conditions, and all ionic residue levels for these assemblies fell within limits for reliable field performance. Table 2 shows ion chromatography results on follow up samples with suggested changes; figure 3 is a depiction of changes made to component design and details.

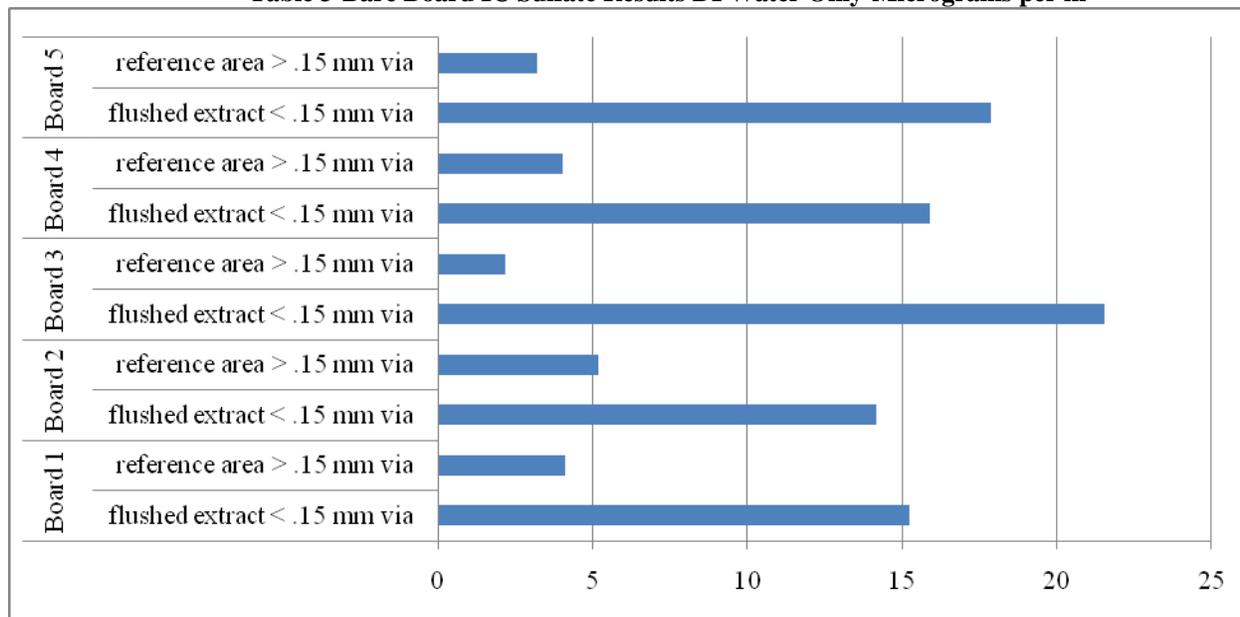
Table 3-Bare Board IC Sulfate Results DI Water Only-Micrograms per in²

A companion issue to flux residue beneath the PQFN package is a concern with contaminated vias, especially when directly under components. We have found a few bare board fabricators that historically have had no issues with bare board cleanliness that were being asked to put tighter cleanliness acceptance levels in place because of the sensitive nature of the surface mount PQFN problems previously discussed. When the process window tightens, all of the materials involved must be held to cleaner standards than ever before. For years, vendor X produced boards with typical levels of <3 +/- 2 from time-to-time on sulfate without issue, but when one of the assembly houses began building with several of the PQFN packages, a series of field failures were found directly related to cleanliness underneath these low standoff components. A study of via cleanliness was performed, and areas with vias >.15 mm were found to be much cleaner than the vias that were smaller than that. Simple surface tension was the main culprit. The normal DI water alone was not able to penetrate the smaller vias, and remove the etchants used in processing. The level of sulfate residues in addition to other process residues, and a normal amount of humidity found in service, was enough to cause the failures (see table 3). A 5% solution of saponifier/DI water was put in place, and this was enough of a decrease in surface tension to access the etchant residues entrapped in the smaller vias, and adequately rinse them out (see table 4). Levels dropped to very comparable sulfate residue amounts across the surface of the bare board. We have not found any further field failures to date with this product related to the cleanliness in vias issue.

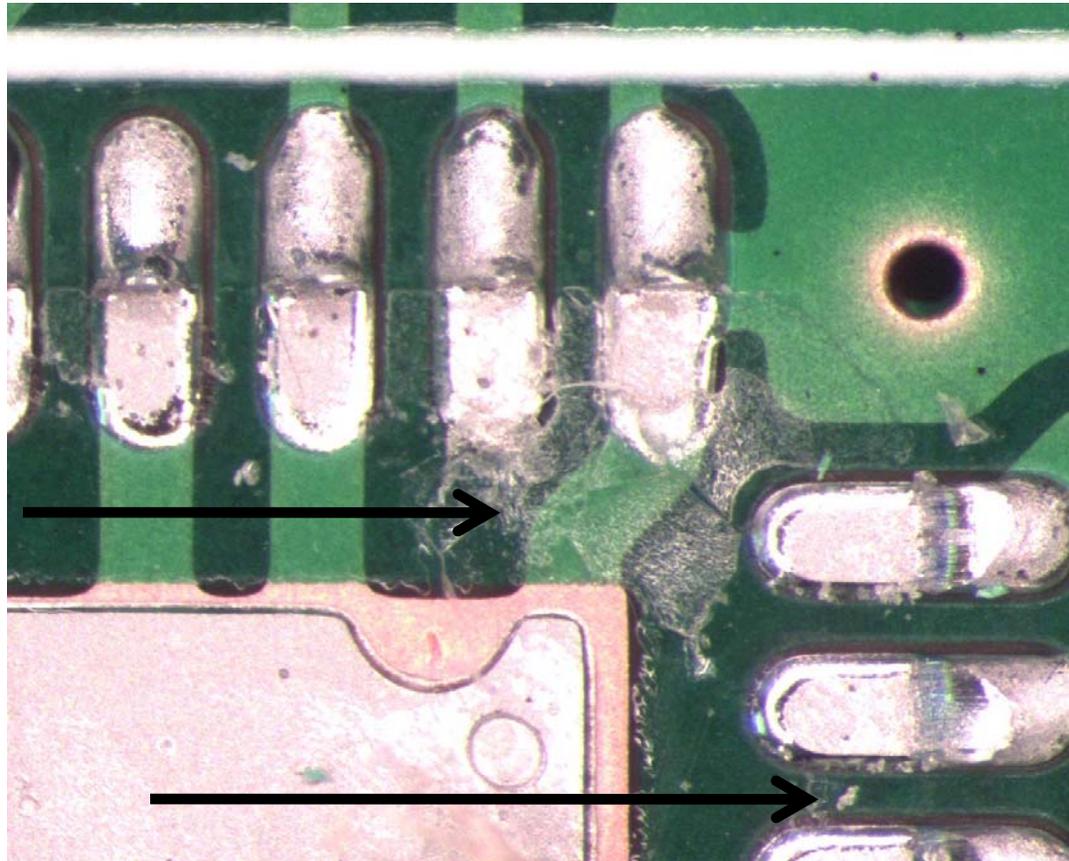
Board Level #1

Heavy Flux Residue Under PQFN

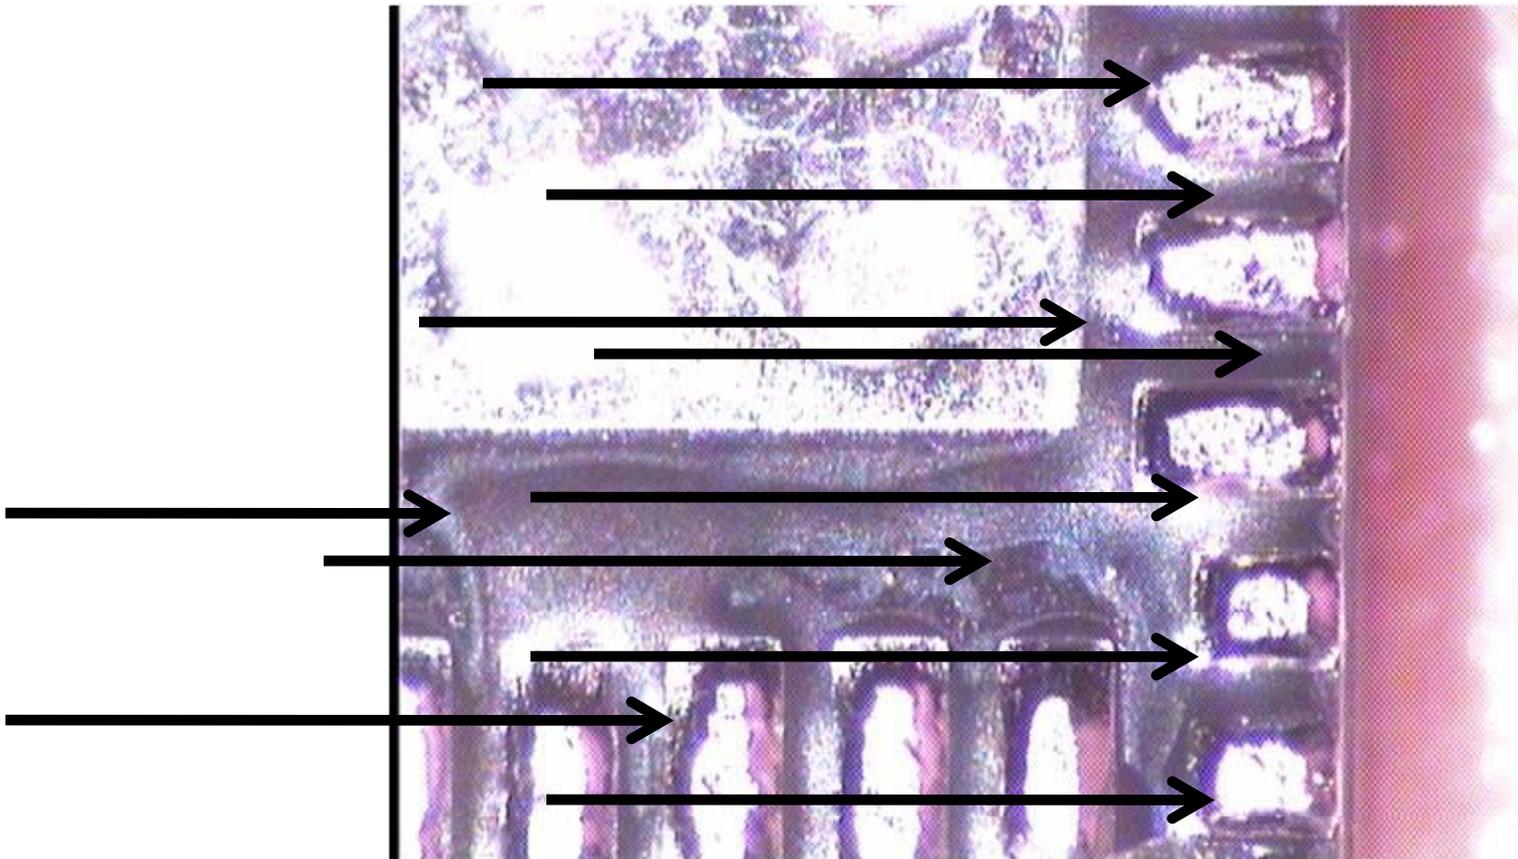
Board Level #2

Sorry, there is lots of active flux here

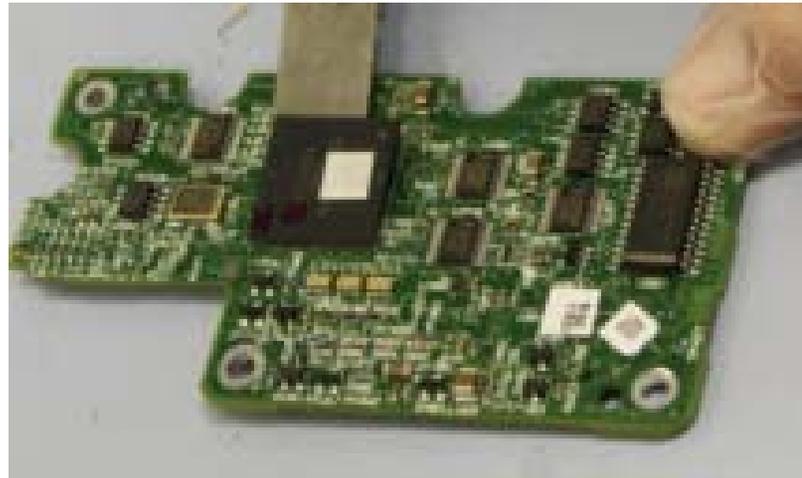
IC Procedure

The component was mechanically removed with a clean blade to expose the flux residues. Remember that any secondary thermal exposure it can alter results.

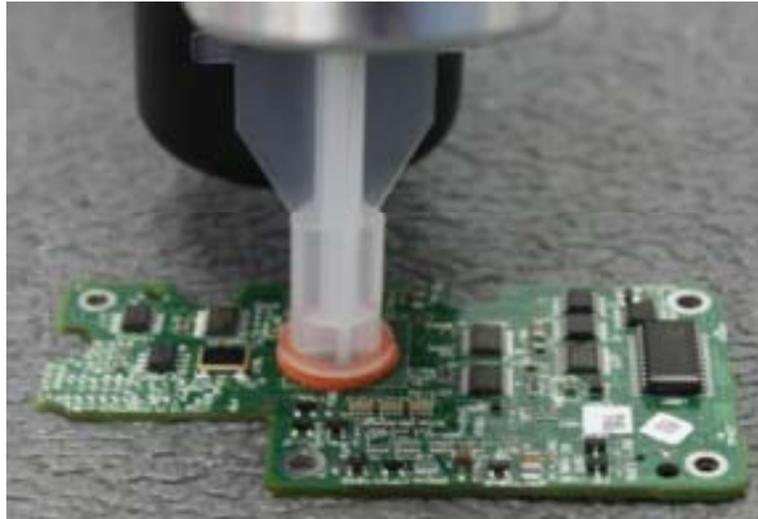
Localized Extraction

A commercially available localized extraction method was used to harvest sample for IC analysis. An overall standard extraction would not tell if there is an issue beneath components

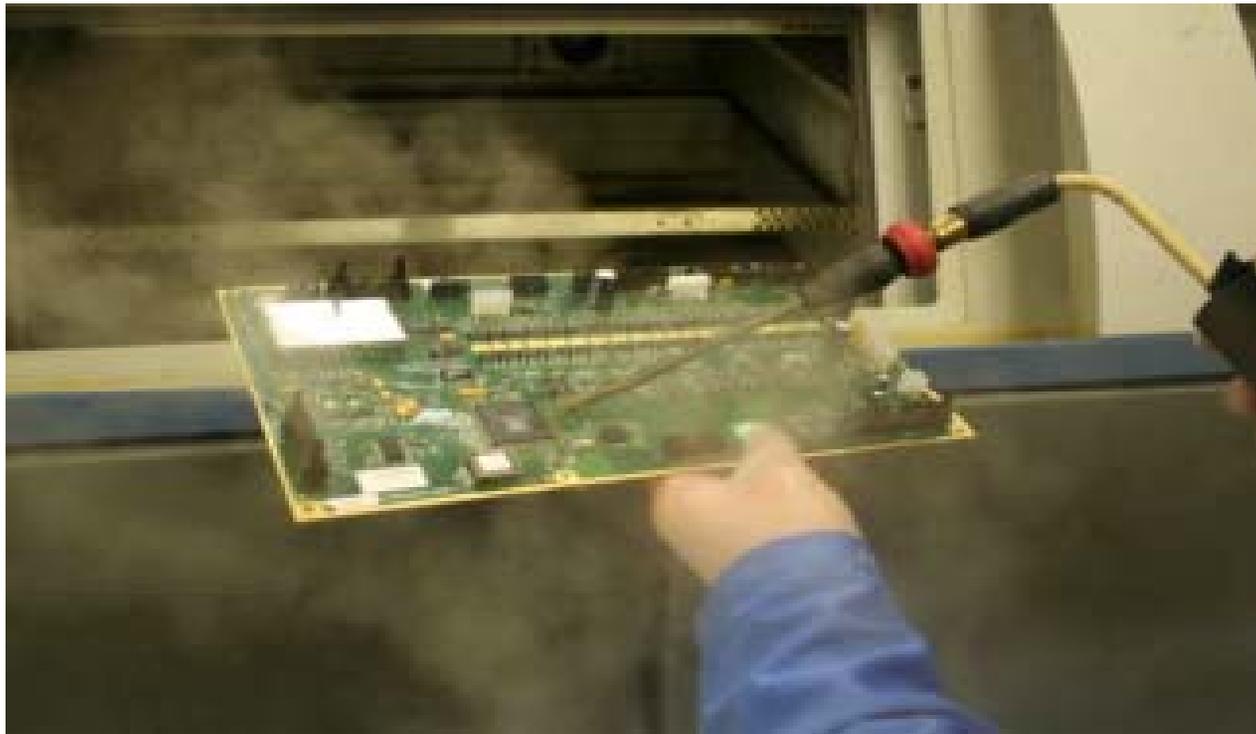
Steam Cleaning Recap

- Recovery cleaning of all suspect assemblies can mitigate this issue. As I have reported in previous presentations this can be done with a mix of low pressure saponified in-line wash techniques that also incorporate a secondary steaming step that uses enough heat and pressure to “push” the saponifier under low standoff components and remove the detrimental amounts of active flux residues.

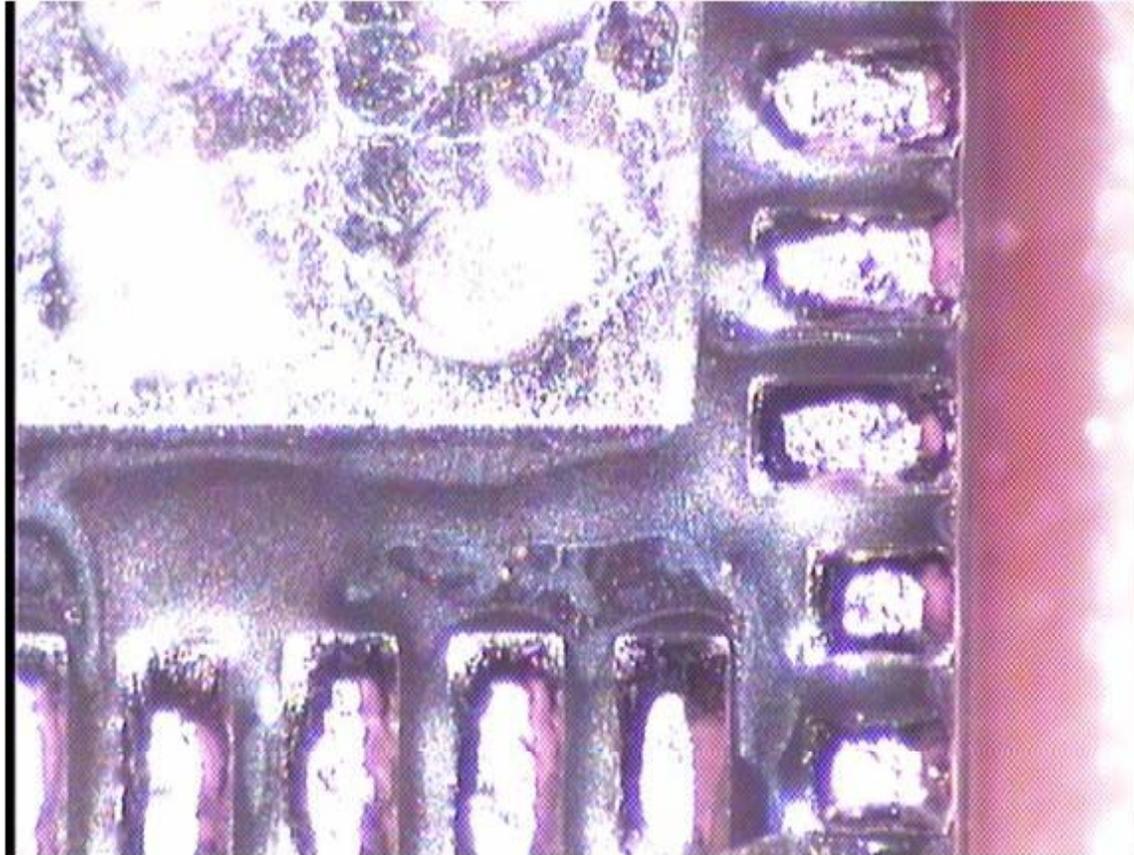
The large thermal ground pad in the center of the pad causes a lot of problems with residues

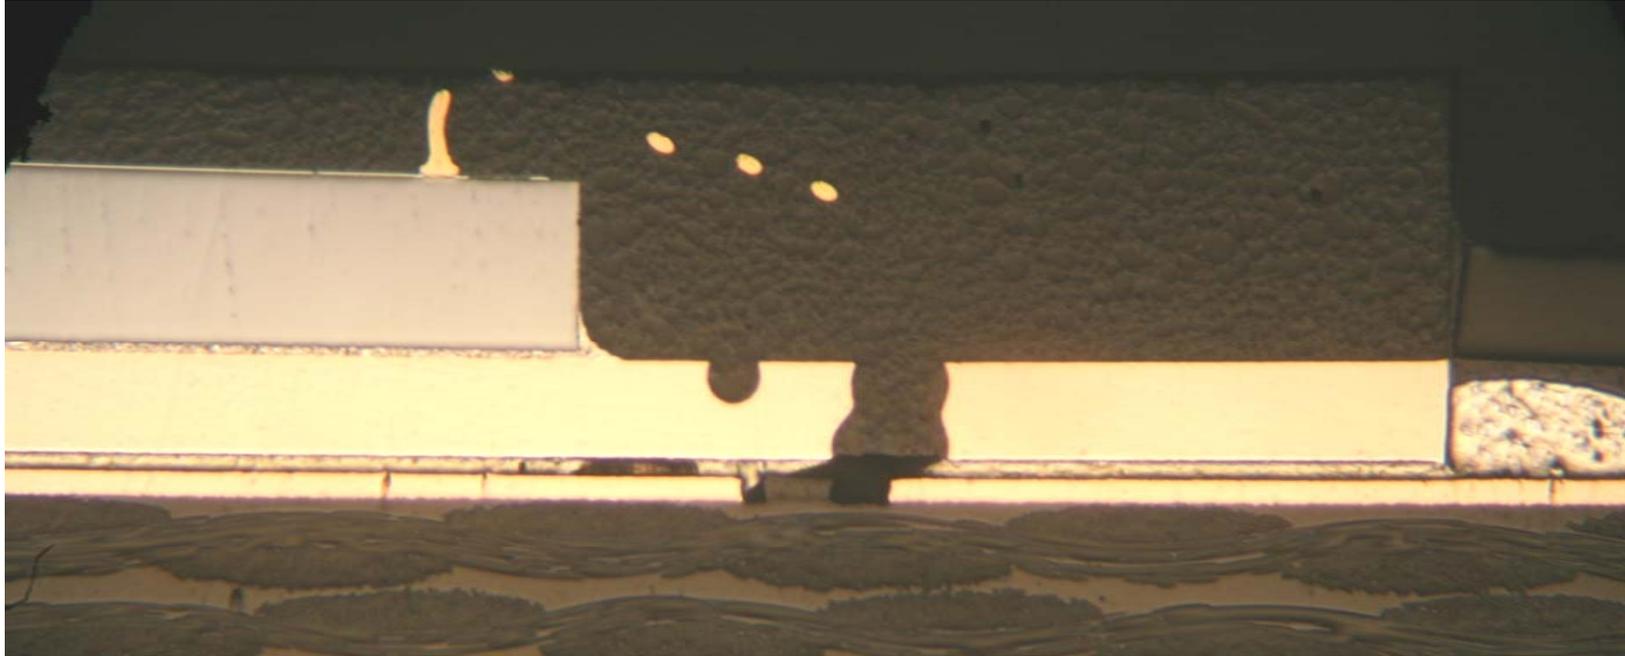
Cross Section Analysis at 50X

We have found the main issue with flux being trapped under low stand-off components is the inability to find an exit path from underneath the part. Paste is applied in the 6mil range and as the solder melts the part drops down to the 3mil range, thus creating dams in areas meant to vent flux gasses. This is very clear after cross section analysis.

QFN pulls down to 2.0 mils off the board surface trapping flux and the flux carrier between the center pad (ground) and power pad, also the QFN is not self centering and shows a shift occurs reducing the space from 10 mils to 5 mils or less. You can also see a large amount of solder pushed from beneath the component on right hand side.

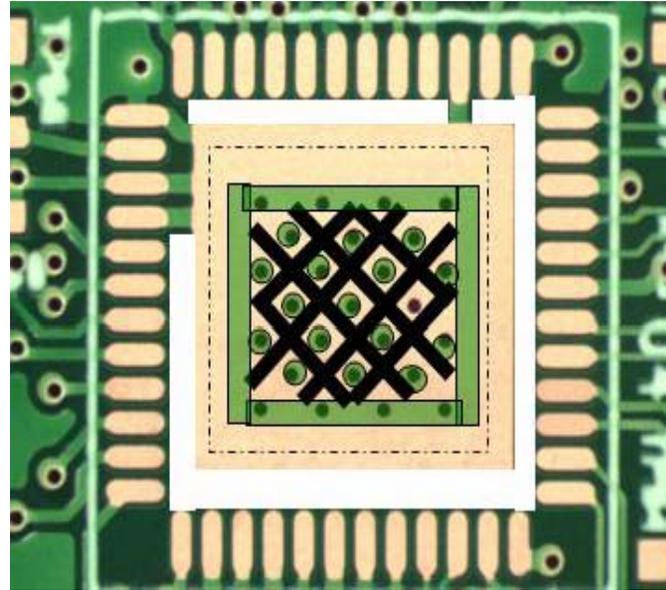
Possible Solutions

1. Remove inside area soldermask (except on ground contact pads or attach the ground to the thermal vias on the other side and eliminate traces to ground pad)
2. Reduce Center pad by 15% on all sides
3. Plug all via's with mask
4. Solder mask in the defined area with diamonds (black)

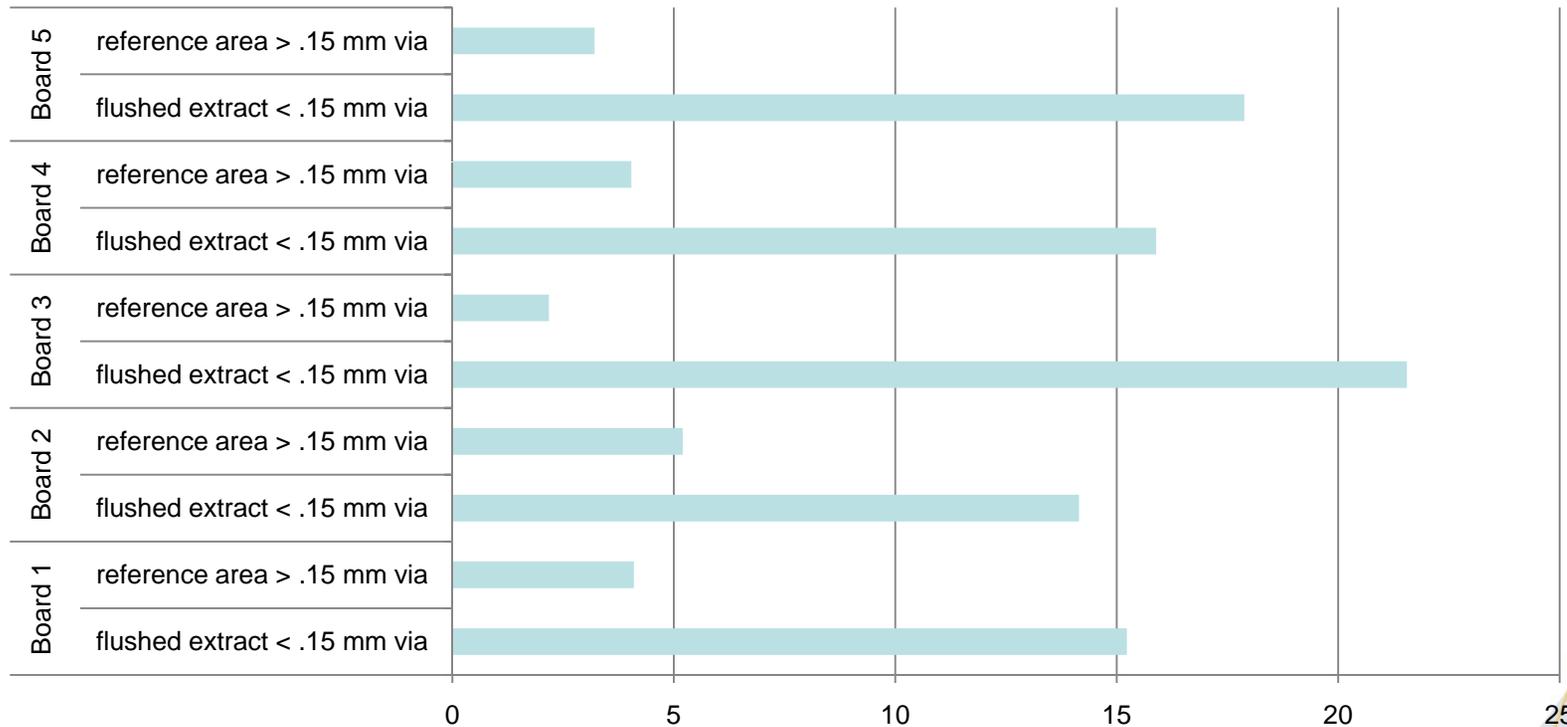
Board IC Sulfate Results DI Water Only- Micrograms per in²

- Dirty vias and the inability to clean them with normal water wash process.
- Boards with vias smaller than .15mm were found to have high levels of sulfate due to DI waters inability to penetrate and clean board fab residues that compound the problem.
- Comparatively larger vias were found to be much cleaner and did not add to the problem
