Effects of Tin Mitigation Processes on Whisker Growth and Solder Joint Reliability for Chip and Small-Outline Package Components

Tom Lesniewski and Tom Higley
Northrop Grumman Network Communications
San Diego, CA 92128

This paper reports the results of an evaluation of tin mitigation processes for components, i.e. converting parts with pure tin (Sn) and other lead-free (Pb-free) finishes to tin-lead (SnPb) finishes.

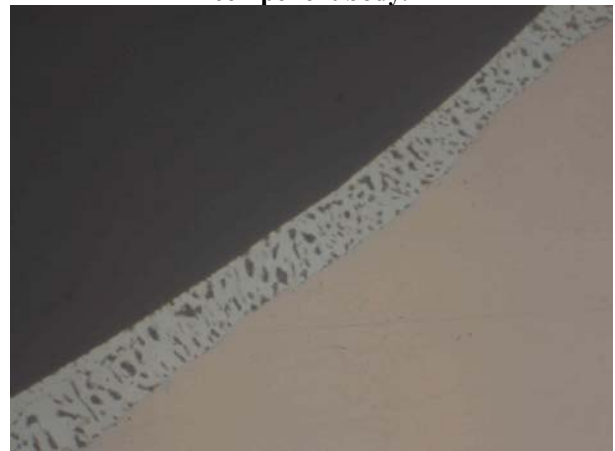
Figure 4. Cross section of a PLCC lead after tin mitigation. From cross section images, pure tin finish appeared to be completely removed and replaced with SnPb. No mechanical damage was observed on any of the parts after tin mitigation.

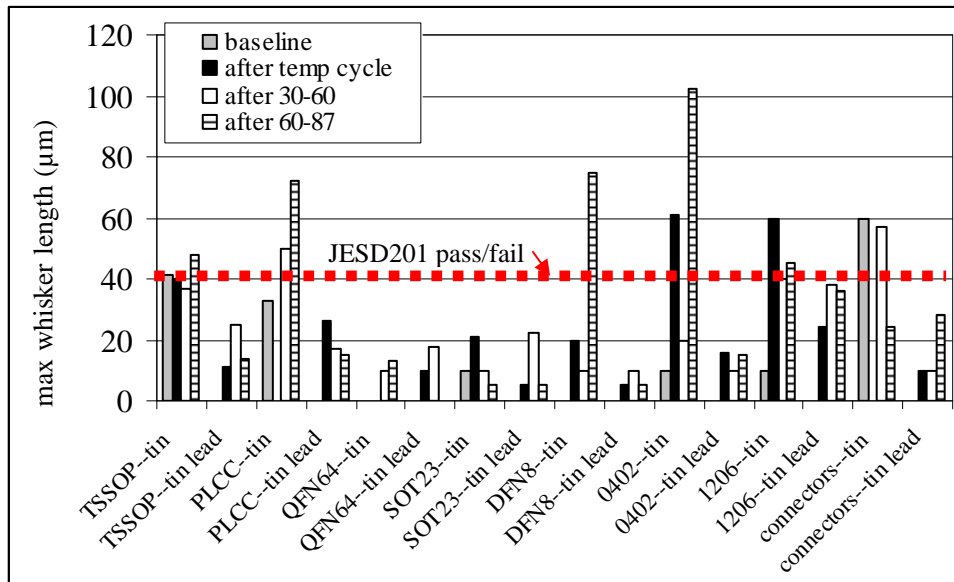
Figure 5. Maximum measured tin whisker lengths observed on different part types before and after temperature cycle and temp/humidity tests. Lengths were measured by visual inspection at 50-100X and by Scanning Electron Microscopy.

Visual inspection/SEM results are summarized in Table 3 (whisker densities) and Figure 5 (whisker lengths). Photos of the components before and after the testing are shown in Figures 1 through 4. The data showed that

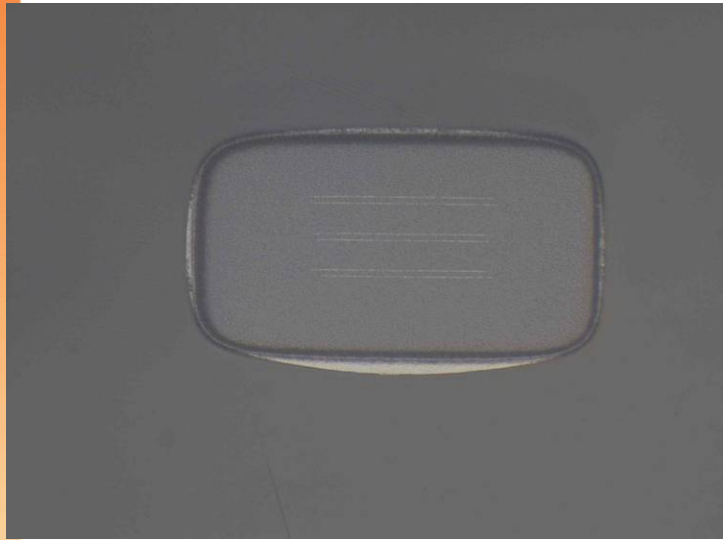
Cross section of ceramic chip part shows no cracks or damage to ceramic. Minimal solder coverage at corners—possible solderability issue
