# Impact of Hole-Fill and Voiding on Pin Through-Hole Solder Joint Reliability

Jennifer Nguyen, Dan Rooney, Ph. D, Dongkai Shangguan, Ph.D  
Flextronics International  
San Jose, CA 95131

## Abstract

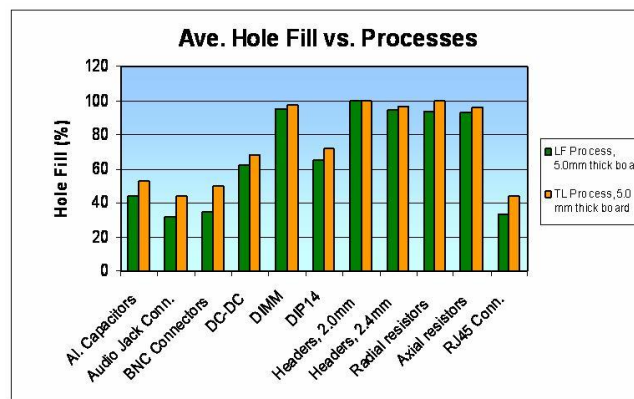
Figure 4 - Hole-fill vs. Component Type and Process. There was a slightly better hole-fill for components waved in tin-lead process as compared with the same components waved in lead-free process.

Typically, there is no hole-fill issue with board thickness below 2.4mm, when a lead-free wave soldering process is used, (Figure 2). As the board thickness increases, the hole-fill will decrease depending on the board design (number of connected copper ground planes and copper thickness) and the component type. Figure 3 shows the hole-fill percentage of many different components wave soldered in lead-free process using the 5.0mm thick boards. Many components had less than 50% hole-fill using fully optimized process conditions. In comparison, Figure 4 shows the hole-fill of the same components wave soldered in tin-lead wave soldering. As can be seen, there was slightly better hole-fill for components wave soldered in tin-lead process as compared with the same components in the lead-free process. The board thickness and the thermal mass of the connected copper ground planes make it more difficult to achieve good hole-fill for certain component types, regardless of the solder alloy (Figure 4).

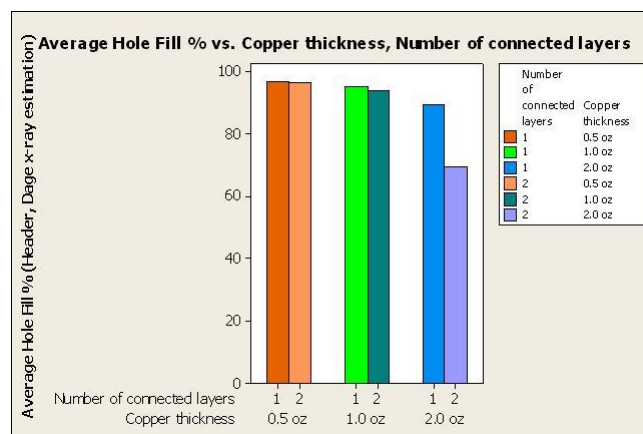
Figure 5 – Thermal effect on hole-fill

The internal copper plane had a significant impact on hole-fill. Copper thickness (copper weight) and the number of connected layers had an effect on hole-fill, with the influence of copper thickness on hole-fill being more noticeable. With the same amount of copper weight, the PTH component that is connected to multiple, but thinner copper layers resulted in better hole-fill than the PTH component connected to a heavy ground plane of the same amount of copper weight. For example, the PTH components that are connected to 2 layers of 0.5 oz copper resulted in better hole-fill than the components connected to 1 layer of 1.0 oz copper thickness. Similarly, the PTH components connected to 2 layers of 1.0 oz of copper thickness resulted in better hole-fill than the components connected to 1 layer of 2.0 oz of copper thickness (Figure 5). There was about 20-25% drop in hole-fill when the PTH solder joints were connected to 2 layers of 2 oz of copper thickness (Figure 5).

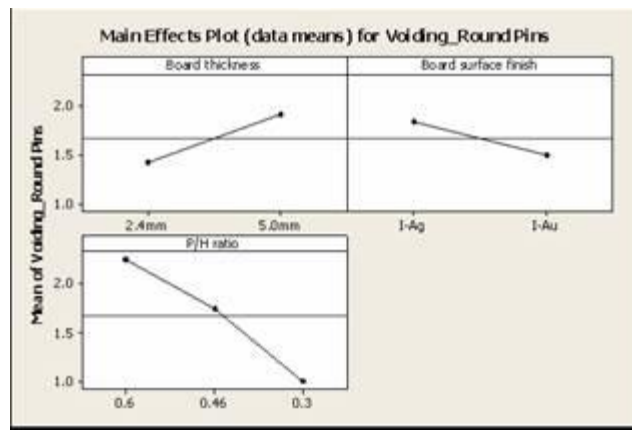
Analysis of Variance for Voiding\_Round Pins, using Adjusted SS for Tests

Source	DF	Seq SS	Adj SS	Adj MS	F	P
Board thickness	1	0.08333	0.08333	0.08333	4.00	0.184
Board surface finish	1	1.33333	1.33333	1.33333	64.00	0.015
P/H ratio	2	2.62500	2.62500	1.31250	63.00	0.016

S = 0.144338 R-Sq = 99.17% R-Sq(adj) = 95.42%

**Figure 8 – Voiding vs. board thickness and board surface finish.**

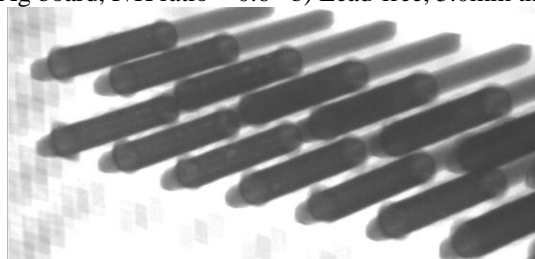
a) Tin-lead, 5.0mm thick, I-Ag board, P/H ratio = 0.6    b) Lead-free, 5.0mm thk, I-Ag board, P/H ratio= 0.6

c) Lead-free, 5.0mm thick, ENIG board, P/H ratio of 0.6

d) Tin-lead, 5.0mm thick, I-Ag board, P/H ratio = 0.6 e) Lead-free, 5.0mm thk, I-Ag board, P/H ratio= 0.6

**Figure 10 – X-ray images of PTH solder joint voids for different board thicknesses and board surface finishes.**

Voids were seen on both tin-lead and lead-free solder joints (Figure 10). The study revealed that the P/H ratio significantly affected the amount and size of voids in the PTH solder joints (Figure 6). The smaller the PTH ratio (or the larger the hole diameter), the lower the extent of voiding. Figure 7 shows the images of PTH solder joints with different hole sizes. From the left to the right, the P/H ratios are 0.59, 0.53, 0.46, 0.36 and 0.30, respectively. As can be seen from the pictures, the P/H ratio of 0.59 had many voids, whereas almost no voiding was seen on the solder joints with P/H ratio of 0.3. Although more voids were seen on the components that had round pin shape as compared with square pins or rectangular pins (while the P/H ratio was the same), the effect of pin shape on voiding was not significant (Figure 7). More voids and larger voids were seen on the solder joints of 5.0 mm thick board than on the solder joints of 2.4 mm thick board. However, the pin-to-hole ratio was still the dominant factor that influences voiding. The ENIG boards had less voids than the immersion silver boards (Figure 8). More voids were seen on the solder joints without pin protrusion than on the solder joints with some pin protrusion (Figure 9). Figure 10 illustrates the voiding amounts of tin-lead and lead-free solder joints, and of lead-free solder joints with different board thicknesses and board surface finishes at the pin-to-hole ratio of 0.6 (the worst case).

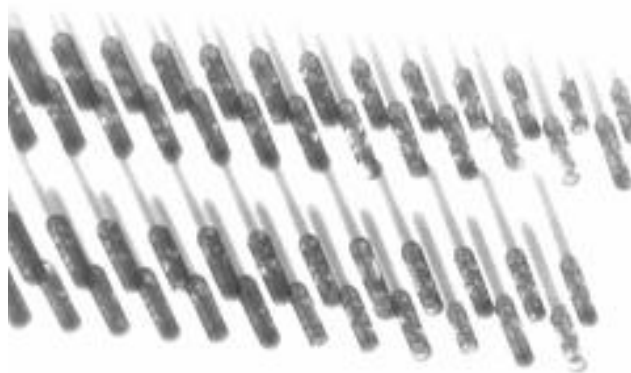
**Figure 11 - X-Ray showing intentionally extensive voiding in PTH solder joints.**

Samples of different hole-fill percentages, with immersion silver finish PCBs, were prepared for thermal cycle testing (Table 2). Two different board thicknesses (2.4mm and 5.0mm) and three different hole-fill percentages (30%, 50% and 100%) were investigated. The components were daisy chained for continuous monitoring during the testing. Solder joints with pin protrusion and without pin protrusion were considered. Samples with extensive voiding in the solder joints were also tested (Figure 11). Only the pin headers and axial resistors were included in the reliability test.

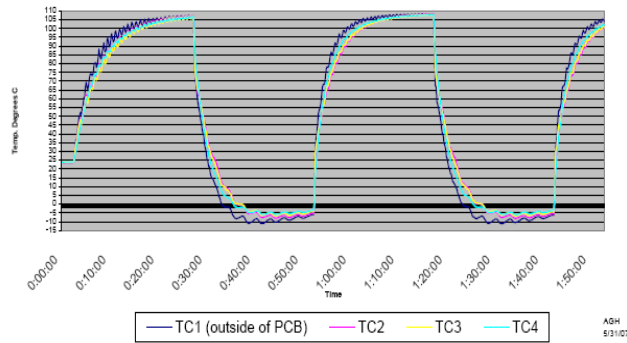
**Figure 12 - Thermal Cycle Temperature Profile – 0 to 100 degrees C**

The thermal cycle testing was performed in an air-to-air thermal cycle chamber, from 0 to 100°C with 15-minute dwell time at each peak temperature, and a temperature ramp rate of approximately 15°C per minute. The chamber profile of temperature versus elapsed time is shown in Figure 12.
