Printed Circuit Board Fabrication Processes and Their Effects on Fine Copper Barrel Cracks

Edward Arthur[1], Charles Busa[2], Melissa Durfee[3], Chad Gibson[2], Wade Goldman P.E.[2]
[1]Raytheon Company, Space and Airborne Systems, El Segundo, California
[2]The Charles Stark Draper Laboratory, Inc., Cambridge, Massachusetts
[3]Raytheon Company, Integrated Defense Systems, Sudbury, Massachusetts

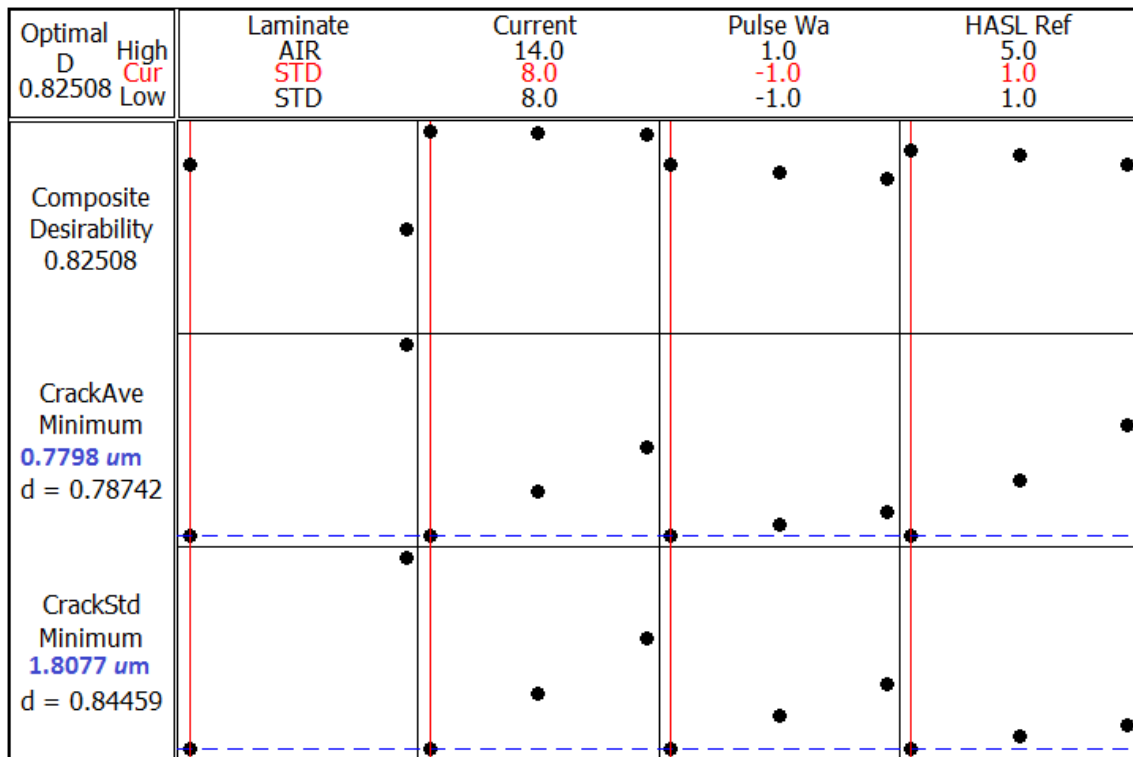
Figure 3 - Optimization Plot of Crack Length Average and Standard Deviation (optimal settings)

The optimization plot shown in Figure 3 indicates that, within the design space tested, the optimal settings to minimize crack length average (ave) and crack length standard deviation (std) are as shown in Table 3.

Figure 3 uses a composite desirability index since the behavior of one response may differ from another response for certain factor settings. However, the response slopes for both the average and standard deviation are parallel, with the exception of HASL reflow, where the standard deviation slope is fairly flat. An ideal desirability index equals 1.0, which is a unitless measure of how well the optimal DOE factor settings result in meeting the specification limits for the response variables. A goal (or target) of zero (i..e., no crack) was specified with an upper limit, which is required by the optimization scheme, equal to 33.0 μm. The zero target, or no cracks, is weighted by a constant, ten on a scale of one to ten, since the goal is minimization of crack lengths. The predicted average crack length, if observed, is 0.7798 μm with standard deviation of 1.8077 μm. The composite desirability index, D, based upon the separate desirability indices, d, for each response variable, equals 0.82508.

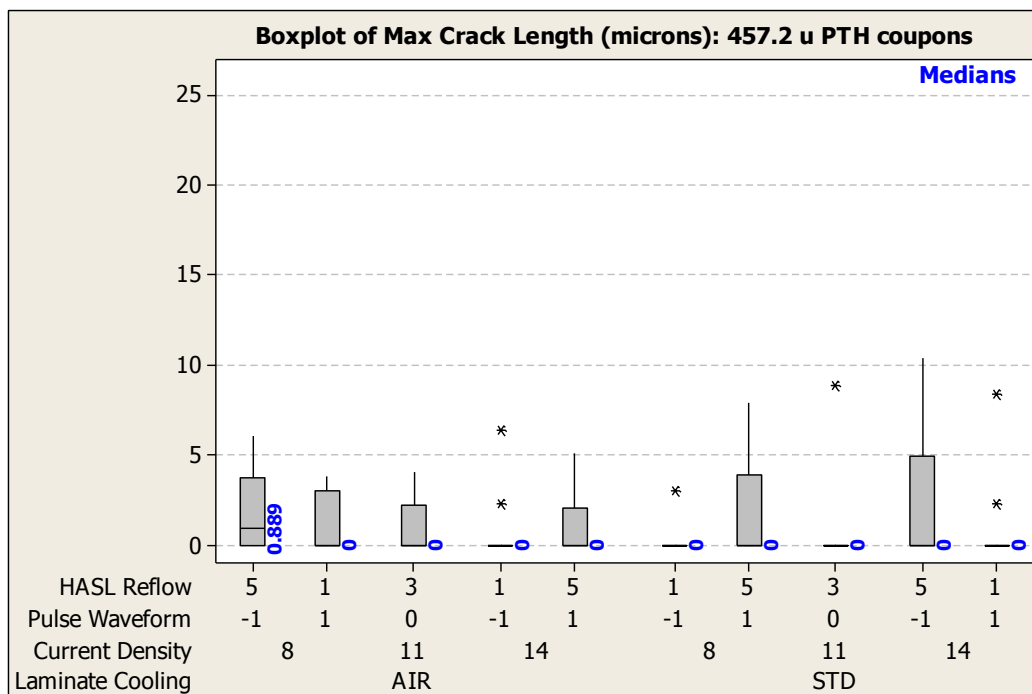
**Figure 4 - Box Plot of Maximum Crack Length (457.2 µm PTH coupons)**

Box plots are useful for examining both the centering and variability of response data as well as identifying outliers. Outliers may stem from measurement or data entry error and may warrant investigation depending on the frequency and thus influence on the final analysis. In general, the buried via coupon type has the highest median values for most DOE factor settings, notably with air cooling, and 457.2 μm PTH indicates the lowest crack lengths. The graphs are plotted on the same y-axis scale to facilitate comparing magnitudes.

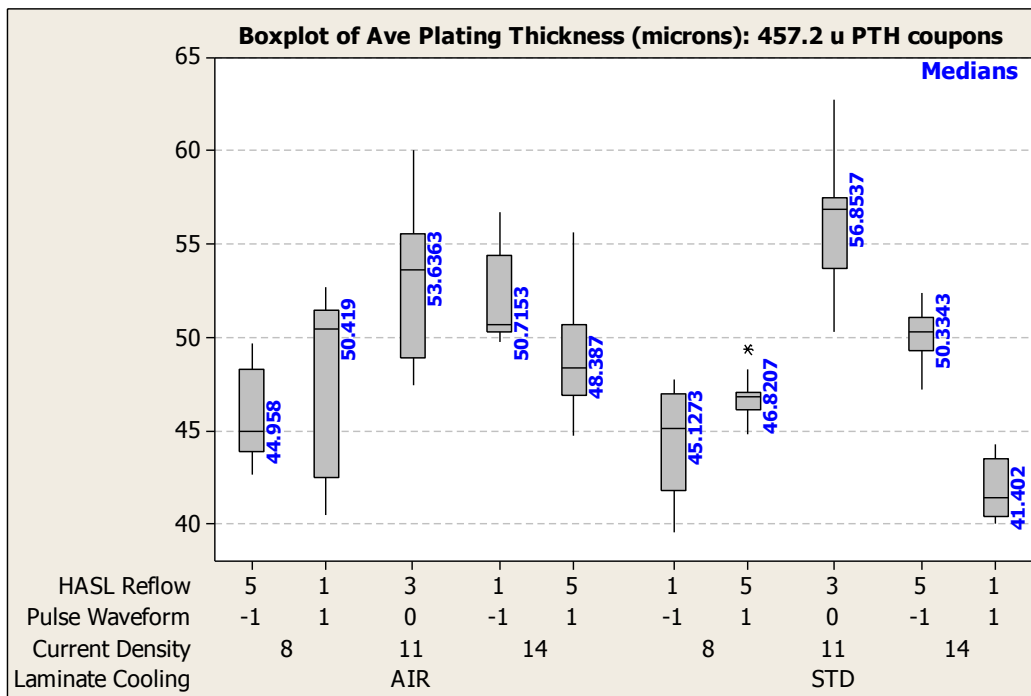
Figure 7 - Box Plot of Average Plating Thickness (457.2 μm PTH coupons)

Figure 7, Figure 8, and Figure 9 depict the box plots for average plating thickness by coupon location. In general, the plating thickness of buried vias exhibits less variability than the other coupon types for most of the factor settings. All DOE factor settings and coupon locations meet the plating thickness specification minimum of 30.48 μm (0.0012")

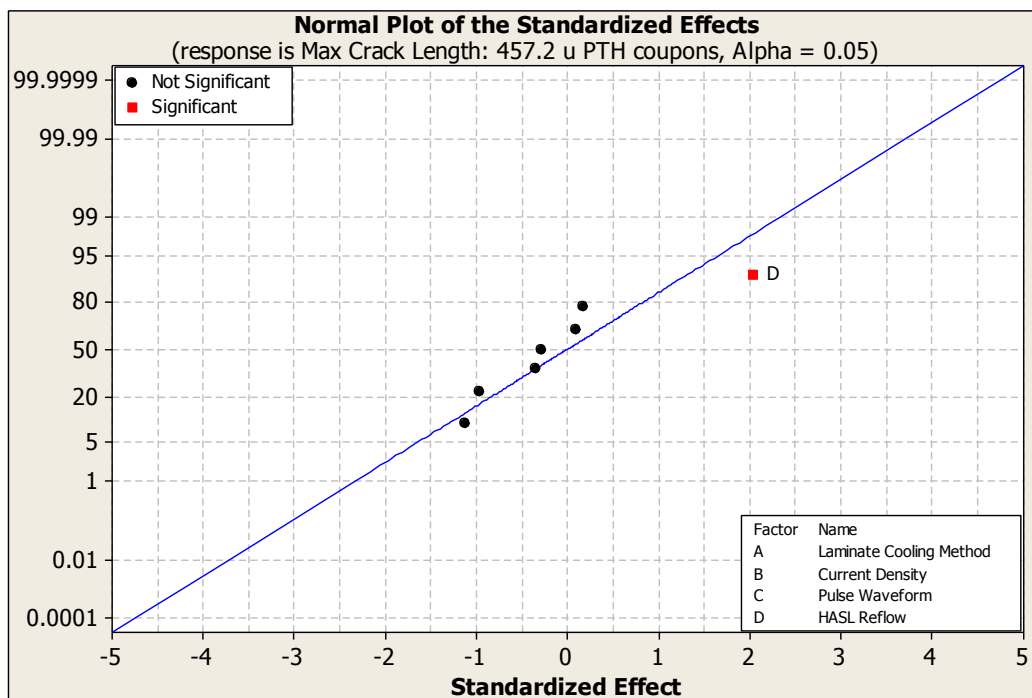
Figure 10 - Normal Probability Plot of the Effects: Maximum Crack Length (457.2 μm PTH coupons)

Figure 10 indicates that with 95% confidence (i.e., 5% chance of concluding that a factor is significant, when, in reality, the factor does not have an impact on the response), only HASL reflow, with the effect plotted in red, has a significant impact on maximum crack length for the 457.2 μm PTHs. No significant interaction effects (e.g., laminate cooling*current density) are identified and are therefore not plotted for this via type. A plot of the main (or first order) effects (Figure 11) indicates that one HASL reflow is the preferred setting for 457.2 μm PTHs, which corresponds with the optimal recommendations in Table 3.

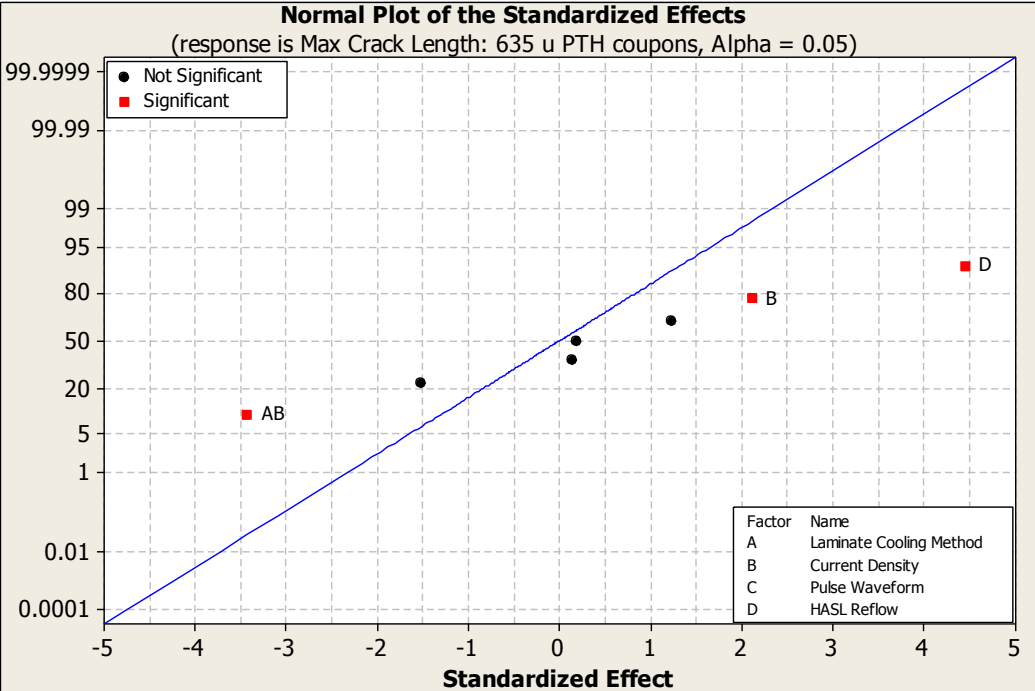
Figure 12 - Normal Probability Plot of the Effects: Maximum Crack Length (635 μm PTH coupons)

Figure 12 indicates that current density, HASL reflow, and the interaction effect, laminate cooling method*current density, are significant for maximum crack length for 635 μm PTHs.

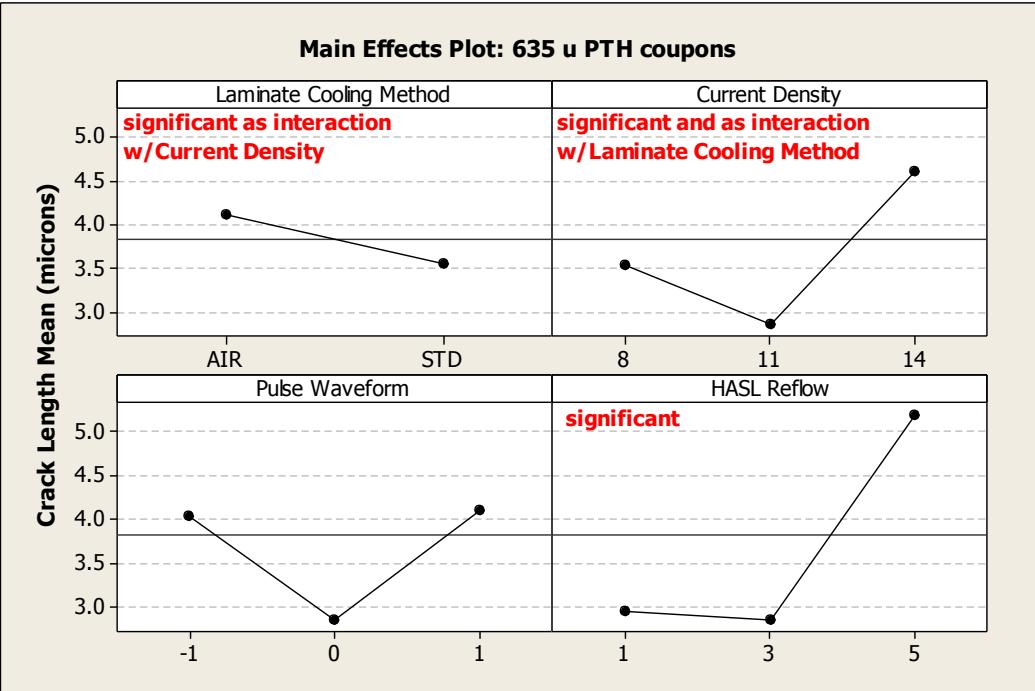
Figure 13 - Main Effects Plot: Maximum Crack Length (635 μm PTH coupons)

Figure 13 indicates that one HASL Reflow is preferred for 635 μm PTHs, which corresponds with the optimal recommendations in Table 3. The significant interaction effect, identified in Figure 12, is interpreted by reviewing Figure 14.

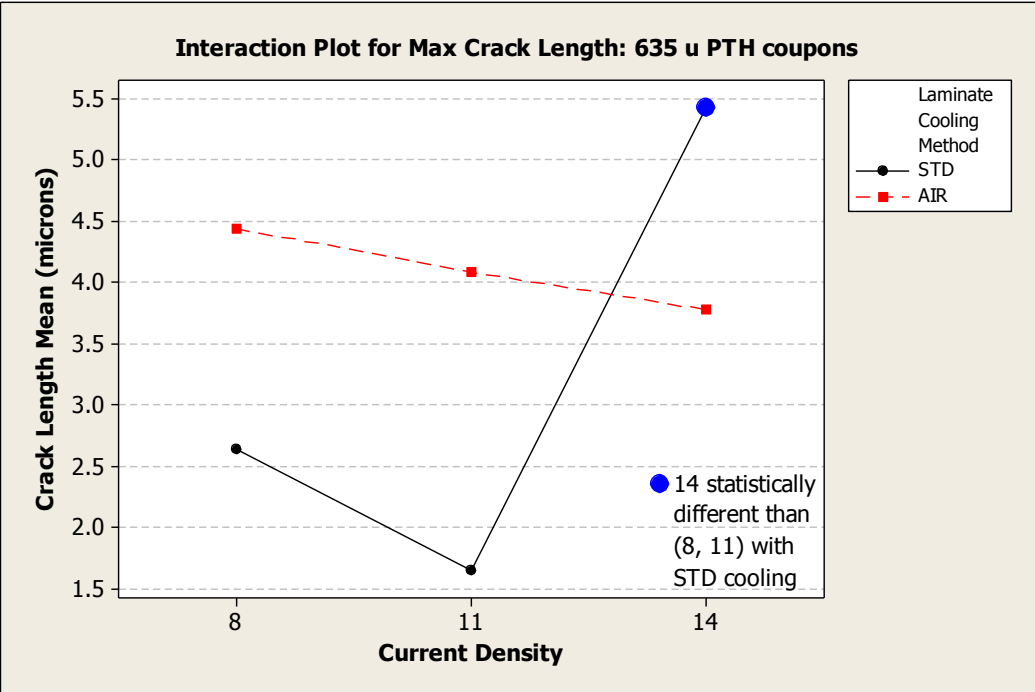
Figure 14 - Interaction Plot (Laminate Cooling Method*Current Density): Maximum Crack Length (635 µm PTH coupons)

The laminate cooling method*current density interaction is shown in Figure 14. Interactions are evident when lines connecting the mean values are not parallel, and a stronger effect is indicated by intersecting lines. In other words, the resultant mean is interrelated between two (or more) factor settings. Since this DOE is a screening design, only second-order interactions are analyzed. For water cooling, only current density 14 is statistically different (in this instance worse) than either current density 8 or 11, which are not statistically different. To minimize cracking for 635 µm PTHs, water cooling is recommended in conjunction with current density 8 or 11. Thus, the optimal recommendations based on all locations, water cooling with current density 8 as presented in Table 3 remain substantiated.

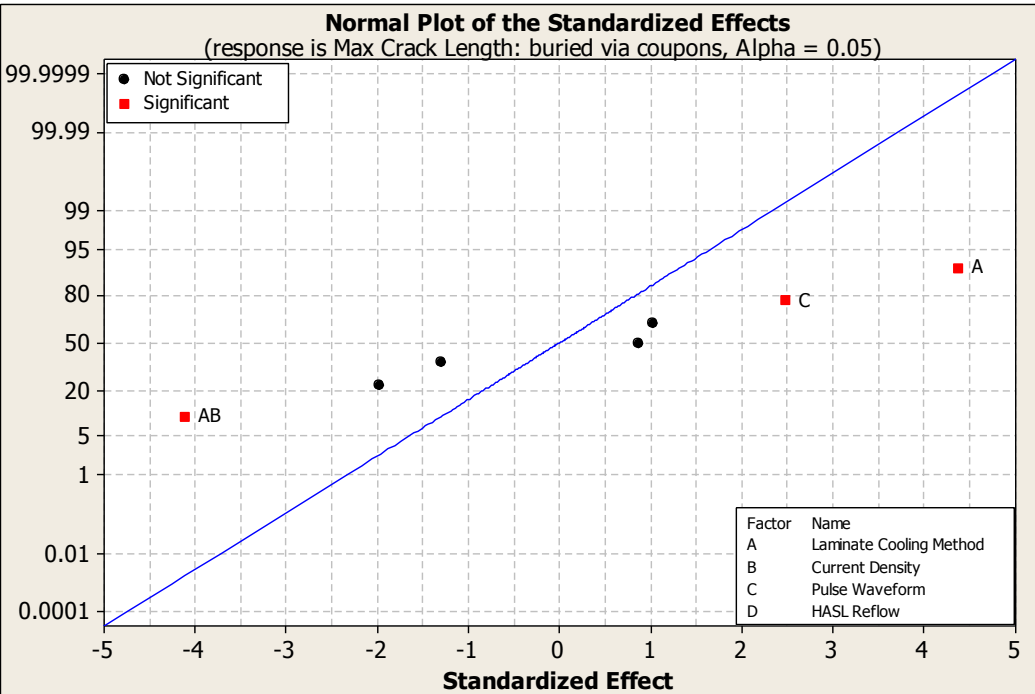
Figure 15 - Normal Probability Plot of the Effects: Maximum Crack Length (buried via coupons)

Figure 15 indicates that pulse waveform, laminate cooling method, and the interaction effect, laminate cooling method*current density, are significant for maximum crack length for buried vias.

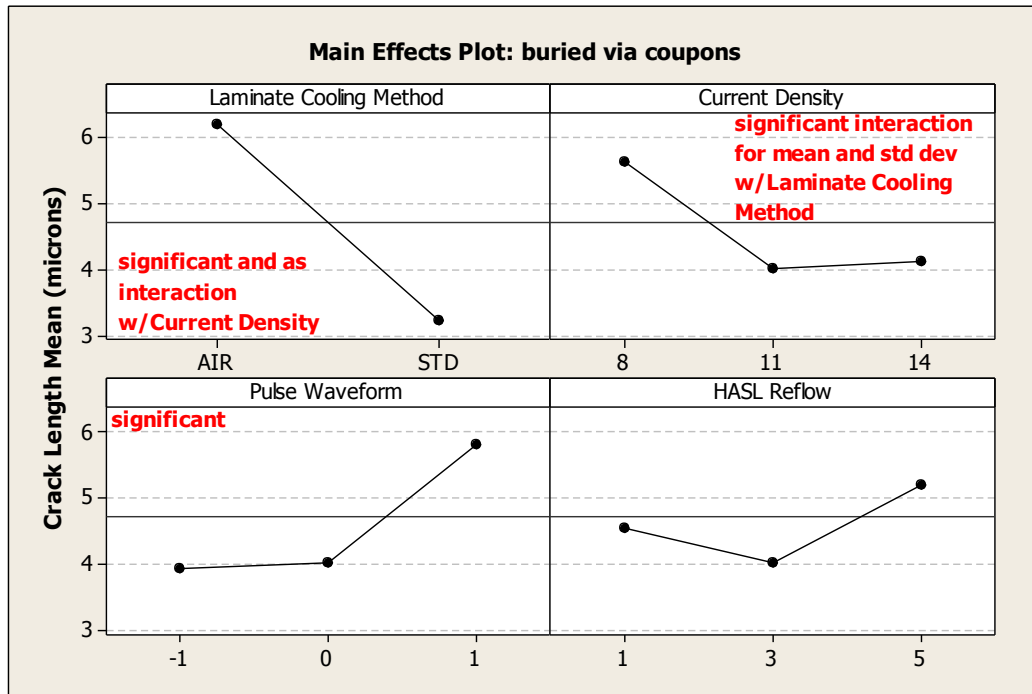
Figure 16 - Main Effects Plot: Maximum Crack Length (buried via coupons)

Figure 16 indicates that the water cooling method and a pulse waveform not equal to a setting of 1 are preferred for buried vias, which corresponds with the optimal recommendations in Table 3.

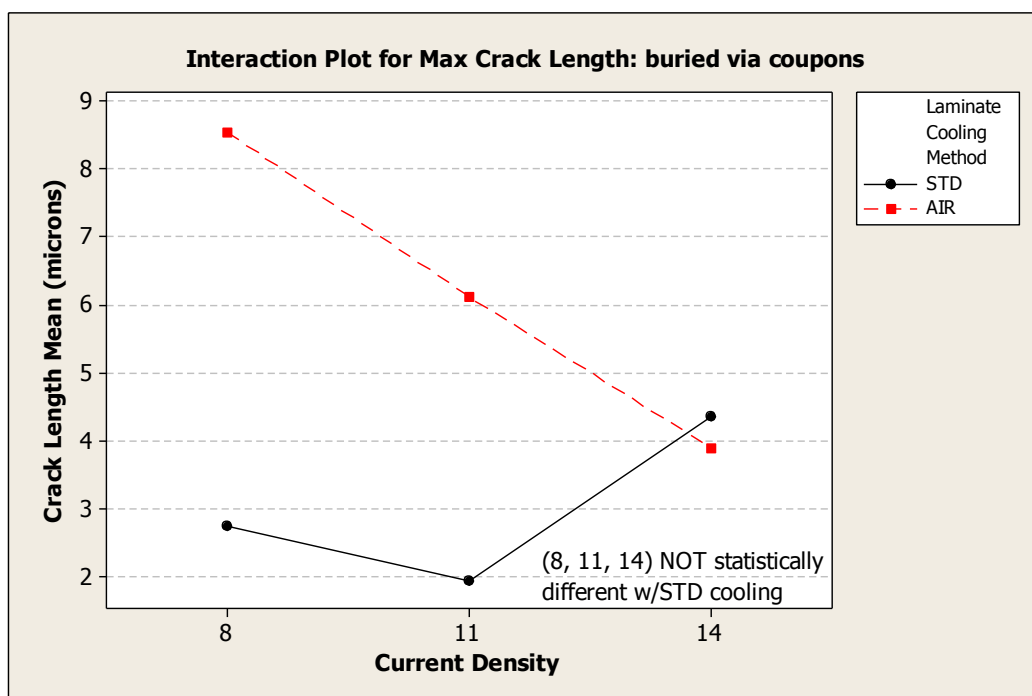
Figure 17 - Interaction Plot (Laminate Cooling Method*Current Density): Maximum Crack Length (buried via coupons)

The laminate cooling method*current density interaction is shown in Figure 17. This interaction also impacted the maximum crack length standard deviation, as shown in Figure 18. For standard cooling, the current density settings (8, 11, 14) are not statistically different. Thus, the optimal recommendations based on all coupon locations, standard cooling with current density 8, as presented in Table 3, remain substantiated.

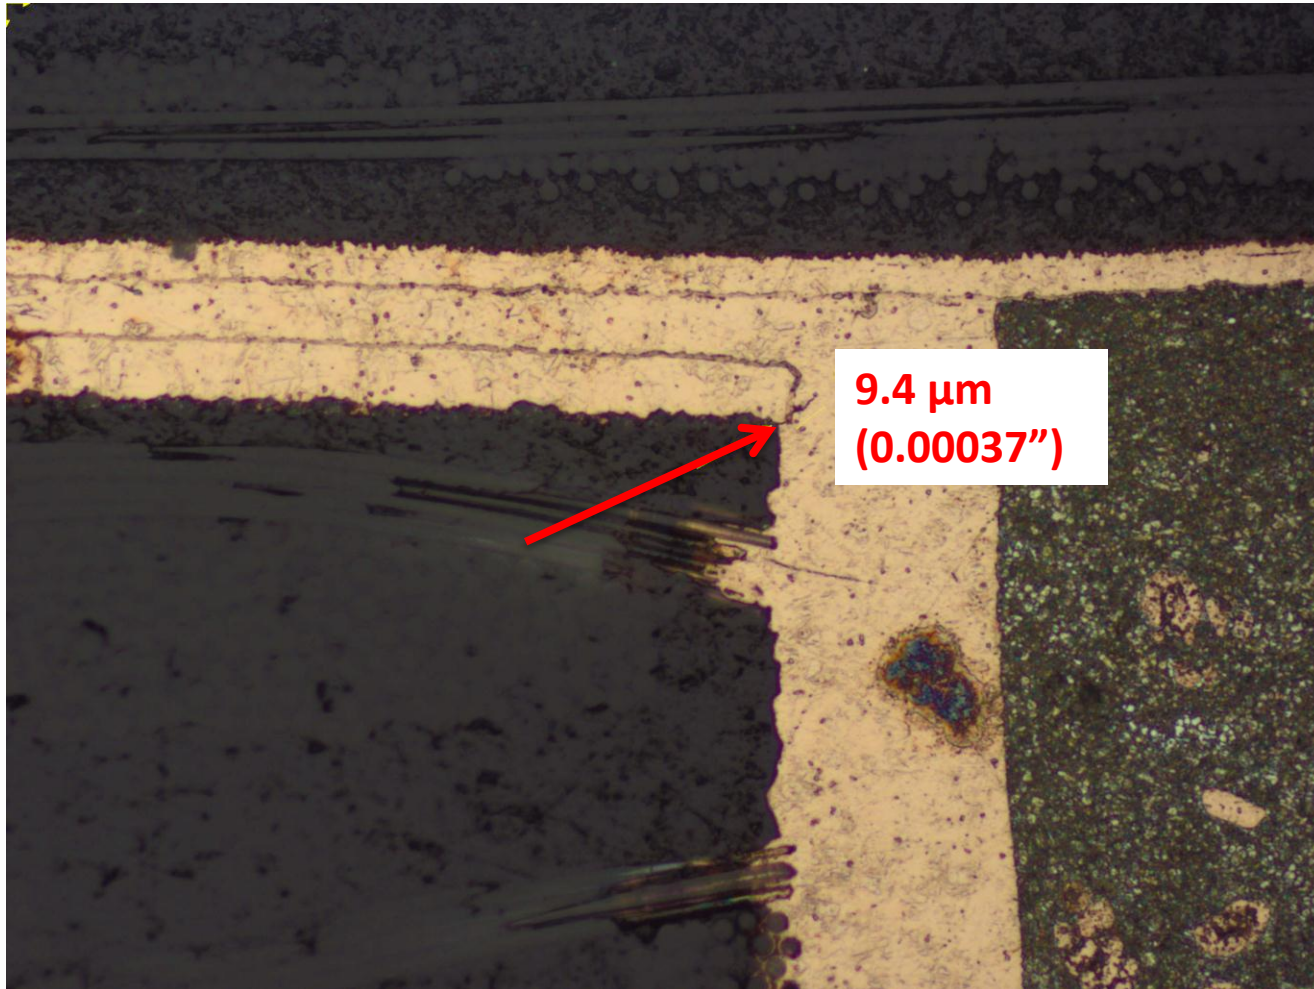
- Fine copper barrel cracks were found in plated vias during qualification testing (post thermal shock) of printed circuit boards (PCBs).

- Crack incidence rate was 15%.

9.4 µm (0.00037")

Fine barrel crack example
