Durability of Repaired and Aged Lead-free Electronic Assemblies

Anupam Choubey, Michael Osterman, Michael Pecht
Center for Advanced Life Cycle Engineering (CALCE)
Department of Mechanical Engineering
University of Maryland

Abstract

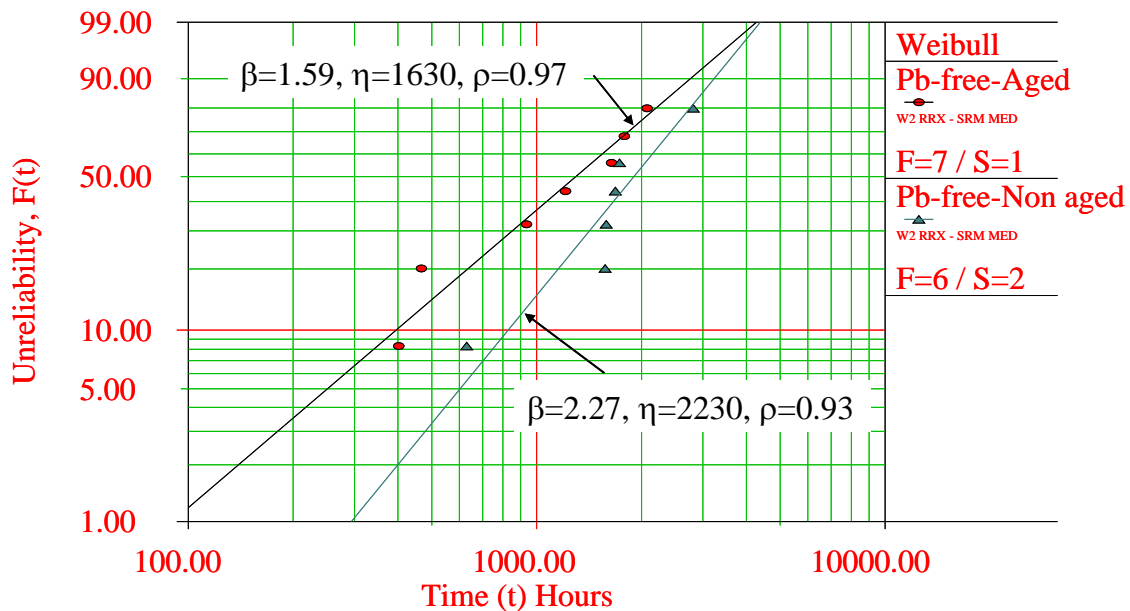
After the majority of PBGA packages experienced failure due to temperature cycling, a comparison was made in the cycles to failure. Figure 10 provides a two-parameter Weibull plot of non-repaired lead-free BGA test data for aged and non-aged assemblies. Figure 11 provides a similar plot for the lead-based assemblies. Results indicate that thermal aging reduces the characteristic life of the PBGAs on the lead-free assemblies by approximately twenty-five percent, while the lead-based PBGAs showed only a five percent reduction in life due to thermal aging. In addition, a wider variation in cycles to failure is observed for the lead-free assembled PBGAs than for the lead-based assemblies.

Figure 10 - Durability comparison of aged and non-aged lead-free solders joints

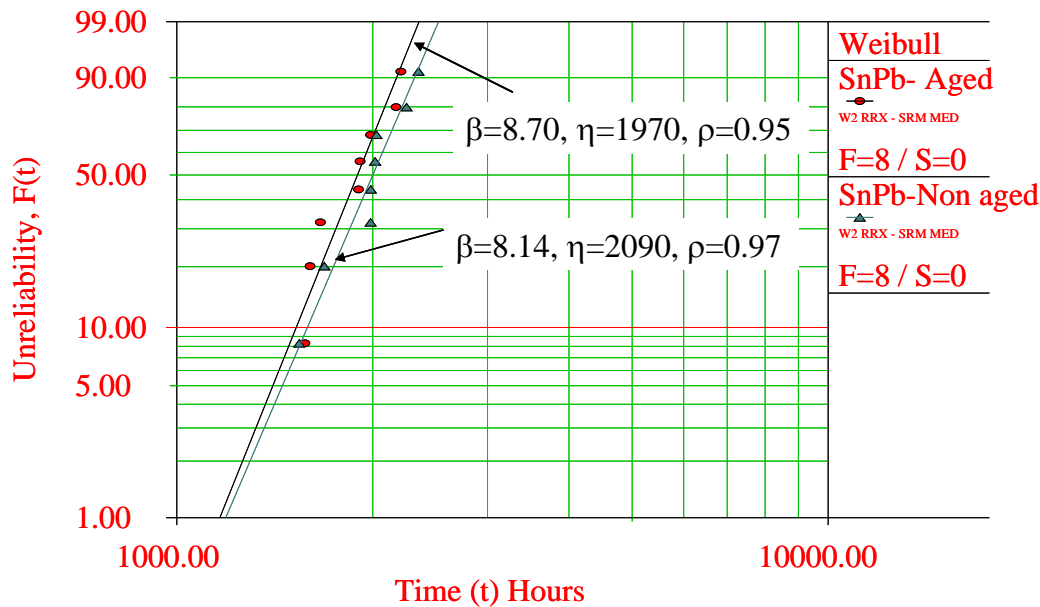
Figure 11 - Durability comparison of aged and non-aged SnPb solder joints

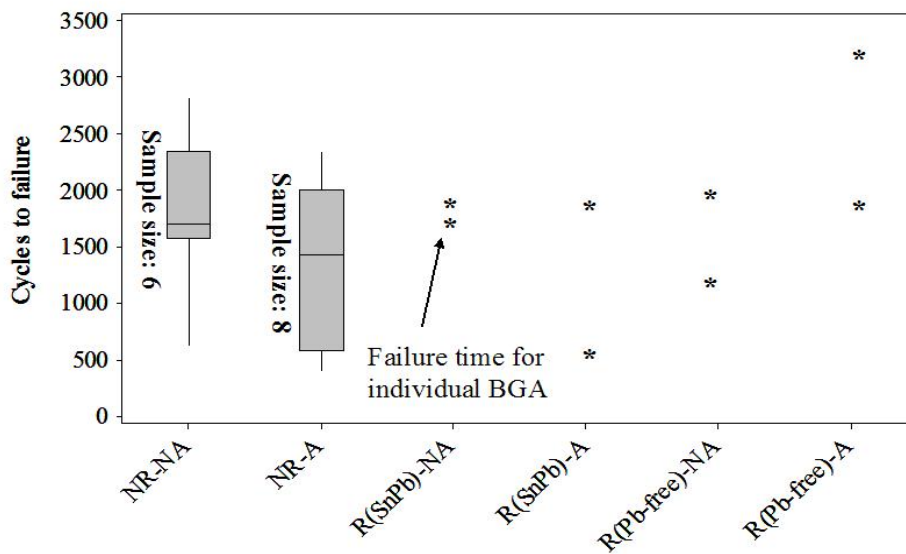
The recorded cycles to failure for the repaired PBGAs on the aged and non-aged lead-free assemblies are compared to the non-repaired PBGAs in Figure 12. In this figure, R (SnPb) indicates the original lead-free BGA was replaced by a lead-based PBGA. R (SnAgCu) indicates the lead-free PBGA was replaced by another lead-free BGA. The NA indicates a non-aged assembly and the A indicates a thermal aged assembly. Figure 13 shows a similar plot for lead-based assemblies. In this case, the R (SnPb) indicates that the original lead-based component was replaced by another lead-based component and the R (SnAgCu) indicates that the lead-based component was replaced by a lead-free component. Results show a large variation in failure times for repaired lead-free solder joints (see Figure 12) as compared with lead-based assemblies (see Figure 13).

Figure 12 - Durability of repaired and non-repaired Pb-free solder joints

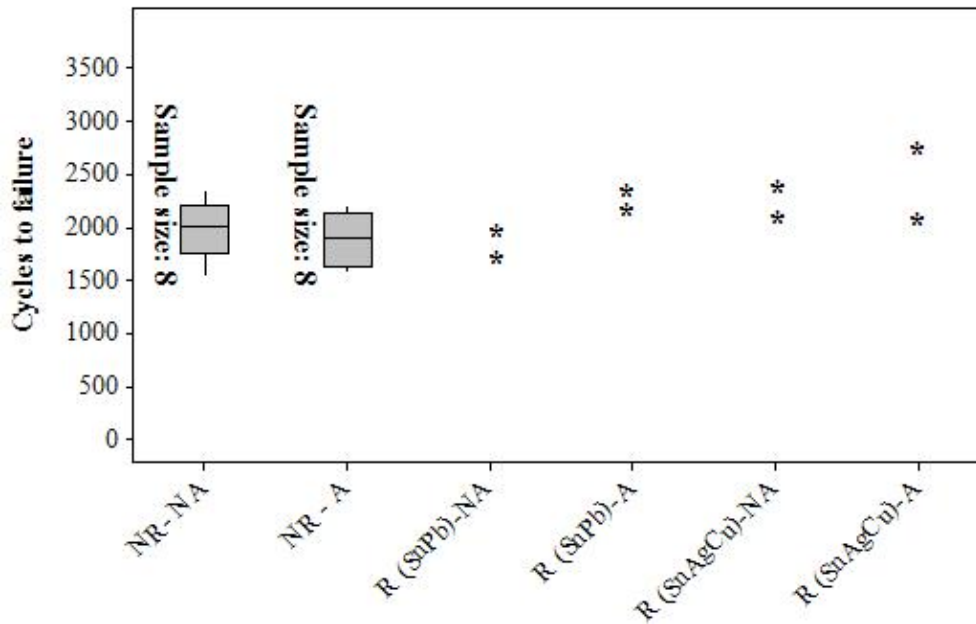
Figure 13 - Durability of repaired and non-repaired SnPb solder joints

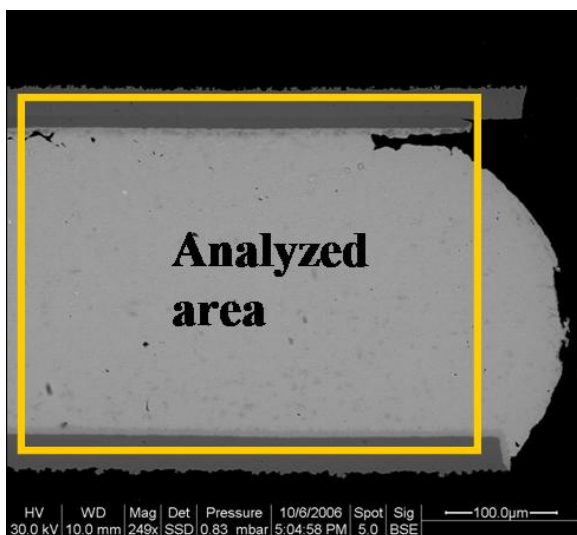
Further analysis was conducted to investigate whether lead was present in the solder joints formed when lead-free PBGAs were used to replace lead-based PBGAs on the HASL-finished boards. Energy-dispersive X-ray (EDX) analysis did not indicate the presence of lead in the repaired solder joint. Figures 18-22 show elemental mappings for various elements found in the microstructure of a replacement lead-free solder joint.

Figure 18 - Area analyzed for the presence of Pb

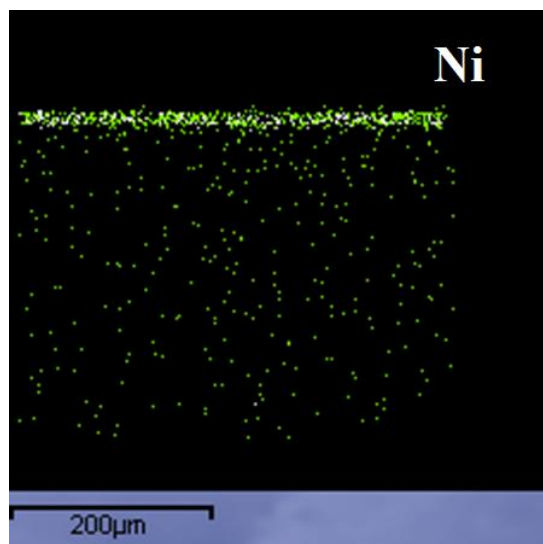
Figure 19 - Amount of nickel found in the area under analysis

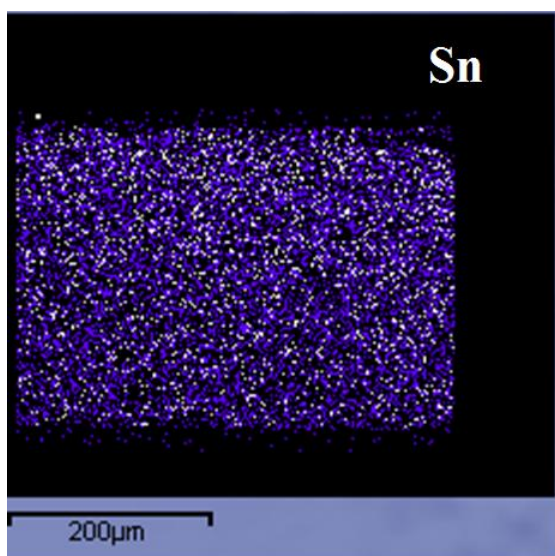
Figure 20 - Amount of tin found in the area under analysis

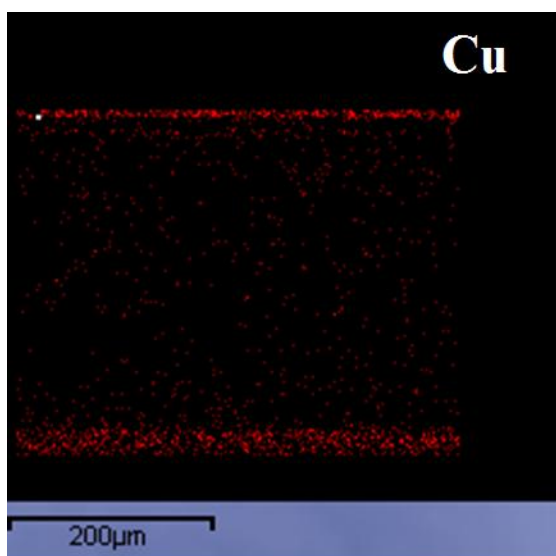
Figure 21 - Amount of copper found in the area under analysis

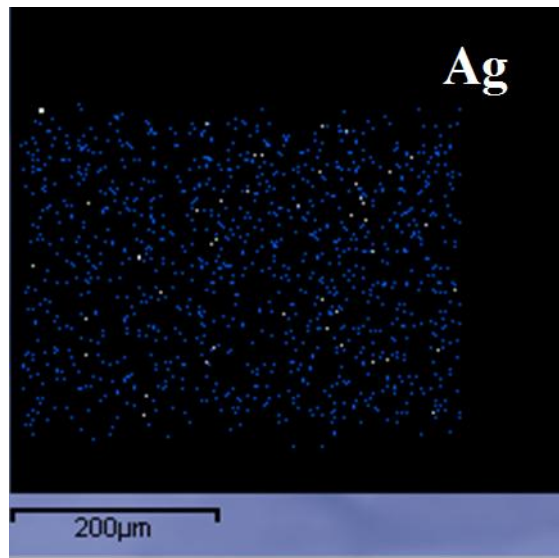
Figure 22 - Amount of silver found in the area under analysis

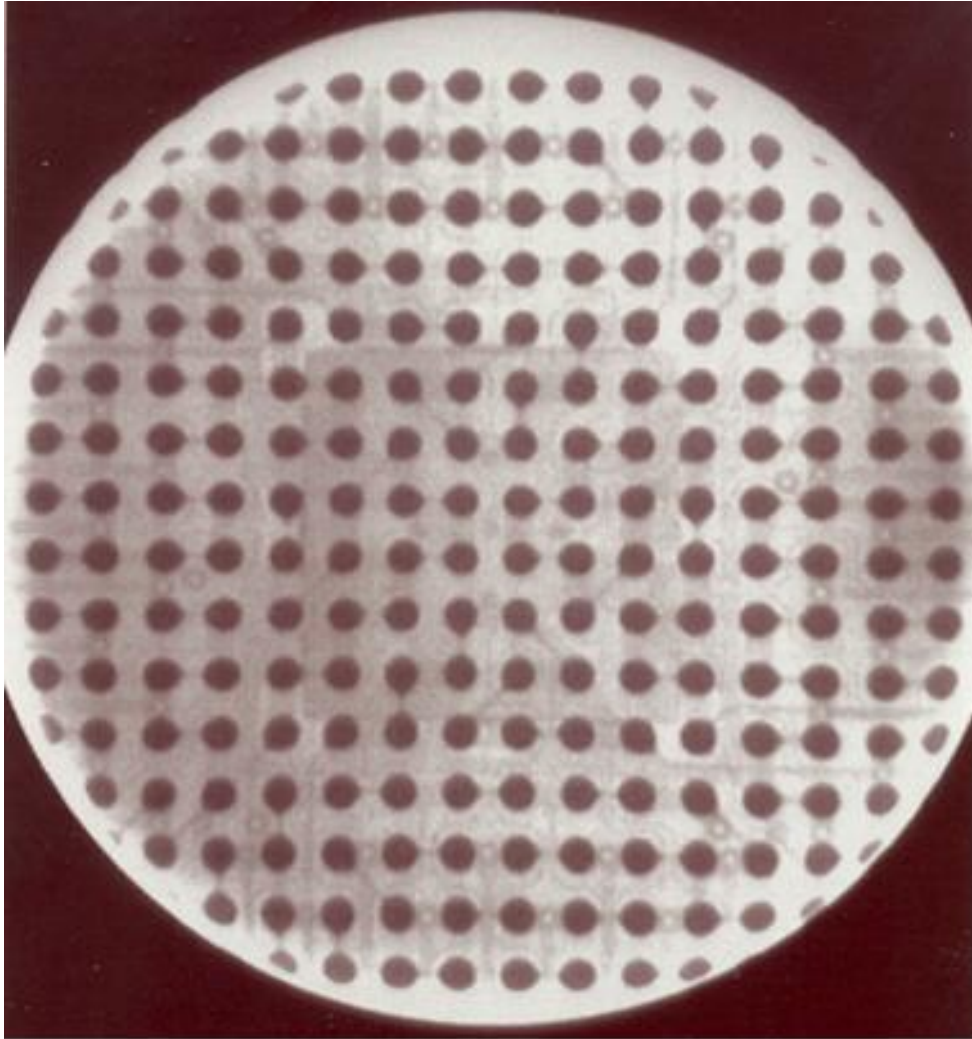
X-Ray Image of Reworked BGA

After BGA replacement, electrical continuity testing and X-ray imaging was used to verify solder ball attachment.

No defects were observed at the depot.

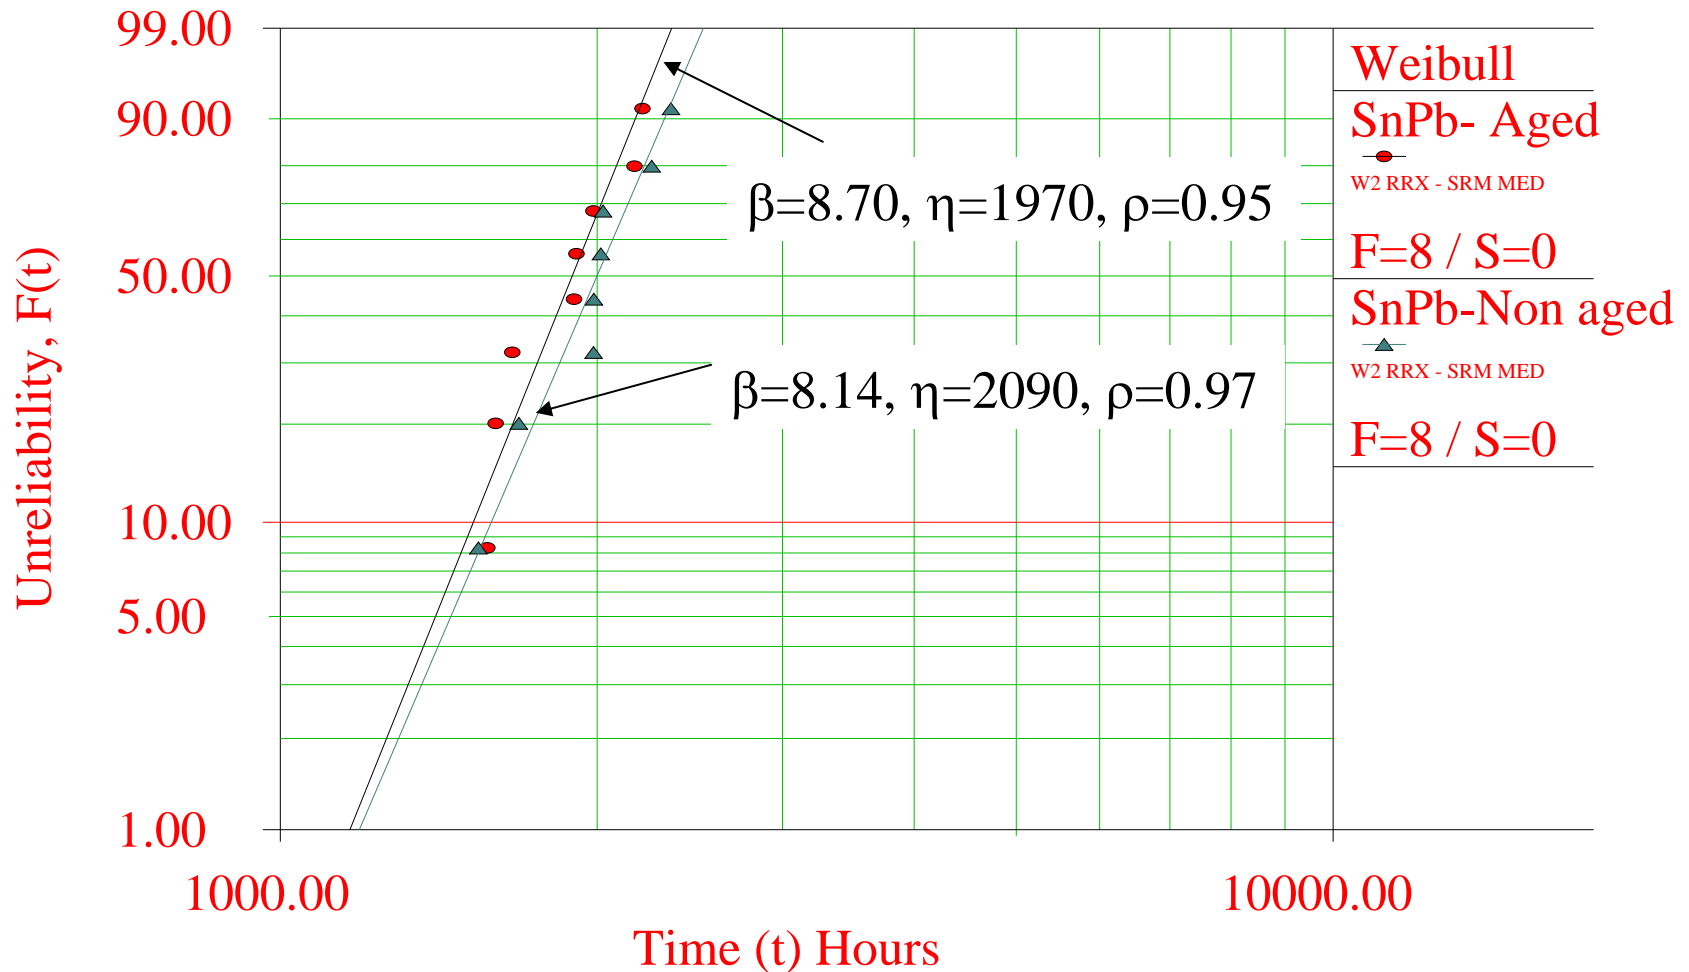
- BGA(Sn37Pb) – Sn37Pb Solder – HASL Pad Finish -

A decrease in life of 5% was observed between aged and non aged assemblies.

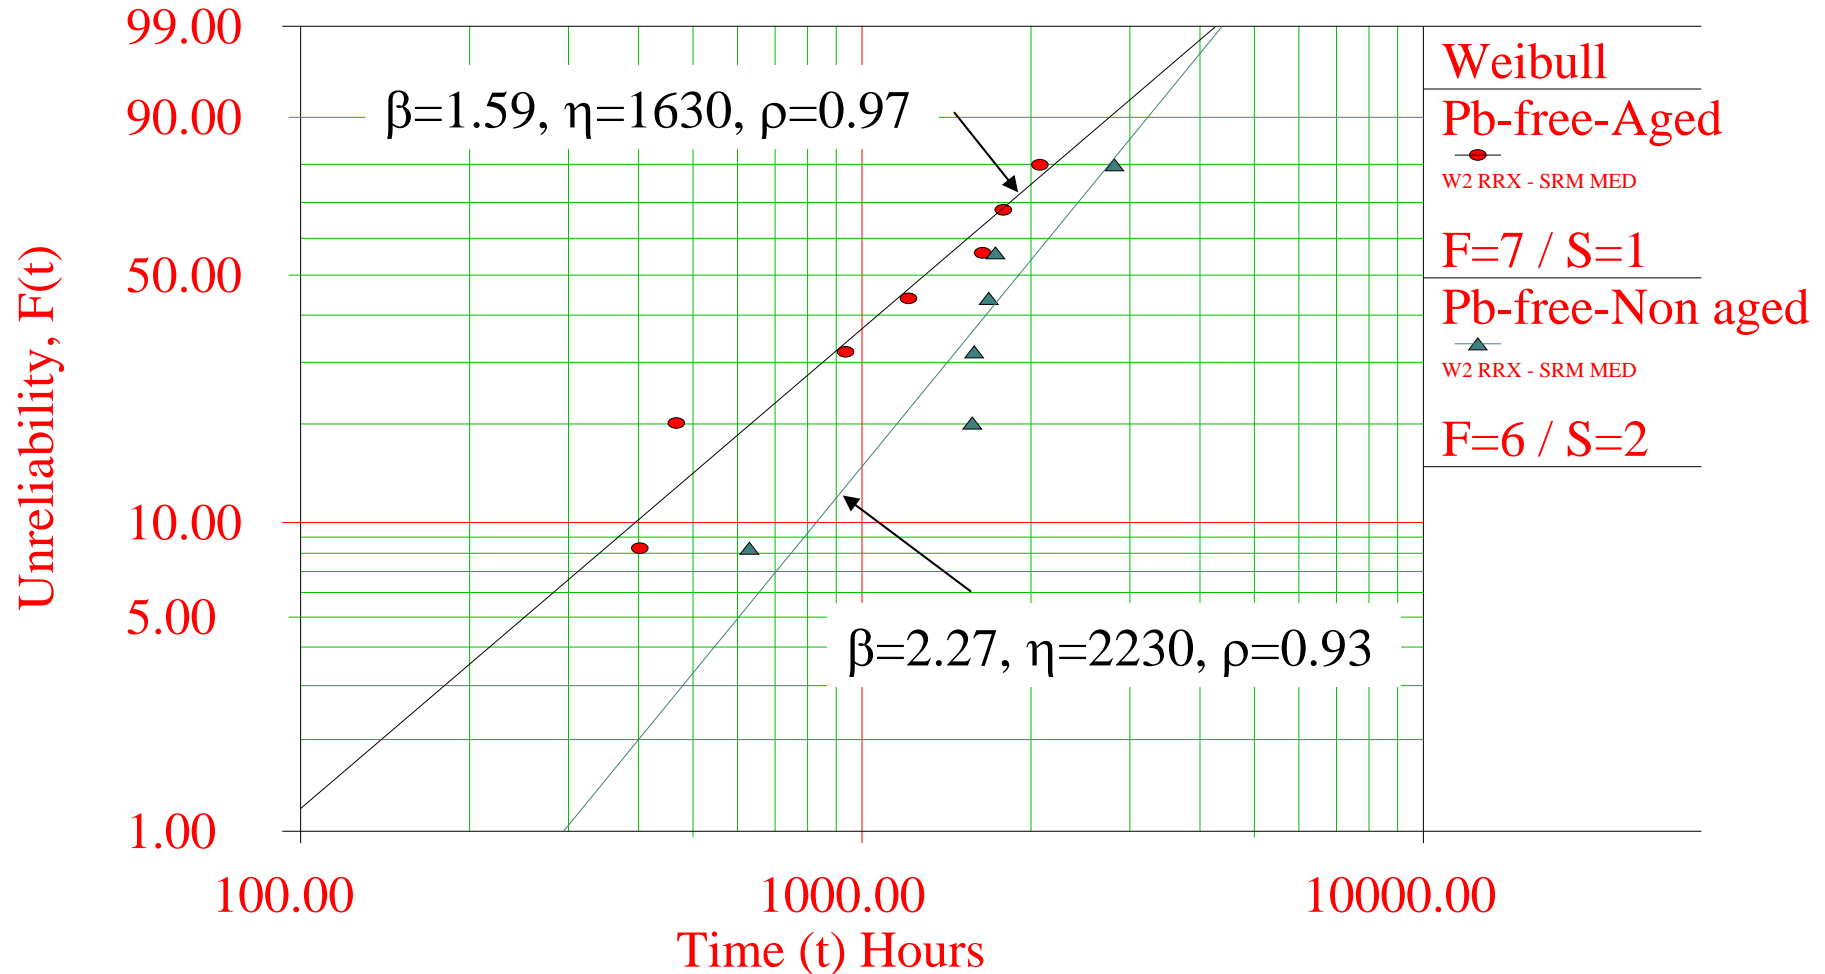
- BGA (Sn3.0Ag0.5Cu) – Sn3.0Ag0.5Cu Solder – ImSn Pad Finish

A decrease in life of 25% was observed between aged and non aged assemblies.

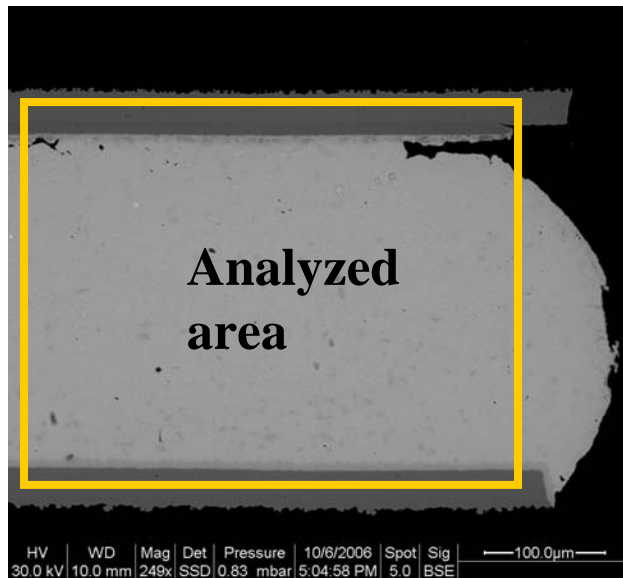
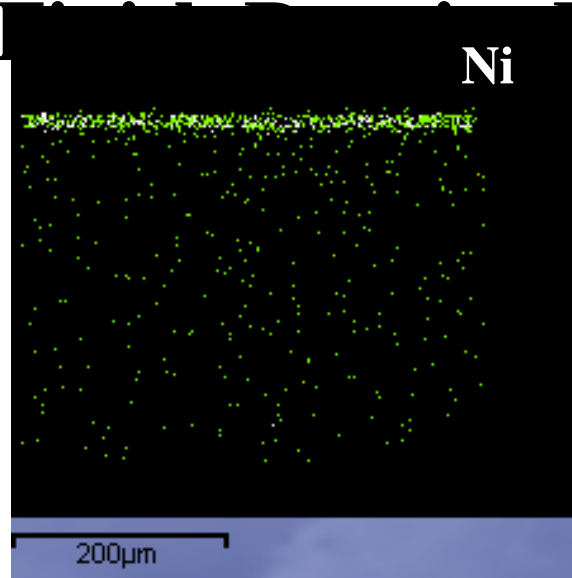
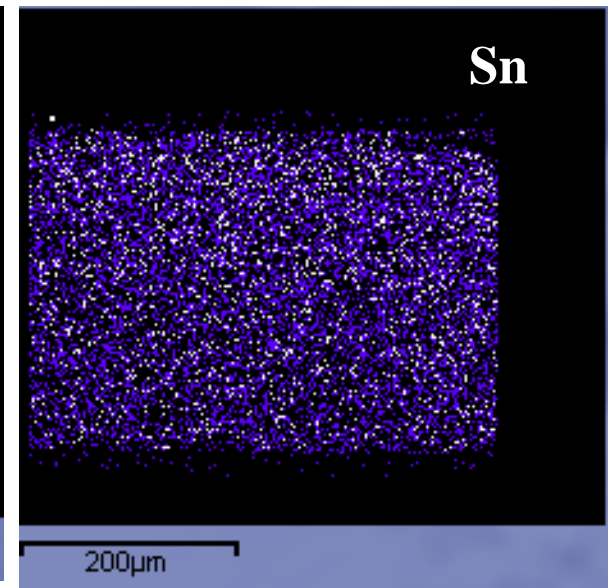
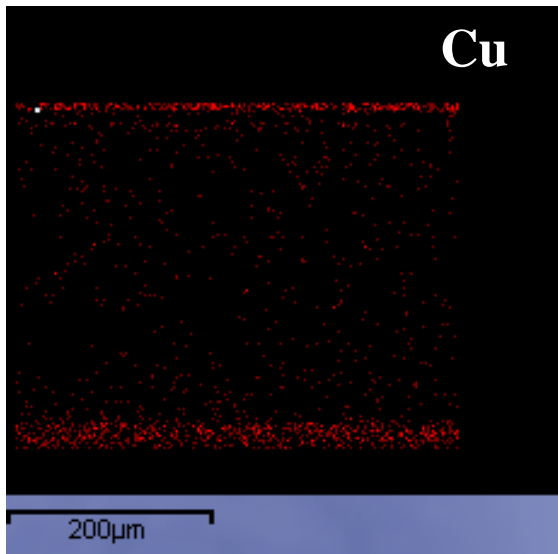
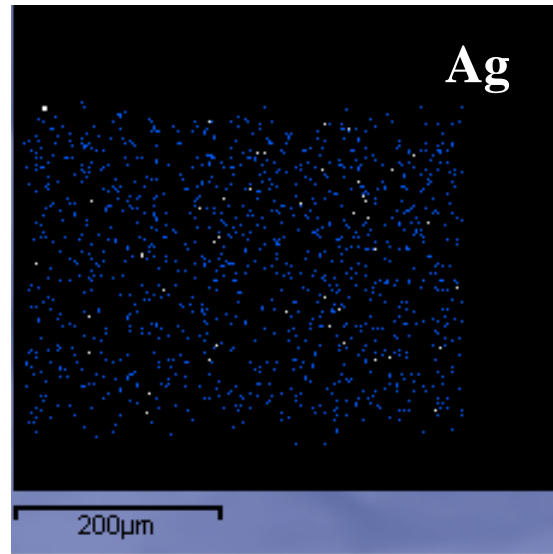
BGA (SnAgCu) on HASL (SnPb) Pad

- BGA (SnPb) replaced with BGA (SnAgCu) on HASL(SnPb) assembly
- No Pb was found in the solder joint
