IPC Electronics Midwest 2010

Drop Testing of a Pb-Free Board after Assembly and SnPb-Rework

P. Snugovsky, J. Bragg, E. Kosiba, M. Thomson, B. Lee, R. Brush,
S. Subramaniam, M. Romansky
Celestica International Inc.

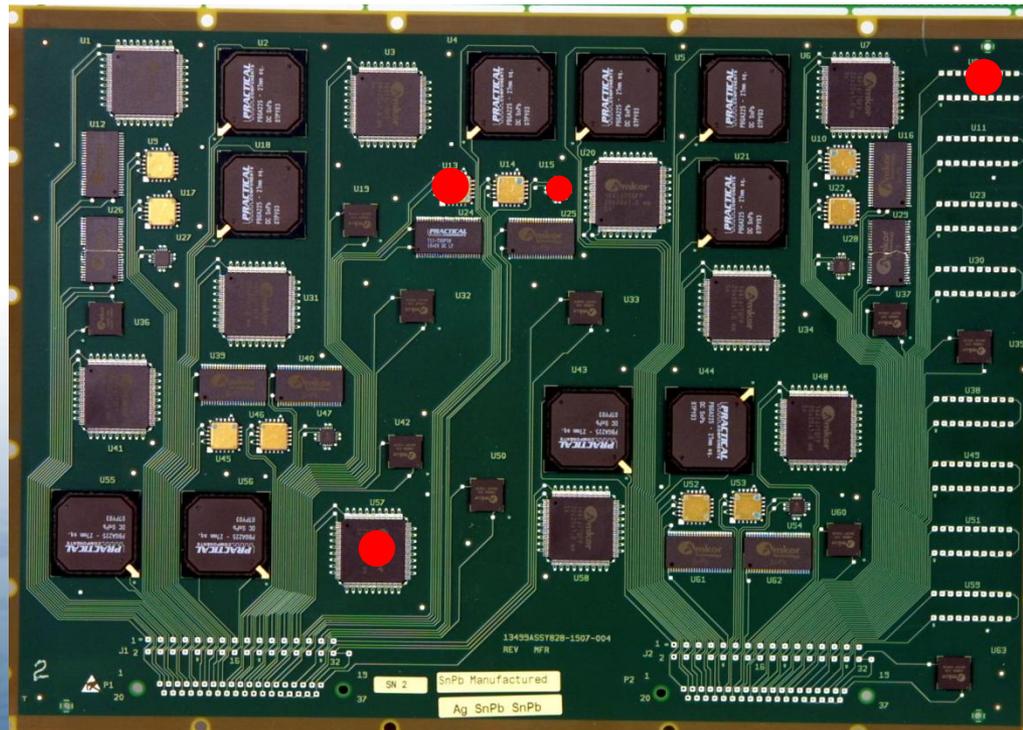
Red = Mechanical failure – All pad craters
All BGAs are Electrically Failed
No leaded parts on this exact board electrically failed
Blue Dots on Some Parts = # of SnPb Hand Reworks
