Bare Board Material Performance after Pb-free Reflow

Ted Lach, Alcatel-Lucent

IPC Midwest Conference Sept, 2009

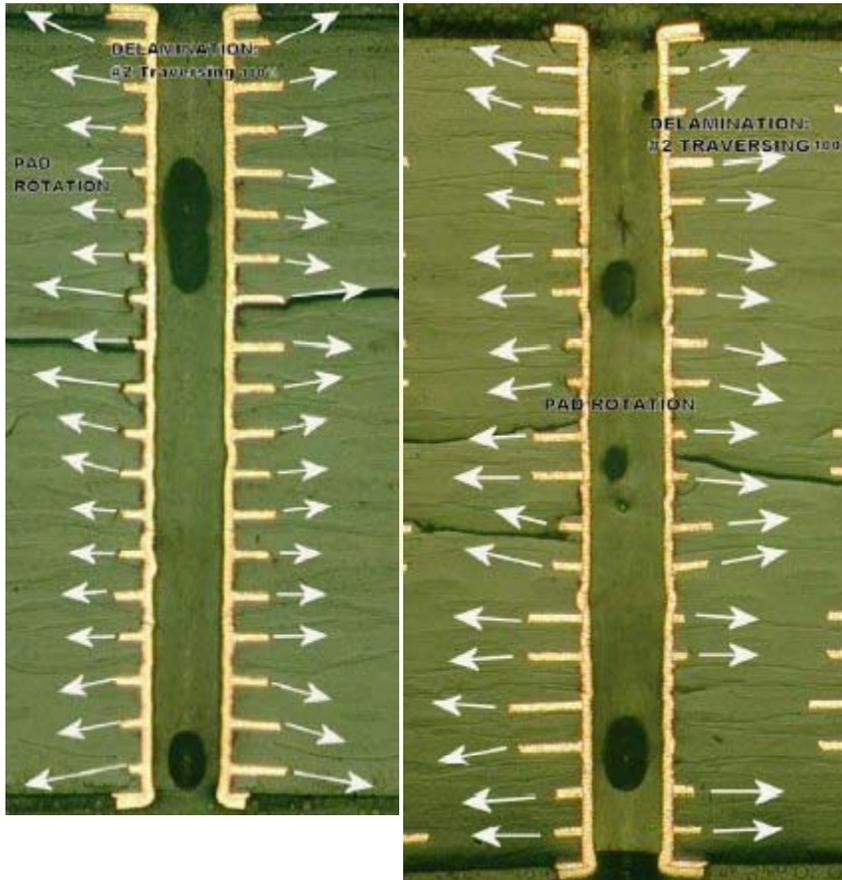
Laminate Integrity Summary

- Performance and Reliability Risks of Internal Delamination/Material Degradation
 - Possible Pathways for CAF
 - Possible Loss of Dielectric Strength
 - Possible Changes in Localized Electrical Properties
 - Reduced Via Integrity
 - False Positive Via Reliability
 - False Positive CAF test performance

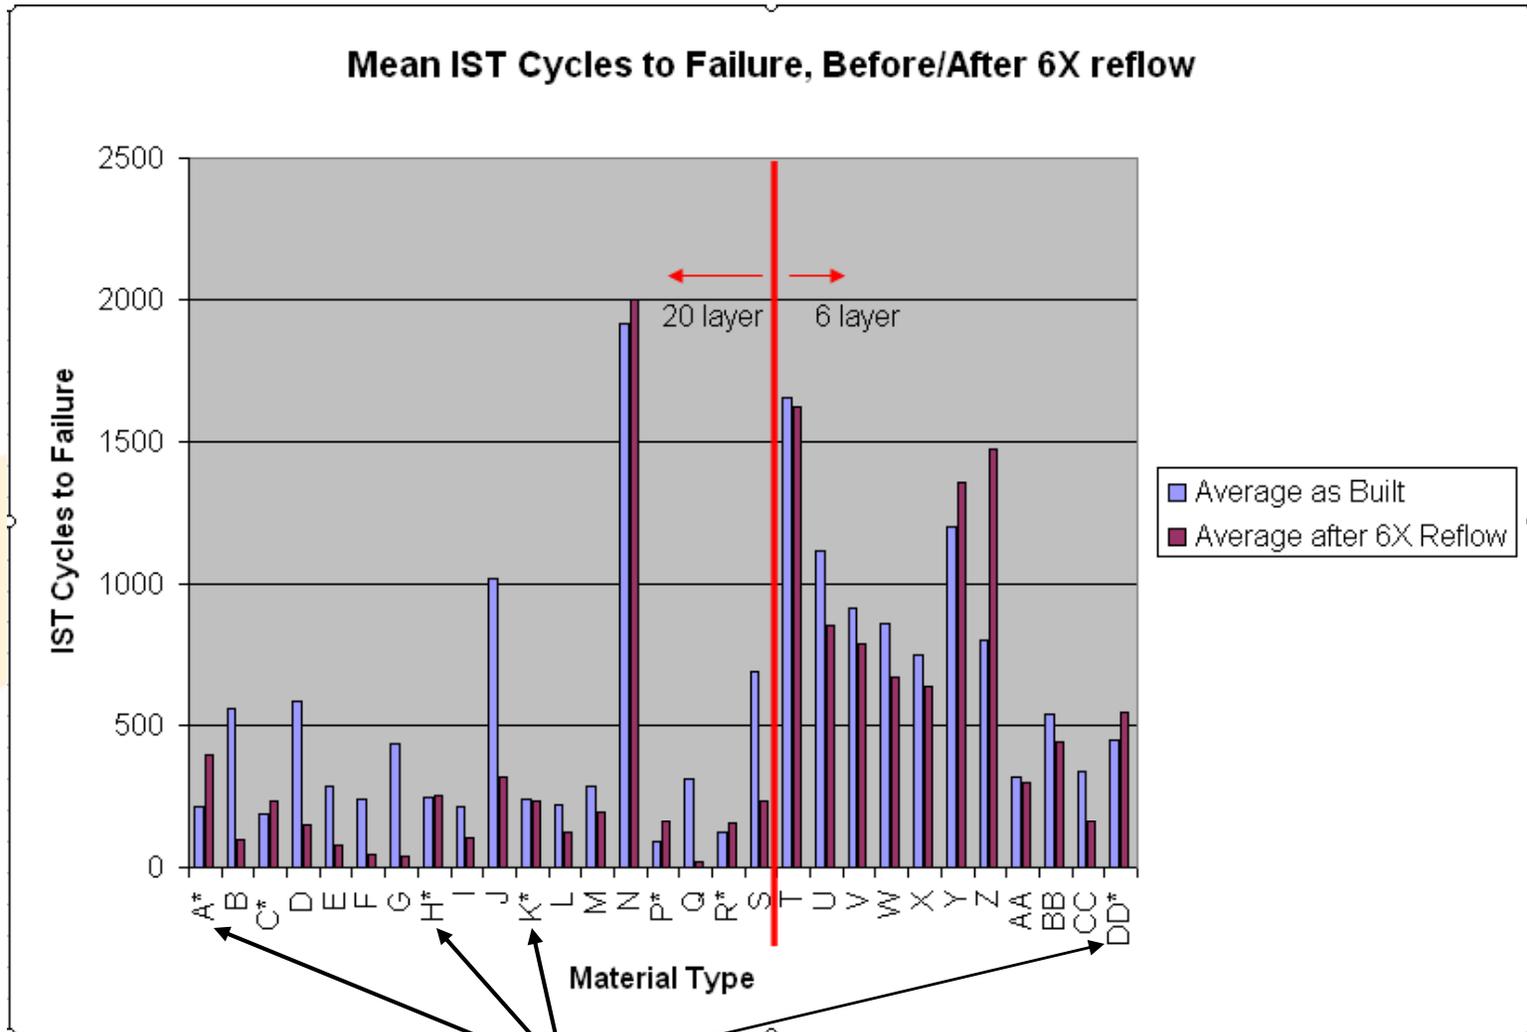
IST Results

* Indicates materials that had indication of delamination in IST cycling (false positives) after reflow

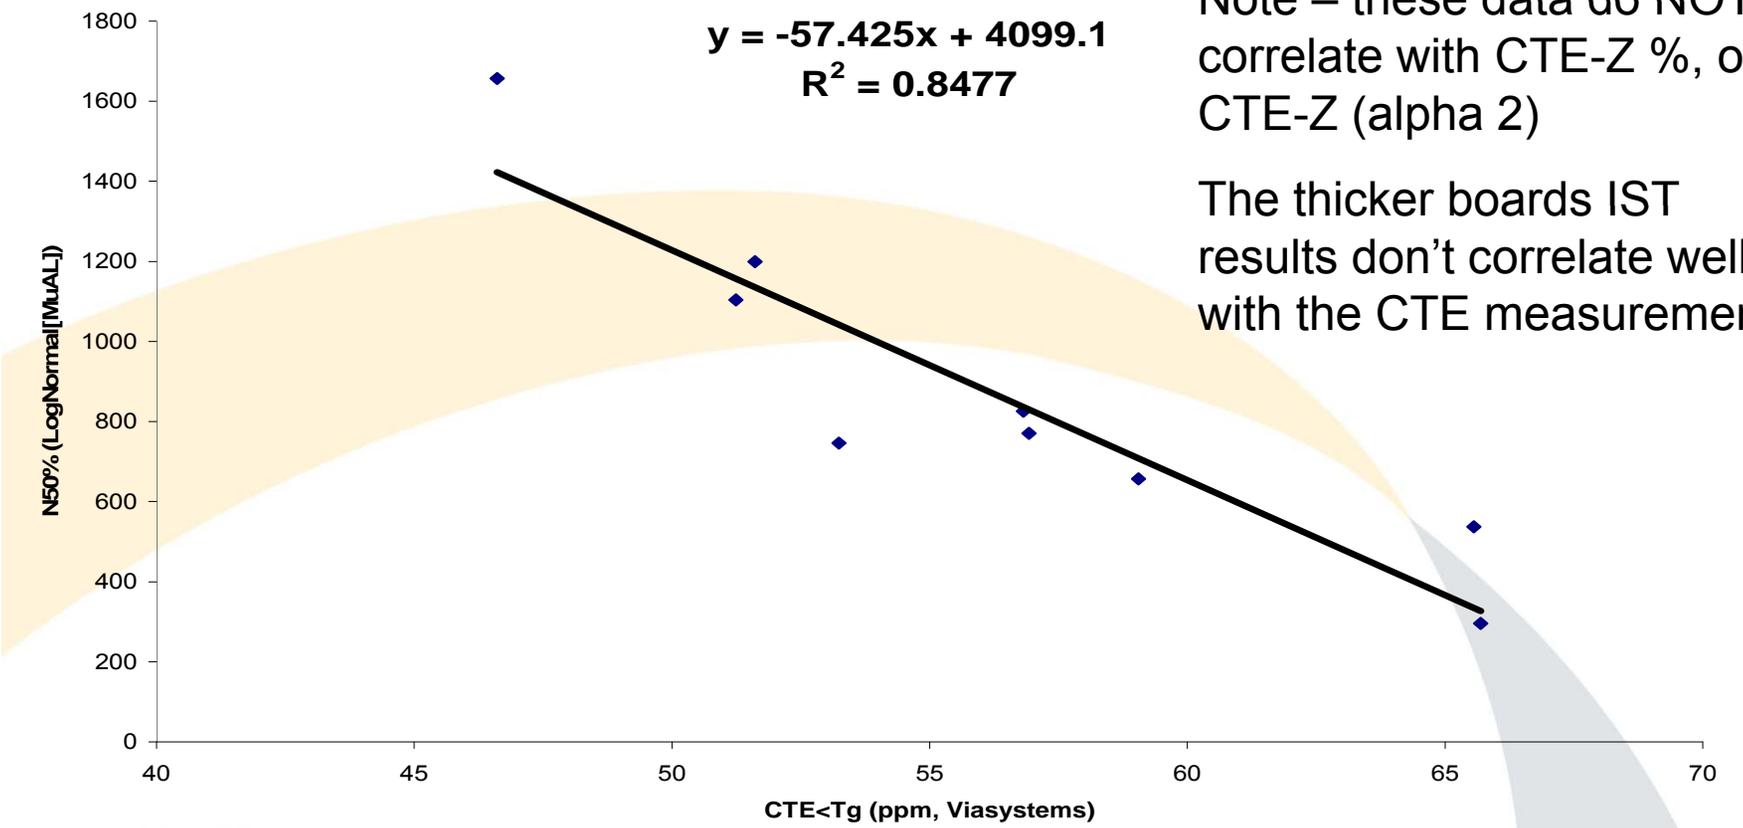
Scatter Chart (CTE<Tg (ppm, Viasystems) vs IST N50% As Built (LogNormal[MuAL]))

IST Results compared to CTE-Z (alpha 1), as Measured on the boards, 6 layer, .062 constructions only

Note – these data do NOT correlate with CTE-Z %, or CTE-Z (alpha 2)

The thicker boards IST results don't correlate well with the CTE measurements

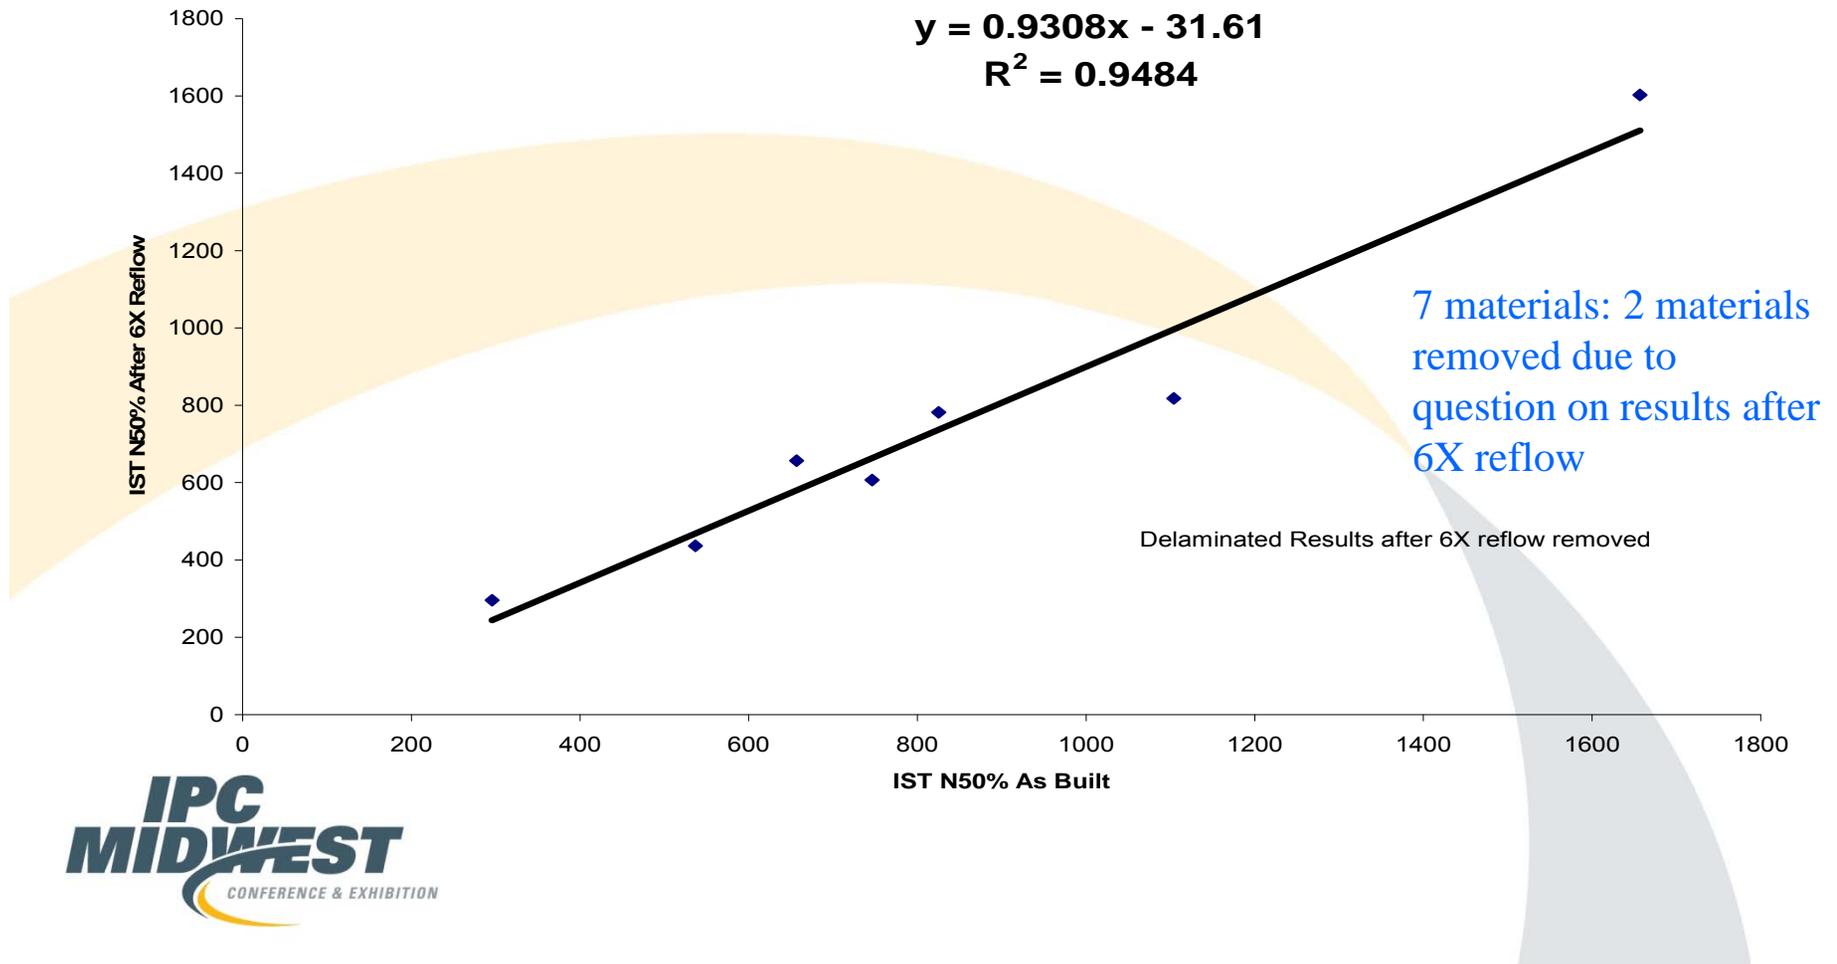
Scatter Chart. .062" Thick 6 layer coupons only (IST N50% As Built vs
IST N50% After 6X Reflow)

IST Before and After 6X Reflow: before reflow and after reflow correlate very well

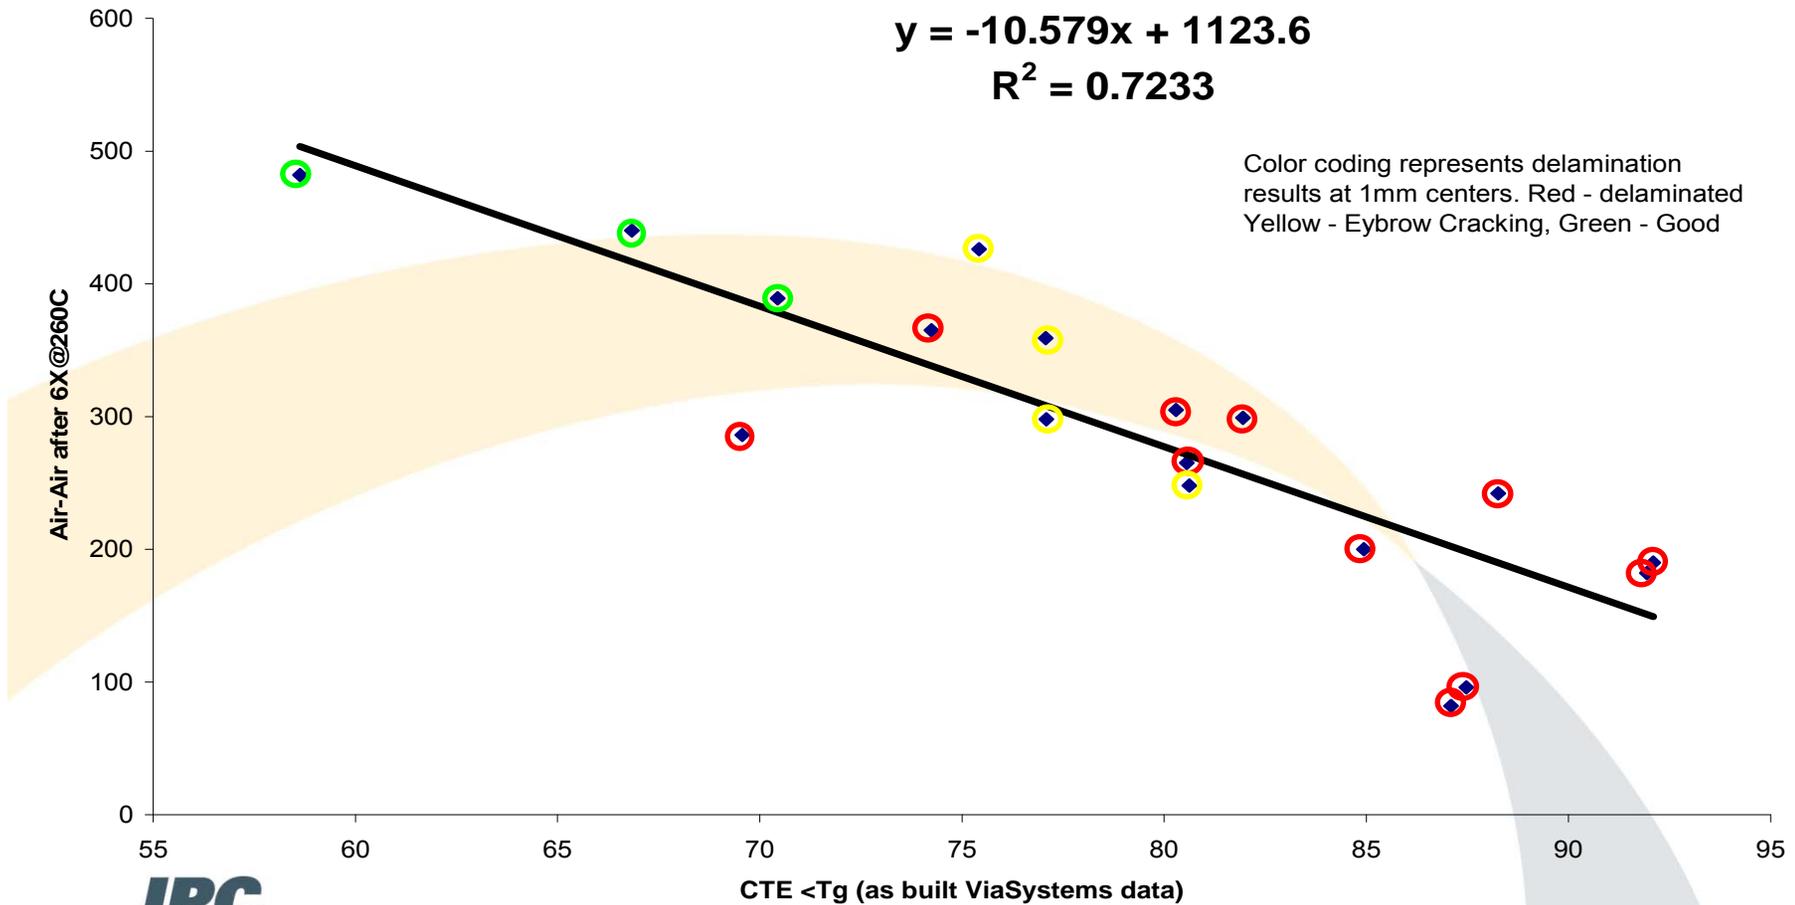
Scatter Chart (CTE <Tg (as built ViaSystems data) vs Air-Air after 6X@260C)

ATC results correlated to Actual CTE

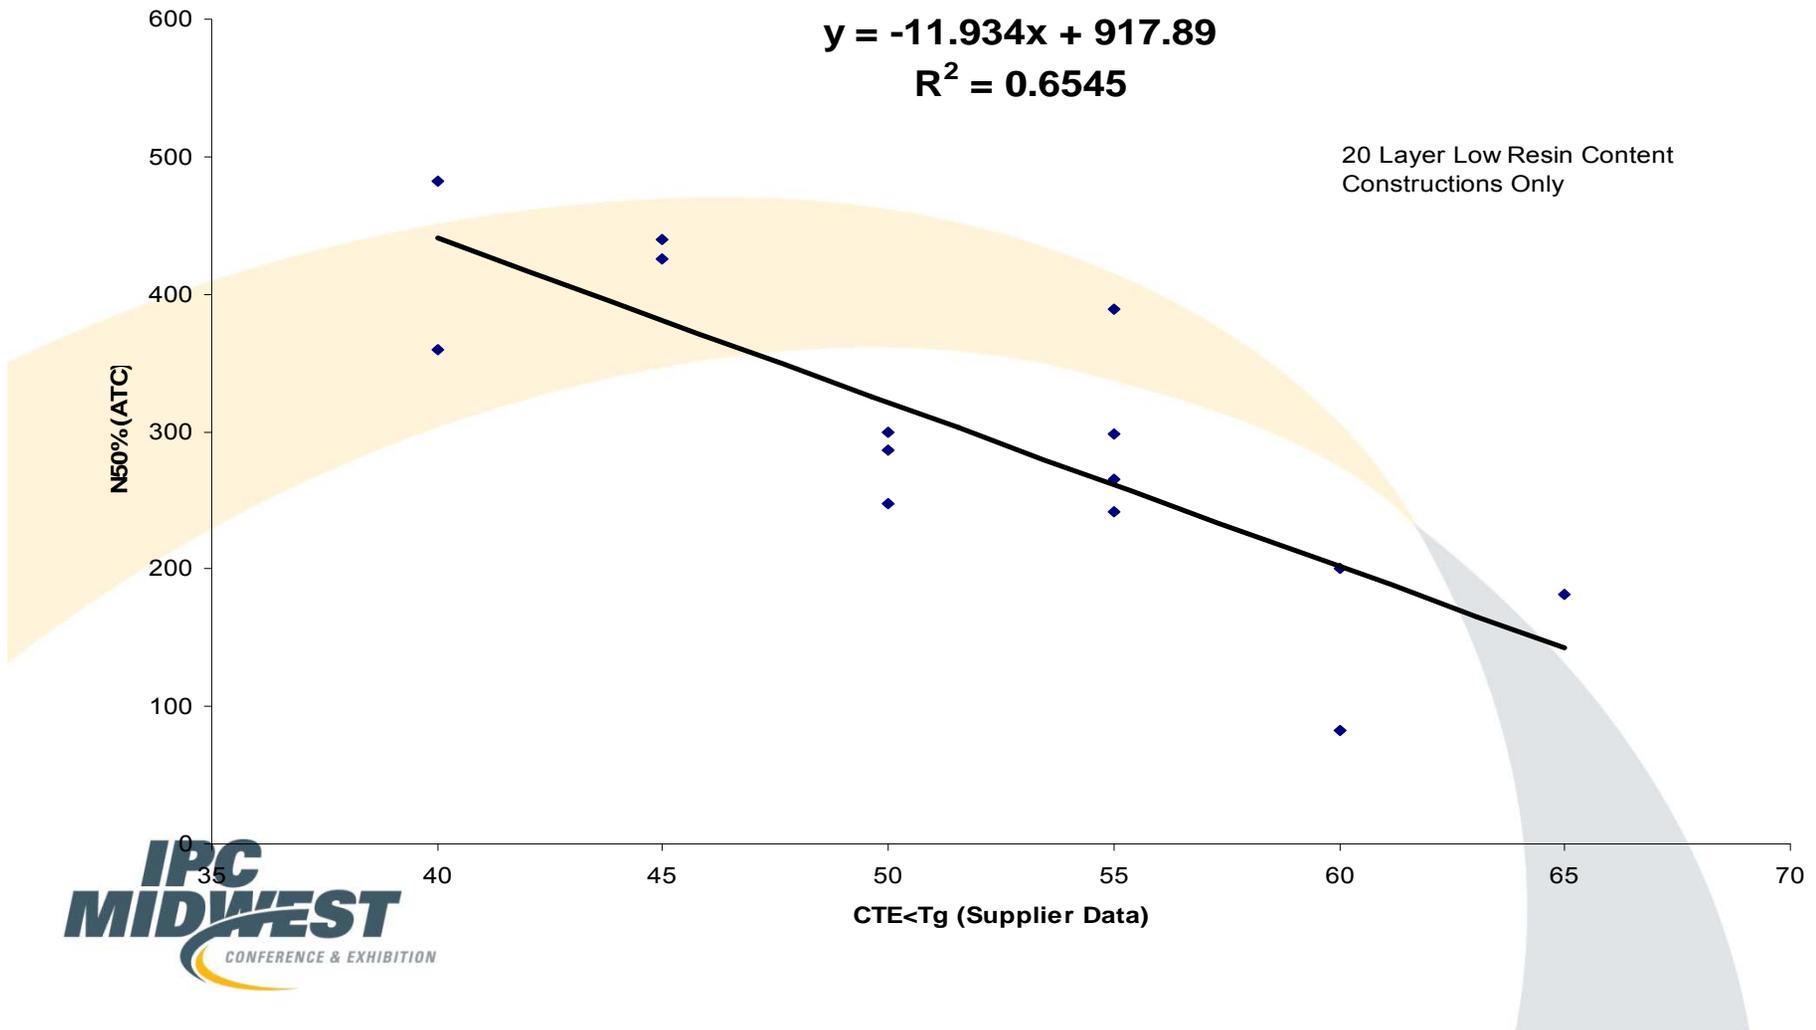
Scatter Chart (CTE<Tg[Supplier Data] vs. N50% ATC)

Supplier Data Sheet CTE's don't track so well

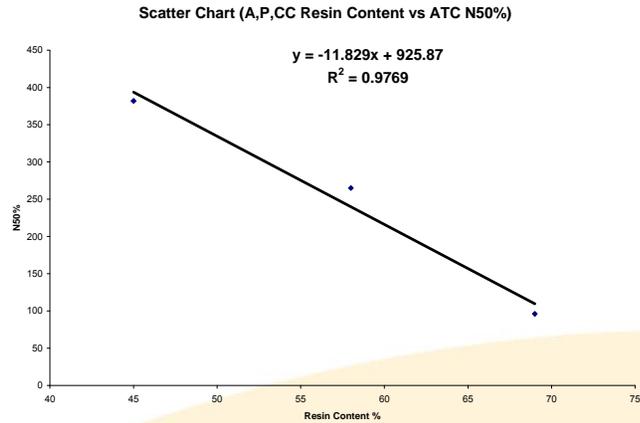
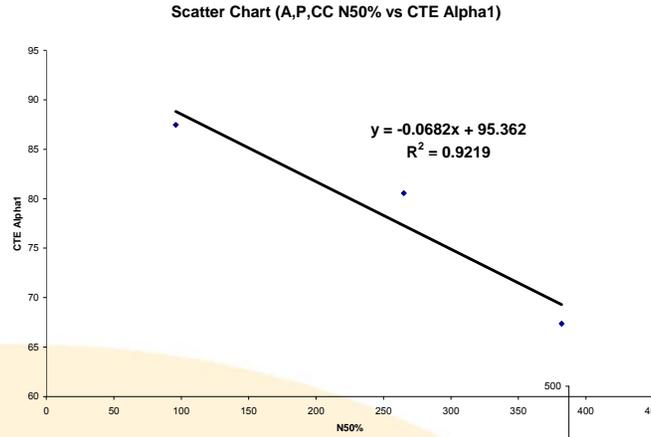
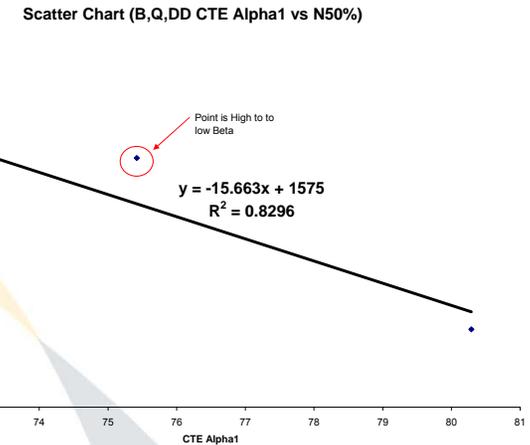
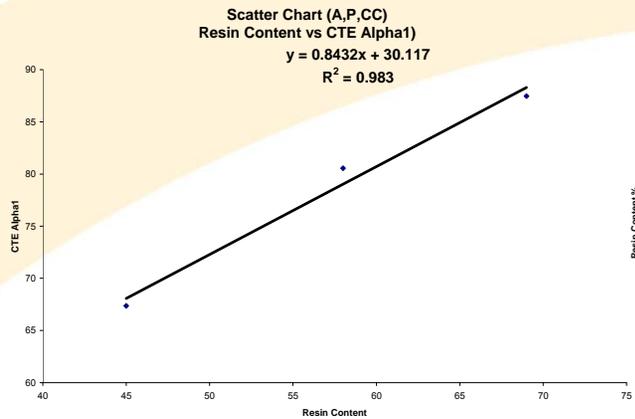
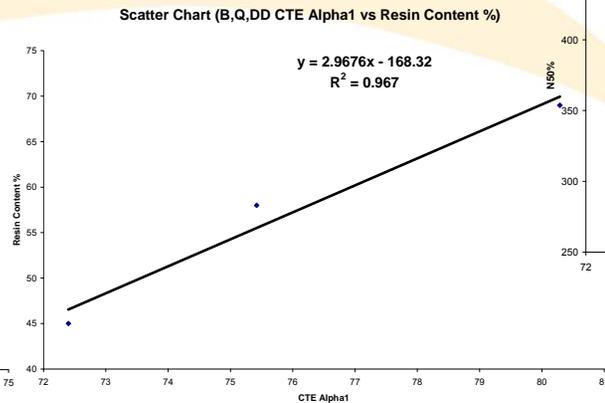
Z-Axis CTE or Layers?

Primary effect is Resin Content – directly linked to Z-CTE
Layer count is a secondary affect

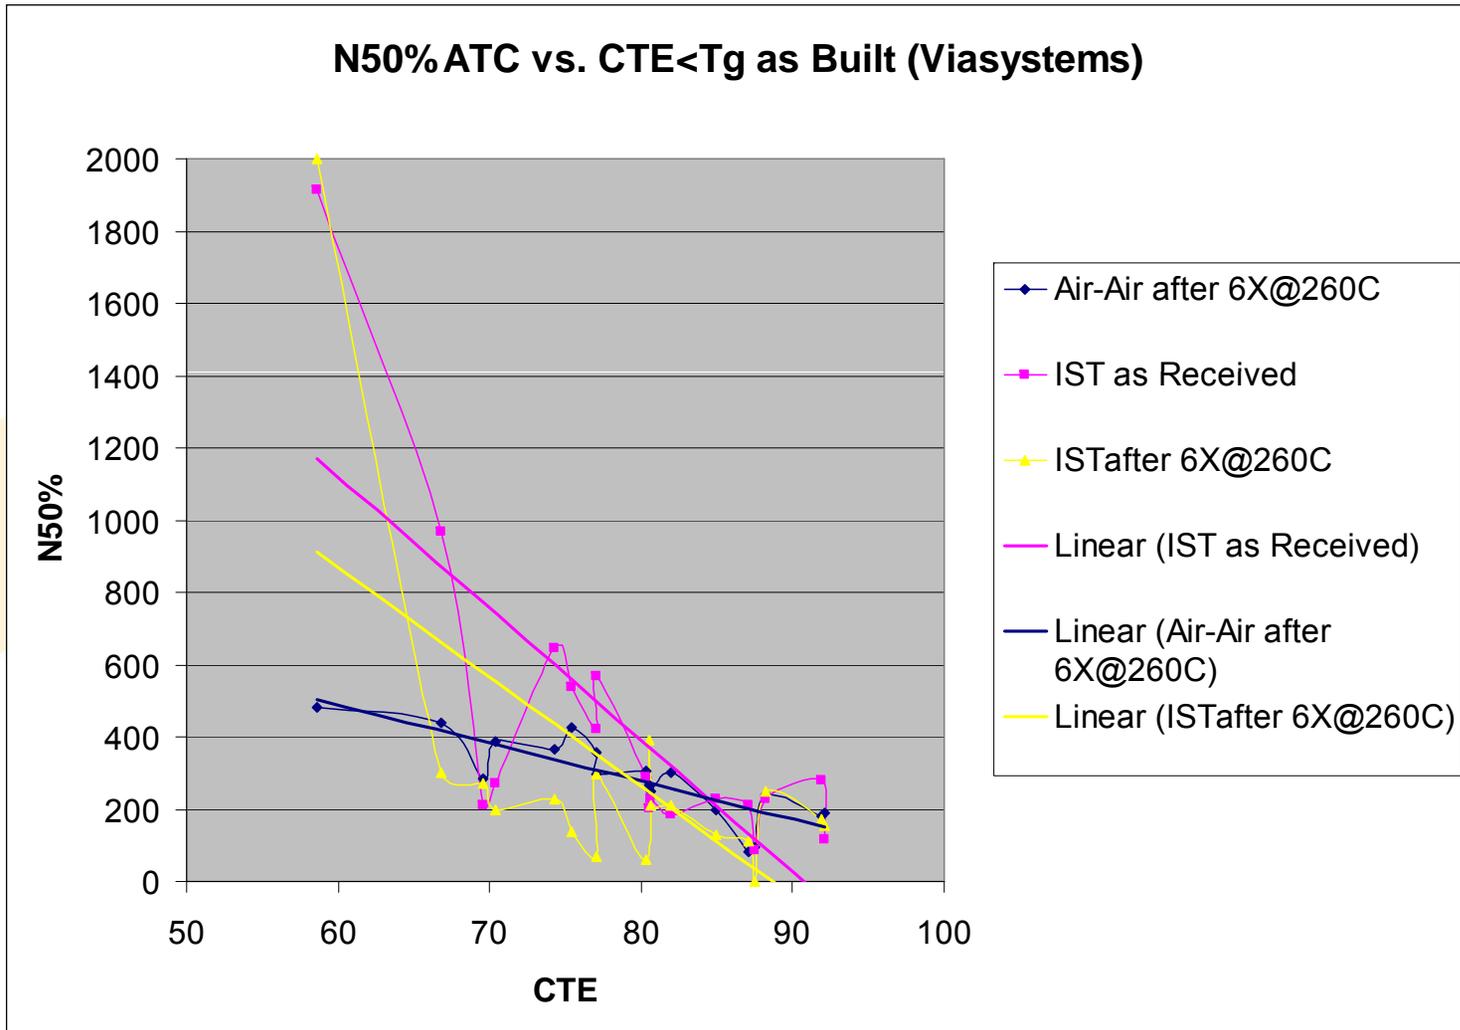
IST and ATC vs. CTE (20L)

- First – comparison must be same constructions (graph on previous page is) – these are all 20 layer, 58% RC – but correlation is poor
 - R^2 between the ATC and IST results is only .43 and .47 for as built and after 6X IST respectively (plots not shown), and the fit of the data is poor.
