# Double Reflow-Induced Brittle Interfacial Failures in Pb-free Ball Grid Array Solder Joints

## ABSTRACT

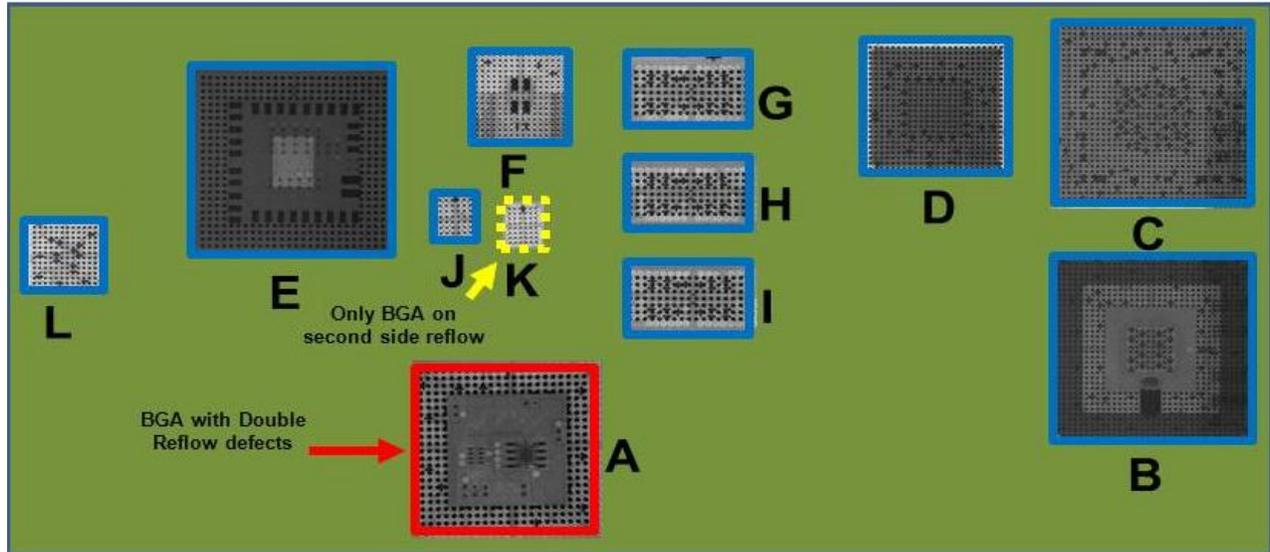
Figure 1: PCBA BGA Component Descriptions, Locations and Reflow Process.

Figure 1 shows the layout of the printed circuit board assembly (PCBA) that contained the soldering defects. Table 1 provides detailed component descriptions for all the area array devices assembled onto the PCBA. All the BGA components

with the exception of Component K were subjected to two reflow cycles. Due to the properties of the printed circuit board (PCB), soldering was done using two vapor phase reflow cycles, instead of the more typical hot air convection reflow cycles. Following the second reflow, the assembly exhibited parametric failures at test. The parametric failures were traced to the plastic ball grid array component (PBGA) labeled Component A and designated by the red box in Figure 1. Component A, which is a perimeter array BGA, 31 mm<sup>2</sup>, 304 I/O solder balls of 1.27 mm pitch and 0.76 mm diameter, exhibited intermittent solder joint electrical opens. There were no indications of solder joint electrical opens on any of the other components on the PCBA.

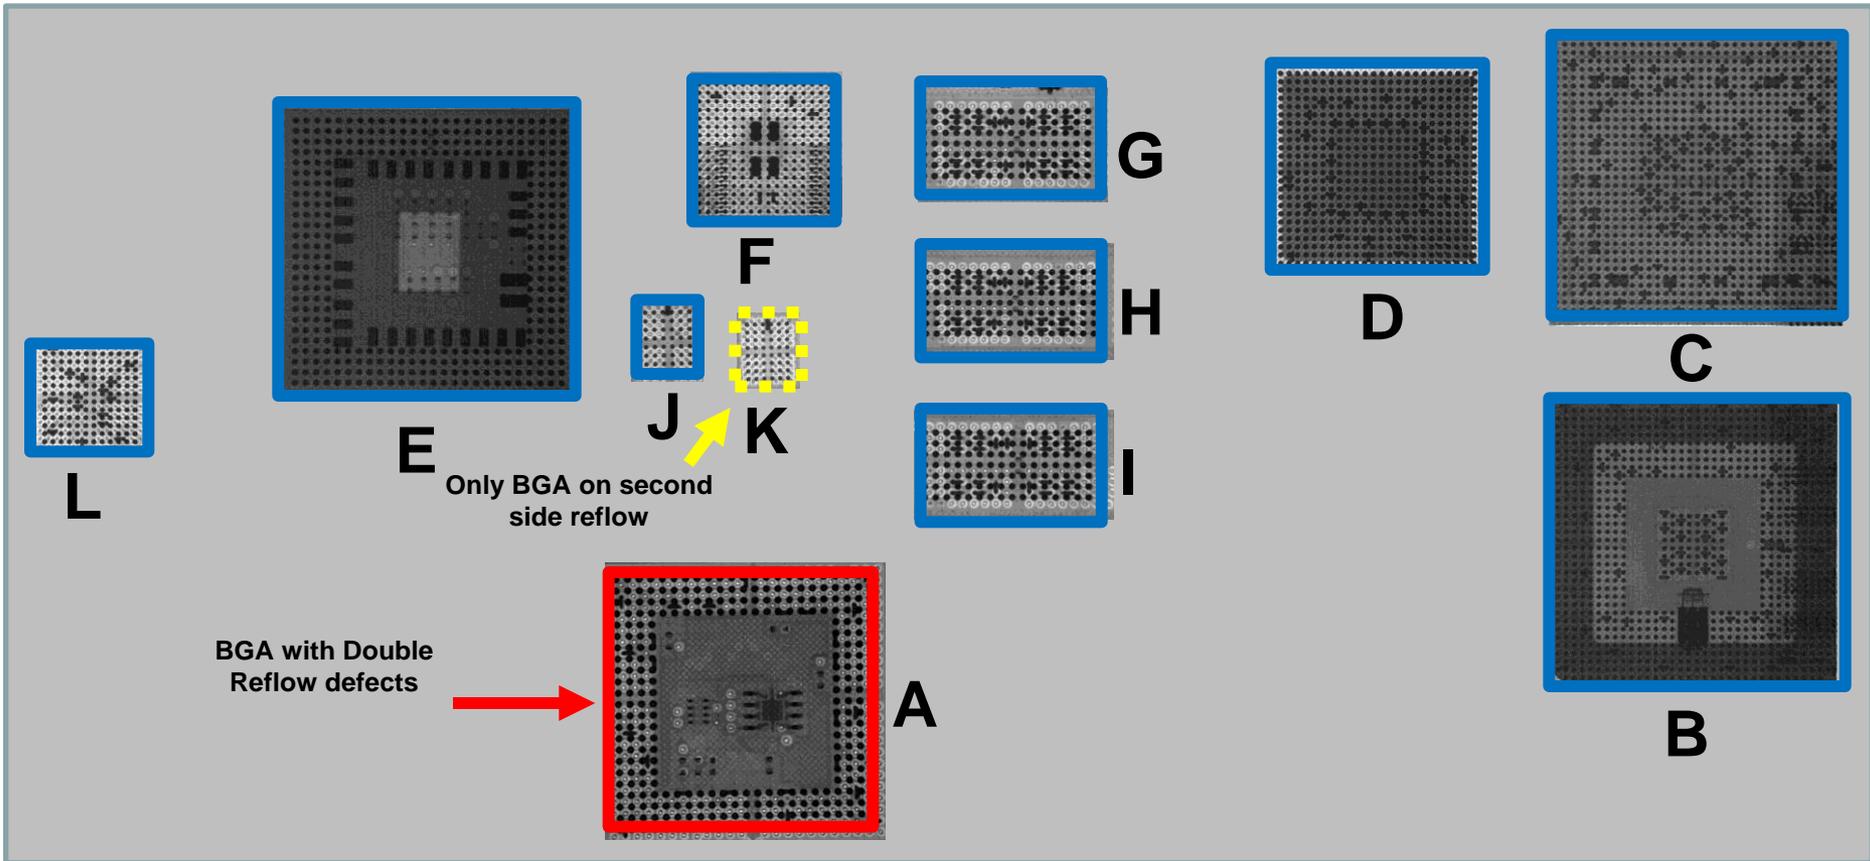
### Layout of the PCBA

All the BGA components, with the exception of Component K, were subjected to two vapor phase reflow cycles.

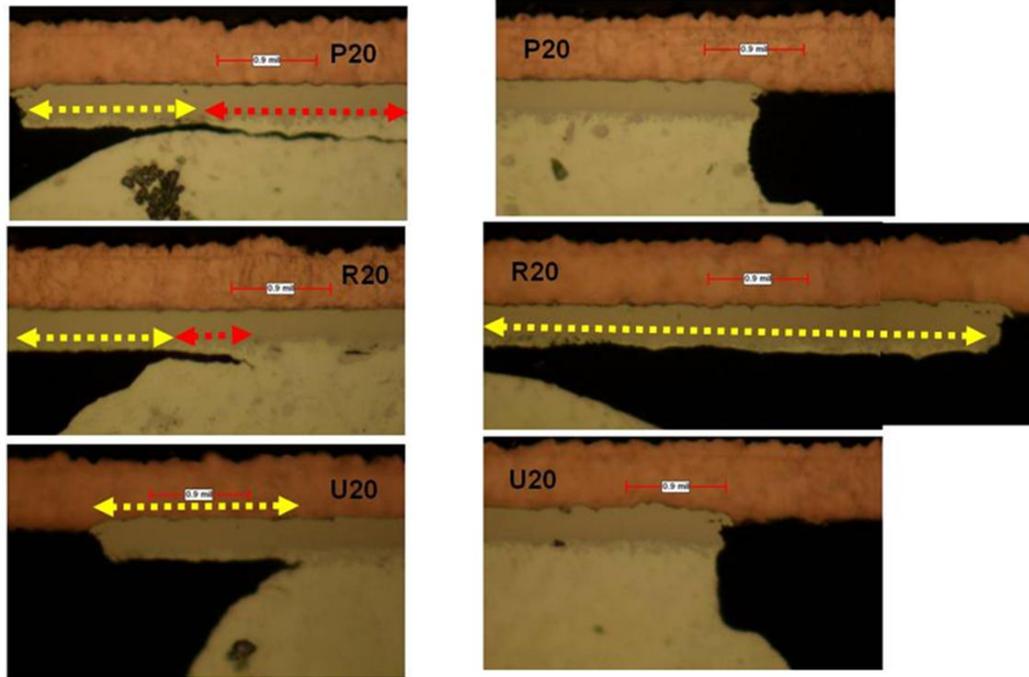
## Double Reflow Mechanism:

- The solder strength decreases with increasing temperatures and reaches a minimum as the temperature approaches the melting point during the 2<sup>nd</sup> pass reflow.
- Solder joint fracture is initiated by local and global stresses due to a combination of CTE mismatch and warpage of the component and PCB.
- In the most likely scenario, the solder joints fail during temperature ramp up during the 2<sup>nd</sup> reflow.
- Differential melting across the component body could cause the stress to be redistributed and concentrated on the remaining unmelted joints at the inner rows of the array.
- Subtle differences in local solidification and stress could account for the observed distribution of the inner row failures and the variation in the extent of the cracking from site to site along the inner rows.
