# **Influence of Salt Residues on BGA Head in Pillow (Hip)**

J. Servin, C. Gómez,  
M. Domínguez, A. Aragón  
CONTINENTAL CUAUTLA  
Av. Ignacio Allende Lote 20  
Parque Industrial Cuautla  
Cd. Ayala, Morelos 62749, México  
E-mail: [jose.servin@continental-corporation.com](mailto:jose.servin@continental-corporation.com)  
[cynthia.gomez@continental-corporation.com](mailto:cynthia.gomez@continental-corporation.com)

## **Abstract**

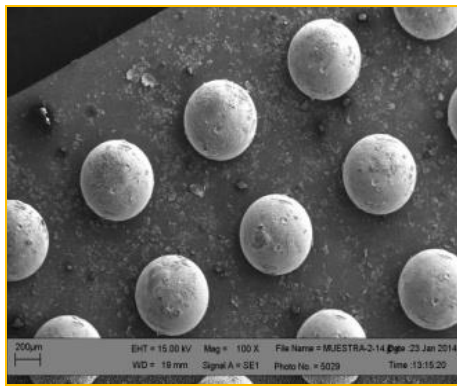
(B)

In the analysis of SEM/EDX, components have the presence of several elements on the surface. Figure 6 shows the results for the components at 16 hrs steam. Several elements are found (Mg, Ca, Al) beside Na and Cl. It is interesting to mention the solder balls have specific spots of the elements. Only components with 16 hrs of steam show more uniform distribution of the elements on the surface.

(b) 16hrs in 10% NaCl in tap water-Sample 2-

Figure 6. SEM Images of components at 16 hrs of steam, Samples 1 and 2 (A and B), EDX results (a and b)

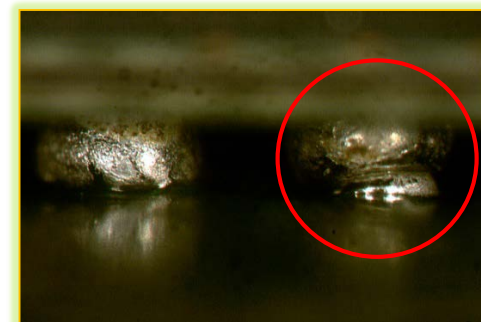
Figure 1. Head In Pillow Defect in a BGA connection (See the red circle)

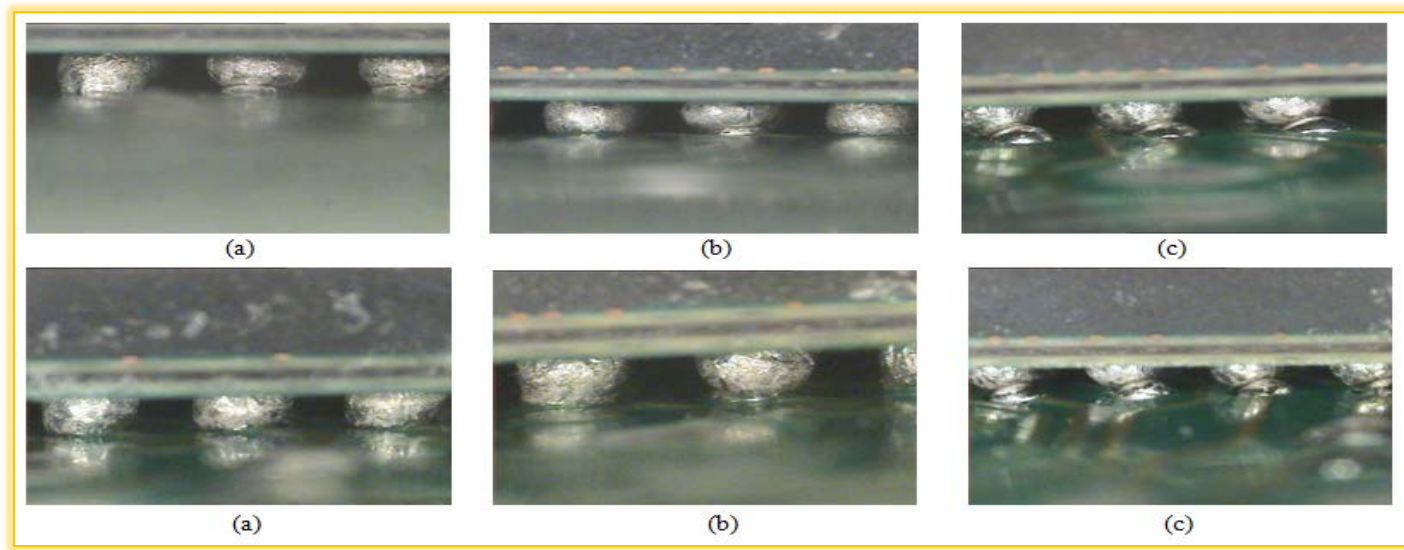
The images in Figure 4 show the HiPs resulted in DOE 1. These components got misplaced due to the number of HiPs. According to the results and comparisons, we can consider that the longer the time, the more defects.

Figure 4. DOE 1 Results: (a) Components at 4 hrs of steaming, (b) Components at 8 hrs of steaming, and (c) Components at 16 hrs of steaming, the components are misplaced due to number of HiP's.

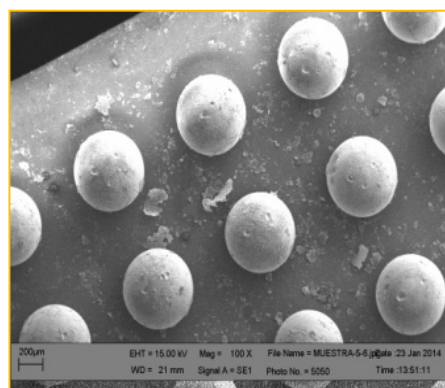
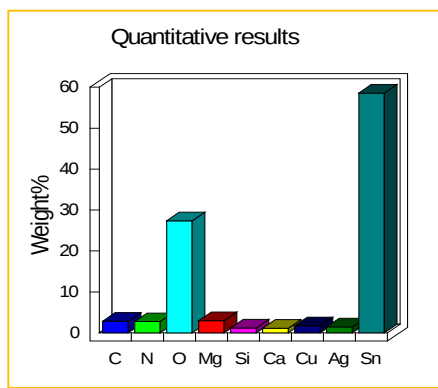
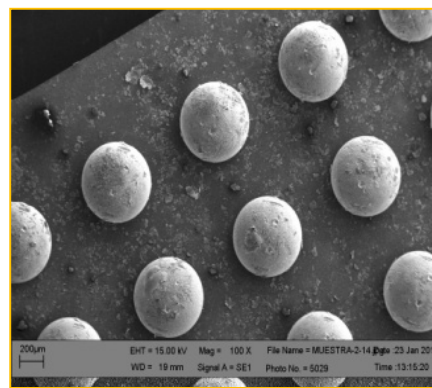
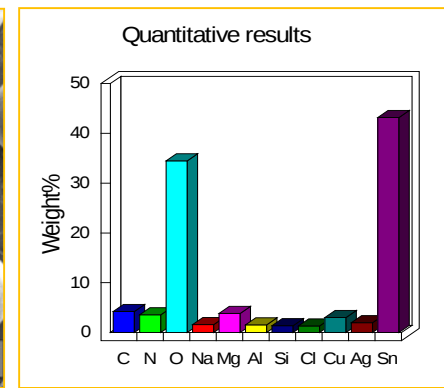
In the analysis of SEM/EDX, components have presence of several elements on the surface. Figure 5 shows the results for the components at 16 hrs steam. Several elements are found (Mg, Ca, Al) beside Na and Cl. It is interesting to mention the solder balls have specific spots of the elements. Only components with 16 hrs of steam show more uniform distribution of the elements on the surface.

Figure 5. SEM Images of components at 16 hrs of steam, samples 1 and 2 (A & B), EDX results (a & b)

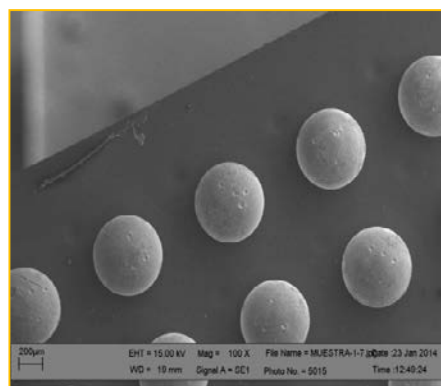
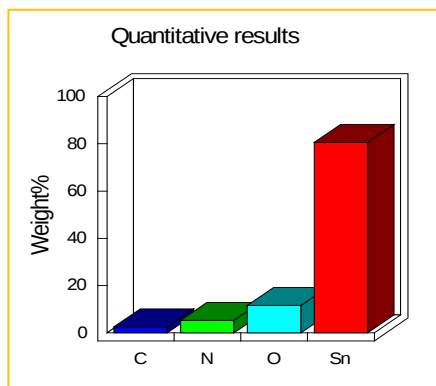
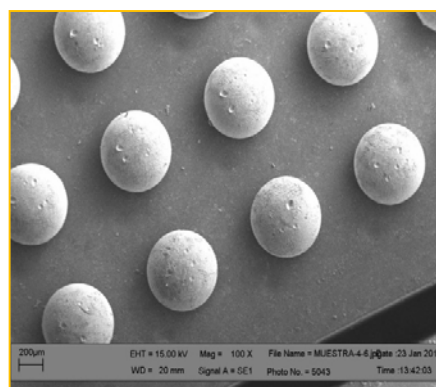
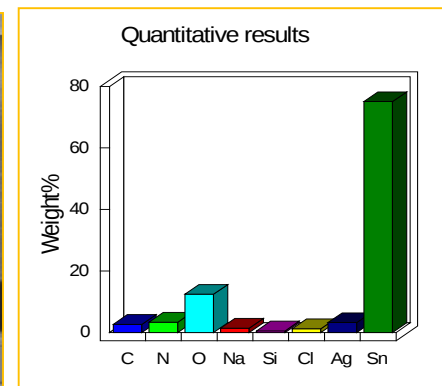
We analyzed several components before soldering with SEM/EDX. The BGA images are in raw material after steaming. The EDX results are from specific areas where salt was detected and not general analysis. SEM images do not see NaCl presence until it is too high. This means analyzing images is not so reliable as expected to detect Cl presence because the NaCl presence exist but the detection is too low as expected.

Figure 8. DOE 2. SEM Analysis Influence of NaCl in several conditions

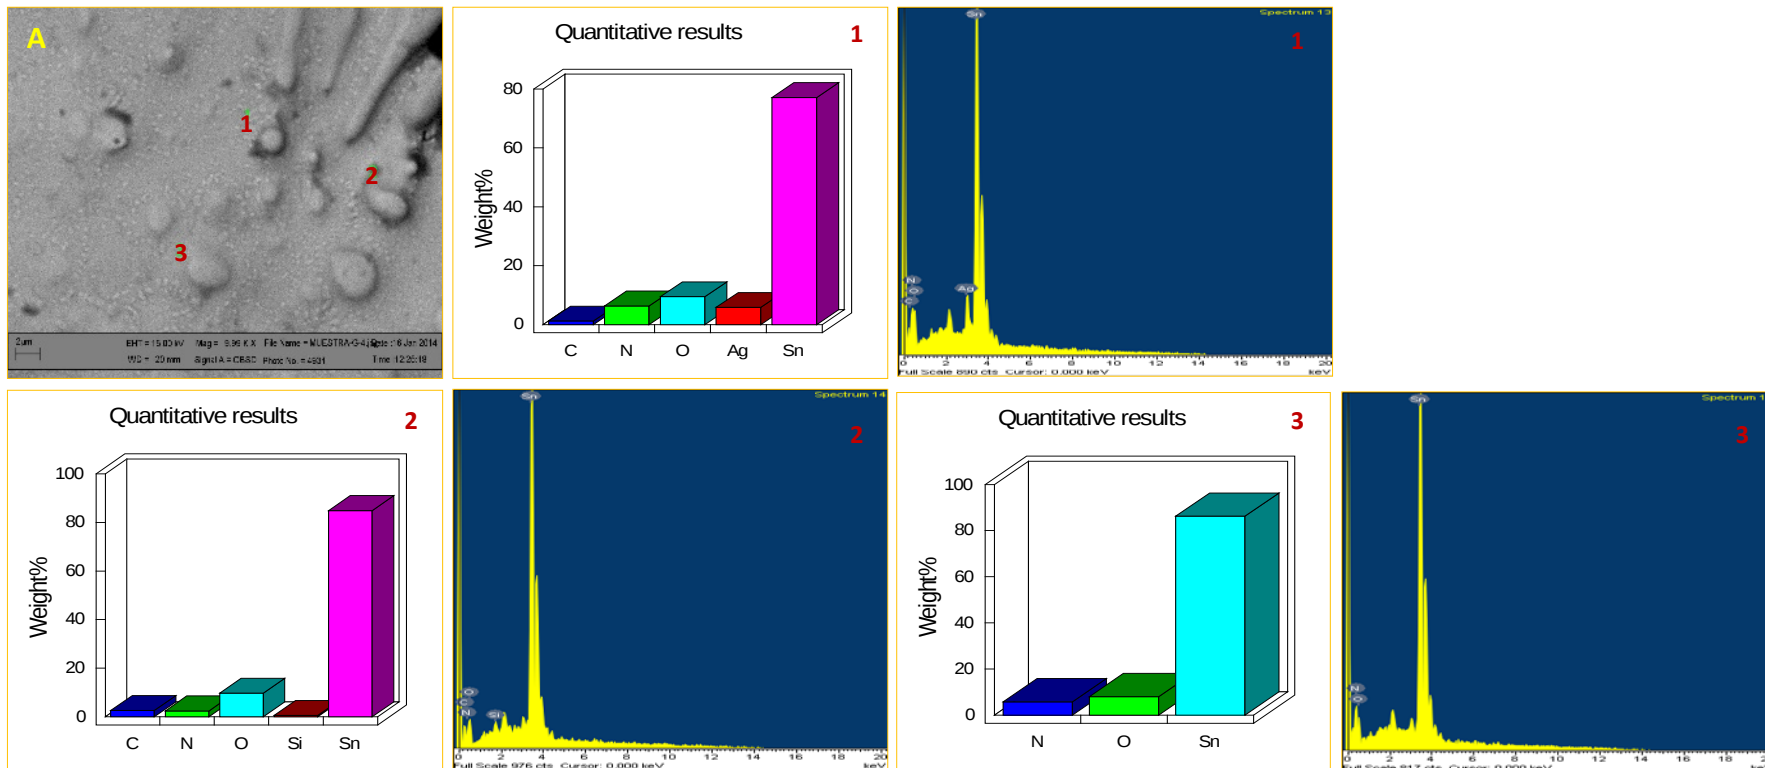
The next sample analyzed in SEM / EDX, were steamed for 16 hrs with deionized water.

Figure 13. The (A) shows three red numbers representing the punctual areas. The (1) corresponds to the analyzed point 1, (2) to the analyzed point 2, and (3) to the analyzed point 3. The sample comes from 16 hrs test and DI water.

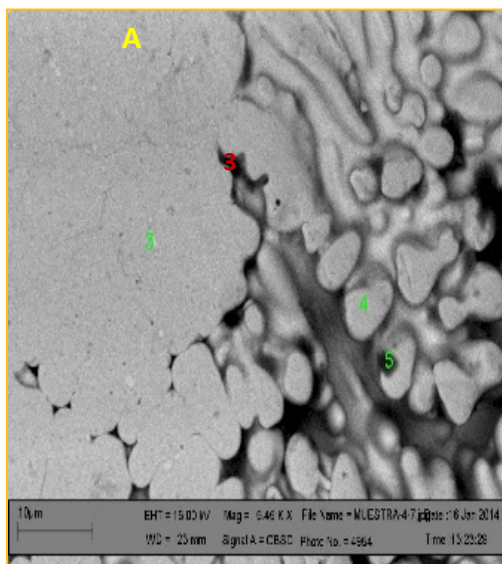
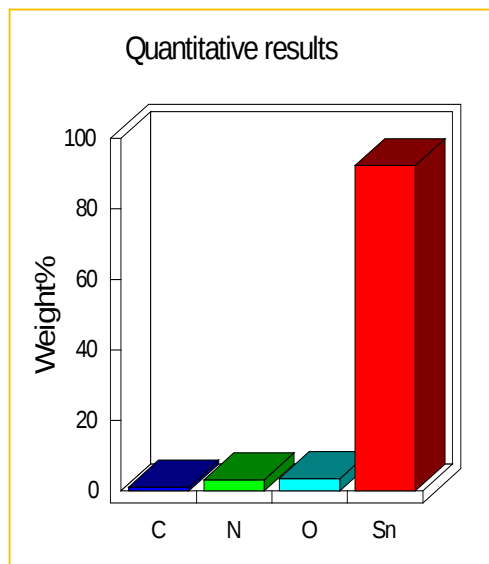
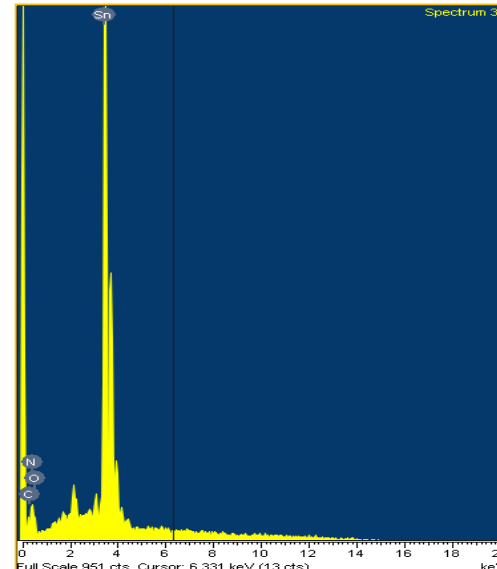
In this case, the results show a small concentration of chloride on the surface of the tin, see Figure 14; however, the presence of these chlorides is not evenly distributed across the surface of the ball but is found at specific points around the same; these points are located randomly.

Figure 14. The Images (A) is analyses of the sample with deionized water and 0.5% NaCl for 4 hrs

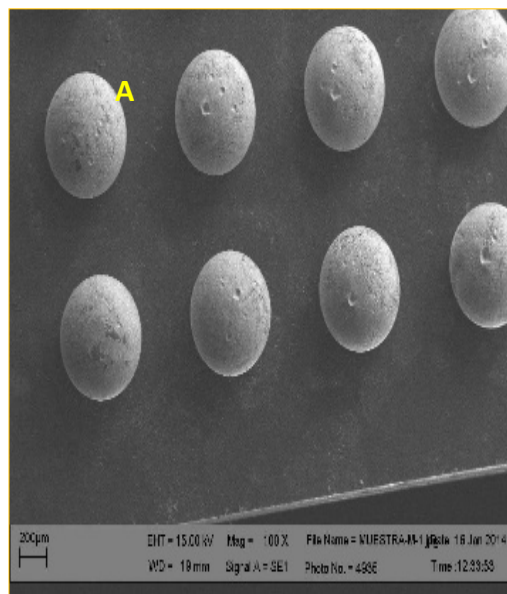
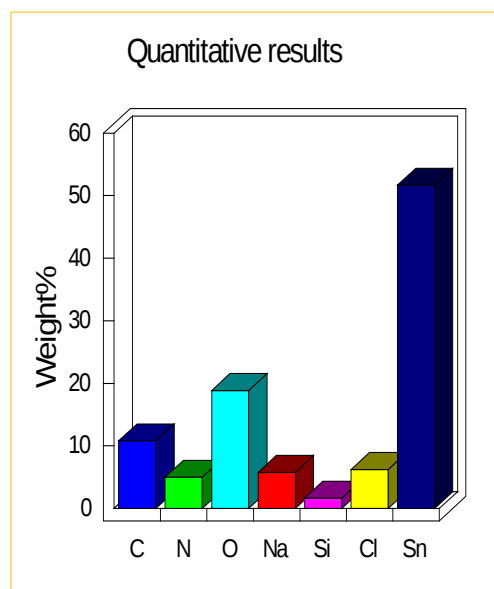
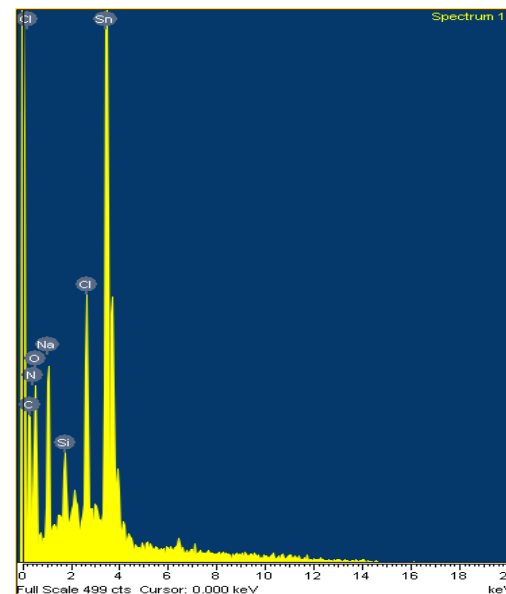
In Figure 15, the sample of analysis comes from deionized water and 1% NaCl at 4 hrs steam.

The samples are more contaminated with NaCl than BGA in Section II.

The results show higher sodium chloride concentrations at specific points around the ball.

Figure 15. (A) Results SEM Analysis (NaCl), Sample deionized water at 4 hrs.

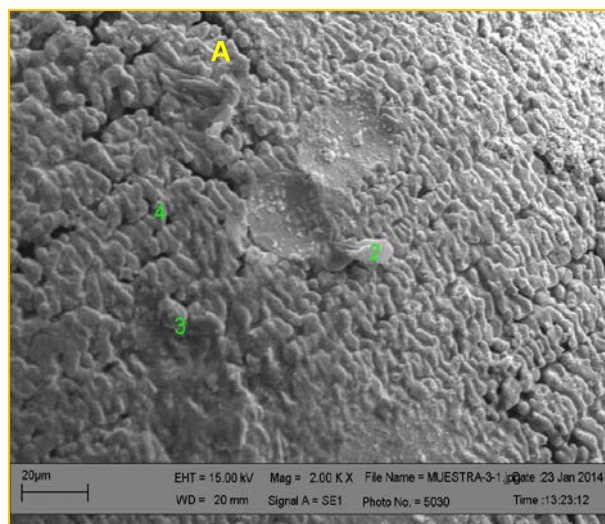
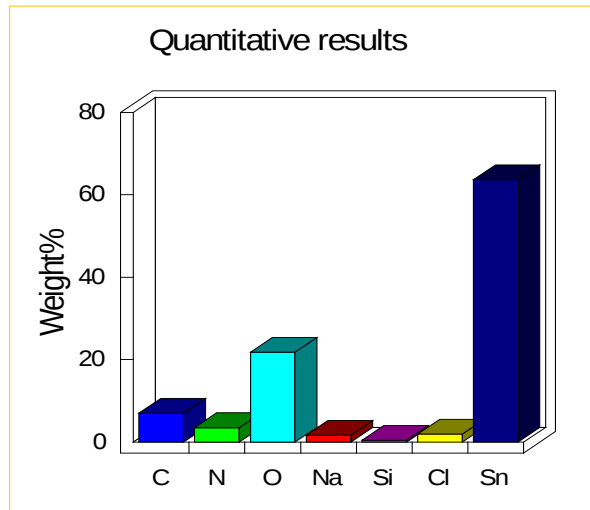
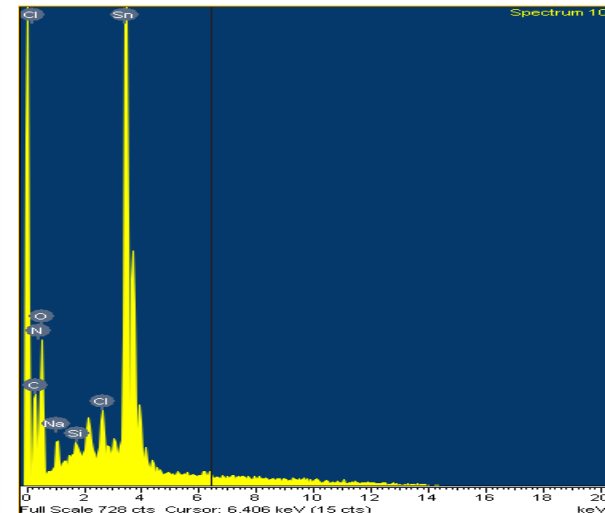
The results, Figure 16, show similar behavior to the previous sample, in which stains on of surface areas increases.

These areas are those containing a higher concentration of sodium chloride but do not cover the entire area of the ball but certain regions.

Figure 16. The (A) is a general Analysis SEM. The sample was steamed with deionized water at 5% (NaCl) for 16 hrs

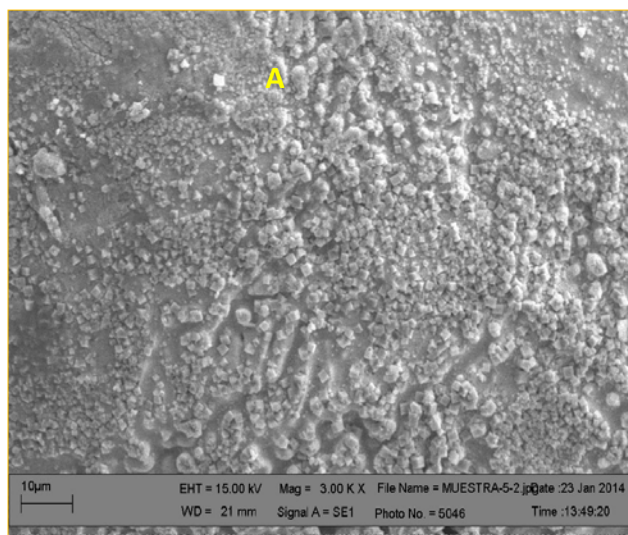
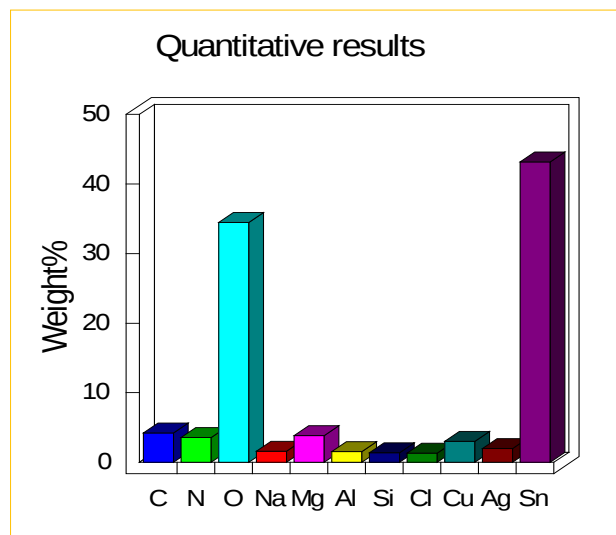
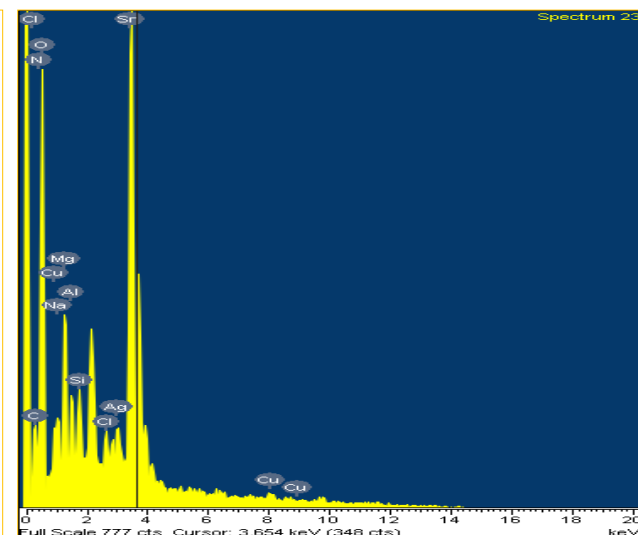
The analysis of this sample presents a large concentration on the surface of the ball in several chemical elements not only NaCl. See Figure 17 (A). These elements are Aluminum and Magnesium which also decrease the solderability of the balls.

Figure 17. (A) Sample in tap water at 10% for 16 hrs. Aluminum and Magnesium are presented elements, which can affect the solderability.

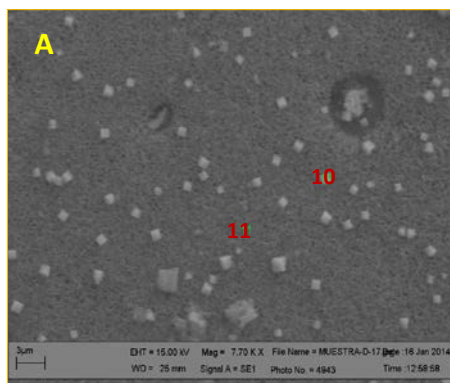
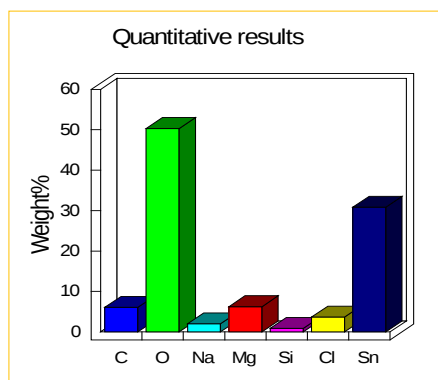
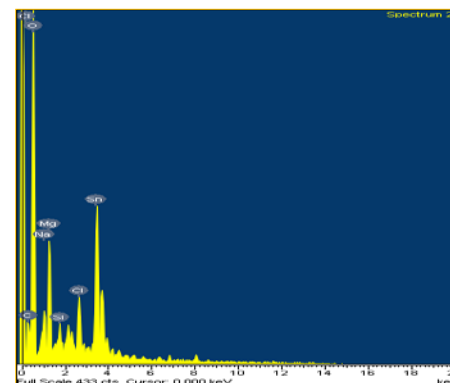
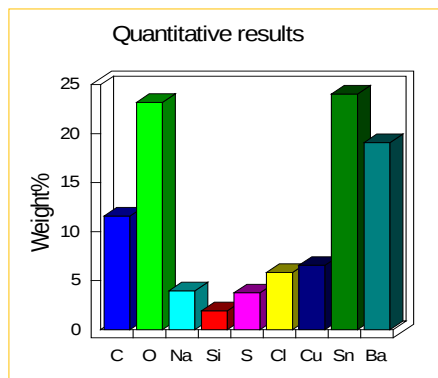
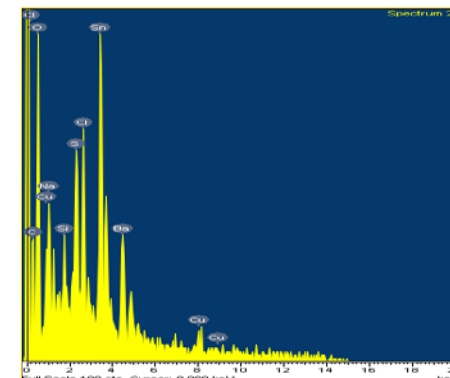
The SEM analysis shows contamination of NaCl in BGA body in this case, see Figure 18. The contamination is in form of small squares.

Figure 18. (A) General analysis body component (b) corresponds at point 10, and (c) is the point 11.

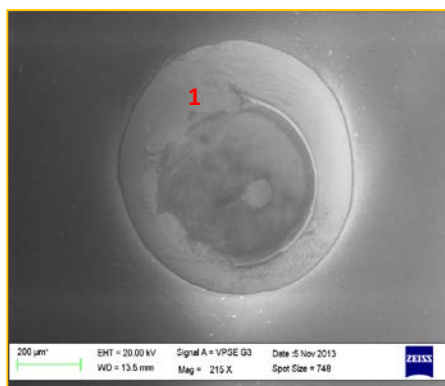
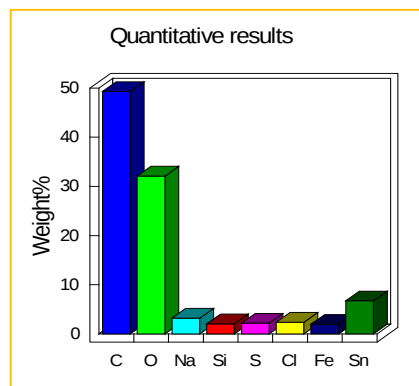
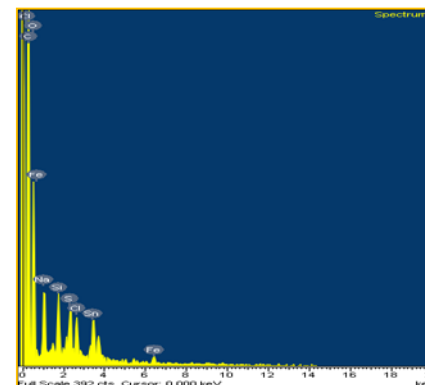
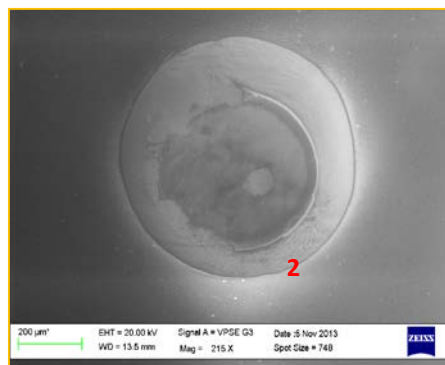
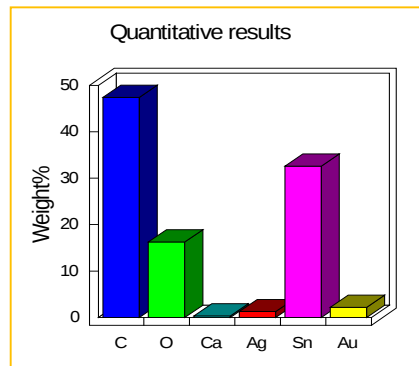
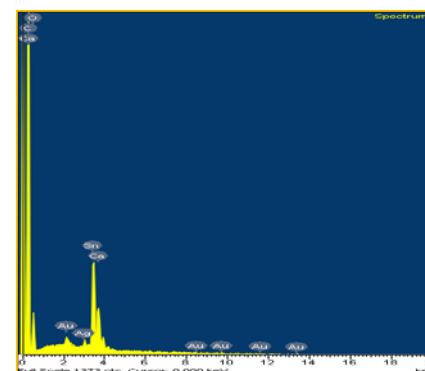
## Ball 1: HiP defect

Figure 19. (A) The analysis of analyzed point 1 presents Cl; (B) is the analyzed point 2 not shows Cl.

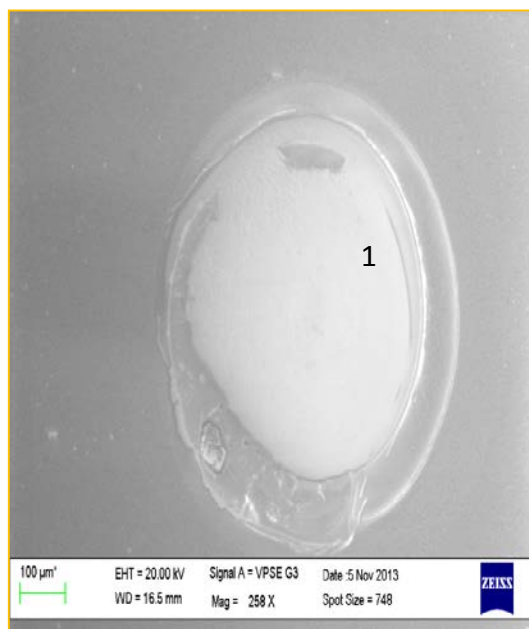
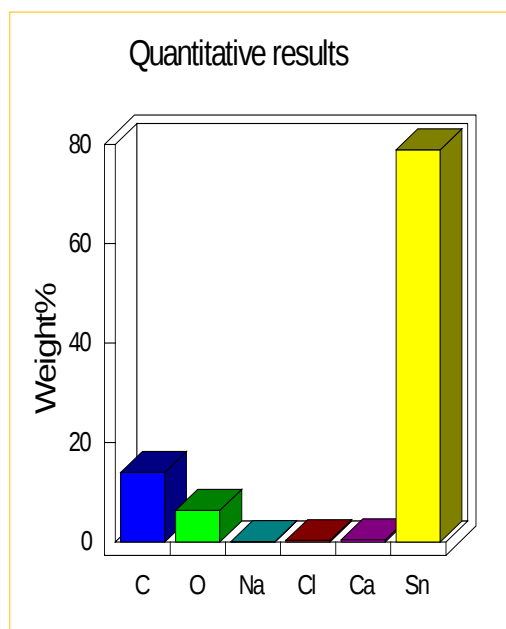
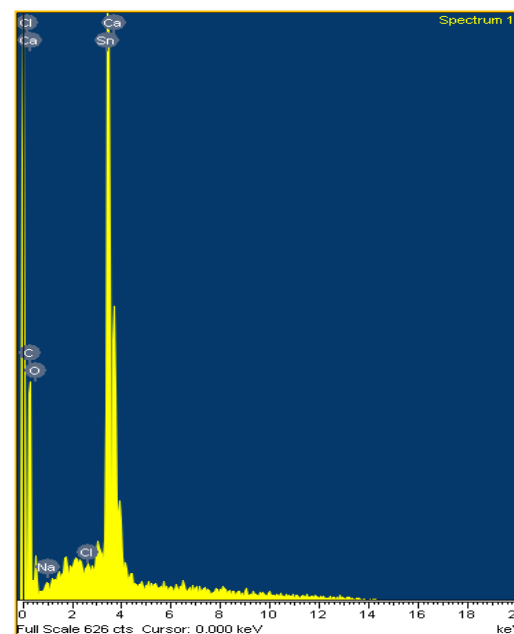
The following images show HiP SEM/EDX Analysis made on the pad.

There are only small residues of NaCl left on the surface.

Figure 20. (A) The sample presents NaCl on the pad
