# **A Structured Approach for Failure Analysis and Root Cause Determination for a Complex System Involving Printed Wiring Assemblies**

**Wade Goldman P.E.<sup>1</sup>, Alisa Grubbs<sup>1</sup>, Edward Arthur<sup>2</sup>**

<sup>1</sup>The Charles Stark Draper Laboratory, Inc., Cambridge, Massachusetts

<sup>2</sup>Raytheon Company, Space and Airborne Systems, El Segundo, California

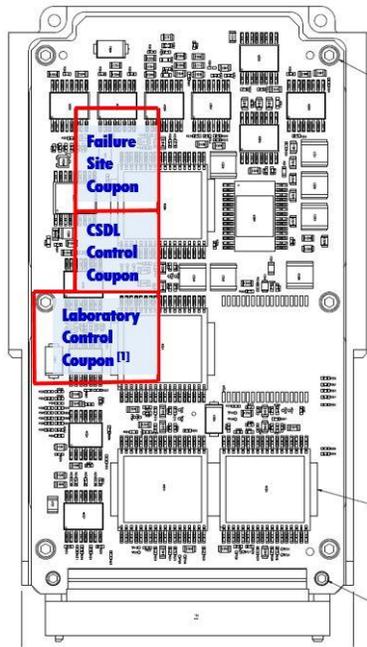
Figure 9 - Module Section locations (red lines indicate sectioning cut planes)

The justification for the failure mechanism was based upon a number of observations. Foreign inclusions exceeding the acceptable length in IPC 4101 were found in both the conformance coupons of panel 070 (the manufacturing panel that the failed PWB came from) and the three coupons removed from the failed PWA2. When other conformance coupons from this date code were reviewed, there were some foreign materials (possibly the result of Automated Optical Inspection AOI rework) found through dark field and SEM analysis. Figure 9, below, shows the locations where the three sections were taken. Figure 10 indicates resin-like inclusions found in one of the conformance coupons from panel 070. The right photograph is bright field, and the inclusion was found to be resin-like material. It is important to note that it was just slightly noticeable using standard light field illumination, but when dark field was used (which is not a current requirement), the defect could be seen more clearly in the left photograph. After some grinding and polishing, that inclusion was determined to be copper. IPC 4101 does not allow any encapsulated metallic particles of any size, whether in a core or prepregged material. Figure 11 is another example of a nonconforming inclusion, found in one of the two control coupons from PWA2. This was also determined to be a resin-rich, crack-like inclusion.
