Identifying and Combatting Counterfeiters

Edward Laliberte

Northrop Grumman Systems Corporation
Charlottesville, Virginia

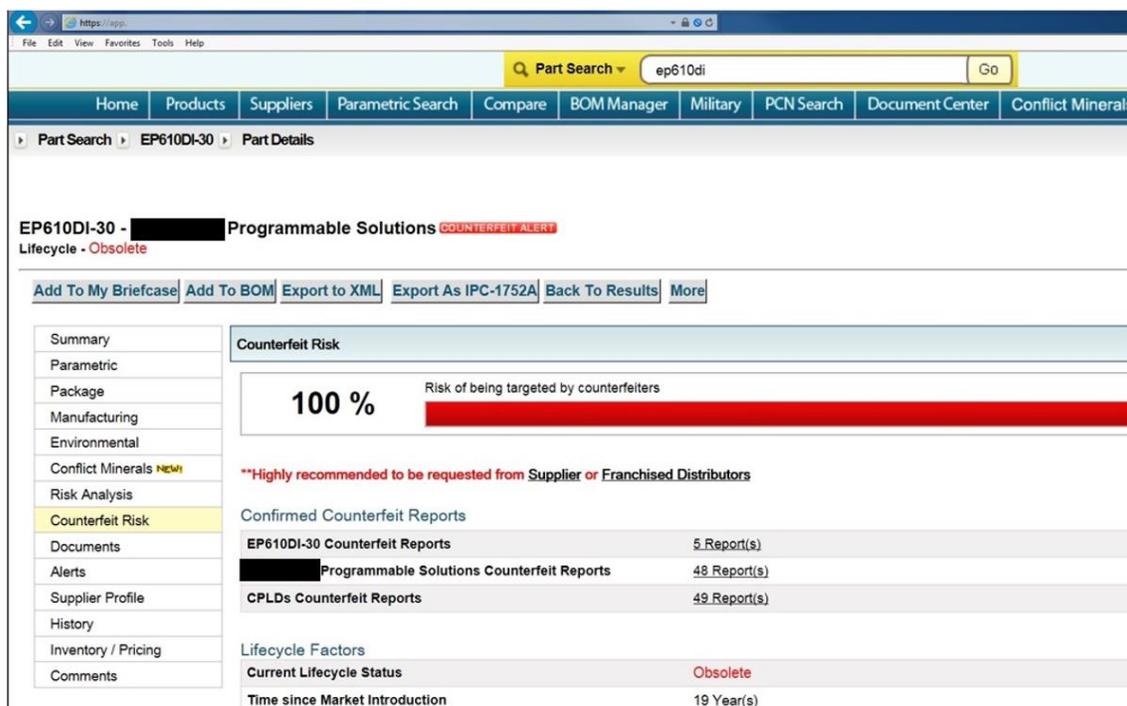
Figure 2: Counterfeit Risk Assessment for EP610DI-30 Component

If a part has some visual anomalies (e.g. bent pins, poor markings, multiple date codes in same package, etc.), the inspector should be suspicious and ask for mission assurance and engineering guidance. If a part is thought to be suspect counterfeit by an inspector, mission assurance should review the potential counterfeit risk of a part by reviewing GIDEP reports such as the list in Table 1 for the EP610DI-30 Ultra Violet (UV) Erasable Programmable Logic Device (EPLD) component. If access to the GIDEP reports (<http://www.gidep.org/>) is not available, the engineer could use any number of available industry part search tools offered by distributors or private held companies to determine the risks as shown in Figure 2.

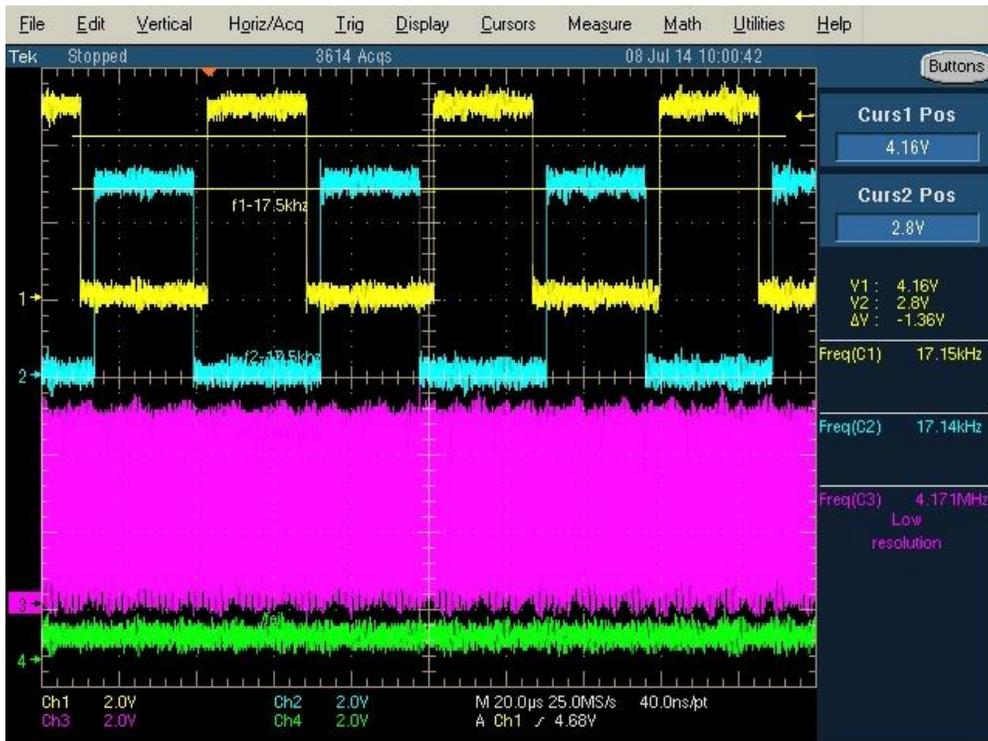
Figure 5: Known Good EPLD

Both EP610DI-30 UV EPLD components depicted in Figures 3 and 4 verified at the Data IO Programming Station with the correct checksum. The engineer erased one of the problematic EPLD components in the UV eraser for 25 minutes. The EPLD component was then reprogrammed and verified successfully. However, the part timing appeared even worse than the original condition, shown in Figures 3 and 4. The EPLD component was then put into the UV eraser for 1 hour and reprogrammed. Finally, the EPLD component started to perform similar to the known good EPLD component. Even though

the parts were programmed and verified, apparently some internal fuse links were not cleared during the erasing of the EPLD component resulting in unpredictable behavior. Also, UV erasing a “new” EP610DI-30 EPLD component for 1 hour prior to programming the part is not a standard procedure. Typically, only 10 to 20 minutes under the UV lamp is all that is needed to do a reliable erasure. Therefore, further investigation into the authenticity of the components needed to be performed.

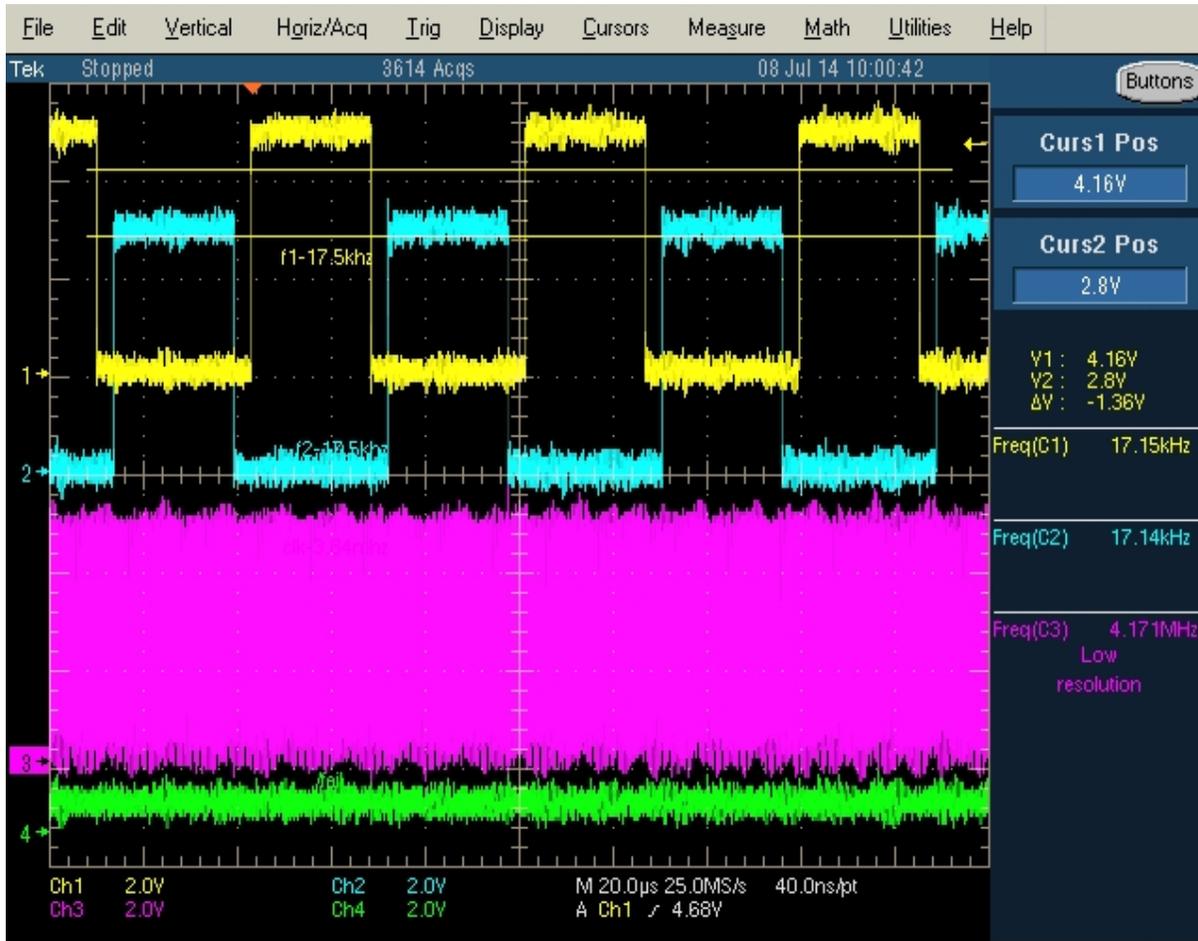
KNOWN GOOD EPLD TIMING

Comparing the Timing of EPLD Output Signals
