# Solder Joints Failure Under Low Strain-rate Cyclic Loading

Jie Lian, Ph.D., Dennis Willie, Jada Chan, Francoise Sarrazin, Ph.D., Kelvin Wong, Christopher Vu, Wesley Tran, Tuyen Nguyen, Tu Tran, Anwar Mohammed, Ph.D., Michael Doiron  
FLEX International, Milpitas, CA

## Abstract

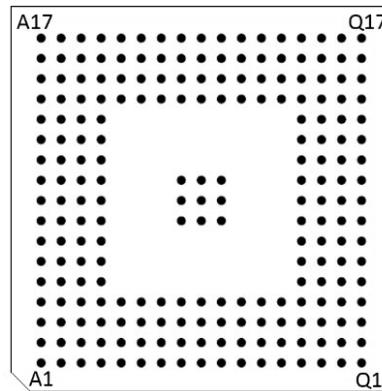
Figure 1. BGA land pattern with solder ball numbers labeled.

From the dye and pry test on sample 1 from group 1, the solder joints in A14-17, B16,17, C17, E17 and G17 were identified with failures, where either full or partial red colored regions were observed. Figure 3 (a) shows one representative solder ball A17 in sample 1 at the PCB side after Dye and Pry testing. The presence of red dye indicates cracks in the area of interest. To further understand the failure mode of the solder joint, the BGA package in sample 2 from group 2 was cross sectioned in row A17-Q17 and column A1-A17, where failures were found from Dye and Pry tests. Figure 3(b) shows the cross section

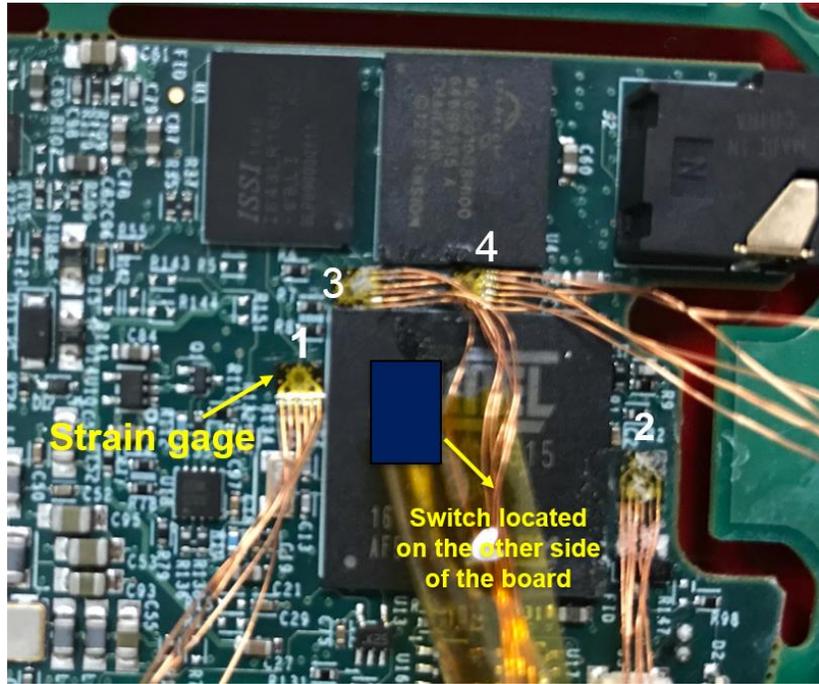
Figure 6. Four strain gages installed around the BGA

Figure 6 shows that four strain gages were installed around the BGA on the PCB board. Strain gages were chosen to be installed to places where no components were in place. In addition, from the board design, the switch was located near the top left corner of the BGA as illustrated in Figure 6, so strain gage 1, 3 and 4 were installed in that corner. Figure 7 illustrates the electronic device structure with the old button and new button on the enclosure, switch on the top side of PCB board, and the BGA on the bottom side of the PCB board. The switch is located near one corner of the BGA. The old button was made of rubber material, while new button was made of plastic material, which is softer than the rubber material.

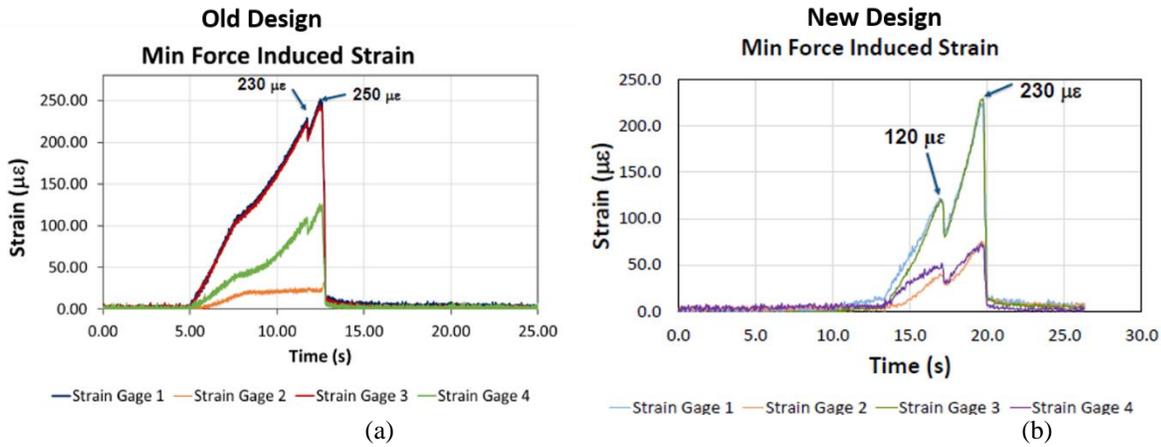
Figure 8. Strain changes upon one cycle of button push test with minimum force to activate the button for (a) old design, and (b) new design

Figure 8 shows the strain variation with the one cycle button push. When there is a load drop and a strain drop, the maximum force before the drop was recorded as the minimum force to activate the button. For human operating tests, a few button push tests were performed by two persons, and the maximum strain was recorded. Figure 9 shows the strain variation upon a few cycles of human button push tests for both the old design and new design. Figure 10 compares the strain at the minimum force activating the button, switch and in real operation conditions. For all three conditions, the new design shows a much lower strain level than the old design, which indicates an improvement in structural design to lower the impact of board bending. Because the plastic materials in the new button are less rigid than the rubber materials in the old button, the stress applied to the new button can be much lower, thus the strain levels are usually lower in the new button push tests. The strain at the minimum force activating the button and switch fall within the IPC/JEDEC-9704 standard [ref. 5] for both the old

design and new design. However, the strain level of 700  $\mu\epsilon$  in the old design and 500  $\mu\epsilon$  in the new design for human operation conditions are approaching the limit of IPC/JEDEC-9704 standard, which could be a potential risk for failures.

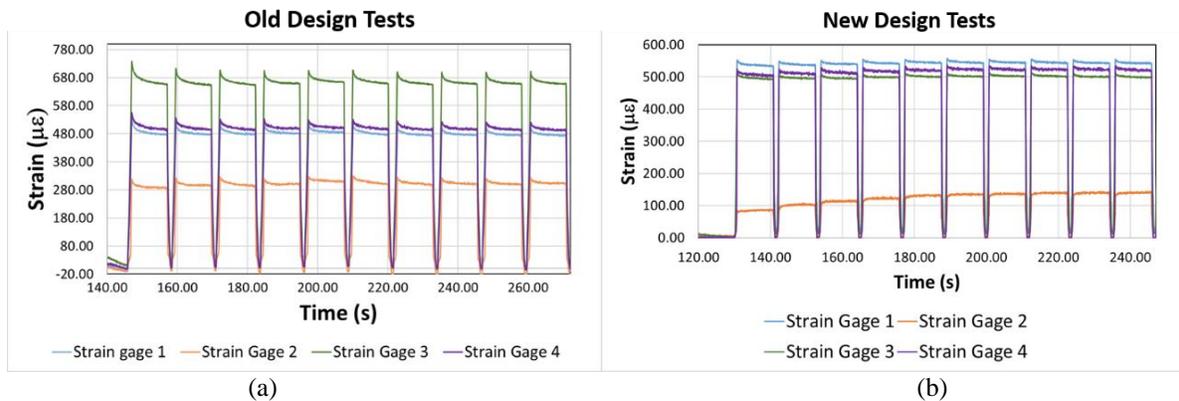
Figure 11. Strain changes during the low strain-rate cyclic button push tests for (a) old design, and (b) new design

Figure 11 (a) and (b) shows the strain changes during the low strain-rate cyclic button push tests for the old design and new design. Four strain gages were installed around the four corners of the BGA, which were labeled as strain gage 1,2,3,4. The strain gages that show the highest level of strain were used for comparison studies. The strain differences in the different strain gage indicate that the BGA experienced non-uniform strain and stresses. Figure 12 (a) and (b) show the cracks in the solder joints in the old design product, and Figure 13 (a)-(d) show the cracks in the solder joints in the new design product. Three failure modes were identified. The first failure mode was the same as seen from Figure 3 (b), i.e. a brittle crack between the solder joint and the copper pad, which is because of the “Black Pad” effect. The corroded Ni layer made it weak at the interface between the IMC layer and the pad, thus cracks are prone to initiate in this area. The second failure mode is the ductile fracture in the bulk solder part that is close to the pad on both board side and component side. The third failure mode is the crack in the IMC at the board side. Figure 12 (a), (b) and Figure 13 (a) show a mixture of the failure modes mentioned above. The brittle cracks were thought to be first formed at early stages of the cyclic button push tests, and the ductile cracks were later formed at longer cycles of button push tests. Similar failure modes were also observed in Sn/Pb Solder joints from thermal cycling tests. [ref.6] Figure 13 (b), (c) and (d) show the ductile crack mode that initiated after long cycles of bending from the button push. Cracks tend to initiate at the edge of the pad that connect to trace lines, which are thought to be due to the high stress concentrations in these regions.

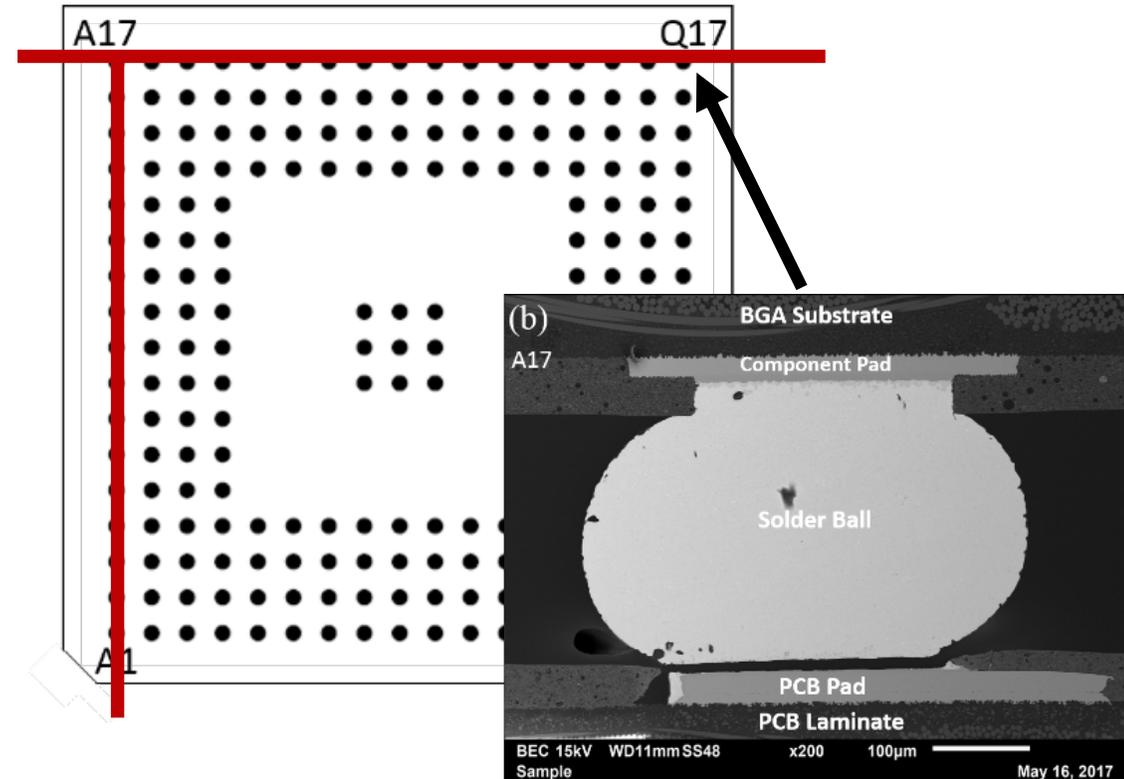
- High failure rate was found in a consumer portable electronic device
- Based on electrical function tests, the BGA was found to be the main failed part
- Failing BGA Device subjected to repeated bending stresses during operating conditions
- Failure analysis plans including dye & pry, cross section and X-ray analysis were proposed to identify the failure locations and learn about failure mode

*BGA land pattern with solder ball numbers labeled with picture of Solder Ball separated from PCB Pad.*

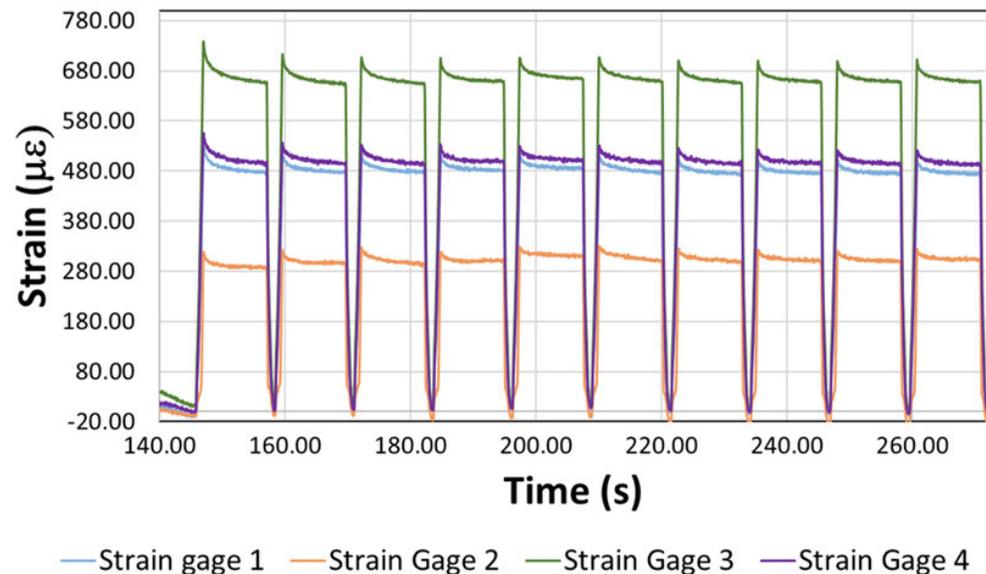
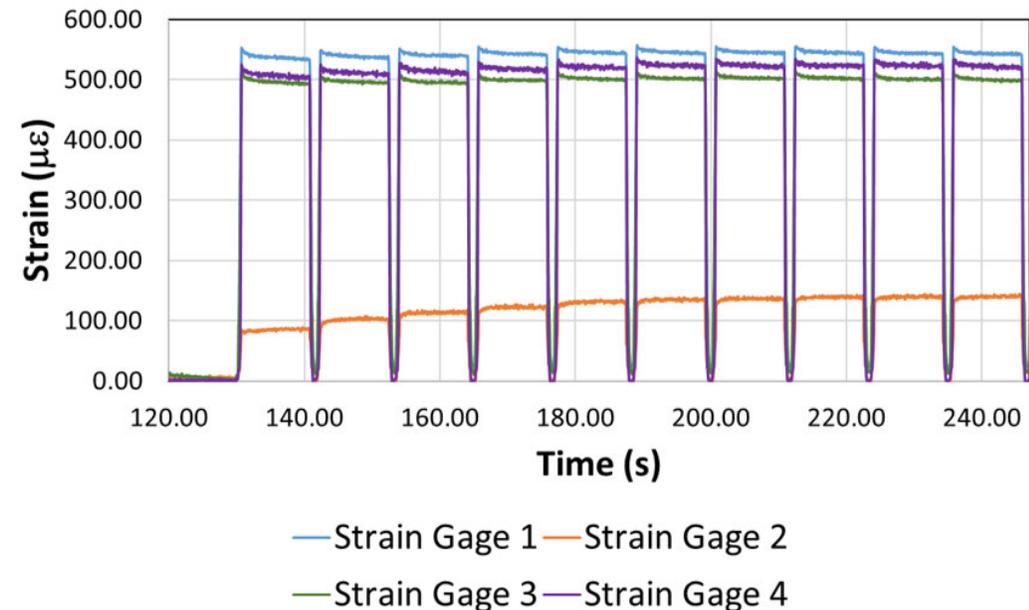
- Only the first 10 cycles were shown in the plots, similar strain levels after 10 cycles were obtained
- Strain gage 3 shows highest strain in the old design of 700  $\mu\epsilon$
- Strain gage 1, 3, and 4 shows similar highest level of strain of 500-550  $\mu\epsilon$  in the new design

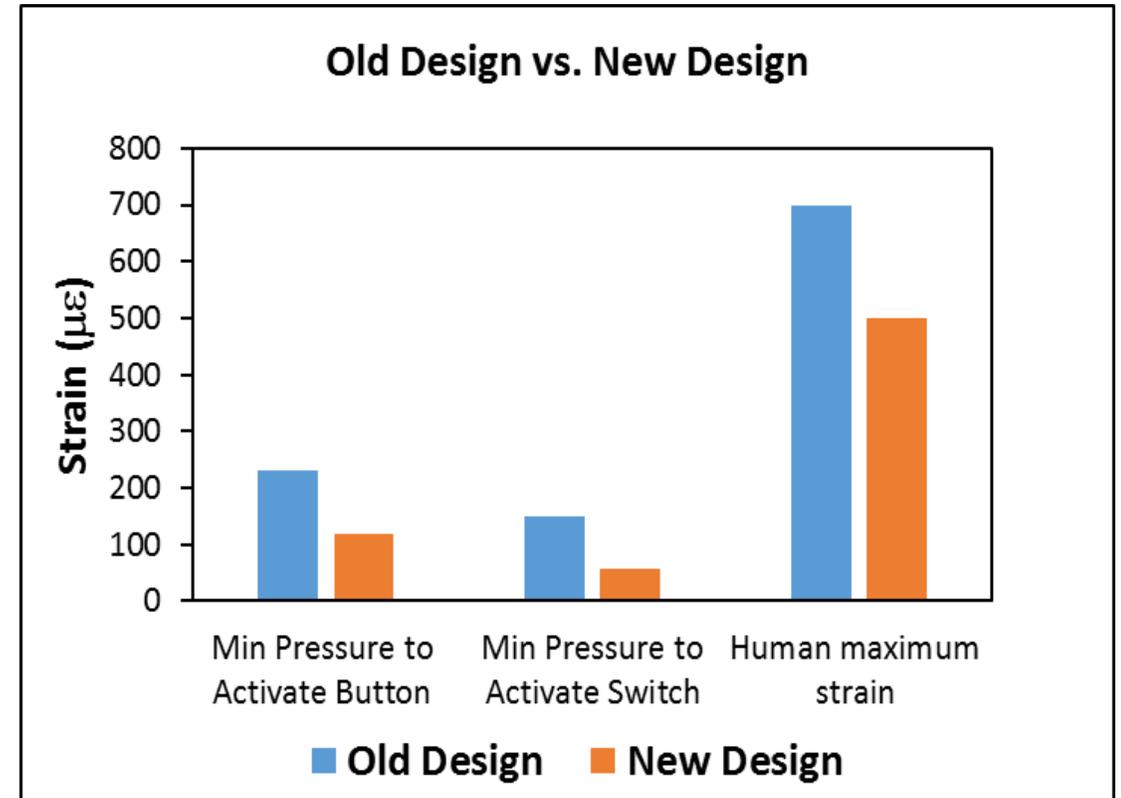
- **Two Structures**
  - Old Design: rubber button
  - New Design: plastic button, different shape
- **Three Loading Conditions**
  - Minimum pressure to activate the button
  - Minimum pressure to activate the switch
  - Human operated pressure
- **Summary**
  - The minimum pressure to activate the button, switch, and human operated pressure are all lower in the new design
  - Improvement was obtained with less strain levels in different testing conditions in the new design
  - Further optimization of design is suggested to eliminate the failure
