Analyzing a Printed Circuit Board Weave Exposure Condition and its Effects on Printed Wiring Assembly Functional Performance

Wade Goldman P.E.¹, Andrew Dineen¹, Hailey Jordan¹, Curtis Leonard¹,
Timothy Redling¹, Edward Arthur²

¹The Charles Stark Draper Laboratory, Inc., Cambridge, Massachusetts

²Raytheon Company, Space and Airborne Systems, El Segundo, California

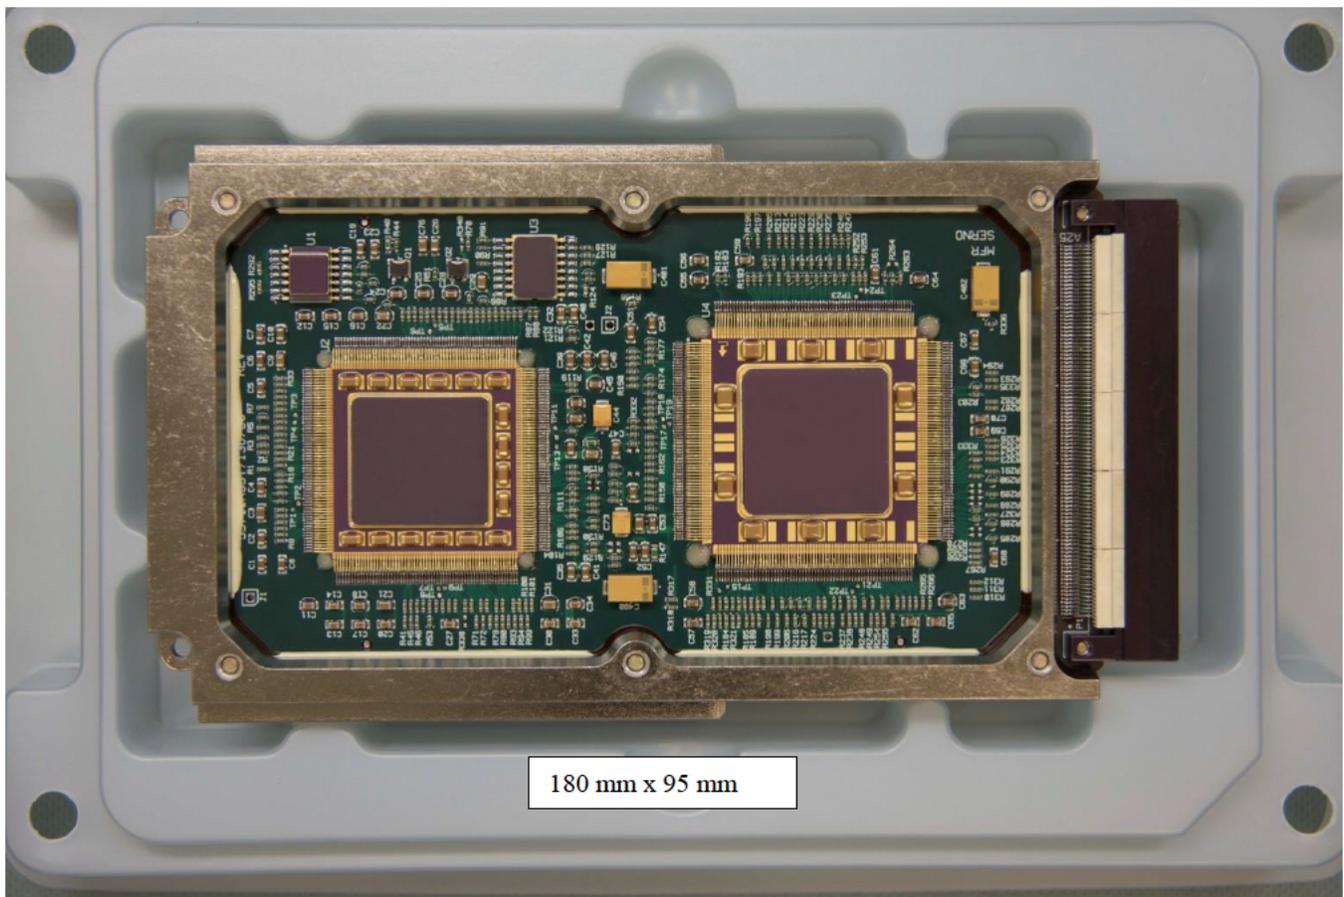
Figure 1- Example of a non-impacted PWA

A section of an affected PWA was subjected to SEM analysis. This section was comprised of a row of pads from the multi-leaded component shown in Figure 1. The analysis focused on random areas between pads where the reinforced glass fibers were overlapping (or perpendicular) to each other. See Figure 11 and Figure 12. The results depicted a number of areas where the surface laminate was separating and lifting from the PCB weave. It also shows areas where the surface laminate had ruptured. These findings provided confirmation that not only did weave exposure exist, but also lamination separation occurred, which is not a desirable outcome.

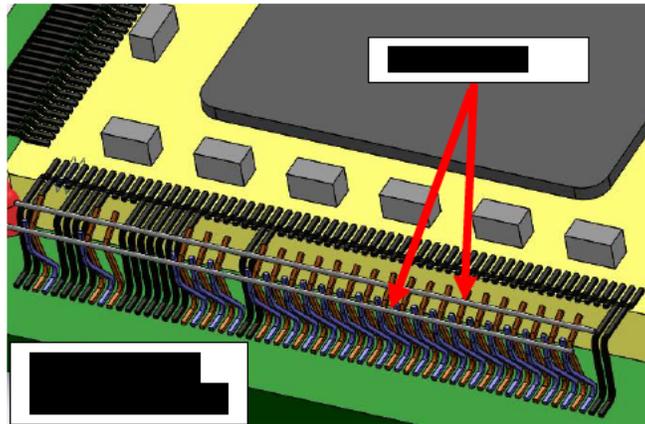
Figure 15–Dielectric breakdown setup – two circuits

A test was designed using one row of the closely pitched component pads in Figure 1. The test was designed so that the leads from a component on one side were configured in such a way to provide a two-row pattern where the leads were bussed together to form two circuits. See

Figure 15. Voltage was applied using a Hi-Pot tester capable of reaching 6kV DC and gradually increased until the tester tripped. The voltage was captured using a digital multi-meter.

The data sheets for the material used reported that the dielectric breakdown is 4.7×10^4 V/mm (1200 V/mil). Two separate samples were tested. The results ranged from $0.8 - 1.1 \times 10^4$ V/mm (215 V/mil to 277 V/mil). These values were far below the data sheet reported values and orders of magnitude greater than the typical voltage on the component pins. This indicates that PWAs with this weave exposure condition have severely compromised electrical strength and are susceptible to

electrical breakdown between adjacent conductors. Even though no control sample was used for this test, it did provide useful information to the analysis and led us to investigate CAF and cleanliness testing.

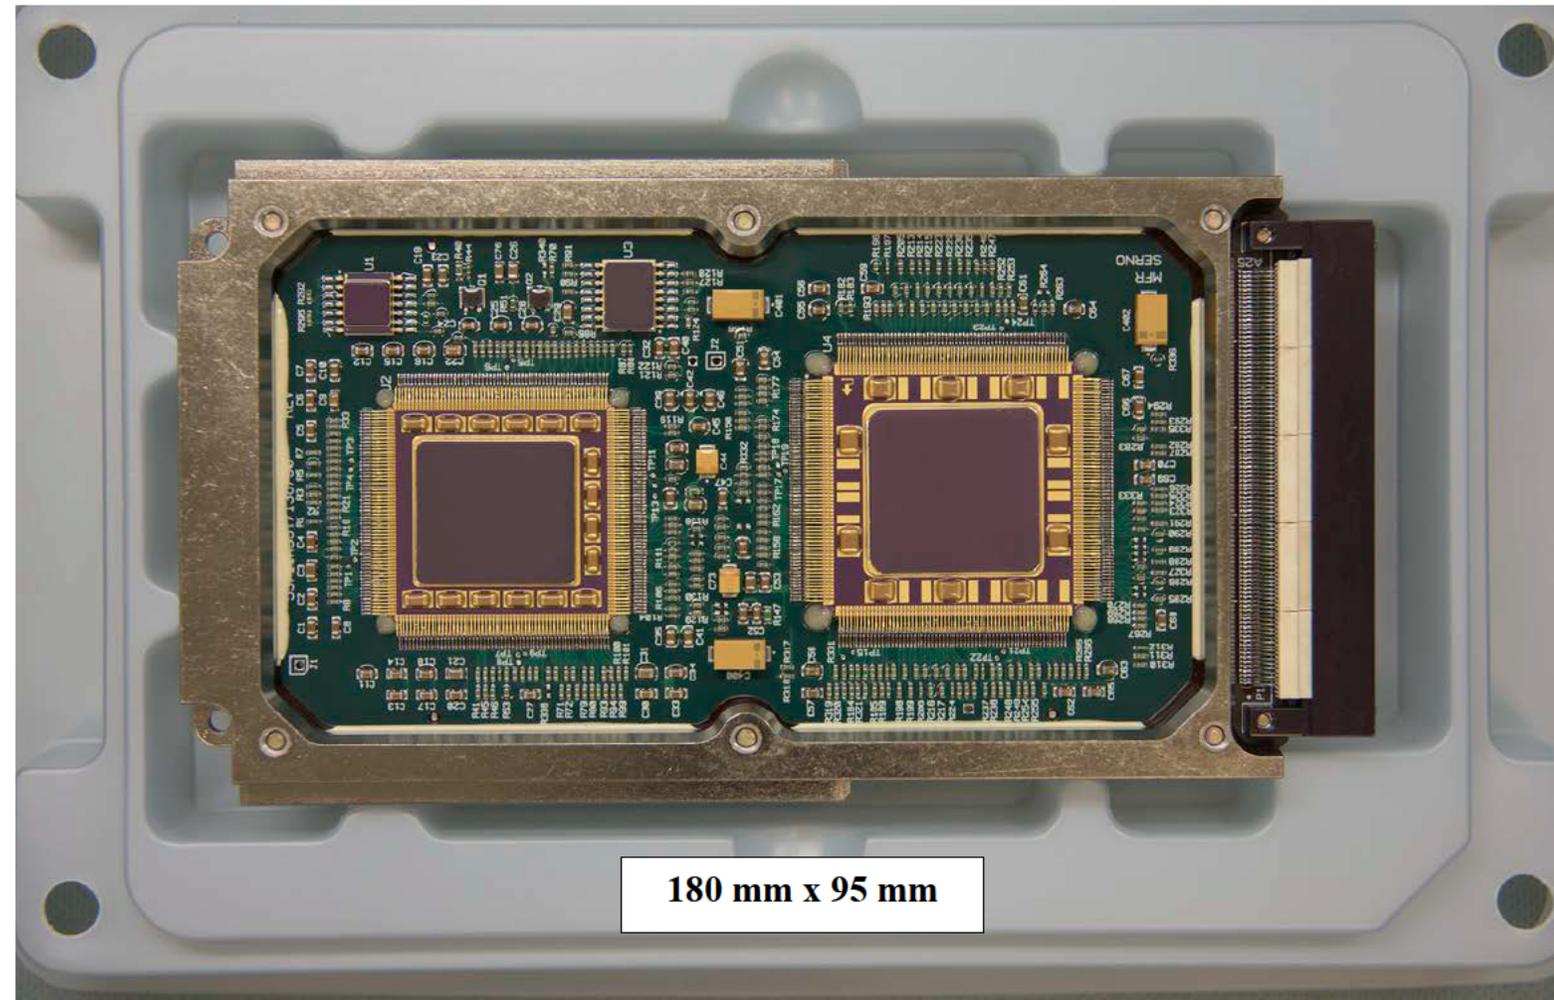
PWA Overview

- PCBs, manufactured a few years ago, were found to have weave texture. Condition was not noticed until a number of PCBs were assembled into PWAs. IPC-A-600 was the visual workmanship standard used.
 - *16 layer, polyimide, liquid photo imageable soldermask, MIL-PRF-31032/1*
- Weave exposure may appear similar if appropriate inspection techniques are not employed at the time of the inspection. Soldermask or conformal coat coverage may drastically affect the ability to discern between texture and exposure.
- The PCB manufacturer and procuring agent remotely reviewed pictures from the PWA manufacturer and agreed with the initial assessment.
- Observed mostly on areas not covered with soldermask.

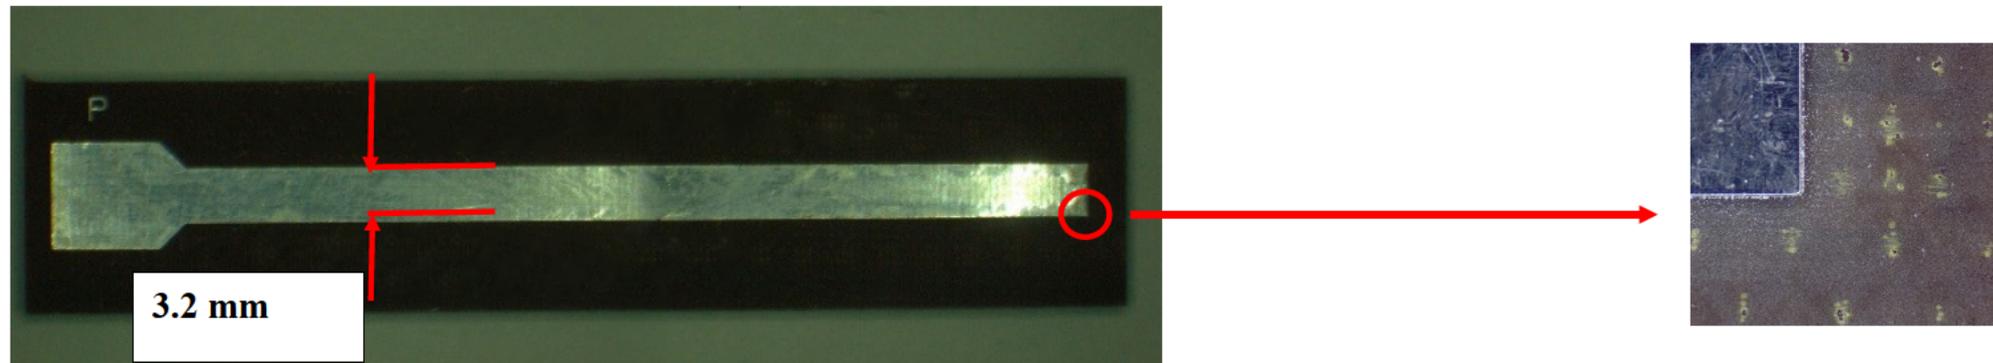
Evaluation and analysis – Visual inspection

- Peel strength coupons provide a soldermask free coupon for visual examination by high power (200X to 400X)
- Buried via conformance coupons were microsectioned and reviewed
- Areas under soldermask had significantly less damage than areas of surface laminate that were directly subjected to the stripper solvent.

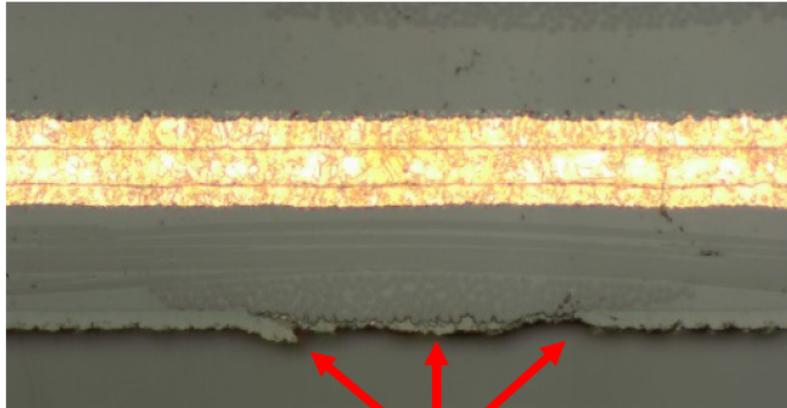
Evaluation and analysis – Microsection

In addition to inspecting the peel strength coupons, buried via conformance coupons were reviewed. The coupons from the affected lot underwent additional microsectioning where additional evidence of exposed weave was found. In general, areas under the soldermask had less damage to the resin than those areas of the surface laminate that had no soldermask. This is likely due to the fact that the soldermask, when originally subjected to the stripping solvent, masked that part of the laminate and prevented the damage from being as extensive as those areas with no soldermask. See Figure 8 for example of a buried via microsection conformance coupon.

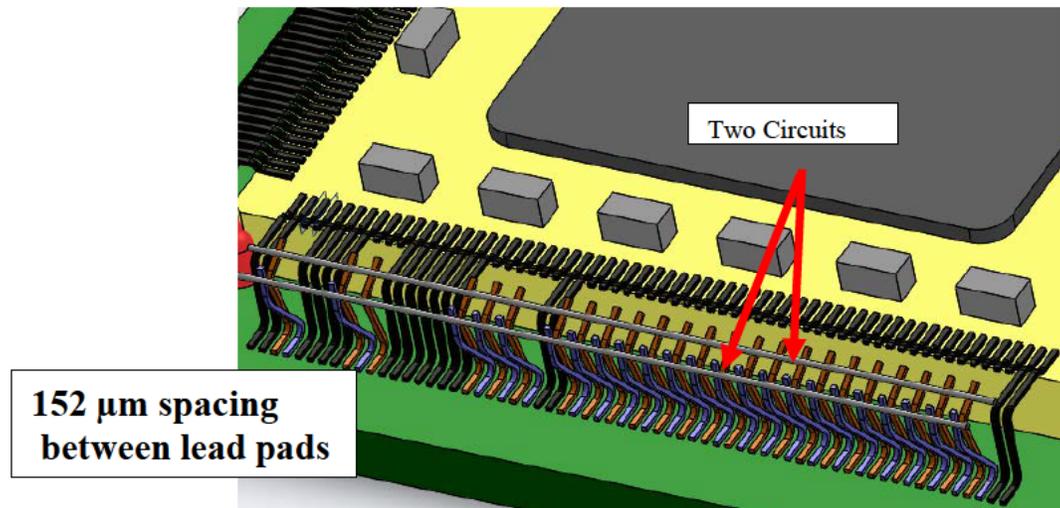
Evaluation and analysis – Dielectric Breakdown

- Test performed in accordance with IPC-TM-650, method 2.5.6.3
- Material data sheet: $4.7 \times 10E04$ V/mm (1200 V/mil)
- Results: $0.8 - 1.1 \times 10E04$ V/mm (215 V/mil to 277 V/mil). Orders of magnitude greater than typical voltages on the pins.
- No control sample was used. Results indicated electrical breakdown between adjacent conductors and led us to CAF and cleanliness testing.
