# Investigation of Pad Cratering in Large Flip-Chip BGA using Acoustic Emission

Anurag Bansal, Cherif Guirguis and Kuo-Chuan Liu  
Cisco Systems, Inc.,  
San Jose, CA  
anurbans@cisco.com

Electronics assemblies with large flip-chip BGA packages can be prone to either pad cratering or brittle intermetallic (IMC) failures under excessive PCB bending. Pad cratering cracks are not detected by electrical testing or non-destructive inspection methods, yet they pose a long term reliability risk since the cracks may propagate under subsequent loads to cause electrical failure. Since the initiation of pad cratering does not result in an instantaneous electrical signature, detecting the onset of this failure has been challenging. An acoustic emission methodology was recently developed by the authors to detect the onset of pad cratering [1, 2]. The instantaneous release of elastic energy associated with the initiation of an internal crack, i.e., Acoustic Emission (AE), can be monitored to accurately determine the onset of both pad cratering and brittle intermetallic (IMC) failures.

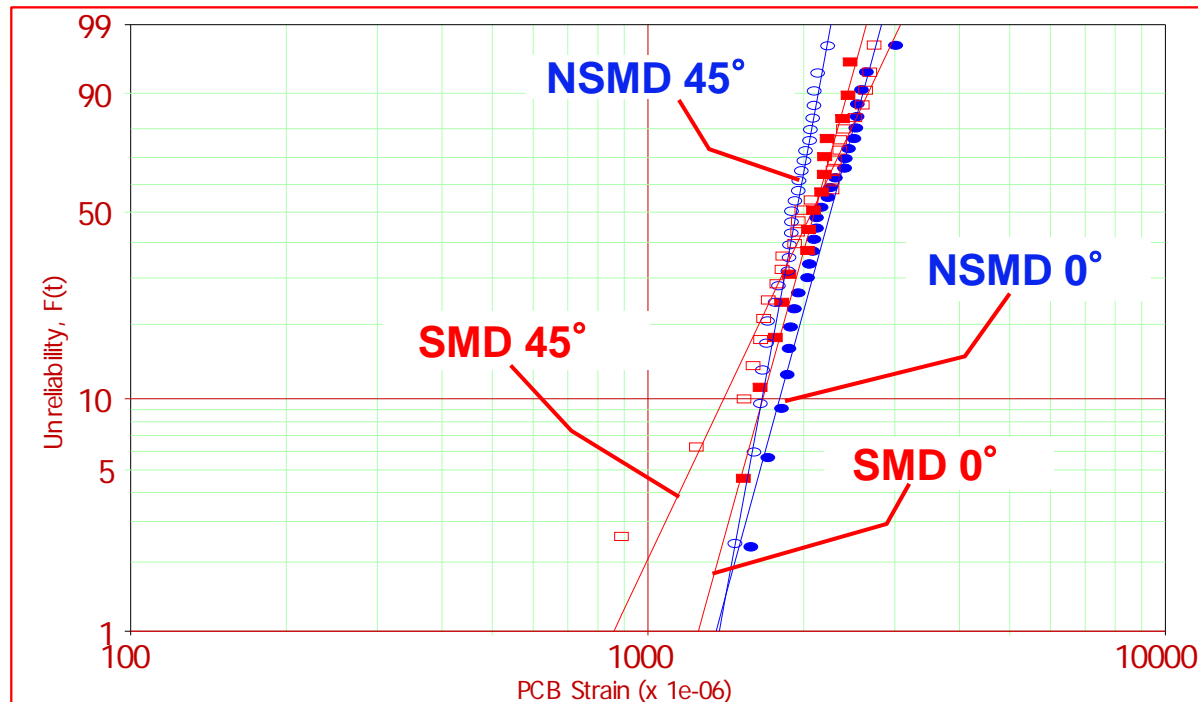
# What's the Allowable Strain Limit?

For Pad Cratering failure,  $\epsilon_{\max} = 1250$

For IMC Brittle Fracture,  $\epsilon_{\max} = 860$
