# Drop Test Performance of A Medium Complexity Lead-Free Board After Assembly and Rework

P. Snugovsky, J. Bragg, E. Kosiba, M. Thomson, B. Lee, R. Brush, S. Subramaniam, M. Romansky  
Celestica International Inc.

# Drop Testing of a Pb-Free Board After Assembly and SnPb-Rework

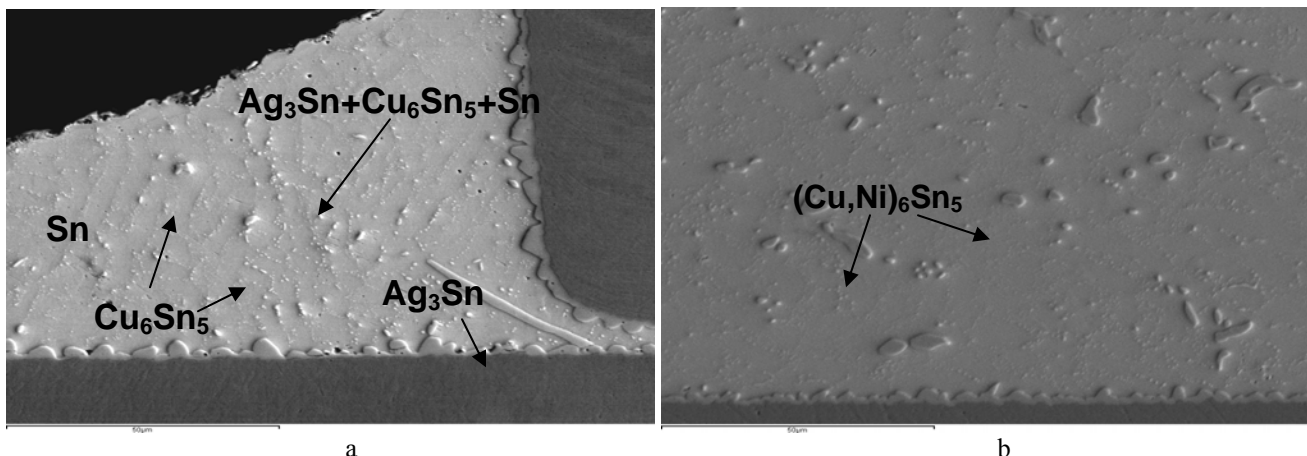
**Figure 5: Typical microstructure of SAC305 solder joints before rework, SEM 1000x: a-TQFP-144; b-TSOP-50**

Figure 5 shows the microstructure of Pb-free joints before rework. The joints consist of highly branched primary-like Sn dendrites, and  $\text{Ag}_3\text{Sn}+\text{Cu}_6\text{Sn}_5+\text{Sn}$  eutectic in interdendritic spaces and between the Sn dendrite arms. Both primary  $\text{Ag}_3\text{Sn}$  platelets and  $\text{Cu}_6\text{Sn}_5$  were identified by EDX in the TQFP-144 solder joints. Relatively small  $\text{Ag}_3\text{Sn}$  platelets were attached to the pad intermetallic layer. No  $\text{Ag}_3\text{Sn}$  primary platelets were detected in the TSOP-50 solder joints. The primary intermetallic particles in these joints were  $\text{Cu}_6\text{Sn}_5$  type that contained about 2% Ni and in some cases about 1% Fe. The sources of the Ni and Fe atoms were the Ni barrier layer and the Alloy 42 lead-frame material of the TSOP-50 components. The intermetallic formed between the Cu pads and solder in TQFP-144 and TSOP-50 was rather thin, 1.8 to 2.9 microns, and was of the  $\text{Cu}_6\text{Sn}_5$  type.

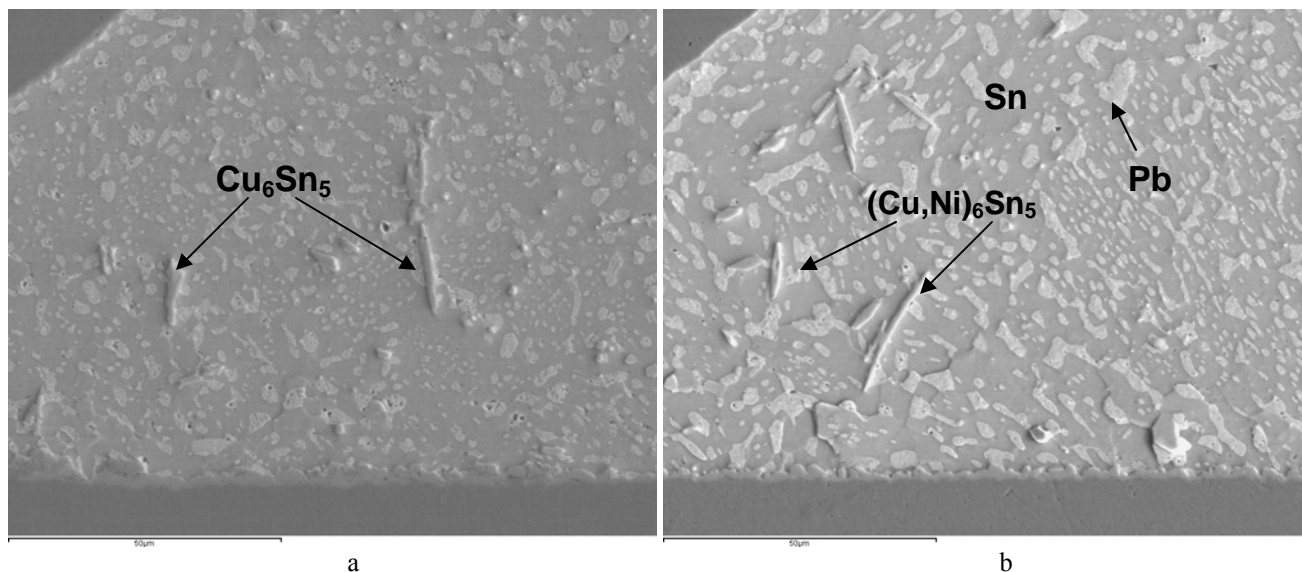
**Figure 6: Typical microstructure of 1X reworked solder joints using SnPb solder, SEM, 1000X: a – TQFP-144; b – TSOP-50**

The Pb-free leaded components were reworked with SnPb solder. As expected, the SnPb microstructures of all reworked joints were quite different from that of the as-assembled Pb-free parts. After 1X rework the joints had a SnPb eutectic structure with some primary intermetallic crystals (Figure 6). EDX analysis showed that these intermetallic particles were of the  $\text{Cu}_6\text{Sn}_5$  type. Some joints also contained some Ni, particularly in the TSOP-50. The number of the primary intermetallic crystals was lower in the QFP-20 reworked joints than in the TQFP-144 and TSOP-50.

A significant portion of primary intermetallic solidifies first, followed by the SnPb eutectic and depends on the primary SAC305 alloy composition. The reason for such a significant shift in composition was found in our previous study on ball grid array component rework [4]. During the pad redress step, most of the Pb-free solder left after component removal was consumed by using a Cu solder wick. The rest of the solder was heavily enriched with intermetallic particles. This remaining solder then mixed with the eutectic SnPb alloy used for rework. The excessive intermetallic particles caused a shift in SnPb solder composition from the near eutectic to off-eutectic.

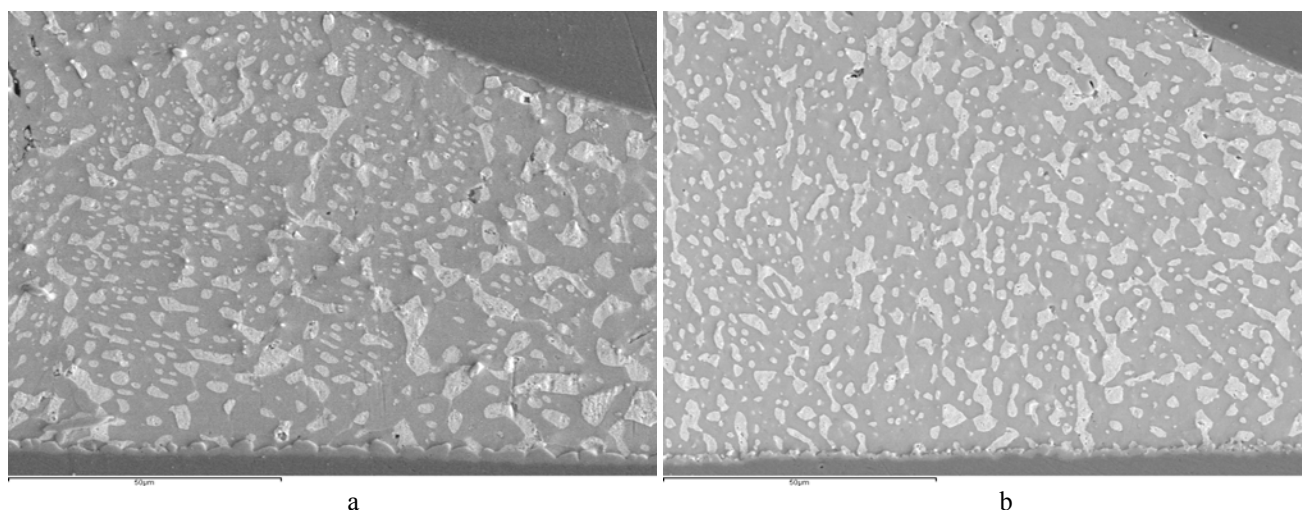
**Figure 7: Typical microstructure of 2X reworked solder joints using SnPb solder, SEM, 1000X: a – TQFP-144; b – TSOP-50**

After 2X rework, the solder joint microstructure looks like that of a conventional SnPb interconnect - there are no large primary  $\text{Cu}_6\text{Sn}_5$  crystals present in the solder joint (Figure 7)

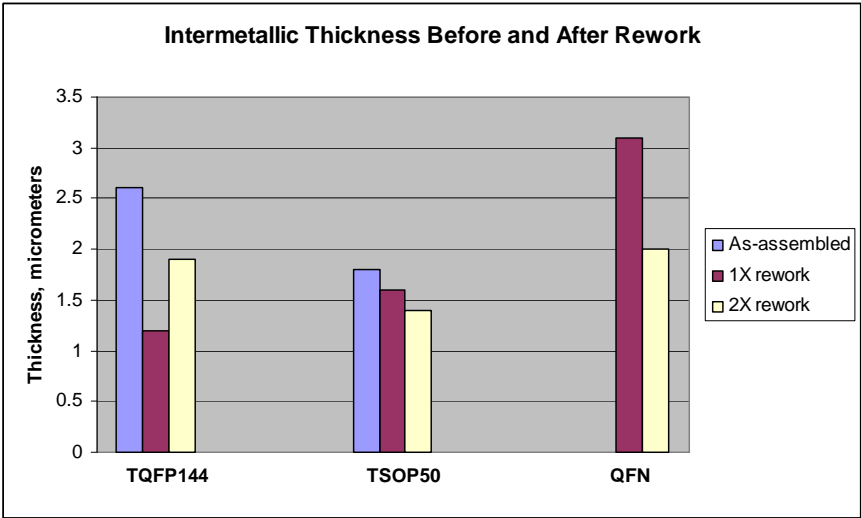
Figure 8: Intermetallic thickness before and after rework.

The intermetallic layer formed between the Cu pads and solder in reworked SnPb joints was thinner than in SAC305 as-assembled joints (Figure 8). In the TSOP-50 and QFN-20 it was even thinner after 2X rework. Such a phenomenon was observed by the authors previously and may be explained by dissolution of the intermetallic layer in a fresh solder placed during rework. However, this thickness of intermetallic should not affect the quality or reliability of the solder joints.

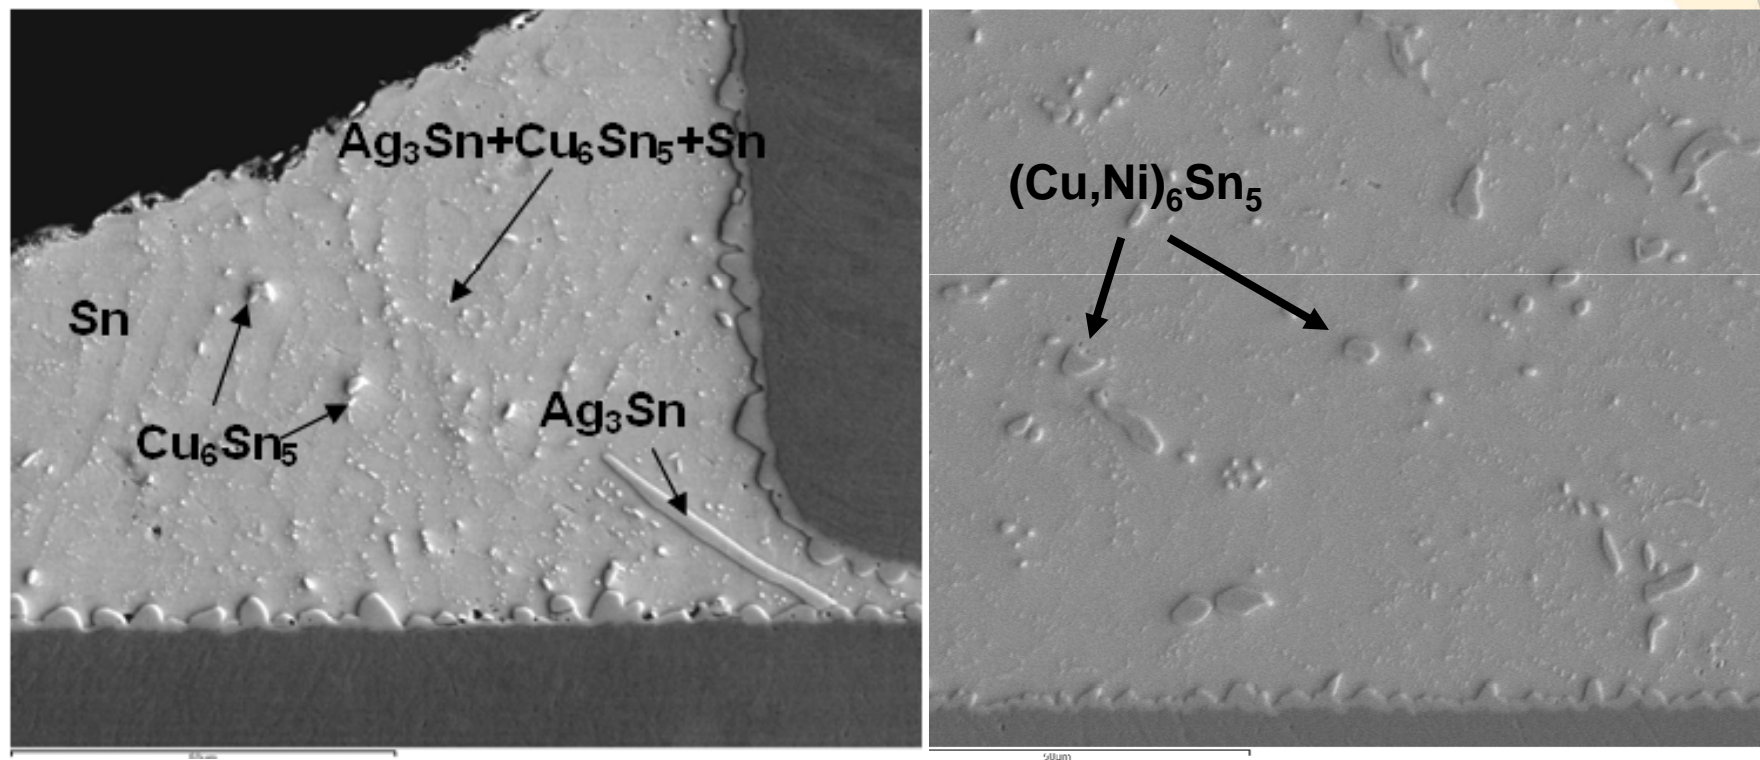
Microstructure of SAC305 solder joints before rework (SEM 1000x)  
LHS = TQFP (Cu), RHS = TSOP (alloy 42)

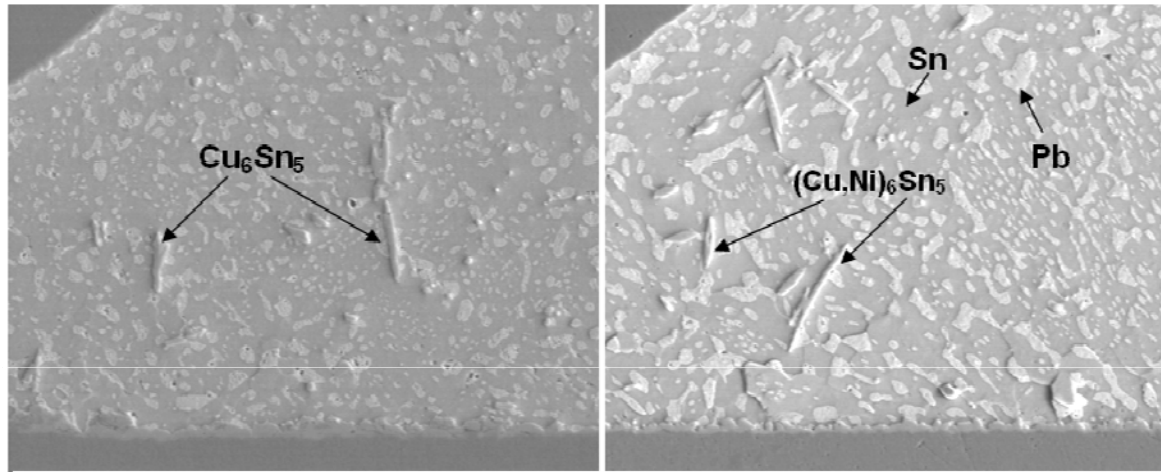
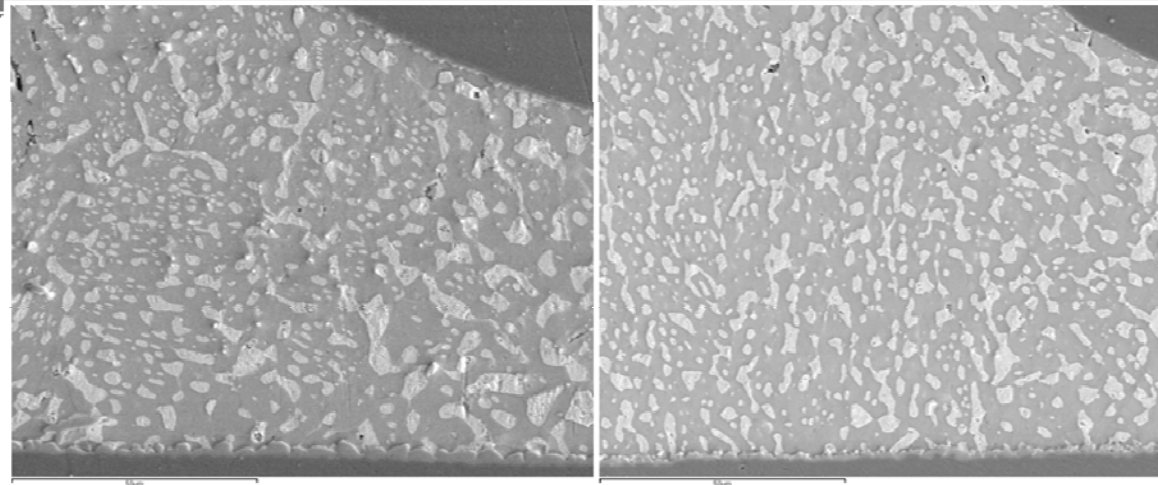
Microstructure of SAC 305 reworked using SnPb solder (SEM, 1000x)  
LHS = TQFP (Cu), RHS = TSOP (alloy 42)
