“Metal Whiskers”

Does Surface Contamination Have an Effect of Whisker Formation?

Terry Munson / Paco Solis
Foresite Inc.
Kokomo Indiana

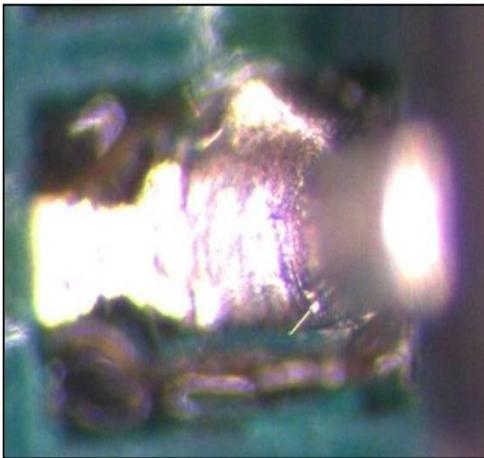
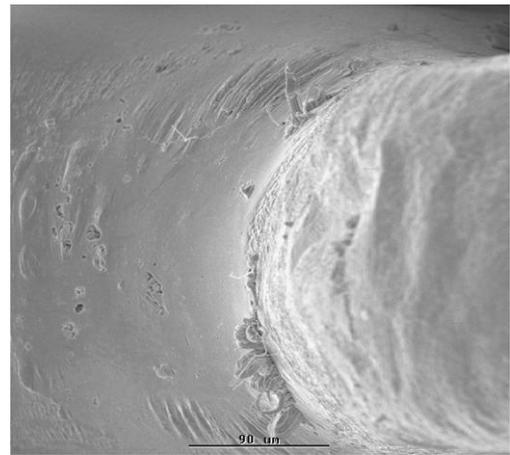
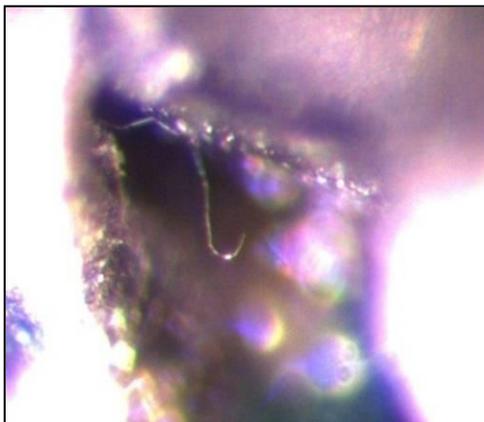
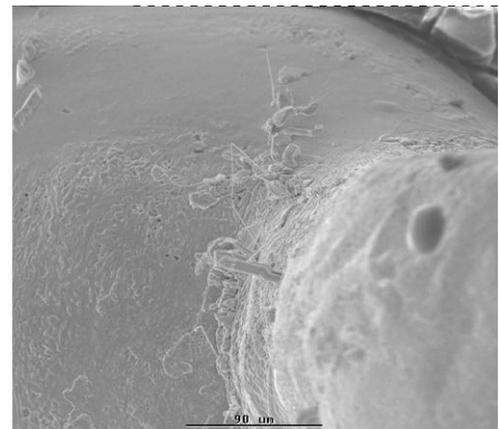
The ion chromatography data below shows high Chloride, sulfate, and Ammonia contaminations coinciding with the highest occurrences and density of whisker growth (shown in red).

- Localized D.I. steam cleaning with a saponifier has proven effective at preventing reoccurrences when total ionic contamination has been reduced.
- Inversely - areas doped with high levels of ionic contamination show a significantly higher occurrence of whisker formations.

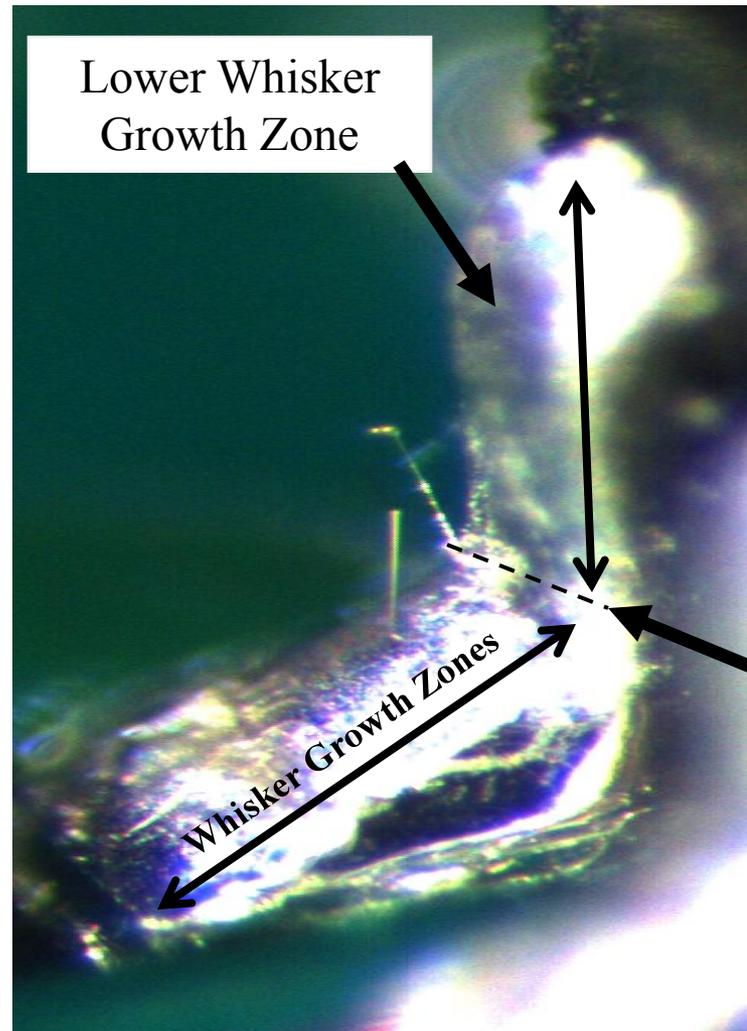
Gull Wing Lead

SEM Image – Top end of reflow zone

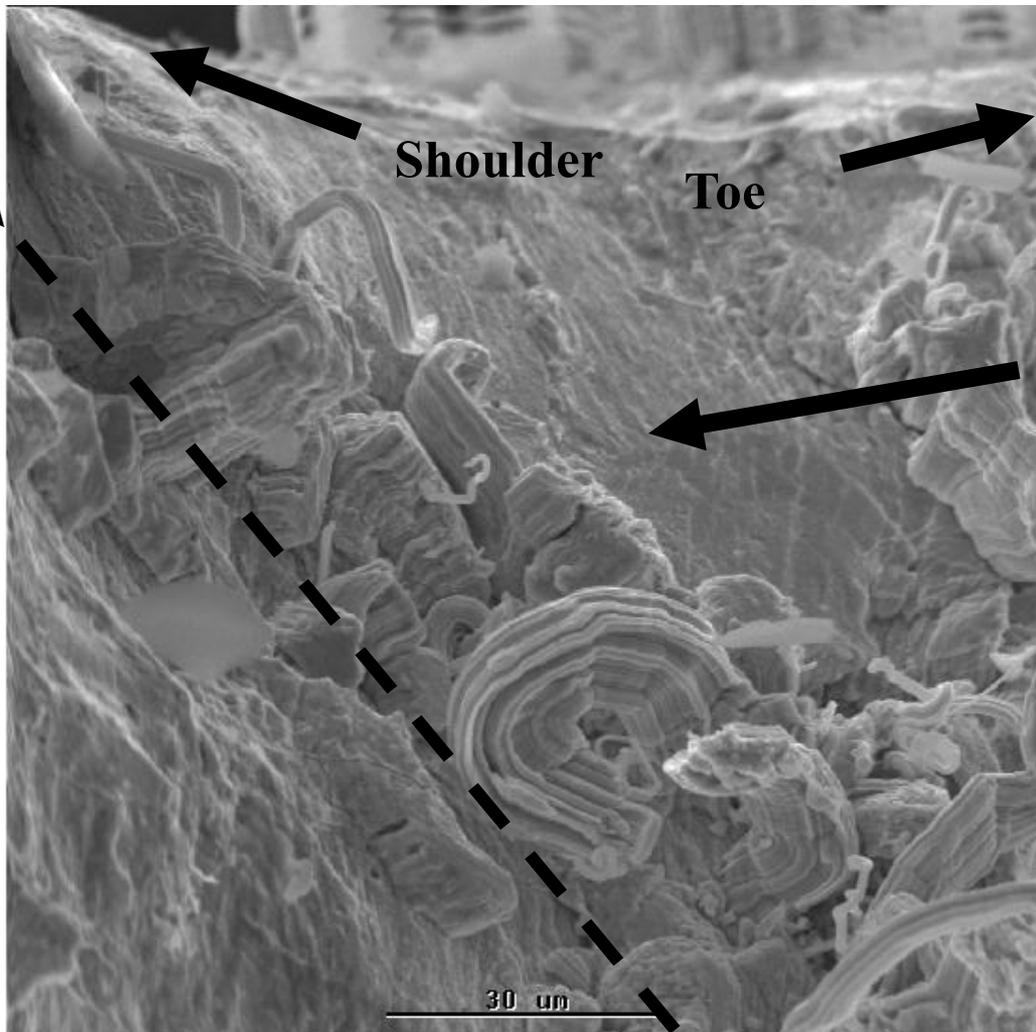
Flux Line

During reflow, high concentrations of flux residues flow up the termination and accumulate at the gull wing bend. Although solder reflow occurs from toe to shoulder, the flux accumulation settles at the lead bend. A second item noted was the discovery of nano-whiskers which form from the flux line extending over 200 μm in serpentine length and under 1 μm in width.

Flux Flow up
Termination

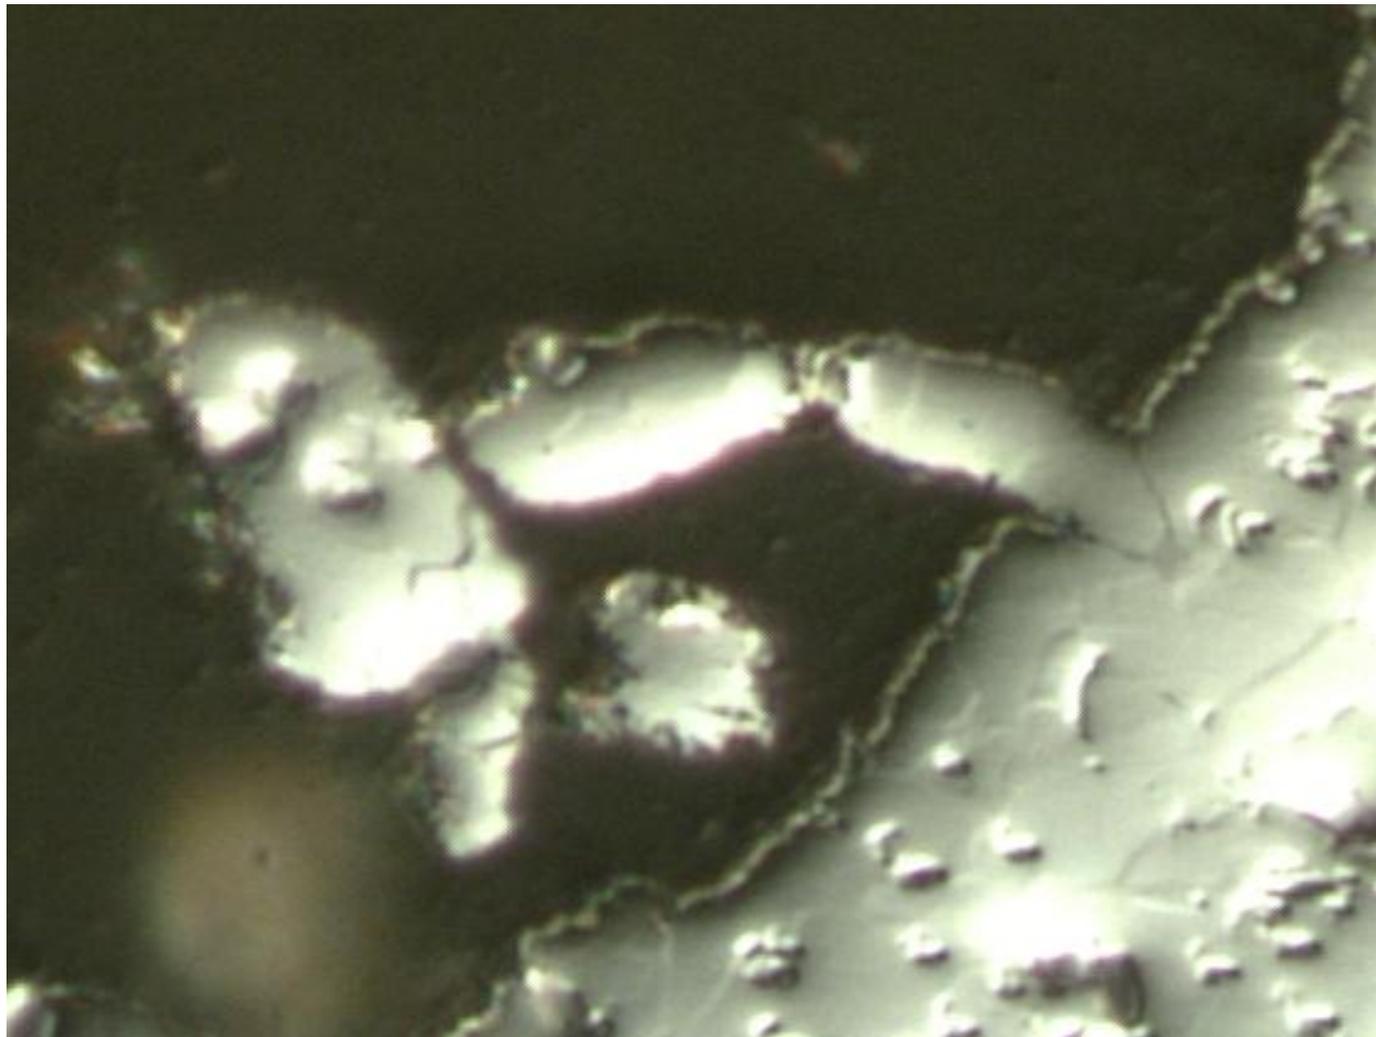
Cross-section at 1000X

In cross-section a single grain dislocation can be seen at the whisker extrusion site. More samples like these are needed to further study this condition. This sample was prepared with pH 9 gamma colloidal silica slurry for grain delineation. The sample was unfortunately compromised before it was submitted to SEM analysis.

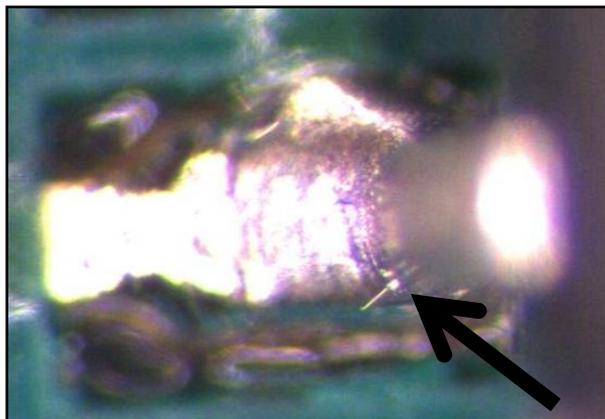
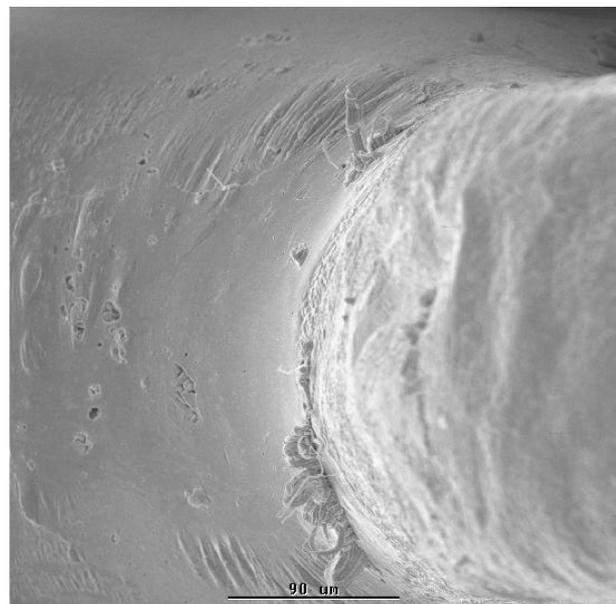
Case History #2 Data

all values are in ug/in2		Ion Chromatography			
Sample Area	Location	Chloride	Sulfate	Ammonia	WOA
Assembly "X"					
Area #1 SOT	Via	3.91	2.04	0	0
	Pads	4.11	1.47	2.34	21.02
	Component	2.14	0.24	1.21	11.74
Area #2 SOT	Via	4.15	1.68	0	0
	Pads	3.98	0.74	0	12.36
	Component	1.41	0.11	0	8.69
Area #3 SMT Resistor	pads	2.11	1.69	0	17.95
	component	1.79	0.47	0	4.75
Area #4 14 pin Dip	Via	3.14	2.11	0	0
	Pads	2.47	0.67	0	22.61
	Component	2.04	0	0	9.17
Reference area 8 pin DIP	Via	3.77	1.21	0	0
	Pads	2.11	0.69	0.47	15.42
	Component	1.36	0	0.26	10.41
Reference Board	Board	1.79	1.02	1.01	10.63
no via area

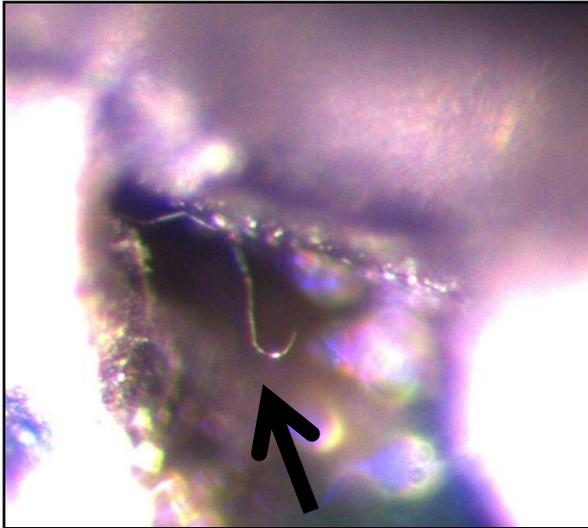
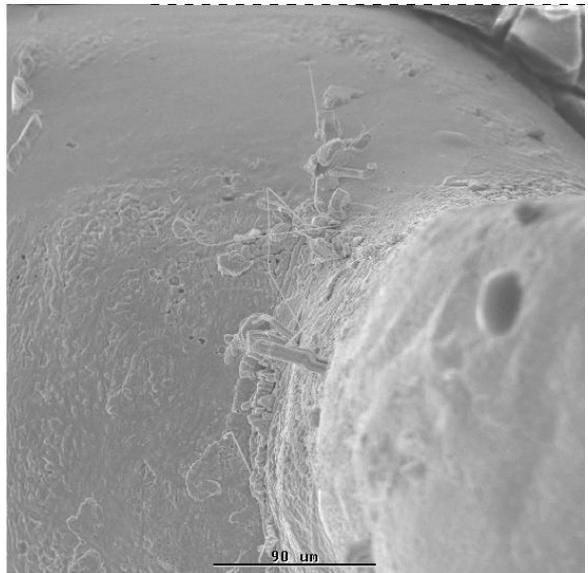
Case History #2 Data Con't

all values are in ug/in2		Ion Chromatography			
Sample Area	Location	Chloride	Sulfate	Ammonia	WOA
Assembly "Y"					
Area #1 SOT	Via	4.85	3.11	0	0
	Pads	3.98	2.74	2.32	24.36
	Component	1.24	0	3.11	19.54
Area #2 SOT	Via	1.22	1.44	0	0
	Pads	0.95	0.36	0	16.24
	Component	0.77	0	0	11.47
Area #3 SMT Resistor	pads	1.69	1.04	0	15.24
	component	1.55	0	0	6.96
Area #4 14 pin Dip	Via	1.05	0.77	0	0
	Pads	0.78	0.59	0.85	20.04
	Component	0.36	0	1.21	7.87
Refence 8 pin DIP	Via	2.04	1.11	0	0
	Pads	0.69	0.45	2.41	18.65
	Component	0.27	0	2.95	14.21
Reference Board	Board	1.24	0.14	1.02	14.25
no via area

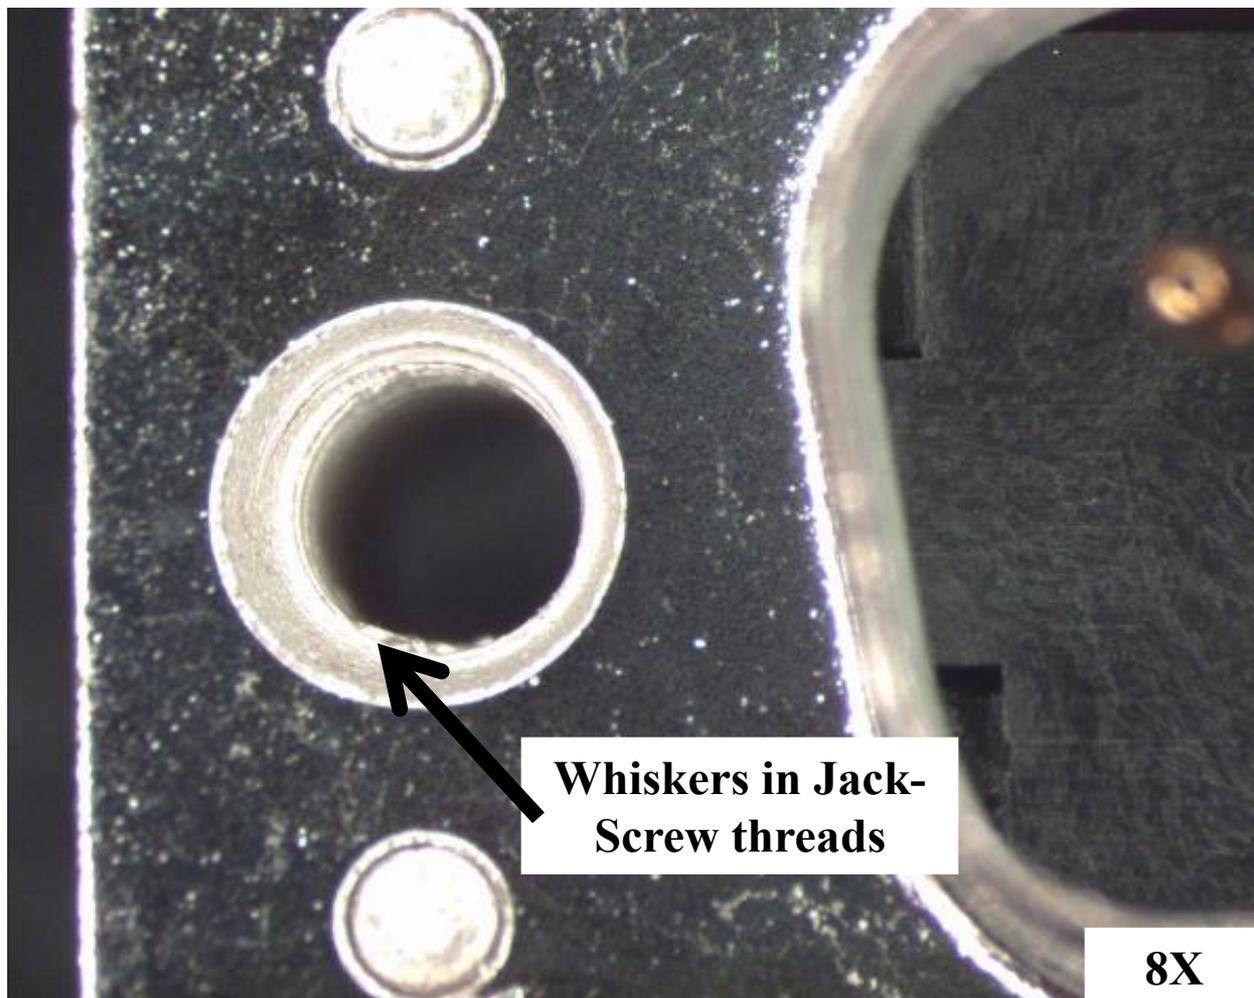
Ongoing Activity “D-Sub Connector”

Whiskers are forming in the jack screws of lead free connectors. Preliminary data has shown high levels of Chlorides, Sulfates, and Amines are present in the Jack Screws. Analysis is ongoing to study the contamination effects in these locations and the retardation effects of cleaning. Data on this analysis is will published in updates to this paper.

D-Sub Connector Sn Whiskers on Jack-Screw threads
