# IPC Electronics Midwest 2010

## Addressing the Challenge of Head-in-Pillow Defects in Electronics Assembly

# Solder Sphere Head-In-Pillow

## **Causes & Solutions**

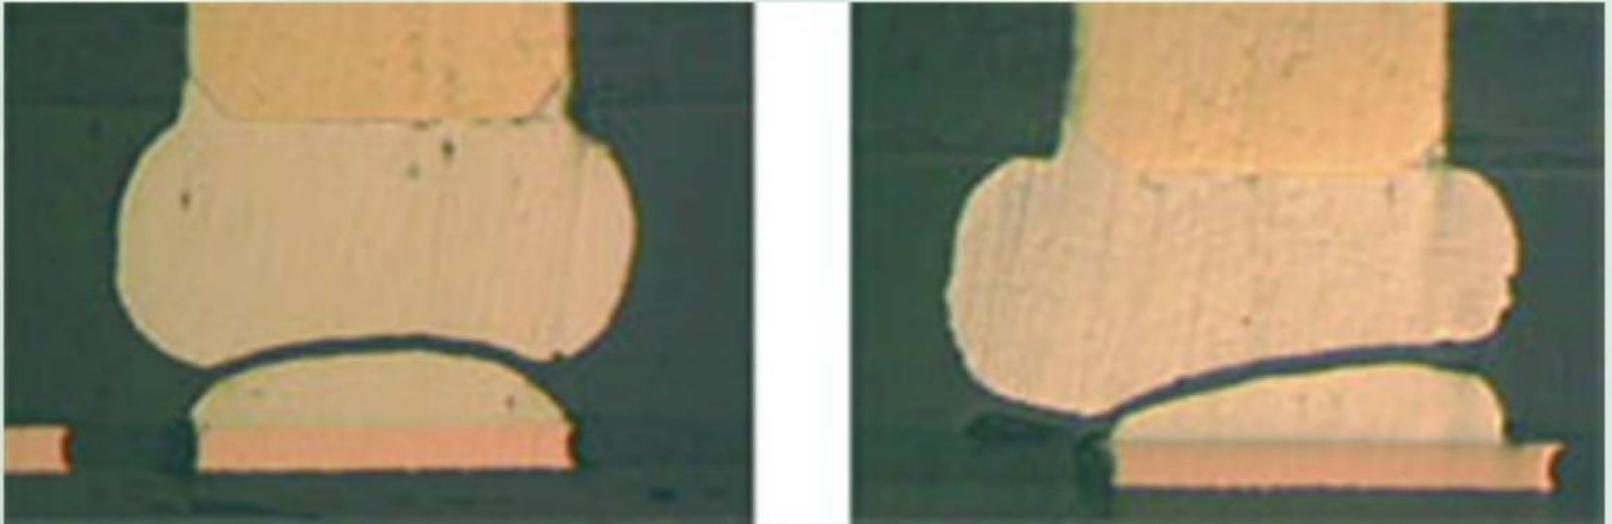
## ■ Type A - Poor Wetting (Random)

Source: Nikkei Electronics Asia (August 2006)

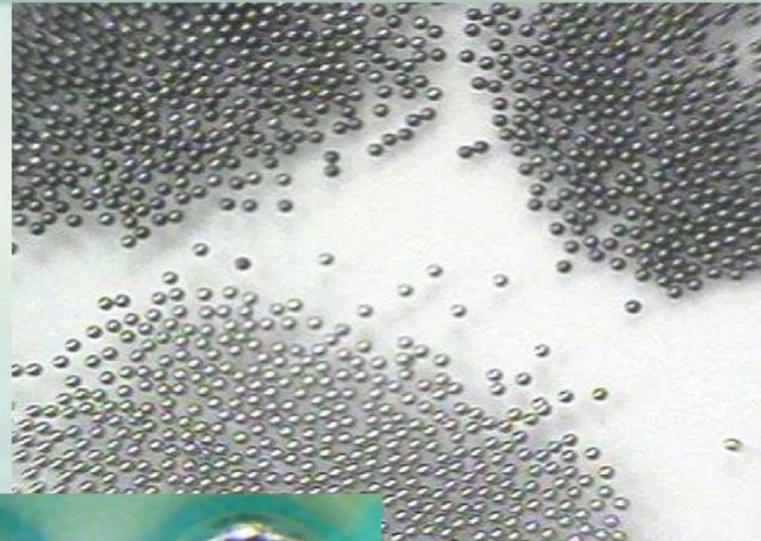
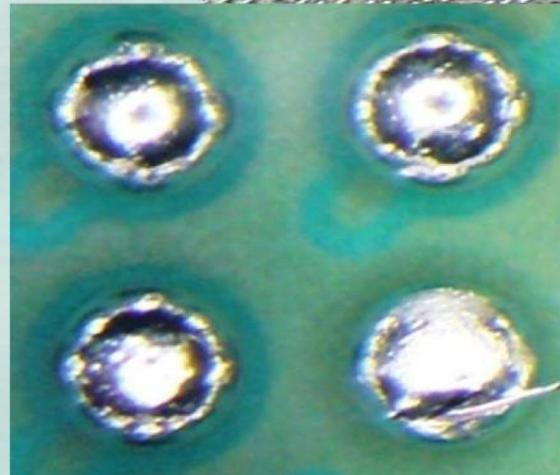
- Sphere Oxidation
  - Uncontrolled manufacturing
  - Packaging
  - Storage
- Silver Segregation
  - Cases seen as high as 36% silver content at the surface.
  - Silver tailing
- Beyond Indium's control

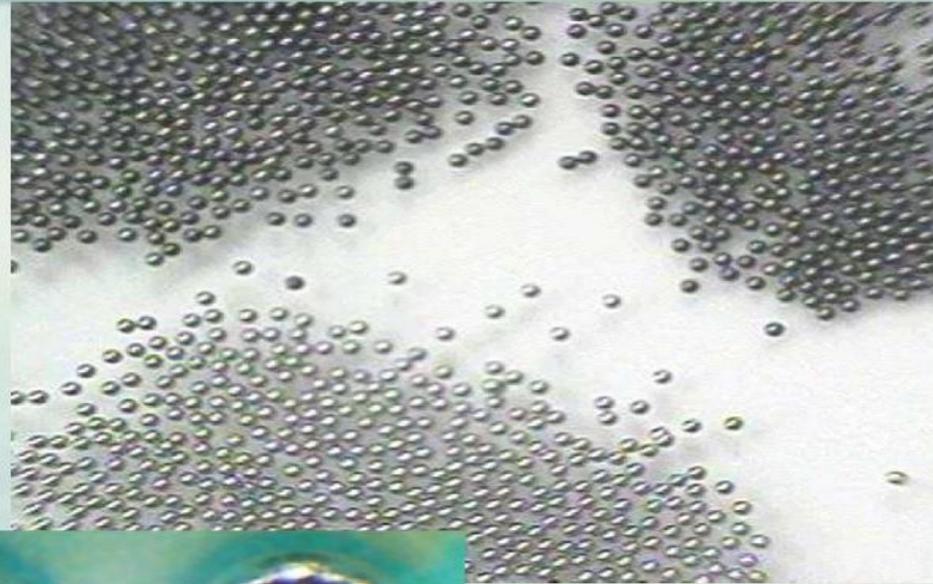
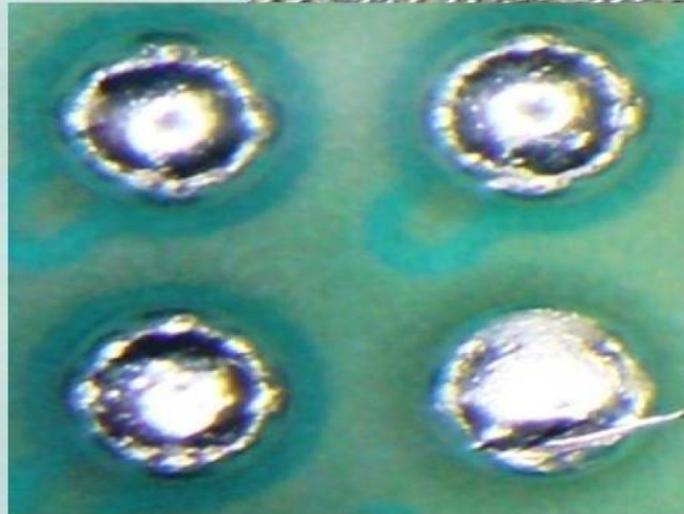
- **Printing**
  - Registration accuracy
  - Improper printer setup
  - Stencil Design
- **Placement**
  - Off pad
  - Out of plane
  - Pressure
- **Reflow**
  - Warpage
  - Flux exhaustion

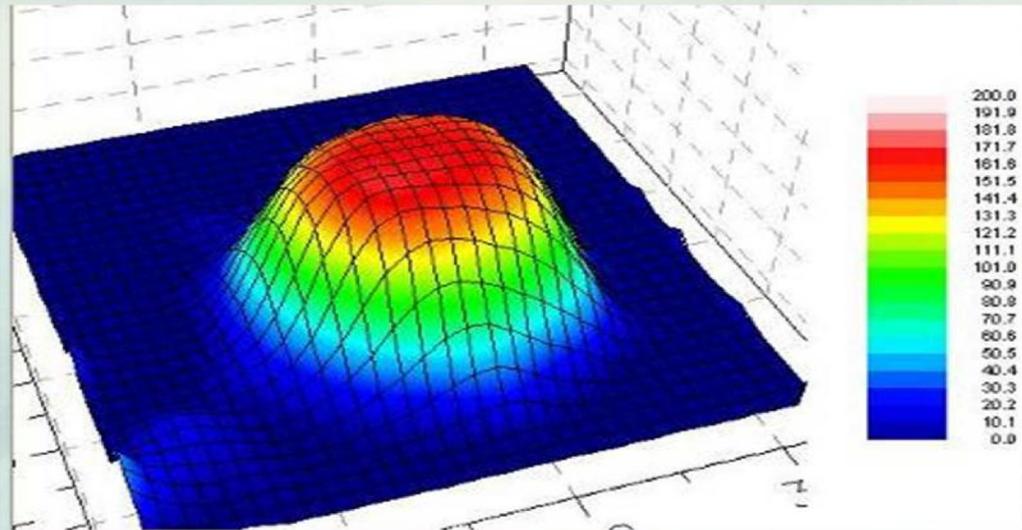
- Poor transfer efficiency
- Insufficient oxidation barrier
- Low stability

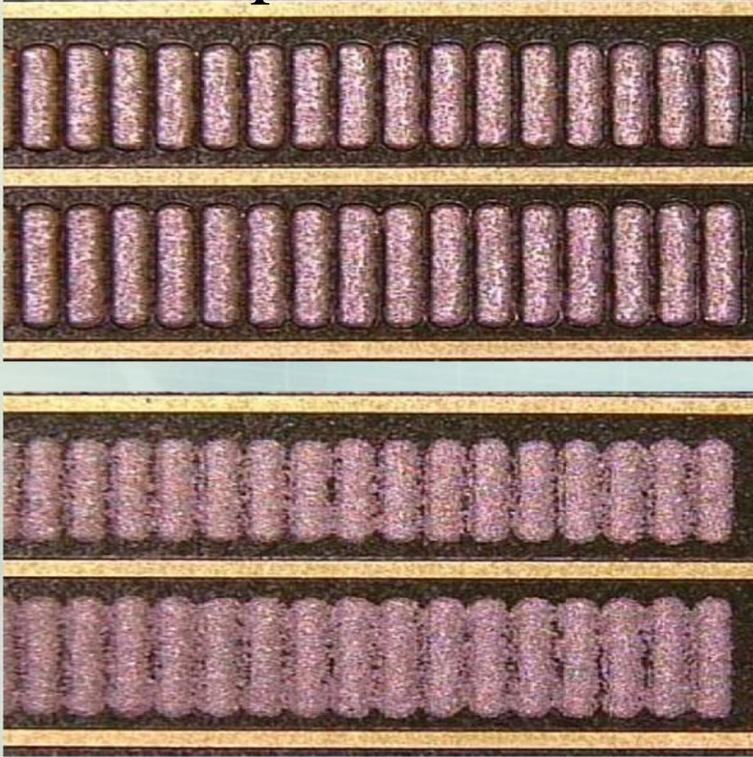
## Slump Resistance

Fresh

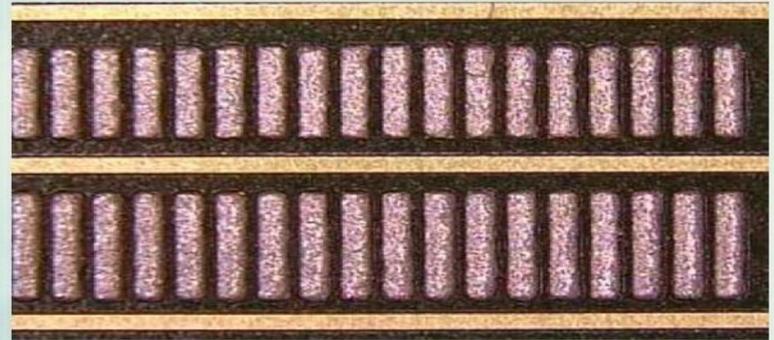
Hot Slump  
180° C

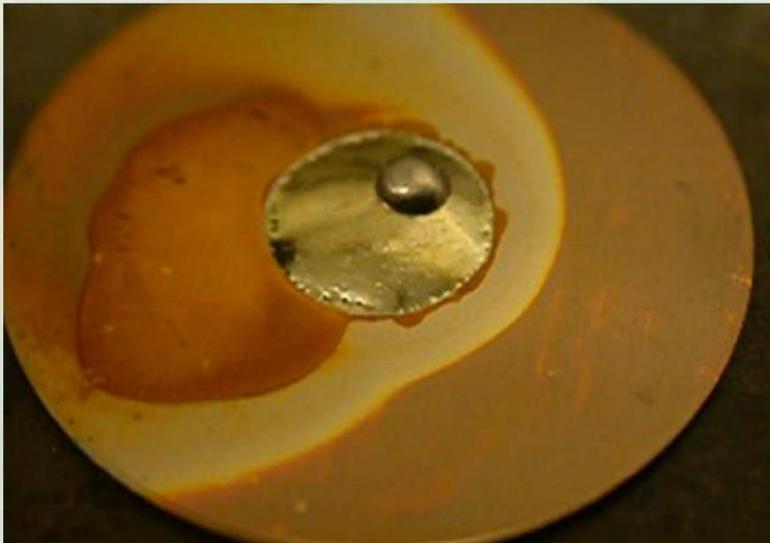
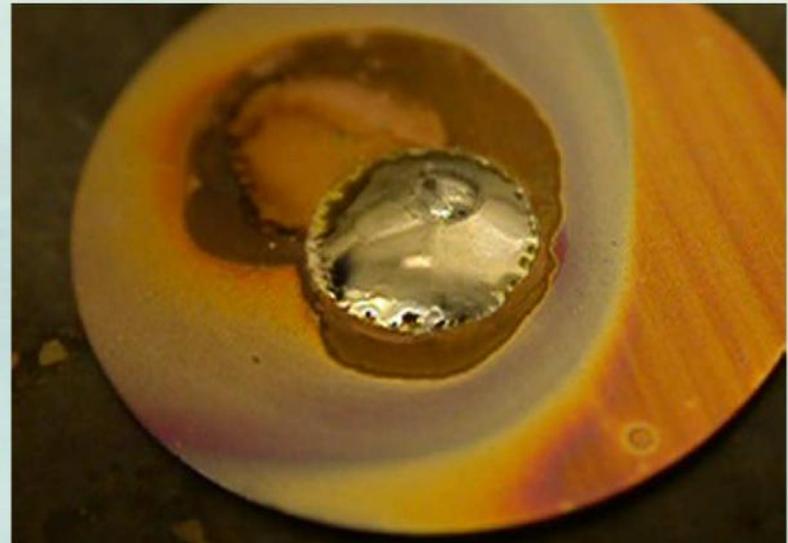
## Oxidation Resistance Testing

- 90s Time above liquidus (TAL)
- 25°C above liquidus
- Sn/Pb and SAC alloy
- SAC sphere

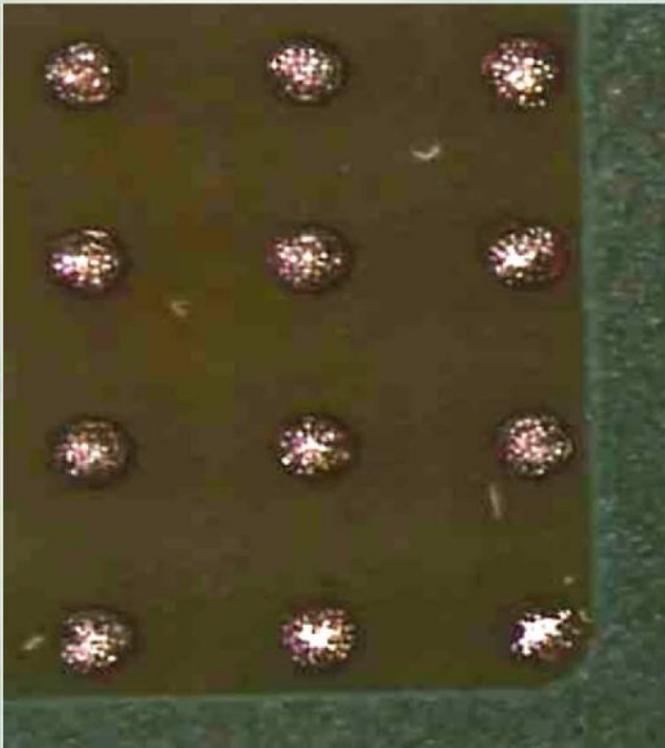
Good Solder Joint

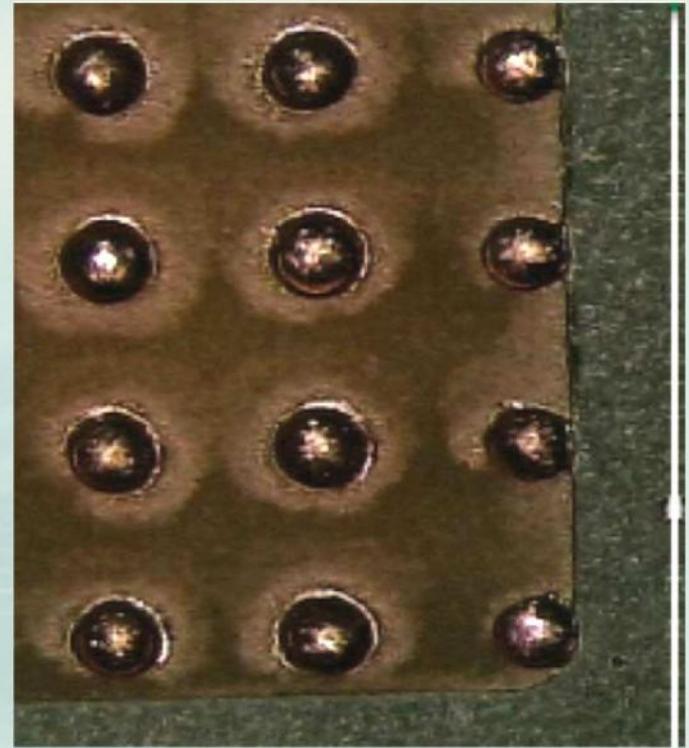
Graping

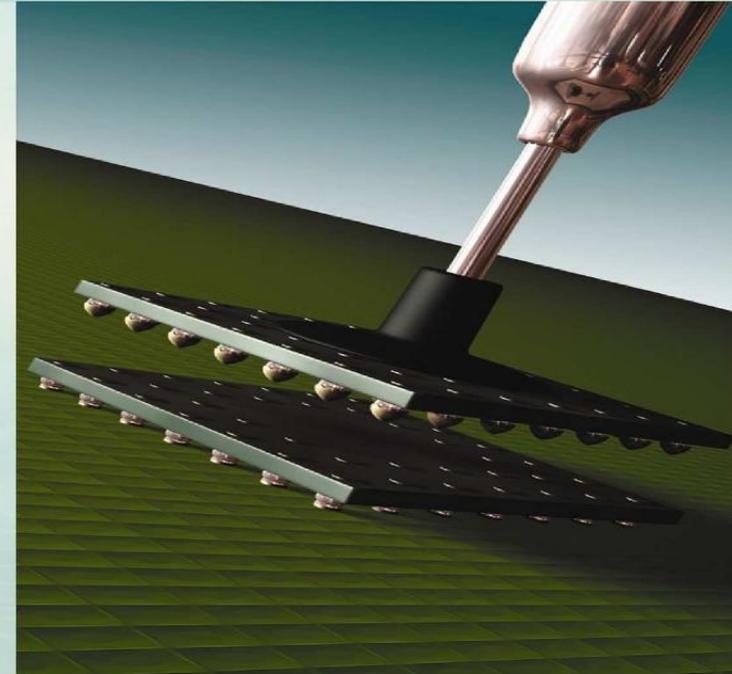
## Dipping process (flux or paste)

- Flux
  - Increases activity
  - Extra oxidation barrier
- Paste
  - Type 5
  - Metal load
  - Flux rheology
- Flux or paste can also be rework

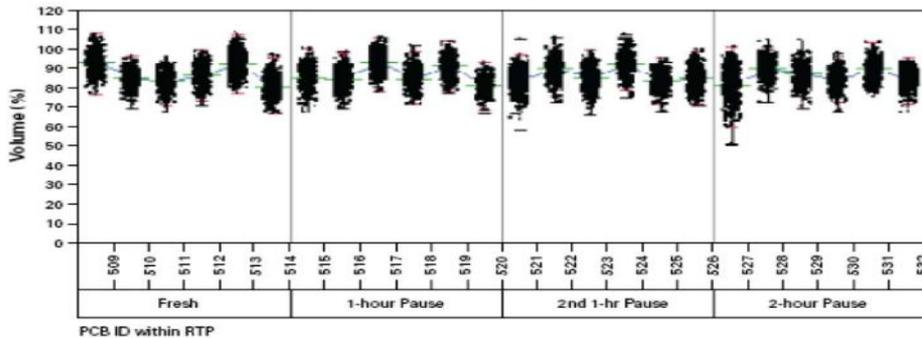
**12-mil Round Apertures**  
5-mil Laser cut Electropolished stencil  
100mm/sec

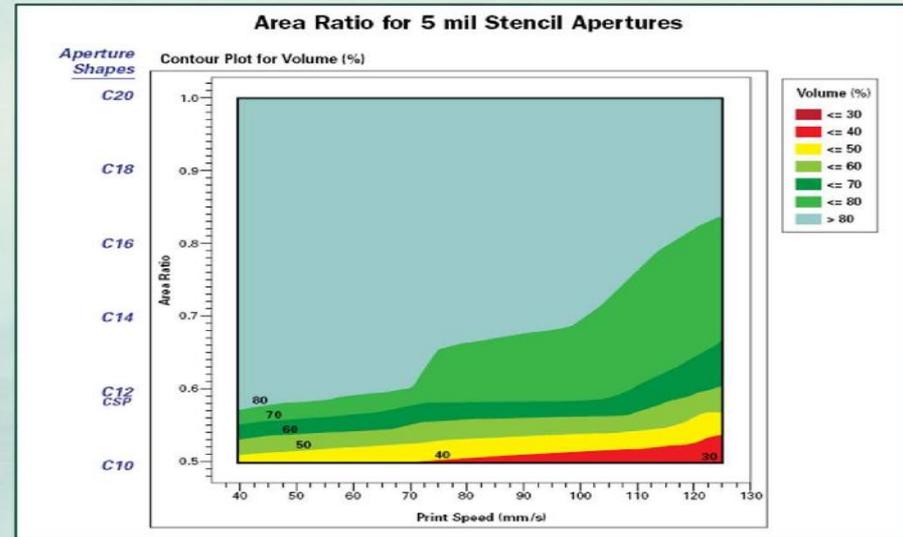
## Transfer Efficiency (Volume%):
