THE INFLUENCE OF THE PWB FABRICATION/ELECTRODEPOSITION PROCESS ON COPPER EROSION DURING WAVE SOLDERING

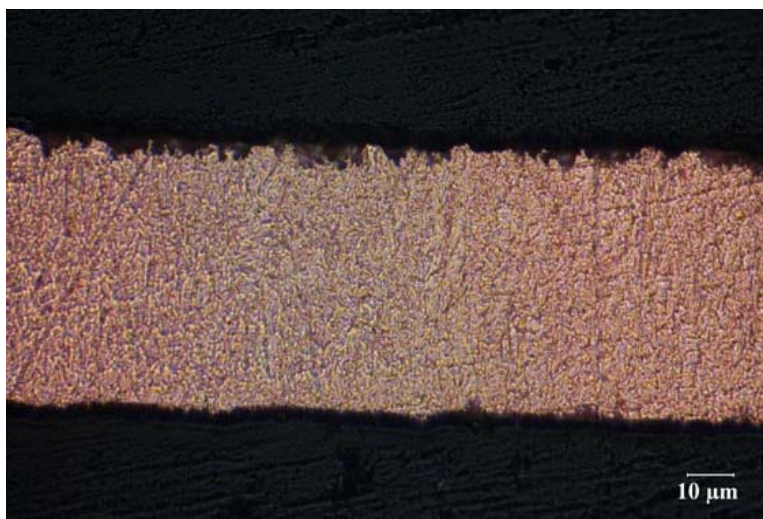
Sample D

Erosion rate: 0.88 u/sec Total copper loss (20 sec): 18 u

UTS: 215 MPa Elongation: 14.5%

Erosion Rank: 3 (medium)

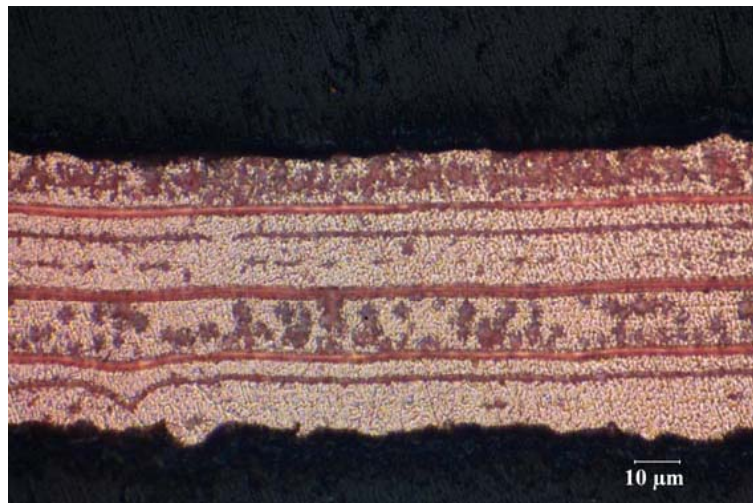
UTS: 293 MPa Elongation: 14.02 %

Erosion Ranking: 4 (high)

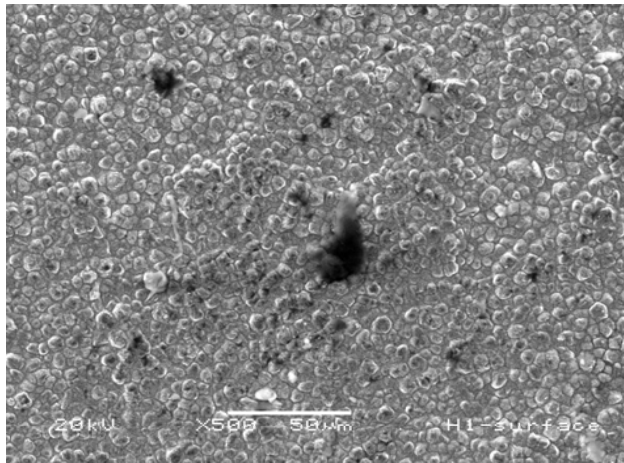
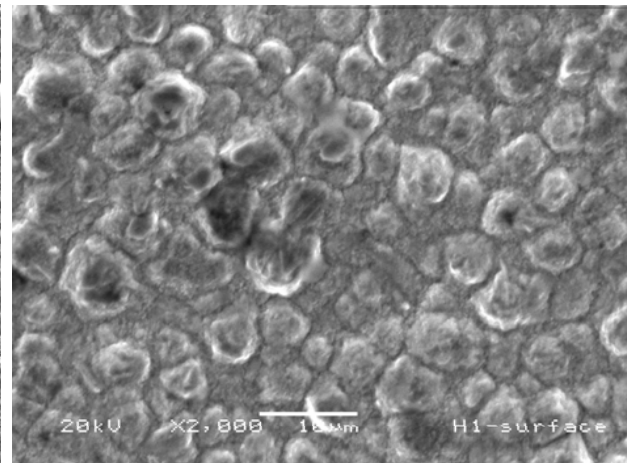
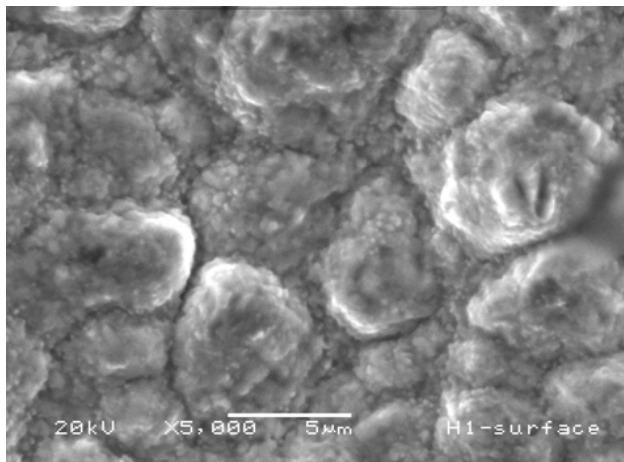
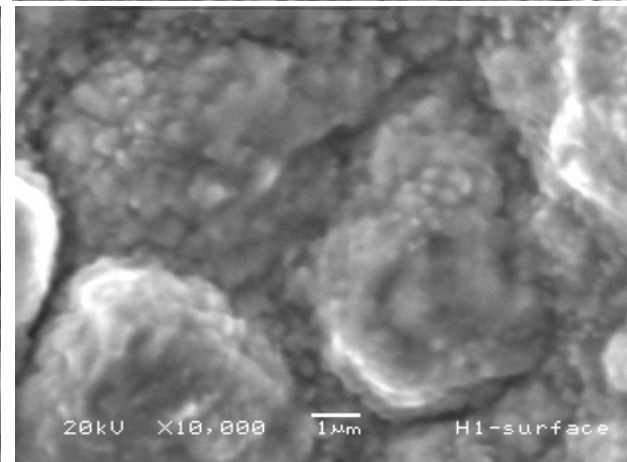
Sample H Surface

Erosion rate: 0.76 u/sec Total copper loss (20 sec): 15 u

UTS: 241 MPa Elongation: 22.6%

Erosion Rank: 2 (low)
