Lead Free Flip Chip and Chip Scale Package Inspection: New Challenges Will Require New Inspection Technologies

Mark Cannon and Juergen Friedrich
ERSA GmbH
Wertheim, Germany

By Mark Cannon
President and Chief Operating Officer
ERSA GmbH

APEX 2005

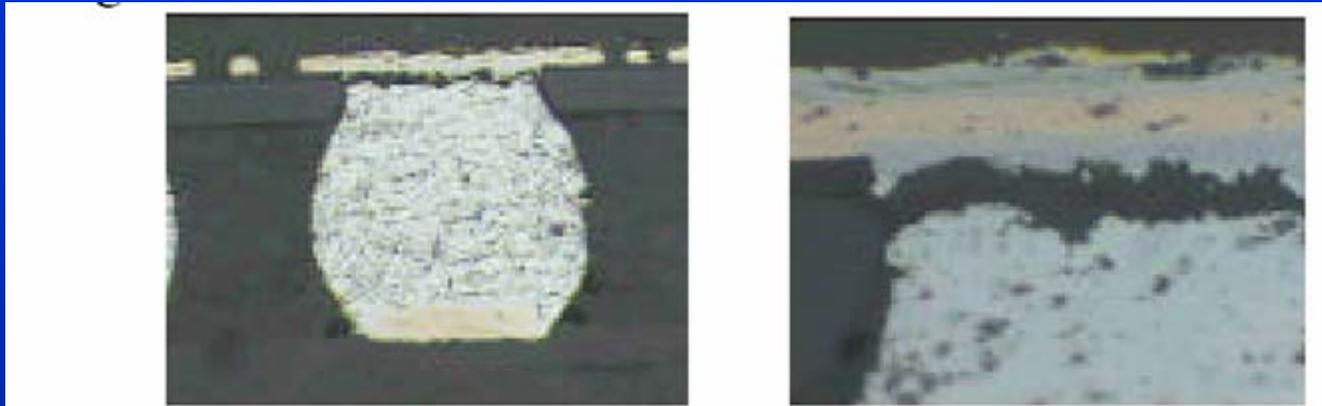
Figure 2: Typical failed SnAgCu solder joint cross-section.

“In all cases reported here, the solder joints failed at package interface. Figure 2 shows a typical cross-section of failed joint showing crack very close to intermetallic on package side.”

In a more recent publication, “Accumulated Creep Strain and Energy Density Based Thermal Fatigue Life Prediction Models for SnAgCu Solder Joints”, Mr. Ahmer Syed further underscored this problem: “In all cases reported here, the solder joints failed at package interface. Figure 2 shows a typical cross-section of failed joint showing crack very close to intermetallic on package side.” Figure 2 from that reference is reproduced below as Figure 12.

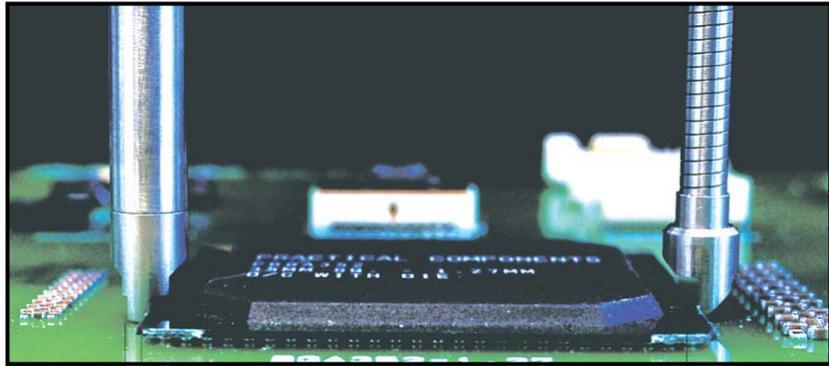
Original Optical Head

Flip Chip Inspection: Original vs. New Optical System
