## Paste Inspection Study

Stig Oresjo  
Agilent Technologies  
Loveland, CO

Vishal Chatrath  
Nokia  
Oulu, Finland

### Abstract

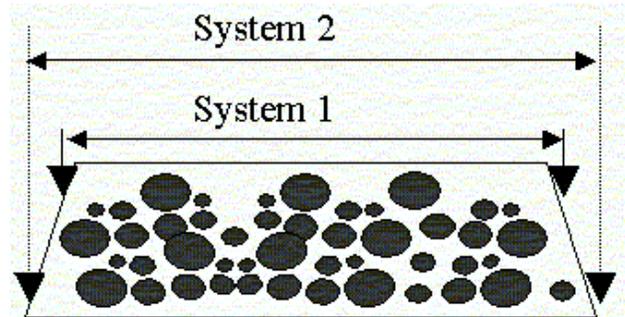
**Figure 1 - Why The Two Systems Have Small Discrepancies In Area Measurement**

study we were measuring solder paste height, area, and volume. The paste inspection system is measuring the metallic content, the flux, and the carrier content. The x-ray system is only measuring the metallic content of the paste. Therefore it should be expected that paste height and volume should be significantly lower reported by the x-ray system compared to the solder paste system. The area measurement should be similar but there is also one item that should be considered for small measurement discrepancies. This item is where the measurement system locks on when it is determining the slope of the solder paste. (See figure 1.) The key fact is that the solder paste brick does not have a vertical edge of 90 degrees. Instead it is more like a steep slope. Now one inspection system could “lock on” very deep on this slope, resulting in larger area measurements, while the other system can “lock on” almost at the top of the solder paste brick, resulting in smaller area measurements.

The AXI area measurements were slightly larger than the API area measurements but both Nokia and Agilent were both comfortable with this rather small discrepancy based on the explanation made above in the text and in Figure 1.

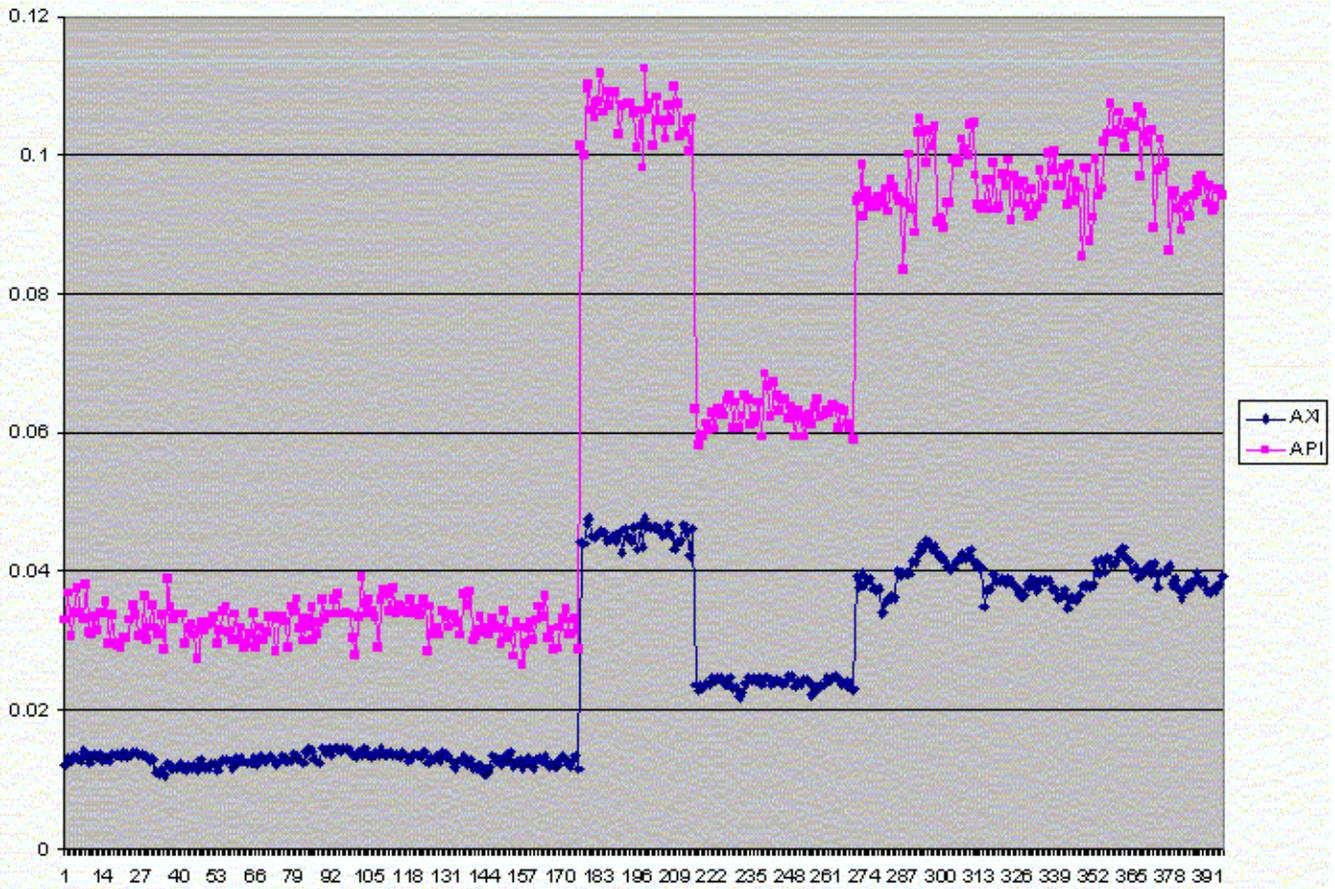
Figure 2 - Average Paste Volume (AXI Lower Curve, API Upper Curve) - Correlation between the Two Data Sets are 0.9915 - Pads Where Paste were Removed are Excluded

The volume measurement, Figure 2, by the x-ray system is significantly lower than what is measured by the paste inspection system. (Figures 2 to 5 are at the end of the paper.) This is to be expected as explained above. The overall correlation between the two systems was 0.9915, which indicates a very good correlation. (1 is perfect correlation and 0 is no correlation at all.) The pads with solder paste removed are shown as removed in Figure 2, and the resulting correlation number is presented. The height measurement was around 0.2 mm measured by the API system, which was to be expected since a 200-micron stencil was used. The AXI system measured the height to 0.05 mm and again a significantly lower height measurement is to be expected as explained above.

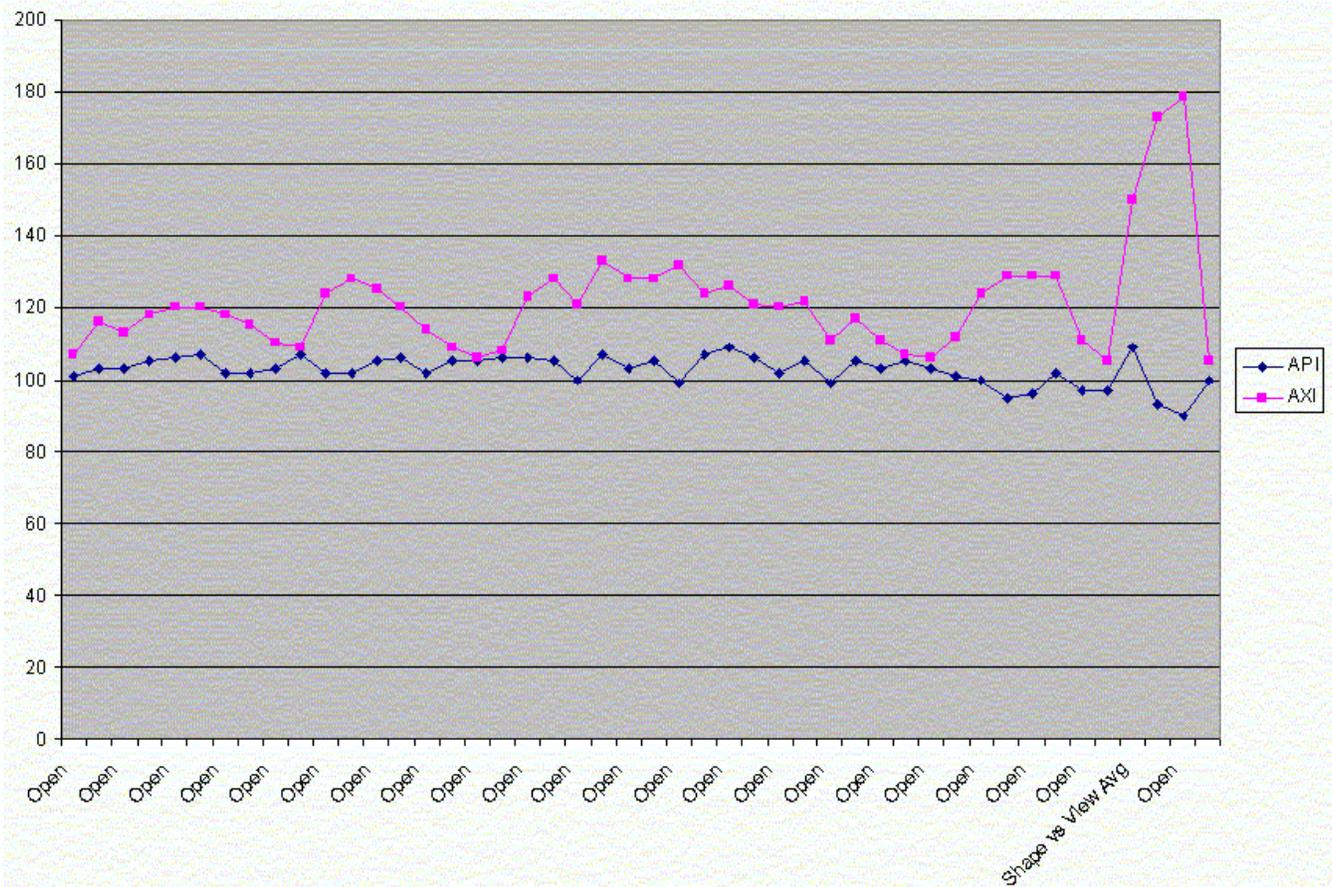
**Note that paste volume for all defects are over around 90%**

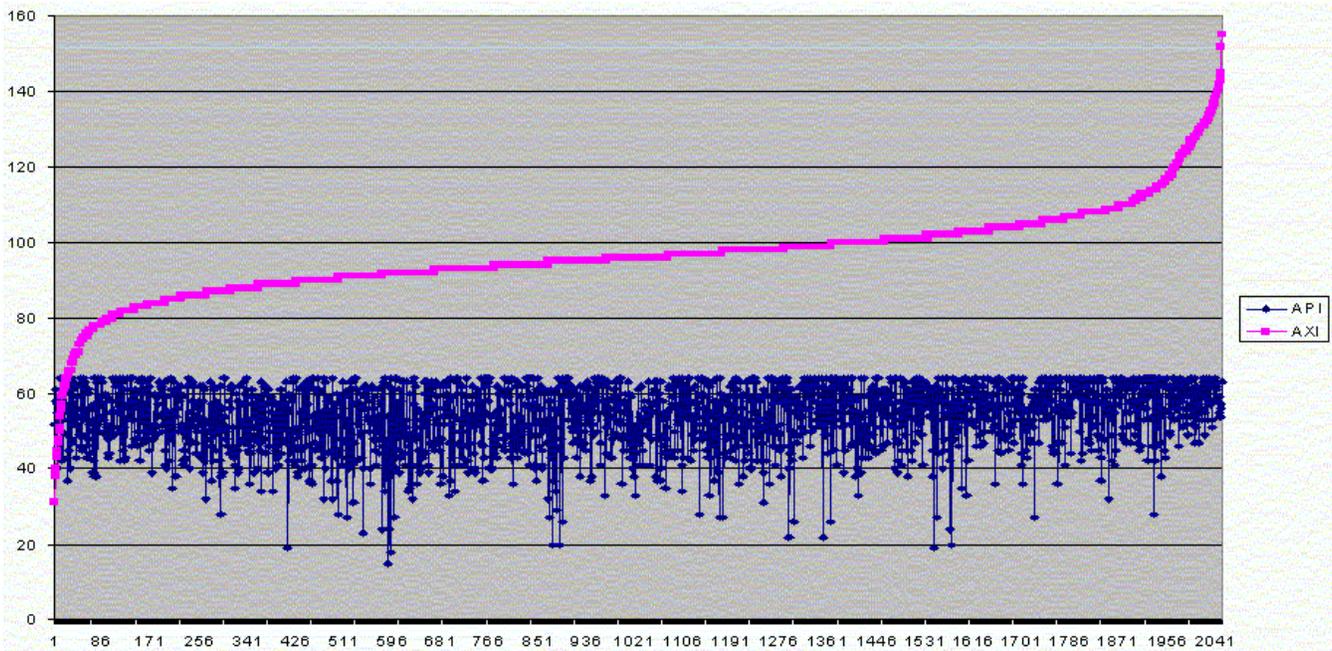
**Figure 5 - All 2,053 Pads with Paste Volume Under 65% - Data is Sorted in Increasing Solder Volume Measured at X-ray**

Figure 5 shows all of the 2,053 pads with paste volume below 65%. Average solder volume was also measured at the x-ray inspection. In this figure the pads / solder joints have been sorted by increasing solder volume measured at

x-ray. Note that there is very little correlation between the paste volume measured and solder volume after reflow. Since Agilent did the data analysis after leaving the Nokia test site, no additional measurements have been done to investigate this further. Also note in figure 5 that the paste volume for some pads were below 20%, but still resulted in good solder joints.
