IPC Workshop on Head-in-Pillow Defects December 9, 2010

Topic 1: Introduction to Head-in-Pillow Defects

Guhan Subbarayan PhD
Assembly Sciences and Technology Group
Manufacturing Operations
Cisco Systems Inc, San Jose, CA
[Email: gusubbar@cisco.com](mailto:gusubbar@cisco.com)

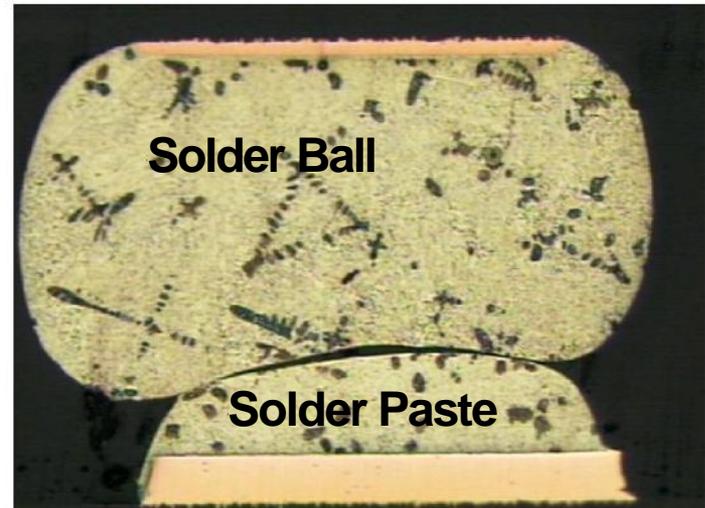
X-Section of a HiP Joint

UDefinition: Non-coalescence (Non wetting) between the solder ball and the solder paste during reflow process.

- Also referred to as “Ball and Socket” defect or “Head on Pillow Defect”.
- Not an “open” joint as there is weak intermittent contact.
- Occurs mostly on corner balls at low DPMO.

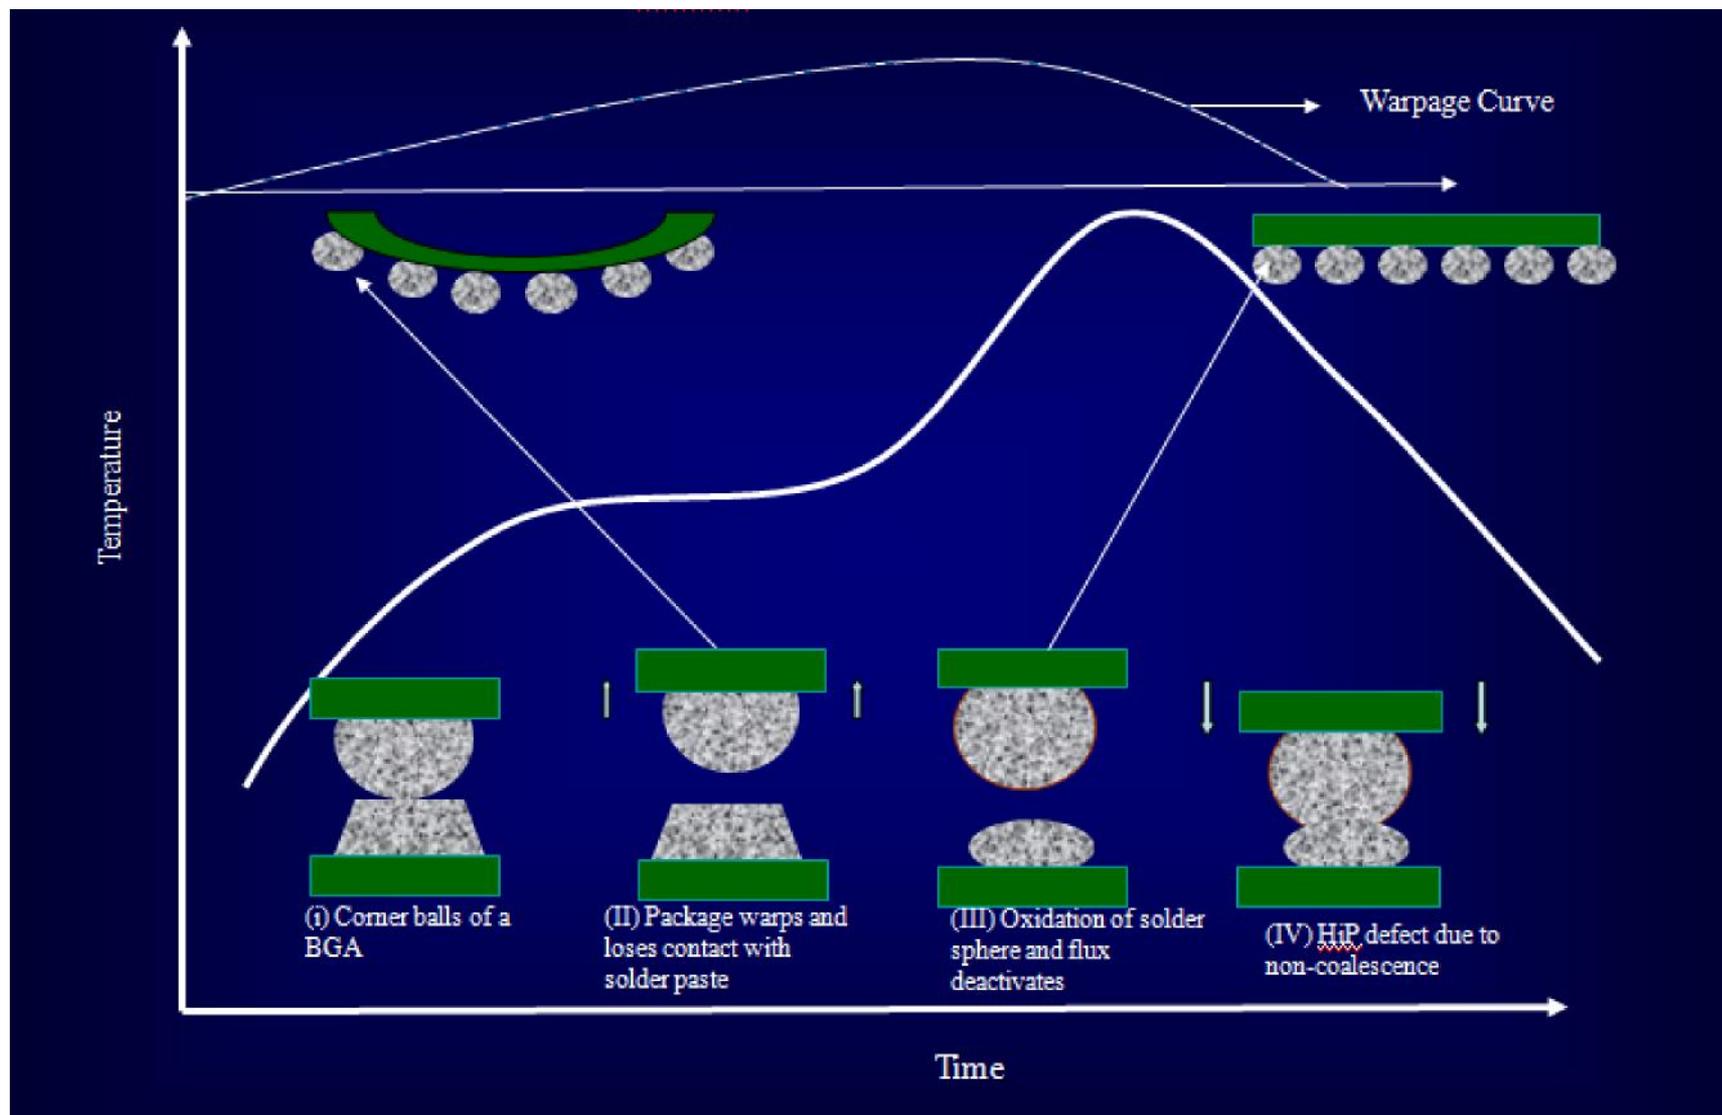
HiP Mechanism

UWarpage must occur during reflow process.

UThe ball has to reestablish contact again with the solder paste.

UFlux must be inactive or exhausted when solder ball makes contact with solder paste again.

UHiP occurs when there is no contact until the peak temperature but contact during cooling stage.

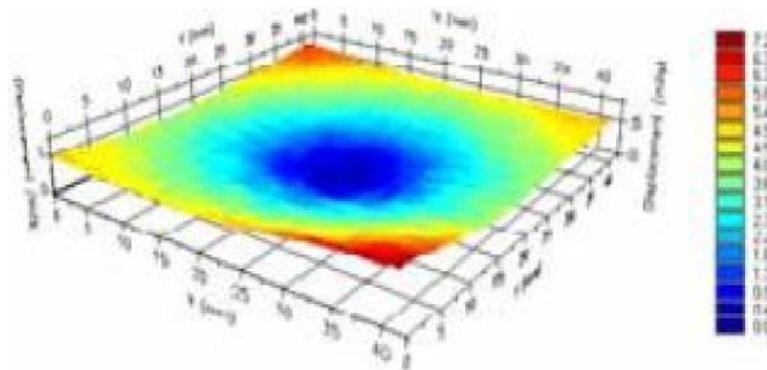
- Shadow Moire Interferometer is used to measure warpage at different points of the reflow process.
- Understanding warpage curve is important for mitigating HiP defects.
 - Flip chip packages usually have a concave shape initially and become convex at high temperature.
 - In these cases, HiP will occur at the corners.
- Timing of warpage is more critical than maximum initial warpage at room temperature.

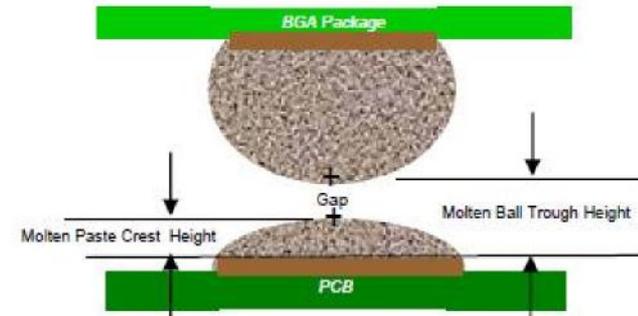
- Insufficient solder paste volume at corner balls.
 - Increasing paste volume at corner balls will increase the likelihood of the solder ball making contact with solder paste.

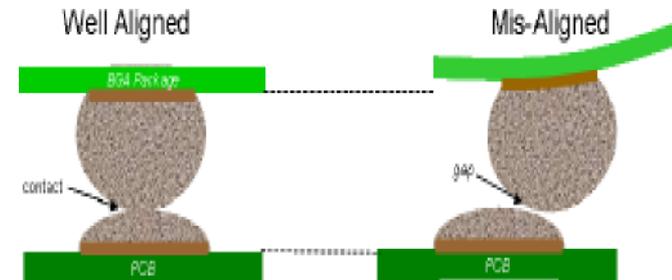
U Solder ball misalignment

- Misalignment alone would not cause HiP defects
- If there is significant warpage coupled with misalignment, a gap can be created between solder ball and solder paste.

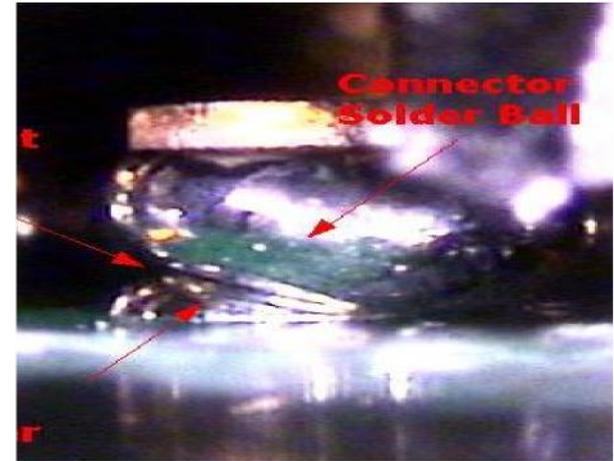
UOptical side view inspection

- Can only detect corner joints

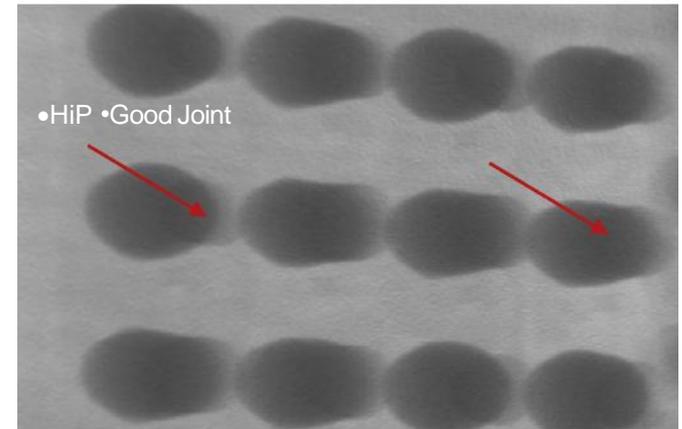
• 2D oblique X-ray inspection

- HiP joints show as clear separation between ball and paste
- Very tedious method

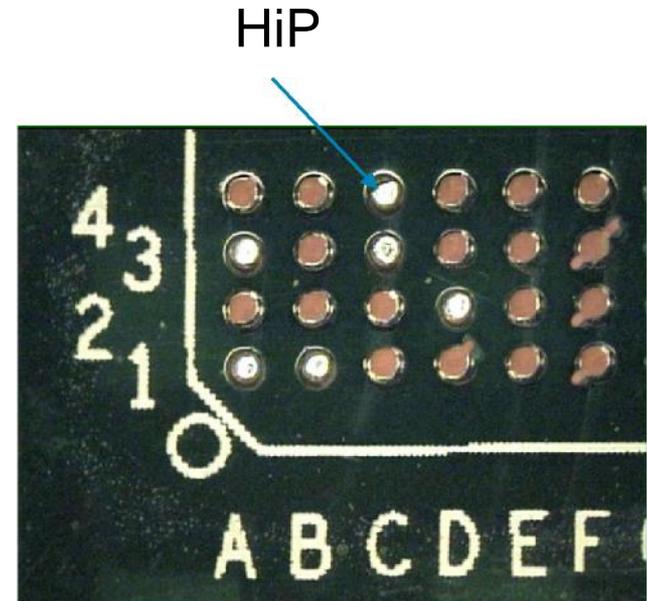
- Pry analysis
 - Destructive method
 - Small BGAs can be pryed using a screw driver.
 - HiP joint break at interface than at pads.

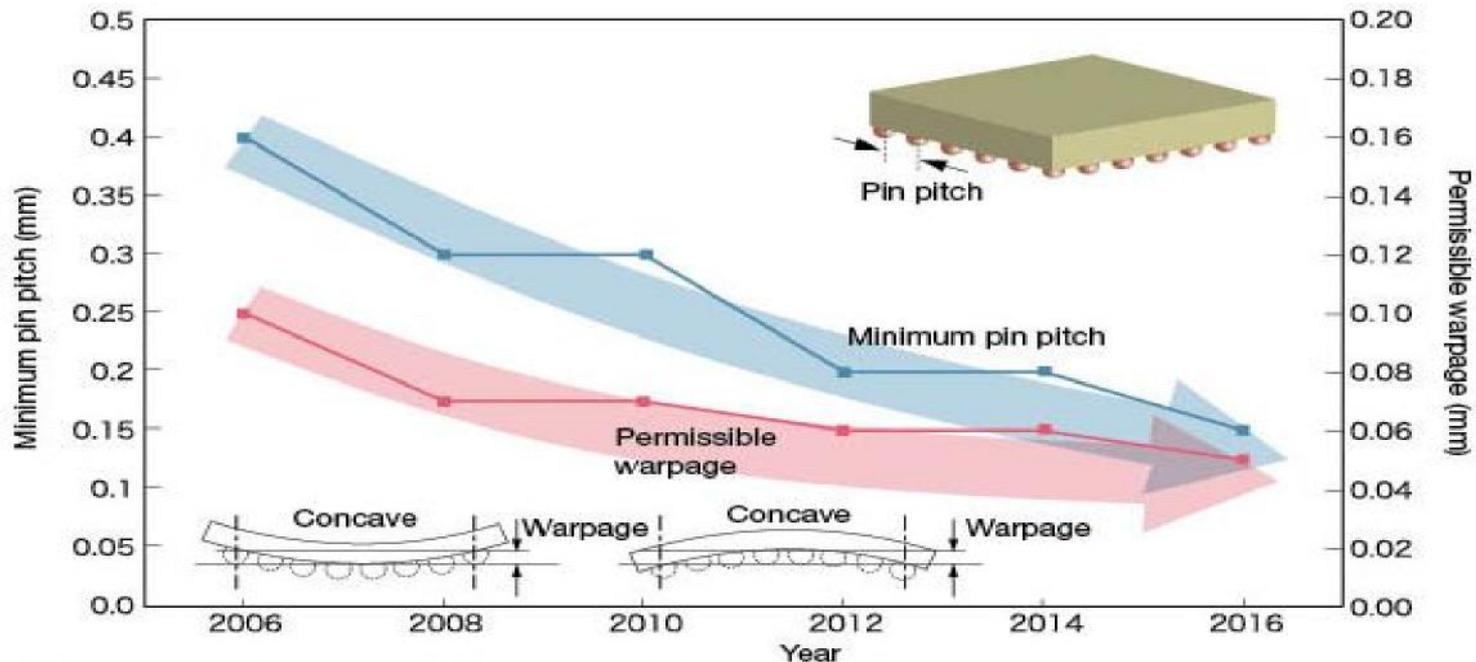
Ref: JEITA Roadmap

- Reducing dynamic warpage in components
 - Current JEDEC warpage limit is 8 mils. All BGA should packages meet this standard
 - Elimination of warpage is challenging due to material constraints
 - Warpage expected to decrease in next 5 years

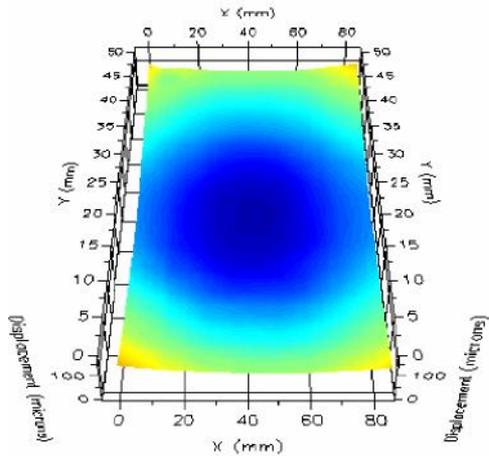
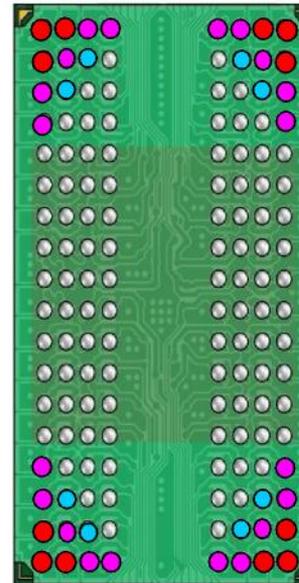
- Bulls eye stencil (increase aperture on corner pads)

- = Circular 1:1
- = Circular +.001"
- = Circular +.002"
- = Circular +.003"

- Increases chance for bridging.
- Stencil has to be designed specifically for each package.
- Works only if warpage is convex.

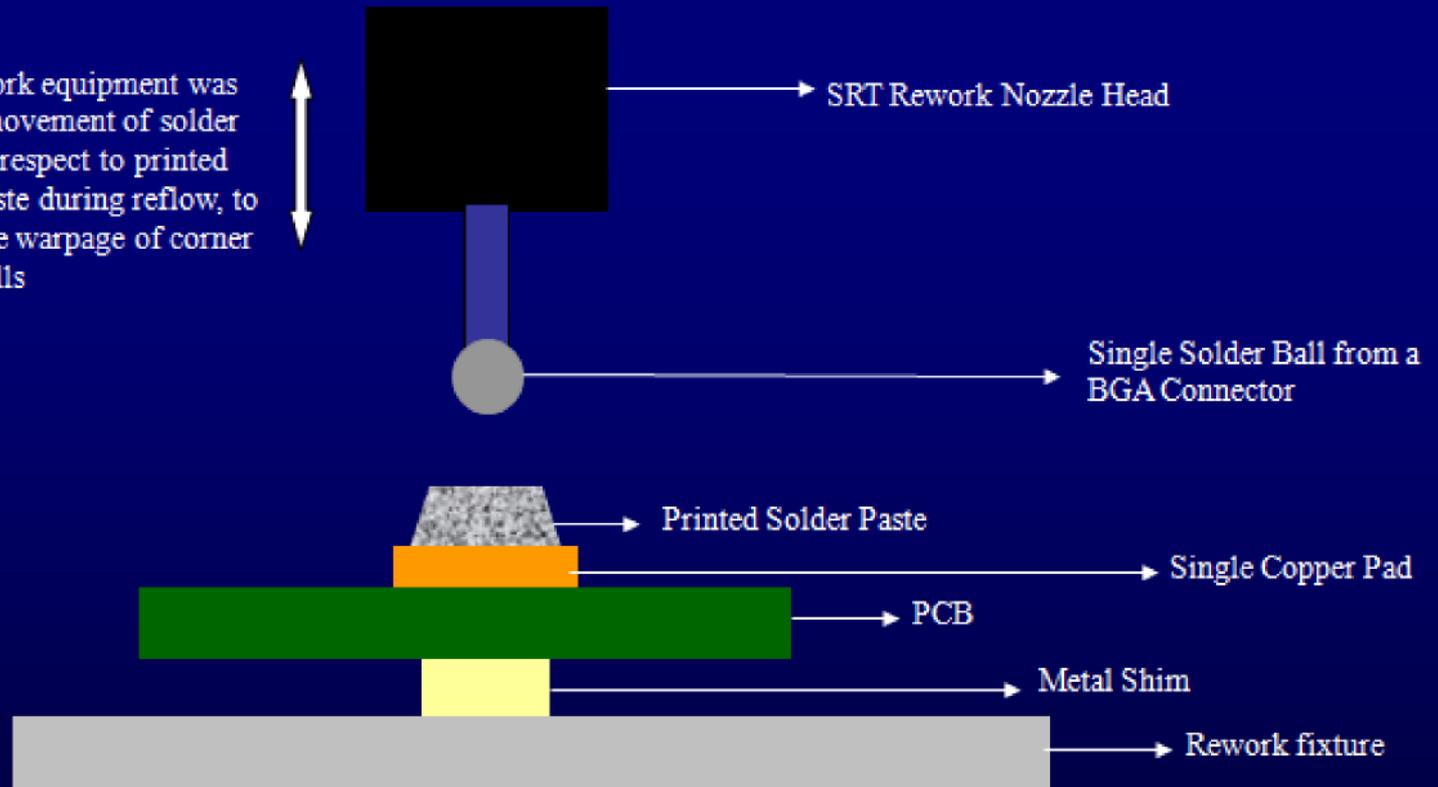
Cisco Jabil Test Method

SRT rework equipment was used to movement of solder ball with respect to printed solder paste during reflow, to mimic the warpage of corner solder balls

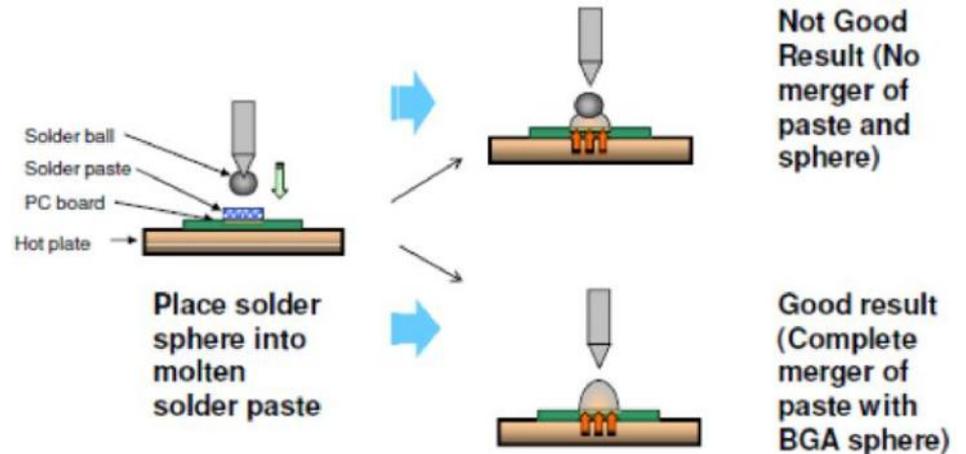
Koki Test Method

U Solder paste printed and melted.

U Balls placed at different intervals during reflow

After 30sec		After 50sec		After 70sec

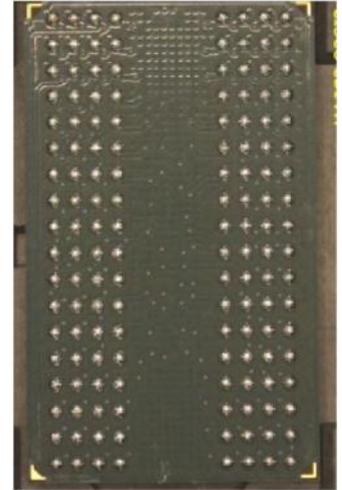
Shadow Moiré Analysis

- U Package type: DRAM, Thin Flip Chip BGA
- U Root Cause: RLDRAM warpage
- U Number of IOs: 144
- U Pitch: 0.8 mm
- U Observations:
 - HiP defects not limited to corners

Temperature (°C)	Min	Max	Coplanarity (mils)
26 Initial	-2.5	1.5	4
150 Heating	-0.6	1.6	2.1
170 Heating	-1	1.9	2.9
183 Heating	-1.2	2.2	3.4
200 Heating	-1.4	2.4	3.8
220 Maximum	-2.1	3	5.1
200 Cooling	-1.6	2.4	4
183 Cooling	-1.3	2	3.4
170 Cooling	-1.1	1.8	2.9
26 Final	-2.7	1.5	4.2

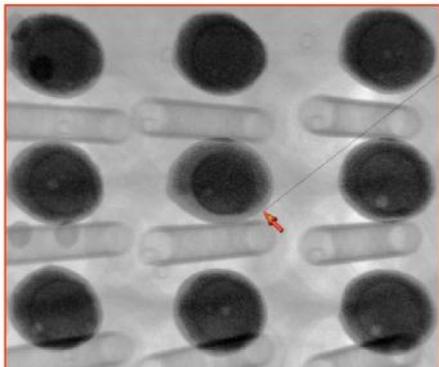
Signature 1

Darker Pad

Tube voltage: 125 kV
 Tube power: 2.18 W
 Filter method used: MaxMag
 Averaging: 128 frames

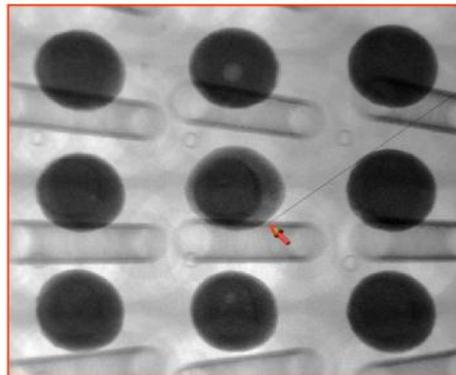
Signature 2

Off Circular
Ball Shape

Tube voltage: 125 kV
 Tube power: 2.18 W
 Filter method used: MaxMag
 Averaging: 128 frames

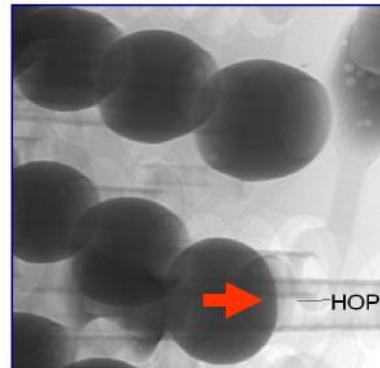
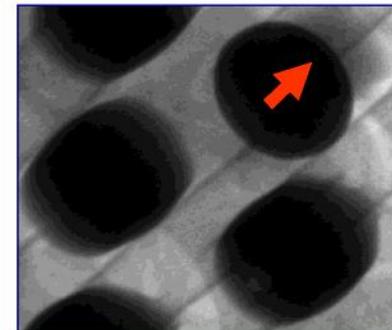
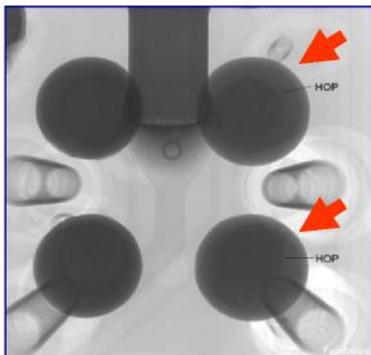
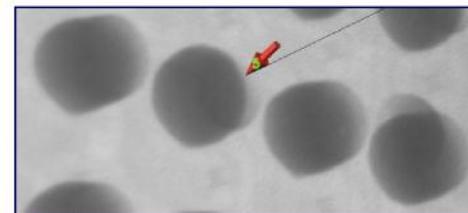
Signature 3

Clear Separation - Ball & Pad
Require Oblique Angle View

Tube voltage: 125 kV
 Tube power: 1.98 W
 Filter method used: None
 Averaging: 212 frames

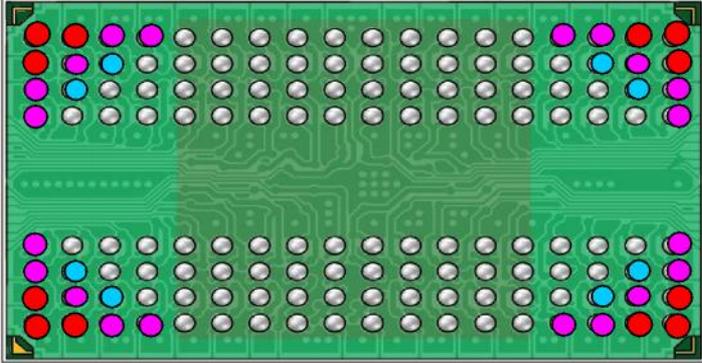
Bull Eye Stencil Design

- = Circular 1:1
- = Circular +.001"
- = Circular +.002"
- = Circular +.003"
