# To be or not to be (before reflow): That is the question (in AOI)

Lyle Sherwood Landrex Technologies Santa Clara, CA

Pamela Lipson Imagen Incorporated Cambridge, MA

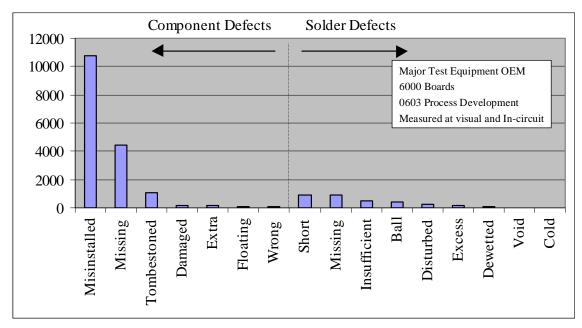
Figure 1: Defect spectrum from a high mix/low volume OEM

We looked at three types of customers. For each type of customer we inspected the boards using the Landrex Optima optical inspection systems. Figures 1-3 show defect paretos for these customers.

The data for each of these customers and aggregated across them shows that *the majority of defects were related to component* placement issues than post-reflow issues. Over all the customers, component placement issues were approximately 90% of the total number of defects. While we understand that this data represents is a sample of customers and further sampling of their boards, it is striking (and surprising) to see that post-place defects dominated the spectrum.

A major test equipment manufacturer collected defect data over time to determine where best to employ AOI. Their defect data, illustrated in Figure 1, shows that 90% of the defects totaling 15000 defects were placement related. If the repair costs present above are useful estimates then the cost of repair at post place in this case would be \$1500 dollars. At post reflow perhaps as high as \$15,000 dollars and in test an astounding \$150,000 dollars.

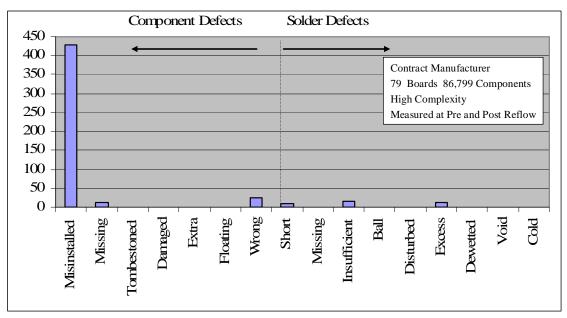
Figure 2: Defect spectrum from a low volume/high mix EMS

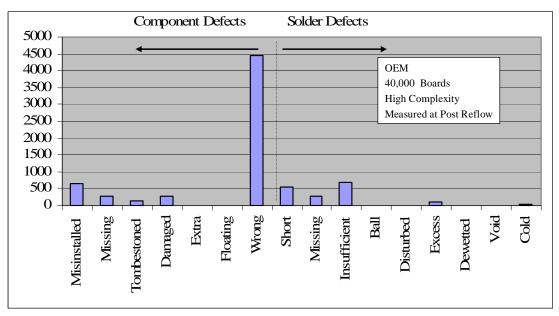
Figure 3: Defect spectrum from a high volume/low mix OEM

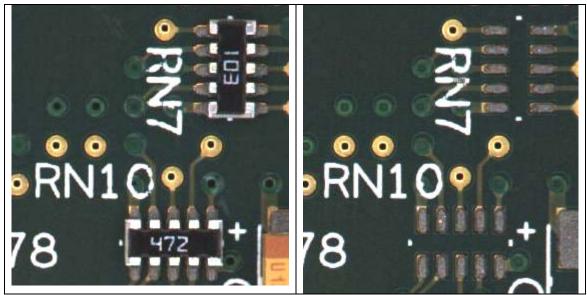
Figure 4: The majority of the insufficient/excess solder defects were due to design errors. For RN7 and RN10, imaged at postplace (left) and also post-paste (right), the corner endcaps are larger than the inner endcaps. However, the pad dimensions for all the leads are the same. This resulted in insufficient solder at the corner endcaps and excess in the center endcaps. It is interesting that paste inspection would not have caught this design defect (see right image). However, some more sophisticated processing at post-place could have discovered this design error.

On this particular assembly 0402 resistor networks were responsible for majority of the solder insufficient and solder excess. The root cause was found to be solder pad to pin width ratio. The incorrect solder pad to pin ration

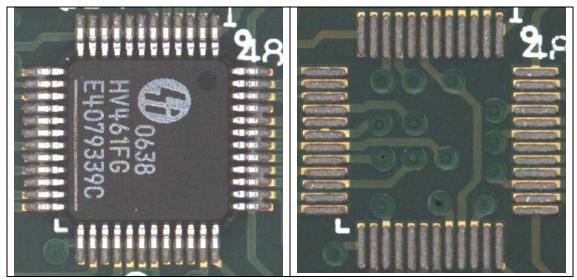
Figure 5: Image of at post-place (left) and post-paste (right). In all cases, the paste deposition for this part was "correct" (e.g. without bridges). However, the part consistently failed for solder bridges after the oven. Looking at the post-place image, it is easy to see that the paste is being "squashed" by the pick and place process and, therefore, causing the bridges to occur. This bridging defect could also be caught at post-place rather than post-reflow.

Most of the solder bridges were found on the IC shown in figure 5. We found that the root cause of the bridges were due to excess pressure on the part during placement. This could be corrected at the placement system by changing the placement pressure or the component height.

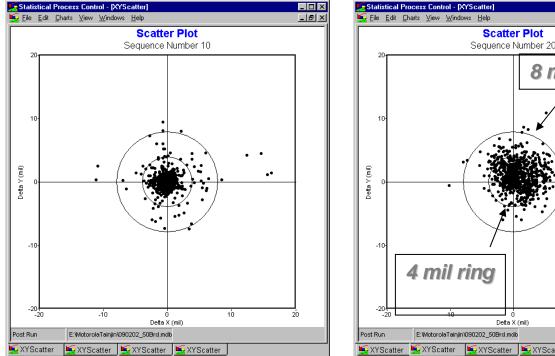
XYScatter XYScatter XYScatter Figure 7: The scatter plot shows the measured position of the parts (delta x, delta y) with respect to where they should have

been placed (0, 0). The left plot and right plot are of the same type of board generated from two different lines. The lines happened to be configured with all the same type of equipment. The plot on the left shows 3x more gross defects than the plot on the right. However, the plot on the right shows that the line that generated this board is likely to go out of control generating many more gross defects.

This theory has been around for a long time. If one believes this theory, it suggests that post-place inspection is like Chicken Little exclaiming that the "sky is falling" when in reality things aren't that bad when the board exits the oven. However, we have seen at multiple customer sites that the oven can mask or disguise some real problems that should be addressed. Figure 6 and 7 illustrate some of the hidden problems that can't be diagnosed at post-reflow.

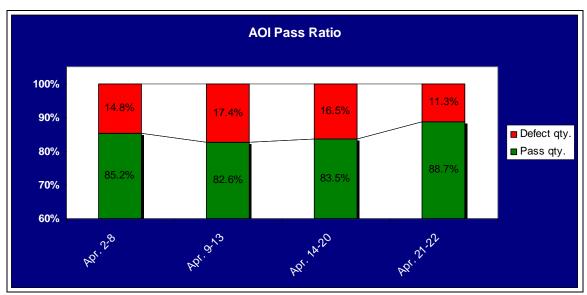
Figure 8: Without any AOI, this figure shows an analysis of yield over time indicating an average yield of 85%. In other words, 15% of boards have defects.

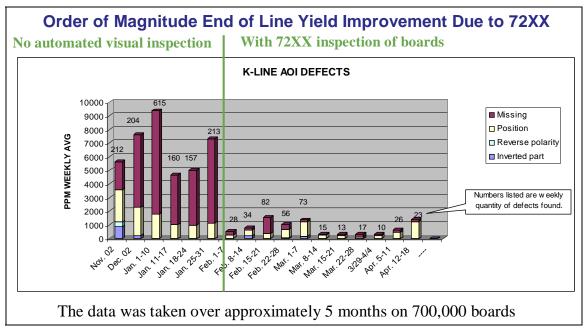
Figure 9: Long term study of defects found before and after the introduction of post-place AOI. This customer could only use post-place AOI because shields were put on prior to reflow. The result of using only post-place inspection alone was dramatic defects decreased by an order of magnitude.

The customer added the optima 7200 post-place inspection system into their line. They fixed the defects that were found and attempted to do some elementary root cause analysis based on the data. They were skeptical that only post-place inspection could increase their end of line yield, so they performed a long-term study where they measured the defects prior to the introduction the machine and the defects after the machine. Addition of post-place inspection reduced their total number of defects by an order of magnitude and greatly increased their end of line yield. In this case, post-reflow inspection combined with functional inspection at the end of the line was sufficient to meet their inspection needs.

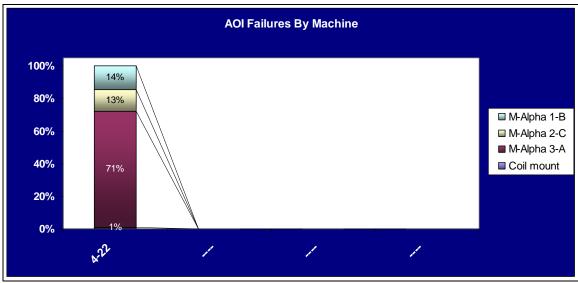
Figure 10: Analysis of one week's worth of data from the post-place inspection system shows that the third-placement machine is causing the majority of the defects. Information such as this makes the role of a process engineer much more effective. Without post place AOI the production line is in "fire fighting" mode; Trying to correct defects that have already occurred without the knowledge of how they occurred.

In addition to simply finding and fixing defects, further analysis of the data showed that a single placement equipment was responsible for 71% of the defects. Thus, by analyzing the data, they were able to quickly go in and fix the "fat rabbit"

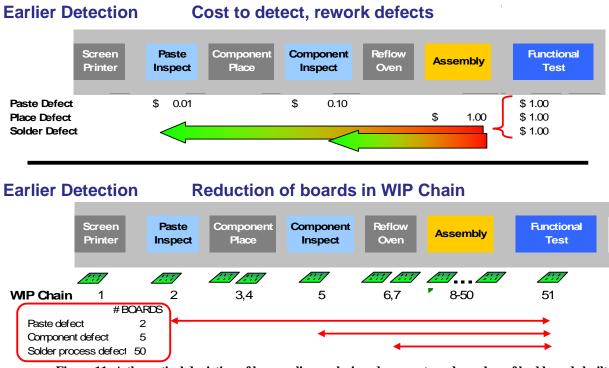
Figure 11: A theoretical depiction of how earlier analysis reduces costs and number of bad boards built.

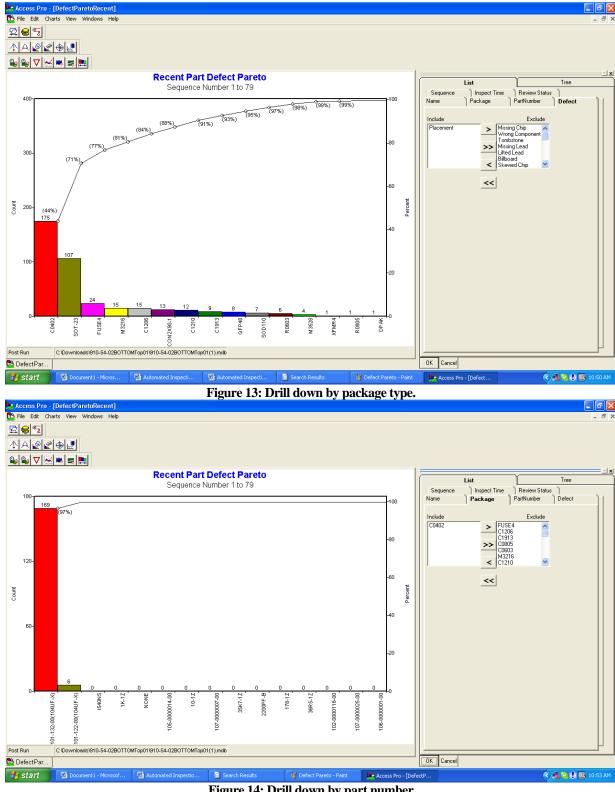
Figure 14: Drill down by part number

Figure 12 shows that 87% of the defects are placement errors. Figure 13 shows that 72 percent of the placement errors are made up of two package types. Almost half of the defects (44%) were 0402 Chip Capacitors. Figure 14 shows that 97% of the CC0402's were of a single part number.

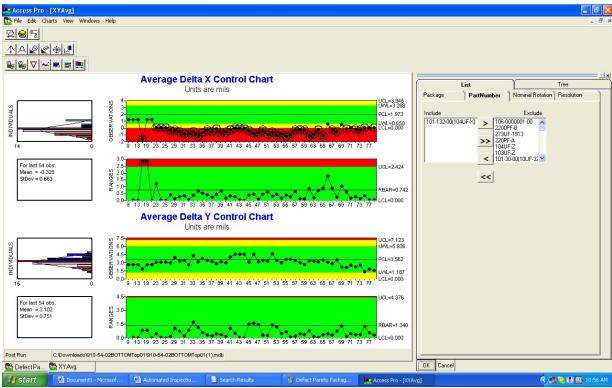
Figure 15: X-Bar R chart for the problematic part number.

placement position. A scatter plot of CCO402 indicates that the placement offsets are widely distributed. The total analysis indicates a vision file tolerance error or worn nozzle, which can easily be corrected.

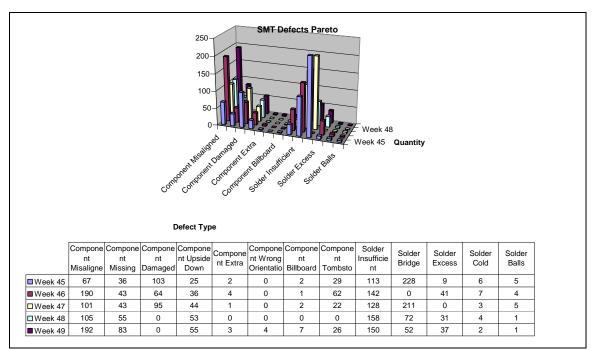
Misaligned components are now seen as the lead cause of defects, followed by missing components and upside down components. Unfortunately variable data is not available post reflow. The Process Engineer must try to determine the root cause without the benefit of drill down SPC.

In this example, the distribution of defects appears bipolar. This is because component defects are separated from solder defects. What jumps out clearly is that Wrong Parts are 10x higher than any other defect. If we can eliminate wrong parts our process looks very different. In fact, wrong parts are a very expensive defect. The wrong components must scrapped after removal and the inventory levels are affected for what ever product those parts were intended.
