Effectiveness of Conformal Coat to Prevent Corrosion of Nickel-palladium-gold-finished Terminals

Michael Osterman

Center for Advanced Life Cycle Engineering

Effectiveness of Conformal Coat to Prevent Corrosion of Nickel- palladium-gold-finished Terminals

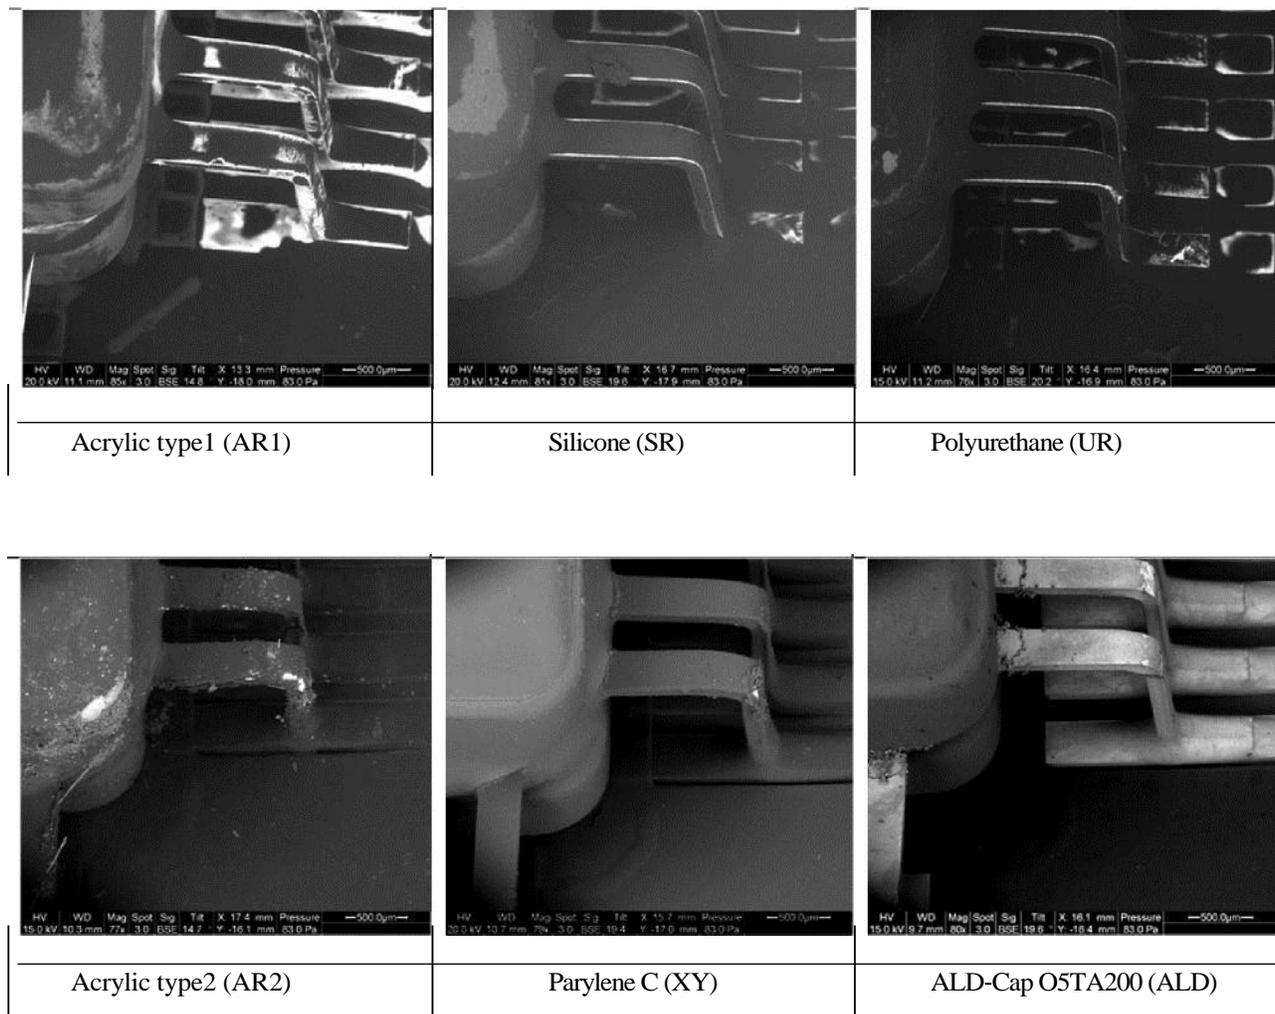
Figure 1 Initial inspection prior to environmental loading sequences.

Initial inspections of assembled parts prior to the environmental loading sequences showed that all spray-applied conformal coating had non-uniform coverage of lead edges compared to those that underwent the vacuum deposition method, as shown in Figure 1. Acrylic coating type 1 (AR1) showed that the pads under the leads and the sides of the leads had poor coverage compared to other spray-applied coatings. Other spray-applied conformal coatings, AR2, UR, and SR, also did not uniformly cover the edges of the leads. For conformal coating by vacuum deposition, the Parylene C and ALD coatings had uniform coating coverage, and all the surfaces, including the lead edges and pads, were fully covered by coating. Mechanical surface damage, such as scratches, were observed on both the non-coated and conformally coated samples.

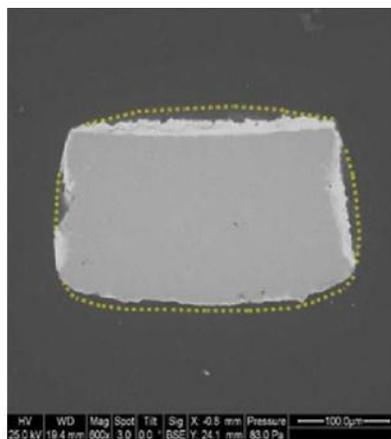
Figure 2 Cross-section of terminal with SR coating.

A cross-section of a SR coated terminal, depicted in Figure 2, shows the negligible coating occurring at the edges of the terminal. Coating coverage was similar for AR1, AR2, and UR samples. The thickness of the coatings measured from cross-sections at the top surface of each terminal is provided in Table 5.

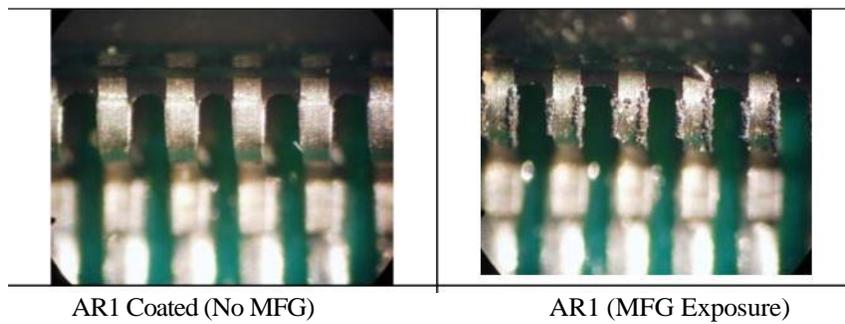
Figure 3 Optical images for AR1 coated specimens without and with MFG exposure.

After three sequential load profiles, corrosion products were observed on all specimens subjected to MFG exposure. However, corrosion products on the parylene-coated specimens were only associated with areas where the coating was damaged prior to the test due to handling. An example of optical images for AR1 coated specimens without and with manufacturing (MFG) exposure are shown in Figure 3. The worst corrosion was observed on the silicone-coated specimen. Figure 4 shows an optical image of multiple SR-coated terminals. On the SR-coated terminals, corrosion products migrated across the coated surfaces. ALD-coated terminals exhibited the next worst corrosion. Figure 5 depicts ALD coated terminals. For the urethane- and acrylic-coated specimens, the corrosion was limited to regions of poor coverage. Optical inspection of specimens after three completed cycles found no corrosion on specimens that did not undergo MFG exposure.

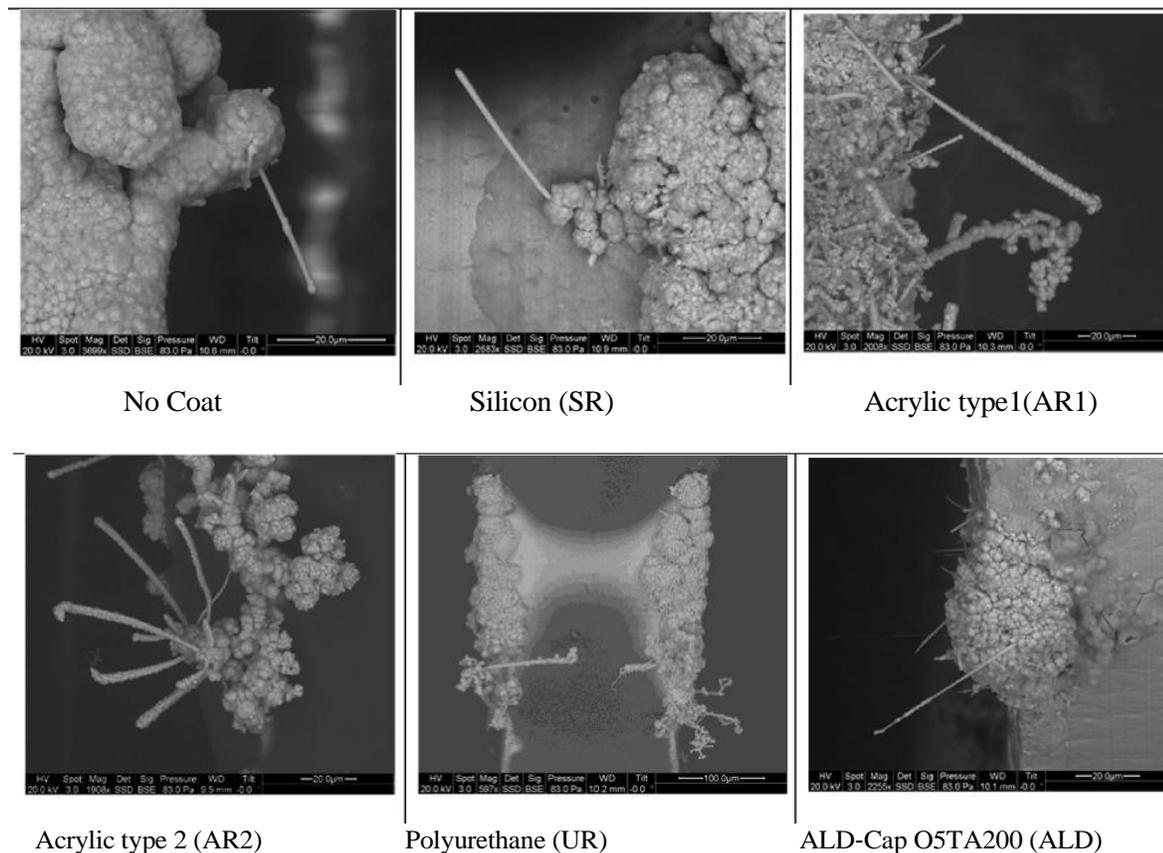
Figure 6 High magnification images of copper sulphide structures.

Examination of the corrosion products under scanning electronic microscopy revealed complex corrosion structures. Figure 6 provides high magnification images of corrosion products from all sample types subjected to MFG exposure.

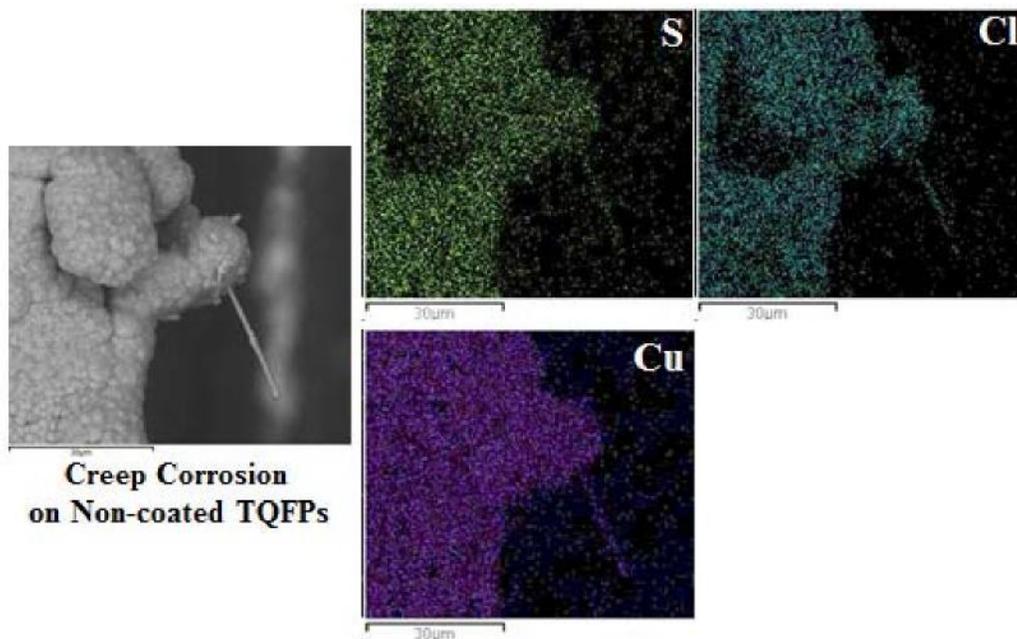
Figure 7 Energy dispersive spectrum (EDS) analysis identified copper, sulfur, and chlorine within the corrosion structure.

X-ray energy dispersive spectroscopy (EDS) of the corrosion products on all examined terminations showed they were composed of copper, sulfur, and chlorine. An elemental mapping is presented in Figure 7. The likely corrosion products were copper sulfide (Cu_2S) and copper chloride (CuCl_2).

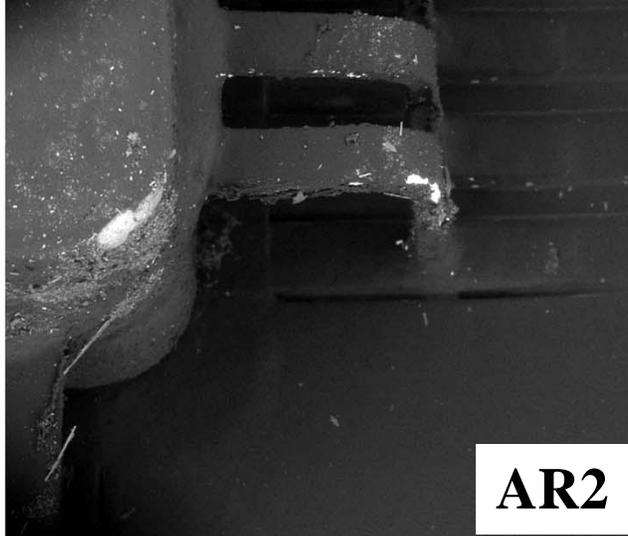
UR

HV	WD	Mag	Spot	Sig	Tilt	X: 16.4 mm	Pressure	—500.0µm—
15.0 kV	11.2 mm	76x	3.0	BSE	20.2 °	Y: -16.9 mm	83.0 Pa

- The coating thickness on the flat surfaces of the PCB was found to be at specification, but was thinner and not uniform on the leads.
- Parylene (XY) was the thickest coating material around the leads and offers better protection against tin whisker growth
- Silicone (SR) provided the thickest coverage of the PCB

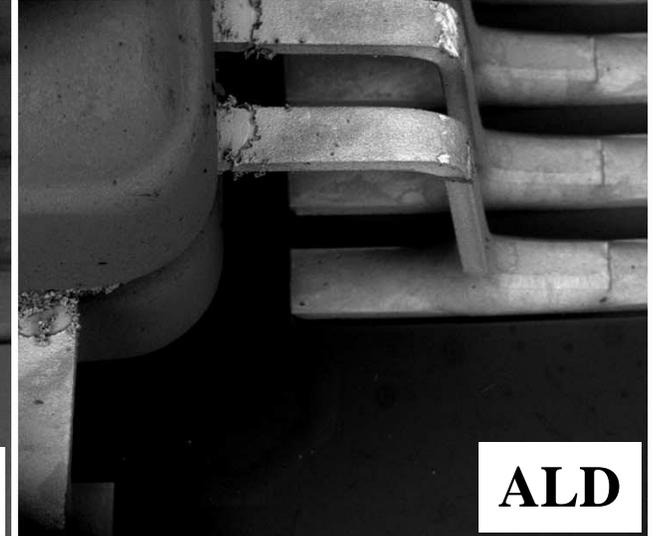
XY

HV	WD	Mag	Spot	Sig	Tilt	X: 15.7 mm	Pressure	—500.0µm—
20.0 kV	10.7 mm	79x	3.0	BSE	19.4 °	Y: -17.0 mm	83.0 Pa

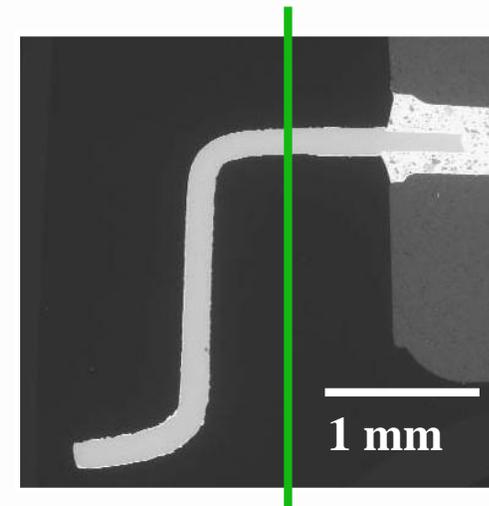
Cross-section location

- One QFP package of each coating type was molded and cross-sectioned across the top of the leads, as shown below.
- Using an optical microscope, thickness measurements of the conformal coating and plating layer were taken and averaged to produce an average thickness.
- A portion of the PCB for each part was also photographed and measured in the same manner, taking thickness measurements of the solder mask and the coating layer.

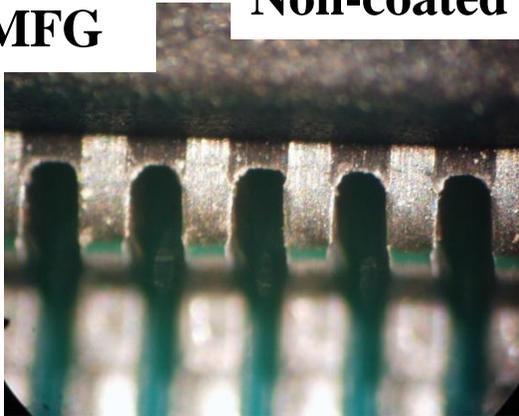
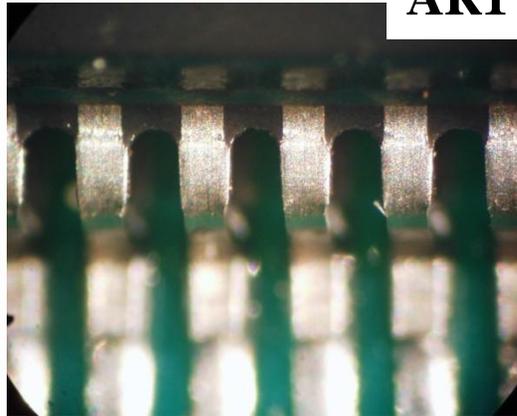
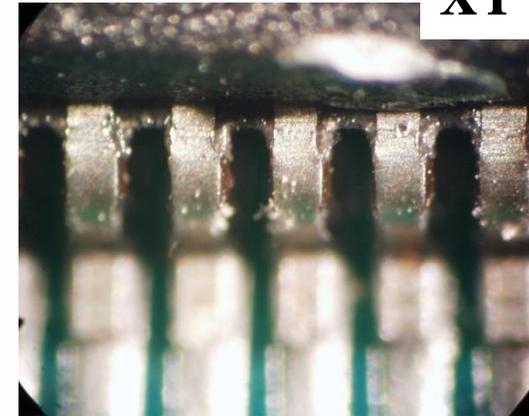
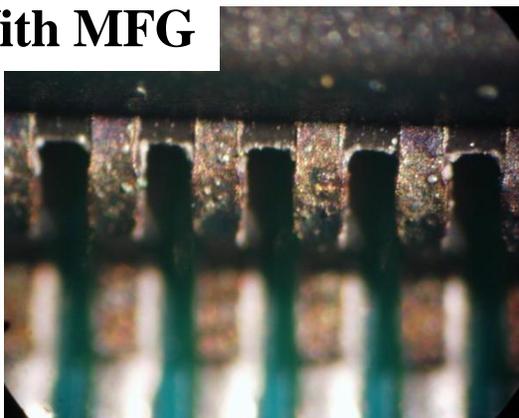
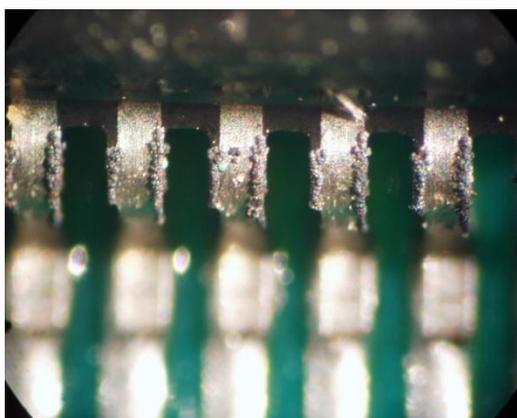
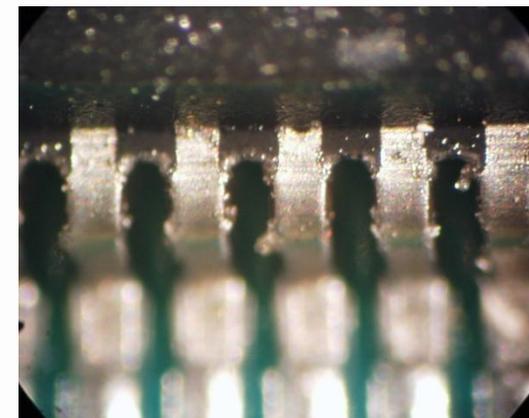
- With the exception of Parylene C, corrosion products were observed on the surfaces of all Ni/Pd/Au finished TQFP leads which were subject to MFG exposure.

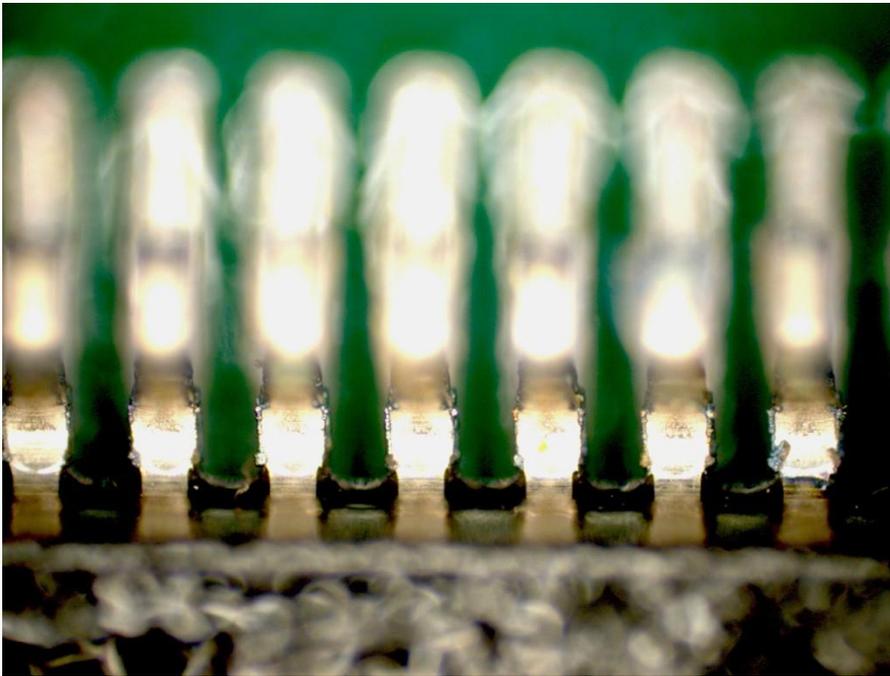
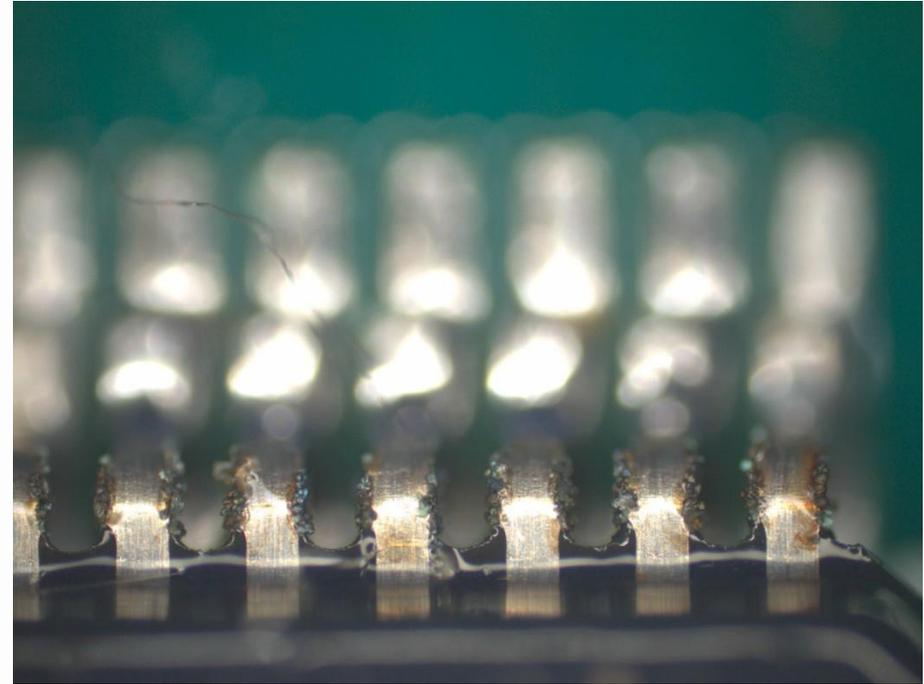
For the acrylic coatings, corrosion products were restricted to the edge of the terminals where coating coverage was thin or non-existent. Here, AR1 performed better than AR2. This result may be due to the differences in coverage. An examination of coverage is under way.

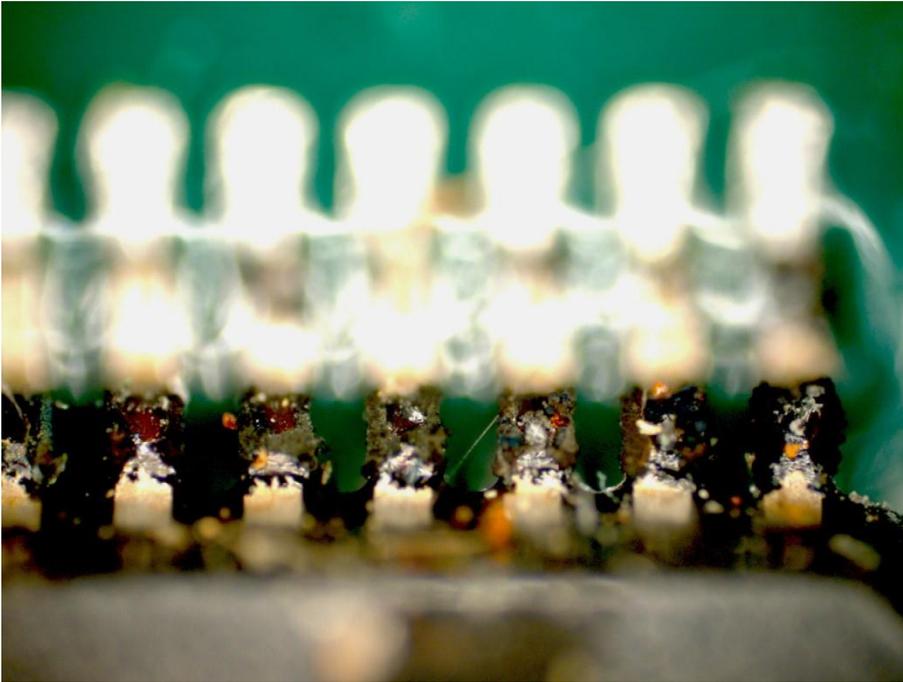
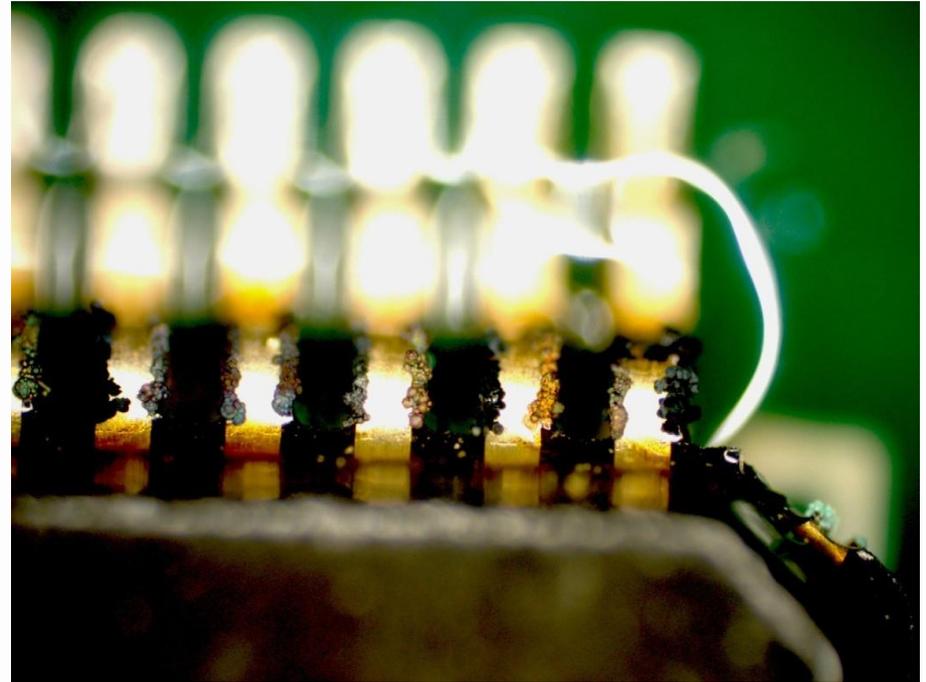
Silicone showed substantial damage while UR was restricted to edges that had little to no coverage.

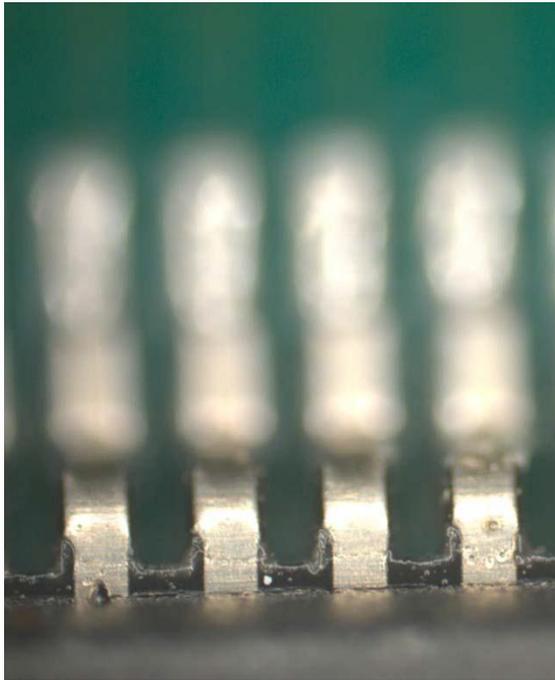
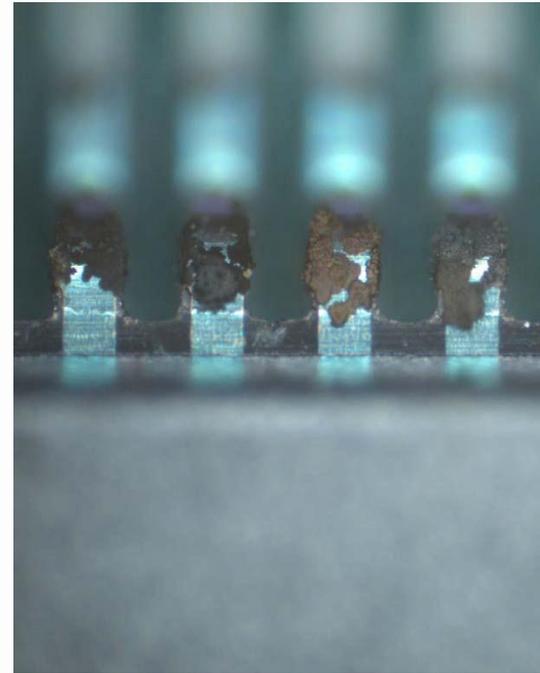
Other than areas that had damage prior test, the Parylene coated specimens show no corrosion damage. The ALD coating showed corrosion on all terminals.

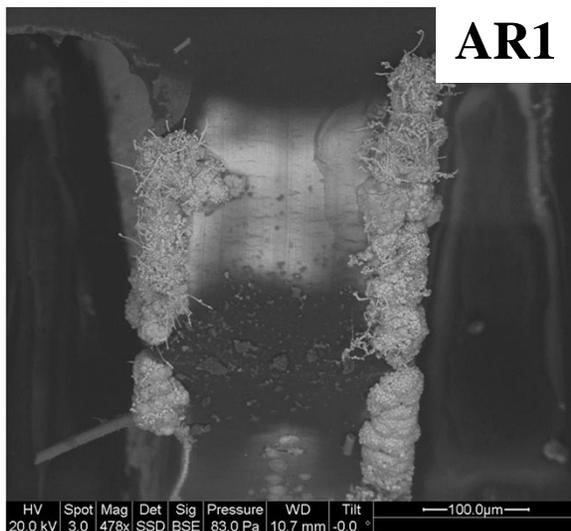
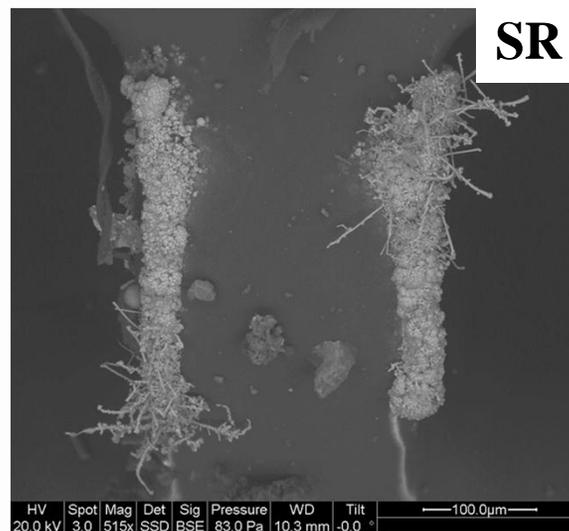
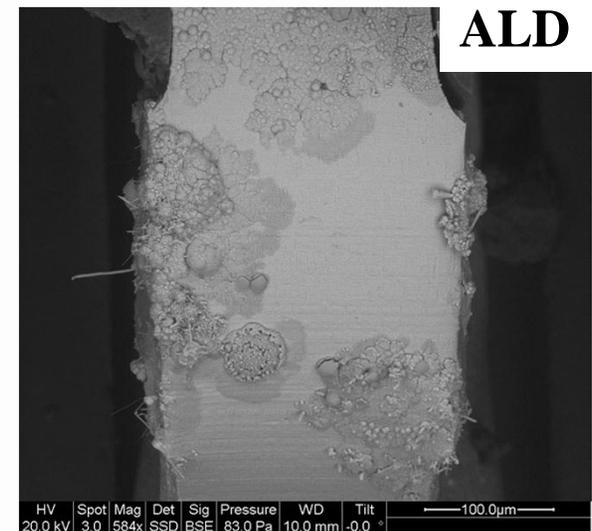
- Cu whiskers and dendrites were observed on the corroded surface of TQFPs with MFG exposure on non-coated and AR1, AR2, SR, UR and ALD coating.
- The sulfur (S) and chlorine (Cl) were detected via EDX on the corroded surfaces.
- Only Parylene C coated specimens were free from corrosion and no whiskers or dendrites were observed.
