AXI Applications with BTC and Connectors in Flextronics

KH Ooi, Ivan Khaw, Zhen (Jane) Feng, Ph. D., David Geiger, Murad Kurwa

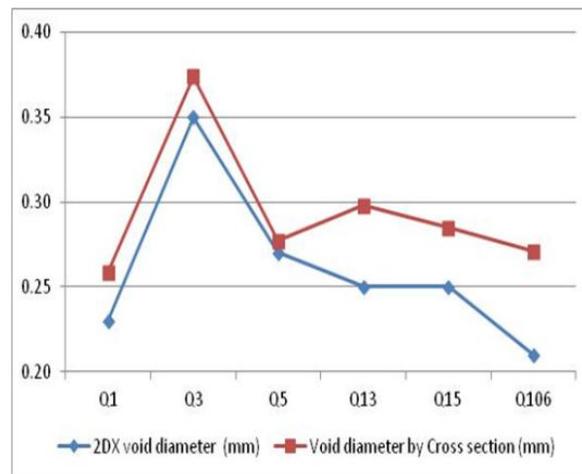
Figure 5. Voids Diameter Comparison of 2DX and Cross-section

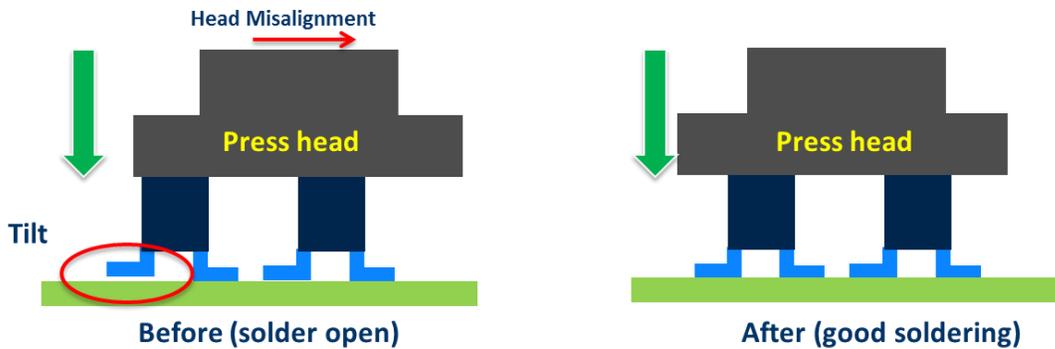
Figure 11. Before and After Improvement for DIMM Connector Process

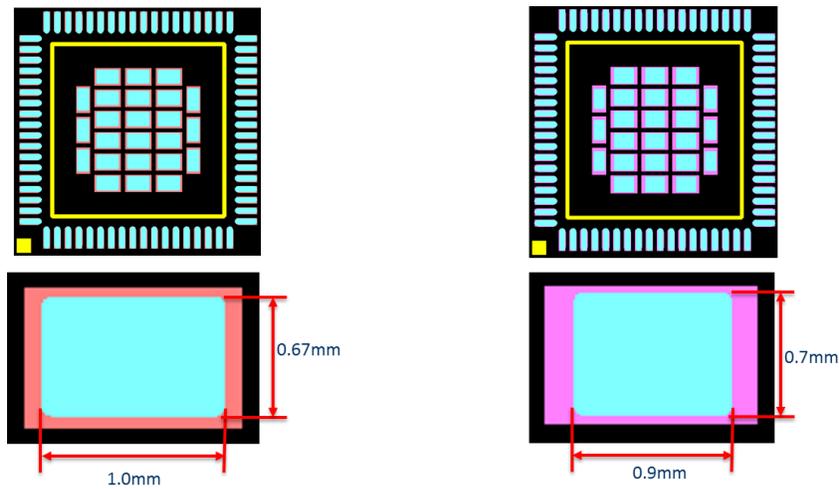
Figure 13. Before (left) and after (right) Stencil Design Improvement for DIMM Connector

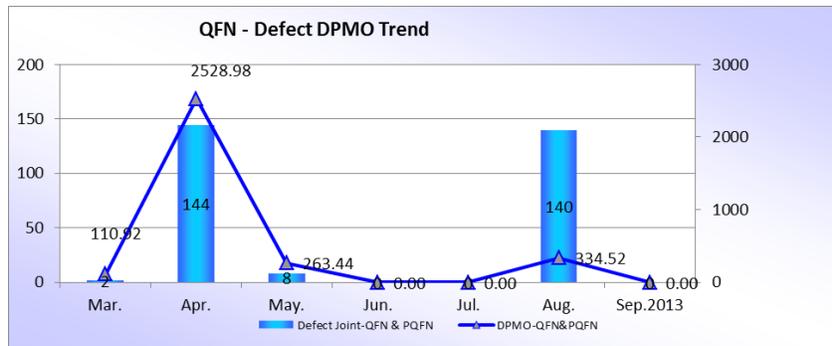
Figure 14. DPMO of QFN (March – September, 2013)

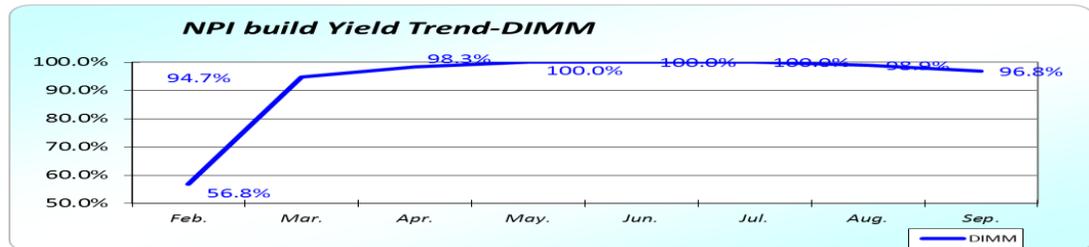
Figure16. Yield of DIMM SMT Connector (March – September 2013)

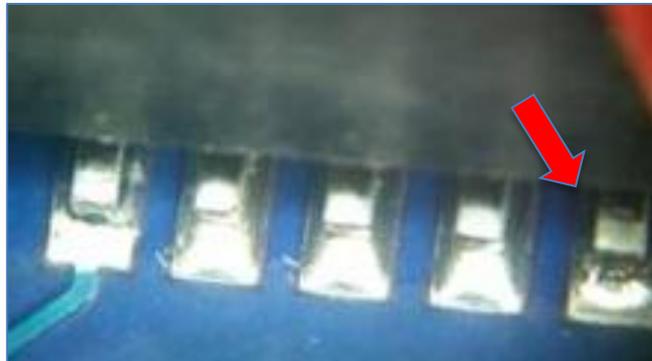
Open Solder on SMT Connector

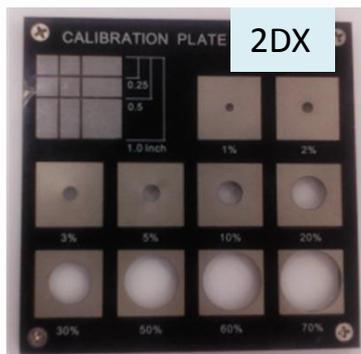
2DX standard voids samples

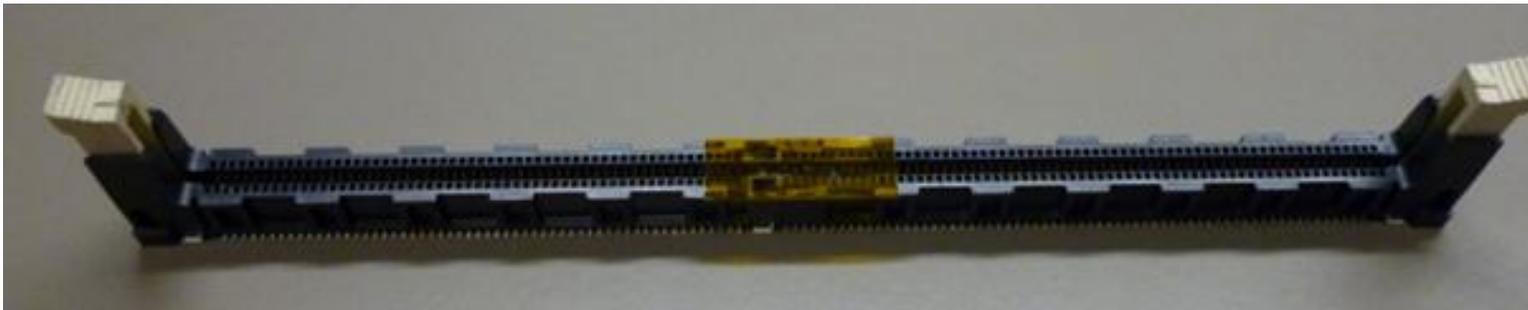
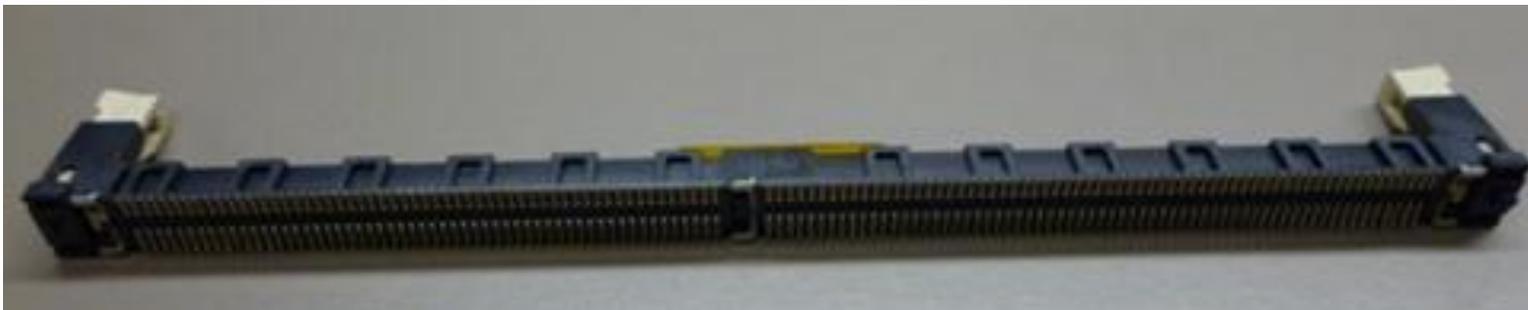
DDR3 DIMM SMT Connector (240 pins with 1mm pitch size)
